1 **Towards the resilience of Attica Region’s Provincial Road 3 in**
2 **Greece, due to slope failure by applying civil engineering**
3 **techniques and Rock Engineering System assessment**

4 N. Tavoularis¹

5 ¹Regional Administrative Authority of Attica, Directorate of Technical Works, Athens, 117 41, Greece

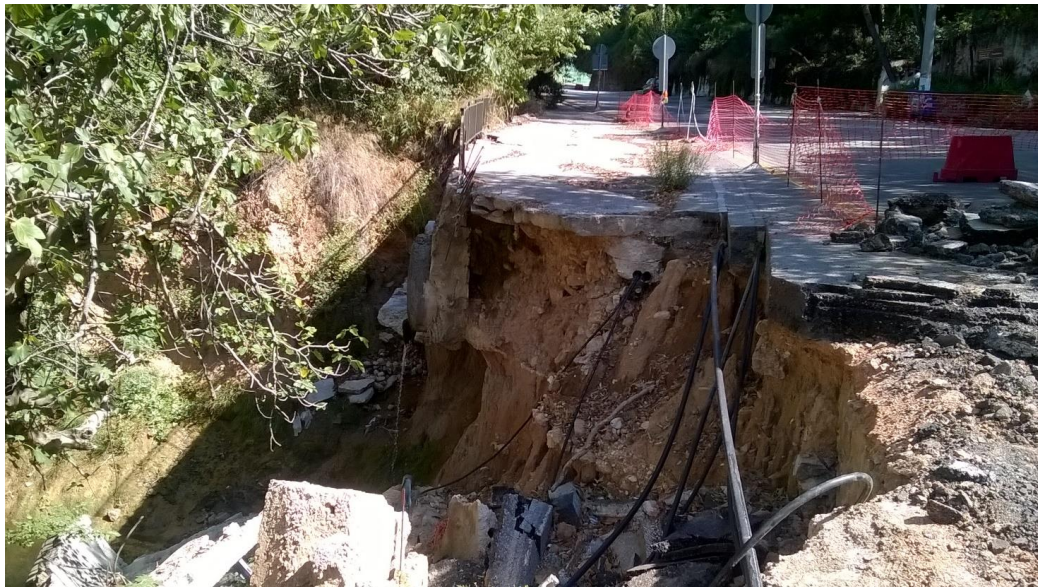
Figure 2: View from the slope failure (fall) of the examined road (Region of Attica/Directorate of Technical Works).

227 addition, the uncontrolled surface flow of rainwater on the road surface causes localised undermining of the road. (Fig.
228 2).

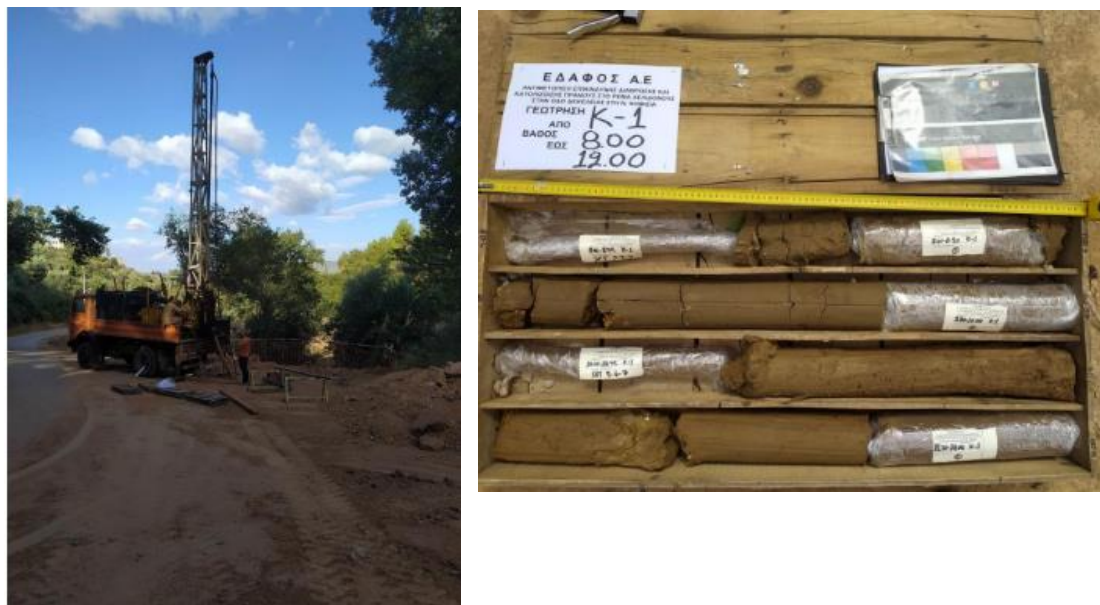
122 **Figure 4: Borehole drilling (left photo) and on the right photo a part of the borehole findings (Sand to Clayey geomaterial)**
123 **from 8.00 – 12.00 meters depth, is depicted (EDAFOS Consulting Engineers, Region of Attica/Directorate of Technical Works).**

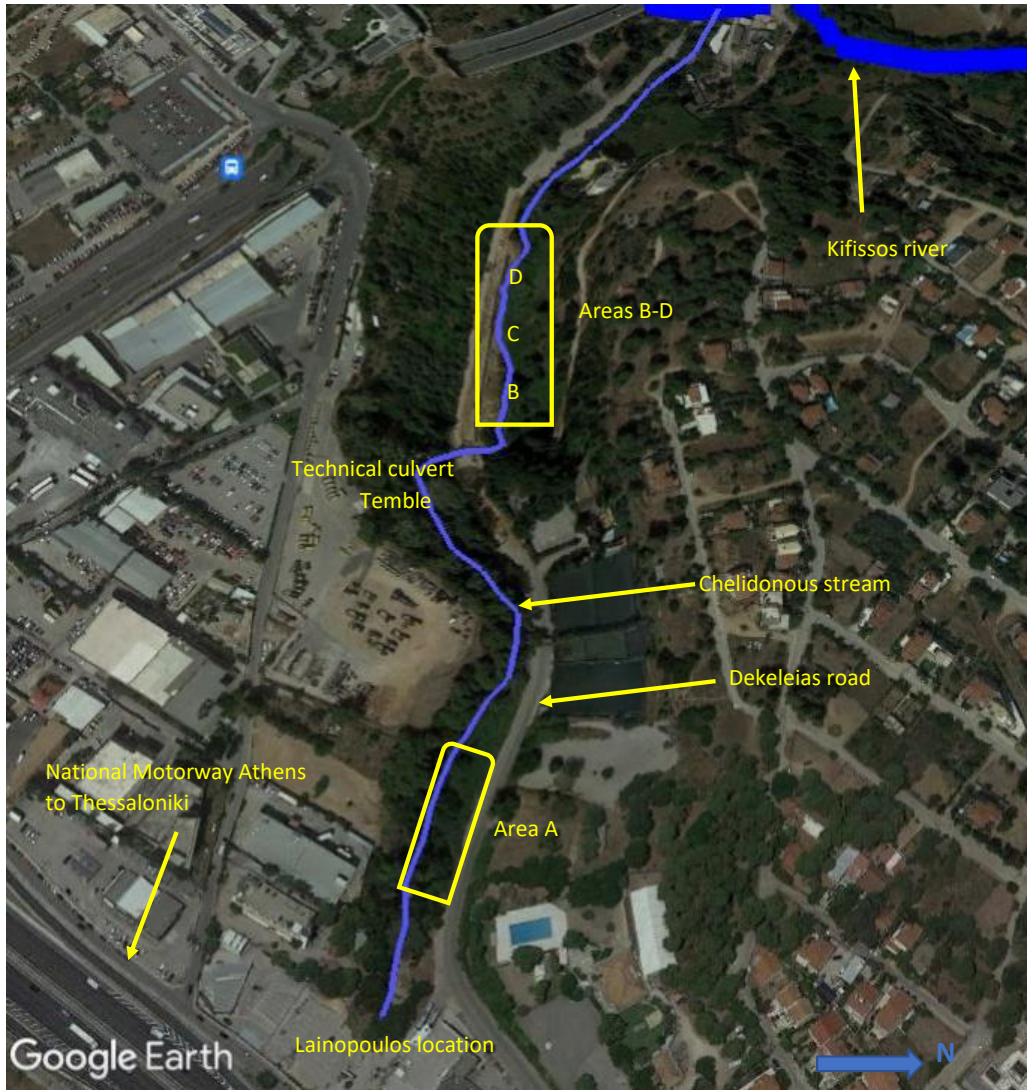
Figure 5: Visualization of the division of the study area into sub-areas A to D on a satellite image (source: © Google Earth).

193 In Area A, the main contributing factor to the failure mechanism is estimated to be, based on the failure morphology, the
194 flow of the stream as the stream bed approaches the roadway slope (Fig. 5). Area A was divided into three sub-areas (A1,
195 A2, A3).

209 The main factor causing the failure mechanism in areas B to D is the flow of the Chelidonous stream, which causes
210 erosion at the foot of the road slopes (Fig. 5). The erosion of the foot and the gradual change in slope gradient to steeper
211 gradients cause generalized slope stability problems affecting the existing Dekeleias Road in the form of soil movement
212 and subsidence of the roadway on the stream side. It should be noted that in areas where the stream, due to its natural
213 flow, is in close proximity to the Dekelias road, such as in areas B and D, the foot of the road slopes is also the boundary
214 of the stream bed and as a result the instability problems are more pronounced. In area C the stream is moved away, and
215 the erosion problems appear milder (EDAFOS, 2018).

196 Sub-area A1 starts after the turn from the Athens Lamia Highway (Lainopoulos location) and extends 8.50m to the west.
197 To address the erosion mechanisms in sub-area A1, it was decided to construct a pile wall with interlocking piles Ø1.00m
198 with the reinforced piles having an axial spacing of 1.7m.

199 Sub-area A2 starts from the end of area A1 and extends for 32.90m to the west. In this area, significant undermining has
200 occurred on the existing road with the crown of the existing - steep slopes bounded within the road zone. To address the
201 erosion mechanisms, anchor walls of 3.0m and 5.5m high will be constructed founded on interlocking piles of Ø1.00m
202 diameter at 1.7m intervals. In this section the retaining elements (piles, retaining walls) are required to be anchored.

203 Sub-area A3 starts from the end of area A2 and extends for 5.10m towards the westwards. In order to address the erosive
204 mechanisms in area A3 it was decided to construction of a pile wall with intersecting Ø1.00m piles with the reinforced
205 piles to have an axial spacing of 1.7m.

229 To address the erosive mechanisms in sub-area B1, it was decided to construct a pile wall with interlocking Ø1.20m piles
230 with the reinforced piles having an axial spacing of 2.0m.

231 Sub-area B2 starts from the end of area B1 and extends for 24.20m to the west. In this area, the main contributors to the
232 failure mechanism are estimated to be stream flow and groundwater, while surface water flow appears to have little or no
233 contribution based on the morphology of failures. As a result, localized soil instabilities and subsidence are occurring in
234 Area B2, affecting the existing Dekelias Road, but on a smaller scale than the adjacent Area B1. To address the erosive
235 mechanisms in sub-area B2, it was decided to construct a pile wall with Ø1.00m piles at an axial spacing of 1.7m.

236 Area C starts from the end of area B2 and extends for 28.20m to the west. In area C it is estimated that the road slopes
237 are in a state of limit equilibrium. The main factor contributing to their destabilization mechanism is estimated to be the
238 erosive action of the stream. The local soil instabilities and subsidence that may occur immediately are small in scale due
239 to the removal of the natural flow of the stream from the road slope, but works are required to contain the erosive
240 mechanisms in order to protect the road from future larger scale failures. To address the erosive mechanisms in Area C,
241 it was decided to construct a pile wall with Ø1.00m piles at an axial spacing of 2.3m.

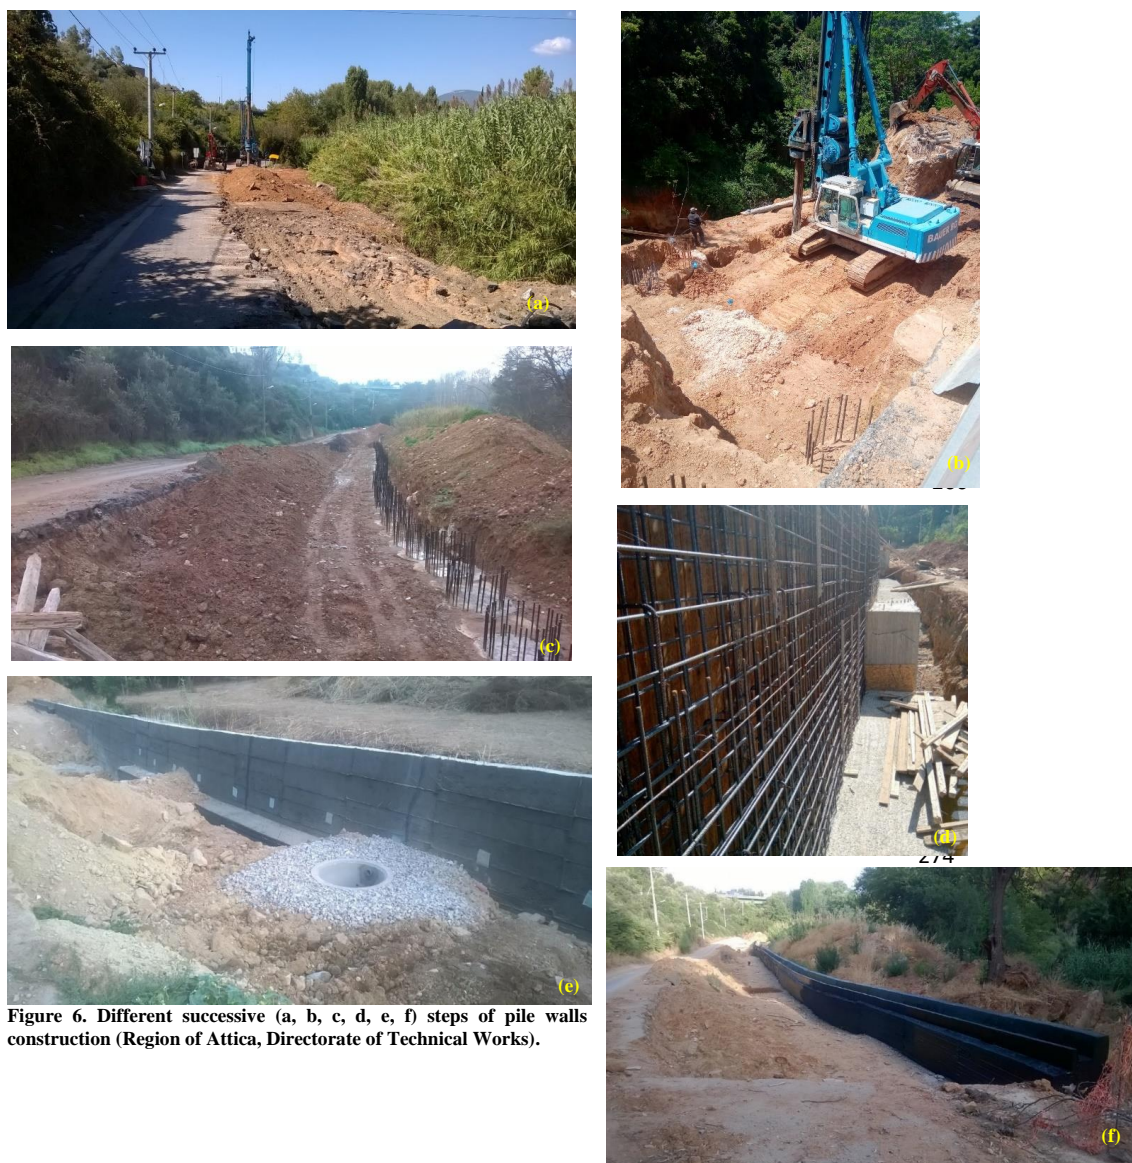
275 **Figure 6. Different successive (a, b, c, d, e, f) steps of pile walls**
276 **construction (Region of Attica, Directorate of Technical Works).**

249 it was decided to construct interlocking piles Ø1.00m and Ø1.20m with the reinforced piles having an axial spacing of
250 1.7m and 2.0m respectively. In sub-areas D2, D3 and D4 it is also planned to construct retaining walls of 1.5m to 3.0m
251 high founded on the aforementioned interlocking piles. It should be noted that in all areas and sub-areas the project was
252 decided upon and then the diameter of the piles and their axial spacing were calculated.
253 The geotechnical study fulfilled on January 2019, whereas the stabilization works started on September of 2020. Due to
254 the pandemic of COVID-19, the progress of the project is, so far, equal to about 70%. In Figure 6, characteristic views
255 from the construction phase are depicted.
