Point-by-point response to comments made by Reviewer #2

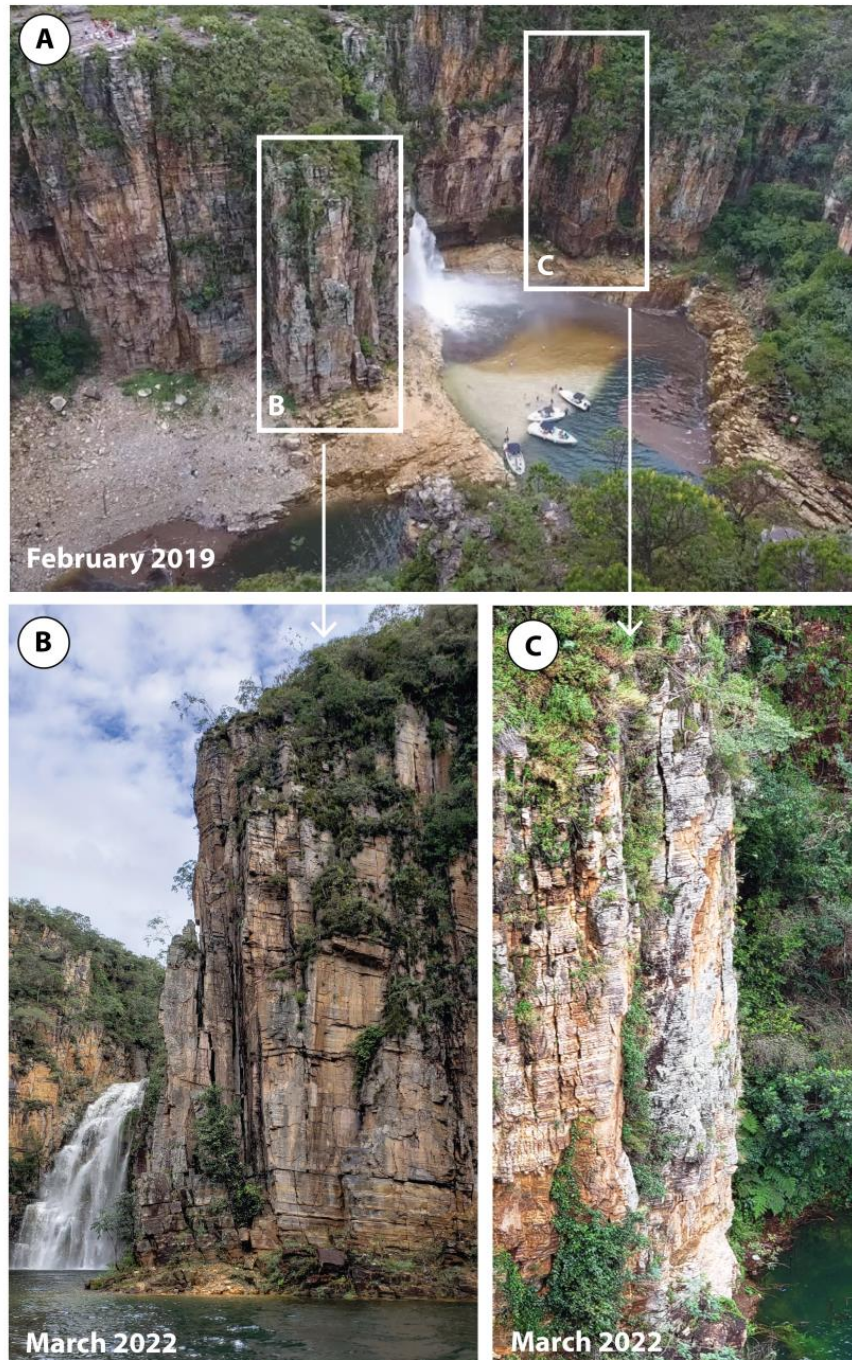
Figure 5: Stability analysis. A) Overview of the Capitólio canyon showing the location where the stability analysis is conducted (B) and the site where the rock-toppling event occurred (C). This picture is from before the event (February, 2019), when reservoir water level was much lower (around 755 m asl) than in February and March, 2022, when our field campaigns were conducted (765 m asl). (Source: Ion David Zarantonelli, 2019). B) Location where the analysis is conducted, interpreted as having a similar geological-geotechnical condition as the location of the rock instability. C) Post-event profile photo of the location where the rock toppling occurred.

The stability analysis is conducted in a site in the Capitólio canyon that is similar to the one where the rock-toppling occurred (**Figure 5A** and **Figure 13A**), as no high-resolution data from before the 2022 event was made available to our team. As in the date of our photogrammetric data acquisition (May 2022) the reservoir water level was different from the day of the event (January 2022), we performed our seepage analysis using FEM assuming a daily increase similar to what occurred in the days leading to the disaster (**Table 11** and **Figure 13B**).

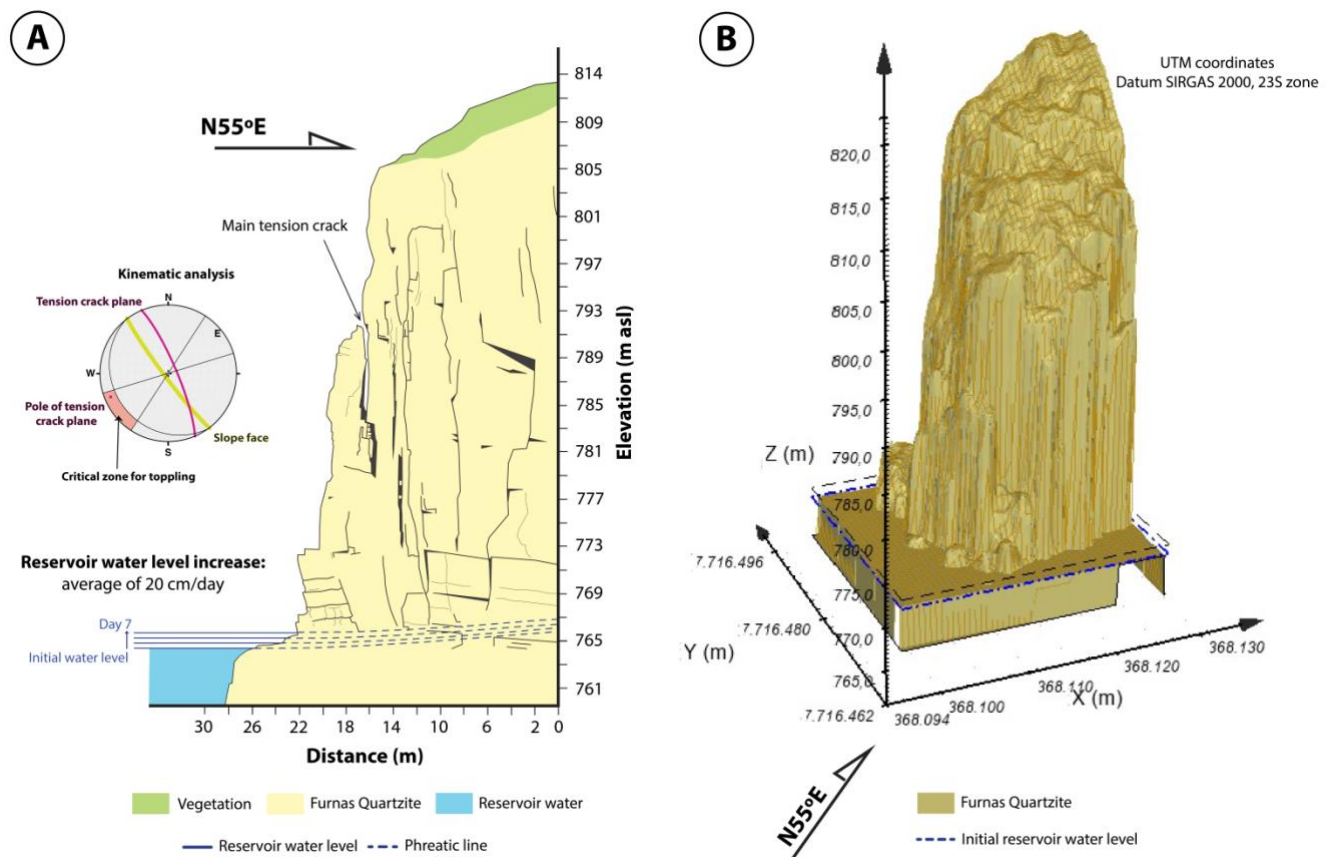
Figure 13: Slope stability analysis. A) Cross-section of the location interpreted as having a similar geological-geotechnical characteristic as the site that failed on January 8, 2022. The Stereonet highlights that this portion is prone to toppling, especially considering the main tension crack in the slope. B) 3D stability analysis on Slope/W from Geostudio (Seequent, 2025), considering reservoir water-level fluctuations and the structural geology.

When only water-level fluctuations were considered, the numerical results show that it impacted slightly the FoS of the slope, decreasing from 1.309 to 1.299 in the eight-day period (**Figure 14 and Table 11**). The impact of rainfall on the FoS was slightly higher, decreasing to 1.297 from 1.309 in the considered timeline. The combined effect of rainfall and reservoir water-level fluctuation impacted the FoS the most, decreasing from 1.309 to 1.293. While these scenarios were not sufficient to cause a slope failure at this location, it can suggest how these different factors impacted the site that did fail on January 2022. Thus, based on this relationship between FoS, water-level variations and precipitation, it can be suggested that both rainfall and reservoir water level had a role on the rock-toppling initiation, with rainfall infiltration with a slightly stronger influence on slope stability.

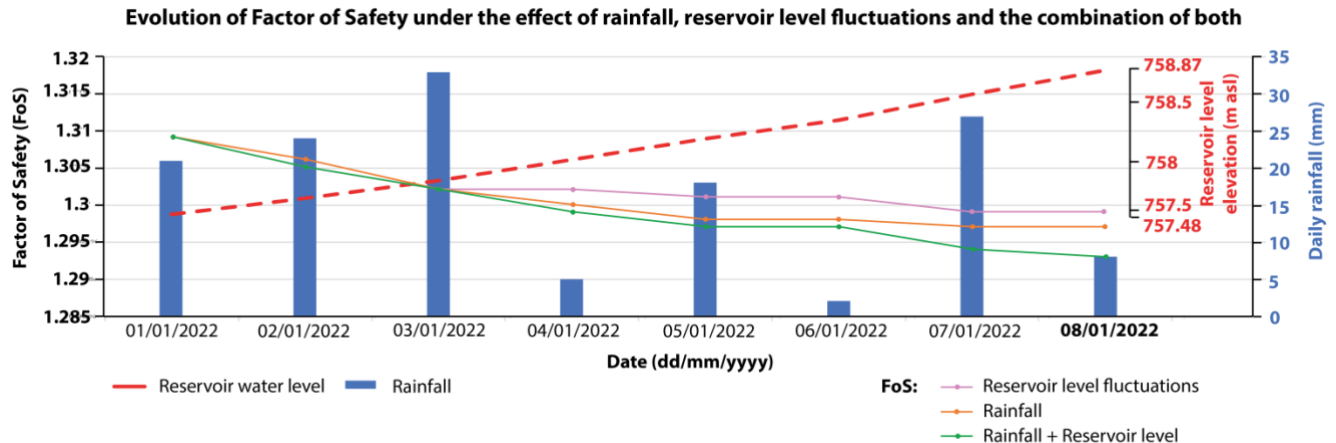
From the results of the stability analysis, considering the eight-day period prior to the disaster (January 1 – 8, 2022), we could observe that the Factor of Safety (FoS) of the slope was more impacted by the combination both rainfall and reservoir water-level increase, with rainfall suggested as having a slightly more influence over the overall stability than the water-level fluctuations, when they were analyzed separately.

Figure 14: Evolution of Factor of Safety based on the effect of rainfall, reservoir level increase and the combination of both processes.”

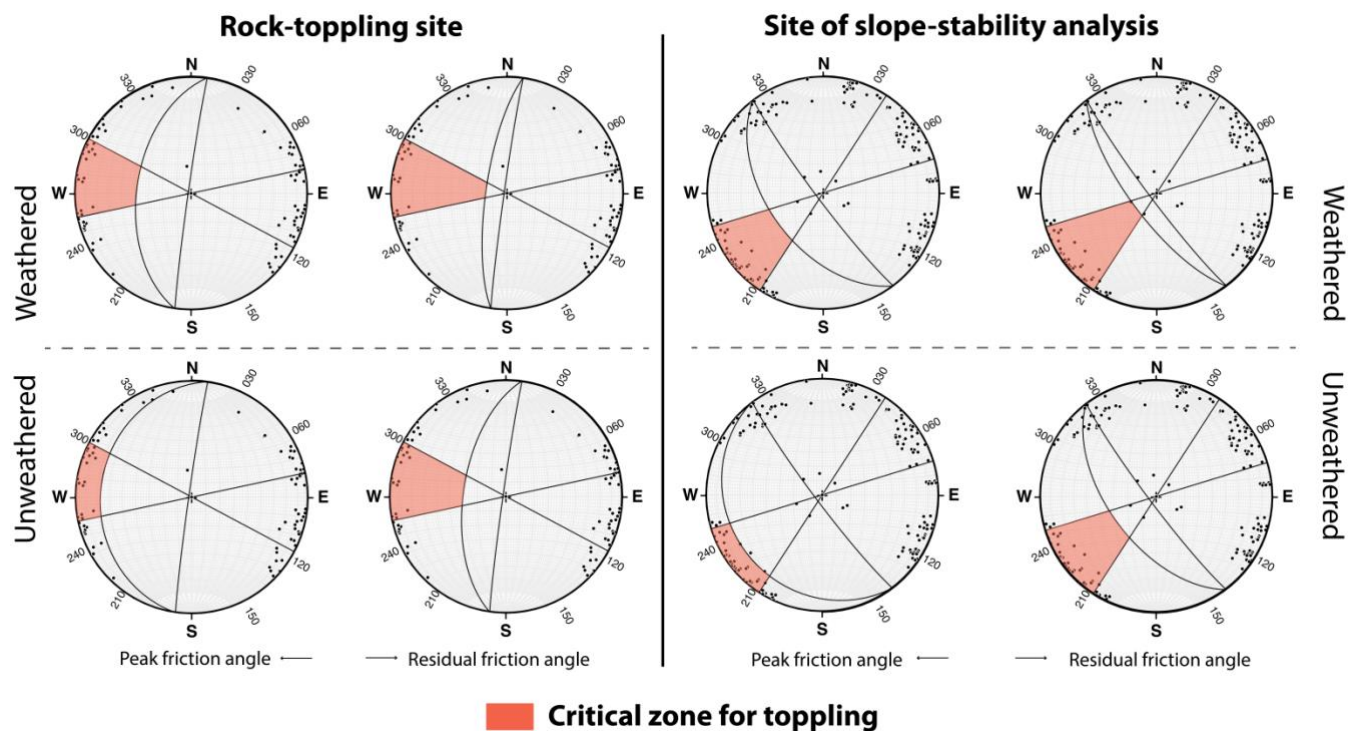
Although not showing an overall high susceptibility to toppling in the kinematic analysis, probably due to the generalization of the slope-face direction, Compartment C2 shows a very high joint frequency (**Figure 5B** and **Figure 7A**) and signs of slope movements, with a tilting 20 m rock column that can potentially experience a similar fate to the slope that toppled on January 2022. The kinematic analysis of this section in Compartment C2, which is interpreted to have a similar condition to the site where the 2022 rock-toppling event occurred, further highlights that this specific region has a high susceptibility to toppling, with a similar probability to this geodynamic process as the slope-failure site (**Table 10** and **Figure 10**).

Figure 10: Kinematic analysis of the rock-toppling site (left) and the site that is interpreted as having a similar geological-geotechnical condition as the one that failed on January 2022 (right). The kinematic analysis was conducted considering weathered and unweathered portions of the rock mass, as well as both the peak and residual friction angle.

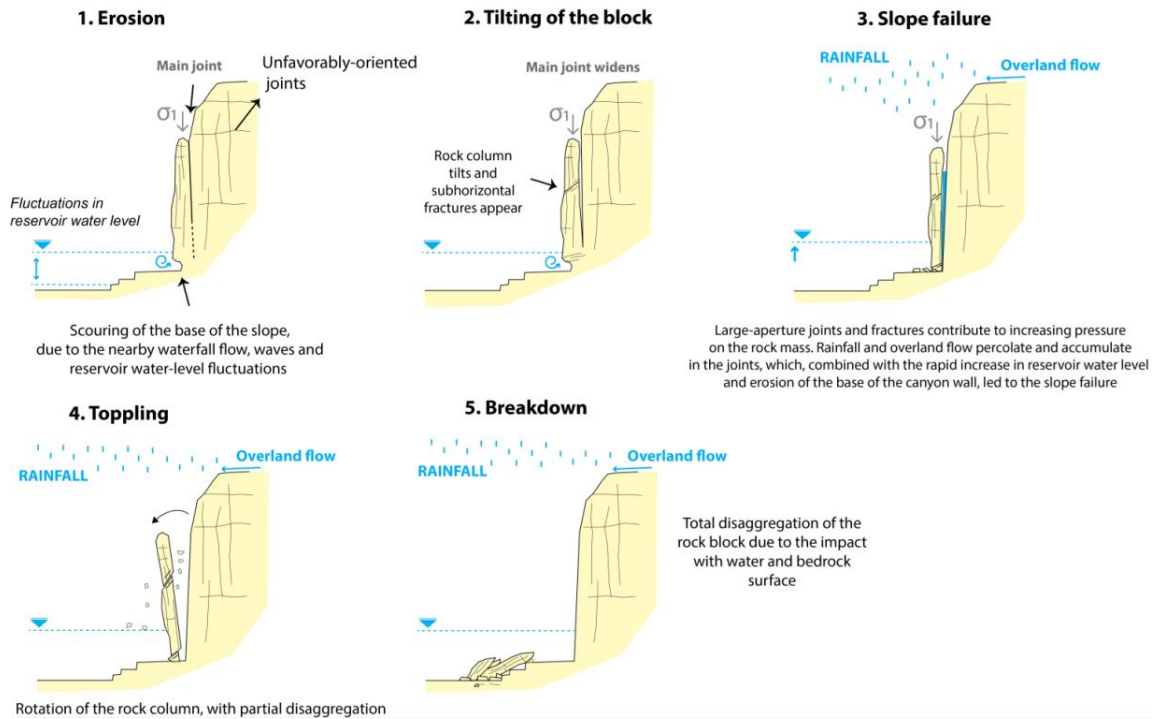
“Based on the slope stability assessment, we can interpret that the rock-toppling event in the Furnas reservoir was initiated by the combination of (i) the rapid increase in reservoir water-level, (ii) rainfall infiltration in the joint system and, potentially, the (iii) overland flow pathways that accumulate on the site of the disaster. The structural geology and geomechanical analysis, as well as the kinematic evaluation, further demonstrated that the site had a high susceptibility to toppling, especially due to the pervasive sets of unfavorably oriented joints (discontinuities) and the erosion of the base of the canyon wall. **Figure 16** summarizes the rock-toppling dynamics in the canyon, which resulted in the January 2022 disaster.

Figure 16: Steps that led to the catastrophic rock-toppling event in the Capitólio canyon, with σ_1 representing the main stress tensor. 1) The intense scouring at the base of the slope, due to the waterfall flow nearby and fluctuations in the reservoir water level, undermined the underlying support of the heavily-jointed rock column. 2) Due to weathering, the sub-vertical joints widen and sub-horizontal fractures appear due to its own weight in middle and bottom portions of the rock column. 3) Water percolates and accumulates in the joints and fractures, increasing pressure on the rock mass, leading to slope failure. The increase in reservoir water level raises the local groundwater level and, consequently, the stress conditions in the rock mass, also contributing to the occurrence of rock instabilities. 4) The toppling event occurs and (5) the rock column disaggregates, due to the impact with water and the bedrock surface. Image adapted from a previous version presented in the World Landslide Forum 6 (WLF6), in Florence - Italy (2023).

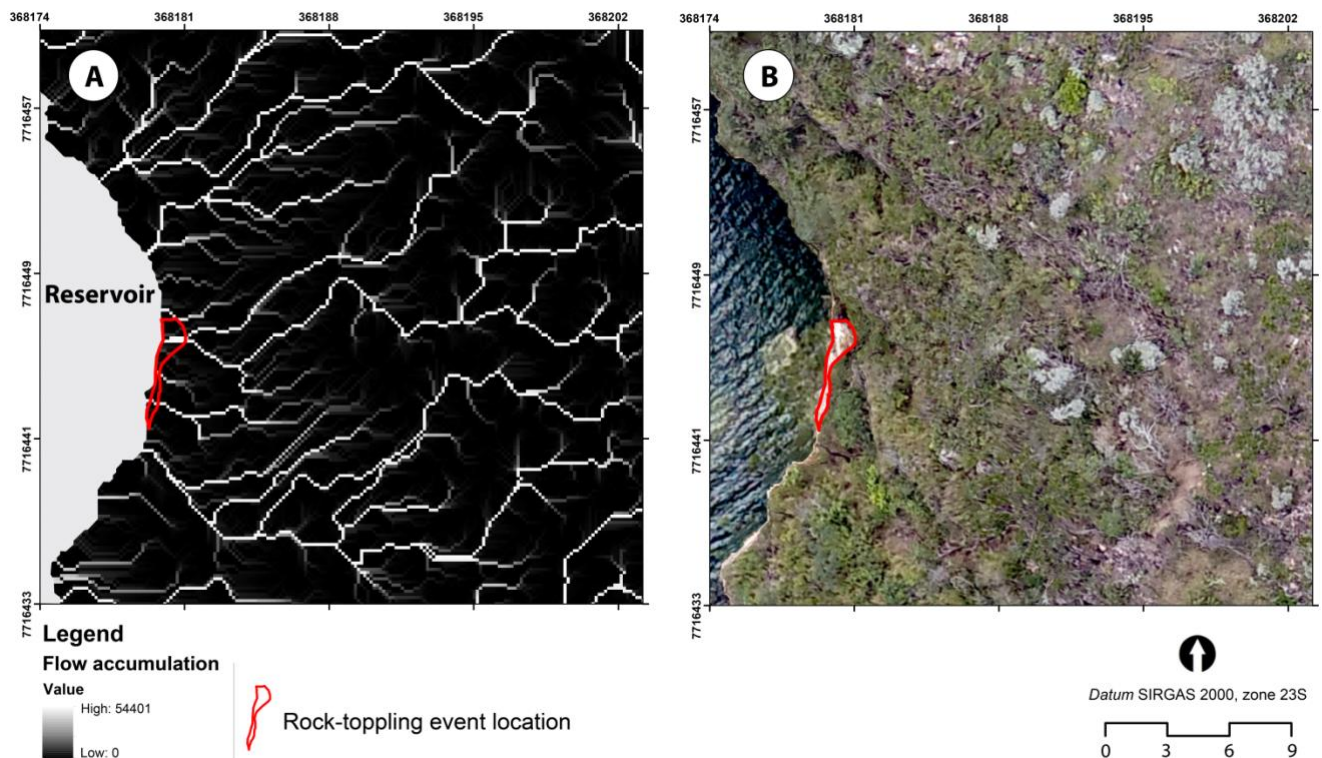
“Furthermore, overland flow accumulation in the site of the rock-toppling event (**Figure 12**) can also contribute to increasing the water content in the fracture and joint system, adding more pressure on rock column that ultimately toppled. The overland flow pathways in the region right at the top of the rock-toppling event concentrate in the area that failed, which, besides increase water accumulation in the joints, can also intensify the erosion and increase the susceptibility of this area to rock instabilities.

Figure 12: Overland flow on the region at the top of the Capitólio canyon. A) Overland flow accumulation on the top of the canyon, showing that there is a significant accumulation at the location (red contour) of the rock-toppling event. B) Orthophoto of the top of the canyon, with the slope-failure location delimited in red.”

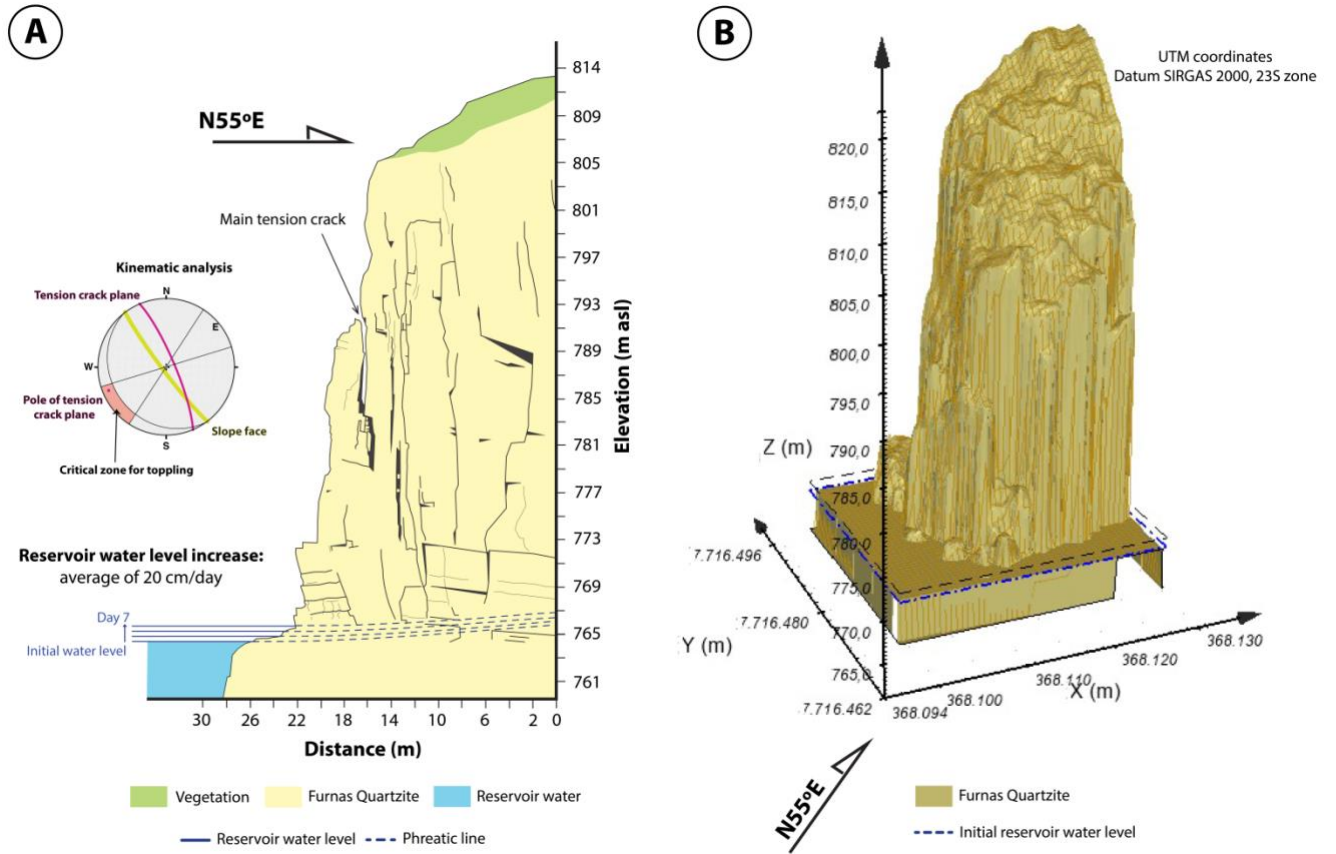
Figure 13: Slope stability analysis. A) Cross-section of the location interpreted as having a similar geological-geotechnical characteristic as the site that failed on January 8, 2022. The Stereonet highlights that this portion is prone to toppling, especially considering the main tension crack in the slope. B) 3D stability analysis on Slope/W from Geostudio (Seequent, 2025), considering reservoir water-level fluctuations and the structural geology.

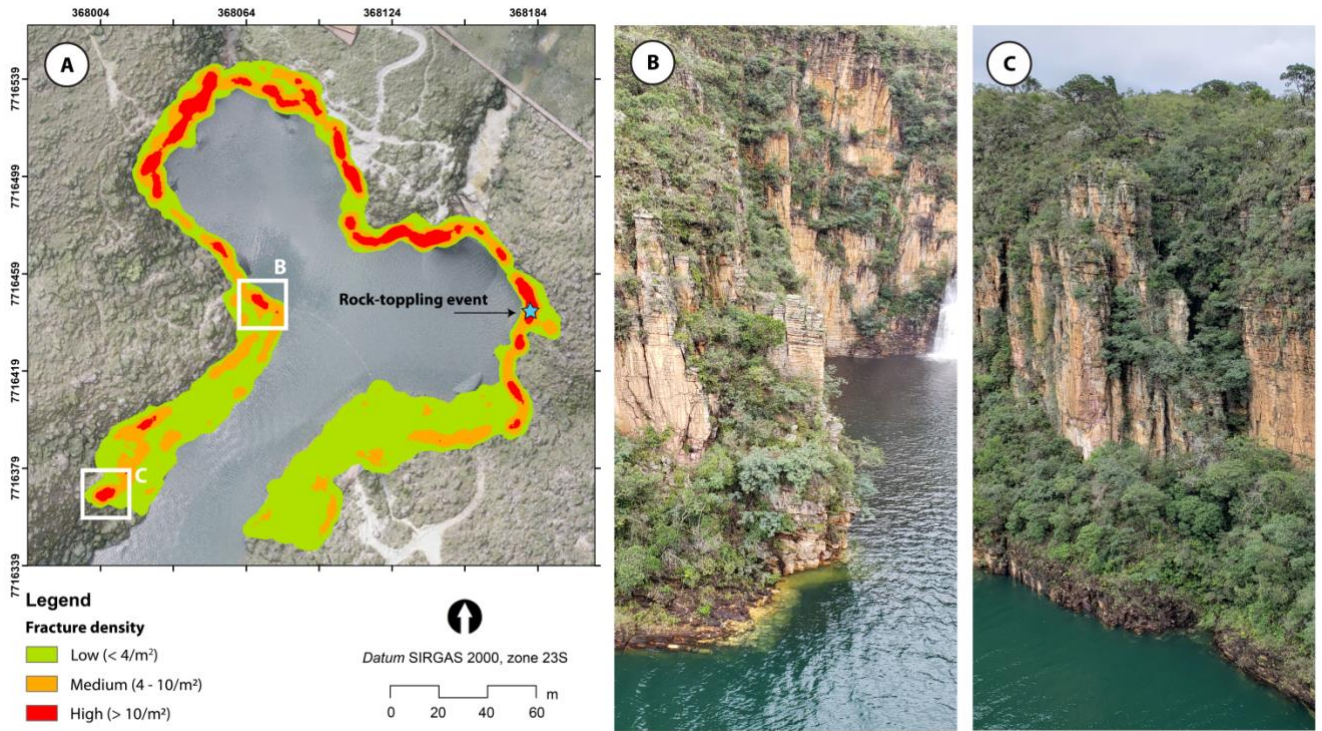
“Near the intersection of these perpendicular-oriented joint sets (F_2 and F_3) and fault zone (Family F_4), the density of fractures in the bedrock is higher, showing a stronger persistence in the canyon walls, extending from the base to the top of the rock slope (**Figure 6C**). The rock column that toppled in the event of January 2022 was located in the intersection of these structural features (**Figure 6B and 6C**), with a clear increase in discontinuities density. The fracture density map shown in **Figure 7** further highlights that in the portions that discontinuities/fractures show a higher density per square meter, the susceptibility to rock instabilities is apparently higher, with tilting

rock columns observed in these areas (**Figure 7B and 7C**), indicating movements in the rock slope. Larger apertures in the joints, especially at the top portion of these rock columns, are also observed, which are another indication of slope movement. The intersection of joint sets with perpendicular strikes favors the formation of these individual rock columns, which, combined with the horizontally dipping bedding, contribute to rock instabilities in the canyons.

Figure 7: Fracture density in the Capitólio canyon. A) Fracture density map, showing the regions in the rock mass with higher frequency of joints/discontinuities per square meter. B) Detail of a section in the canyon where the density of discontinuities is high. In this portion, the intersection of different joint families create rock columns, with large apertures (>10 cm), with an apparent high susceptibility to rock instabilities. C) Another section of the canyon with an apparent high susceptibility to rock instability, where the density of fractures is high.”

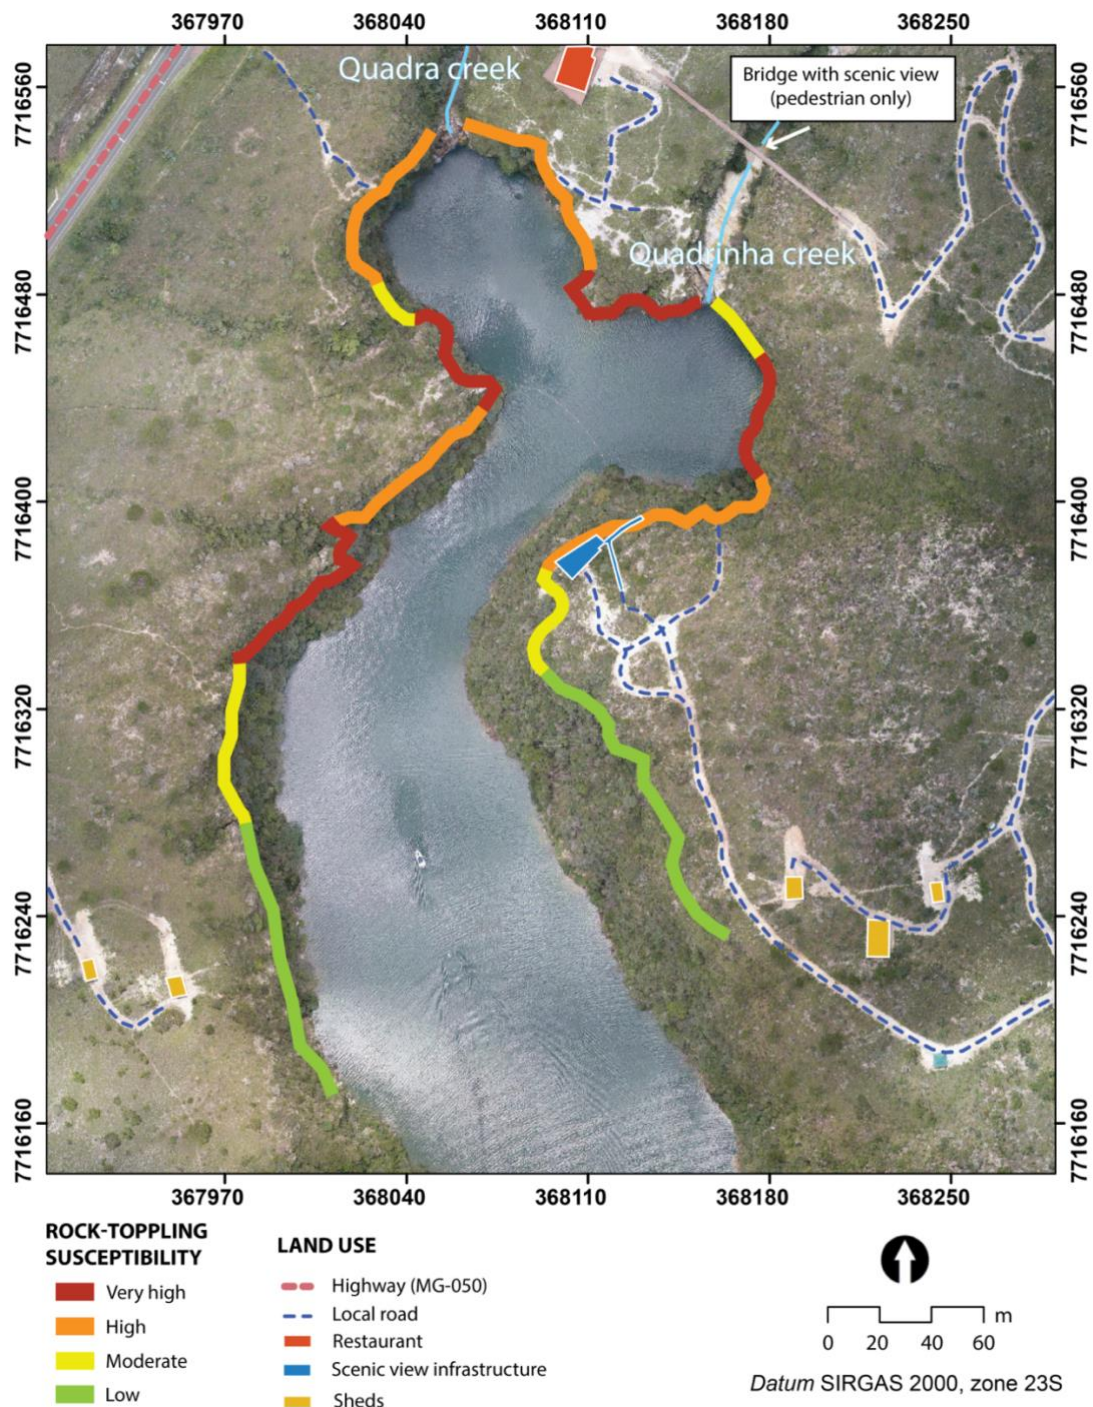
To support the proposal of safety recommendations for the operation of the canyons, a rock-toppling susceptibility map is proposed (**Figure 17**), based on slope angle, geomechanical and kinematic analysis, as well as our *in situ* observations and structural geology investigation. The criteria, in priority order, for the delimitation of each susceptibility class are:

Figure 17: Rock-toppling susceptibility map of the Capitólio canyon.

Areas with very high susceptibility to rock instabilities (**Figure 18**), where constant monitoring should be conducted, were identified and delimited in all four canyons. These areas are characterized by a bedrock with poor mechanical quality (C1.1, C1.2 and C1.3) and unfavorable structural geology, considering the relationship of slope face and bedrock discontinuities. Also, movement signs in the slopes can be observed in the field and are areas where the overland flow pathways tend to concentrate, which can facilitate erosion. The location of the sites that should be monitored more closely in the four canyons is available as Supplementary Information (Figure S1). The implementation of retention structures and other safety measures, such as destruction of the rock body and/or manual acceleration of the slope movement (i.e., hazard elimination practices) can potentially be implemented by public authorities and park administrators, although a more long-term analysis is needed to assess their efficacy, especially considering that it severely impacts the landscape and can impact tourist revenue. The isolation of areas that already show slope movements signs and keeping a safety distance from the canyons, especially where the rock-mass quality is weaker, can more adequately support a safer visitation experience, without visual impacts, and is strongly suggested to be implemented.

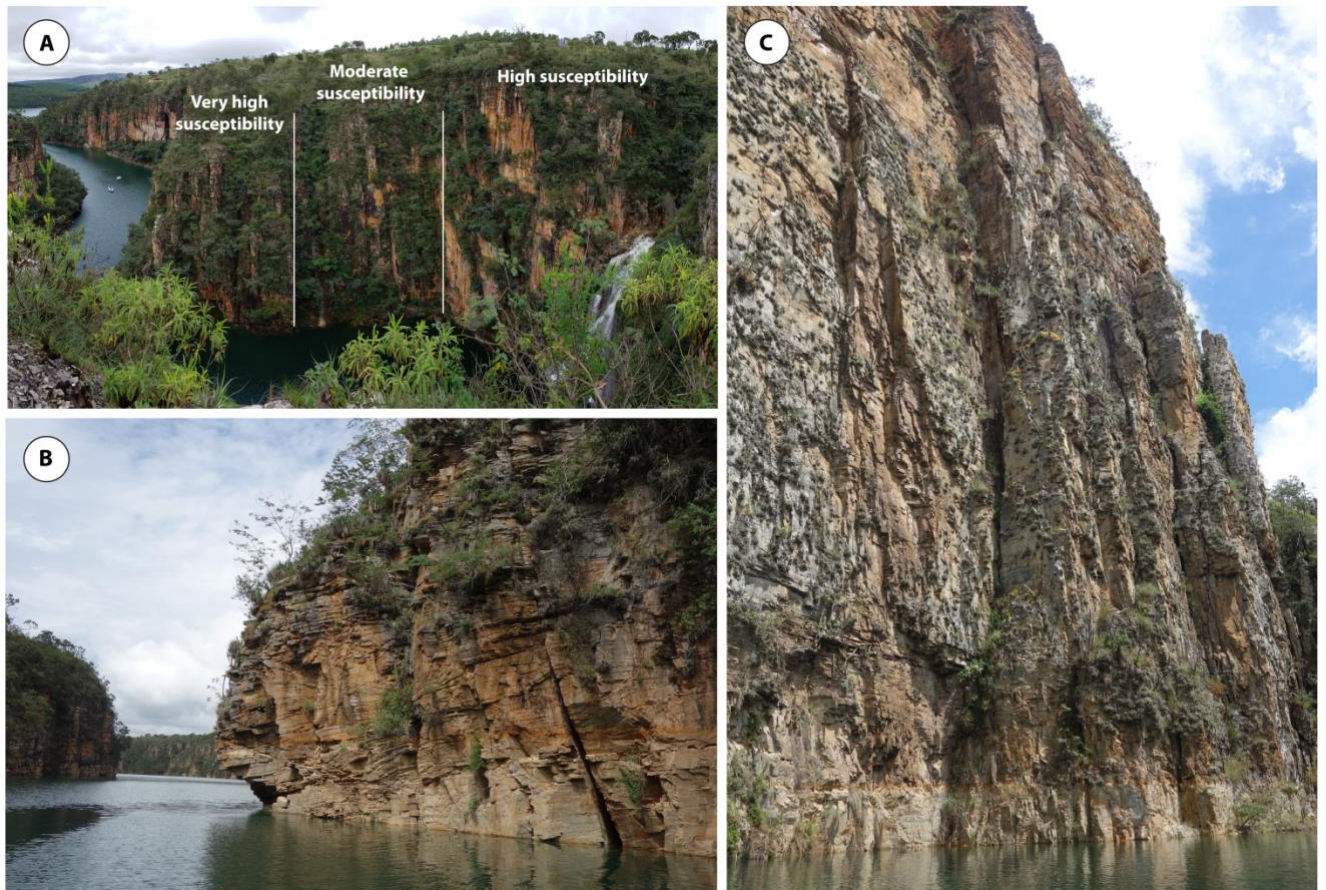
Figure 18: Overview of areas with very high susceptibility to toppling. A) In the Capitólio canyon, very high susceptibility areas have a high density of fractures, with slope movement signs and fractures with large aperture (>20 cm). B) In the Cascatinha canyon, several very high susceptibility scenarios are observed along the access to the waterfall located at the end of the canyon. In this example, the underlying support of the slope is severely impacted and movement signs are observed. C) The Cabritos canyon is located near the Furnas dam. The canyon wall can reach up to 100 m high and very large rock columns show signs of movement, such as the inclination towards the canyons area and fractures with very large (>50 cm) aperture."

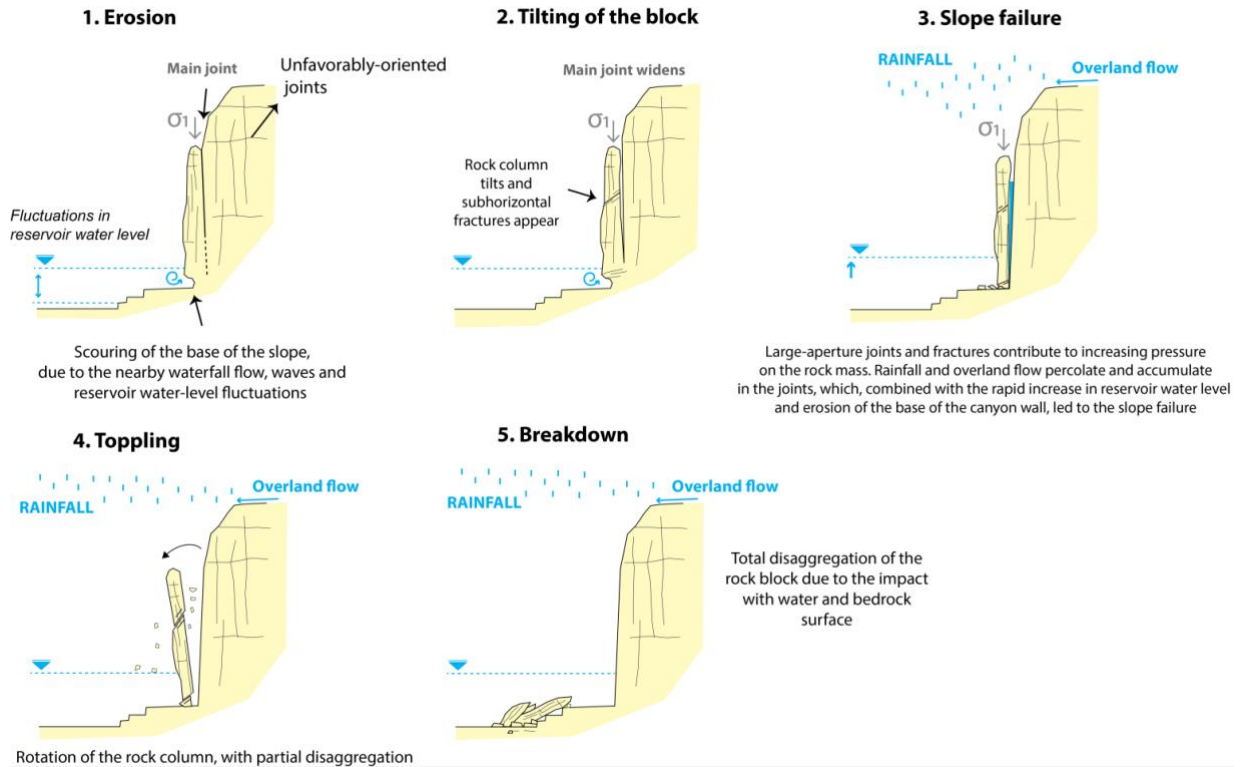
15. Figure 6: As shown, the rainfall cannot fill the back joint. There must be a way to bring water there: overland flow or the water table level.

Figure 16: Steps that led to the catastrophic rock-toppling event in the Capitólio canyon, with σ_1 representing the main stress tensor. 1) The intense scouring at the base of the slope, due to the waterfall flow nearby and fluctuations in the reservoir water level, undermined the underlying support of the heavily-jointed rock column. 2) Due to weathering, the sub-vertical joints widen and sub-horizontal fractures appear due to its own weight in middle and bottom portions of the rock column. 3) Water percolates and accumulates in the joints and fractures, increasing pressure on the rock mass, leading to slope failure. The increase in reservoir water level raises the local groundwater level and, consequently, the stress conditions in the rock mass, also contributing to the occurrence of rock instabilities. 4) The toppling event occurs and (5) the rock column disaggregates, due to the impact with water and the bedrock surface. Image adapted from a previous version presented in the World Landslide Forum 6 (WLF6), in Florence - Italy (2023).

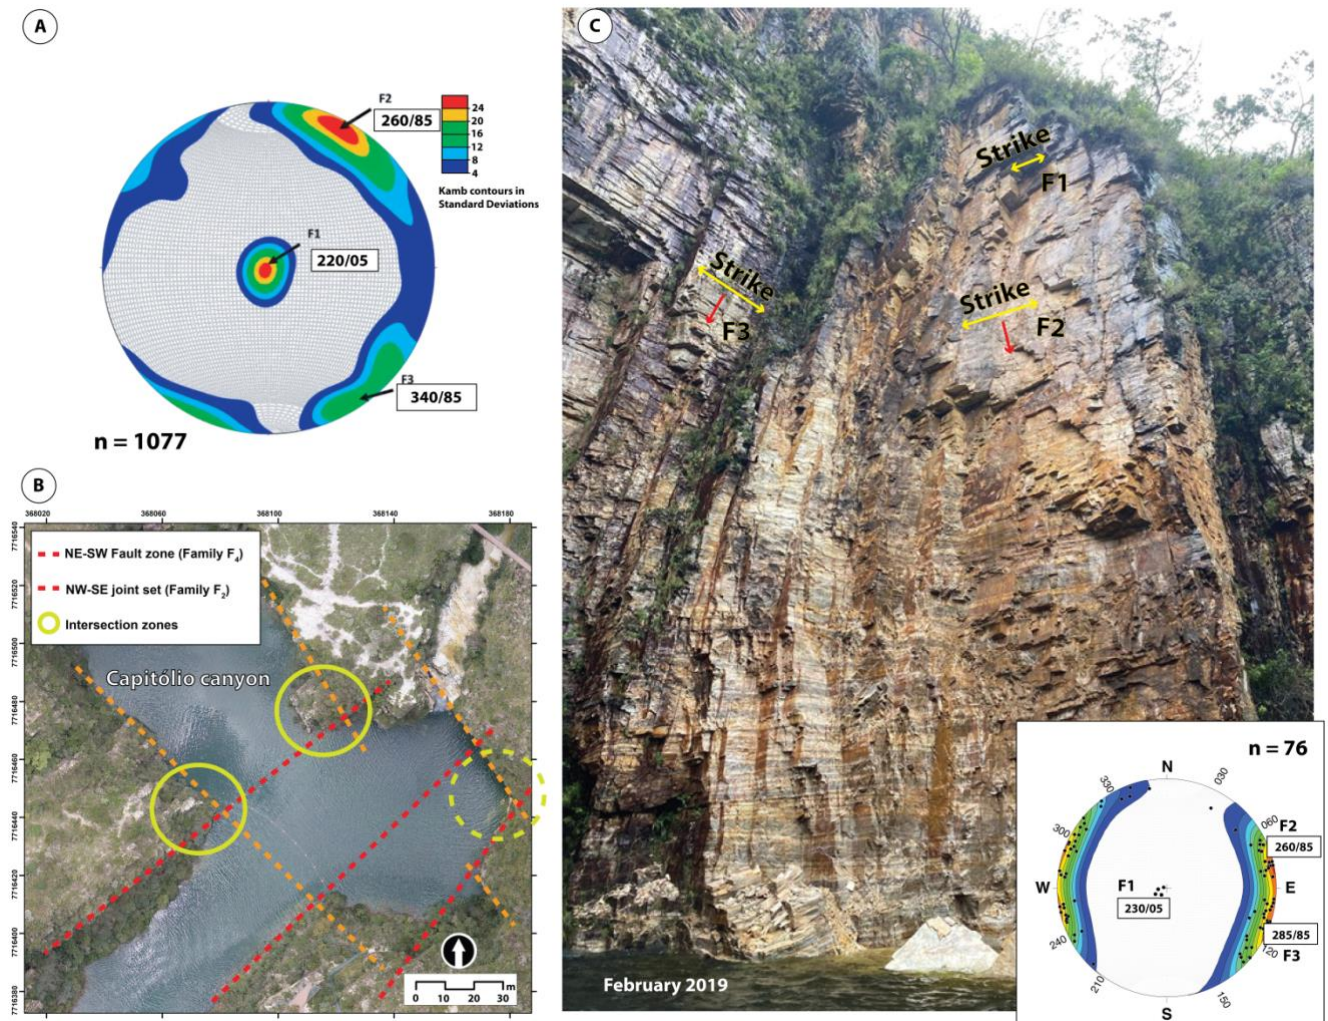
Figure 6: Structural analysis. A) Structural analysis of the bedrock using Stereonet. Three main joint sets were identified in the study site, as well as fault zone parallel to Family F₃ (n = 1077). Measurements showing Dip Direction and Dip. B) Overview of the Capitólio canyon, highlighting areas the NE-SW fault zone (Family F₄), which is parallel to joint family F₃, intersect with Family F₂. The rock-toppling event occurred in the far right (to the east) intersection, highlighted in the dotted yellow circle. C) The fracture density in the bedrock is intensified in areas where two perpendicular joint families intersect. The photograph is from the portion where the fatal rock-toppling event occurred, highlighting the contribution of fractures and joints to the slope failure. The Stereonet plot shows three families individualized, based on *in situ* measurements (n=56). Measurements showing Dip direction and Dip.

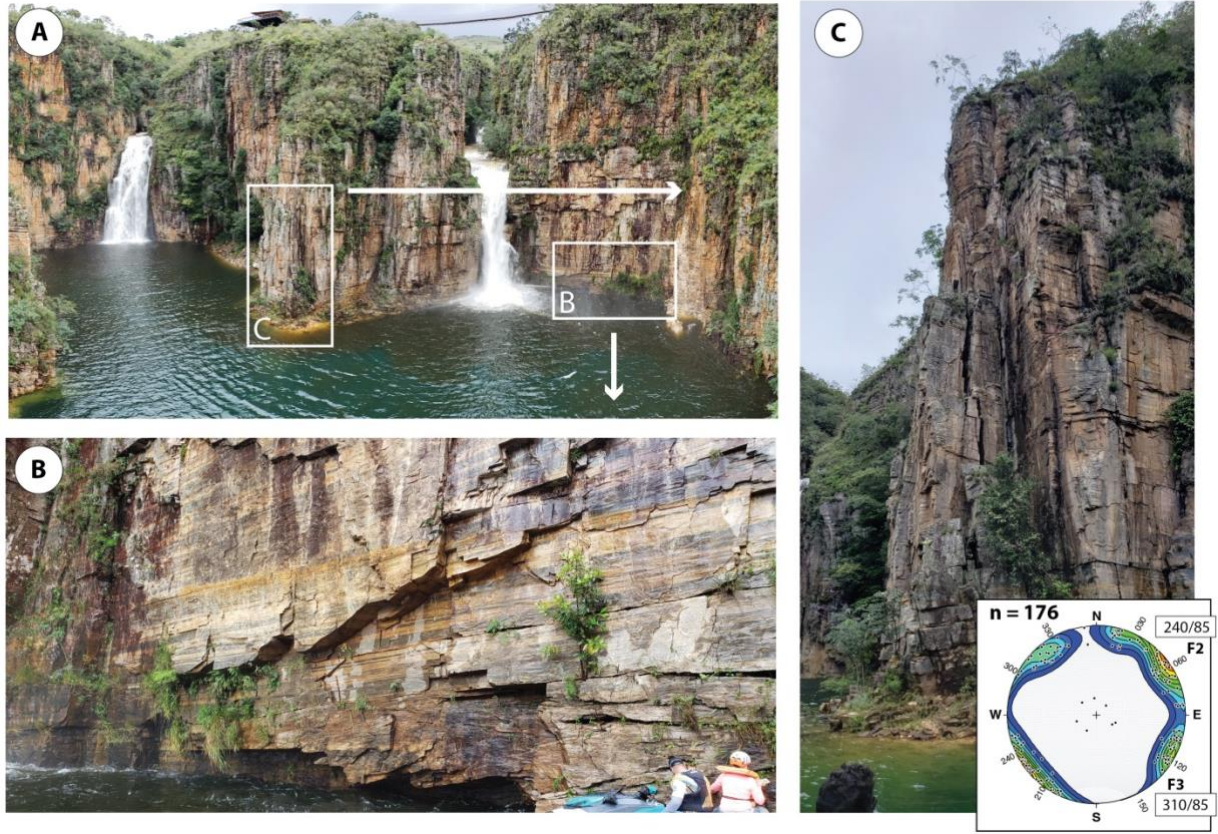
Figure 15: Details of the Capitólio canyon bedrock. A) Overview of the central area of the Capitólio canyon, showing where photos B) and C) were taken. B) A “cave” formed at the bottom of the canyon wall, due to the scouring of the rock mass due to the nearby waterfall flow and variations in the reservoir water level. C) The pervasive set of joints in the bedrock, with large aperture (up to 50 cm), is clearly seen in this portion. In this particular area, two fault zones intersect (NW-SE and NE-SW strikes), contributing to the increase in jointing and fracturing of the rock mass and facilitating slope failures. In this portion, the isolation of the area is suggested, as there is a high susceptibility to toppling. The stereonet illustrate the joint sets identified in this portion of the slope, based on 206 measurements, both *in situ* and acquired using the 3D point cloud.

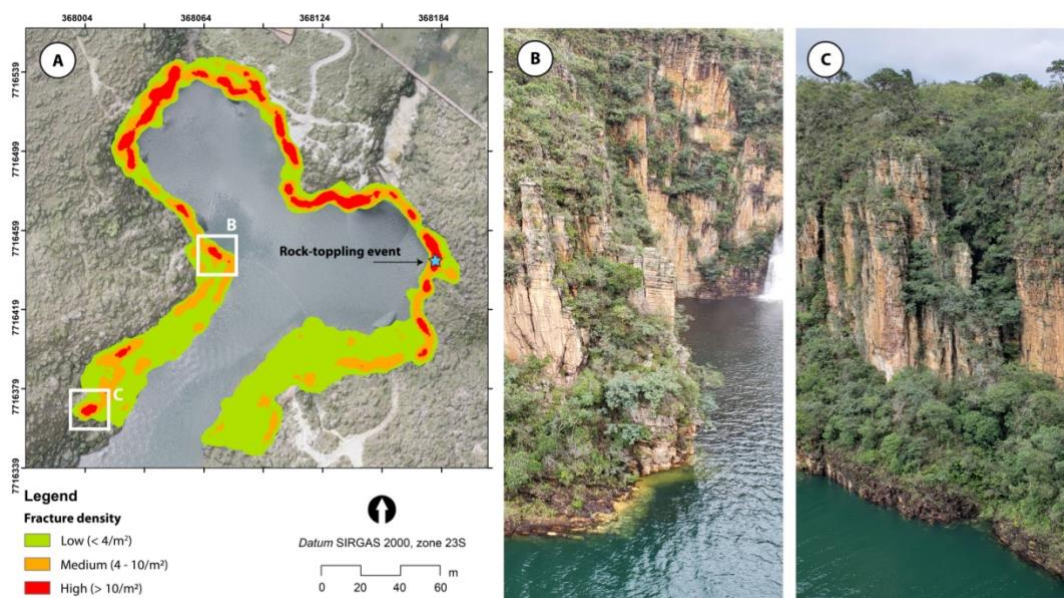
“The fracture density map shown in **Figure 7** further highlights that in the portions that discontinuities/fractures show a higher density per square meter, the susceptibility to rock instabilities is apparently higher, with tilting rock columns observed in these areas (**Figure 7B and 7C**), indicating movements in the rock slope. Larger apertures in the joints, especially at the top portion of these rock columns, are also observed, which are another indication of slope movement. The intersection of joint sets with perpendicular strikes favors the formation of these individual rock columns, which, combined with the horizontally dipping bedding, contribute to rock instabilities in the canyons.”

Figure 7: Fracture density in the Capitólio canyon. A) Fracture density map, showing the regions in the rock mass with higher frequency of joints/discontinuities per square meter. B) Detail of a section in the canyon where the density of discontinuities is high. In this portion, the intersection of different joint families create rock columns, with large apertures (>10 cm), with an apparent high susceptibility to rock instabilities. C) Another section of the canyon with an apparent high susceptibility to rock instability, where the density of fractures is high.”
