Geological-geotechnical analysis of a rock-toppling prone canyon in Furnas, Brazil, after a fatal event

Abstract. When a disaster related to a natural phenomenon occurs in areas dependent on Geotourism, restoring tourist confidence can be a challenge. An example is the rock-toppling event that occurred on January 2022 in one of the four canyons located in the Furnas reservoir in Brazil, which caused 10 fatalities. Visitation fear and their temporary closure severely impacted the economy of the surrounding municipalities that rely on tourism. To support a safer operation of the canyons to visitation, our study investigates the factors that can lead to landslide events in the region, based on the combination of field investigations, rock-mass quality evaluation (RMR14) and kinematic analysis. We hypothesize that the assessment of rock-mass quality can successfully identify specific areas in the bedrock that are prone to rockfall and rock toppling, supporting risk management strategies in tourist regions. Our results indicate that the 2022 rock-toppling event occurred due to the combination of different factors, such as rainfall infiltration in the unfavorably-oriented joints of the

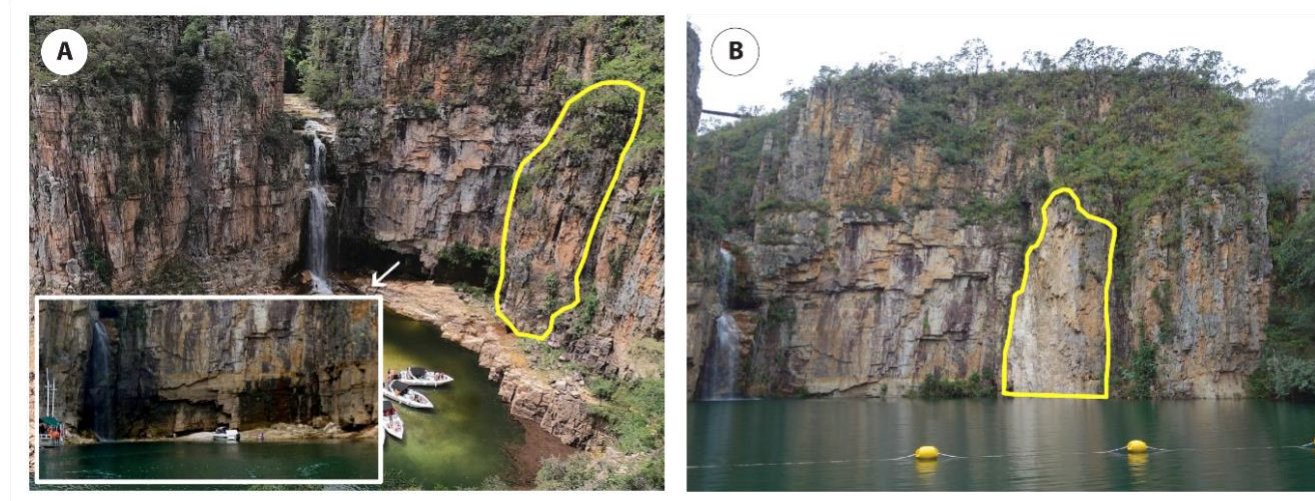
Figure 2: Overview of the Capitólio canyon before (A) and after (B) the fatal event. A) The large rock column that toppled is highlighted in yellow. Note the intense scouring at the base of the canyon wall (Source: Ion David Zarantonelli, 2019). The agglomeration of boats in the canyons was a common practice before the catastrophe. B) The location of the rock column that collapsed is indicated in yellow, highlighted by a less weathered (lighter) portion in the bedrock. Reservoir water level was much higher in March 2022 (B) than in July 2019 (A).

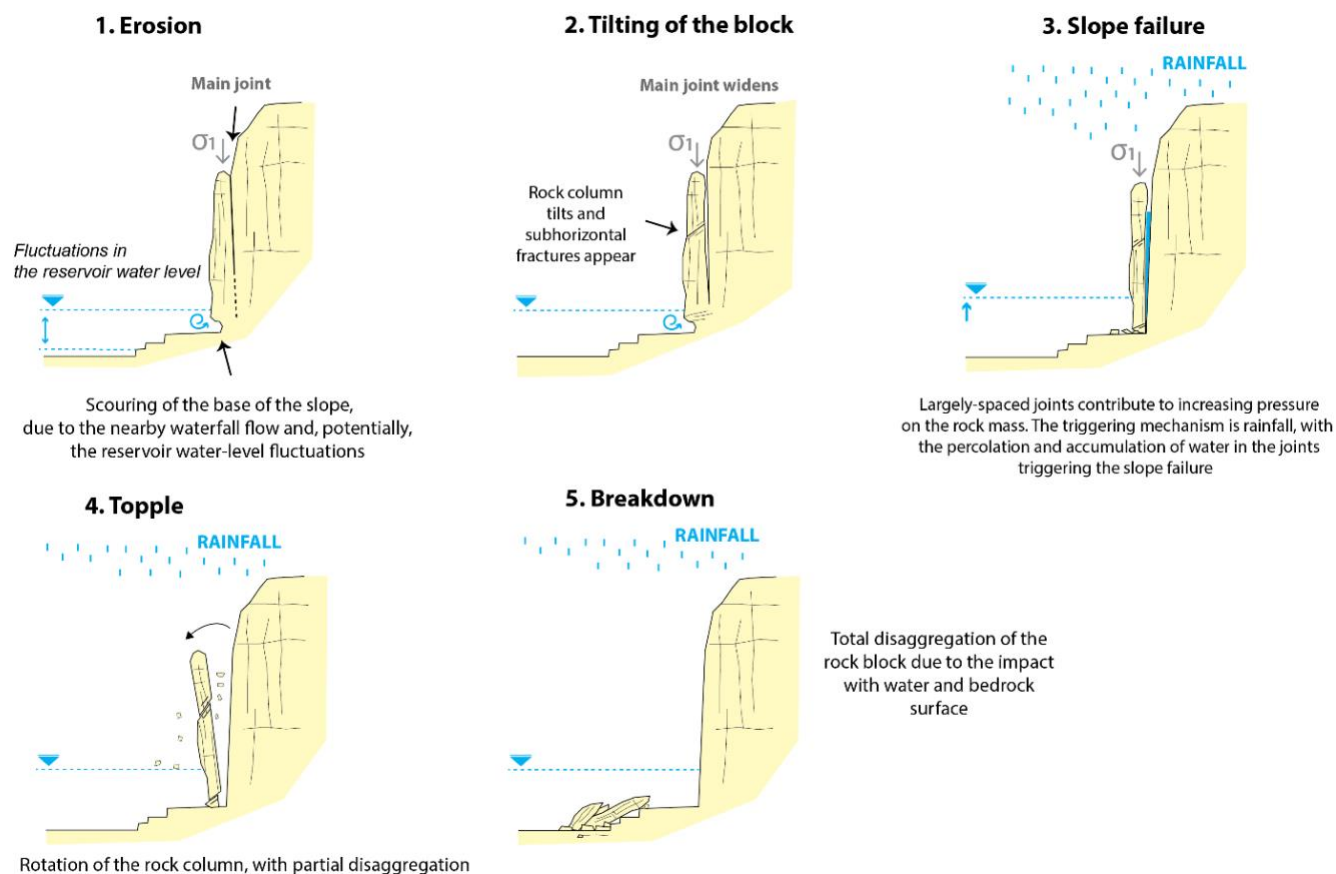
The field surveys revealed that the long-term erosion at the base of the rock slope, caused by the adjacent waterfall flow and, potentially, the fluctuations in the reservoir water level, was one of the main causes of the January 2022 rock-toppling event (**Figure 6**). The erosion at the bottom portion of the slope caused the middle section to lose underlying support, with an added pressure of the water accumulated in the joints. As pointed by Cruden (1991), self-weight alone is not sufficient to cause toppling, with external forces needed to initiate the process.

Besides the erosion of the canyon wall's bottom portion (**Figure 7A** and **7B**), the pervasive sets of unfavorably oriented joints (discontinuities) also strongly contributed to the slope failure. The joint sets often showed very large aperture (up to 50 cm), with the discontinuity planes exhibiting highly weathered surfaces with the formation of soil and vegetation (**Figure 7C**), especially at the top portion of the canyon wall. The infiltration of water in the bedrock's joint system potentially contributed with the "added pressure" needed for the initiation of the slope failure.

Figure 6: Steps that led to the catastrophic rock-toppling event in the Capitólio canyon, with σ_1 representing the main stress tensor. 1) The intense scouring at the base of the slope, due to the waterfall flow nearby and fluctuations in the reservoir water level, undermined the underlying support of the heavily-jointed rock column. 2) Due to weathering, the sub-vertical joints widen and sub-horizontal fractures appear due to its own weight in middle and bottom portions of the rock column. 3) Water percolates and accumulates in the joints and fractures, increasing pressure on the rock mass, leading to slope failure. The increase in reservoir water level raises the local groundwater level and, consequently, the stress conditions in the rock mass, contributing to the occurrence of instabilities. 4) The toppling event occurs and (5) the rock column disaggregates, due to the impact with water and the bedrock surface.

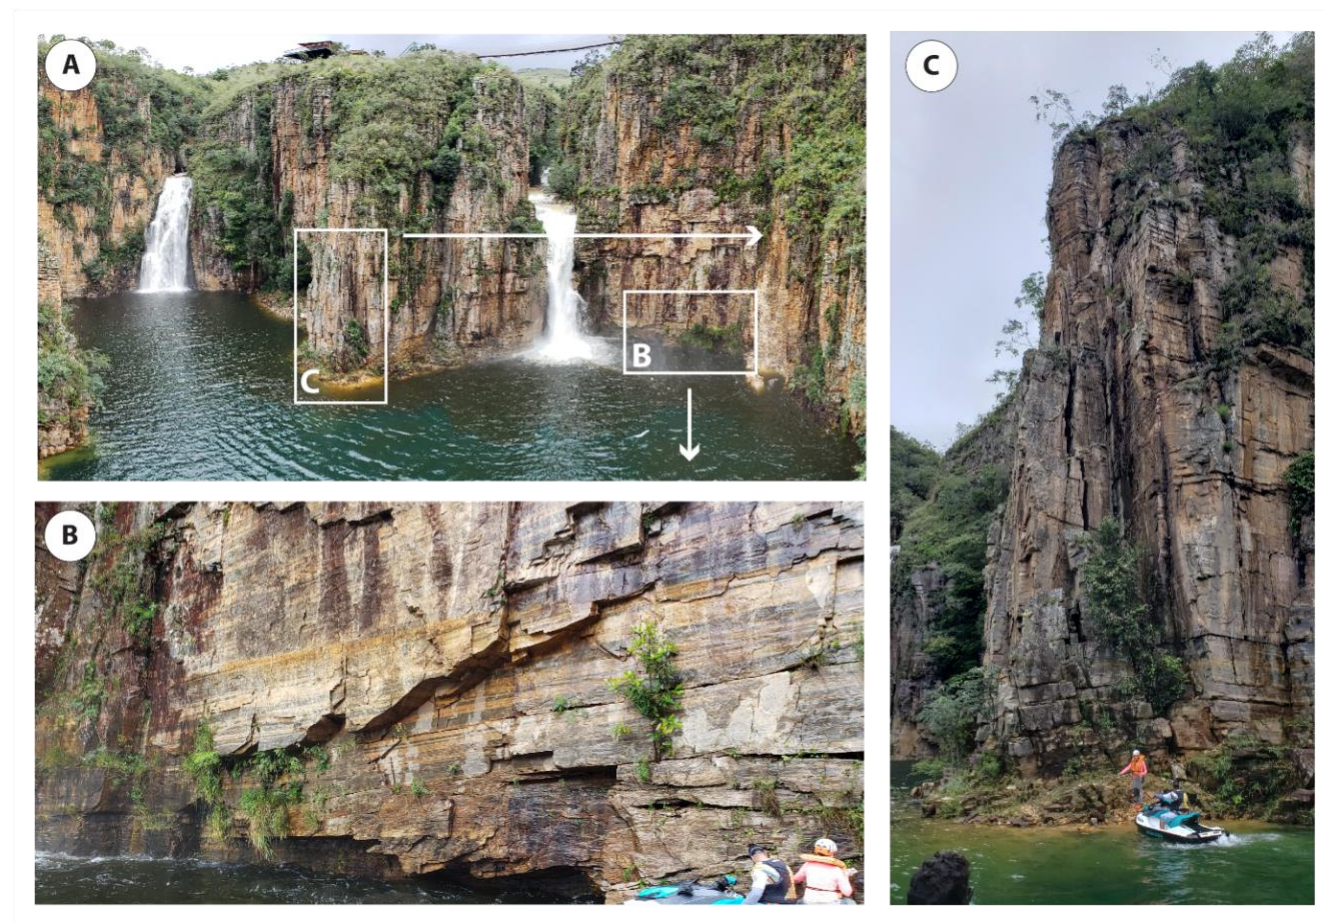
Figure 7: Details of the Capitólio canyon bedrock. A) Overview of the central area of the Capitólio canyon, showing where photos B) and C) were taken. B) A “cave” formed at the bottom of the canyon wall, due to the scouring of the rock mass due to the nearby waterfall flow and variations in the reservoir water level. C) The pervasive set of joints in the bedrock, with large aperture (up to 50 cm), is clearly seen in this portion. In this particular area, two fault zones intersect (NW-SE and NE-SW strikes), contributing to the increase in jointing and fracturing of the rock mass and facilitating slope failures. In this portion, the isolation of the area or the implementation of a retention structure is suggested, as there is a high susceptibility to toppling.

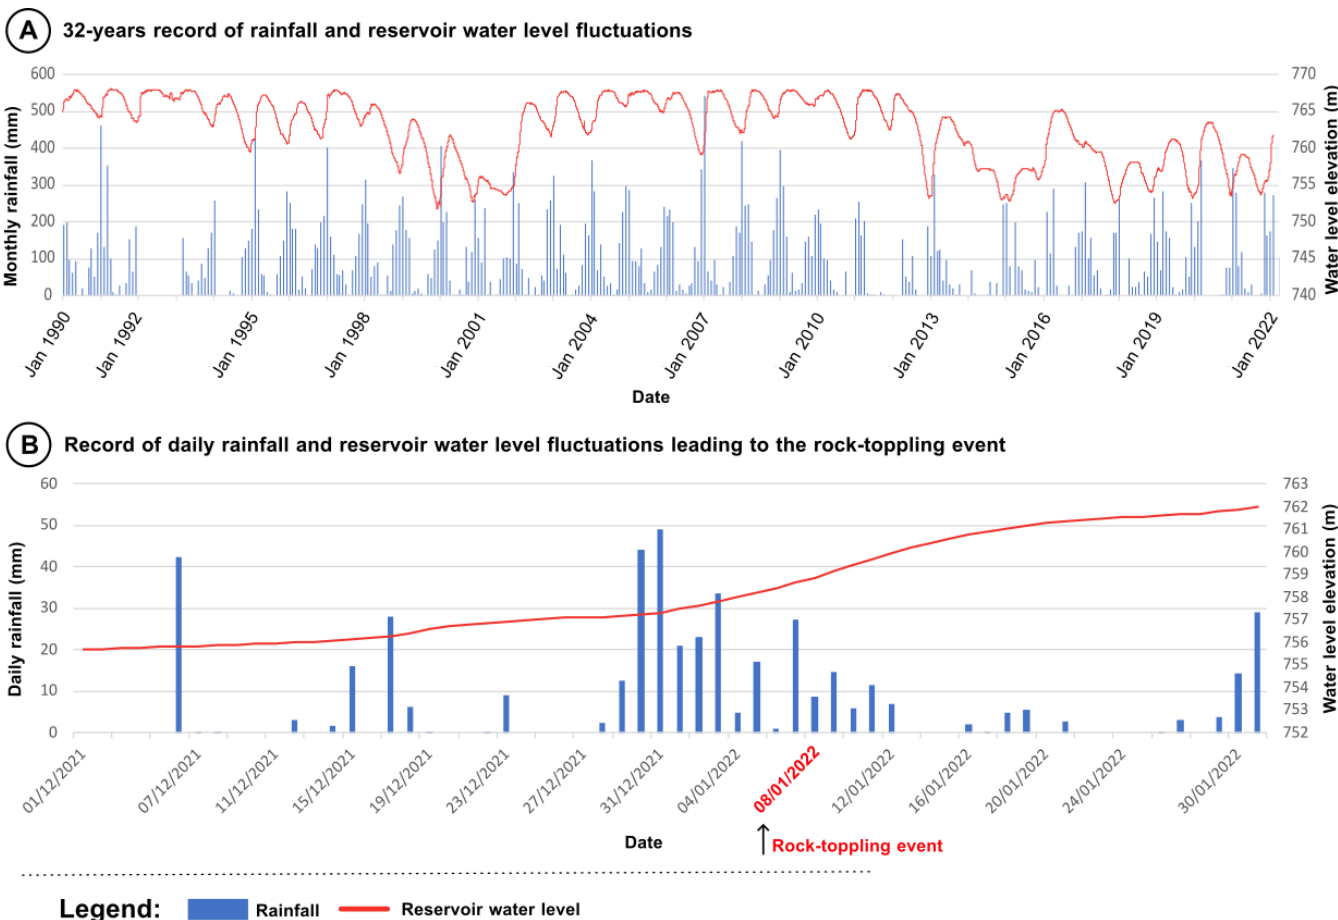
Moreover, water-level fluctuations in the reservoir may have also contributed to the slope failure. The annual variations of the Furnas water level in the last 32 years (**Figure 8A**) show that after a sharp decrease in 2013, the reservoir level has been varying greatly, contrasting with the long period of somewhat stable levels between 2001 and 2012. The sharp decrease in 2013 can be associated with the drought that Southeast Brazil experienced in the 2013 – 2017 period (Finke et al., 2020), as reservoirs can be significantly affected by changes in annual and seasonal precipitation, as well as temperature variations (Mukheibir, 2013).

When the water level in the month leading to the slope failure is considered (**Figure 8B**), we can observe that there was a 3 m increase in this period, from 755.8 m asl on December 8, 2021, to 758.87 m asl on January 8, 2022. In the seven-days period prior to the catastrophe, the average water-level increase rate was 20 cm/day. Rapid increases in water level and reservoir volume can profoundly impact the local groundwater level and stress behavior on the slope, which, as highlight by Jin et al. (2023), can cause deformation and slope failure(s). The rock-toppling event in the Furnas reservoir, therefore, can potentially be attributed both to the rapid water-level increase and rainfall infiltration in the joint system, combined with the weakened support of toe of the slope due to erosion.

Figure 8: Water level of the Furnas reservoir and rainfall record. A) Long-term (32 years) variations in reservoir water level (red line) and rainfall data (blue bars). B) Reservoir water level variation in the month leading to the rock-toppling event.

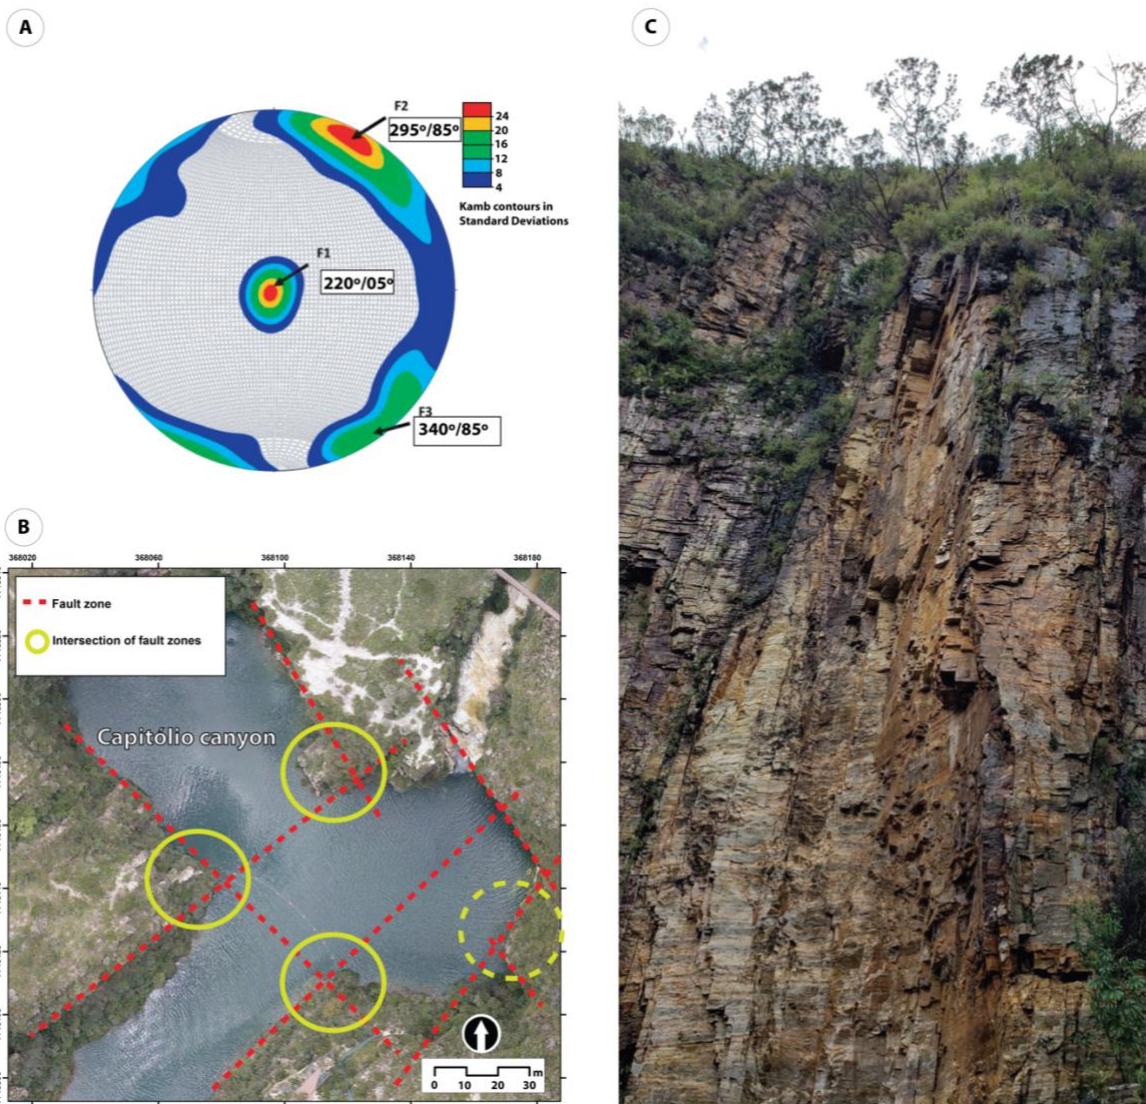
- Family F₁: sub-horizontal joints, often associated with the bedrock foliation, which preferential strike is N75W/15 NE (Figure 9A). The thin layers of more micaceous facies interbedded with the quartzite control the sub-horizontal fracture planes;

- Family F₂: NW-SE strike, with dip that varies from 80° to 90°, with a primary SW dip direction and, secondarily, NE dip direction (**Figure 9A**);
- Family F₃: NE-SW strike, dip direction SE (primary) and NW (secondary), with subvertical dip (80° – 90°) (**Figure 9A**);
- Family F₄: Unique structures associated with NE-SW geological faults, related to the decrease in joint spacing and increase in joint frequency, conditioning the shape of the canyons (**Figure 9B**).

Figure 9. Structural analysis. A) Structural analysis of the bedrock using Stereonet. Three main joint sets were identified in the study ($n = 577$). **B)** Overview of the Capitólio canyon, highlighting areas where two fault zones intersect. The rock-toppling event occurred in the far right (to the east) intersection, highlighted in the dotted circle. **C)** The fracture density in the bedrock is intensified in areas where two perpendicular fault zones intersect. The photograph is from the portion where the fatal rock-toppling event occurred, highlighting the contribution of fractures and joints to the slope failure.

The rock mass is conditioned by NW-SE and NE-SW subvertical joint sets and by sub-horizontal joints associated with the foliation and bedding. These three different families (F_1 , F_2 and F_3) control the formation of regular blocks in the rock mass, in a parallelepiped-like shape. Moreover, singular structures, such as geological faults, shape the canyons, as well as erosive processes at the base of the slopes caused by the action of waves resulted from waterfalls and boats, in addition to the fluctuations in reservoir water levels. It is observed that these NE-SW faults condition the geometry of the entrance of the canyon, as well as the lateral extremities on the left and right side, forming rectilinear rock walls (**Figure 9B**). The same is observed for the NW-SE joint sets.

Near the intersection of these perpendicular-oriented fault planes, the density of fractures in the bedrock is higher, showing a stronger persistence in the canyon walls, extending from the base to the top of the rock slope (**Figure 9C**). The rock column that toppled in the event of January 2022 was located in the intersection of these two fault zones (**Figure 9B and 9C**), with a clear increase in discontinuities density.

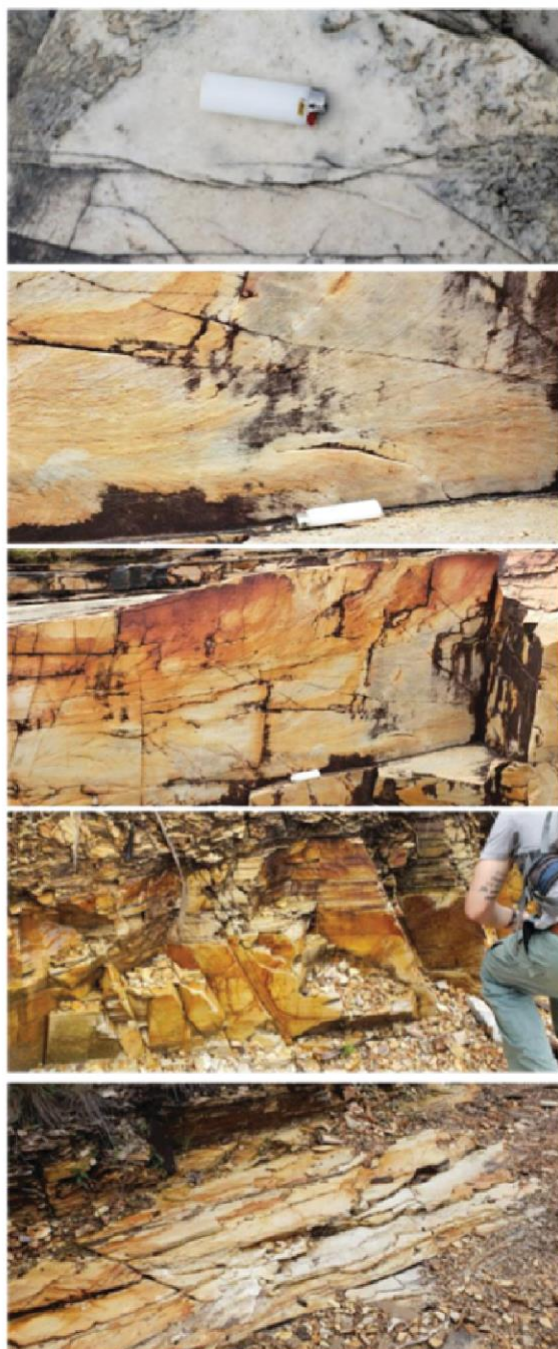
Weathering degree I - Fresh rock

No weathering evidence and strong resistance to geological hammer.

Very altered minerals that brittle very easily. Rock-mass structure is easily desintegrated with the pressure of hands. It is only observed in more micaceous facies of the bedrock.

360 **Figure 10: Different weathering degrees observed in the bedrock.**

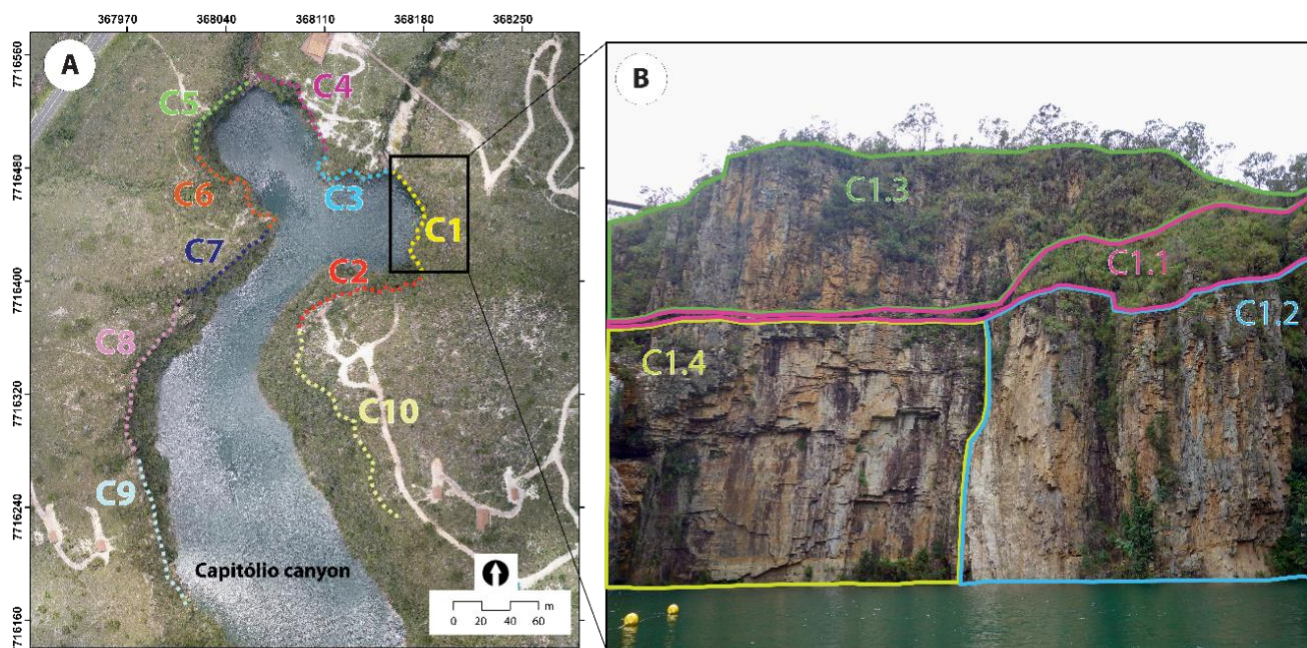
- C1.1: rated as a “Very Weak” rock mass (Final Rating: 14), as it shows a high density of joints and fractures, as well as a high weathering degree (saprolite). Water infiltrates and percolates through the joints, where soil and vegetation are formed. This structural zone is located in the intermediate portion of the rock wall, characterized by a slightly more micaceous facies in the Furnas Quartzite.

- C1.2: rated as "Very Weak" rock mass (Final Rating: 20), corresponding to the portion where the rock-toppling event occurred. The spacing between joints is narrow (< 30 cm) (**Figure 9C**), with water percolating in rainy periods. The joints can show a large aperture (up to 50 cm) in this structural zone, which may be filled with soil and vegetation that can favor the occurrence of slope failure. The fault zone with NW/SE and NE/SW direction heavily influences the geomechanical behavior of this structural zone;

- C1.3: rated as a “Very Weak” rock mass (Final Rating: 20), due to continuous and persistent joints in the bedrock, with the occurrence of soil and vegetation in joint planes that can potentially accelerate slope failures. This compartment is located in the upper portions of the canyon wall;

- C1.4: rated as "Normal" rock mass (Final Rating: 52), as the joints in this portion are more spaced from one another (> 60 cm), also showing a much narrower aperture, making this portion less prone to instabilities.

Figure 11. Geomechanical classification of the rock mass in the Capitólio canyon. A) Ten compartments were individualized in the canyon, representing each canyon wall. B) In each canyon wall, the rock mass was further compartmentalized in smaller structural zones, due to differences in the bedrock properties that translate into different geomechanical behaviour.

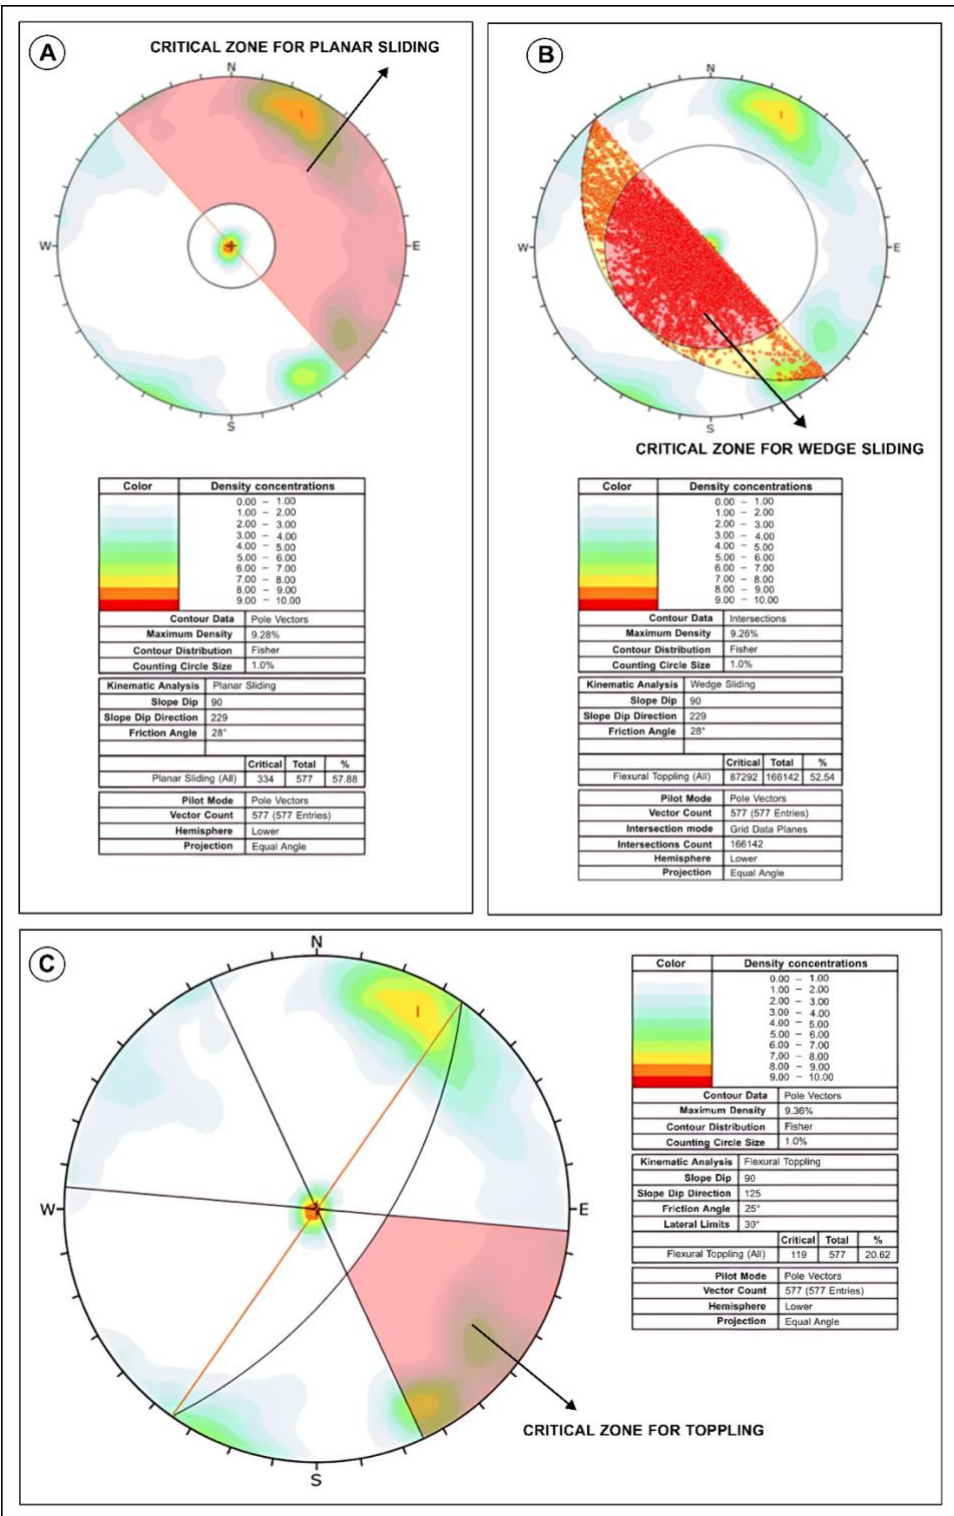
The kinematic analysis further supports these observations and interpretations, providing an overview of the susceptibility to different types of slope failure considering each geomechanical compartment. Overall, the canyons show a high susceptibility to planar failures (**Figure 12A**), and low susceptibility to both wedge failure and toppling (**Figure 12B and 12C**, respectively). However, when certain slope face directions are considered, some portions of the canyons can show a higher susceptibility to toppling (**Table 8 and 9**).

Geomechanical compartments with slopes faces with a dip direction/dip of 142/90 (compartment C5), 135/90 (C7), 125/90 (C8) and, secondarily, 54/90 (C6) tend to show higher susceptibility to toppling when compared to other slope faces (**Table 9**). These compartments are notable due to the formation of rock columns (**Figure 13A**), up to 50 m high, which are areas on the canyons that already show movement signs in the slopes. Moreover, considering that the slope faces in the canyons are characterized by abrupt changes in strikes, more localized unfavorable conditions can occur in other compartments as well.

Figure 12: Kinematic analysis results using Rocscience DIPS. A) Planar failure. B) Wedge failure. C) Topping failure.

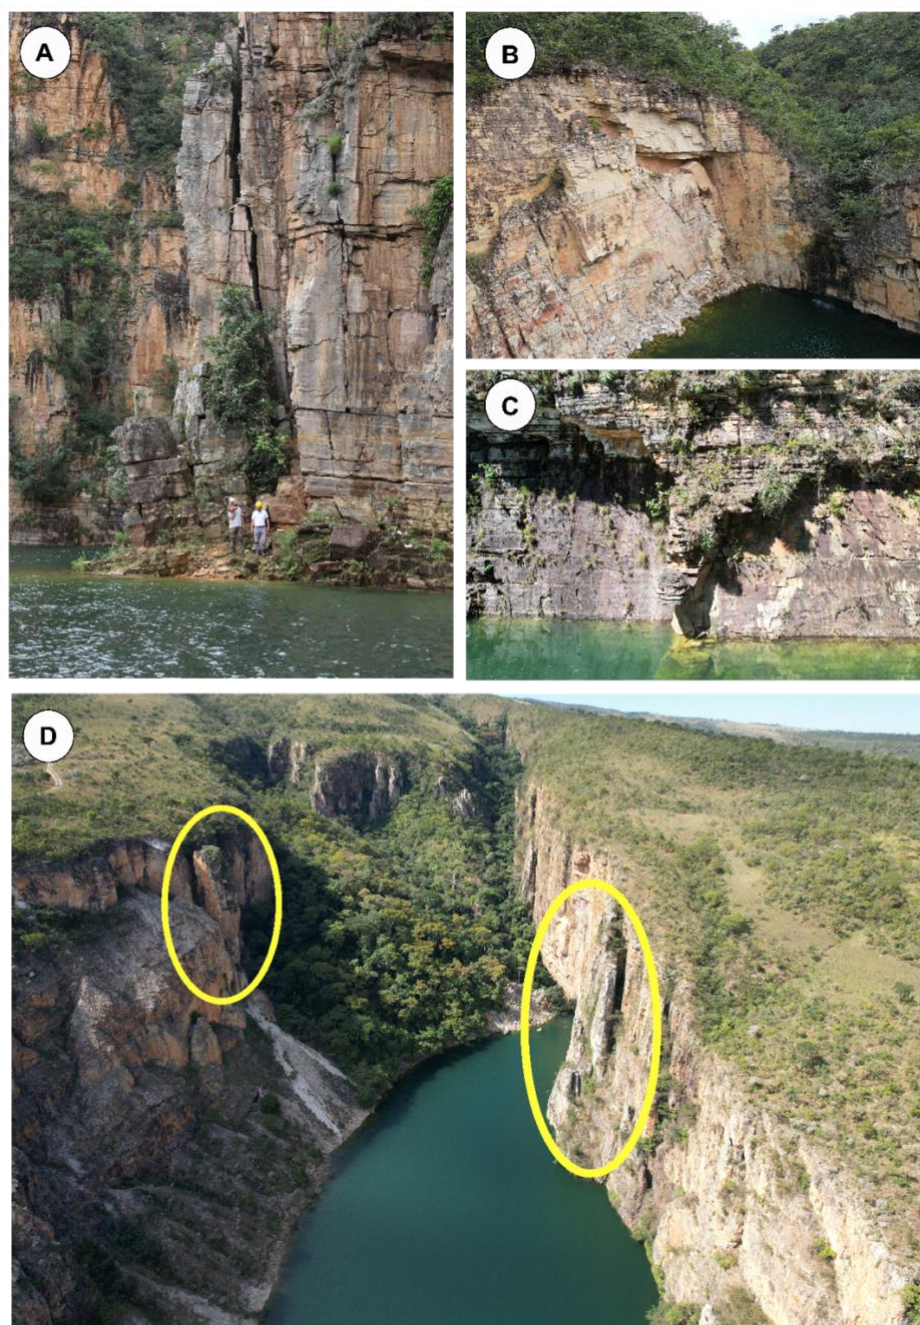
410 Abrupt changes in the direction of slope faces can be observed, for instance, in compartment C1, where the 2022 event occurred, with the intersection of NW-SE (dip dir/dip = 229/90) and NE-SW (dip dir/dip = 295/90) slope faces (**Figure 8C**). These areas, as highlighted earlier, are also associated with the intersection of the NW-SE and NE-SW fault zones. Compartment C2 also show a similar condition (**Figure 13A**), with a rock column of 20 m showing signs of movements, which can potentially experience a similar fate to the slope that toppled on January 2022.

Figure 13: Overview of areas with high landslide susceptibility in the four canyons. A) In the Capitólio canyon, very fractured rock columns are observed, with aperture of up to 50 – 60 cm. This high susceptibility scenario supports the restriction of the core area of the canyon to visitation. B) In the Tucanos canyon, high susceptibility scenarios near the entrance of the canyon are observed. C) In the Cascatinha canyon, several high susceptibility scenarios are observed along the access to the waterfall located at the end of the canyon. In this example, the rockfall hazard is high. D) The Cabritos canyons is located near the Furnas dam. The canyon wall can reach up to 100 m high and very large rock columns show instability signals, such as the inclination towards the canyons area (left ellipse) and fractures with very large aperture - up to 1 m (right yellow ellipse).

420 The implementation of retention structures and other safety measures, such as destruction of the rock body and/or manual acceleration of the slope movement (i.e., hazard elimination practices) can potentially be implemented by public authorities and park administrators, although a more long-term analysis is needed to assess their efficacy. The isolation of areas that already show slope movements signs and keeping a safety distance from the canyons, especially where the rock-mass quality is weaker, can also support a safer visitation experience, without impacting the landscape. The location of the sites that should
