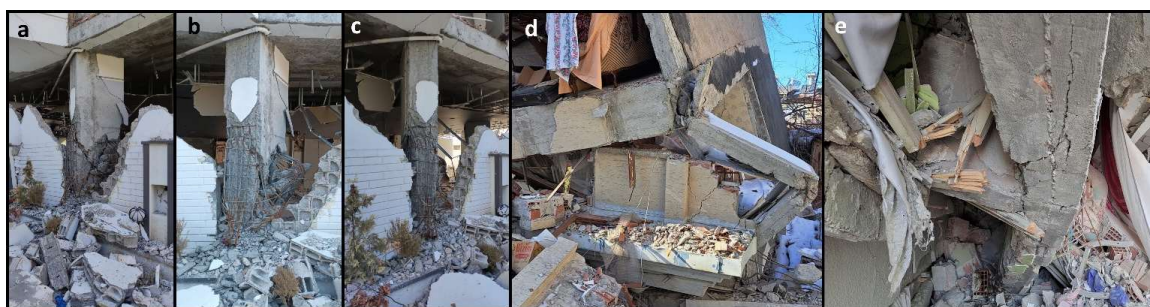
182 **Figure 4.** Representative column damage observed in reinforced concrete (RC) buildings affected by
183 the February 6, 2023, Kahramanmaraş earthquake sequence.

185 Severe column damage observed in a relatively new RC building in Adiyaman, including concrete
186 crushing, spalling, and exposure of longitudinal reinforcement (Figure 4 a–c). Similar column damage
187 observed in an older RC building in Malatya, characterized by loss of confinement and extensive
188 deterioration of primary load-bearing elements (Figure 4 d–e).

189 The examples illustrate that severe column damage occurred in both newer code-era and older RC
190 buildings, although the underlying causes may differ. Soft-storey mechanisms were also widely observed,
191 especially in buildings with open ground floors used for commercial purposes or parking. In such cases,
192 the abrupt reduction in lateral stiffness at the ground-storey level led to concentration of drift demand and,
193 in many instances, severe damage or partial collapse (Sezgin et al., 2024). Torsional effects were
194 frequently observed together with soft-storey response, particularly in buildings with asymmetric plan
195 configurations or irregular stiffness distribution. Representative before- and after-earthquake examples
196 illustrating severe structural damage associated with soft-storey behavior and related failure patterns are
197 shown in Figure 5.

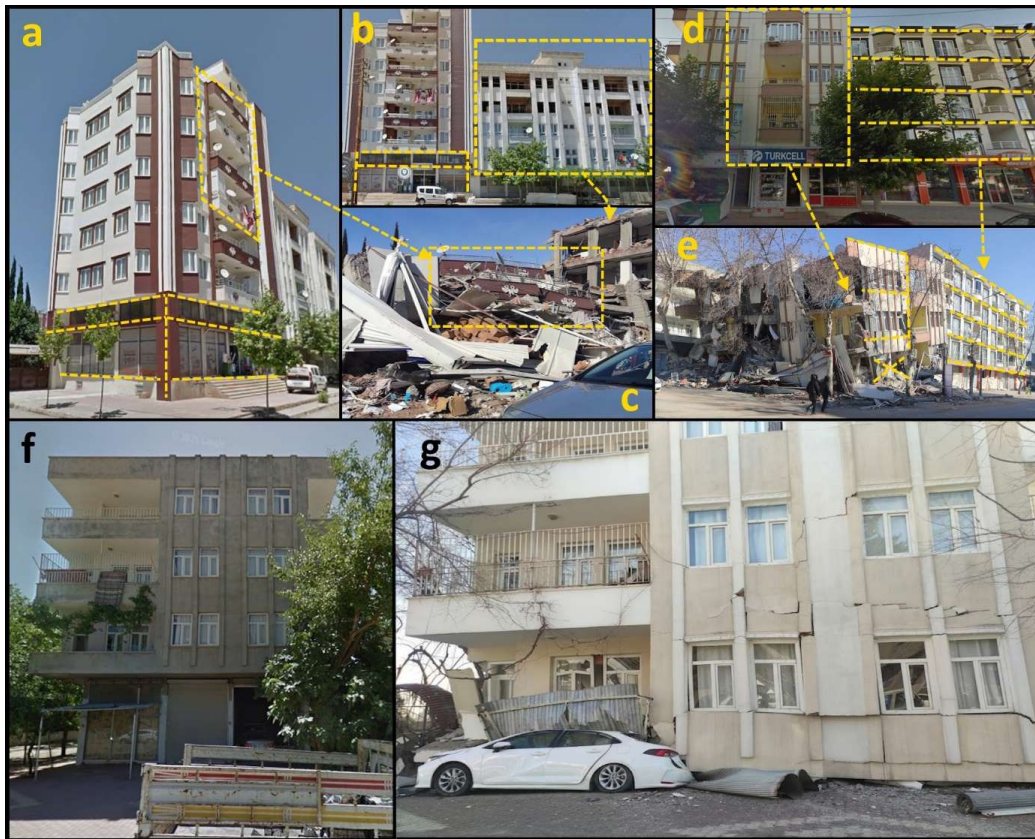
200 **Figure 5.** Before- and after-earthquake conditions of RC buildings affected by the February 6, 2023,
201 *Kahramanmaraş earthquake sequence.*

203 Pre-earthquake views of a relatively new, code-compliant RC building in Adıyaman with an open ground
204 storey used for commercial purposes are presented in Fig. 5a,b. The post-earthquake condition of the same
205 building (Fig. 5c) shows collapse and severe damage, primarily concentrated at the ground-storey level.
206 Similarly, Fig. 5d illustrates the pre-earthquake condition of an older RC building in Malatya with an open
207 ground floor, while Fig. 5e shows the post-earthquake state, characterized by widespread damage and
208 partial collapse. Another older RC building in Malatya is shown before the earthquake in Fig. 5f and after
209 the event in Fig. 5g, where severe damage to the main load-bearing elements is evident. In addition to
210 these observations, detailing-related deficiencies, such as inadequate lap splice regions, insufficient
211 anchorage lengths, and improper reinforcement arrangement, played a significant role in the progression

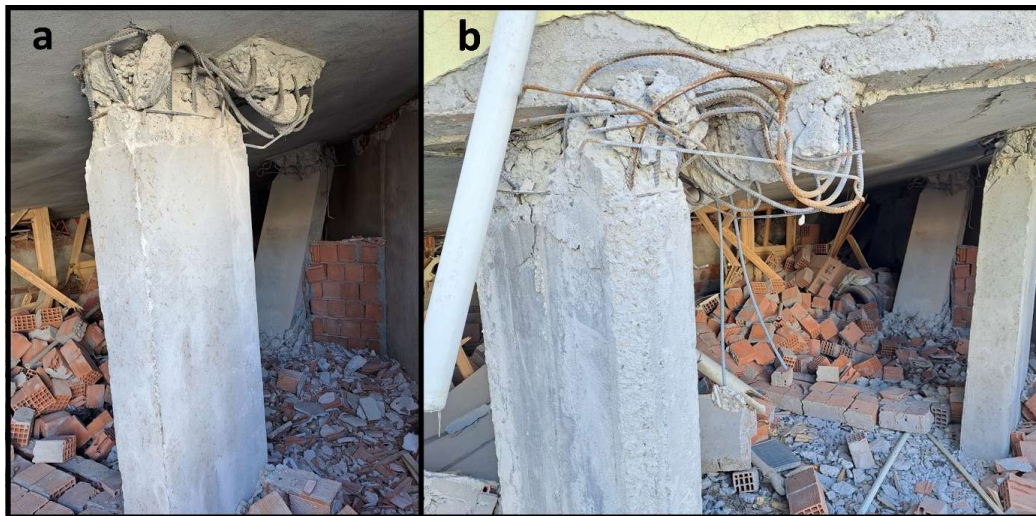
Figure 6. Torsional damage patterns observed in RC buildings affected by the February 6, 2023, Kahramanmaraş earthquake sequence

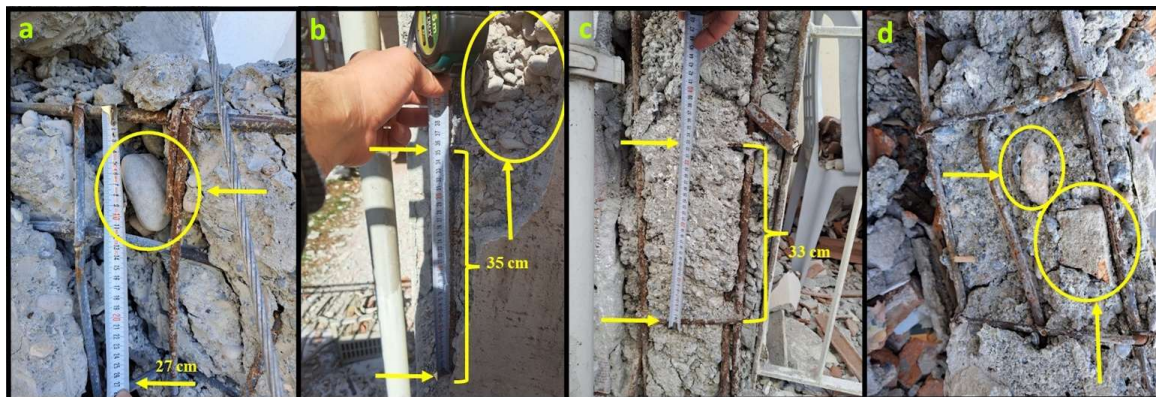
Figure 7. Reinforcement detailing deficiencies and material-quality-related damage observed in older RC buildings following the February 6, 2023, Kahramanmaraş earthquake sequence.

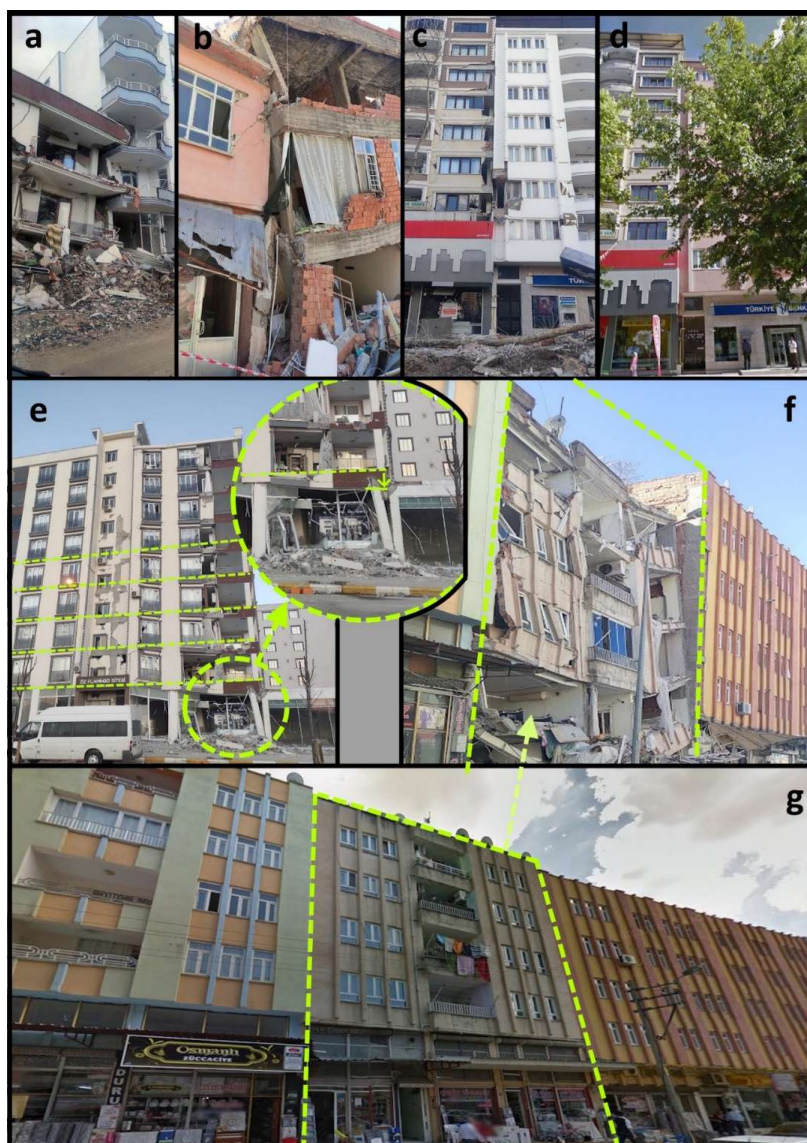
The pounding effect can be clearly observed in both older buildings constructed in accordance with previous seismic codes and in more recently designed structures built under current regulations such as the 2018 Turkish Seismic Code (TSC-2018). As shown in Figure 8, field observations following the earthquake, together with the corresponding pre-event conditions, clearly highlight the widespread occurrence of the pounding effect in closely spaced buildings. Figure 8a) presents a representative case from Adiyaman, where severe structural damage is observed after the seismic sequence. The comparison between pre- and post-earthquake conditions in Figures 8 c) and 8 d) further illustrates the extent of structural deterioration, ranging from extensive damage to partial collapse. A particularly critical case is depicted in Figure 8 e), where the missing of an adequate seismic separation gap, combined with a ground-floor commercial extension characterized by a relatively short dynamic period, resulted in a pronounced

235 pounding interaction. This interaction primarily affected the corner column located at the building edge,
236 leading to severe local failure and near-collapse conditions. In this instance, the impact demands arising
237 from dynamic incompatibility between adjacent structures were further amplified by stiffness
238 irregularities at the lower storey. Finally, Figures 8 f) and 8 g) present the pre- and post-earthquake
239 conditions of adjacent mid-rise residential blocks arranged in a row configuration. The observed damage
240 pattern in Figure 8 f) confirms that pounding was not an isolated phenomenon but rather a recurrent failure
241 mechanism in densely built urban areas, particularly where adequate separation joints were either absent
242 or insufficiently detailed.

245 **Figure 8.** Seismic damage observations and corresponding pre-earthquake conditions of adjacent and

246 *mid-rise buildings: (a) Adıyaman; (b–c) member collapse; (d) pre-earthquake of (c); (e) localized*
247 *collapse by pounding; (f–g) comparison of pre- and post-earthquake conditions.*

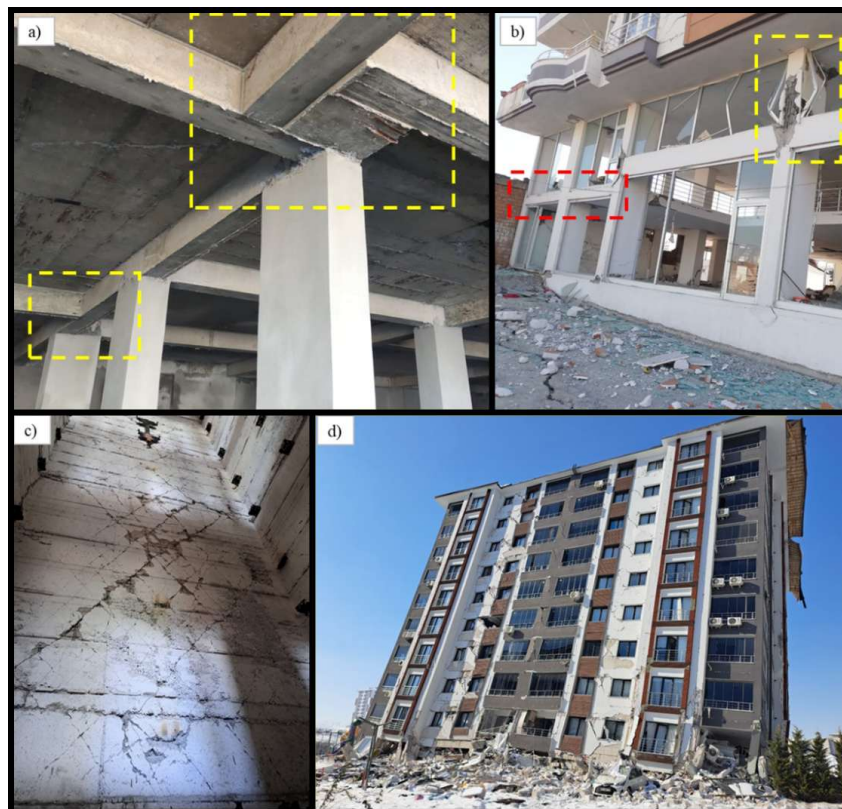
259 susceptibility of these buildings to severe damage under strong ground motions (Onat et al., 2024; Sezgin
260 et al., 2024; Yön et al., 2025) . Representative examples of such damage are presented in Figures 9 c) and
261 9 d), which include photographs taken in Malatya Province illustrating the observed deficiencies in the
262 field. In addition, deviations between the intended design and the as-built structural system were
263 documented in several damaged buildings. These deviations included deficiencies associated with
264 construction quality, inadequate site supervision, and execution-related inconsistencies. Such factors
265 contributed to unsatisfactory seismic performance even in buildings designed in accordance with modern
266 seismic code provisions (Erbaş et al., 2025; Yön et al., 2025). In this context, a field photograph taken in
267 Adıyaman Province, illustrating representative examples of these deficiencies, is presented in Figure 9 a).

Figure 9. Damage mechanisms observed in newer RC buildings

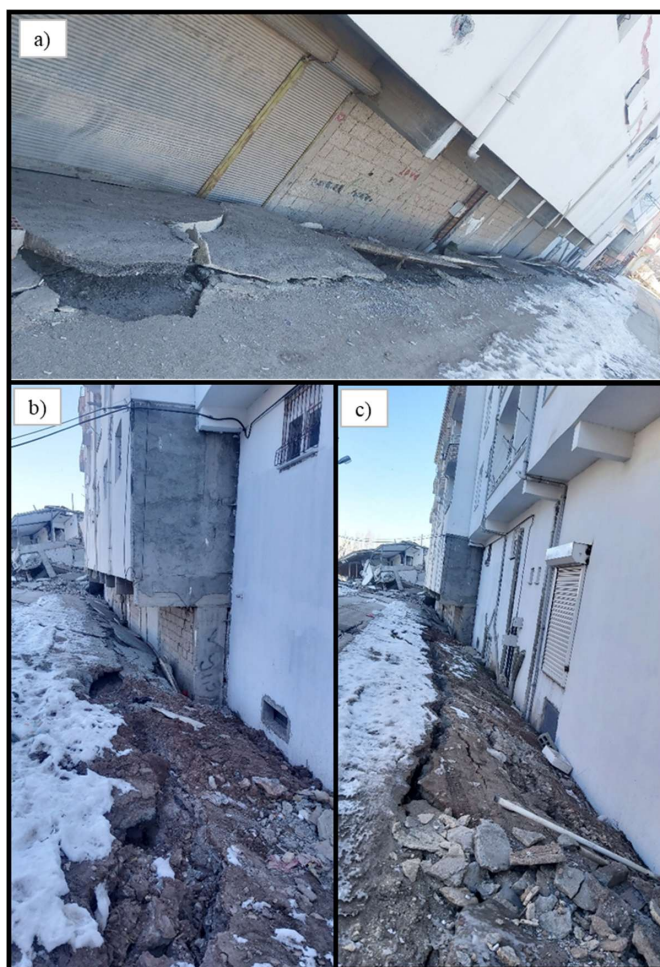
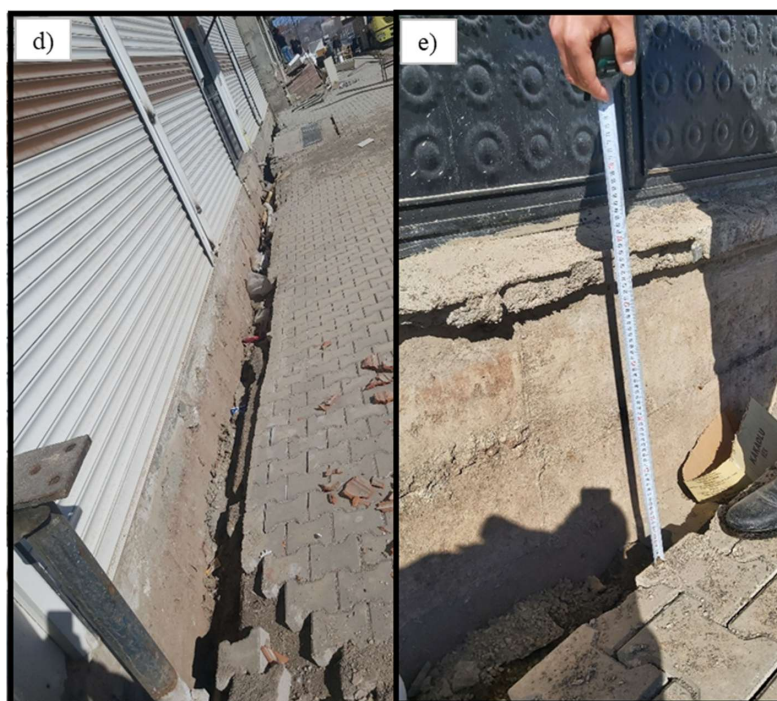
292 Within the investigated areas, earthquake-induced liquefaction led to significant ground settlements and
293 the partial sinking of several structures into the soil. As a result, damage and collapses were observed in
294 many buildings, with settlements reaching 60 cm or more in some cases (Fig 11).

Figure 11. Settlements of superstructure induced by bearing capacity loss and differential foundation settlement

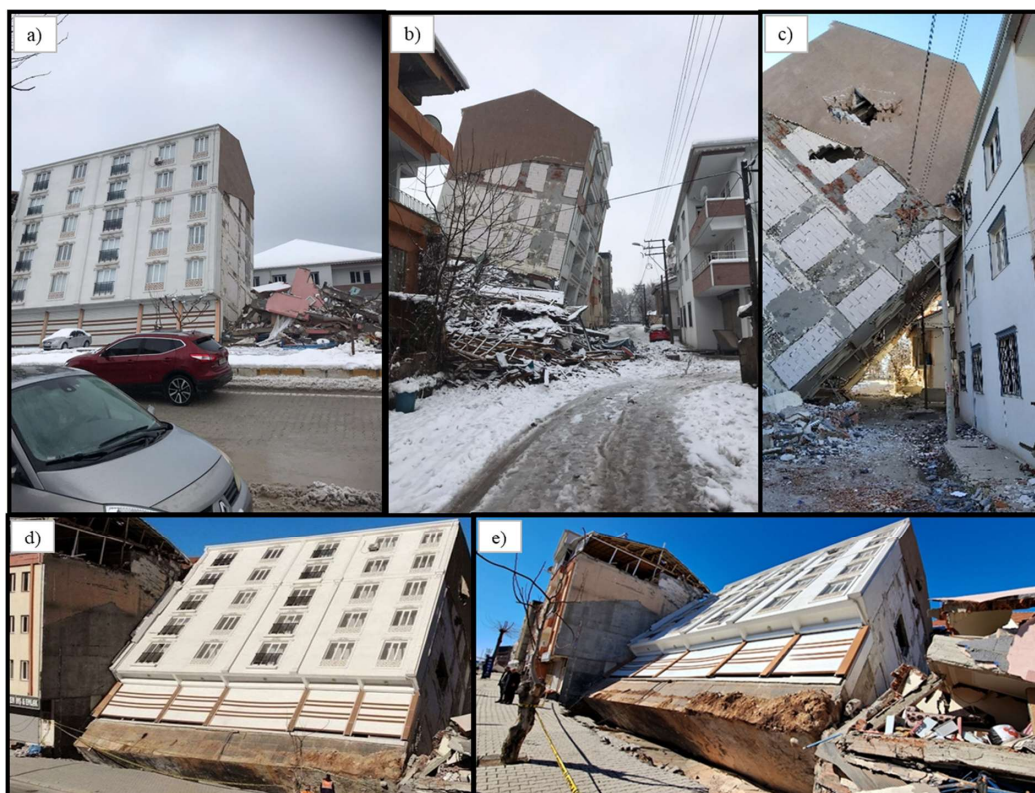
As illustrated in Figure 12, the consequences of liquefaction on structural performance can be observed in a progressive manner. The affected building gradually penetrated into the softened ground due to the loss of soil bearing capacity and eventually experienced substantial overturning, coming to rest against the neighboring structures located behind it. Such field evidence demonstrates that earthquake-induced damage may be governed not only by the seismic resistance of the superstructure but also by the response of the supporting ground. Therefore, the observed damage patterns should be interpreted as the combined outcome of liquefaction susceptibility, foundation performance, and soil–foundation–structure interaction rather than as a consequence of superstructure behavior alone. (Erbaş et al., 2025).

311 **Figure 12.** *Overturning of a superstructure step by step due to low bearing capacity of soil with high*
312 *ground water table*

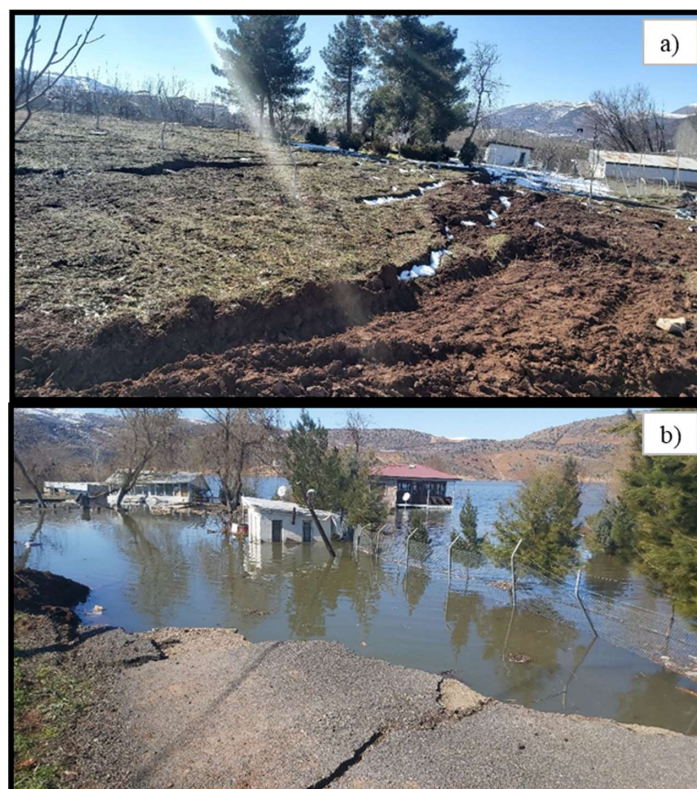
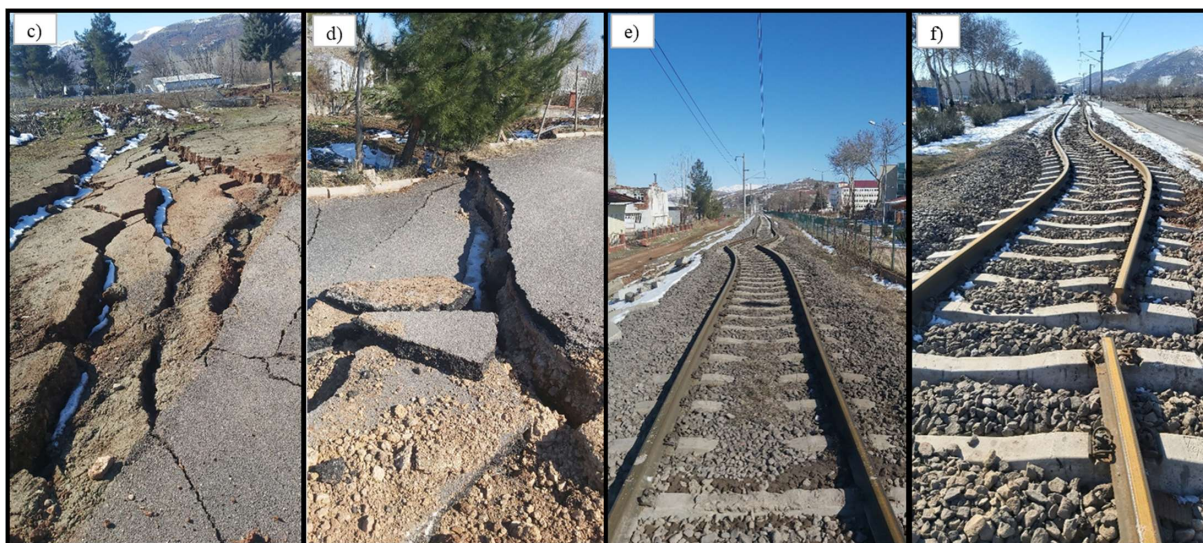
314 Lateral spreading was also observed in the investigated area as a result of earthquake-induced liquefaction (Figure
315 13 a and c). The combined effects of liquefaction and lateral spreading caused severe damage and, in some cases,
316 collapse in buildings, highways, and railway infrastructure (Figures 13 b, d, e and f).

Figure 13. Lateral spreading observed in the ground

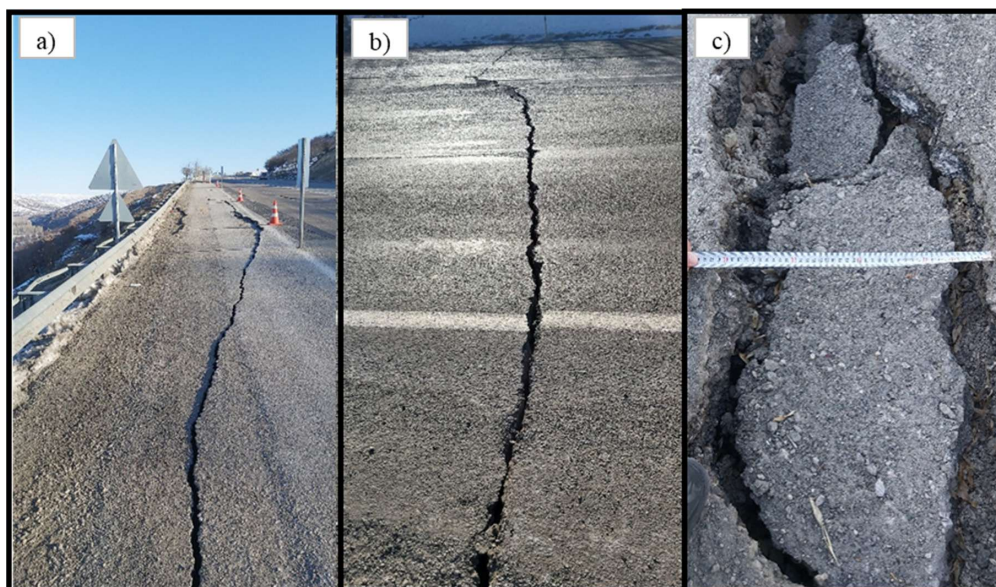
323 During the field observations conducted along the Malatya–Gölbaşı route, earthquake-induced damage
324 was identified on several roadway sections. The inspections revealed cracks in the road pavement reaching
325 widths of up to 40 cm in some locations (Fig 14).

Figure 14. Damage observed on roadways

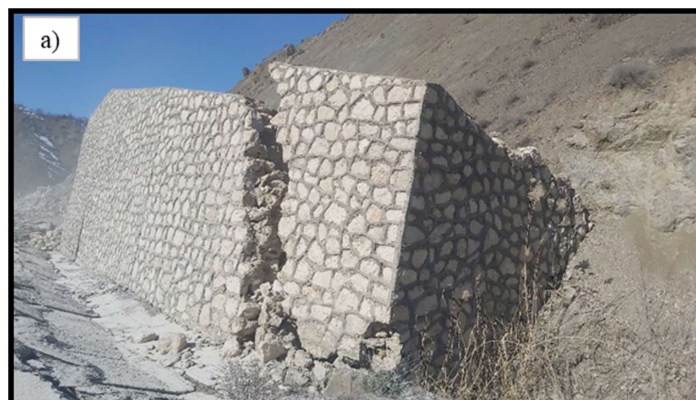
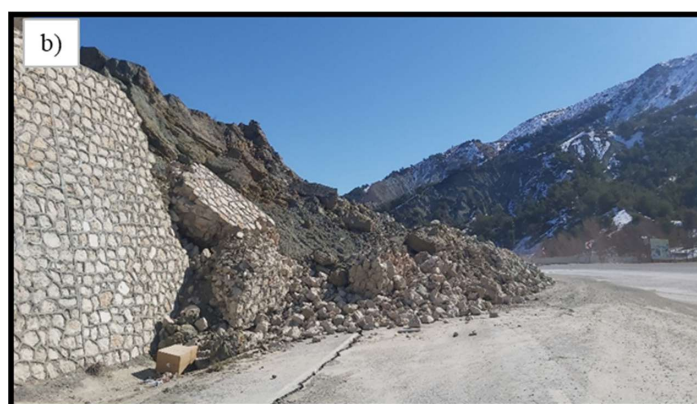
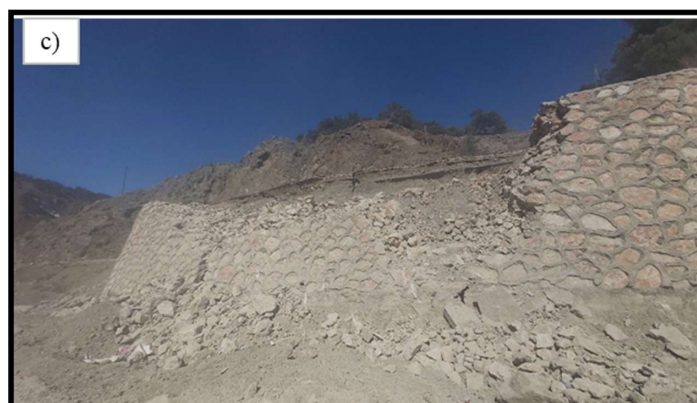
328 In the investigated areas, damage was particularly observed in gravity-type stone retaining walls located
329 along roadways. In sloping terrain, landslides together with the failure of these retaining walls led to the
330 closure of road transportation in certain sections of the affected region (Fig 15).

Figure 15. Damage observed in gravity-type stone retaining walls

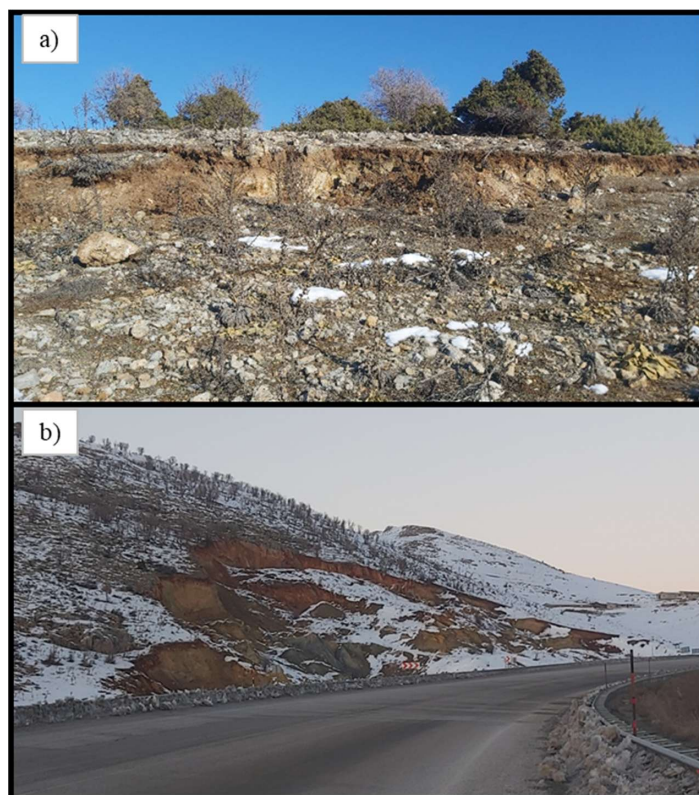
339 As a result of the earthquakes, the loss of soil strength in sloping areas triggered landslides and rockfalls
340 at various locations within the affected region (Figs 16 and 17).

Figure 16. Landslides observed in the investigated areas

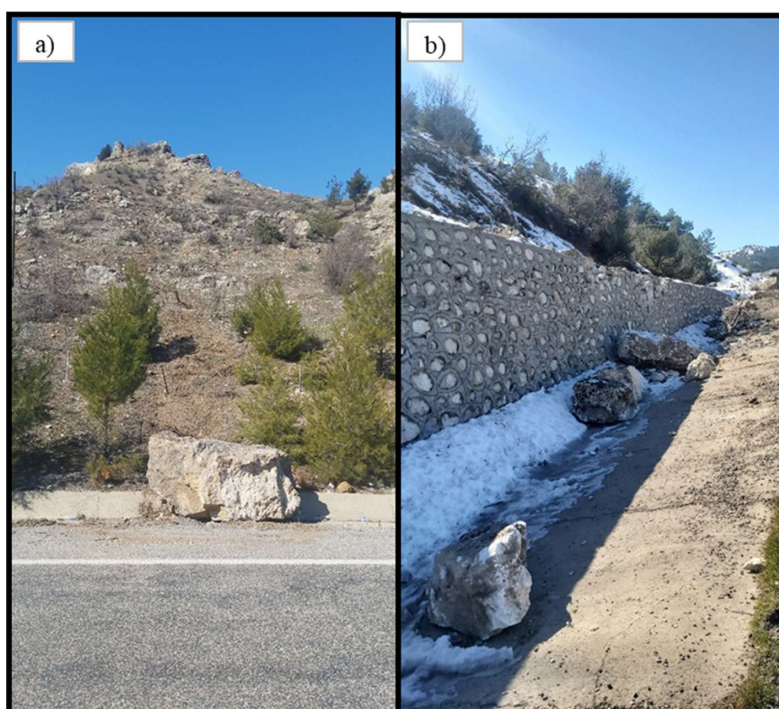
Figure 17. Rockfalls observed in the investigated areas
