Reliability of flood marks and practical relevance for flood hazard assessment in south-west Germany

Annette Sophie Böсмеier¹, Iso Himmelsbach², Stefan Seeger³

¹Chair of Geomorphology and Recent Morphodynamics, University of Freiburg, Freiburg, 79085, Germany

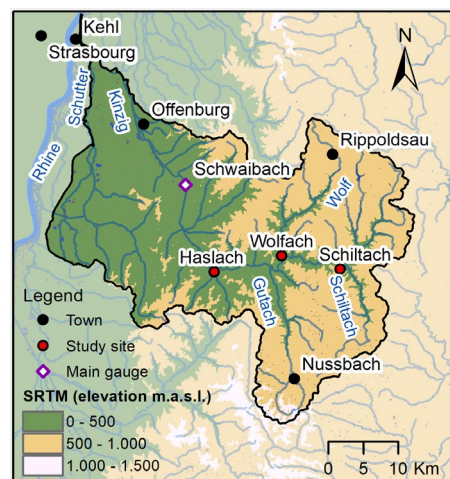
Figure 1: The Kinzig catchment with its main tributaries and relevant locations. Data: channel network and catchment shape from “Amtliches Digitales Wasserwirtschaftliches Gewässernetz” (AWGN) provided by the LUBW; SRTM (Shuttle Radar Topography Mission): Jarvis et al. (2008).

The Kinzig catchment is located in the west of Baden-Wuerttemberg, south-west Germany (Fig. 1). It extends from the central Black Forest mountain range with an altitude of about 1080 m down to the southern Upper Rhine Valley at 134 m. With a size of 1406 km², it is the largest tributary to the Upper Rhine river from the western side of the Black Forest. The catchment is to a large extent covered by a hilly to mountainous landscape, has a compact shape, and a large headwater area with a number of narrow sub-catchments with a steep gradient. This contributes to rapid flood generation and high flood discharges, e.g. 1050 m³s⁻¹ for the 100-year flood (HQ100) in comparison to the annual mean flow of 23.5 m³s⁻¹ at the main gauge Schwaibach.

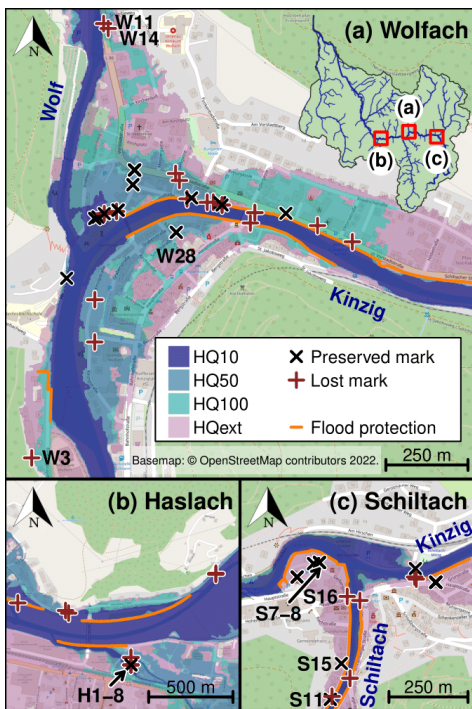
Figure 2: Locations of collected marks, both preserved and lost but documented, at the three study sites (a-c). The flood protection walls and the areas most likely to be flooded during HQ10 to HQextreme flood events were extracted from the FHM (LUBW, 2018). The labels, which refer to the mark location by the site initials and to the utilized sequential numbering, e.g. H1, are displayed for particular marks. Basemap: distributed under the Open Data Commons Open Database License (ODbL) v1.0.

It appeared that flood marks were less likely to be ‘lost’ when installed at houses in the town (Schiltach and Wolfach) than positioned directly along the river (Haslach, compare Fig. 2). Generally, flood marks that had been attached to bridges before the 20th century were not found any more as the bridges across the Kinzig and its tributaries were frequently destroyed and rebuilt. Similarly, flood mark stones or pillars positioned along the river embankment or on roads close to the river were mostly not preserved. Likely reasons may be construction activities along the river such as the renewal or extension of dams, walls,

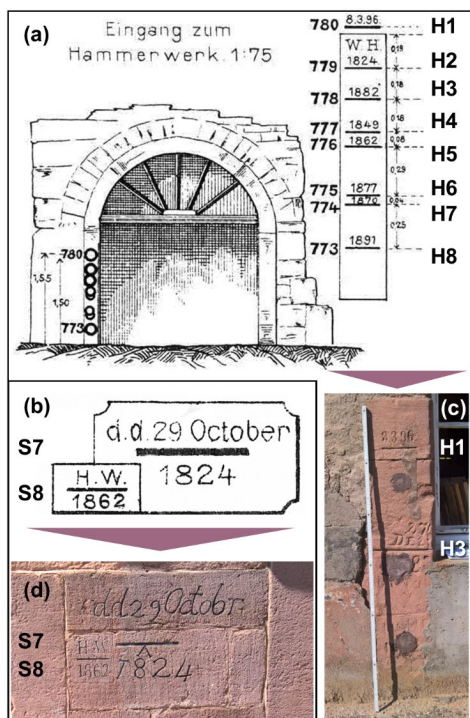
Figure 3: Historical documentation of flood marks (modified from CMH, 1908) in Haslach (a) and Schiltach (b). The remaining preserved marks at these sites in July 2018 are displayed in (c) and (d). The labels refer to Fig. 2.

With regard to type and appearance, the mapped markings are mostly made of notches engraved in bricks or house walls, indicating the maximum flood level. A number of marks are located on particular stone slabs and a few on metal slabs. Some are rather painted than engraved, and often, weathered engravings have been repainted. Most of the collected flood marks are not only engraved but also painted. Some older marks appear repainted, obviously in order to preserve the signs (Fig. 3d), however due to weathering, it is not always clear whether or not they initially also had been engraved. Typically, the year of the flood event is inscribed next to the notch, frequently in combination with the labels “H.W.” or “Hochwasser”, which is German for “flood”. Some marks even show the exact date of the flood, occasionally with the prefix “d.d.” which is an abbreviation for the Latin *de dato* (“from the date”, see Fig. 3b,d).

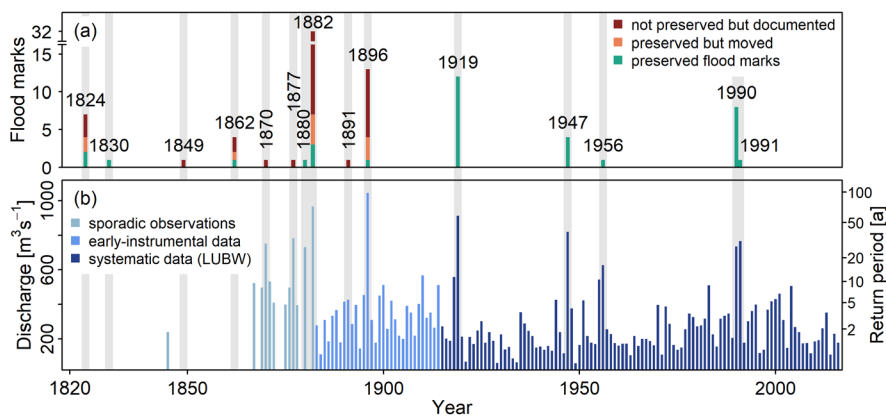
Figure 4: Number of collected flood marks in Haslach, Wolfach, and Schiltach with red and orange bars showing deviations from the historical flood mark survey (a), and associated peak discharges at the gauge Schwaibach (b). The record of annual discharge maxima combines data reconstructed from peak water levels (1845–1914) with systematic measurements since 1915 (Bösmeier, 2020).

The results of this consistency check showed that 10 out of 17 preserved flood marks likely obviously had been moved and reinstalled (Fig. 4a, in orange). Yet, a considerable (> 15 cm) height difference between the historical and the current position was only found for seven marks, as shown in Fig. 5d. One potential reason may be the integration of cornerstones with engraved flood marks into new buildings, regardless of their original position, inducing significant alterations. This might have caused the 0.5-m height difference between the documented and preserved marks H1 and H3 in Haslach (Fig. 3a,c, Fig. 5d). Then, 10 marks showed an insignificant height difference to their historical position, among them seven marks without and three with clear indications of reinstallation (Fig. 5d). Hence, some flood marks have been maintained and reinstalled close to the original after a new building construction. Nevertheless, even some marks in a very good condition – apparently maintained and repainted – were found to be significantly (about 30 cm) below their documented historical position (Fig. 5d, S24–27). Thus, clear signs of flood mark conservation are no proof for their trustworthiness. As a consequence, the historical information in CMH (1908) was generally assigned higher credibility if preserved marks showed considerable alterations. A precondition for this, however, was a successful plausibility check between the historical flood mark description and further written sources, as described above.

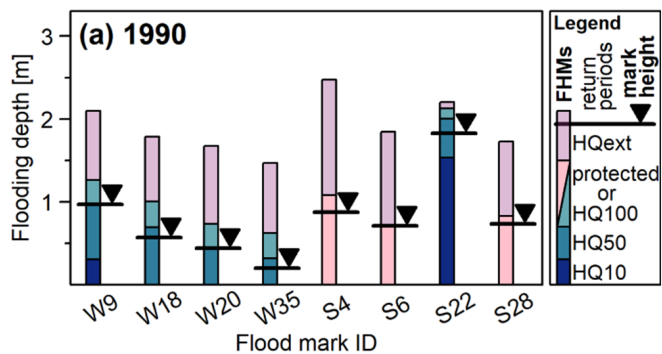
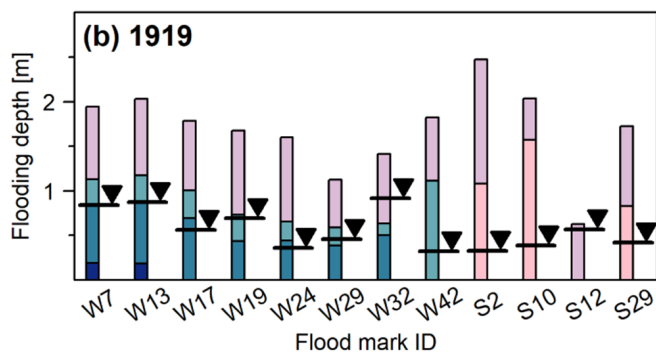
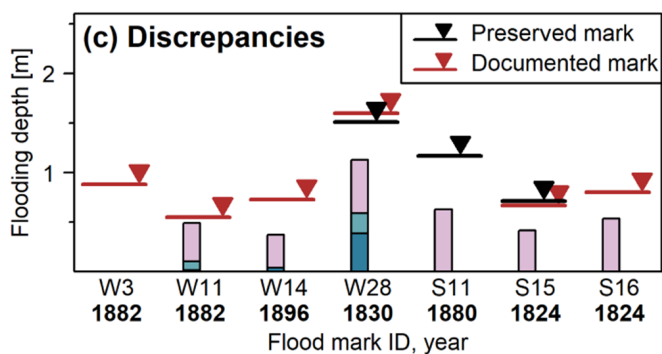
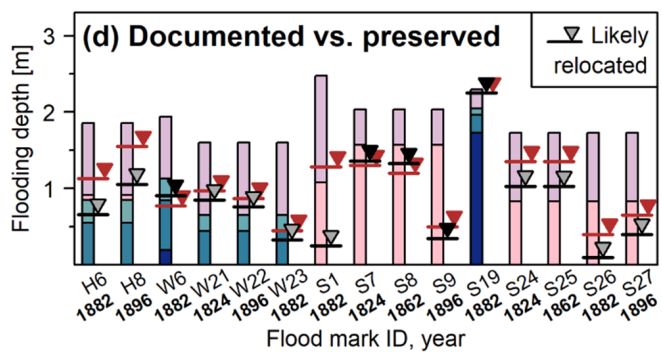
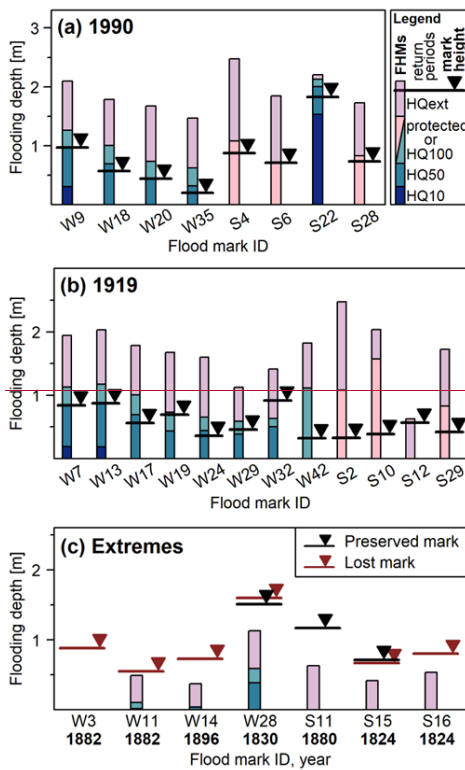
415 **Figure 5: Flood marks and the local flooding depths of the flood hazard maps (LUBW, 2018). All marks in Wolfach and Schiltach are displayed (a) which refer to the flood on February 15, 1990, (b) the flood in December 1919, or (c) which exceeded the HQextreme. (d) All other pairs of documented and preserved marks with indication of likely reinstalled marks.**

A further systematic plausibility check demonstrated that the large majority of the marks are ~~also~~ well supported by written sources, such as the chronicles of Schiltach (Trautwein, 1898) or Wolfach (Disch, 1920). These sources describe – in parts very detailed – the temporal evolution, extent or severity of the floods. ~~Firstly~~, all flood marks, except one, could be associated with flood events that were documented by written information. Reports were only missing for the ~~already-mentioned~~ 1891 mark in Haslach, which as a consequence was classified as ~~questionable-doubtful~~. Secondly, the qualitative comparison between the marks and the content of the associated written documents did not reveal explicit and considerable discrepancies. By contrast, some statements literally verify particularly high marks by describing the extent or maximum water level in reference to specific landmarks, buildings or bridges. One example represents the extreme flood in 1896, when the Kinzig tributary Wolf tore parts of the graveyard in Wolfach away (Disch 1920). Another example is the disastrous ice jam in 1830: according to the chronicle of Wolfach, the flood followed a very cold winter. Since a large amount of ice, unrooted trees, and other material blocked the river bed in Wolfach, the Kinzig forged its way through the suburb (Disch, 1920). The consequence was an outstandingly high flood water level which even reached the first floor, as reports stated. This is documented by an extraordinary high mark in Wolfach (W28, Fig. 5c).

Then, an event-specific relative comparison between marks and FHMs demonstrated an overall good agreement, which can be considered a mutual verification between marks and modeled hazard maps. In February 1990, for instance, the Kinzig catchment was struck by a severe flood with a recurrence interval between 20 and 50 years at Schwaibach in the lower catchment; with several flood marks recording local flood levels. Several marks remind of this incident (Fig. 5a). Since long gauge records were not available directly at the study sites, it was not possible to reconstruct and assign local return periods to the marks using conventional flood frequency analysis approaches (Bösmeier, 2020). Therefore, the absolute FHM flooding depths could not be verified directly and precisely utilizing the flood marks. However, a relative comparison was possible: all four marks in Wolfach are placed at heights approximately corresponding to HQ50 adding confidence to the HQ50 estimation and mapping. It is remarkable how clearly the mark heights mimic the FHM flooding depths, which points to a systematic and reliable installation. In Schiltach, one mark (S22) also points to a flood between HQ20 and HQ50. However, three other marks are situated within an area meanwhile protected against floods up to HQ100 by walls at the waterside of the Kinzig and its tributary, the river Schiltach. Hence, local hydraulic conditions cannot be compared with the situation during the flood in 1990. This may also explain why the recurrence intervals in Fig. 5a do not match with the other marks. Similar results, yet with larger deviations, were found for the extreme flood in December 1919, which was an event between HQ50 and HQ100 according to the measurements at Schwaibach (Fig. 5b).
