Reliability of flood marks and practical relevance for flood hazard assessment in south-west Germany

Annette Sophie Bösemeier¹, Iso Himmelsbach², Stefan Seeger³

¹Chair of Geomorphology and Recent Morphodynamics, University of Freiburg, Freiburg, 79085, Germany

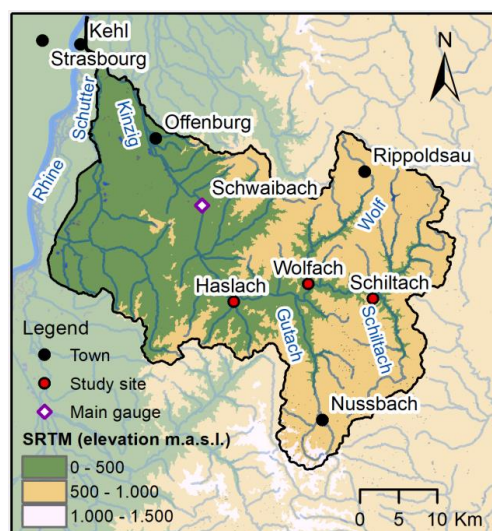
125 **Figure 1: The Kinzig catchment with its main tributaries and relevant locations. Data: channel network and catchment shape from “Amtliches Digitales Wasserrwirtschaftliches Gewässernetz” (AWGN) provided by the LUBW; SRTM (Shuttle Radar Topography Mission): Jarvis et al. (2008).**

The Kinzig catchment is located in the west of Baden-Wuerttemberg, south-west Germany (Fig. 1). It extends from the central Black Forest mountain range with an altitude of about 1080 m down to the southern Upper Rhine Valley at 134 m. With a size of 1406 km², it is the largest tributary to the Upper Rhine river from the western side of the Black Forest. The catchment is to a large extent covered by a hilly to mountainous landscape, has a compact shape, and a large headwater area with a number of narrow sub-catchments with a steep gradient. This contributes to rapid flood generation and high flood discharges, e.g. 1050 m³s⁻¹ for the 100-year flood (HQ100) in comparison to the annual mean flow of 23.5 m³s⁻¹ at the main gauge Schwaibach.

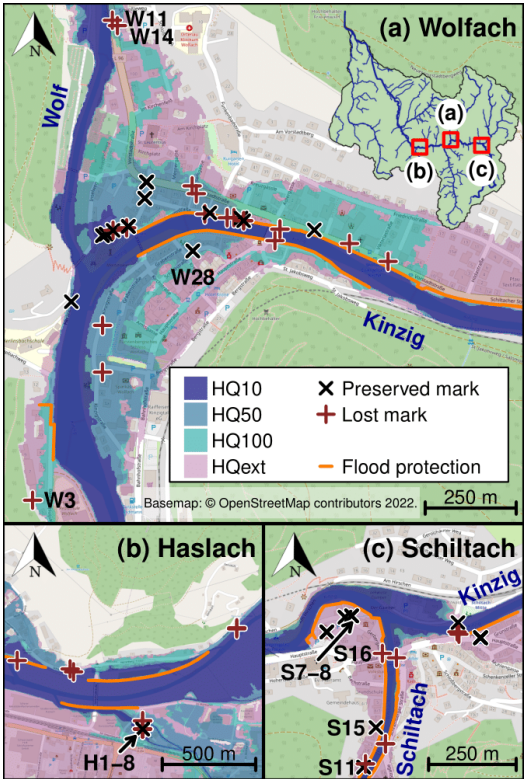
Figure 2: Locations of collected marks, both preserved and lost but documented, at the three study sites (a-c). The flood protection walls and the areas most likely to be flooded during HQ10 to HQextreme flood events were extracted from the FHMs (LUBW, 2018). The labels, which refer to the mark location by the site initials and to the utilized sequential numbering, e.g. H1, are displayed for particular marks. Basemap: distributed under the Open Data Commons Open Database License (ODbL) v1.0.

The majority of the flood marks were attached to houses along the river and to the river embankment, and some can be found at bridges or bridge abutments. Hence, they exist or existed in close proximity to the river. Yet, a few flood marks are also located at a distance of more than 100 m to the river (Fig. 2). While many single marks can be found, more than one mark has been installed at most locations. A gateway in Haslach once even displayed a series of eight different marks referring to some of the largest flood events of the past centuries (Fig. 3a). A large majority of the currently preserved marks is well-visible from public places. Only a small number is strongly weathered or somewhat hidden so that a close look at the right location is necessary to discover the mark.

It appeared that flood marks were less likely to be ‘lost’ when installed at houses in the town (Schiltach and Wolfach) than positioned directly along the river (Haslach, compare Fig. 2). Generally, flood marks that had been attached to bridges before the 20th century were not found any more as the bridges across the Kinzig and its tributaries were frequently destroyed and rebuilt. Similarly, flood mark stones or pillars positioned along the river embankment or on roads close to the river were mostly not preserved. Likely reasons may be construction activities along the river such as the renewal or extension of dams, walls,

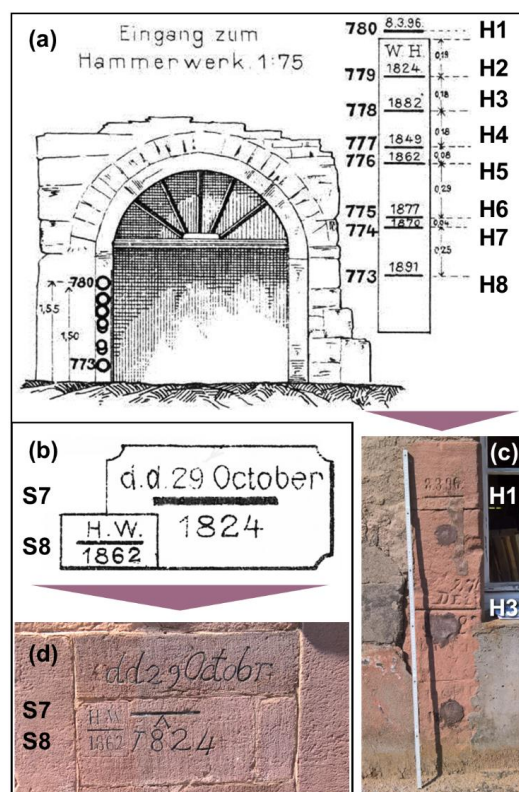
Figure 3: Historical documentation of flood marks (modified from CMH, 1908) in Haslach (a) and Schiltach (b). The remaining preserved marks at these sites in July 2018 are displayed in (c) and (d). The labels refer to Fig. 2.

With regard to type and appearance, the mapped markings are mostly made of notches engraved in bricks or house walls, indicating the maximum flood level. A number of marks are located on particular stone slabs and a few on metal slabs. Some are rather painted than engraved, and often, weathered engravings have been repainted, obviously in order to preserve the signs (Fig. 3b). Typically, the year of the flood event is inscribed next to the notch, frequently in combination with the labels “H.W.” or “Hochwasser”, which is German for “flood”. Some marks even show the exact date of the flood, occasionally with the prefix “d.d.” which is an abbreviation for the Latin *de dato* (“from the date”, see Fig. 3b,d).

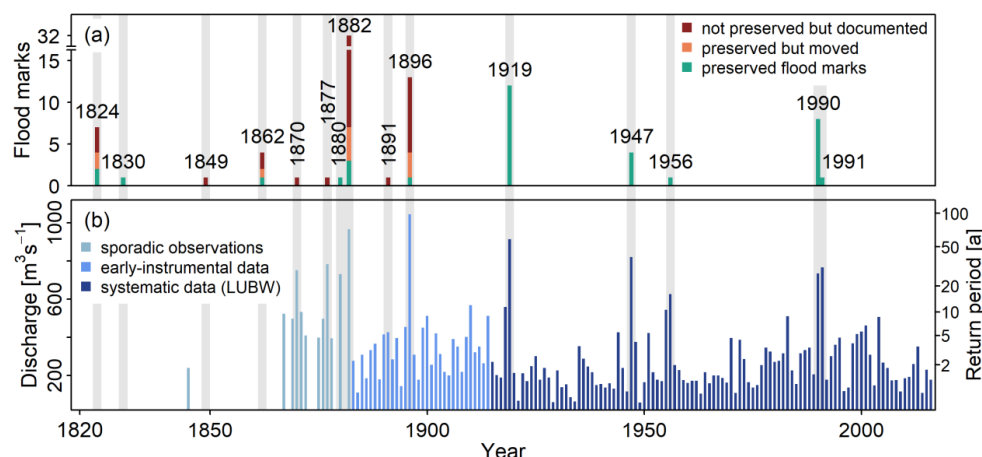
Figure 4: Number of collected flood marks in Haslach, Wolfach, and Schiltach with red and orange bars showing deviations from the historical flood mark survey (a), and associated peak discharges at the gauge Schwaibach (b). The record of annual discharge maxima combines data reconstructed from peak water levels (1845–1914) with systematic measurements since 1915 (Bösmeier, 2020).

The results of this consistency check showed that 10 out of 17 preserved flood marks obviously had been moved and reinstalled (Fig. 4a, in orange). Yet, a considerable (> 15 cm) height difference between the historical and the current position was only found for seven marks. One potential reason may be the integration of cornerstones with engraved flood marks into new buildings, regardless of their original position, inducing significant alterations. This might have caused the 0.5 m height difference between the documented and preserved marks H1 and H3 in Haslach (Fig. 3a,c). Then, 10 marks showed an insignificant height difference to their historical position, among them seven marks without and three with clear indications of reinstallation. Hence, some flood marks have been maintained and reinstalled close to the original after a new building construction. Nevertheless, even some marks in a very good condition – apparently maintained and repainted – were found to be significantly (about 30 cm) below their documented historical position. Thus, clear signs of flood mark conservation are no proof for their trustworthiness. As a consequence, the historical information in CMH (1908) was generally assigned higher credibility if preserved marks showed considerable alterations. A precondition for this, however, was a successful plausibility check between the historical flood mark description and further written sources, as described above.

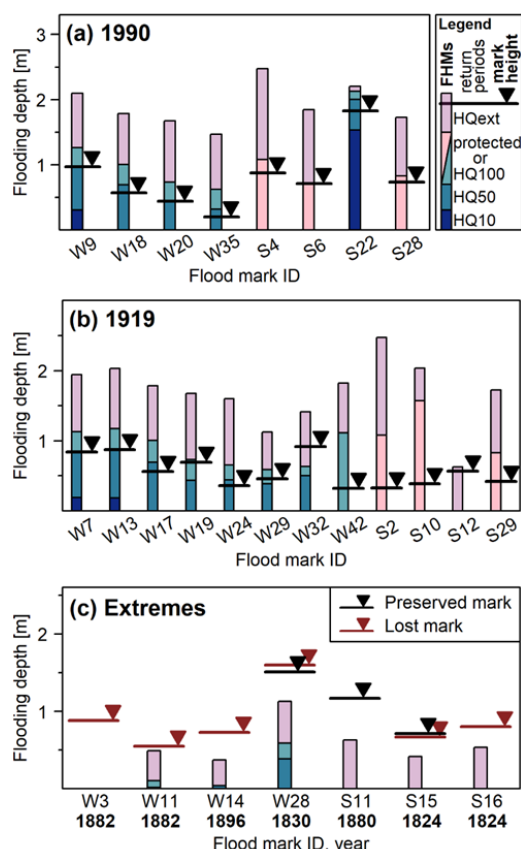
395 **Figure 5: Flood marks and the local flooding depths of the flood hazard maps (LUBW, 2018). All marks in Wolfach and Schiltach are displayed (a) which refer to the flood on February 15, 1990, (b) the flood in December 1919, or (c) which exceeded the HQextreme.**

A further systematic plausibility check demonstrated that the large majority of the marks are also well supported by written sources, such as the chronicles of Schiltach (Trautwein, 1898) or Wolfach (Disch, 1920). These sources describe – in parts very detailed – the temporal evolution, extent or severity of the floods. Firstly, all flood marks, except one, could be associated with flood events that were documented by written information. Reports were only missing for the already mentioned 1891 mark in Haslach, which as a consequence was classified as doubtful. Secondly, the qualitative comparison between the marks and the content of the associated written documents did not reveal explicit and considerable discrepancies. By contrast, some statements literally verify particularly high marks by describing the extent or maximum water level in reference to specific landmarks, buildings or bridges. One example represents the extreme flood in 1896, when the Kinzig tributary Wolf tore parts of the graveyard in Wolfach away (Disch 1920). Another example is the disastrous ice jam in 1830: according to the chronicle of Wolfach, the flood followed a very cold winter. Since a large amount of ice, unrooted trees, and other material blocked the river bed in Wolfach, the Kinzig forged its way through the suburb (Disch, 1920). The consequence was an outstandingly high flood water level which even reached the first floor, as reports stated. This is documented by an extraordinary high mark in Wolfach (W28, Fig. 5c).

390 Hence, local hydraulic conditions cannot be compared with the situation during the flood in 1990. This may also explain why the recurrence intervals in Fig. 5a do not match with the other marks. Similar results, yet with larger deviations, were found for the extreme flood in December 1919, which was an event between HQ50 and HQ100 according to the measurements at Schwaibach (Fig. 5b).

Finally, a number of marks with extreme heights in comparison to the FHM were found. Seven marks exceeded the modeled flooding depths of an HQextreme event, most of them quite considerably (Fig. 5c). Searching for factors that could explain these discrepancies, the individual cases were examined. Two of the seven marks are located along the Kinzig: W3, which appeared plausible as aforementioned, and W28. The latter is a reminder of the massive ice jam in Wolfach in February 1830 and its plausibility could be verified (Sect. 4.1.2). Strikingly, five of the seven marks above the HQextreme were situated along tributary rivers. In Wolfach, W11 and W14 existed along the Wolf roughly 500 m upstream of the confluence between Wolf and Kinzig. In Schiltach, S11, S15, and S16 were or still are situated along the Schiltach river. There, protective walls have been installed (Fig. 2), which considerably improved the flood situation and changed hydraulic conditions. Nevertheless, the height of the marks is exceptional – note however, that S11 might have been installed post-hoc (compare 4.1.3) and may be doubtful despite available reports about the flood in 1880. In any case, as opposed to the Schiltach, protective walls do not exist along the Wolf near W11 and W14. Assuming that the historical circumstances are approximately comparable with the current situation, the marks W11 and W14 are evidence of the particular severity of the floods in 1882 and 1896 along the Wolf river. At least for the 1896 event, documentary data confirmed an exceptional destructive power of the Wolf, as described above. These results might indicate a local underestimation of the flood hazard along tributary rivers by the FHM and encourage a review.
