Reliability of flood marks and practical relevance for flood hazard assessment in south-west Germany

Annette Sophie Bösmeier¹, Iso Himmelsbach², Stefan Seeger³

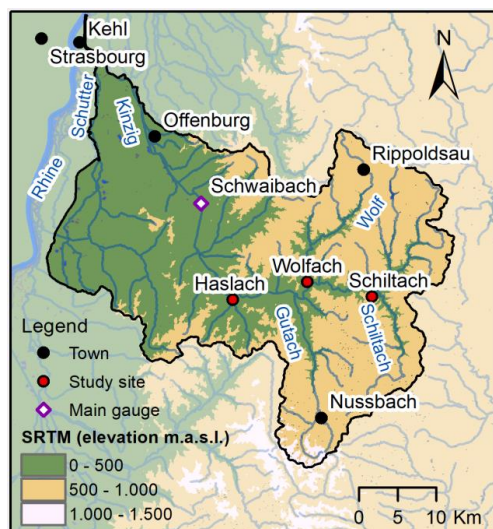
125 **Figure 1: The Kinzig catchment with its main tributaries and relevant locations. Data: channel network and catchment shape from “Amtliches Digitales Wasserwirtschaftliches Gewässernetz” (AWGN) provided by the LUBW; SRTM (Shuttle Radar Topography Mission): Jarvis et al. (2008).**

The Kinzig catchment is located in the west of Baden-Wuerttemberg, south-west Germany (Fig. 1). It extends from the central Black Forest mountain range with an altitude of about 1080 m down to the southern Upper Rhine Valley at 134 m. With a size of 1406 km², it is the largest tributary to the Upper Rhine river from the western side of the Black Forest. The catchment is to a large extent covered by a hilly to mountainous landscape, has a compact shape, and a large headwater area with a number of narrow sub-catchments with a steep gradient. This contributes to rapid flood generation and high flood discharges, e.g. 1050 m³s⁻¹ for the 100-year flood (HQ100) in comparison to the annual mean flow of 23.5 m³s⁻¹ at the main gauge Schwaibach.

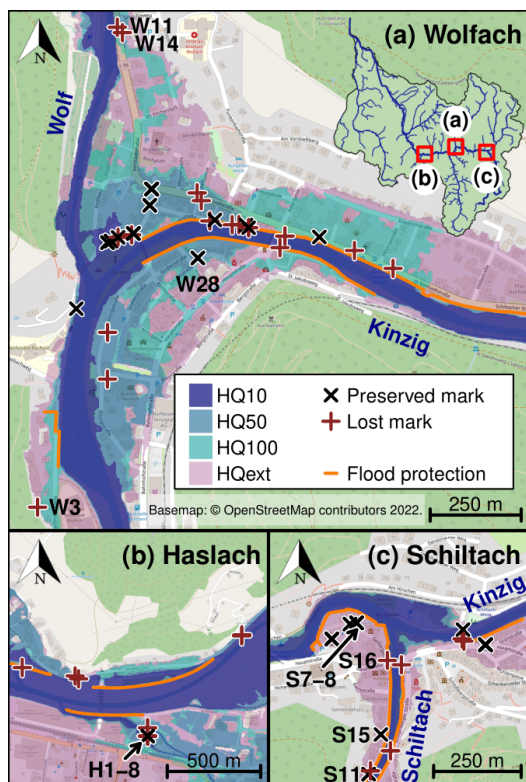
265 **Figure 2:** Locations of collected marks, both preserved and lost but documented, at the three study sites (a-c). The flood protection walls and the areas most likely to be flooded during HQ10 to HQextreme flood events were extracted from the FHMs (LUBW, 2018). The labels, which refer to the mark location by the site initials and to the utilized sequential numbering, e.g. H1, are displayed for particular marks. Basemap: distributed under the Open Data Commons Open Database License (ODbL) v1.0.

It appeared that flood marks were less likely to be ‘lost’ when installed at houses in the town (Schiltach and Wolfach) than positioned directly along the river (Haslach, compare Fig. 2). Generally, flood marks that had been attached to bridges before
 325 the 20th century were not found any more as the bridges across the Kinzig and its tributaries were frequently destroyed and rebuilt. Similarly, flood mark stones or pillars positioned along the river embankment or on roads close to the river were mostly not preserved. Likely reasons may be construction activities along the river such as the renewal or extension of dams, walls,

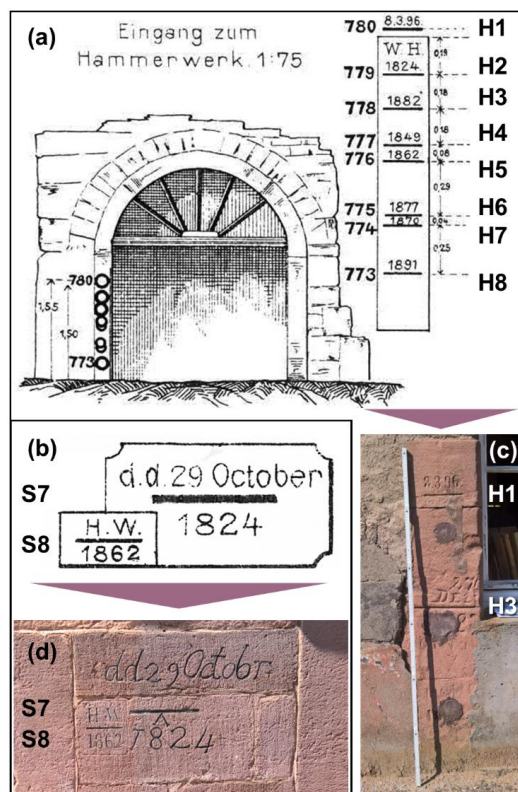
Figure 3: Historical documentation of flood marks (modified from CMH, 1908) in Haslach (a) and Schiltach (b). The remaining preserved marks at these sites in July 2018 are displayed in (c) and (d). The labels refer to Fig. 2.

275 With regard to type and appearance, the mapped markings are mostly made of notches engraved in bricks or house walls, indicating the maximum flood level. A number of marks are located on particular stone slabs and a few on metal slabs. Some are rather painted than engraved, and often, weathered engravings have been repainted, obviously in order to preserve the signs (Fig. 3d). Typically, the year of the flood event is inscribed next to the notch, frequently in combination with the labels “H.W.” or “Hochwasser”, which is German for “flood”. Some marks even show the exact date of the flood, occasionally with the
 280 prefix “d.d.” which is an abbreviation for the Latin *de dato* (“from the date”, see Fig. 3b,d).

A major reservation regarding flood marks and other historical evidence originates from the question of a realistic
comparability between the historical and the current situation. In the Kinzig catchment, the assumption of stationary
hydrological and hydraulic conditions can hardly be retained for the past 200 years in light of several alterations. The possibly
most radical modification in the Kinzig catchment was the river rectification during the 19th century. It affected large parts of
515 the lower and middle reaches, and though the effects are hardly quantifiable, it is assumed to have aggravated historical floods
locally (Bösmeier, 2020). Therefore, the study focused on the upper catchment. Due to its geographical setting, the flood
situation in Haslach may have been influenced by the rectification works, Wolfach and Schiltach, however, are located clearly
above the cut off meanders. In fact, a few floods were represented by marks in Haslach (compare Fig. 3) but they were not

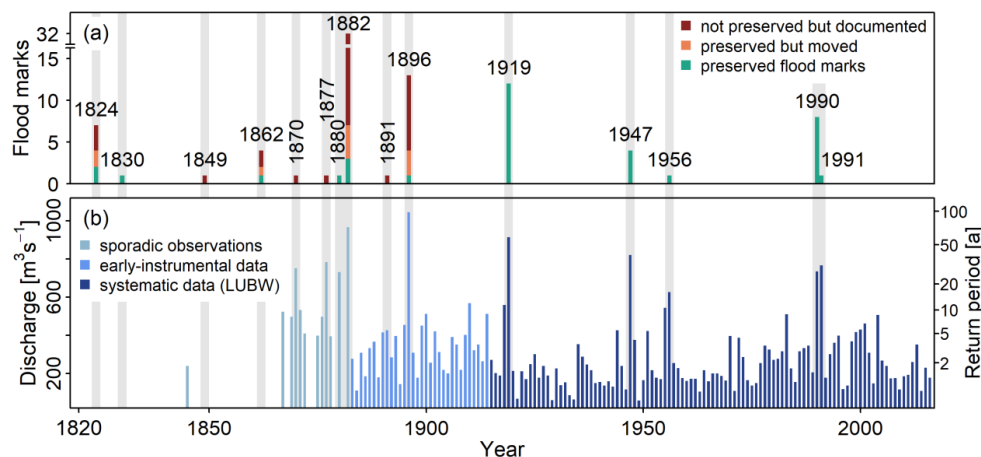
300 **Figure 4: Number of collected flood marks in Haslach, Wolfach, and Schiltach with red and orange bars showing deviations from the historical flood mark survey (a), and associated peak discharges at the gauge Schwaibach (b). The record of annual discharge maxima combines data reconstructed from peak water levels (1845–1914) with systematic measurements since 1915 (Bösmeier, 2020).**

The results of this consistency check showed that 10 out of 17 preserved flood marks obviously had been moved and reinstalled
(Fig. 4a, in orange). Yet, a considerable (> 15 cm) height difference between the historical and the current position was only
found for seven marks. One potential reason may be the integration of cornerstones with engraved flood marks into new
buildings, regardless of their original position, inducing significant alterations. This might have caused the 0.5 m height
350 difference between the documented and preserved marks H1 and H3 in Haslach (Fig. 3a,c). Then, 10 marks showed an
insignificant height difference to their historical position, among them seven marks without and three with clear indications of
reinstallation. Hence, some flood marks have been maintained and reinstalled close to the original after a new building
construction. Nevertheless, even some marks in a very good condition – apparently maintained and repainted – were found to

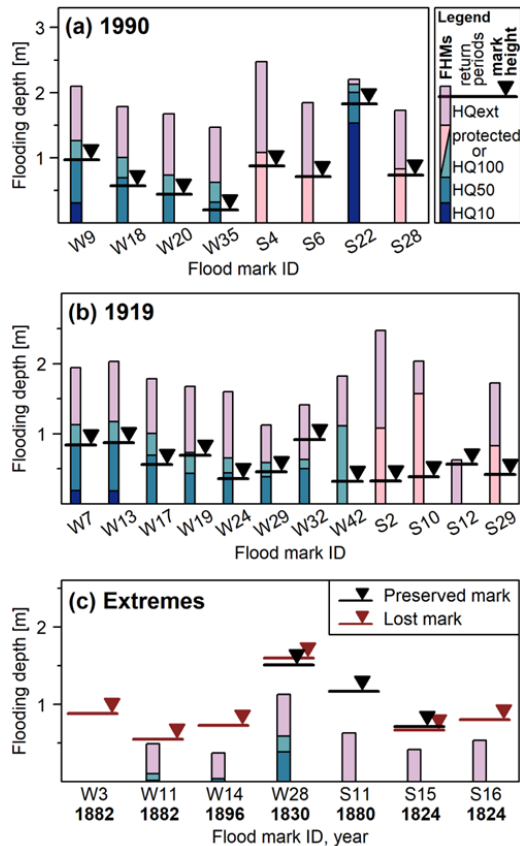
395 **Figure 5: Flood marks and the local flooding depths of the flood hazard maps (LUBW, 2018). All marks in Wolfach and Schiltach are displayed (a) which refer to the flood on February 15, 1990, (b) the flood in December 1919, or (c) which exceeded the HQextreme.**

315 Wolfach (W28, Fig. 5c).

380 Then, an event-specific relative comparison between marks and FHMs demonstrated an overall good agreement, which can be considered a mutual verification between marks and modeled hazard maps. In February 1990, for instance, the Kinzig catchment was struck by a severe flood with a recurrence interval between 20 and 50 years at Schwaibach in the lower catchment. Several marks remind of this incident (Fig. 5a). Since long gauge records were not available directly at the study sites, it was not possible to reconstruct and assign local return periods to the marks (Bösmeier, 2020). Therefore, the absolute 385 FHM flooding depths could not be verified directly and precisely utilizing the flood marks. However, a relative comparison was possible: all four marks in Wolfach are placed at heights approximately corresponding to HQ50. It is remarkable how clearly the mark heights mimic the FHM flooding depths, which points to a systematic and reliable installation. In Schiltach, one mark (S22) also points to a flood between HQ20 and HQ50. However, three other marks are situated within an area meanwhile protected against floods up to HQ100 by walls at the waterside of the Kinzig and its tributary river Schiltach. 390 Hence, local hydraulic conditions cannot be compared with the situation during the flood in 1990. This may also explain why the recurrence intervals in Fig. 5a do not match with the other marks. Similar results, yet with larger deviations, were found for the extreme flood in December 1919, which was an event between HQ50 and HQ100 according to the measurements at Schwaibach (Fig. 5b).
