More than heavy rain turning into fast-flowing water – a landscape perspective on the 2021 Eifel floods

Abstract. Rapidly evolving floods are rare but powerful drivers of landscape reorganisation that have severe and long lasting impacts on both the functions of a landscape's subsystems and the affected society. The July 2021 flood that particularly hit several river catchments of the Eifel region in West Germany and Belgium was a drastic example. While media and scientists highlighted the meteorological and hydrological aspects of this flood, it was not just the rising water levels in the main valleys that posed a hazard, caused damage, and drove environmental reorganisation. Instead, the concurrent coupling of landscape elements and the wood, sediment and debris carried by the fast-flowing water made this flood so devastating and difficult to predict. Because more intense floods are able to interact with more landscape components, they at times reveal rare non-linear feedbacks, which may be hidden during smaller events due to their high thresholds of initiation. Here, we briefly review the boundary conditions of the 14–15 July 2021 flood and discuss the emerging features that ma

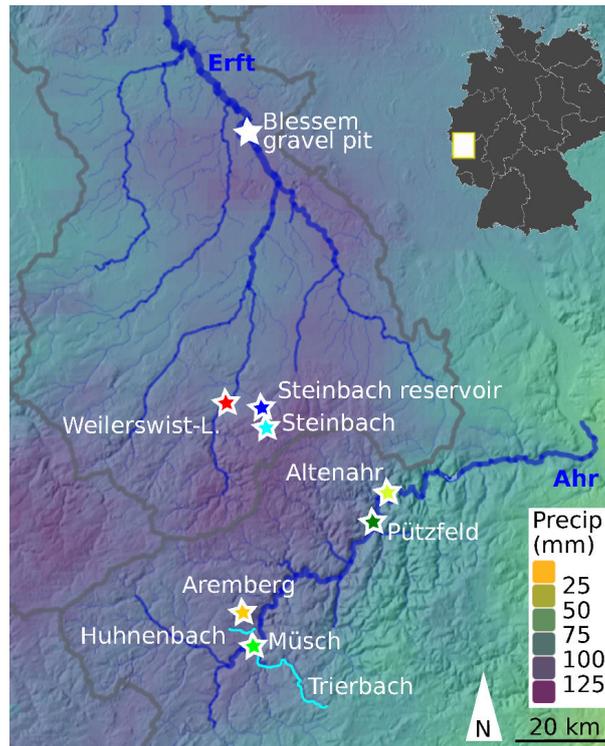
Figure 1. Map of the affected area. 3-day precipitation accumulated for 12–15 July 2021 from RADOLAN data (CDC, 2022). Stars indicate locations of pictures of other figures in this article. Light blue lines depict rivers of special interest mentioned in the text. Background map shows two of the most affected river systems, Erft and Ahr (line width indicating stream order), on top of a hillshade and slope map (red colours). Inset shows the location of the map within Germany.

Nevertheless, we are able to constrain the antecedent conditions, driver mechanisms and, to some extent, the impacts of the flood event based on instrumental data. Spatially resolved precipitation information (Weigl and Winterrath, 2009; CDC, 2022) as 1 km² gridded hourly data were stacked as 72 h sums throughout the main event duration (12–15 July 2021). In addition, 80 instrumental station data (CDC, 2022) of representative sites were used to characterise the severity of the rain event, ~~we~~. We fitted intensity-duration-frequency (IDF) curves to historical annual maximum precipitation measurements. The IDF model was fitted with the extended consistent quantile estimation method (Fauer et al., 2021) and ~~the result is shown~~ evaluated for the DWD station Weilerswist-Lommersum (Fig**1b**) ~~-. 2~~).

According to Fig 1a, based on radar and station observations (RADOLAN data set; (Weigl and Winterrath, 2009)) the precipitation amount for the 72 h period 12–15 July at Weilerswist-Lommersum is similar to the amount observed in Blessem (Fig. 1a). Moreover, the time series at the selected station is sufficiently long for the calculation of robust IDF curves (daily precipitation is available since 1905 and hourly precipitation since 2004). The analysis confirms the unusual extreme character of the precipitation amounts during the July event (black lines and crosses in Fig 1b). Sub-daily as well as daily and multi-day amounts exceeded the values corresponding to a 500-year return period determined under the assumption of stationary climate conditions.

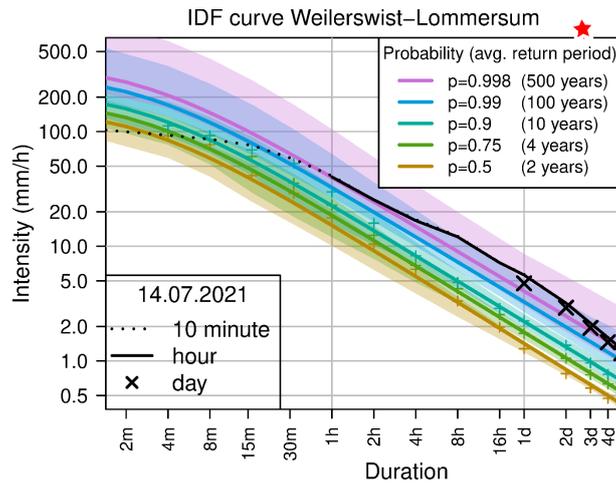
Figure 2. Meteorological measurements and intensity-duration-frequency (IDF) plot. a) 3-day precipitation accumulated for 12–15 July 2021 from RADOLAN data (CDC, 2022). Stars indicate locations of pictures of other figures in this article. Light blue lines depict rivers of special interest mentioned in the text. Background map shows two of the most affected river systems, Erft and Ahr (line-width indicating stream-order), on top of a hillshade and slope map (red colours). Inset shows the location of the map within Germany. b) IDF curve for the weather station Weilerswist-Lommersum. Observations of 14 July precipitation are added in black based on different measurement intervals. Coloured lines depict different non-exceedance probabilities, respective shadings indicate 90 % confidence intervals.

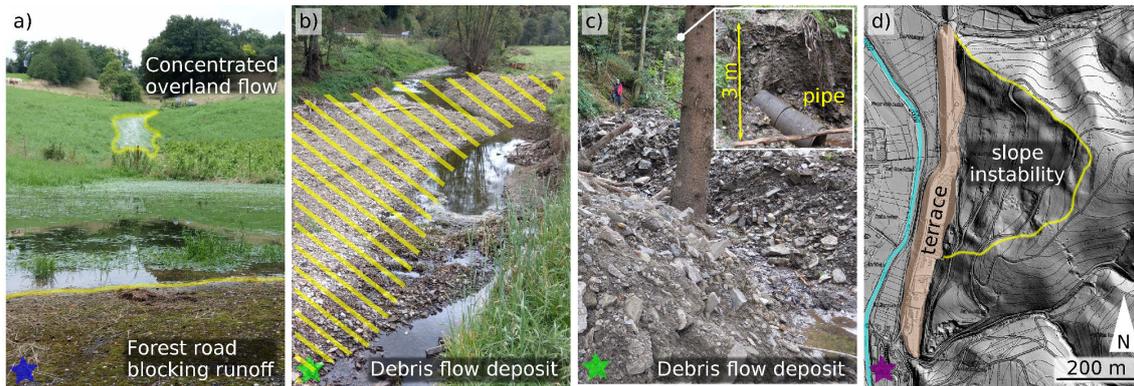
Figure 3. Landscape features emerging from the flood. For locations of these pictures see star signatures in Fig. 1. a) Focused discharge along the hillslope causing deep and fast flow and thus efficient drainage in the background. However, the provided water is not routed downslope in the foreground but ponded by infrastructure, and released at selected spots with increased erosive stream power. b) Deposition area of the debris flow shown in (c), injecting massive debris into the main channel (Trierbach), temporarily blocking the stream and causing severe reorganisation of the hydraulic geometry. c) Lateral deposits of the debris flow at the end of the valley confined section. Inset shows upstream knickpoint formed by overspill and erosion of clogged drainage pipe (50 cm diameter). d) Old slope instability (yellow line) above a 20 m high engineered terrace with industrial infrastructure on it. The terrace just east of the town of Antweiler had been undercut by the Ahr river during the flood.

145 significant parts of valley hillslopes. In some cases, entire hillslopes with older instabilities were undercut (Fig. 23d) and might become reactivated subsequently. One such example of a river meander bend is depicted in Fig. 34b, where a 100 m long and 16 m high rock face was stripped of its debris apron as the Ahr river level rose by about 5 m above the current water level (cf. the flood impact scar in Fig. 34b). Subsequent visits to the site revealed traces of slope movement, such as extending cracks in a paved road crossing just above the rock slope. It is unclear how increased soil moisture during the winter period (Dietze et al.,
150 2020) will affect the transient activity of this rock slide. Hence, further close monitoring of the slope instability is required to anticipate its failure and the potential for subsequent blockage effects on the Ahr River.

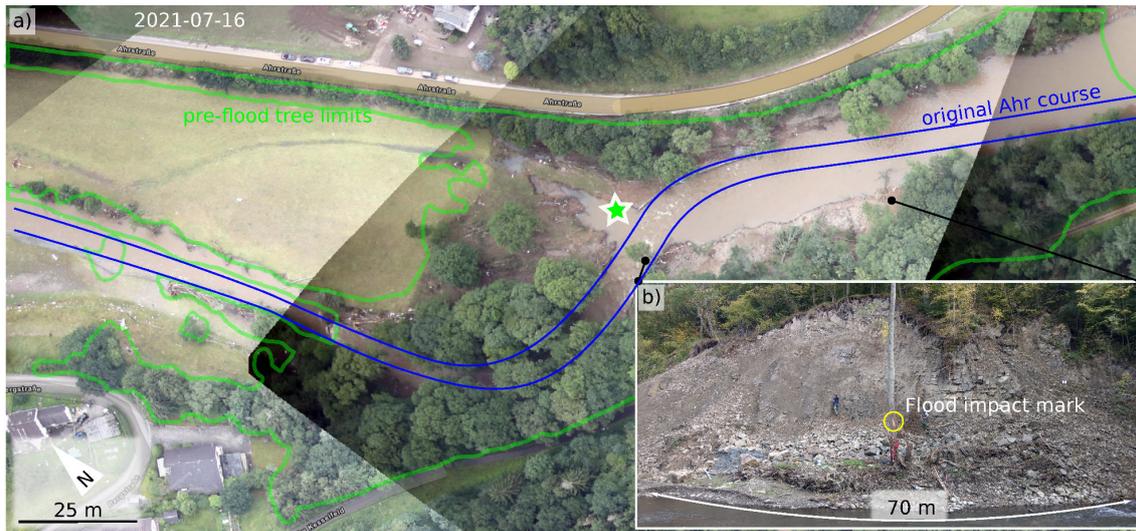
Figure 4. Debris mobilisation features, Ahr valley near Müsch (cf. Fig. 1a) a) Aerial image (BBK-DLR, 2022) taken one day after the flood. The light green outline depicts the tree limit before the flood. Blues lines illustrate the pre-flood course of the Ahr river. b) View from the green star in (a) towards the eroded right bank, which had activated a 16 m high rockslide (persons for scale). Note flood impact mark on a remaining tree at 5 m above current water level.

A further important effect of large woody debris, especially in headwater regions, was the role in ejecting-ejected coarse inorganic debris from the stream bed (Fig. 4b) onto the floodplain. Also fine material was deposited in front of woody debris obstacles (Fig. 45c) and clogged anthropogenic structures, such as bridges. This readily available fine material is now a
 185 temporary source for increased fluvial sediment flux. Hence, even low intensity floods will be able to carry comparably high concentrations of sediment particles. In contrast, the ejected coarse bed particles are currently removed from the fluvial domain until future bank erosion (or human land-use practice) re-incorporates them to the channel. Debris also resulted in permanent alterations to stream courses, due to lateral and vertical erosion, and in some steep channel reaches even led to incision into
 190 the underlying weathered bedrock as mapped out systematically in headwater reaches. This again resulted in undercutting of the banks and local landslides. The spatial reorganisation of sediment in the fluvial domain as well as overall changes in river geometry and bed properties – from small creeks a few kilometres past the watershed to major rivers like the Ahr – inevitably caused a transient in the catchment reaction to future floods.

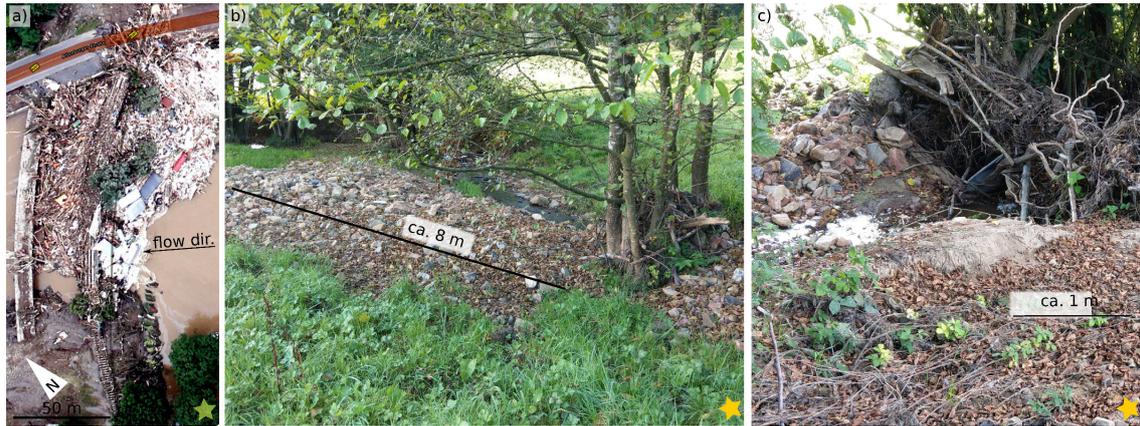
Figure 5. Effects of large woody debris. For locations on wider map see stars in Fig. 1a) Pair of clogged bridges near Altenahr, bypassed along the left and right bank. Note the bipartition of the collected debris with woody material caught by the downstream road bridge and anthropogenic debris collected later by the upstream railway bridge. Note two remaining standing trees in the river depicting the width of the Ahr river before the flood. Aerial image by (BBK-DLR, 2022). b) Huhnenbach near Aremberg about 2 km from its source (see Fig. 1). Note clogging by woody debris at riparian trees and the resulting ejection of coarse bed material out of the channel. c) Another clogging of the Huhnenbach some 20 m upstream of (b), with both ejected coarse debris and deposition of fine sediments in front of the obstacle.

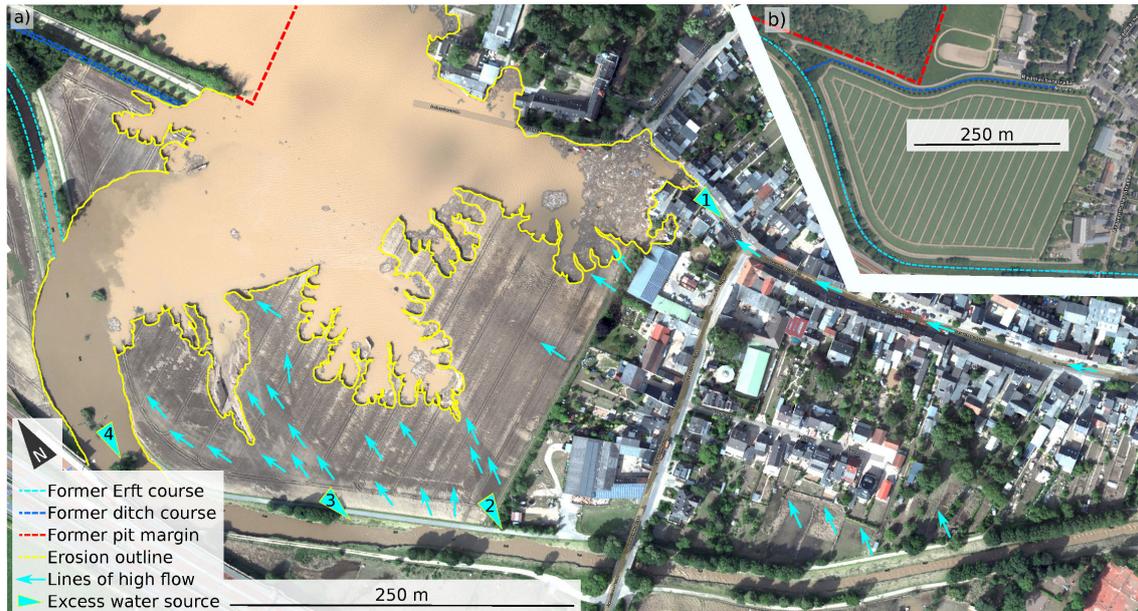
Figure 6. Aerial image (BBK-DLR, 2022) of the town of Blessem. a) Situation shortly after the flood event, with annotated features. The top right inset (b) shows conditions before the flood. The break in slope along the margin of a gravel pit (red dashed line) had started to erode towards the town by fluvial erosion (yellow line) that formed three individual clusters. The erosion was fuelled by overbank discharge of the Erft river, evading the town of Blessem and moving down the main street as well water flowing over the field west of the town margin, following the line of steepest descent. Water flow directions are indicated by blue arrows where visible from aerial imagery. The four numbered blue triangles depict sites of increased water input towards the pit.

At a comparably small scale, the town of Blessem on the Erft river was subject to such an emerging landscape connectivity case. The excess rain water of Blessem was collected and channelized in pipes below the main road (Frauenthaler Straße, then passed to Radmacherstraße). These pipes ended in a drainage ditch at the western town limit that routed the water towards the Erft river (Fig. 56b), passing by a gravel pit that was protected by a few meter high rampart. During the flood, overbank discharge of the Erft river moved water across the main streets of Blessem (light blue arrows in Fig. 56) and injected excess discharge into the drainage pipes but also ran as overland flow along the streets. In addition, Erft overbank discharge was routed over a field west of the town, towards the drainage ditch already carrying the town's excess water. Whether that excess water caused overspilling of the 2 m deep drainage ditch or if the additional water inflow from the field caused the overspill cannot be resolved here. Regardless, the ditch overtopped and discharge followed the line of steepest descent into the gravel pit, whose protection rampart was not fully closed but had a gap through which the water could enter the pit. As the flow path gradient changed from less than 1 to about 20 degrees down the pit slope, the shear stress increased by two orders of magnitude (Anderson and Anderson, 2010). This high shear stress, combined with the high erodibility of the underlying material (a thin loess cover on tertiary Rhine gravel), resulted in extremely rapid erosion and the development of an erosional margin (yellow line in Fig. 45) that cut backwards by about 250 m within a few hours. The final shape of the erosional margin shows four discrete tongues of enhanced slope retreat (cf. numbered triangles in Fig. 56), which correspond to the main sources of excess water: the road and drainage pipes running through the town of Blessem (triangle 1), two overflow spots of the river Erft across the field at the edge of the town (triangles 2 and 3), and ultimately, the river Erft itself (triangle 4), which routed its whole discharge into the eroded gravel pit. This led to rapid inundation of the pit, massive deposition of > 450,000 m³ of material, enhanced lateral erosion along the (new) outer bank of the diverted river, as well as significant depth erosion not only of the new course of the river Erft but also in its old bed, forming a knickzone and resulting in a bed elevation lowering of 1.4–1.8 m.

Despite initial media reports of a landslide (i.e., a gravitational mass wasting process) happening near Blessem, all evidence rather imply that it actually was a process driven by flowing water. That process in turn was the result of a local process connection mechanism: backward erosion of the gravel pit margin. At the same time, the mechanism was also controlled by emerging feedbacks, i.e., the reduction of backward erosion by cessation of overbank discharge through base level lowering of the river Erft as it flowed into the gravel pit. Hence, what happened in Blessem is an example of how geomorphic processes first amplified and later counteracted the impact of a hydrological extreme event.
