More than heavy rain turning into fast-flowing water – a landscape perspective on the 2021 Eifel floods

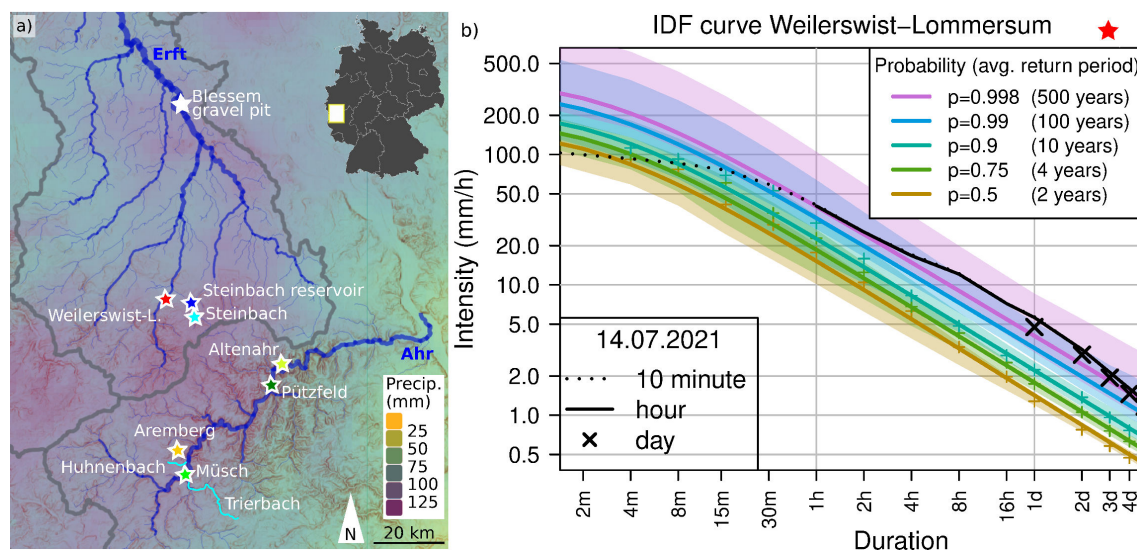
Figure 1. Meteorological measurements and intensity-duration-frequency (IDF) plot. a) 3-day precipitation accumulated for 12–15 July 2021 from RADOLAN data (CDC, 2022). Stars indicate locations of pictures of other figures in this article. Light blue lines depict rivers of special interest mentioned in the text. Background map shows two of the most affected river systems, Erft and Ahr (line width indicating stream order), on top of a hillshade and slope map (red colours). Inset shows the location of the map within Germany. b) IDF curve for the weather station Weilerswist-Lommersum. Observations of 14 July precipitation are added in black based on different measurement intervals. Coloured lines depict different non-exceedance probabilities, respective shadings indicate 90 % confidence intervals.

The 14–15 July 2021 flood in Western Germany as well as parts of Belgium and the Netherlands revealed the unpreparedness of societies, policy makers, and scientists across many dimensions. The anticipated precipitation amounts had been communicated several days ahead, hydrological models and numerous stream gauges were in place, and information chains and authority responsibilities were implemented. Yet the flood, which hit several catchments that originate in the Eifel (Fig 1a), developed into

The next element of the evolutionary trajectory of the crisis was the surface runoff of excess rainfall that was not able to infiltrate into the ground, and hence triggered several non-linear processes, positive feedbacks and process connections (Dietze and Ozturk, 2021). Altogether, these dynamics amplified the impact of the flood on the landscape, particularly in the anthropogenic realm. To understand these dynamics, it is necessary to first examine the different landscape elements activated by the event and then to explore their modes of interplay. The flood hit several European countries. In Germany particularly, it impacted two geomorphically distinct regions: the Eifel with the Ahr Valley to the south and the Lower Rhine Bay with the Erft catchment to the north. The Eifel is a typical low mountain range with steep, deeply incised valleys (see Fig. 1a for the slope signature). These valleys cut through numerous Paleozoic lithologies with varying degrees of fracturing, crack orientation, and ground permeability, which impose a pronounced predisposition to gravitational mass movement (Damm et al., 2010). In general, hillslopes are covered by Pleistocene, 1-3 m thick periglacial cover beds that are largely unstable due to the specific grain-size distribution, sensitive to water supply, and frequently incorporated in landslides (Bell, 2007; Damm et al., 2013). Rockfall dominated cliffs are developed on steep slopes. In contrast, the Lower Rhine Bay region including the Erft catchment is an area of subsidence with smooth topography, filled by highly-permeable Cenozoic sediments with a widespread cover of Quaternary loess deposits. There is no susceptibility to gravitational mass movement in this landscape, except for steep landforms that predominantly result from man-made construction (e.g., road escarpments, waste dumps, open pit mining, cf. Fig 1a). Both regions hold a long legacy of human land use.

To illustrate the severity of the rain event, we fitted intensity-duration-frequency (IDF) curves to historical annual maximum precipitation measurements. The IDF model was fitted with the extended consistent quantile estimation method (Fauer et al., 2021) and the result is shown for the DWD station Weilerswist-Lommersum (Fig 1b). According to Fig 1a based on radar and station observations (RADOLAN data set; (Weigl and Winterrath, 2009)) the precipitation amount for the 72 h period 12–15 July at Weilerswist-Lommersum is similar to the amount observed in Blessem (Fig. 1a). Moreover, the time series at the selected station is sufficiently long for the calculation of robust IDF curves (daily precipitation is available since 1905 and hourly precipitation since 2004). The analysis confirms the unusual extreme character of the precipitation amounts during the July event (black lines and crosses in Fig 1b). Sub-daily as well as daily and multi-day amounts exceeded the values corresponding to a 500-year return period determined under the assumption of stationary climate conditions.

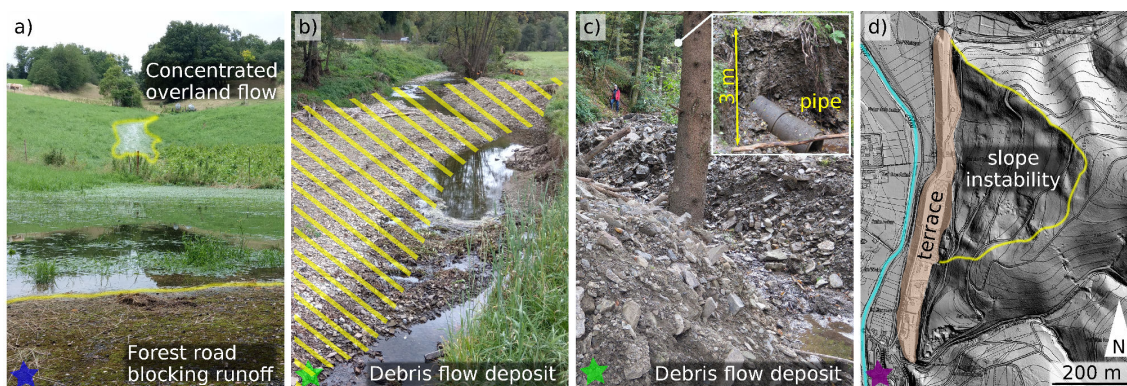
Figure 2. Landscape features emerging from the flood. For locations of these pictures see star signatures in Fig. 1. a) Focussed discharge along the hillslope causing deep and fast flow and thus efficient drainage in the background. However, the provided water is not routed downslope in the foreground but ponded by infrastructure, and released at selected spots with increased erosive stream power. b) Deposition area of the debris flow shown in (c), injecting massive debris into the main channel (Trierbach), temporally blocking the stream and causing severe reorganisation of the hydraulic geometry. c) Lateral deposits of the debris flow at the end of the valley confined section. Inset shows upstream knickpoint formed by overspill and erosion of clogged drainage pipe (50 cm diameter). d) Old slope instability (yellow line) above a 20 m high engineered terrace with industrial infrastructure on it. The terrace just east of the town of Antweiler had been undercut by the Ahr river during the flood.

massive source of mobile material. For example, the debris flow in Fig. 2c mobilised large amounts of material downstream of a 4–5 m high knickpoint, which formed by the overflow of a manufactured forest track crossing the channel. This artificial dam had a 50 cm drainage tube that quickly got clogged, causing backfilling and finally overtopping by the flood water. The high energy release at the resulting waterfall base caused erosion of the surrounding slope sections and the channel bed, sourcing rock material and trees into the debris channel and then into the main channel, the Trierbach, downstream (Fig. 1a). Evidently, there were several previous debris flow deposits visible in the eroded bank of the Trierbach, indicating that the entering debris channel had been active several times in the past.

The landsliding component of hillslope material contribution had a series of triggers, mechanisms and time lags to the precipitation phase. Post flood mapping revealed numerous shallow landslides that were not related to fluvial undercutting as a trigger, but were located on steep concave slope sections, hence at preferentially wetter slope positions (Giuseppe et al., 2021). This suggests that their activity was triggered by excess precipitation before and during the rainfall event. These features typically had a spatial extent of a few to a few tens of metres and were in most cases not connected to a channel. In contrast, there were also numerous river banks on the outer side of river bends that showed significant undercutting and, consequently slope failures (Ozturk et al., 2018). These well-connected landscape elements were able to deliver sediment and woody debris directly to the channel (Fig. 3a). Such slope instabilities ranged in length from a few metres to features that have affected significant parts of valley hillslopes. In some cases, entire hillslopes with older instabilities were undercut (Fig. 2d) and might

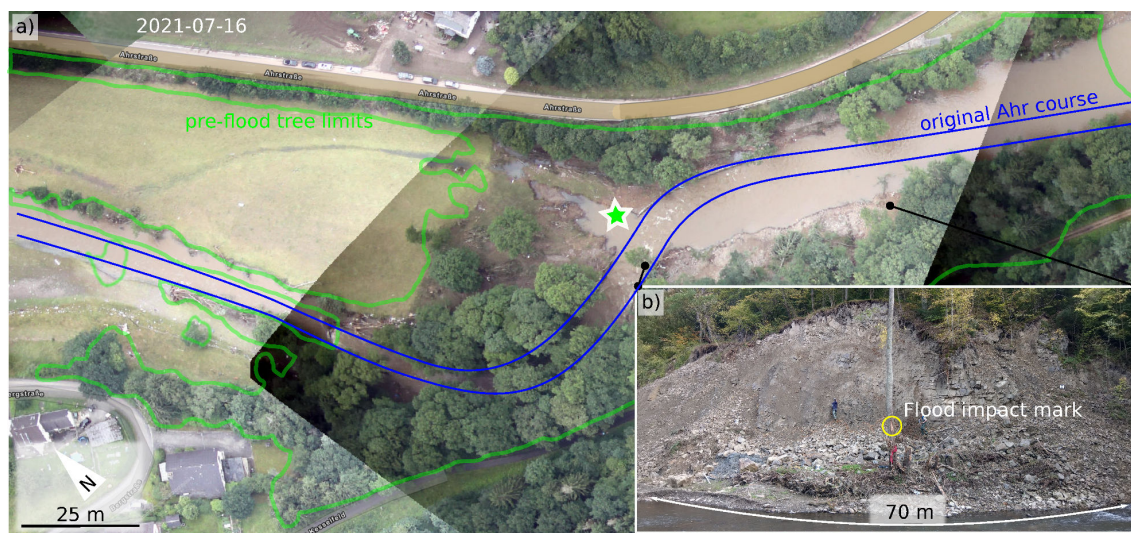
Figure 3. Debris mobilisation features, Ahr valley near Müsch (cf. Fig. 1a) Aerial image (BBK-DLR, 2022) taken one day after the flood. The light green outline depicts the tree limit before the flood. Blues lines illustrate the pre-flood course of the Ahr river. b) View from the green star in (a) towards the eroded right bank, which had activated a 16 m high rockslide (persons for scale). Note flood impact mark on a remaining tree at 5 m above current water level.

115 become reactivated subsequently. One such example of a river meander bend is depicted in Fig. 3b, where a 100 m long and
 16 m high rock face was stripped of its debris apron as the Ahr river level rose by about 5 m above the current water level (cf.
 the flood impact scar in Fig. 3b). Subsequent visits to the site revealed traces of slope movement, such as extending cracks in a
 paved road crossing just above the rock slope. It is unclear how increased soil moisture during the winter period (Dietze et al.,
 2020) will affect the transient activity of this rock slide. Hence, further close monitoring of the slope instability is required to
 120 anticipate its failure and the potential for subsequent blockage effects on the Ahr River.

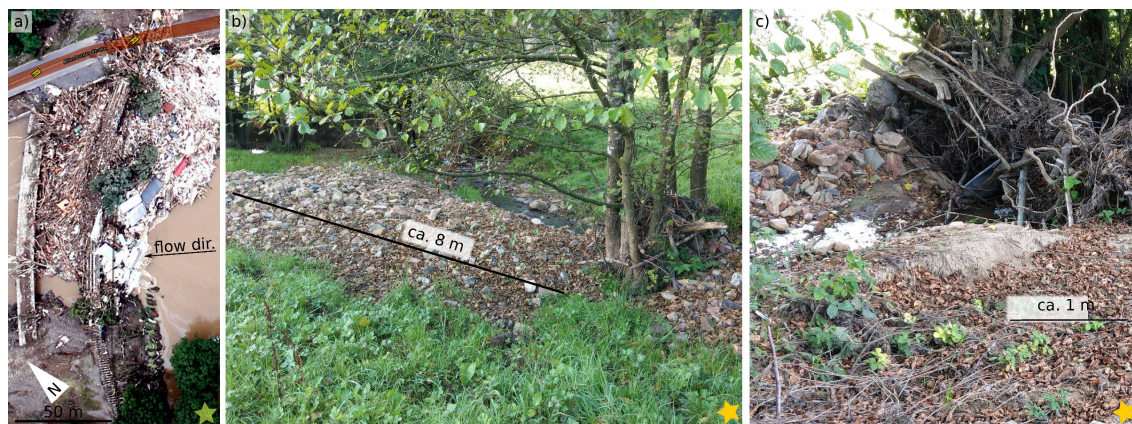
Figure 4. Effects of large woody debris. For locations on wider map see stars in Fig. 1a) Pair of clogged bridges near Altenahr, bypassed along the left and right bank. Note the bipartition of the collected debris with woody material caught by the downstream road bridge and anthropogenic debris collected later by the upstream railway bridge. Note two remaining standing trees in the river depicting the width of the Ahr river before the flood. Aerial image by (BBK-DLR, 2022). b) Huhnenbach near Aremberg about 2 km from its source (see Fig. 1). Note clogging by woody debris at riparian trees and the resulting ejection of coarse bed material out of the channel. c) Another clogging of the Huhnenbach some 20 m upstream of (b), with both ejected coarse debris and deposition of fine sediments in front of the obstacle.

A further important effect of large woody debris, especially in headwater regions, was the role in ejecting coarse inorganic debris from the stream bed (Fig. 4b) onto the floodplain. Also fine material was deposited in front of woody debris obstacles (Fig. 4c) and clogged anthropogenic structures, such as bridges. This readily available fine material is now a temporary source
 155 of sediment particles. In contrast, the ejected coarse bed particles are currently removed from the fluvial domain until future bank erosion (or human land-use practice) re-incorporates them to the channel. Debris also resulted in permanent alterations to stream courses, due to lateral and vertical erosion, and in some steep channel reaches even led to incision into the underlying weathered bedrock. This again resulted in undercutting of the banks and local landslides. The spatial reorganisation of sediment
 160 the watershed to major rivers like the Ahr – inevitably caused a transient in the catchment reaction to future floods.

The flood happened in a cultural landscape with a long legacy of human land-use. Accordingly, there were typical primary effects of land-use, particularly surface features on flood dynamics such as an increased and accelerated surface runoff on cultivated hillslopes (Bronstert et al., 2020), some of which are already mentioned above (e.g., Fig. 2a, Fig. 4a, clogged

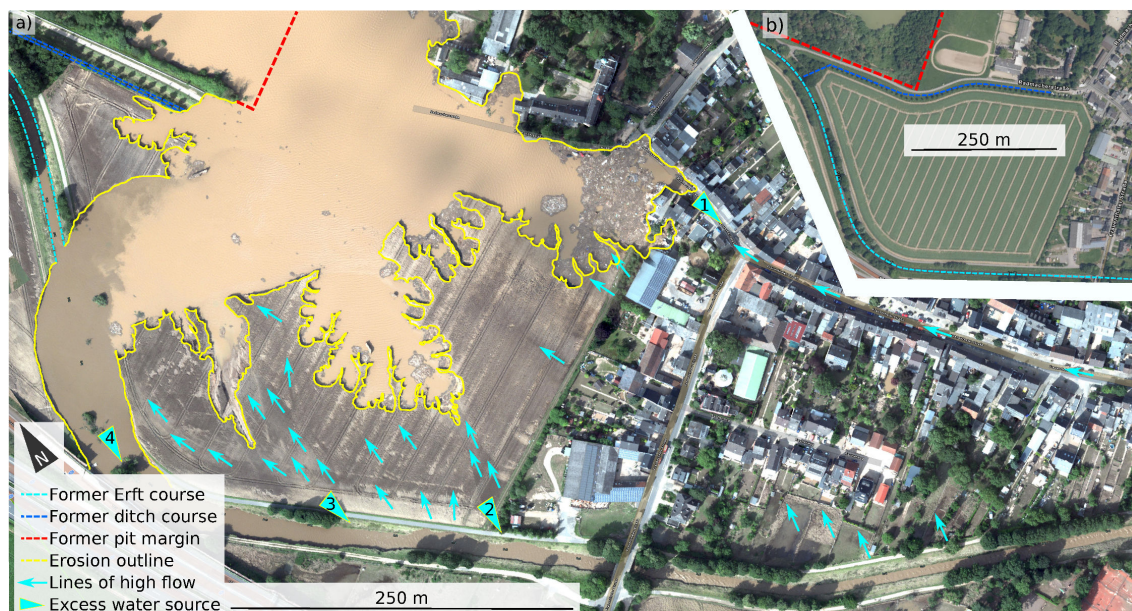
Figure 5. Aerial image (BBK-DLR, 2022) of the town of Blessem. a) Situation shortly after the flood event, with annotated features. The top right inset (b) shows conditions before the flood. The break in slope along the margin of a gravel pit (red dashed line) had started to erode towards the town by fluvial erosion (yellow line) that formed three individual clusters. The erosion was fuelled by overbank discharge of the Erft river, evading the town of Blessem and moving down the main street as well water flowing over the field west of the town margin, following the line of steepest descent. Water flow directions are indicated by blue arrows where visible from aerial imagery. The four numbered blue triangles depict sites of increased water input towards the pit.

At a comparably small scale, the town of Blessem on the Erft river was subject to such an emerging landscape connectivity case. The excess rain water of Blessem was collected and channelized in pipes below the main road (Frauenthaler Straße, then passed to Radmacherstraße). These pipes ended in a drainage ditch at the western town limit that routed the water towards the Erft river (Fig. 5b), passing by a gravel pit that was protected by a few meter high rampart. During the flood, overbank discharge of the Erft river moved water across the main streets of Blessem (light blue arrows in Fig. 5) and injected excess discharge into the drainage pipes but also ran as overland flow along the streets. In addition, Erft overbank discharge was routed over a field west of the town, towards the drainage ditch already carrying the town's excess water. Whether that excess water caused overspilling of the 2 m deep drainage ditch or if the additional water inflow from the field caused the overspill cannot be resolved here. Regardless, the ditch overtopped and discharge followed the line of steepest descent into the gravel pit, whose protection rampart was not fully closed but had a gap through which the water could enter the pit. As the flow path gradient changed from less than 1 to about 20 degrees down the pit slope, the shear stress increased by two orders of magnitude. This high shear stress, combined with the high erodibility of the underlying material (a thin loess cover on tertiary Rhine gravel), resulted in extremely rapid erosion and the development of an erosional margin (yellow line in Fig. 4) that cut backwards by about 250 m within a few hours. The final shape of the erosional margin shows four discrete tongues of enhanced slope retreat (cf. numbered triangles in Fig. 5), which correspond to the main sources of excess water: the road and drainage pipes running through the town of Blessem (triangle 1), two overflow spots of the river Erft across the field at the edge of the town (triangles 2 and 3), and ultimately, the river Erft itself (triangle 4), which routed its whole discharge into the eroded gravel pit. This led to rapid inundation of the pit, massive deposition of $> 450,000 \text{ m}^3$ of material, enhanced lateral erosion along the (new) outer bank of the diverted river, as well as significant depth erosion not only of the new course of the river Erft but also in its old bed, forming a knickzone and resulting in a bed elevation lowering of 1.4–1.8 m.

Despite initial media reports of a landslide (i.e., a gravitational mass wasting process) happening near Blessem, all evidence rather imply that it actually was a process driven by flowing water. That process in turn was the result of a local process connection mechanism: backward erosion of the gravel pit margin. At the same time, the mechanism was also controlled by emerging feedbacks, i.e., the reduction of backward erosion by cessation of overbank discharge through base level lowering of
