Evaluating Post-Wildfire Debris Flow Rainfall Thresholds and Volume Models at the 2020 Grizzly Creek Fire in Glenwood Canyon, Colorado, USA

Abstract. As wildfire increases in the western United States, so do postfire debris-flow hazards. The U.S. Geological Survey (USGS) has developed two separate models to estimate (1) rainfall intensity thresholds for postfire debris-flow initiation and (2) debris-flow volumes. However, the information necessary to test the accuracy of these models is seldom available. Here, we studied how well these models performed over a two-year period in the 2020 Grizzly Creek Fire burn perimeter in Glenwood Canyon, Colorado, USA, through the development of a debris-flow response inventory. The study area had the advantage of a network of 11 rain gauges for rainfall intensity measurements and repeat lidar data for volume estimates. Our observations showed that 89% of observed debris flows in the first year postfire were triggered by rainfall rates higher than the fire-wide rainfall threshold produced by the current USGS operational model (M1). No debris flows were observed in the second year postfire, despite eight rainstorms with intensities higher than th

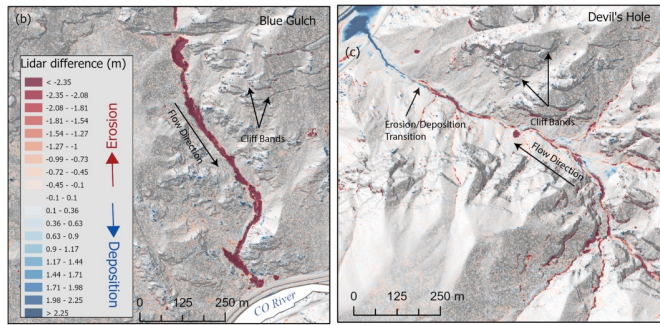
Figure 2. (a) Map showing the burn perimeter, rain gauges, and locations of debris-flow observations. (b) DEM of difference map showing erosion (red) and deposition (blue) in the lower half of the Blue Gulch drainage. (c) DEM of Difference showing erosion (red) and deposition (blue) in the lower half of the Devil's Hole drainage.

Three tipping bucket rain gauges were installed in the burn area on 17 September 2020 by the USGS Landslide Hazards Program. These gauges (USGS_gc_1, USGS_gc_2, USGS_gc_3; Figure 2) were deployed specifically for the task of verifying the hazard assessment model (Figure 1). An additional seven rain gauges (7) were added during the summer of 2021 by the USGS Colorado Water Science Center to provide situational awareness and inform operational warnings by the National Weather Service and CDOT. We were also able to obtain data from the Bair Ranch gauge operated by CDOT. As a result, 11 total rain gauges captured high frequency (15-minute) rainfall intensities in and around Glenwood Canyon (Figure 2), and provided a relatively dense network of rain data to associate with debris-flow events. All gauges were operating by mid-July 2021, beginning on several different dates (Table 1).

Using the two lidar datasets (1 m pixel), we subtracted the elevation of the post-event lidar from the pre-event lidar ($Z_{2021} - Z_{2016}$) to create a DoD map of erosion and deposition throughout the Grizzly Creek burn area (Figure 2 and Figure 3). For each debris-flow observation in our inventory, we mapped erosional and depositional areas in each channel with separate polygons by hand. Hillslope erosion, which is below the detection limit of the lidar, was assumed to be minimal based on post-event field observations that indicated minor hillslope surface erosion. We masked cliff areas from the DoD and all slopes $> 45^\circ$ to eliminate lidar artifacts due to interpolation across steep slopes. Some deposition was observed in the field in the form of levees (Figure S4); however, levees were not systematically mapped in the lidar because they were often smaller than the pixel cells and therefore difficult to confirm without field verification. Additionally, some spurious change was observed on the hillslopes, likely due to vegetation classification errors, and this error was mitigated by focusing our analysis on channelized areas where field observations showed the primary debris-flow activity. The mapped channel polygons allowed us to quantify the provenance of the debris-flow material and its volume as a function of contributing drainage area, as well as to examine the erosion to deposition transition in debris-flow channels.

515 Field observations and the lidar DoD revealed that the majority of sediment incorporated into debris flows in 2021 originated in channelized areas with relatively minor sediment contribution from adjacent hillslopes (Figure 2b-c and Figure 4). Field observations suggest that channel erosion was initiated in part by surface water that was strong enough to uproot grassy vegetation to access sediment below the root zone (Figure 4), as has been observed in grassland settings (Rengers et al., 2016). Moreover, field mapping in multiple watersheds (Blue Gulch, Grizzly Creek, and French Creek) confirm the observations of in-channel debris-flow initiation observed in the DoD. Hillslope rilling was only observed in a few locations with relatively 520 low levels of revegetation in 2021 (Figure S5).

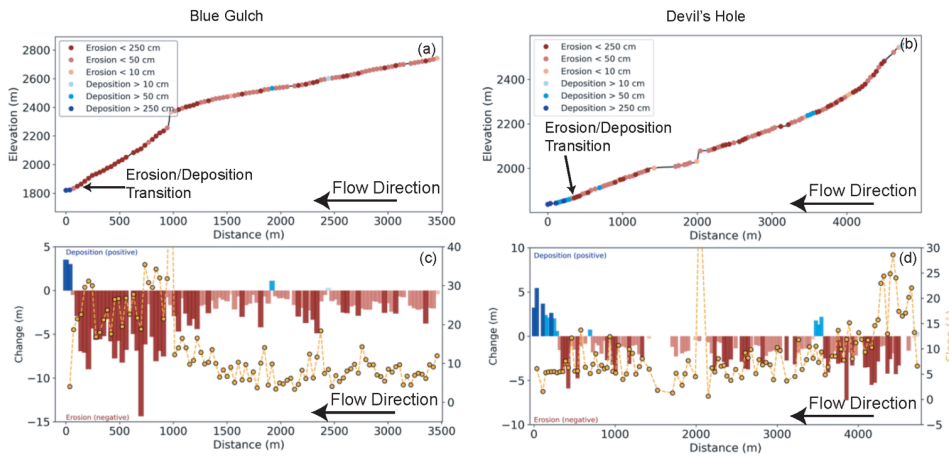
Figure 3. (a) Longitudinal profile of the Blue Gulch watershed. (b) Longitudinal profile of the Devil's Hole watershed. In both (a) and (b), red dots and blue dots represent erosion/deposition, respectively. Areas without a dot did not experience change beyond the level of detection. (c) Measured deposition and erosion in the Blue Gulch watershed. (d) Measured deposition and erosion in the Devil's Hole watershed. In both (c) and (d), local slope is shown on the secondary y-axis.

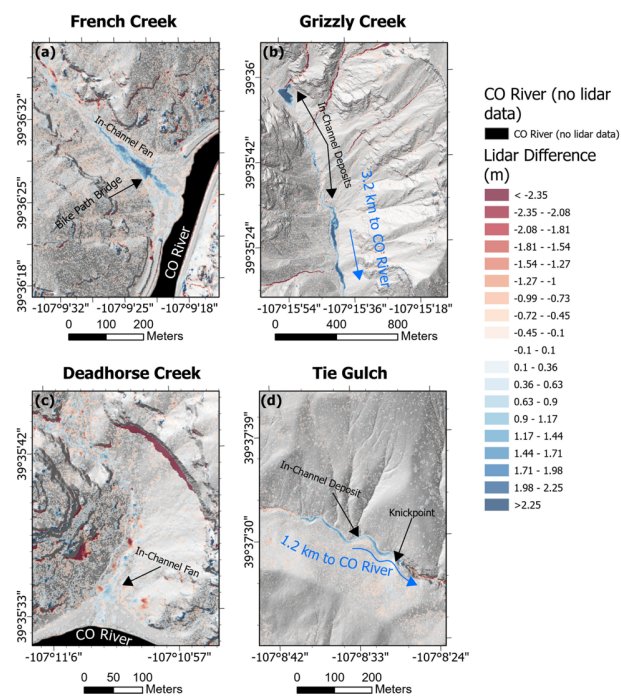
Figure 5. In-channel sediment deposits in large drainage basins. (a) French Creek: a fan forms upstream of the Colorado River, primarily because sediment is blocked by a concrete bike path bridge. (b) Grizzly Creek: Several in-channel deposits formed several kilometers upstream of the Colorado River. No fan formed at the outlet of Grizzly Creek. (c) Deadhorse Creek: relatively minor depositional fan forms upstream of the Colorado River. (d) Tie Gulch: In-channel deposits develops upstream of a knickpoint.

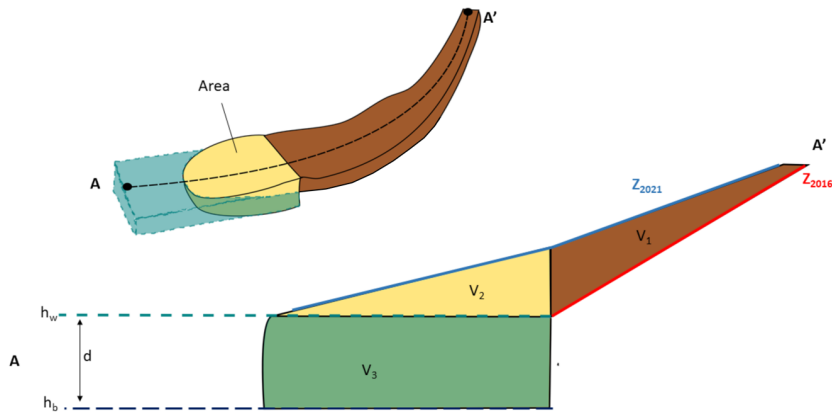
1090 Figure 6. (a) Oblique view and (b) Cross-sectional view of the approach used to estimate the volume of deposited sediment in the Colorado River due to unknown bathymetry. The volume of sediment deposition was divided into three zones. V_1 is the sub-area zone, where a lidar difference can be used to estimate the volume. V_2 is the zone above the water surface. V_3 is the subaqueous zone, and the depth is estimated based on reports from CDOT maintenance crews.

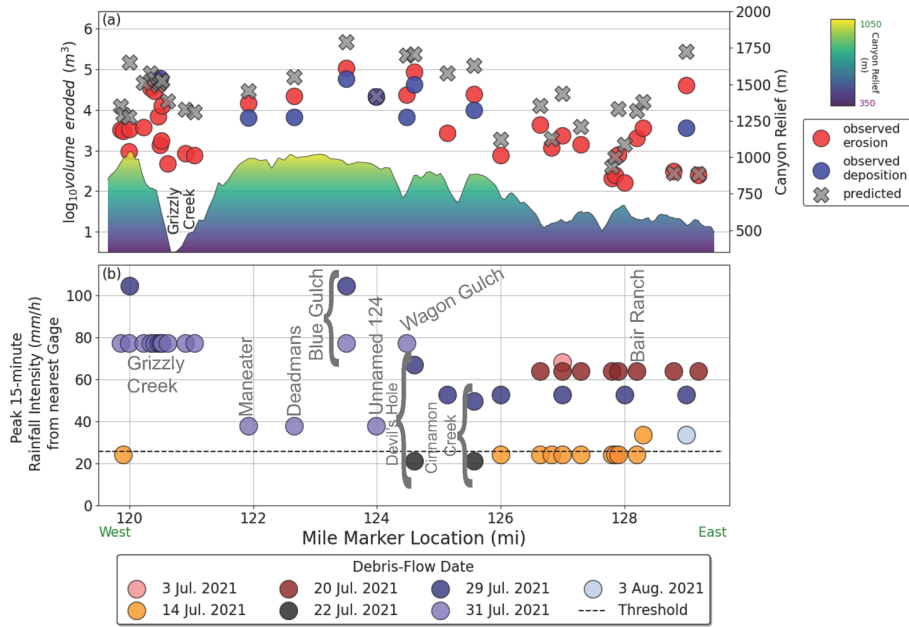
Figure 7. (a) Observed sediment volume (erosional and depositional) and estimated sediment volume using Equation 2 shown as a function of the mile marker location in Glenwood Canyon. For context, the canyon relief is shown on secondary axis. The relief profile indicates the elevation from the north side of the canyon approximately parallel to I-70. (b) Peak 15-minute rainfall intensity from the nearest representative gauge shown at locations identified by debris-flow date. Note that debris flow verification points were associated with a mile marker location at the watershed outlet, as this was the preferred method of identification by CDOT personnel. In cases where the channel outlet did not directly intersect I-70, the outlet was simply translated onto a line segment representing I-70 to estimate a mile marker location.

The high spatial variability in debris-flow occurrence was likely a result of the localized nature of monsoonal storms. Some storms only produced debris flows within a small portion of the burned area (e.g., 14 July 2021, 22 July 2021), whereas other storms produced debris flows across a wider area within the burn perimeter (e.g., 29 July 2021) (Figure 7b). No debris flows

The depositional volumes observed were less than the erosional volumes, as was expected due to sediment disturbance between the time of debris-flow deposition and the lidar flight (Figure 7).

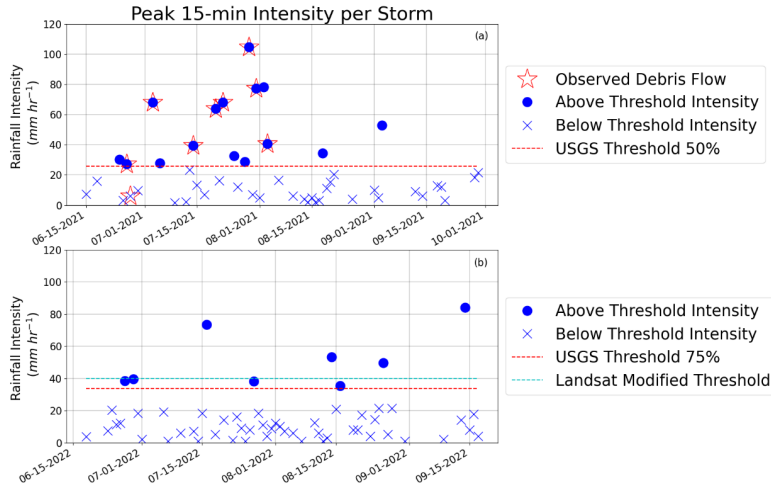
Figure 8. (a) Maximum 15-minute rainfall intensity during each storm from the 11 rain gauges near the Grizzly Creek Fire perimeter during the 2021 monsoon. Rainfall rates below the modelled intensity threshold of 25.9 mm h⁻¹ (50% likelihood) are shown with a cross and those above the modelled threshold are shown with a circle. Any storms that produced a debris flow are indicated with a star. (b) Maximum 15-minute rainfall intensity during each storm from the 11 rain gauges near the Grizzly Creek Fire perimeter during the 2022 monsoon. The year 2 (75% likelihood) of 33.7 mm h⁻¹ was used as the USGS threshold. A recalibrated dNBR value from Landsat at the beginning of the monsoon season was used with the M1 model to develop an additional threshold of 40 mm h⁻¹ using the 50% likelihood of debris flow occurrence. Note that no debris flows were observed in 2022.

When the debris-flow and storm inventories were compared with the P50 rainfall threshold created by the debris-flow hazard assessment in 2021, we observed relatively good performance of the estimated rainfall threshold (Figure 8a). The I15 values associated with initiation of one or more debris flows (Figure 8a), were above the $I15_{T21}$ (25.9 mm h⁻¹) produced by the hazard assessment (Staley et al., 2017) in 8 out of 9 cases during the first year postfire (U.S. Geological Survey, 2022). The only observed debris flow with a rainfall rate below $I15_{T21}$ was on 27 June 2021. However, most of the rain gauges were not operating at that time (Table 1 and Fig. S3); therefore, it is possible that the closest available rain gauge was not reflective of the maximum rainfall rate in the storm. In the second summer postfire, the $I15_{T22}$ was increased (33.7 mm h⁻¹) and several storms generated I15 rainfall intensities larger than $I15_{T22}$, however, no debris flows were documented (Fig. 7b).

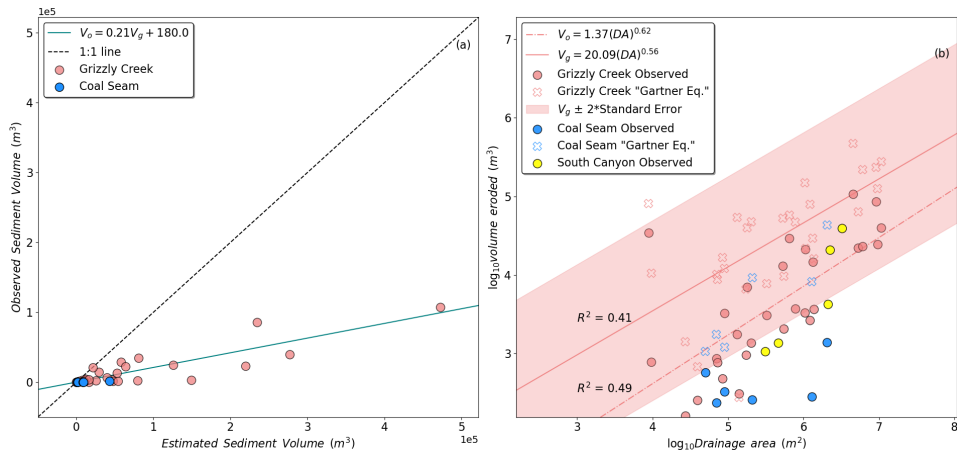
Figure 9. (a) Observed sediment volume (erosional) versus estimated sediment volume using Equation 2 developed by Gartner et al. (2014). Linear trendline shows the relationship between the estimated (V_g) and observed (V_o) volume at the Grizzly Creek Fire. (b) A comparison of the total volume of observed sediment with estimated volume from Equation 2 as a function of upstream drainage area (DA). The observation volumes represent the volume of erosion, upstream of a transition to deposition. Best-fit power law equations (red dashed and solid lines) were fit to the observed (red circles) and estimated (red Xs), data points for the Grizzly Creek Fire, respectively. R^2 values are reported for these fits.

535 The volumes from the Grizzly Creek Fire were similar in magnitude to the observed volumes from the two prior postfire debris flows near Glenwood Canyon, the Coal Seam and South Canyon Fires (Figure 9), suggesting regional similarities between the observed volumes across three different fires. Moreover, the trend of volume overestimation by Equation 2 was observed in both the Grizzly Creek Fire data and the Coal Seam Fire data (Figure 9). This suggests that the overestimation of Equation 2 is not related to fire- or storm-specific characteristics of the Grizzly Creek Fire. Rather the overestimation of Equation 2 is

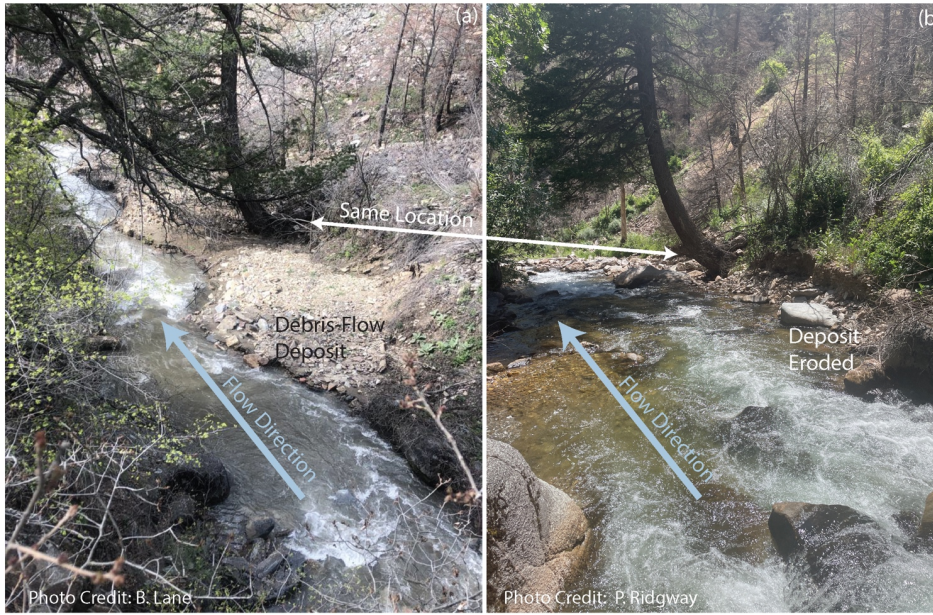
Figure 12 (a) Small debris-flow fan in Grizzly Creek at the beginning of the 2022 snowmelt season. (b) Vertical and horizontal incision of the same fan after the snowmelt runoff.

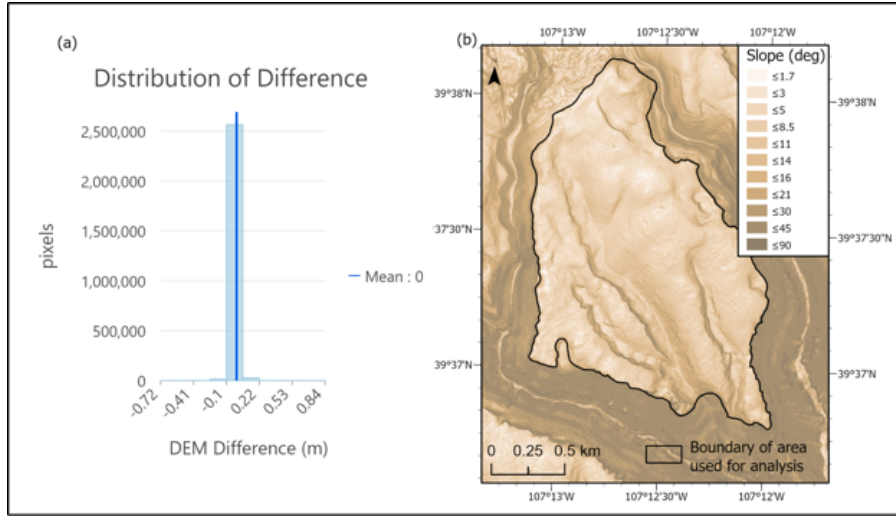
Figure S2. (a) Distribution of all pixels in the DEM of Difference (DoD) area shown in (b), showing most of the change is near 0. This suggests little systematic offset in the DoD. (b) A relatively low sloping area used to analyze the DoD to explore any systematic offset.

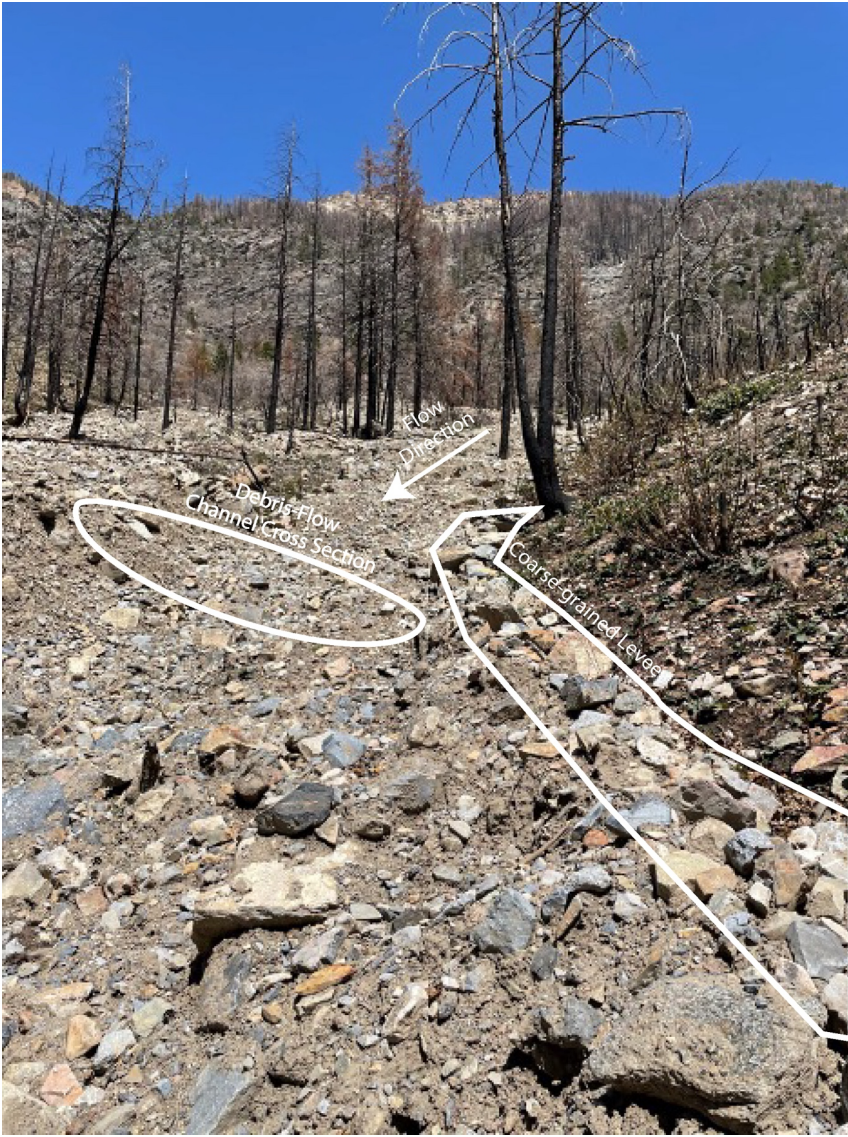
Figure S4. Debris-flow levee with coarse grains shown adjacent to a debris-flow channel. The largest grain sizes in the levee were approximately 30 cm.

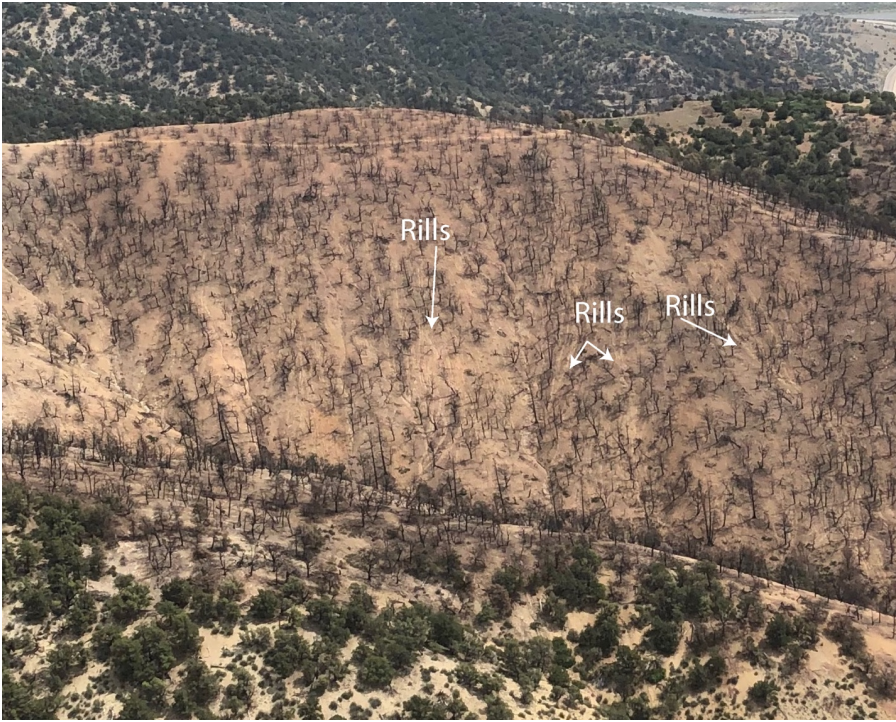
Figure S5. Hillslope rilling in a small watershed adjacent to Tie Gulch (39.620972, -107.140139). Photo acquired August 18, 2021 (Photo Credit: F. Rengers).

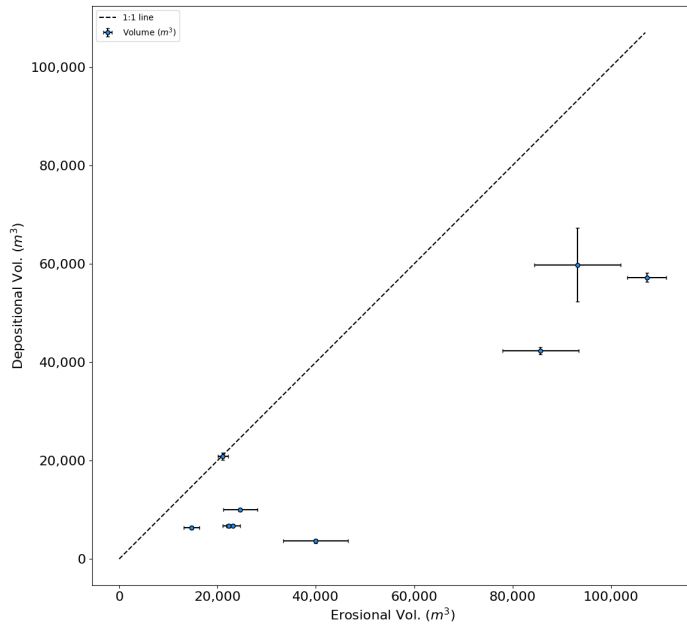
Figure S6. Comparison of all the erosional volumes in locations where we have known depositional volumes. Error bars represent the uncertainty. Note that many channels contributed to an in-channel deposit in Grizzly Creek, but for the purposes of comparing erosion and deposition, all of the erosional channels contributing upstream of the deposit were summed to compare with the deposit volume.

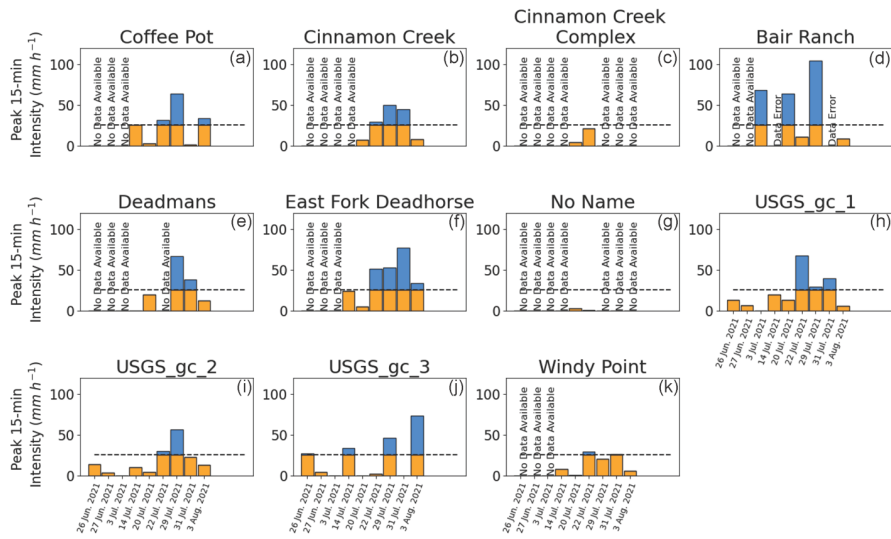
Figure S7. (a-k) The peak 15-minute rainfall intensity (I15) for debris-flow triggering storms measured at each of the eleven available rain gauges across the Grizzly Creek burn area. Dates for observed debris flows are shown as the bins on the x-axis. Peak I15 values below the modelled rainfall threshold (dashed black line) are shown in orange. Peak I15 values greater than the threshold are shown in blue. Storm dates without available rainfall data are labelled as No Data Available.

highly variable. For example, during the storm on 22 July 2021, rainfall intensities only exceeded the rainfall threshold at six of the 11 rain gauges (Figure S7), and the observed debris flows from that storm intersected a narrow section of I-70 (between mile markers 124-126) (Figure 7b). In contrast, during the storm on 29 July 2021, rainfall intensities exceeded the rainfall threshold at 8 of the 9 gauges (two gauges had data gaps at this time, Figure S7), and debris flows were observed throughout most of the canyon (Figure 7b).

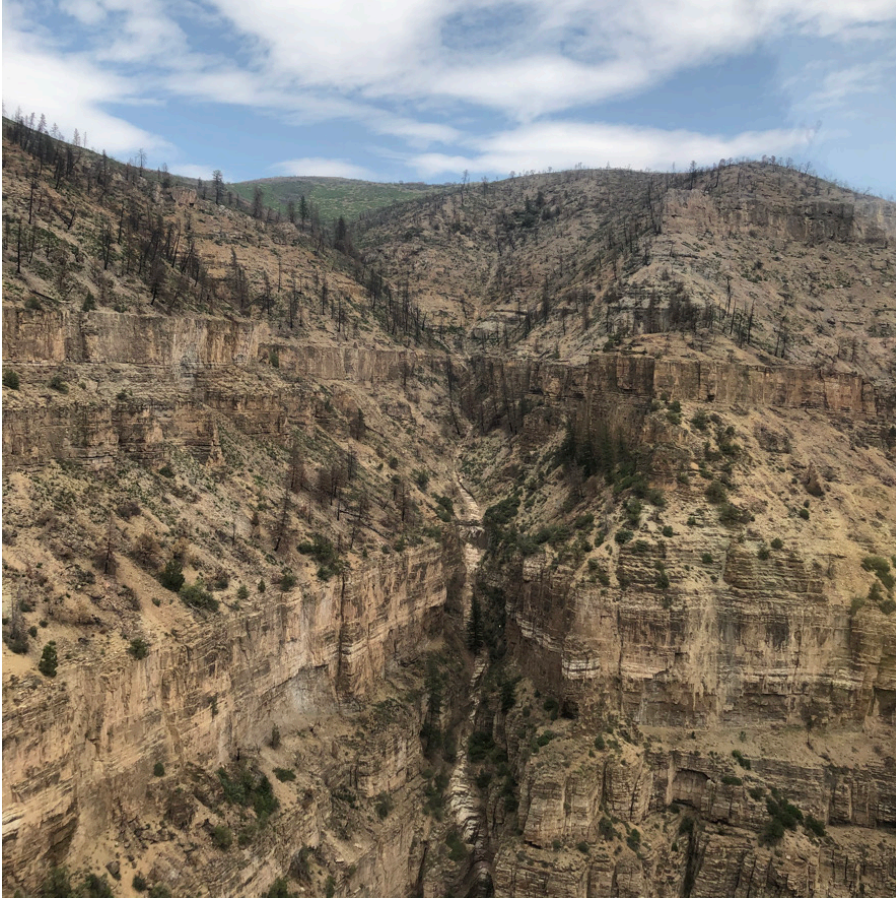
Figure S8. Photo from the upper portion of the canyon showing channelized debris-flow erosion down to bedrock indicating sediment depletion.
