# Evaluating Post-Wildfire Debris Flow Rainfall Thresholds and Volume Models at the 2020 Grizzly Creek Fire in Glenwood Canyon, Colorado, USA

Francis K. Rengers<sup>1</sup>, Samuel Bower<sup>2</sup>, Andrew Knapp<sup>3</sup>, Jason W. Kean<sup>1</sup>, Danielle W. vonLembke<sup>1</sup>,  
5 Matthew A. Thomas<sup>1</sup>, Jaime Kostelnik<sup>1</sup>, Katherine R. Barnhart<sup>1</sup>, Matthew Bethel<sup>4</sup>, Joseph E. Gartner<sup>5</sup>,  
Madeline Hille<sup>4</sup>, Dennis M. Staley<sup>6</sup>, Justin Anderson<sup>7</sup>, Elizabeth K. Roberts<sup>8</sup>, Stephen B. DeLong<sup>9</sup>, Belize  
Lane<sup>10</sup>, Paxton Ridgway<sup>10</sup>, Brendon P. Murphy<sup>11</sup>

<sup>1</sup>Landslide Hazards Program, U.S. Geological Survey, Golden, CO 80401, USA

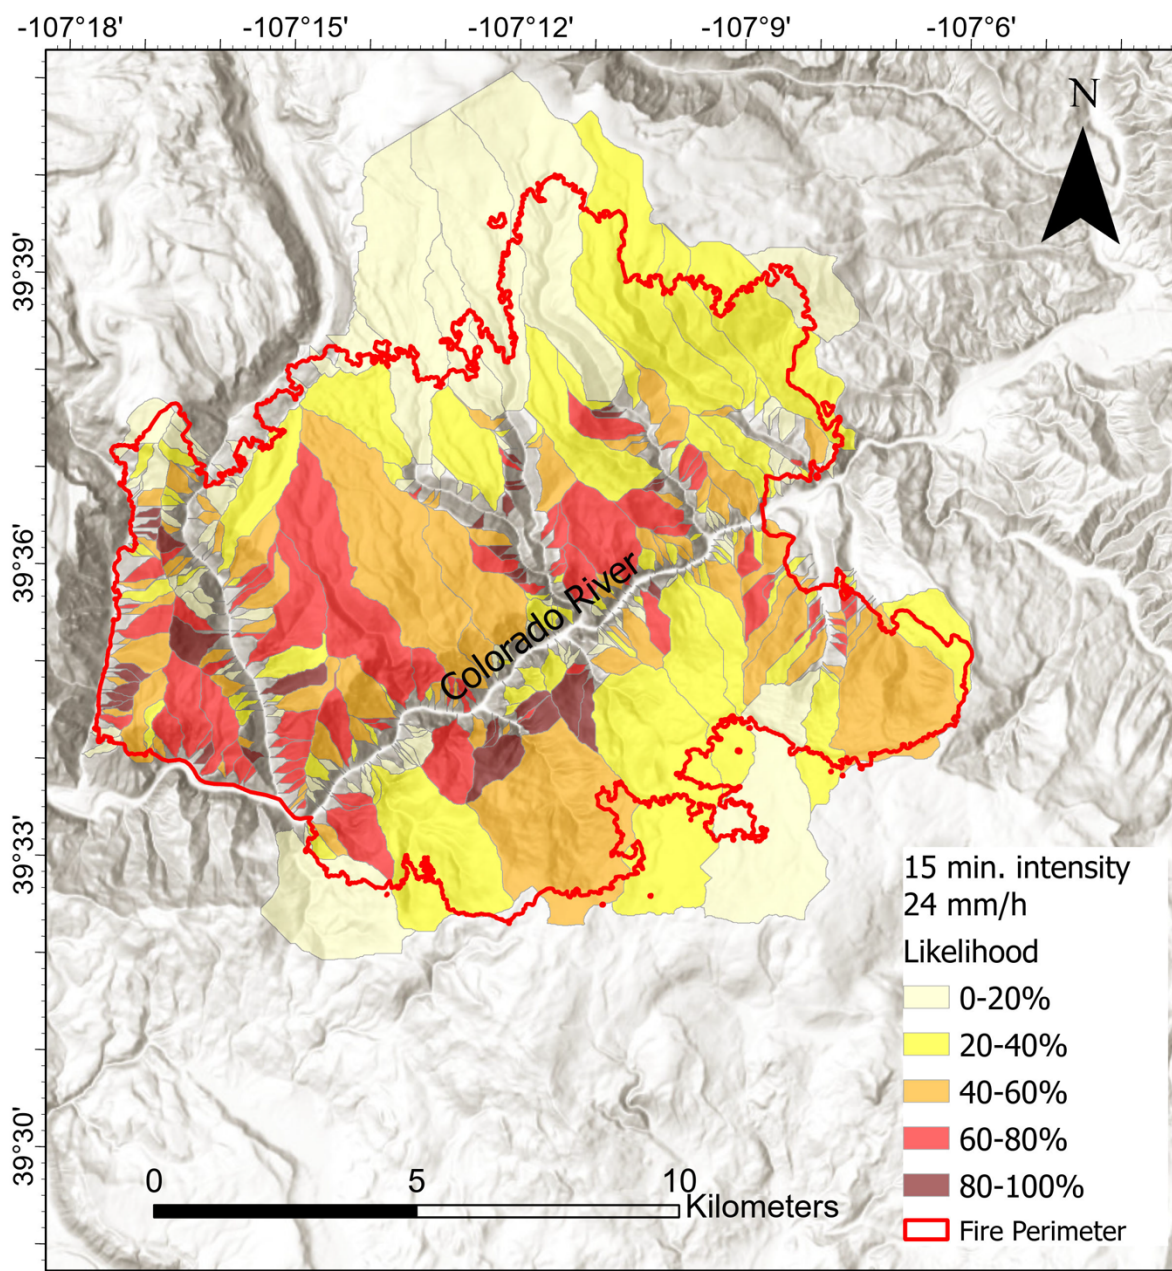
720 **Figure 1.** USGS Debris Flow Hazard likelihood estimate produced for the Grizzly Creek Fire perimeter using Equation 1. The likelihood of debris flow initiation is shown for a modeled rainstorm with a 15-minute rainfall intensity of 24 mm h<sup>-1</sup>.

Three tipping bucket rain gauges were installed in the burn area on 17 September 2020 by the USGS Landslide Hazards Program. These gauges were deployed specifically for the task of verifying the hazard assessment model (Figure 1). An additional seven rain gauges (7) were added during the summer of 2021 by the USGS Colorado Water Science Center to provide situational awareness and inform operational warnings by the National Weather Service and CDOT. We were also  
175 able to obtain data from the Bair Ranch gauge operated by CDOT. As a result, 11 total rain gauges captured high frequency (15-minute) rainfall intensities in and around Glenwood Canyon (Figure 2), and provided a relatively dense network of rain data to associate with debris flow events. All gauges were operating by mid-July 2021, beginning on several different dates (Table 1).

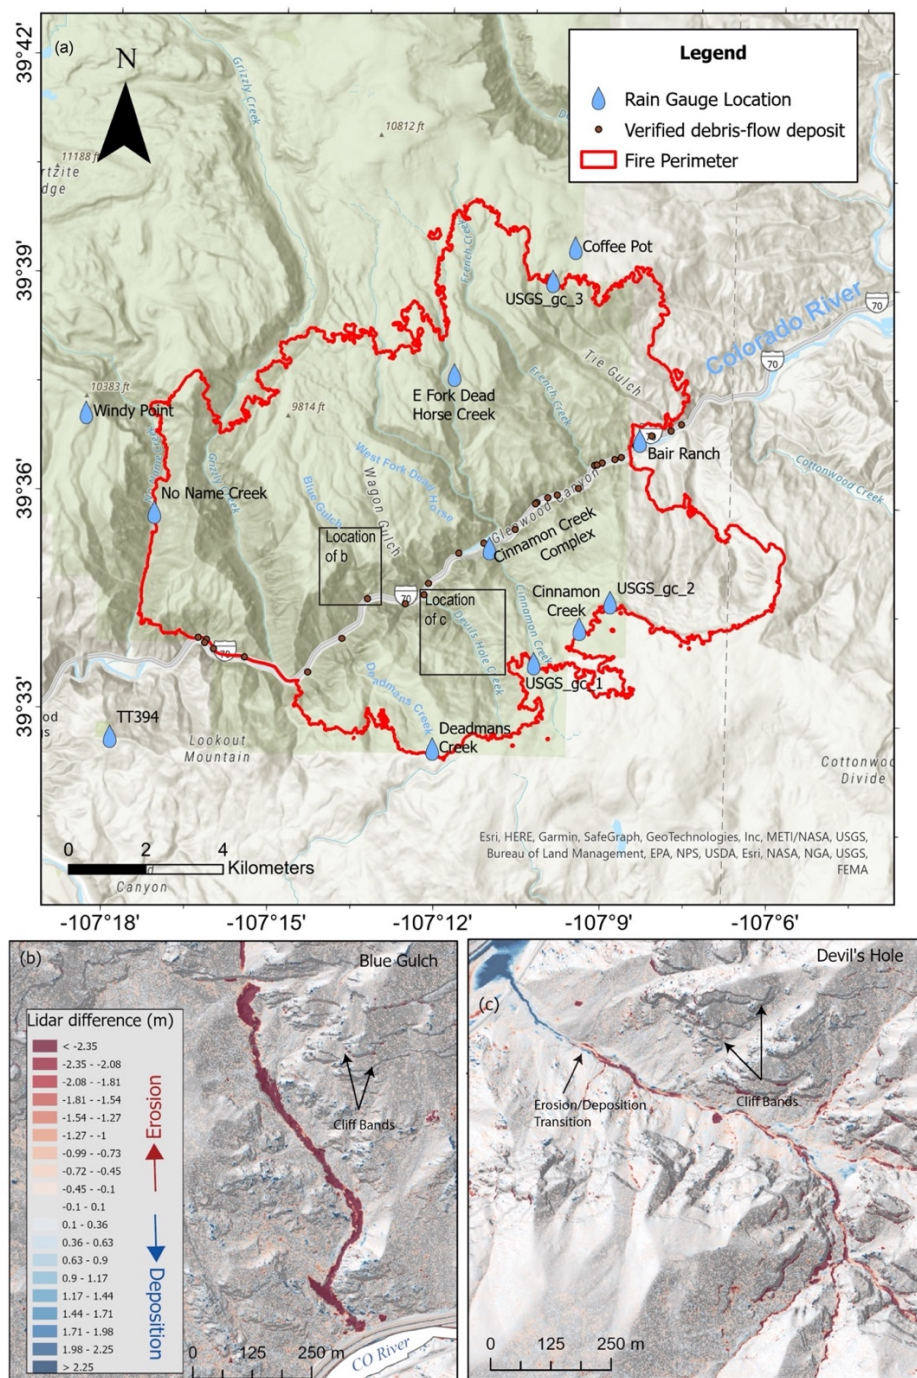
Figure 2. (a) Map showing the burn perimeter, rain gauges, and locations of debris flow observations. (b) DEM of difference map showing erosion (red) and deposition (blue) in the lower half of the Blue Gulch drainage. (c) DEM of Difference (DoD) showing erosion (red) and deposition (blue) in the lower half of the Devil's Hole drainage.

Field observations and the lidar DoD revealed that the majority of sediment incorporated into debris flows in 2021 originated  
in channelized areas with relatively minor sediment contribution from adjacent hillslopes (Figure 2b-c and Figure 4). Field  
observations suggest that channel erosion was nucleated in part by surface water that was strong enough to uproot grassy  
340 vegetation to access sediment below the root zone (Figure 4), as has been observed in grassland settings (Rengers et al., 2016).  
Moreover, field mapping in multiple watersheds (Blue Gulch, Grizzly Creek, and French Creek) confirm the observations of  
in-channel debris-flow initiation observed in the DoD. Hillslope rilling was only observed in a few locations with relatively  
low levels of revegetation in 2021 (Fig. S5).

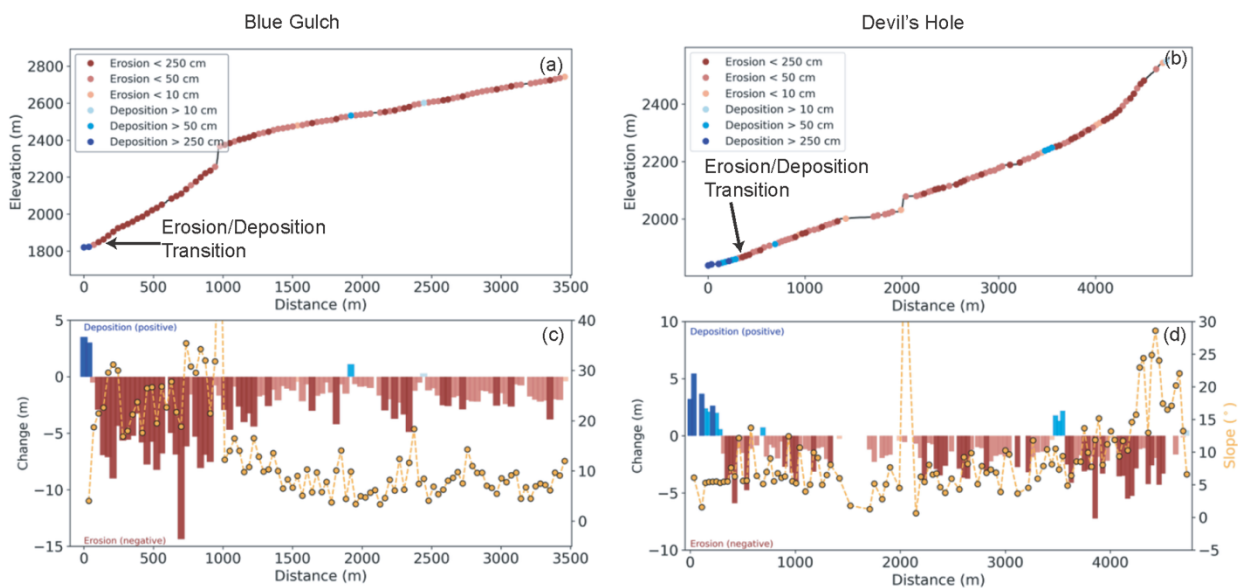
**Figure 3.** (a and b) Elevation as a function of distance from the watershed outlet for the Blue Gulch watershed (a) and Devil's Hole watershed (b). Red dots and blue dots represent erosion/deposition, respectively. Areas without a dot did not experience change beyond the level of detection. (c and d) Measured deposition and erosion as a function of distance from the watershed outlet (primary y-axis). Local slope is shown on the secondary y-axis.

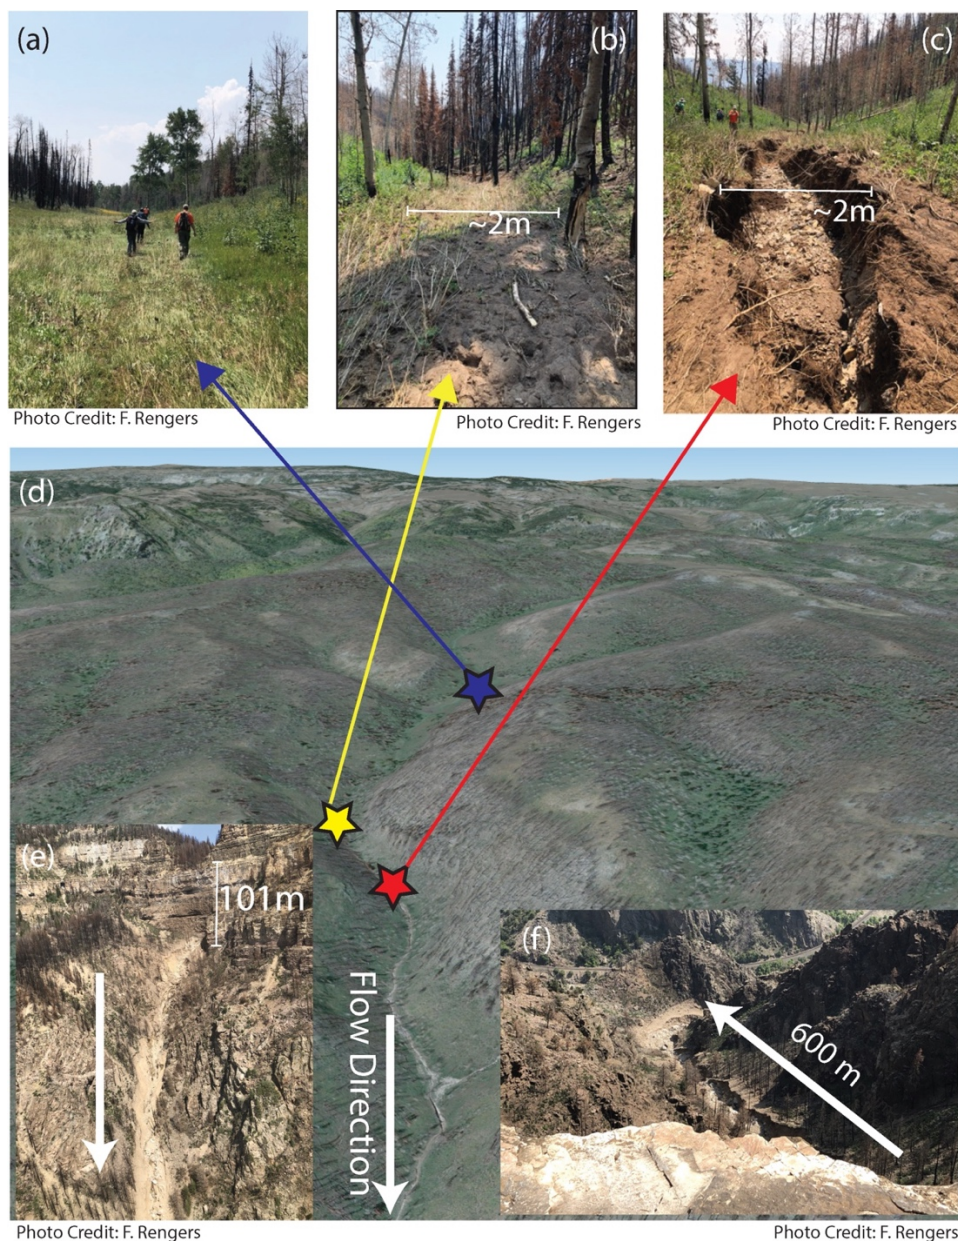
**Figure 4.** Debris flows were triggered in the Blue Gulch Watershed on 29 July 2021 and 31 July 2021. Photos from 17 August 2021 show debris flow initiation transitioning from (a) water flow matting down grass (see people for scale), (b) to incipient erosion of grassy rootwads without distinct channel incision, (c) to channelized erosion below the root layer. (d) © Google Earth imagery of the upper portion of the Blue Gulch watershed. (e) Photo from 18 August 2021 of a cliff (101 m relief) in the Blue Gulch watershed 2.2 km downstream of the initiation location. (f) View from the cliff edge of the debris flow path towards the Colorado River.

455 (e.g., Rengers et al., 2021), debris flows in the Glenwood Canyon study area initiated primarily in channels at small drainage areas and steep slopes (Figure 4). These differences are likely related to the timing of the debris flows with respect to the wildfire. That is, the fire happened in the fall of 2020, allowing time for partial recovery of soil hydrology during the winter freeze thaw cycles and vegetation regrowth during the spring and early summer of 2021 (Figure 4). While hillslope rilling was observed in select areas (Fig. S5), most hillslopes were partially re-vegetated by the 2021 monsoon based on remote sensing

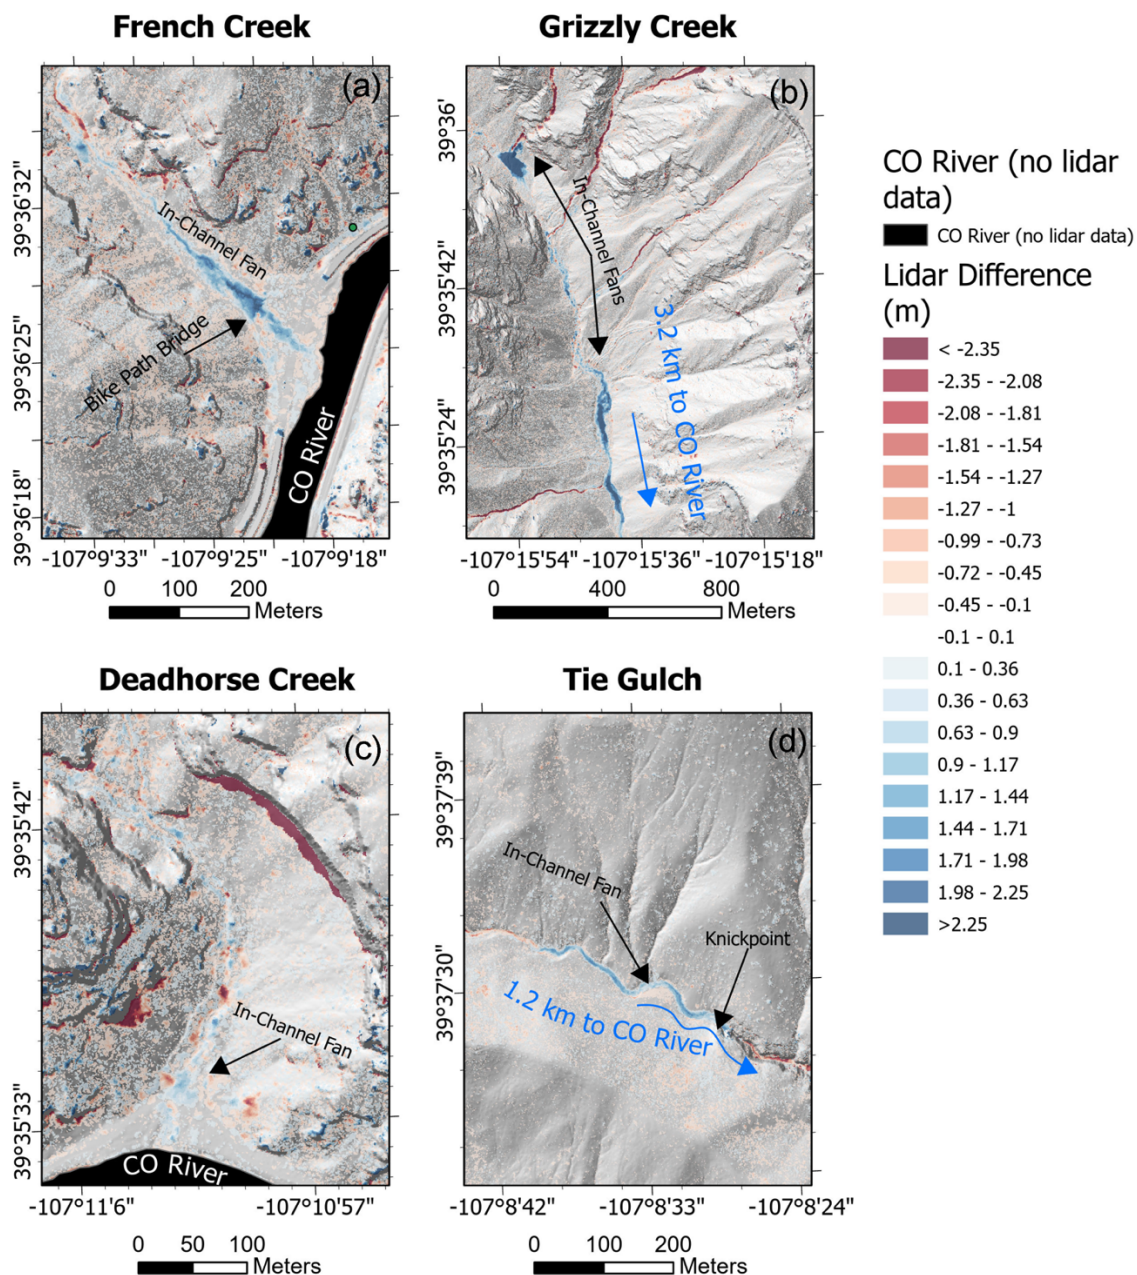
745 **Figure 5.** In-channel sediment deposits in large drainage basins. (a) French Creek: a fan forms upstream of the Colorado River, primarily because sediment is blocked by a concrete bike path bridge. (b) Grizzly Creek: Several in-channel fans formed several kilometers upstream of the Colorado River. No fan formed at the outlet of Grizzly Creek. (c) Deadhorse Creek: relatively minor depositional fan forms upstream of the Colorado River. (d) Tie Gulch: In-channel fan develops upstream of a knickpoint.

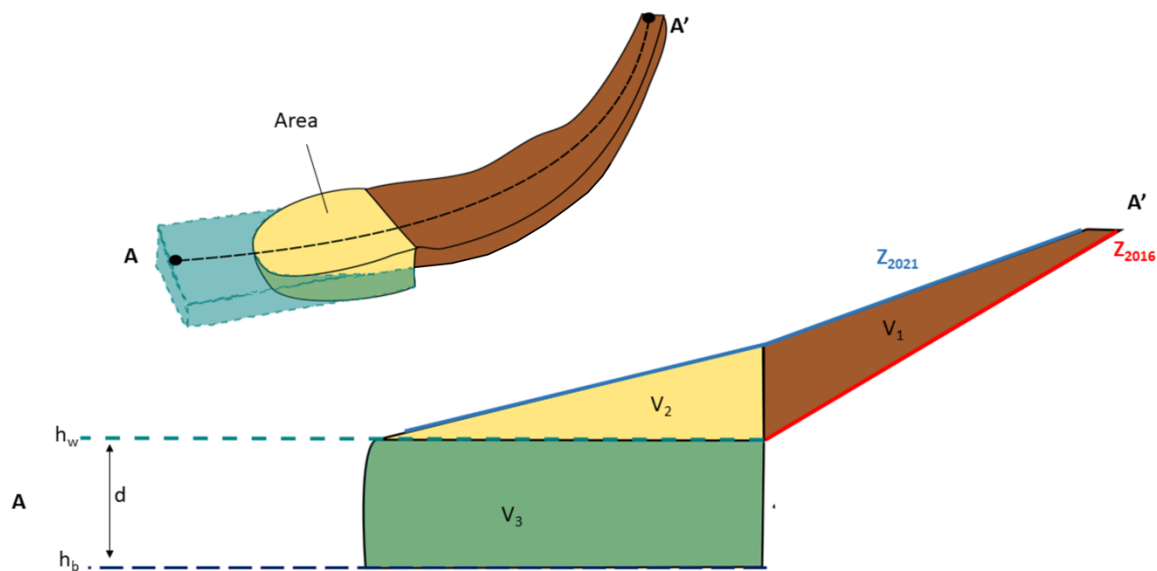
Figure 6. (a) Oblique view and (b) Cross-sectional view of the approach used to estimate the volume of deposited sediment in the Colorado River due to unknown bathymetry. The volume of sediment deposition was divided into three zones.  $V_1$  is the sub-areal zone, where a lidar difference can be used to estimate the volume.  $V_2$  is the zone above the water surface.  $V_3$  is the subaqueous zone, and the depth is estimated based on reports from CDOT maintenance crews.

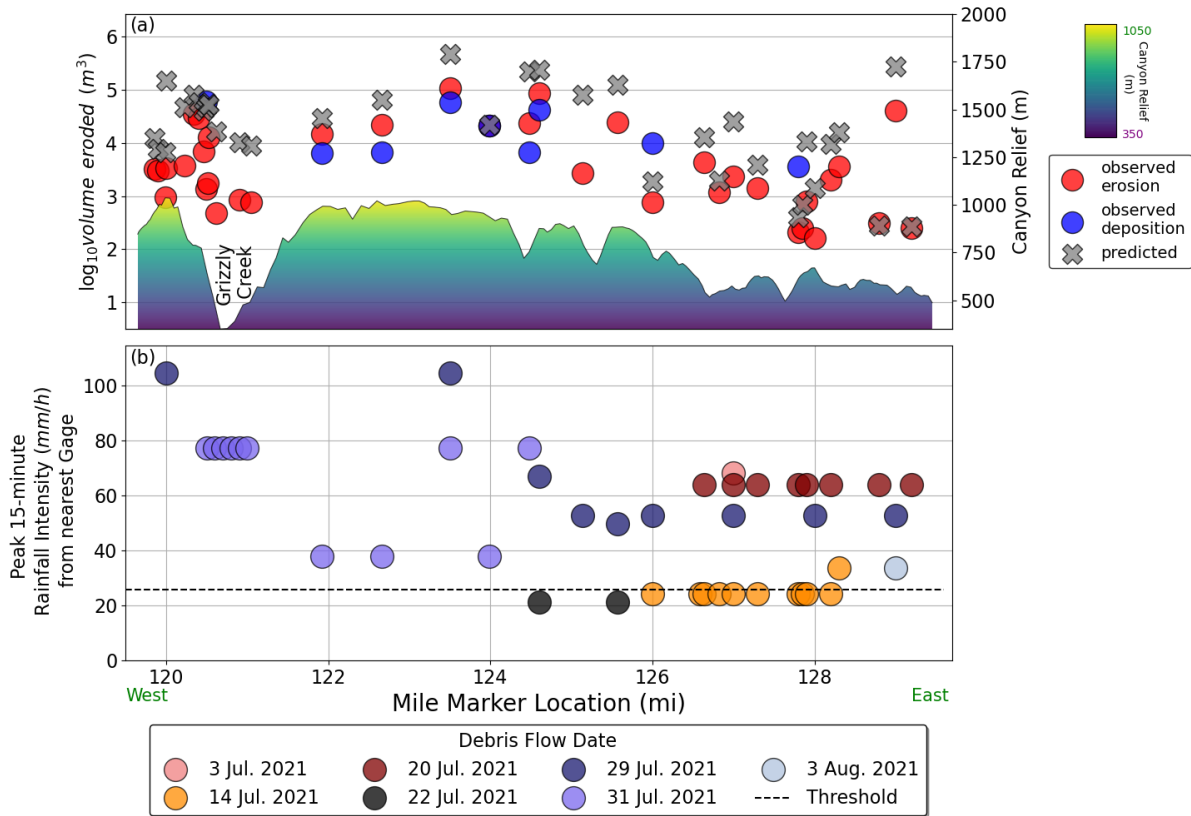
760 **Figure 7. (a) Observed sediment volume (erosional and depositional) and predicted sediment volume using Equation 2 shown as a function of the mile marker location in Glenwood Canyon. For context, the canyon relief is shown on secondary axis. The relief profile indicates the elevation from the north side of the canyon approximately parallel to I-70. (b) Peak 15-minute rainfall intensity from the nearest representative gauge shown at locations identified by debris flow date. Note that channel polygons were associated with a mile marker location at the watershed outlet, as this was the preferred method of identification by CDOT personnel. In cases where the channel outlet did not directly intersect I-70, the outlet was simply translated onto a line segment representing I-70 to estimate a mile marker location.**

350 The observed debris-flow erosional volumes were substantially smaller than the volume predicted by *Equation 2* (Figure 7 and Figure 9). For example, the observed volume of erosion for individual watersheds ranged from  $160 \pm 25 \text{ m}^3$ - $107,000 \text{ m}^3 \pm 3800 \text{ m}^3$ , whereas the predicted volumes ranged from 270-470,000  $\text{m}^3$ . A best-fit line derived from a linear regression was developed to compare the predicted to observed erosion (Grizzly Creek Fire data only):

The depositional volumes observed were less than the erosional volumes, as was expected due to changes between the debris  
355 flows and the lidar flight (Figure 7). In a few cases the depositional volume estimates were slightly larger than the erosional estimates, reflecting the large uncertainty in depositional volumes.

The USGS M1 likelihood model successfully estimated an appropriate rainfall threshold for most debris flows in year 1 using the P50 value. For eight out of nine debris-flow-producing storms in 2021, the observed peak I15 from the rain gauges was  
390 greater than the median fire-wide rainfall threshold produced by the hazard assessment model (U.S. Geological Survey, 2022) (Figure 8). This result is similar to previous research (Kean et al., 2011), showing debris flows initiating during storms with high short-duration rainfall intensities. However, the spatial footprint of any given storm observed at our study area was highly variable. For example, during the storm on 22 July 2021, rainfall intensities only exceeded the rainfall threshold at 6 of the 11 rain gauges (Fig. S3), and the observed debris flows from that storm intersected a narrow section of I-70 (between mile marker  
395 124-126) (Figure 7b). Similarly, during the storm on 29 July 2021, rainfall intensities exceeded the rainfall threshold at 8 of the 9 gauges (two gauges had data gaps at this time, Fig. S3), and debris flows were observed throughout most of the canyon (Figure 7b).

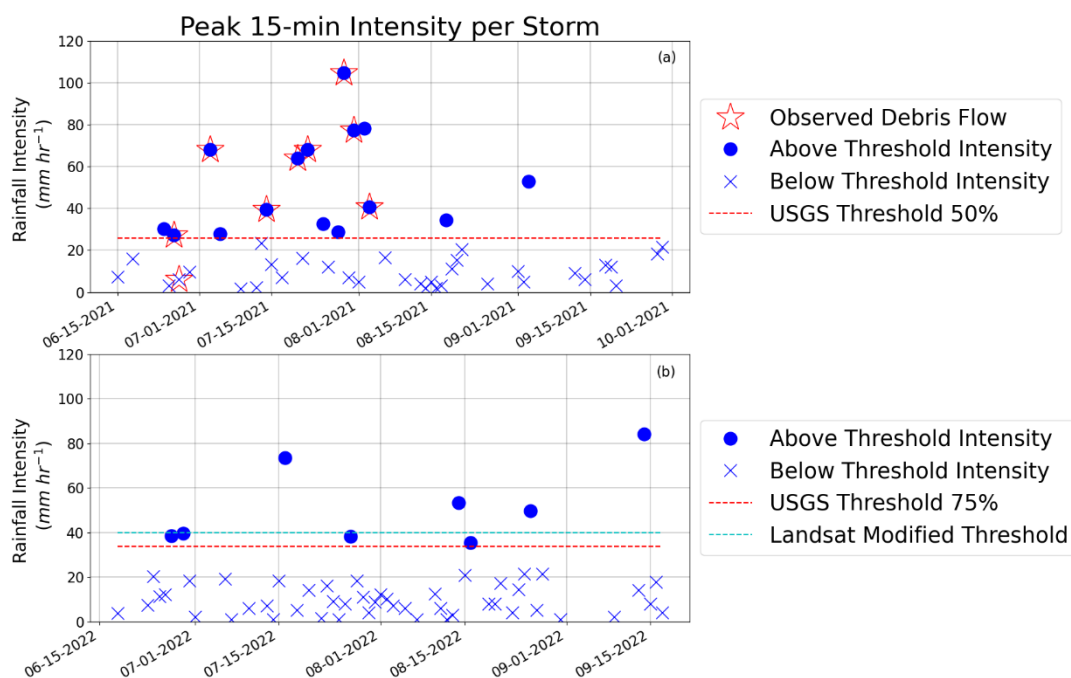
**Figure 8. (a) Maximum 15-minute rainfall intensity during each storm from the 11 rain gauges near the Grizzly Creek Fire perimeter during the 2021 monsoon. Rainfall rates below the modelled intensity threshold of  $25.9 \text{ mm h}^{-1}$  (50% likelihood) are shown with a cross and those above the modelled threshold are shown with a circle. Any storms that produced a debris flow are indicated with a star. (b) Maximum 15-minute rainfall intensity during each storm from the 11 rain gauges near the Grizzly Creek Fire perimeter during the 2022 monsoon. The year 2 (75% likelihood) of  $33.7 \text{ mm h}^{-1}$  was used as the USGS threshold. A recalibrated dNBR value from Landsat at the beginning of the monsoon season was used with the M1 model to develop an additional threshold of  $40 \text{ mm h}^{-1}$  using the 50% likelihood of debris flow occurrence.**

When the debris flow and storm inventories were compared with the P50 rainfall threshold created by the debris-flow hazard  
assessment in 2021, we observed relatively good performance of the estimated rainfall threshold (Figure 8a). The I15 values  
associated with initiation of one or more debris-flows (Figure 8a), were above the  $\overline{I15_{T21}}$  ( $25.9 \text{ mm h}^{-1}$ ) produced by the hazard  
assessment (Staley et al., 2017) in 8 out of 9 cases during the first year postfire (U.S. Geological Survey, 2022). The only  
325 observed debris flow with a rainfall rate below  $\overline{I15_{T21}}$  was on 27 June 2021. However, most of the rain gauges were not  
operating at that time (Table 1 and Fig. S3); therefore, it is possible that the closest available rain gauge was not reflective of  
the maximum rainfall rate in the storm. In the second summer postfire, the  $\overline{I15_{T22}}$  was increased ( $33.7 \text{ mm h}^{-1}$ ) and several

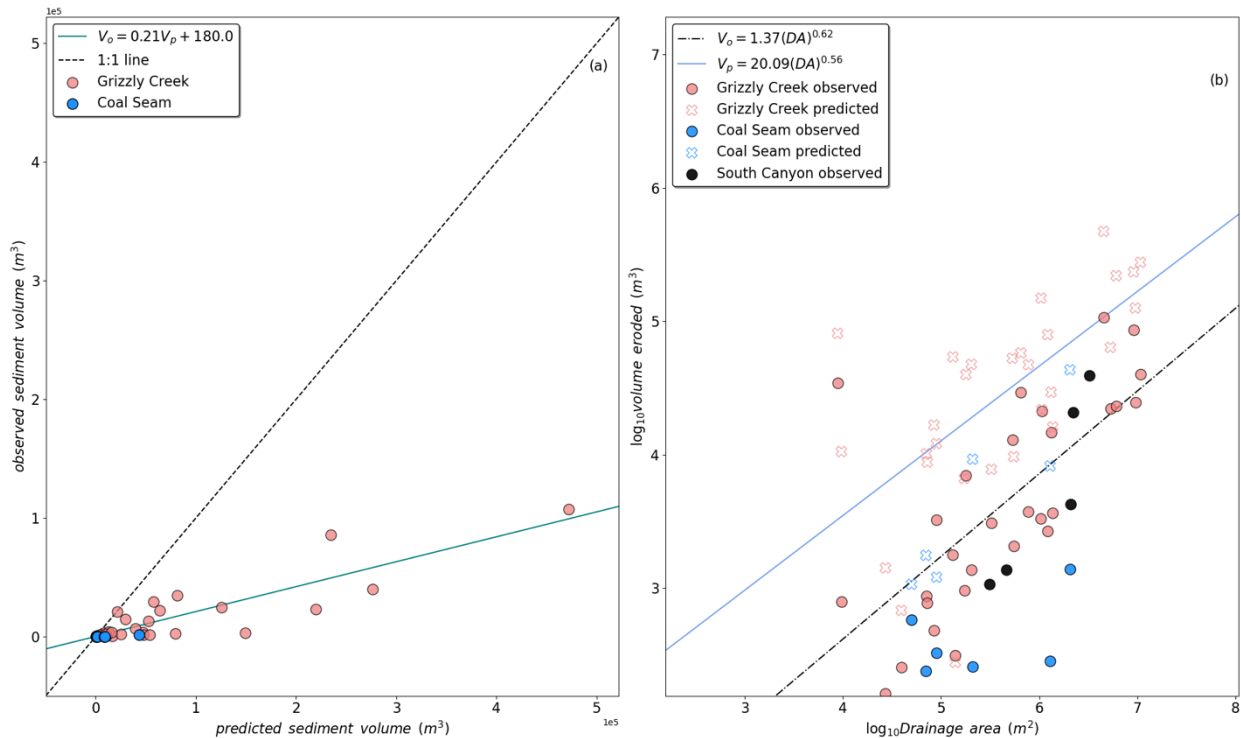
Figure 9. (a) Observed sediment volume (erosional) versus predicted sediment volume using *Equation 2*. Linear trendline shows the relationship between the predicted ( $V_p$ ) and observed ( $V_o$ ) volume at the Grizzly Creek Fire. (b) A comparison of the total volume of observed sediment with predicted volume from *Equation 2* as a function of upstream drainage area (DA). The observation volumes represent the volume of erosion, upstream of a transition to deposition. Best-fit power law equations were fit to the observed and predicted data points for the Grizzly Creek Fire, respectively.

The volumes from the Grizzly Creek Fire were similar in magnitude to the observed volumes from the two prior postfire debris flows in near Glenwood Canyon, the Coal Seam and South Canyon Fires (Figure 9), suggesting regional similarities between the observed volumes across three different fires. Moreover, the trend of volume overprediction by *Equation 2* was observed  
360 in both the Grizzly Creek Fire data and the Coal Seam Fire data (Figure 9). This suggests that the overprediction of *Equation 2* is not related to fire or storm-specific characteristics of the Grizzly Creek Fire. Rather the overprediction of *Equation 2* is more likely related to regional differences in sediment, vegetation, and sediment transport processes tied to the regional geomorphology.

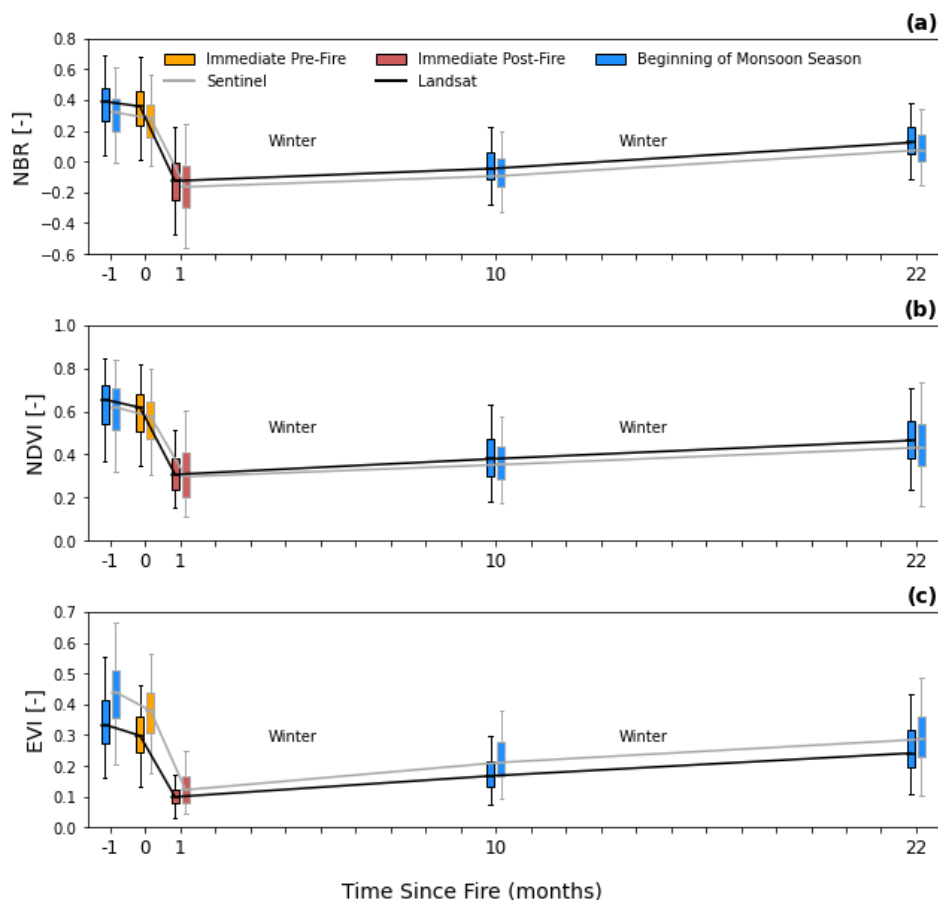
785 **Figure 10.** Landsat- (black outline) versus Sentinel-derived (gray outline) measurements of the (a) Normalized Burn Ratio (NBR), (b) Normalized Difference Vegetation Metric (NDVI), and (c) Enhanced Vegetation Index (EVI) for the 2020 Grizzly Creek Fire. Boxplots summarize the distribution of the mean reflectance metric for each modelled basin (USGS 2022) that intersects the burn area for the beginning of monsoon season (blue), immediately before the fire (orange), and immediately after the fire (red).

All three satellite vegetation indices show similar declines from the prefire period to the postfire period. After this initial decrease, gradually higher vegetation index values are observed in later epochs (Figure 10). Our median Landsat- versus Sentinel-derived NBR, NDVI, and EVI calculations are well correlated at the basin scale for all calculation periods ( $R^2 \geq 0.99$ ). Recovery levels are consistent across satellite platforms but exhibit some variability across vegetation indices. We calculated  
370 16, 21, and 34 % recovery among NBR, NDVI, and EVI for the first postfire monsoon season and 53, 50, and 68 % recovery among NBR, NDVI, and EVI for the second postfire monsoon season. When averaged across satellite platforms and vegetation indices, we estimate 24 % and 57 % recovery for the first and second postfire monsoon season following the fire, respectively. A new P50 estimate for the second year ( $\overline{I15_{T22}}$ ) using updated dNBR values from Landsat imagery (Landsat Modified Threshold) resulted in an updated rainfall threshold ( $40 \text{ mm h}^{-1}$ ). This value was larger than the original P75 rainfall threshold

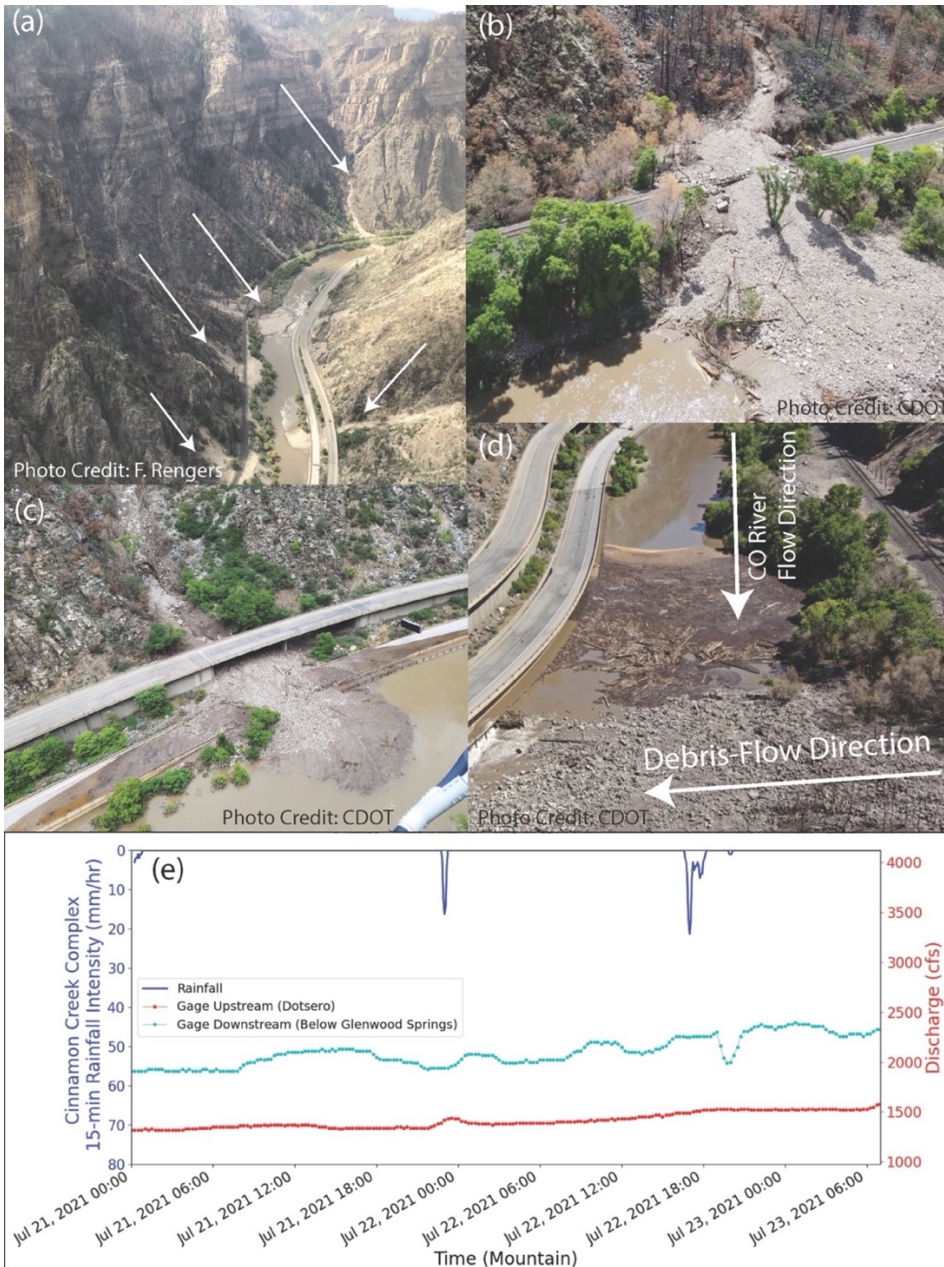
795 **Figure 11. (a) View of debris flow paths and deposits in the Colorado River looking southwest on 18 August 2021. Arrows indicate new debris flow paths. (b) Sedimentation on the railroad in Glenwood Canyon on 1 August 2021. (c) Sedimentation on the lower deck of I-70 on 1 August 2021. (d) Photo of temporary damming of the Colorado River on 22 July 2021. Damming can be observed in the discharge record of the Colorado River on 22 July 2021. The upstream discharge in the Colorado River (Red) rises steadily in response to the closest measured 15-minute rainfall intensity (Blue). When the debris flow at Devil's Hole temporarily dammed the Colorado River, a drop in discharge is observed at the downstream river gauge (Cyan).**

465 damage included buried railroad lines (Union Pacific), road and bridge damage on I-70, and damage/flooding on the bike path that parallels the highway (Figure 11b-d). Substantial sedimentation in the Colorado River impacted whitewater rafting tourism (Stroud, 2022), and increased overbank flood potential by filling in the riverbed (Figure 12a). The debris flow response following the Grizzly Creek Fire illustrates how debris flows can affect multiple locations during many different storm events, putting different types of critical infrastructure at risk.

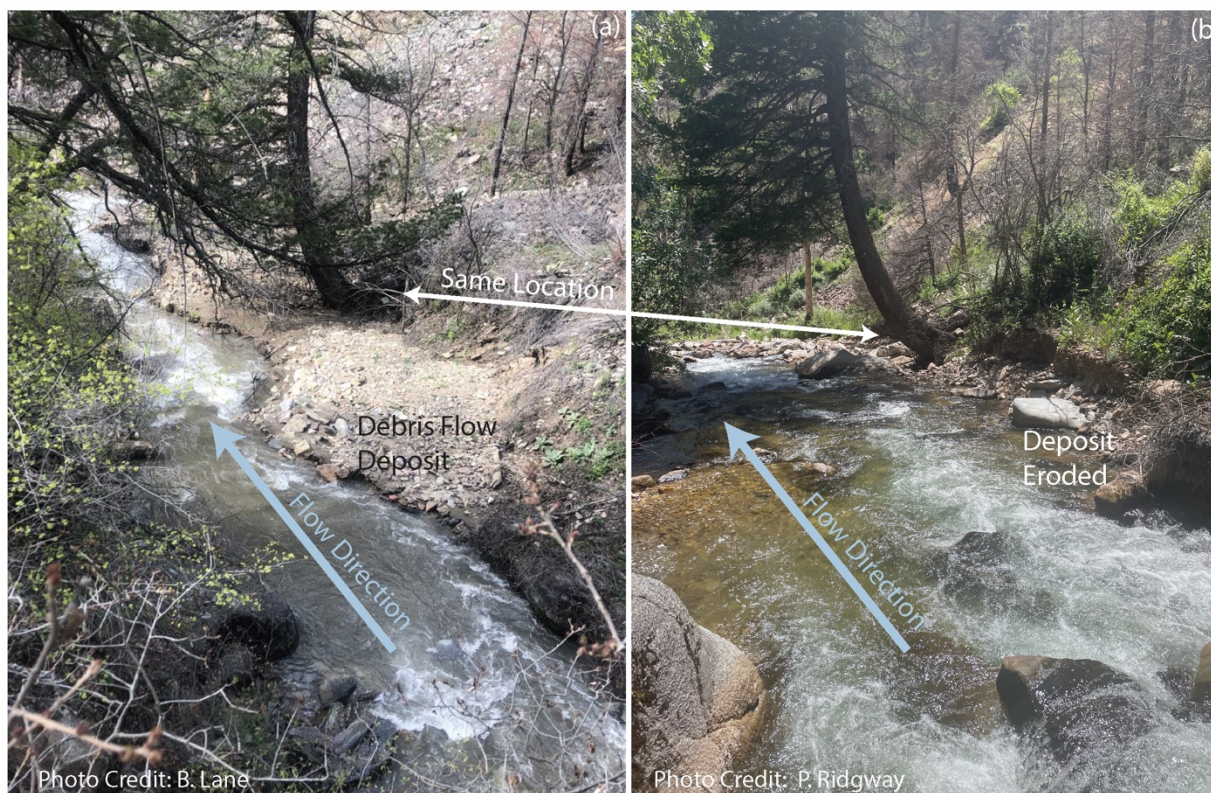
800 **Figure 12 (a) Small debris flow fan in Grizzly Creek at the beginning of the 2022 snowmelt season. (b) Vertical and horizontal incision of the same fan after the snowmelt runoff.**

380 During the collection of our debris flow and storm inventory in Glenwood Canyon, we additionally observed many major impacts from the debris-flow activity. Debris flows within Glenwood Canyon damaged railroad lines (Union Pacific), roads (I-70), and the Colorado River (Fig. 11). One relatively large debris flow sourced from the Devil's Hole watershed (Fig. 2 and Fig. 3) fully blocked the flow of the Colorado River temporarily on 22 July 2021 (Fig. 11d). The storm on 22 July 2021 started at 4:34 pm (local time) and reached a peak intensity of 21.3 mm h<sup>-1</sup>. The upstream flow gauge on the Colorado River showed a slight increase in flow during the storm, however, the downstream flow gauge at Glenwood Springs shows a drop in river  
385 level (Fig. 11d-e). During the second monsoon season in 2022, despite the lack of new debris-flow observations, we observed erosion of debris-flow fan sediment from 2021 via fluvial erosion (Fig. 12a-b).
