Unravelling Landslide Failure Mechanisms with Seismic Signal Analysis for Enhanced Pre-Survey Understanding

Contents of this file

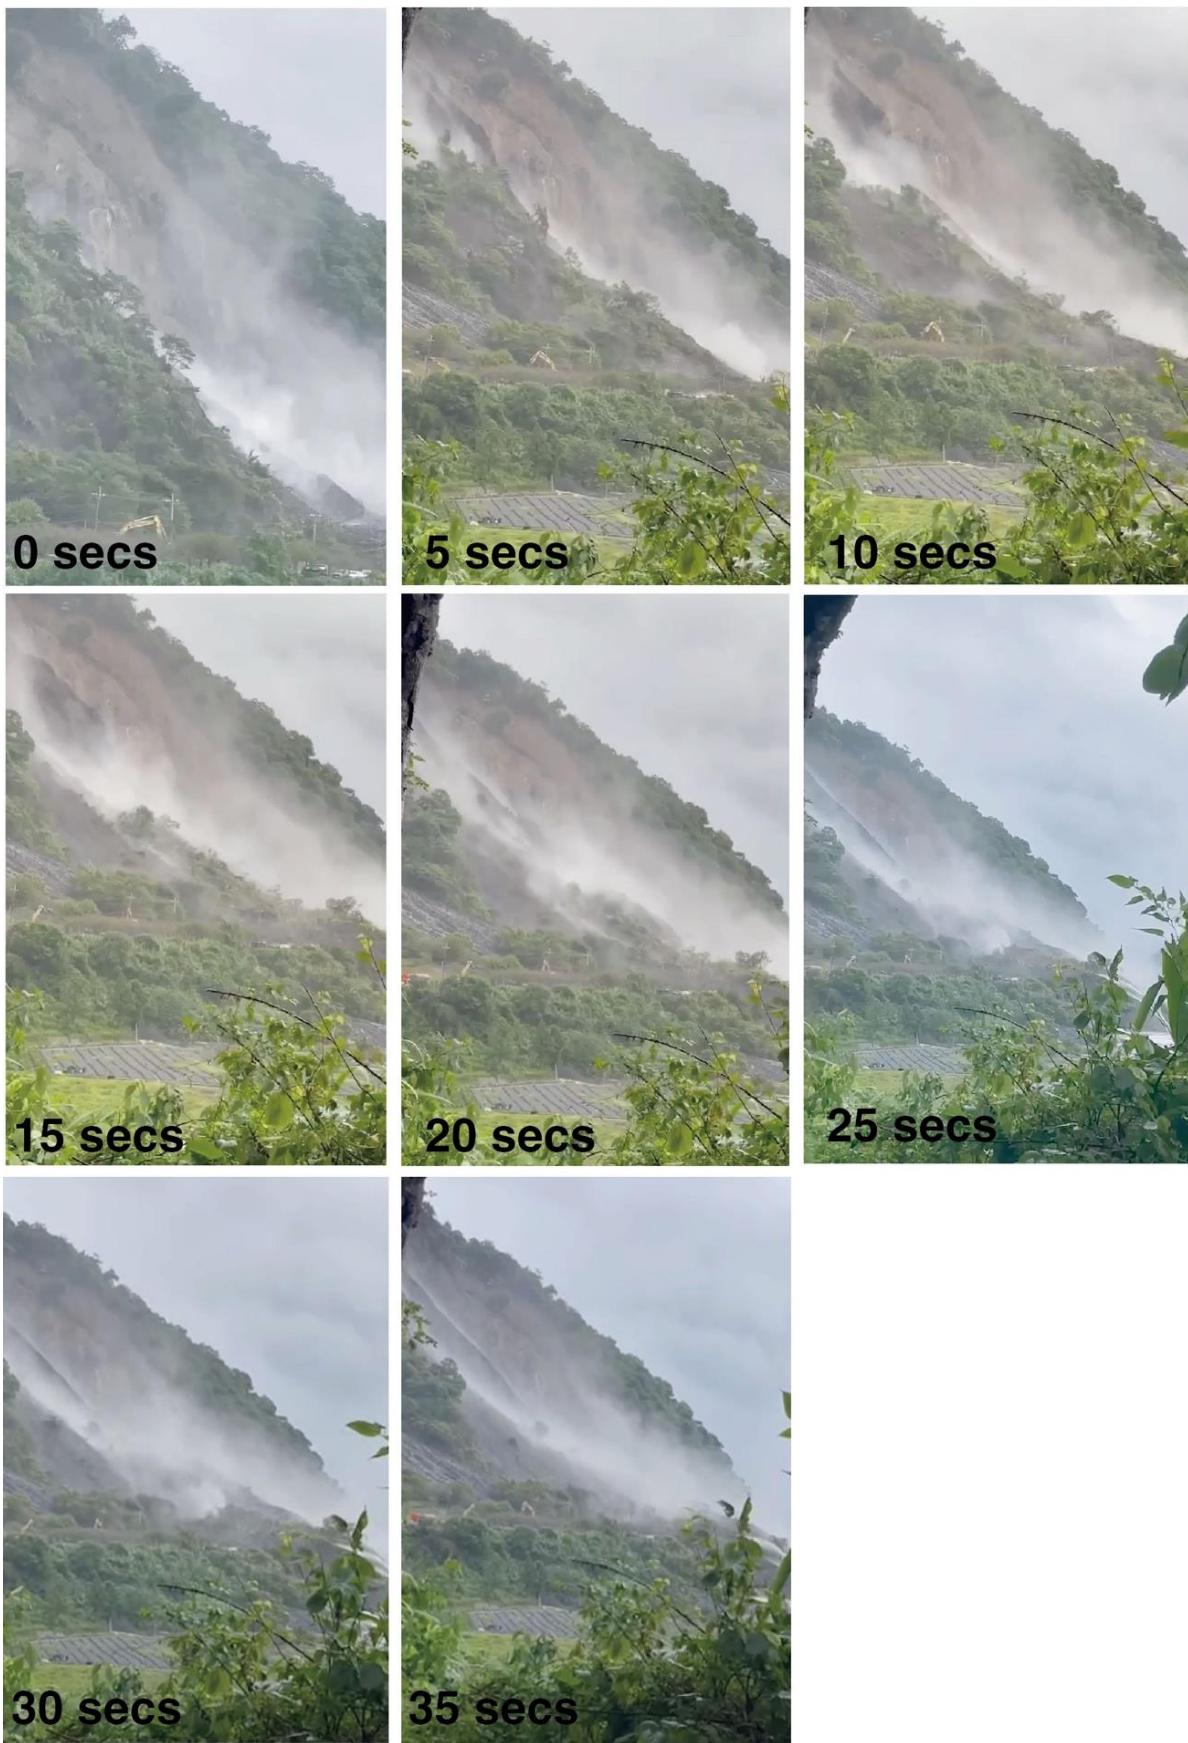
Figure S1 Video caption at different moments of the CL. (https://www.youtube.com/watch?v=cNz_Jlid5aI; last accessed: 2 April 2024)

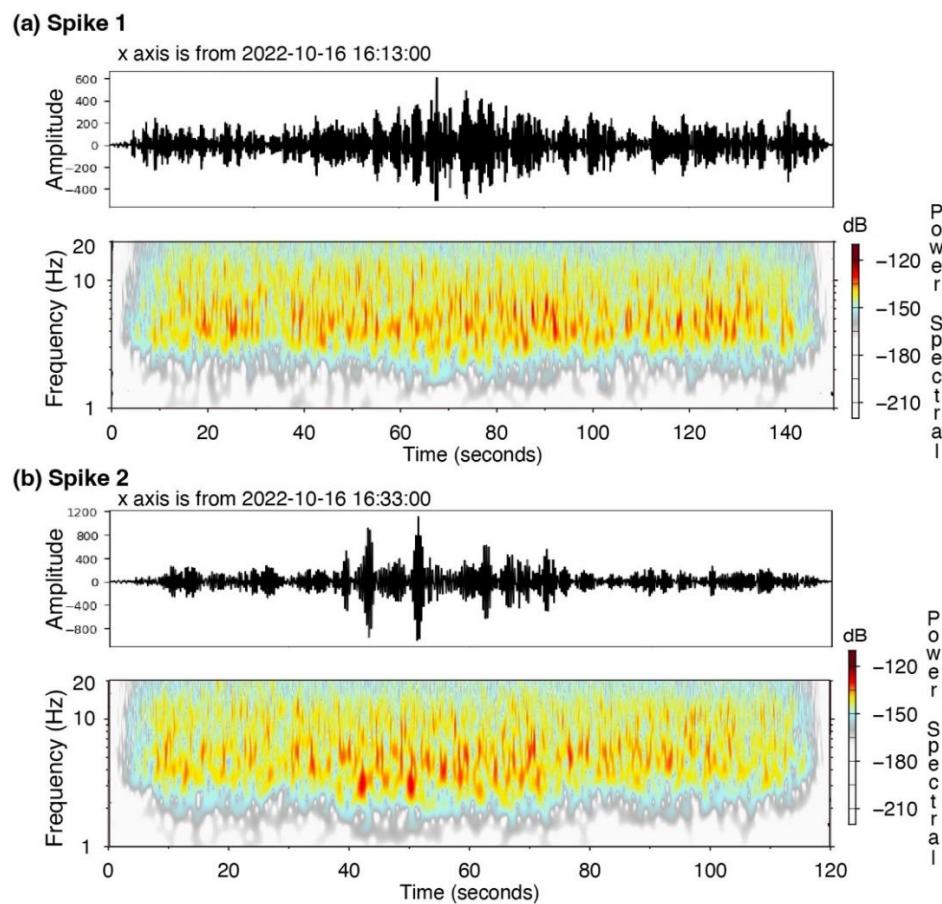
Figure S3 Spectrograms and waveforms of (a) spike 1 and (b) spike 2.

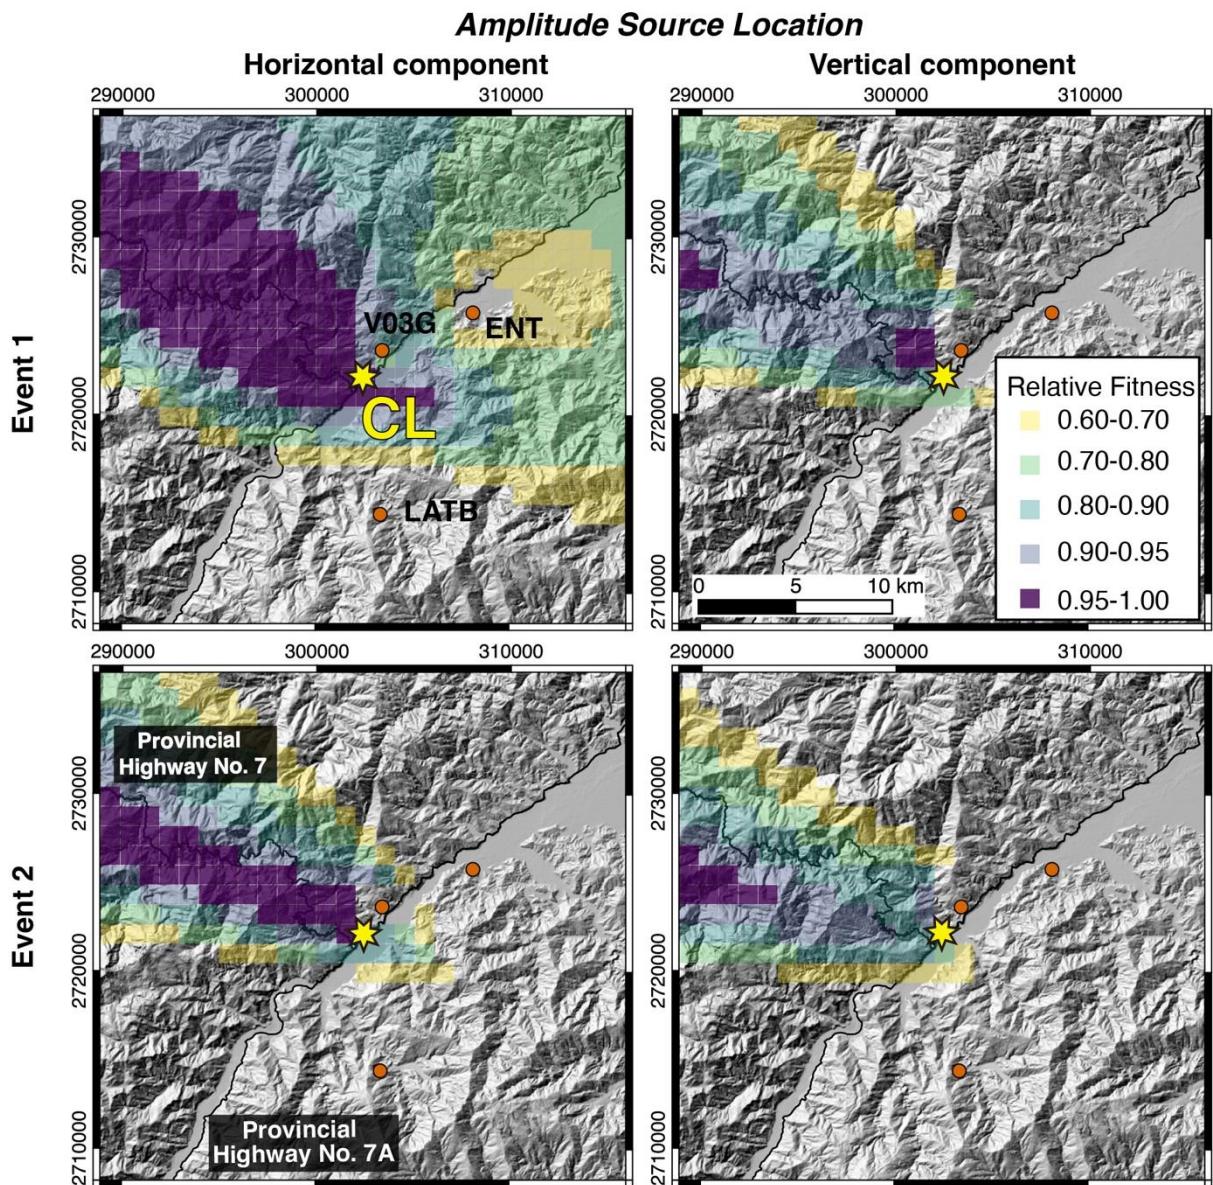
Figure S4 Location determination by amplitude source location of horizontal and vertical components data for Event 1 and Event 2.

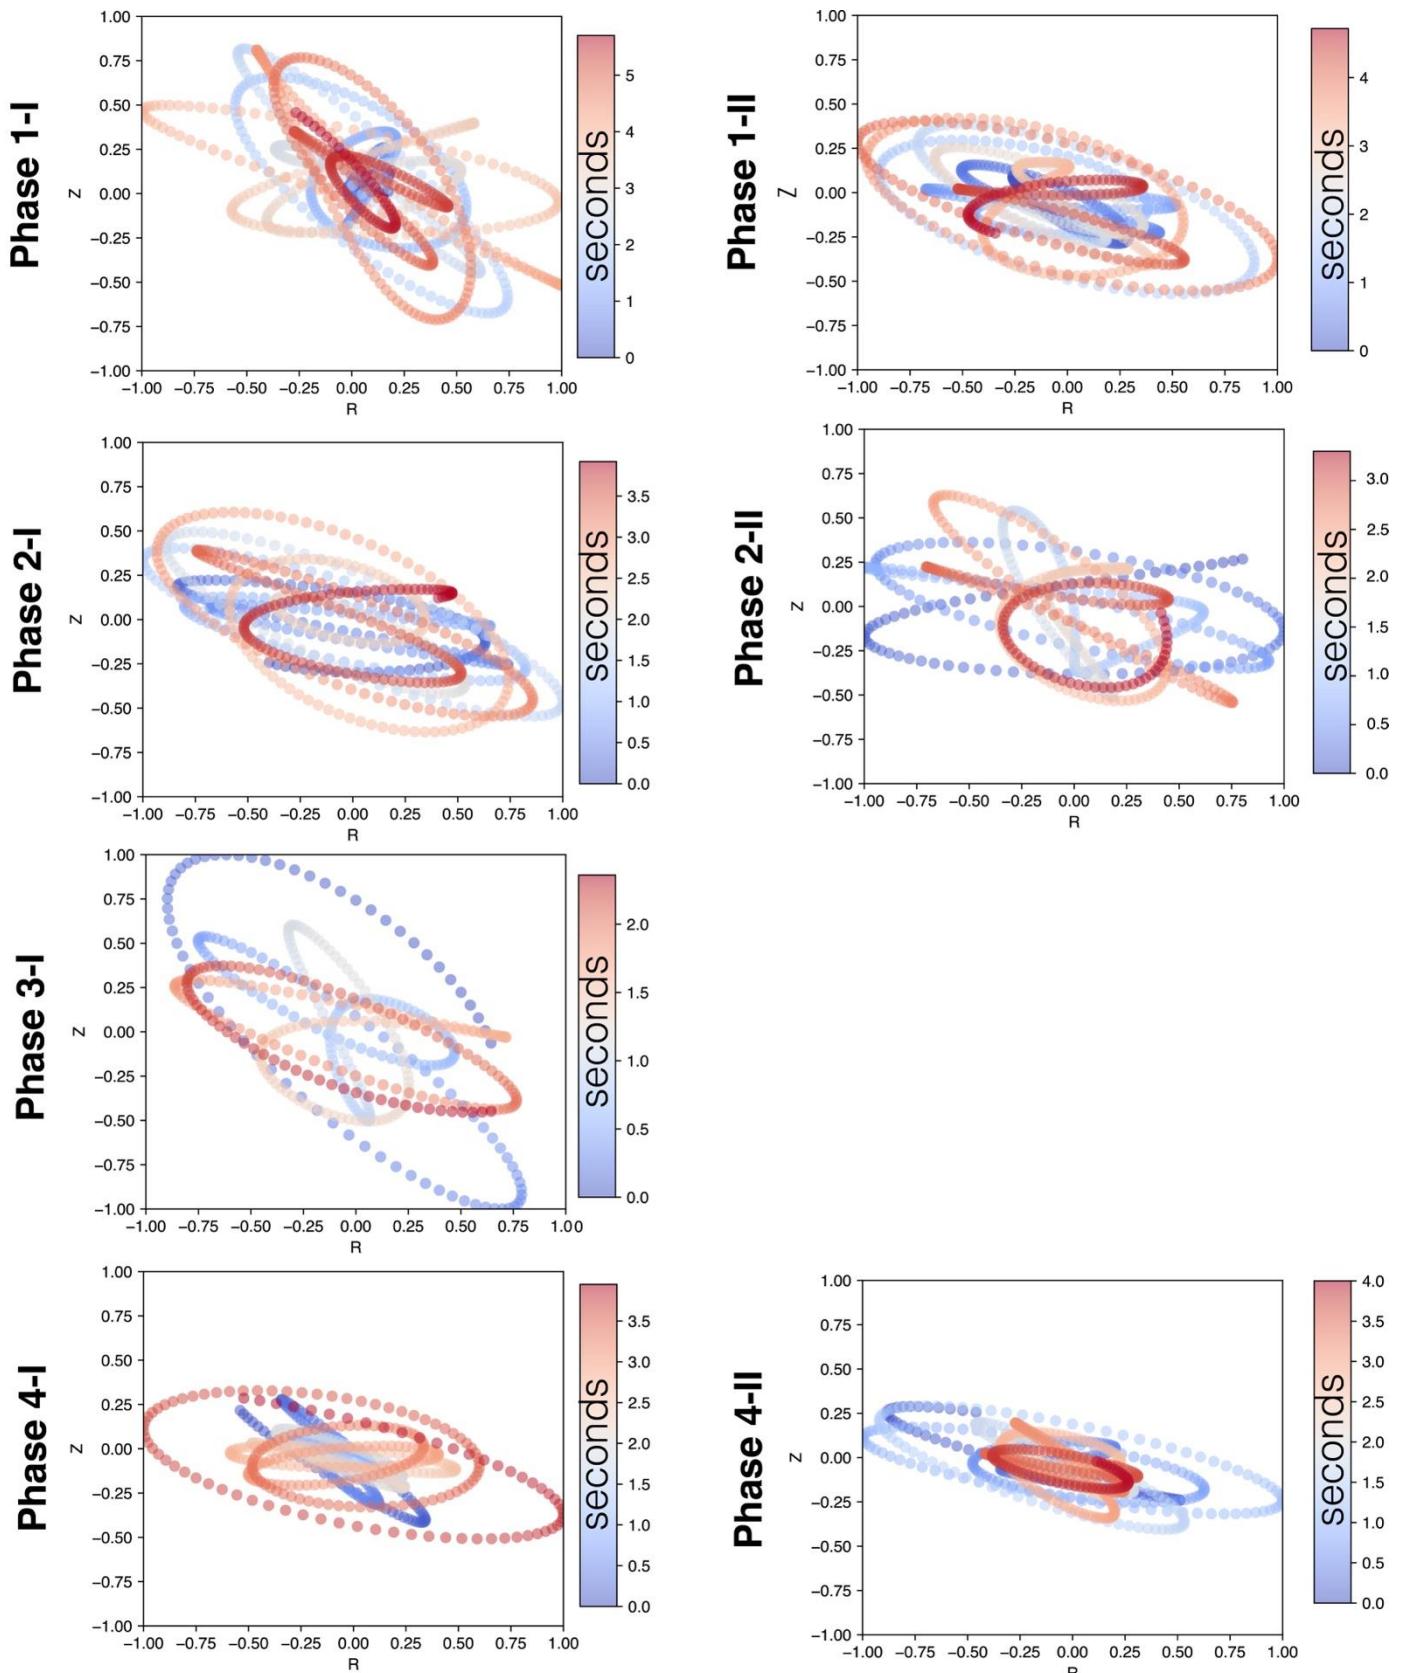
Figure S5 Particle motion of Event 1 for different sliding phases with vertical (Z) and radial(R) components.

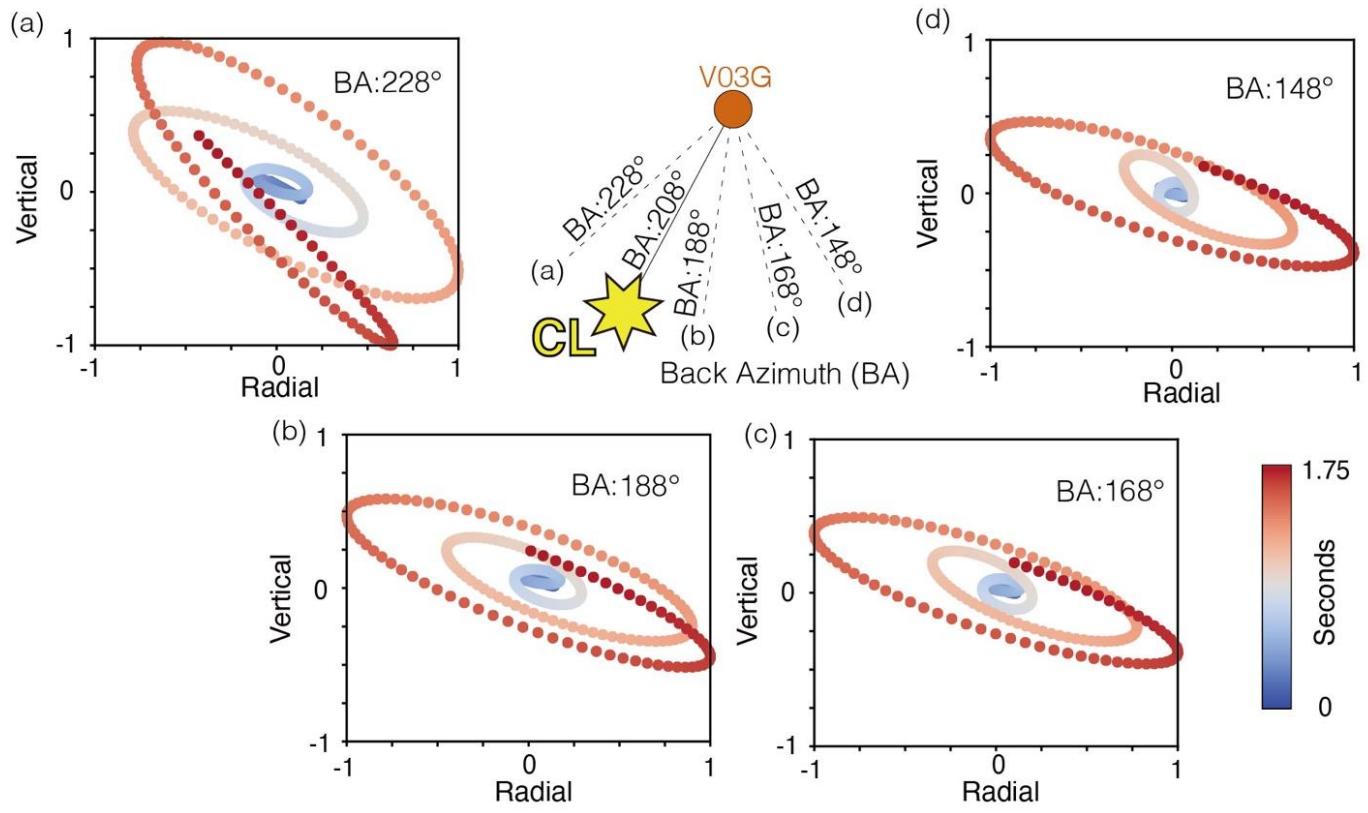
Figure S6 Particle motion of Event 2 rotating different back azimuths to radial components. (a) 228°, (b) 188°, (c) 168°, and (d) 148°.

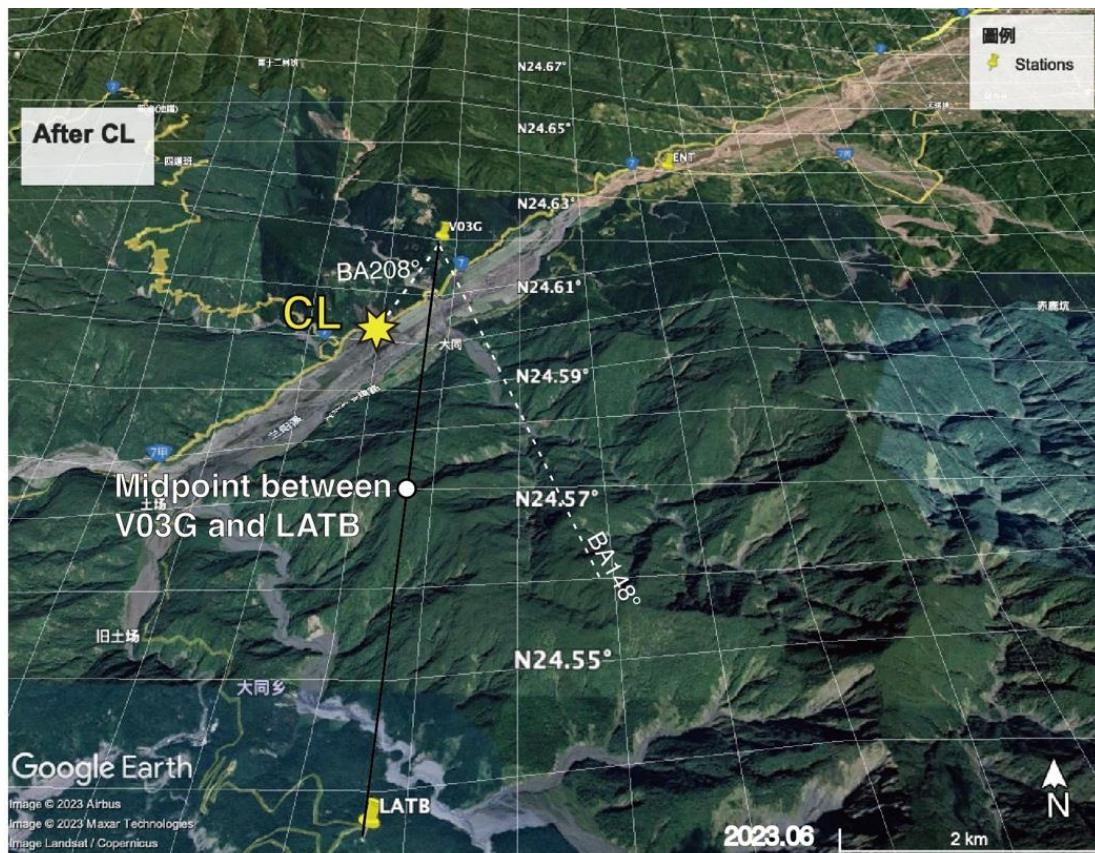
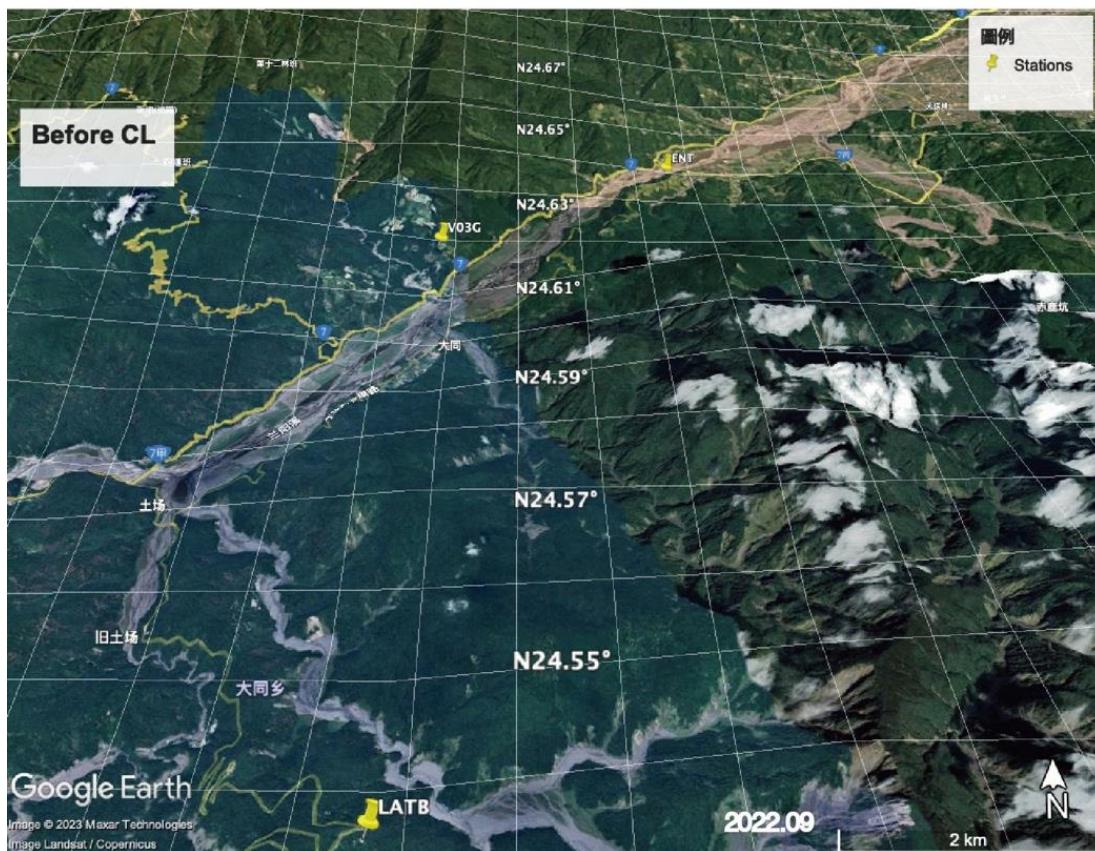
Figure S7 Satellite images before and after the CL.
