Localised geomorphic response to channel-spanning leaky wooden dams

10 **Abstract.** The introduction of leaky wooden dams (or engineered log jams) into river corridors in low order streams in upper catchments has recently become a popular form of natural flood management, particularly in NW Europe. Leaky wooden dams are designed to emulate processes such as those of naturally occurring large wood in river systems, aiming to reduce downstream flood risk through the attenuation of water during higher flows, decreasing in-channel velocities and increasing channel-floodplain connectivity. Leaky wooden dams effectively act as channel roughness agents that disrupt the fluvial and hydrological regime and attenuate the peaks in high river flows thus mitigating downstream flood risk. Despite their widespread installation, there is a paucity of data and understanding concerning the longer-term fluvial geomorphological response to leaky wooden dam installation. Here we present detailed quantification of both the geomorphic and sedimentary response to the installation of two leaky wooden dams in a catchment in Dalby Forest (North Yorkshire, UK) using high-resolution terrestrial laser scannin

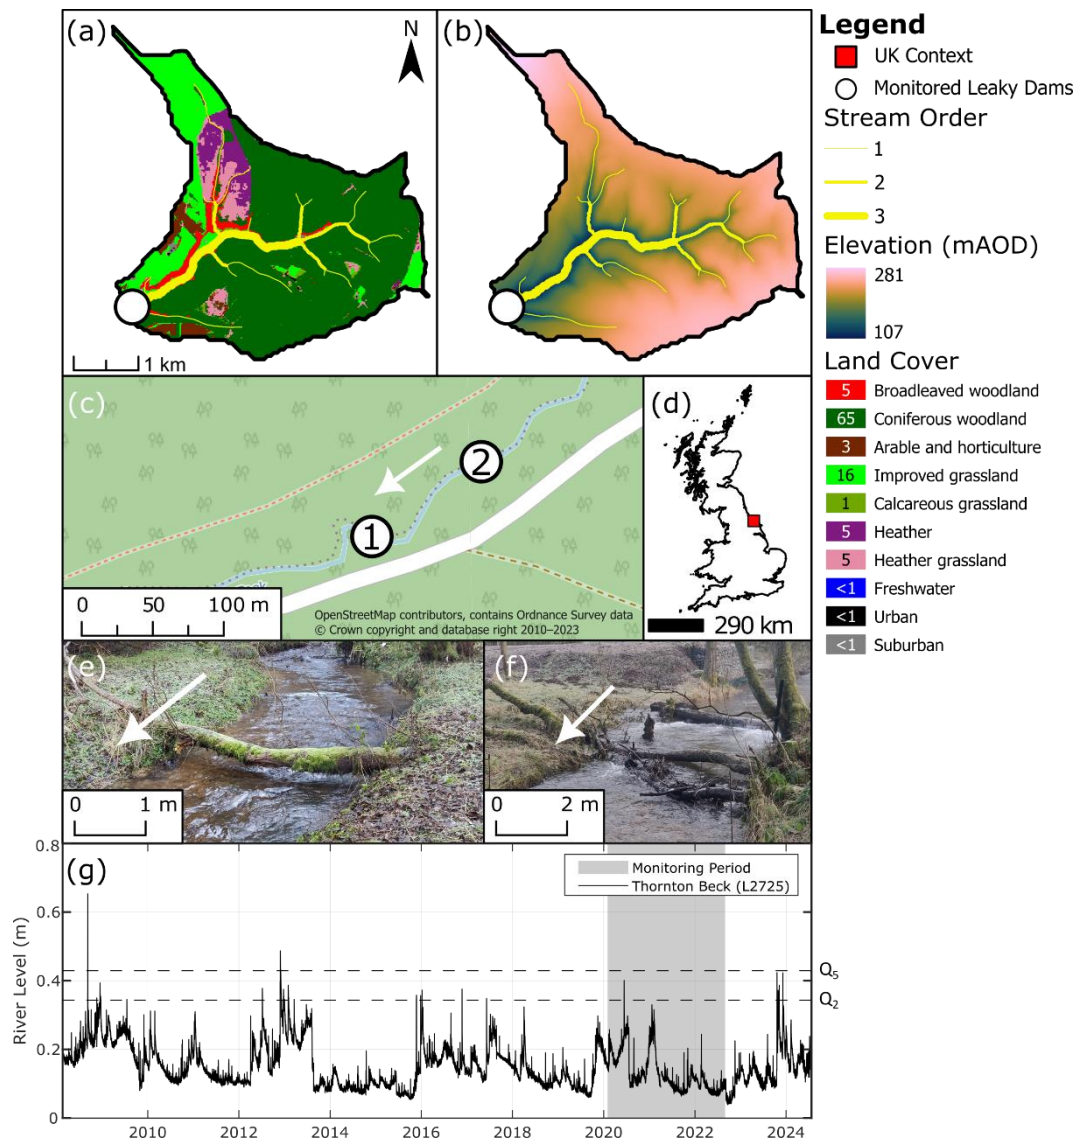
Figure 1: Location of studied leaky wooden dams in relation to the Dalby Forest catchment. (a) 2021 Land cover map with percentage cover shown in the legend (Marston et al., 2022). (b) Stream network generated from terrain data showing Strahler stream order and elevation (Ordnance Survey, 2020). Note same scale as (a). (c) Location of LD1 and LD2, flow direction denoted by white arrow. (d) UK context for site location. (e) & (f) LD1 and LD2, respectively, flow direction denoted by white arrow. (g) River level record 2008–2024 for Thornton Beck, Thornton Le Dale (Grid Reference: SE 83681 83418; Station ID: L2725) approximately 7 km downstream of study area (from Environment Agency) including estimated return period (Q_n) as described in the supplementary material.

105 The catchment is characterised by woodland (70%), with grassland (17%) and heather (10%) the other principal land use types (Marston et al., 2022) as shown in Fig. 1a. It has a mean annual precipitation of 980 mm with monthly averages ranging from 55.6–118.9 mm (1991–2020 mean, Fylingdales weather station at 262 mAOD, 11.2 km NE; Met Office, 2020). The catchment contains 17 km of river corridor, with a mixture of first (9.9 km), second (3.6 km) and third-order (3.5 km) streams following the Strahler (1957) stream order notation (Fig. 1a, b). The channels are between 1 and 4 m wide, widening towards the catchment outlet.

LD1 (Fig. 1e) is a channel spanning LD anchored *in situ* with a wooden stake on the true right bank to reduce the likelihood of displacement during high flows and was embedded into the surface on the true left bank. The channel was 2.7 m wide where the LD was installed. The structure was comprised of a single log which was fully separated from a tree trunk, with
125 some thin branches attached facing upwards. Since this LD is fully channel spanning and thus does not interact with baseflow it is a “Type 1” LD (fully channel spanning, not interacting with baseflows) following the classification of Lo et al. (2021).

LD2 (Fig. 1f) was felled and left *in situ*, remaining attached to its stump to enable growth (a “living” LD). The LD itself was composed of two sub-sections, furthest downstream (LD2a) spanned a 3.85 m wide channel. The structure was partially
130 submerged at the time of installation. LD2a was classified as a “Type 2” LD (fully channel spanning, interacting with baseflows but not touching the stream bed; Lo et al., 2021). LD2 was more complex than LD1 due to the presence of a pre-existing walkway that formed a secondary sub-structure LD2b, that was fixed with wooden anchors. LD2b was a “Type 1” LD (fully channel spanning, not interacting with baseflows at all; Lo et al., (2021). LD2b was installed above the average water depth and spanned a 3.25 m wide channel.

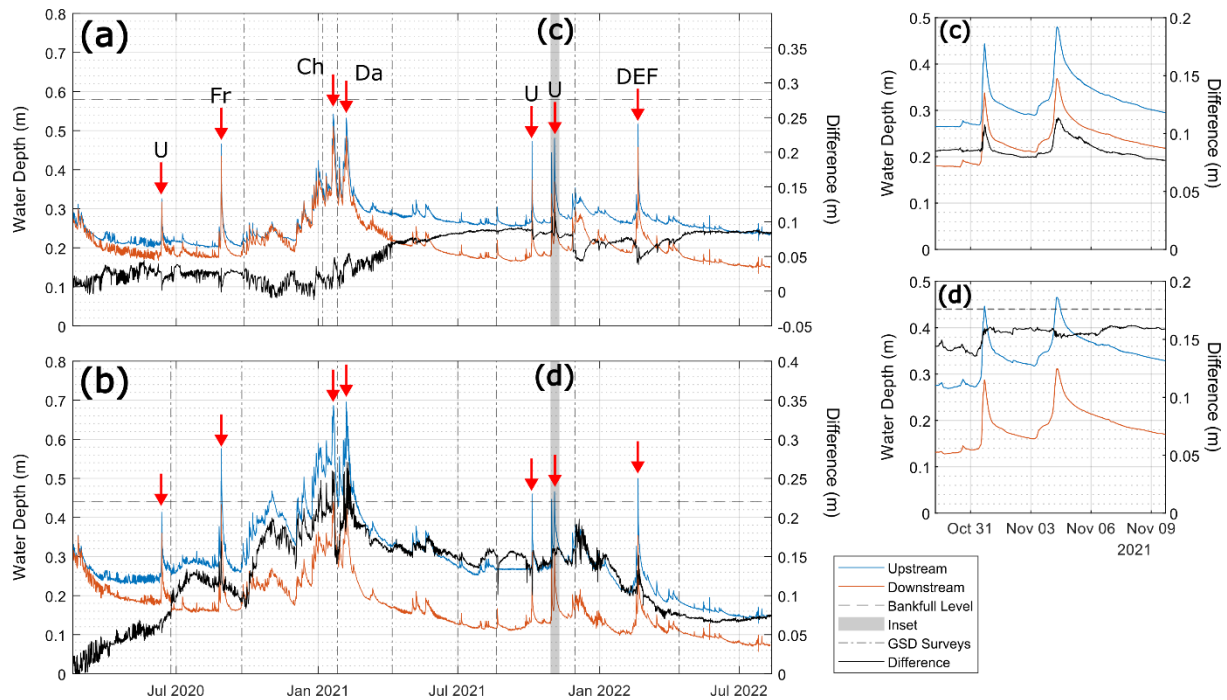
Figure 2: Temporal variations of water depth for LD1 (a) and LD2 (b) with difference between upstream and downstream recordings shown, as well as key peaks and storms (U=unnamed, Fr=Francis, Ch=Christoph, Da=Darcy, DEF=Dudley, Eunice & Franklin). Also shown are dates of GSD surveys and bankfull level. Note different secondary y-axis scale. (c) and (d) show variations in water depth throughout time between the two sites.

Average water depth at site 1 was 0.26 m and 0.21 m (up- and downstream, respectively). Bankfull depth was 0.58 m, however, flow did not engage with LD1 at this site, nor did the channel exceed its banks during the monitoring period. Note
225 that reported depth values are higher than LD1 vertical gap size due to their installation locations. Maximum depth was 0.54

m upstream of LD1 and 0.51 m downstream during Storm Christoph (21/01/2021; estimated Recurrence Interval, RI, of 2.3 years). In contrast, the average water depth at site 2 was 0.29 m and 0.17 m (up- and downstream, respectively). Bankfull depth was 0.44 m and was exceeded upstream for a total of 69 days (7.6%) of the monitoring period but not downstream. The true right bank became partially inundated and flow outflanked LD2b, resulting in increased scour immediately downstream of LD2b, limiting the maximum capacity of the structure during these bankfull periods. The maximum recorded depth was 0.67 m upstream and 0.44 m downstream during Storm Darcy (07/02/2021), with a RI of 1.61 years. Seven storm events occurred during the monitoring period, denoted by red arrows on Fig. 2 linked to key storms identified in Table 1, that resulted in near exceedance or exceedance of bankfull stage at site 2, in addition to increased average water depth throughout winter 2020/21 observed at both sites.

Initially, water depths at LD1 covaried, averaging 0.21 m downstream and 0.22 m upstream between February 2020 and November 2020, increasing to 0.31 m and 0.32 m, respectively, until February 2021, when the upstream depth diverged from the downstream. Throughout the monitoring period, there was an average difference of 0.05 m and a maximum difference of 0.11 m between the two depths, with the upstream depth ranging from 0.20 m to 0.54 m, and the downstream depth ranging from 0.13 m to 0.51 m.

In contrast, the upstream and downstream water depths quickly diverged at LD2, with an average difference of 0.12 m between the upstream and downstream depths. Downstream peaks were generally shorter in duration than upstream (Fig. 2b) due to water being stored upstream and slowly released, extending the peak. Additionally, once the LD was fully engaged with the river, there was a near constant difference between the downstream and upstream depths of up to 0.27 m. This difference decreased to less than 0.10 m following the last notable storms of the monitoring record in February 2022 (Dudley, Eunice and Franklin). Upstream and downstream depths ranged from 0.13 m to 0.70 m and from 0.06 m to 0.44 m, respectively.

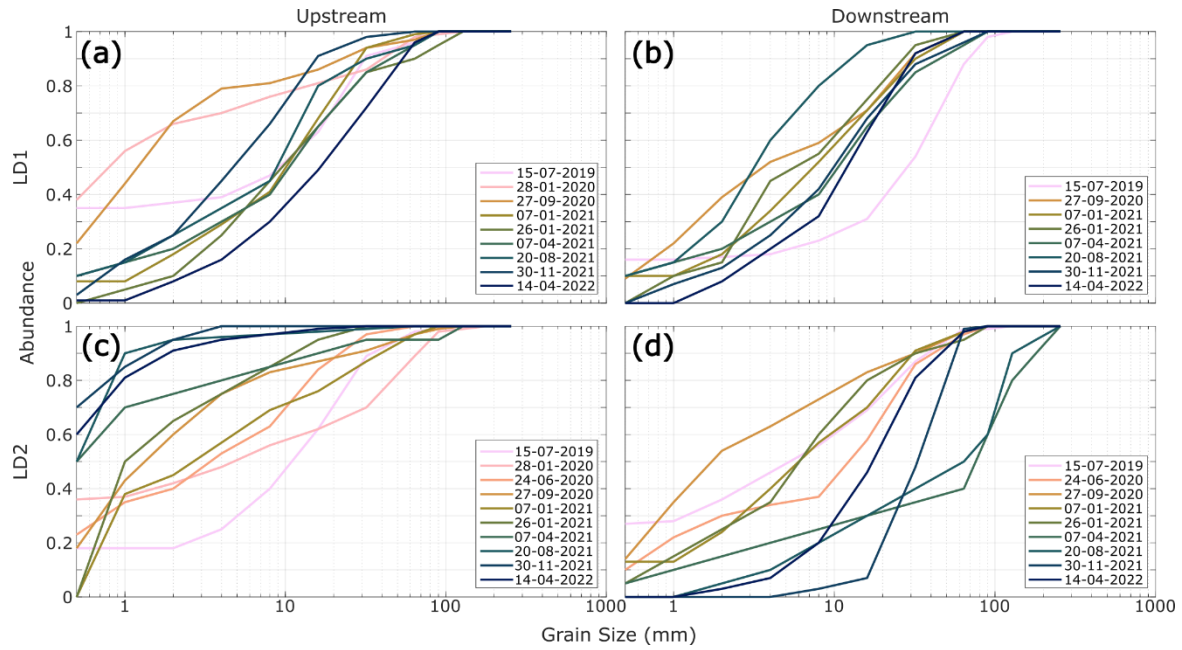
Figure 3: Cumulative density functions of Wolman pebble count data at LD1 (a) & (b) and LD2 (c) & (d). Sites are separated into upstream (a) & (c) and downstream (b) & (d) observations.

When comparing the upstream and downstream GSDs, except for an initial increase of the sand and fine gravel fractions upstream of the structure immediately following installation and until September 2020, the between-event variability is greater than any consistent change to the GSD at LD1 during the monitoring period, although there is some evidence of slight coarsening over the longer record (Fig. 3a, b). In contrast, fine sediment was deposited upstream and scoured downstream at LD2. This was reflected in a consistent fining trend upstream of the structure post-installation, resulting in a decrease of D_{50} from 10 mm to < 1 mm (Fig. 3c) and a consistent coarsening trend downstream of the structure, resulting in an increase of D_{50} from 5 mm to 30 mm (Fig. 3d).

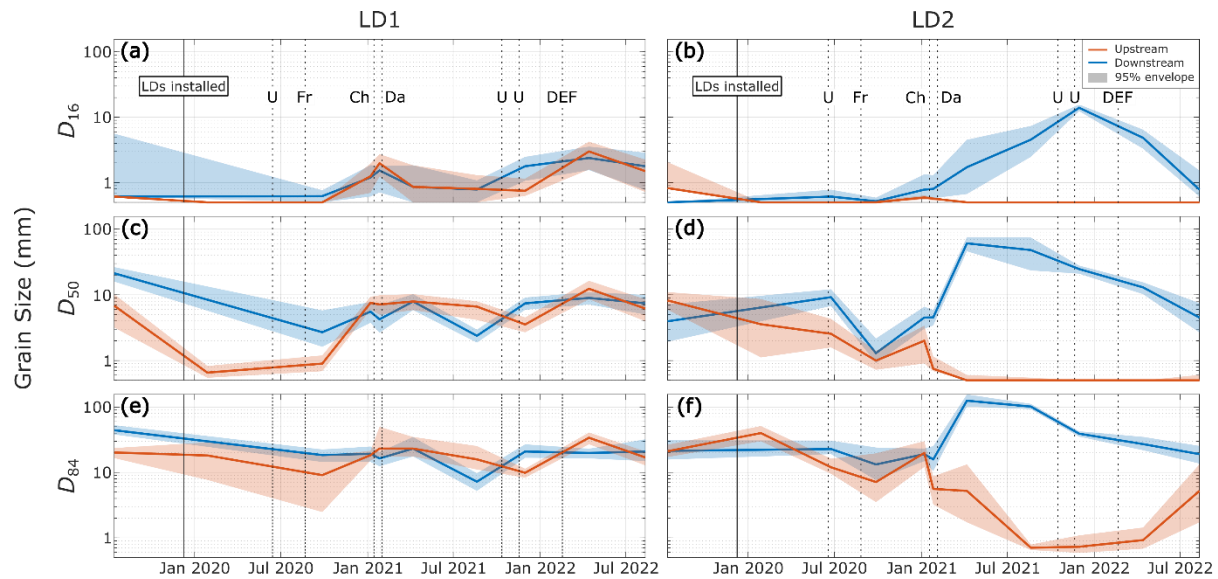
Figure 4: GSD metrics for upstream (orange) and downstream (blue) of the LD structures, with the 95% error envelope shown. Key storms are indicated by dashed vertical lines.

D_{50} and D_{84} highlight the variability between the two sites as well as upstream and downstream of the LD structures as shown in Fig. 4. LD1 showed little difference for all metrics, with upstream and downstream matching closely throughout the monitoring period, often within the calculated 95% confidence interval of the measurements themselves, as such this aligns with the more detailed GSD overview presented in Fig. 3. In contrast, metrics for LD2 diverge notably from January 2021 onwards following the wet 2020/21 winter and storms Christoph (RI=2.3 years) and Darcy (RI=1.6 years), with downstream coarsening and upstream fining. There was a maximum range of 59 mm for D_{50} April 2021, 98 mm for D_{84} in August 2021 and 10 mm for D_{16} in November 2021. At the end of the monitoring period, all grain size metrics converged, most notably upstream of LD2 where D_{84} coarsened to 5.5 mm following winter 2021/22, while D_{16} and D_{50} downstream of the LD both fined to < 1 mm and 5 mm respectively from peaks of 10.5 mm and 60 mm.

The twin-structured LD2 was shown to have a more substantial impact on channel morphological response than LD1. There was a distinct evolution in the bathymetry of the reach up- and downstream of the leaky wooden dam, with increased deposition upstream and enhanced scour downstream. The leaky wooden dam actively influenced the morphology of the river channel through creating geomorphic heterogeneity, as highlighted by the evolution of the deviation from elevation means in Fig. 5c, creating important potential habitats for benthic macroinvertebrates as well as increased spatial variability of benthic habitats in surrounding channels (Lo et al., 2021; Pilotto et al., 2016). Interestingly, the deviation from the mean quickly adjusted to the installation of the leaky wooden dam before becoming relatively stable between September 2020 and August 2021, with the largest period of adjustment between November 2021 and February 2022, likely as a result of Storm Barra (5–9 Dec 2021) where there was a total of 562 mm of precipitation averaged across the catchment (derived from the NIMROD radar system; Met Office, 2003. N.B. data for 08/12/21 are missing therefore true figure is likely higher). A period of accretion of 4 m³ followed this event (Fig. 8). It is clear from Fig. 7 that sediment was stored behind the upstream LD, but sediment also infilled the downstream pool, likely due to mobilised larger sediment from upstream, reflected in Fig. 4f where

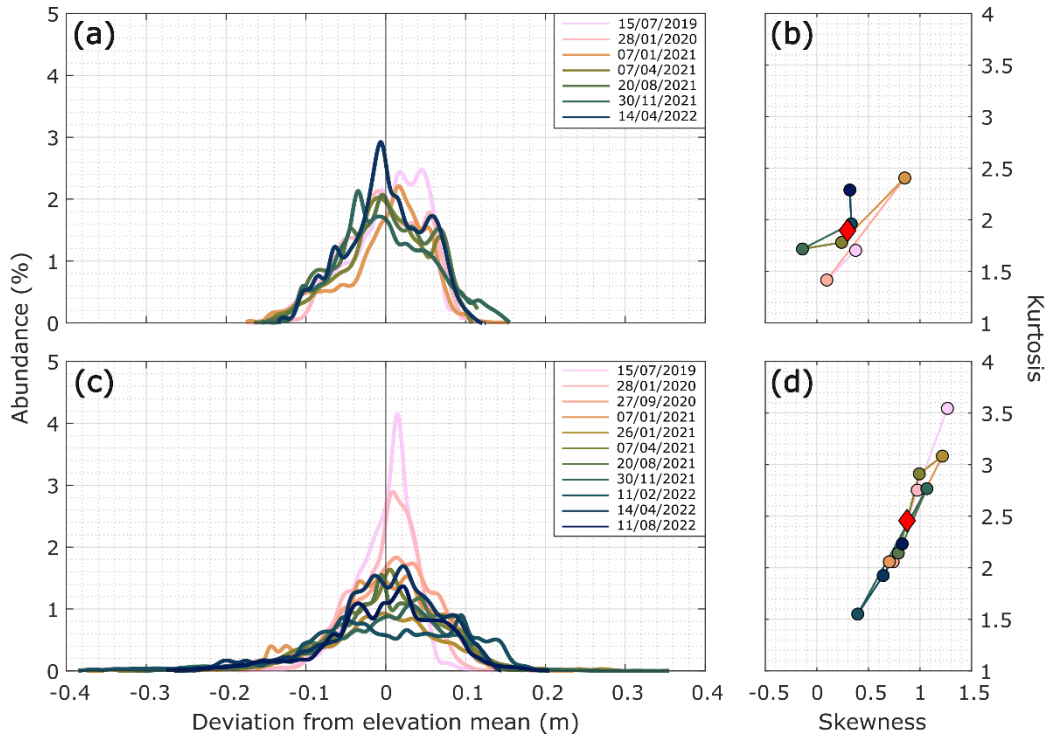
Figure 5: Detrended surface elevations relative to the mean for each bathymetric survey for LD1 (a) and LD2 (c). Associated skewness and kurtosis for each date is also shown with the mean shown as a red diamond (b) & (d) respectively.

Topographic variability across each site was determined by first detrending all gridded data points in CloudCompare and computing the deviation of each point from the elevation mean. Surface elevations were shown to be normally distributed at both sites (Fig. 5a). LD1 had a minimum bed elevation range of 0.26 m before the installation of the LD in July 2019, and a maximum of 0.36 m in January 2021. The deviation from elevation mean did not evolve over time and, although the elevation distribution fluctuated between surveys, the range and distribution of deviations remained similar throughout the monitoring period. Kurtosis was used to represent geomorphic variability and skewness the tendency for deposition or erosion. A distribution with a high-kurtosis represents a clustering around the mean (i.e., lower variability) and low-kurtosis represents more values in the tails of the distribution (higher variability). Skewness and kurtosis for LD1 was shown to vary between -0.2–0.8 and 1.4–2.4, respectively (Fig. 5b), with no clear temporal trend across the surveys, implying that the topographic variability remains unchanged throughout the monitoring period. There was also no generation or removal of existing bedforms, and bed elevation change was likely not influenced by the LD, as further shown in Fig. 6.

In contrast, LD2 (Fig. 5c) exhibited increased topographic variability throughout time, with a minimum bed elevation range of 0.3 m in July 2019 and a maximum of 0.58 m in February 2022 following storms Dudley, Eunice and Franklin. The distribution evolved temporally from one that was predominately above the elevation mean with little variability (i.e., skewness > 1, kurtosis > 3.5; Fig. 5d) to a flatter, wider distribution with up to 0.38 m of deviation from the mean (February 2022), highlighting the development of plunge and underflow pools beneath LD2 (Fig. 7c1, d1). There was clear progression throughout time from the pre-LD survey in July 2019, stabilising following the wet winter in January 2021 and fluctuating

between survey dates. There was a clear relationship between skewness and kurtosis with time, with surveys becoming moderately positively skewed (0.5–1) with increasing geomorphic variability (decreasing kurtosis). Both skewness and kurtosis fell between January and August 2021 when there were no substantial changes to stage—as shown in Fig. 2—and no storm events, but increased following storms Dudley, Eunice and Franklin towards winter 2022. The overall negative trend of the kurtosis indicates that the LD increased internal topographic variability compared to the baseline, while fluctuating skewness generally identifies periods of erosion and deposition throughout the reach.

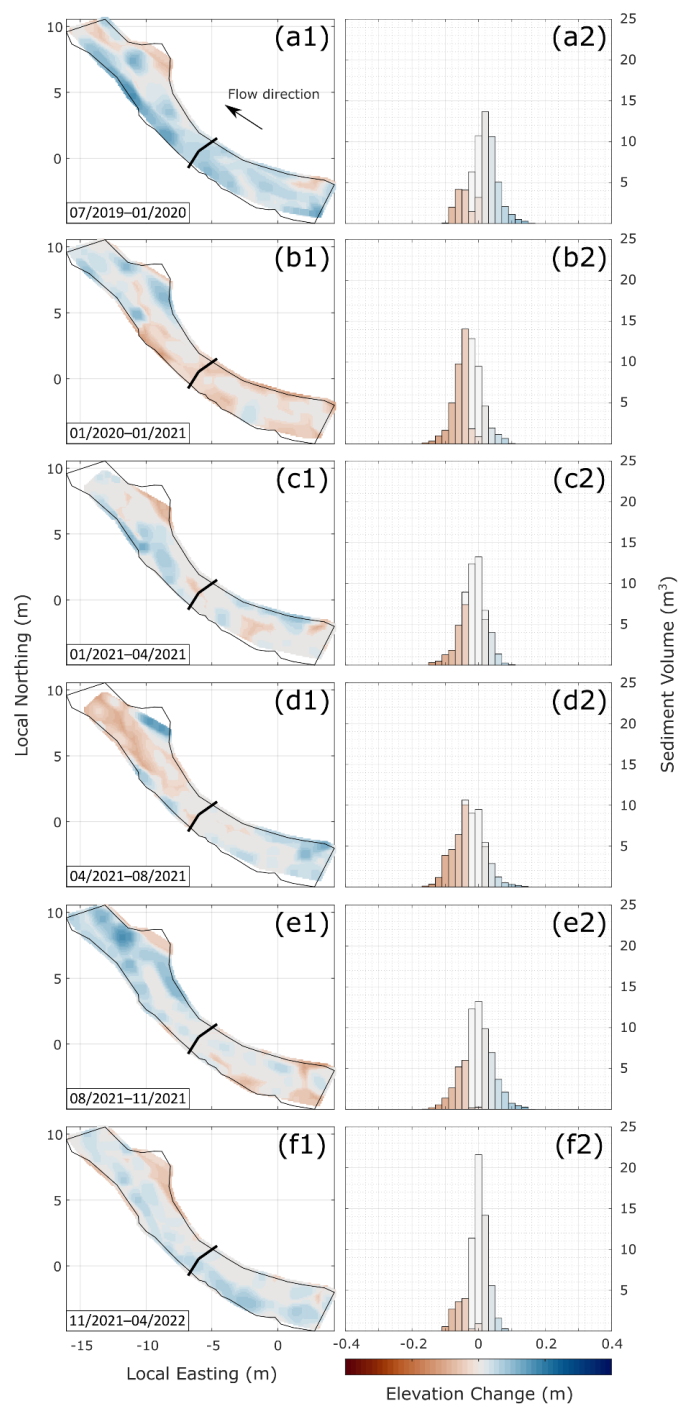
Figure 6: DoDs for LD1 (1) and histograms of elevation change (2). Significant elevation change ($\alpha < 0.05$) denoted by colour (red is erosion, blue is deposition), with insignificant change shown in grey. The channel boundary is shown as a black outline, with the planar view of the LD represented as a thick black line.

LD1 exhibited a maximum scour depth of 0.16 m between January 2020 and November 2021 (Fig. 6b–e) which was distributed throughout the reach, both upstream and downstream of the LD. There was a maximum deposition depth of 0.14 m between April and November 2021 (Fig. 6d, e), situated approximately 5 m downstream of the LD. The range of elevation change did not fluctuate greater than ± 0.04 m throughout time. Spatially, most of the change was situated greater than 5 m from the LD, with the change around the LD being below the LoD threshold.

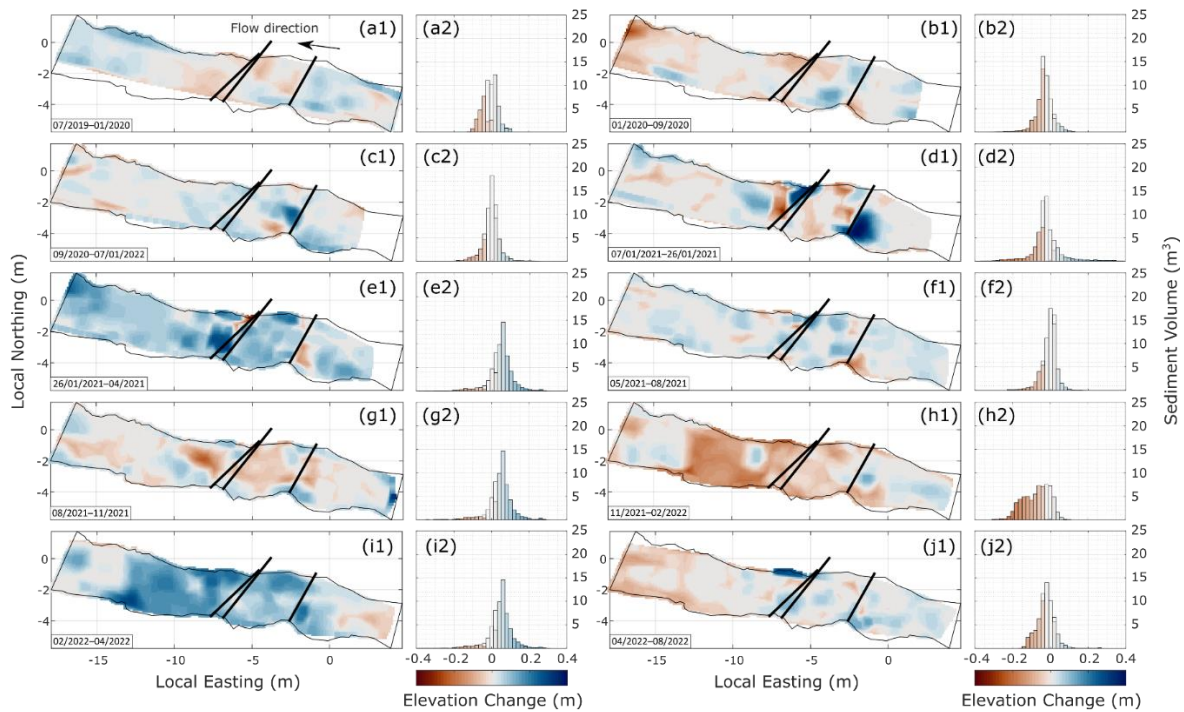
Figure 7: DoDs for LD2 (1) and histograms of elevation change (2). Significant elevation change ($\alpha < 0.05$) denoted by colour (red is erosion, blue is deposition), with insignificant change shown in grey. The channel boundary is shown as a black outline, with the planar view of the LD represented as a thick black line. Flow direction denoted by black arrow in Fig. 7a1.

LD2, which was formed by two linked structures, had a maximum scour depth of 0.38 m between 26/01/2021 and April 2021 (Fig. 7e2), and a maximum deposition depth of 0.4 m (07/01/2021–26/01/2021; Fig. 7d2). The range of elevation change fluctuated throughout time from -0.14–0.12 m immediately after LD installation (July 2019–January 2020; Fig. 7a2) to reported maximum values. Additionally, the DoDs were highly spatially variable, with evidence of pool formation downstream of the lower LD (Fig. 7a, b) which experienced periodic infilling (Fig. 7c, d) and scour (Fig. 7e, h) throughout the monitoring period. Immediately downstream of the upstream LD2a, a secondary pool formed that exhibited similar scour and fill cycles. The upstream LD2a stored sediment during the monitoring period, most clearly illustrated by Fig. 7d1 (07/01/2021–26/01/2021 following Storm Christoph), where a substantial area of the DoD exhibited change greater than the LoD. The depositional zone also fluctuated over time, infilling and scouring on the true left bank of LD2a.

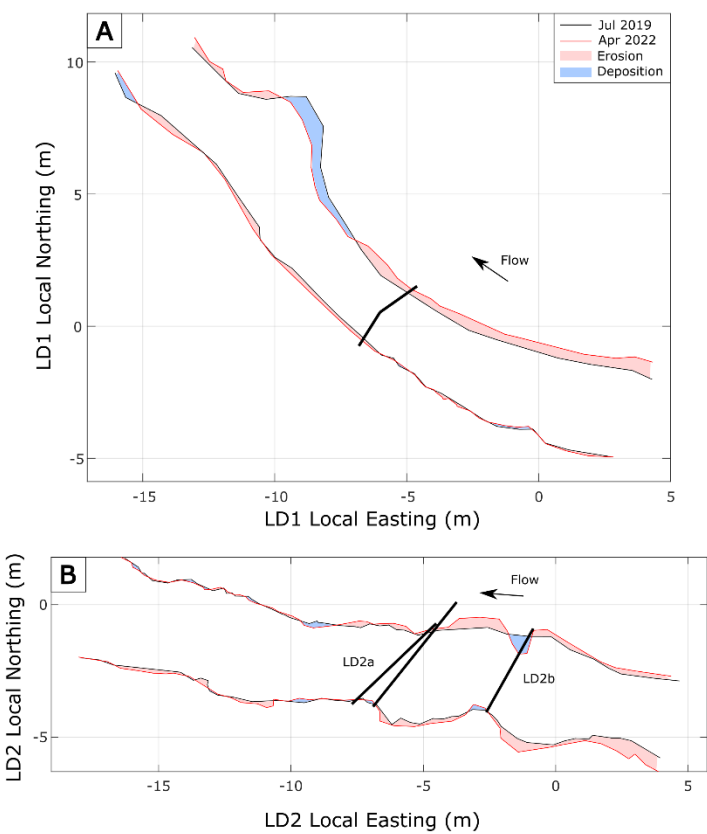
Figure 9: Bank erosion and deposition for LD1 (a) and LD2 (b). Leaky wooden dams are represented as thick black lines.

The banks at LD1 (Fig. 9a) predominantly exhibited erosion upstream of the LD and deposition downstream. The true right bank experienced 2.4 m² of bank erosion and 4.8 m² of deposition, with a net areal change of 2.4 m² (Table 3). In contrast
 355 the true left bank at LD1 predominantly exhibited erosion, experiencing -1.9 m² of bank loss, 0.41 m² of deposition and -1.5 m² of net areal change. Overall net planform area change at LD1 was 0.90 m². The channel at the site is relatively straight, and there was no clear influence from LD1 on bank erosion since the true right bank had a similar magnitude of planform change both above and below the LD.

LD2 (Fig. 9b) predominantly exhibited erosion, with a net planform area change of -1.10 m² but with greater spatial
 360 variability near the LD sequence. Immediately downstream of LD2b on the true right bank was an area of deposition, followed by approximately 0.50 m² of bank erosion, flanking LD2b. A similar pattern was observed on the true left bank, with an area of erosion upstream of LD2b, and a small area of deposition downstream. Often during high flows, the river would exceed the riverbanks — as highlighted above — and flank the true right bank of LD2b. This clearly resulted in localised scour downstream of LD2b on the true right bank. LD2a appeared to have had little impact on the banks, despite
 365 retaining water. Deposition mainly occurred in the mid-structure, preceded and succeeded by bank erosion. There was less

apparent impact from LD2a downstream (Fig. 9b) as, despite having increased structural complexity, the structure engaged with deeper flows less frequently than LD2b.
