Localised geomorphic response to channel-spanning leaky wooden dams

10 **Abstract.** The introduction of leaky wooden dams (or engineered log jams) into river corridors in low order streams in upper catchments has recently become a popular form of natural flood management, particularly in NW Europe. Leaky wooden dams are designed to emulate processes such as those of naturally occurring large wood in river systems, aiming to reduce downstream flood risk through the attenuation of water during higher flows, decreasing in-channel velocities and increasing channel-floodplain connectivity. Leaky wooden dams effectively act as channel roughness agents that disrupt the fluvial and

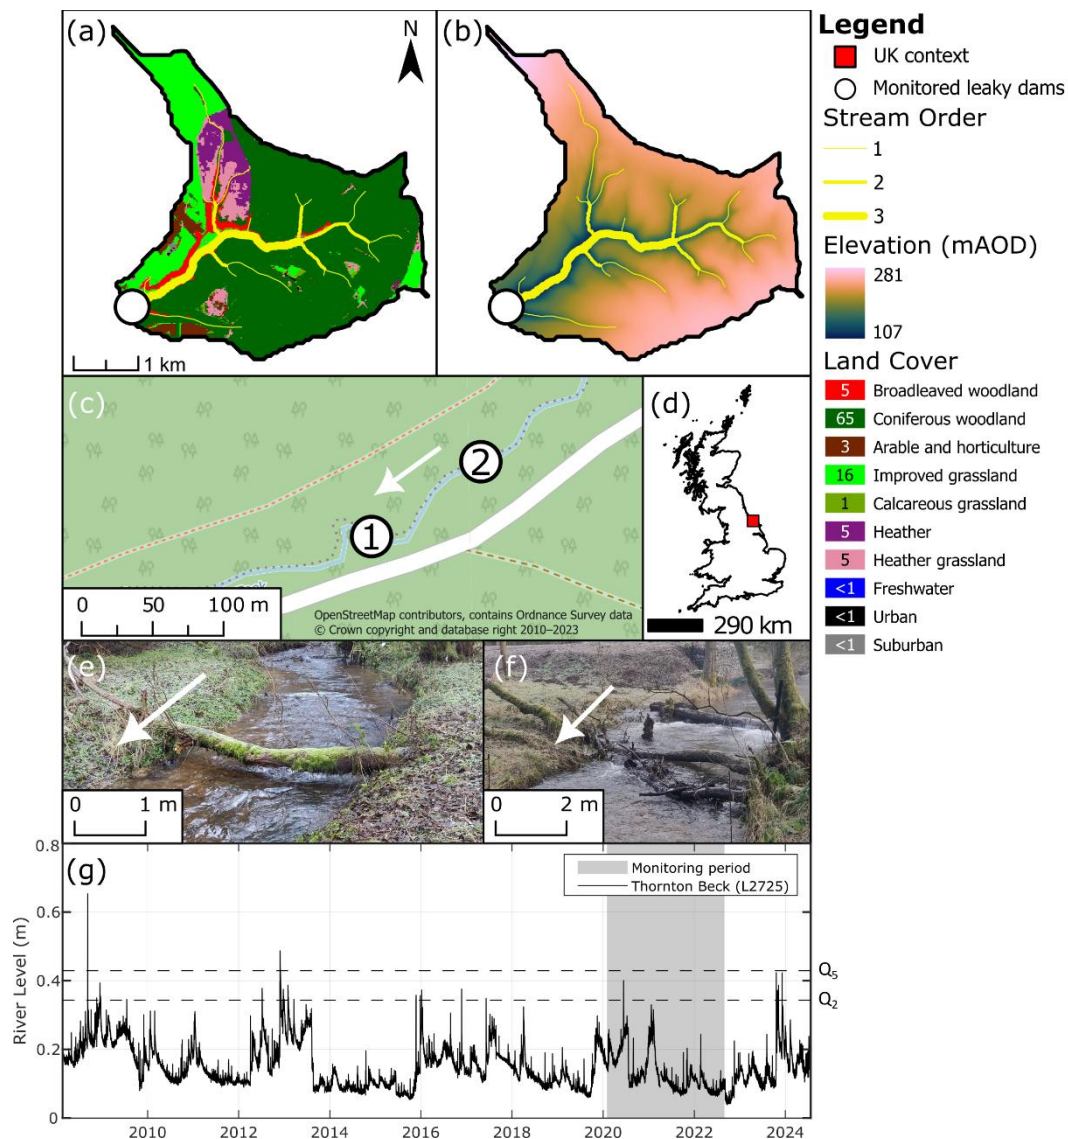
Figure 1: Location of studied leaky wooden dams in relation to the Dalby Forest catchment. (a) 2021 Land cover map with percentage cover shown in the legend (Marston et al., 2022). (b) Stream network generated from terrain data showing Strahler stream order and elevation (Ordnance Survey, 2020). Note same scale as (a). (c) Location of LD1 and LD2, flow direction denoted by white arrow. (d) UK context for site location. (e) & (f) LD1 and LD2, respectively, flow direction denoted by white arrow. (g) River level record 2008–2024 for Thornton Beck, Thornton Le Dale (Grid Reference: SE 83681 83418; Station ID: L2725) approximately 7 km downstream of study area (from Environment Agency) including estimated return period (Q_n) as described in the supplementary material.

105 The catchment is characterised by woodland (70%), with grassland (17%) and heather (10%) the other principal land use types (Marston et al., 2022) as shown in Fig. 1a. It has a mean annual precipitation of 980 mm with monthly averages ranging from 55.6–118.9 mm (1991–2020 mean, Fylingdales weather station at 262 mAOD, 11.2 km NE; Met Office, 2020). The catchment contains 17 km of river corridor, with a mixture of first (9.9 km), second (3.6 km) and third-order (3.5 km) streams following the Strahler (1957) stream order notation (Fig. 1a, b). The channels are between 1 and 4 m wide, widening towards the catchment outlet.

LD1 (Fig. 1e) is a channel spanning LD anchored *in situ* with a wooden stake on the true right bank to reduce the likelihood of displacement during high flows and was embedded into the surface on the true left bank. The channel was 2.7 m wide where the LD was installed. The structure was comprised of a single log which was fully separated from a tree trunk, with
125 some thin branches attached facing upwards. Since this LD is fully channel spanning and thus does not interact with baseflow it is a “Type 1” LD (fully channel spanning, not interacting with baseflows) following the classification of Lo et al. (2021).

LD2 (Fig. 1f) was felled and left *in situ*, remaining attached to its stump to enable growth (a “living” LD). The LD itself was composed of two sub-sections, furthest downstream (LD2a) spanned a 3.85 m wide channel. The structure was partially
130 submerged at the time of installation. LD2a was classified as a “Type 2” LD (fully channel spanning, interacting with baseflows but not touching the stream bed; Lo et al., 2021). LD2 was more complex than LD1 due to the presence of a pre-existing walkway that formed a secondary sub-structure LD2b, that was fixed with wooden anchors. LD2b was a “Type 1” LD (fully channel spanning, not interacting with baseflows at all; Lo et al., (2021). LD2b was installed above the average water depth and spanned a 3.25 m wide channel.

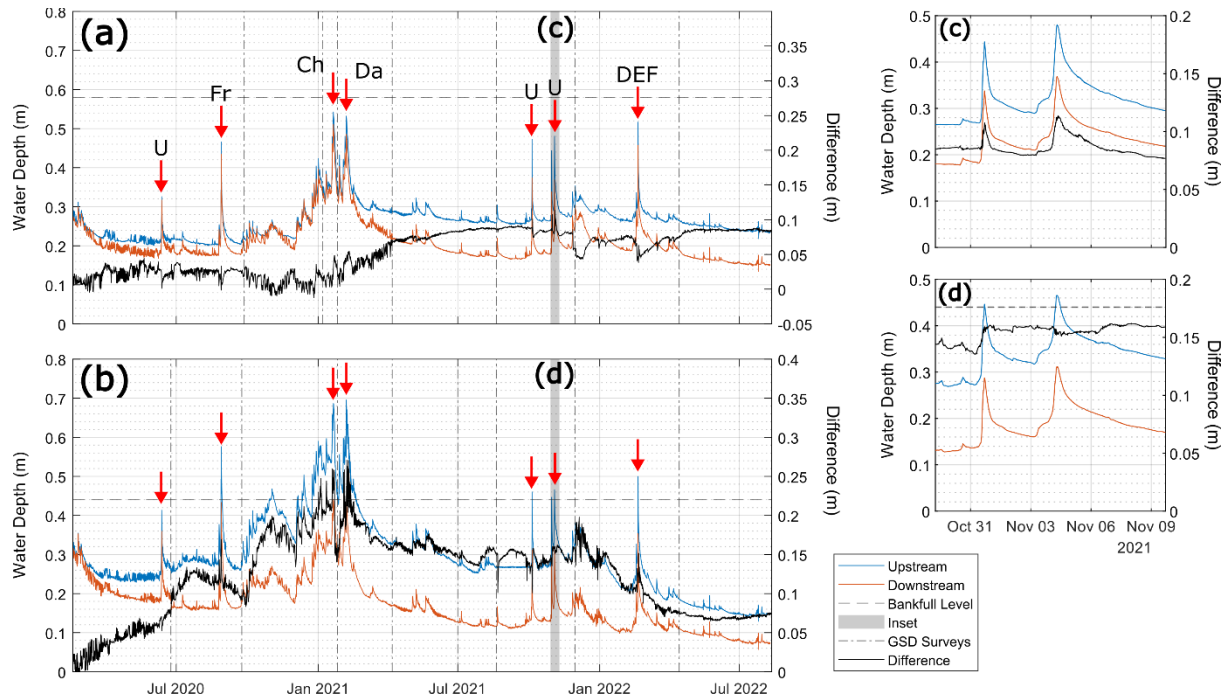
Figure 2: Temporal variations of water depth for LD1 (a) and LD2 (b) with difference between upstream and downstream recordings shown, as well as key peaks and storms (U=unnamed, Fr=Francis, Ch=Christoph, Da=Darcy, DEF=Dudley, Eunice & Franklin). Also shown are dates of GSD surveys and bankfull level. Note different secondary y-axis scale. (c) and (d) show variations in water depth throughout time between the two sites.

Average water depth at site 1 was 0.26 m and 0.21 m (up- and downstream, respectively). Bankfull depth was 0.58 m, however, flow did not engage with LD1 at this site, nor did the channel exceed its banks during the monitoring period. Note
225 that reported depth values are higher than LD1 vertical gap size due to their installation locations. Maximum depth was 0.54

m upstream of LD1 and 0.51 m downstream during Storm Christoph (21/01/2021; estimated Recurrence Interval, RI, of 2.3 years). In contrast, the average water depth at site 2 was 0.29 m and 0.17 m (up- and downstream, respectively). Bankfull depth was 0.44 m and was exceeded upstream for a total of 69 days (7.6%) of the monitoring period but not downstream. The true right bank became partially inundated and flow outflanked LD2b, resulting in increased scour immediately downstream of LD2b, limiting the maximum capacity of the structure during these bankfull periods. The maximum recorded depth was 0.67 m upstream and 0.44 m downstream during Storm Darcy (07/02/2021), with a RI of 1.61 years. Seven storm events occurred during the monitoring period, denoted by red arrows on Fig. 2 linked to key storms identified in Table 1, that resulted in near exceedance or exceedance of bankfull stage at site 2, in addition to increased average water depth throughout winter 2020/21 observed at both sites.

Initially, water depths at LD1 covaried, averaging 0.21 m downstream and 0.22 m upstream between February 2020 and November 2020, increasing to 0.31 m and 0.32 m, respectively, until February 2021, when the upstream depth diverged from the downstream. Throughout the monitoring period, there was an average difference of 0.05 m and a maximum difference of 0.11 m between the two depths, with the upstream depth ranging from 0.20 m to 0.54 m, and the downstream depth ranging from 0.13 m to 0.51 m.

In contrast, the upstream and downstream water depths quickly diverged at LD2, with an average difference of 0.12 m between the upstream and downstream depths. Downstream peaks were generally shorter in duration than upstream (Fig. 2b) due to water being stored upstream and slowly released, extending the peak. Additionally, once the LD was fully engaged with the river, there was a near constant difference between the downstream and upstream depths of up to 0.27 m. This difference decreased to less than 0.10 m following the last notable storms of the monitoring record in February 2022 (Dudley, Eunice and Franklin). Upstream and downstream depths ranged from 0.13 m to 0.70 m and from 0.06 m to 0.44 m, respectively.

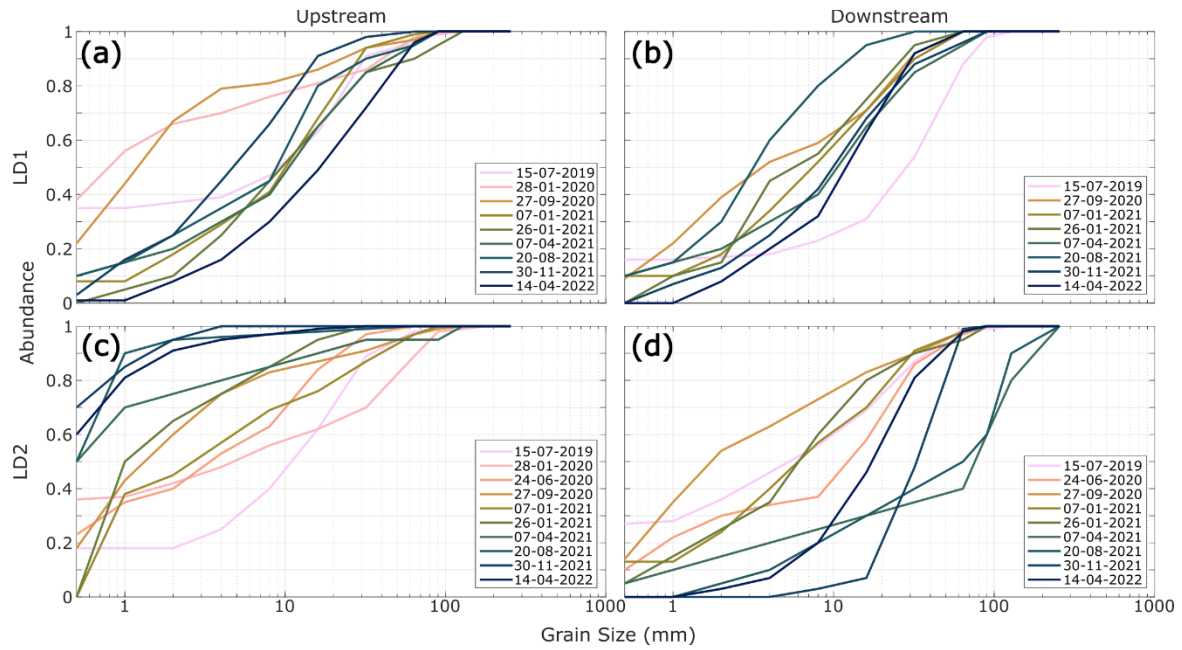
Figure 3: Cumulative density functions of Wolman pebble count data at LD1 (a) & (b) and LD2 (c) & (d). Sites are separated into upstream (a) & (c) and downstream (b) & (d) observations.

When comparing the upstream and downstream GSDs, except for an initial increase of the sand and fine gravel fractions upstream of the structure immediately following installation and until September 2020, the between-event variability is greater than any consistent change to the GSD at LD1 during the monitoring period, although there is some evidence of slight coarsening over the longer record (Fig. 3a, b). In contrast, fine sediment was deposited upstream and scoured downstream at LD2. This was reflected in a consistent fining trend upstream of the structure post-installation, resulting in a decrease of D_{50} from 10 mm to < 1 mm (Fig. 3c) and a consistent coarsening trend downstream of the structure, resulting in an increase of D_{50} from 5 mm to 30 mm (Fig. 3d).

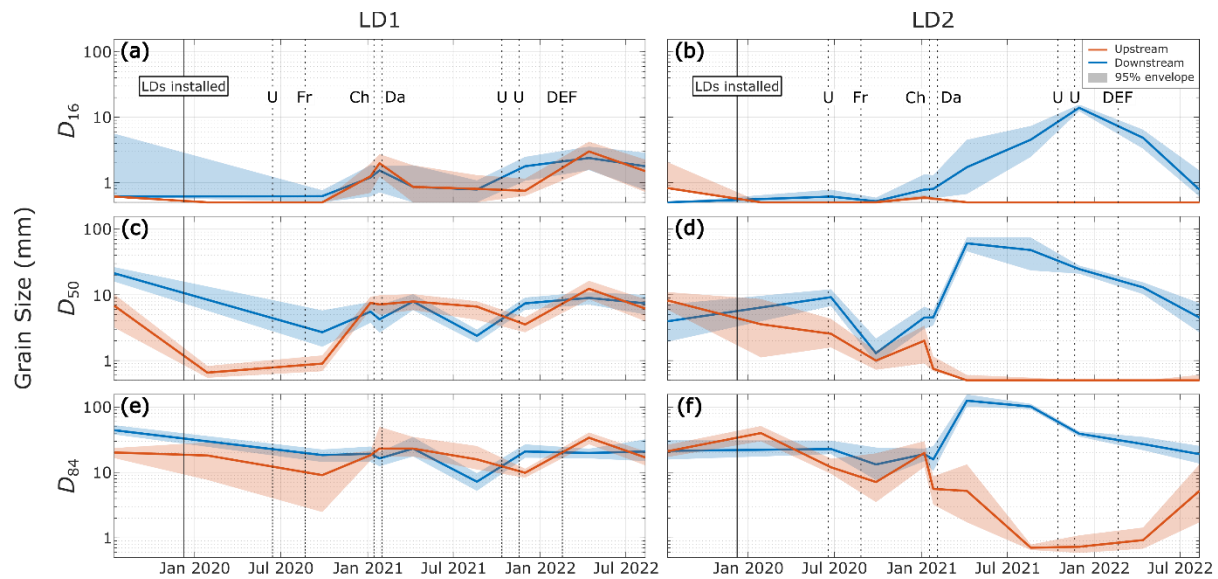
Figure 4: GSD metrics for upstream (orange) and downstream (blue) of the LD structures, with the 95% error envelope shown. Key storms are indicated by dashed vertical lines.

D_{50} and D_{84} highlight the variability between the two sites as well as upstream and downstream of the LD structures as shown in Fig. 4. LD1 showed little difference for all metrics, with upstream and downstream matching closely throughout the monitoring period, often within the calculated 95% confidence interval of the measurements themselves, as such this aligns with the more detailed GSD overview presented in Fig. 3. In contrast, metrics for LD2 diverge notably from January 2021 onwards following the wet 2020/21 winter and storms Christoph (RI=2.3 years) and Darcy (RI=1.6 years), with downstream coarsening and upstream fining. There was a maximum range of 59 mm for D_{50} April 2021, 98 mm for D_{84} in August 2021 and 10 mm for D_{16} in November 2021. At the end of the monitoring period, all grain size metrics converged, most notably upstream of LD2 where D_{84} coarsened to 5.5 mm following winter 2021/22, while D_{16} and D_{50} downstream of the LD both fined to < 1 mm and 5 mm respectively from peaks of 10.5 mm and 60 mm.

The twin-structured LD2 was shown to have a more substantial impact on channel morphological response than LD1. There was a distinct evolution in the bathymetry of the reach up- and downstream of the leaky wooden dam, with increased deposition upstream and enhanced scour downstream. The leaky wooden dam actively influenced the morphology of the river channel through creating geomorphic heterogeneity, as highlighted by the evolution of the deviation from elevation means in Fig. 5c, creating important potential habitats for benthic macroinvertebrates as well as increased spatial variability of benthic habitats in surrounding channels (Lo et al., 2021; Pilotto et al., 2016). Interestingly, the deviation from the mean quickly adjusted to the installation of the leaky wooden dam before becoming relatively stable between September 2020 and August 2021, with the largest period of adjustment between November 2021 and February 2022, likely as a result of Storm Barra (5–9 Dec 2021) where there was a total of 562 mm of precipitation averaged across the catchment (derived from the NIMROD radar system; Met Office, 2003. N.B. data for 08/12/21 are missing therefore true figure is likely higher). A period of accretion of 4 m³ followed this event (Fig. 8). It is clear from Fig. 7 that sediment was stored behind the upstream LD, but sediment also infilled the downstream pool, likely due to mobilised larger sediment from upstream, reflected in Fig. 4f where

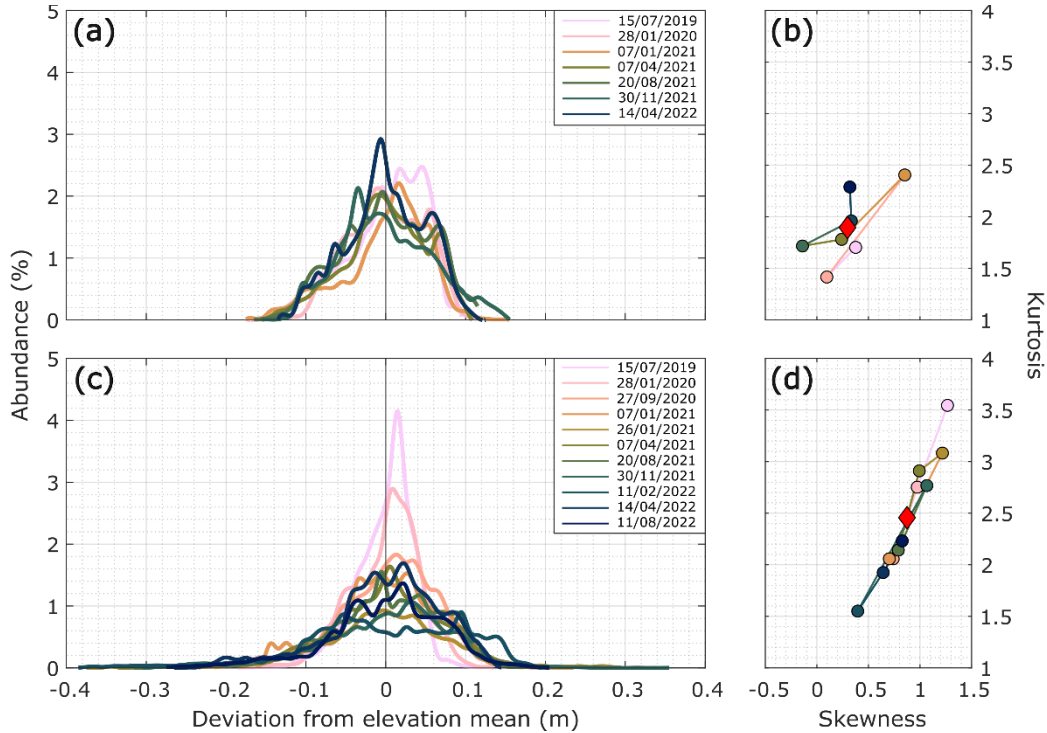
Figure 5: Detrended surface elevations relative to the mean for each bathymetric survey for LD1 (a) and LD2 (c). Associated skewness and kurtosis for each date is also shown with the mean shown as a red diamond (b) & (d) respectively.

Topographic variability across each site was determined by first detrending all gridded data points in CloudCompare and computing the deviation of each point from the elevation mean. Surface elevations were shown to be normally distributed at both sites (Fig. 5a). LD1 had a minimum bed elevation range of 0.26 m before the installation of the LD in July 2019, and a maximum of 0.36 m in January 2021. The deviation from elevation mean did not evolve over time and, although the elevation distribution fluctuated between surveys, the range and distribution of deviations remained similar throughout the monitoring period. Kurtosis was used to represent geomorphic variability and skewness the tendency for deposition or erosion. A distribution with a high-kurtosis represents a clustering around the mean (i.e., lower variability) and low-kurtosis represents more values in the tails of the distribution (higher variability). Skewness and kurtosis for LD1 was shown to vary between -0.2–0.8 and 1.4–2.4, respectively (Fig. 5b), with no clear temporal trend across the surveys, implying that the topographic variability remains unchanged throughout the monitoring period. There was also no generation or removal of existing bedforms, and bed elevation change was likely not influenced by the LD, as further shown in Fig. 6.

In contrast, LD2 (Fig. 5c) exhibited increased topographic variability throughout time, with a minimum bed elevation range of 0.3 m in July 2019 and a maximum of 0.58 m in February 2022 following storms Dudley, Eunice and Franklin. The distribution evolved temporally from one that was predominately above the elevation mean with little variability (i.e., skewness > 1, kurtosis > 3.5; Fig. 5d) to a flatter, wider distribution with up to 0.38 m of deviation from the mean (February 2022), highlighting the development of plunge and underflow pools beneath LD2 (Fig. 7c, d). There was clear progression throughout time from the pre-LD survey in July 2019, stabilising following the wet winter in January 2021 and fluctuating

between survey dates. There was a clear relationship between skewness and kurtosis with time, with surveys becoming moderately positively skewed (0.5–1) with increasing geomorphic variability (decreasing kurtosis). Both skewness and kurtosis fell between January and August 2021 when there were no substantial changes to stage—as shown in Fig. 2—and no storm events, but increased following storms Dudley, Eunice and Franklin towards winter 2022. The overall negative trend of the kurtosis indicates that the LD increased internal topographic variability compared to the baseline, while fluctuating skewness generally identifies periods of erosion and deposition throughout the reach.

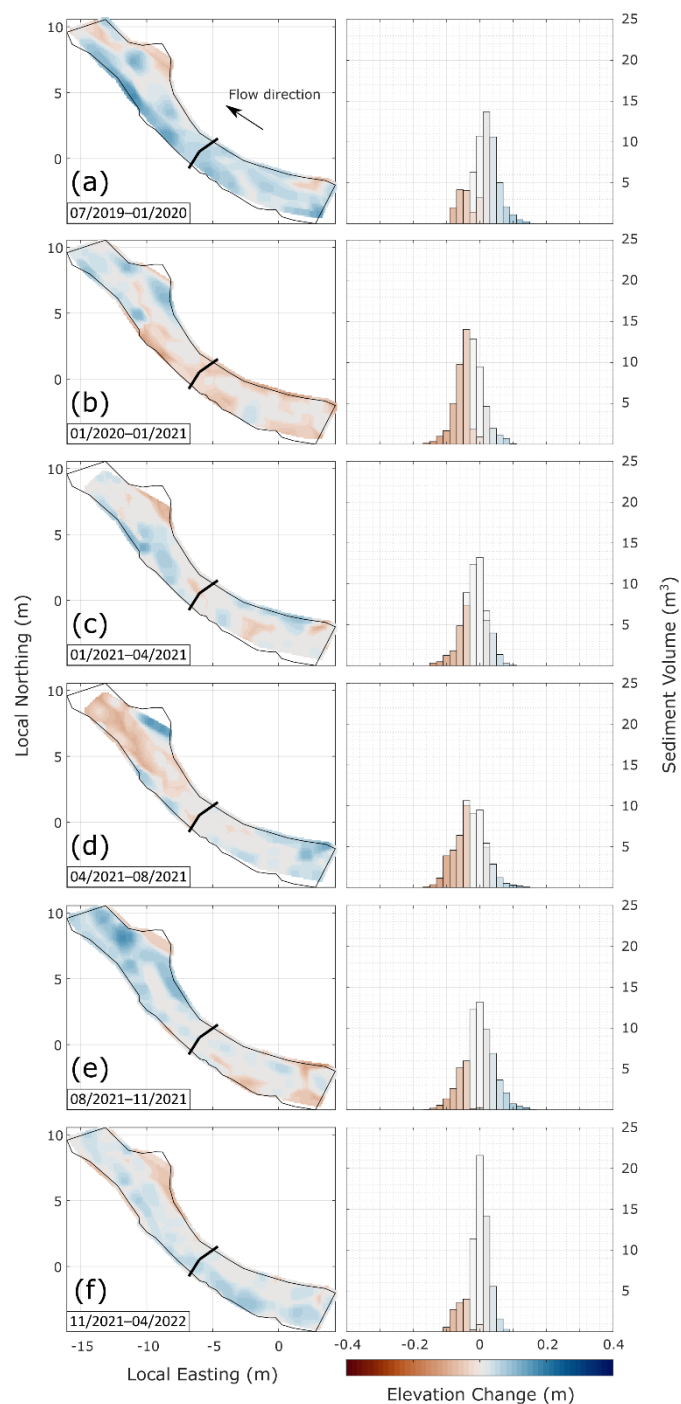
Figure 6: DoDs for LD1 (left column) and histograms of elevation change (right column). Significant elevation change ($\alpha < 0.05$) denoted by colour (red is erosion, blue is deposition), with insignificant change shown in grey. The channel boundary is shown as a black outline, with the planar view of the LD represented as a thick black line.

LD1 exhibited a maximum scour depth of 0.16 m between January 2020 and November 2021 (Fig. 6b–e) which was distributed throughout the reach, both upstream and downstream of the LD. There was a maximum deposition depth of 0.14

310 m between April and November 2021 (Fig. 6d, e), situated approximately 5 m downstream of the LD. The range of elevation change did not fluctuate greater than ± 0.04 m throughout time. Spatially, most of the change was situated greater than 5 m from the LD, with the change around the LD being below the LoD threshold.

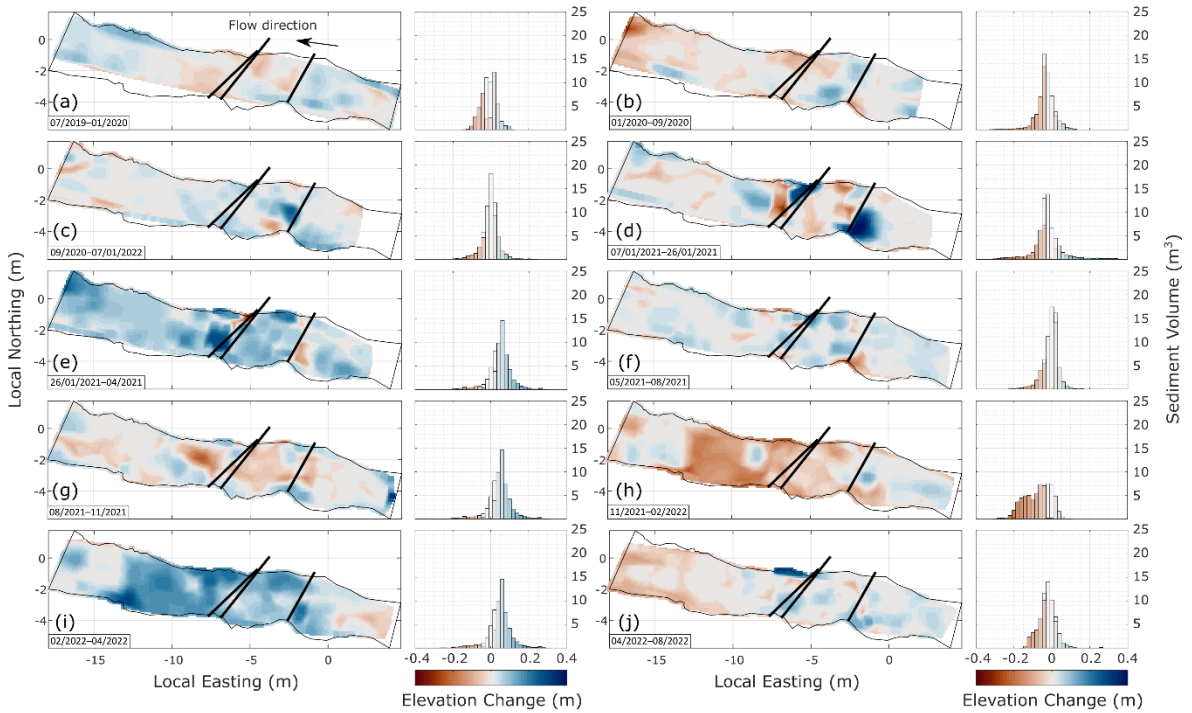
Figure 7: DoDs for LD2 (left column) and histograms of elevation change (right column). Significant elevation change ($\alpha < 0.05$) denoted by colour (red is erosion, blue is deposition), with insignificant change shown in grey. The channel boundary is shown as a black outline, with the planar view of the LD represented as a thick black line. Flow direction denoted by black arrow in Fig. 7a.

LD2, which was formed by two linked structures, had a maximum scour depth of 0.38 m between 26/01/2021 and April 2021 (Fig. 7e), and a maximum deposition depth of 0.4 m (07/01/2021–26/01/2021; Fig. 7d). The range of elevation change
315 fluctuated throughout time from -0.14–0.12 m immediately after LD installation (July 2019–January 2020; Fig. 7a) to reported maximum values. Additionally, the DoDs were highly spatially variable, with evidence of pool formation downstream of the lower LD (Fig. 7a, b) which experienced periodic infilling (Fig. 7c, d) and scour (Fig. 7e, h) throughout the monitoring period. Immediately downstream of the upstream LD2a, a secondary pool formed that exhibited similar scour and fill cycles. The upstream LD2a stored sediment during the monitoring period, most clearly illustrated by Fig. 7d
320 (07/01/2021–26/01/2021 following Storm Christoph), where a substantial area of the DoD exhibited change greater than the LoD. The depositional zone also fluctuated over time, infilling and scouring on the true left bank of LD2a.

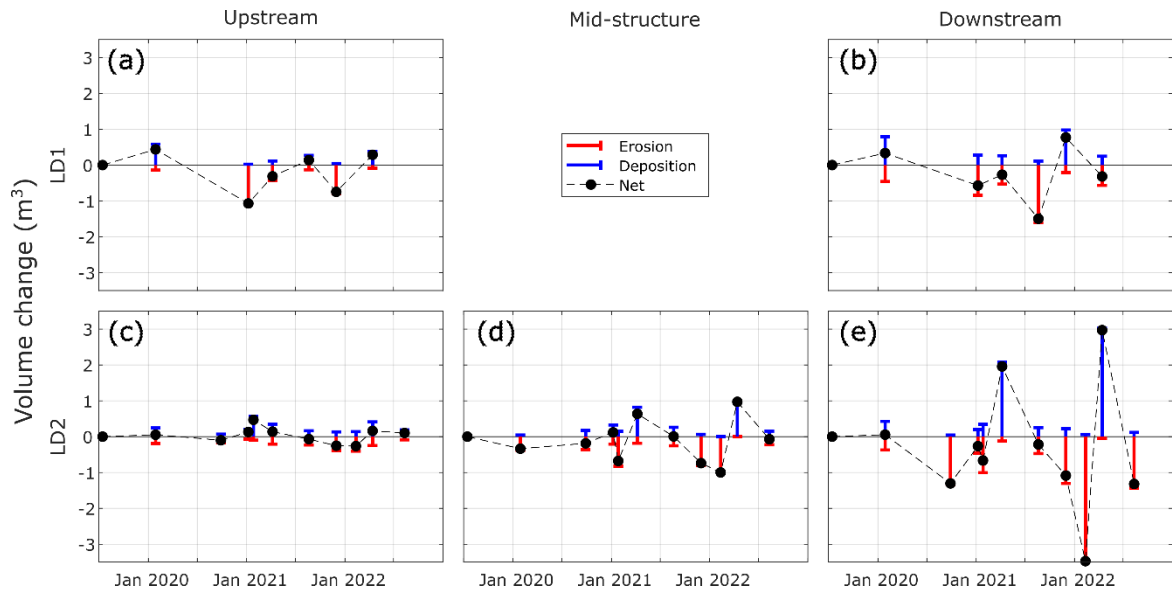
Figure 8: Volumetric change split into erosion and deposition for LD1 upstream (a) and downstream (b), and LD2 (c–e) separated into upstream of LD2b (c), mid-structure (i.e., between LD2a and LD2b; d) and downstream of LD2a (e).

- 330 Upstream of LD1, volumetric change was highly variable (Fig. 8a), with no greater than 0.6 m^3 of deposition immediately after LD installation and 1.1 m^3 of erosion in January 2020. Upstream net change fluctuated throughout the monitoring period, with increased scour following higher flows in winter and increased deposition across summer period lower flows. Downstream of LD1 exhibited a similar pattern (Fig. 8b) but there was increased erosion (maximum of 1.6 m^3 in August 2021) and deposition (up to 1 m^3 in November 2021).

- 335 Upstream of LD2 there was a clearer temporal trend (Fig. 8c). There was a maximum deposition of 0.6 m^3 on 26/01/2021 and increased erosion (0.4 m^3) following higher flows in February, with a clear progression as less sediment was being stored throughout the year. The LD impounded sediment upstream (Fig. 7d) and scoured over the following year prior to infilling again. Although the range of volume change was smaller than upstream of LD1, there was clearly a progression linked to the presence of the LD. There was more variability mid-structure at LD2, ranging from a maximum of 1 m^3 of erosion between January and February 2022 and 1 m^3 of deposition between February and April 2022 (Fig. 8d), reflecting pool formation and cyclic scour and infilling between the two LDs (see also Fig. 7a–d). Downstream of the LDs also exhibited similar variability (Fig. 8e), where plunge pools developed immediately downstream of the structure near the true right bank, followed by deposition further downstream. This section had the greatest range of volume change, with up to 3.4 m^3 of erosion between February and April 2022, and 3.0 m^3 of deposition between January and February 2022. Spatially,

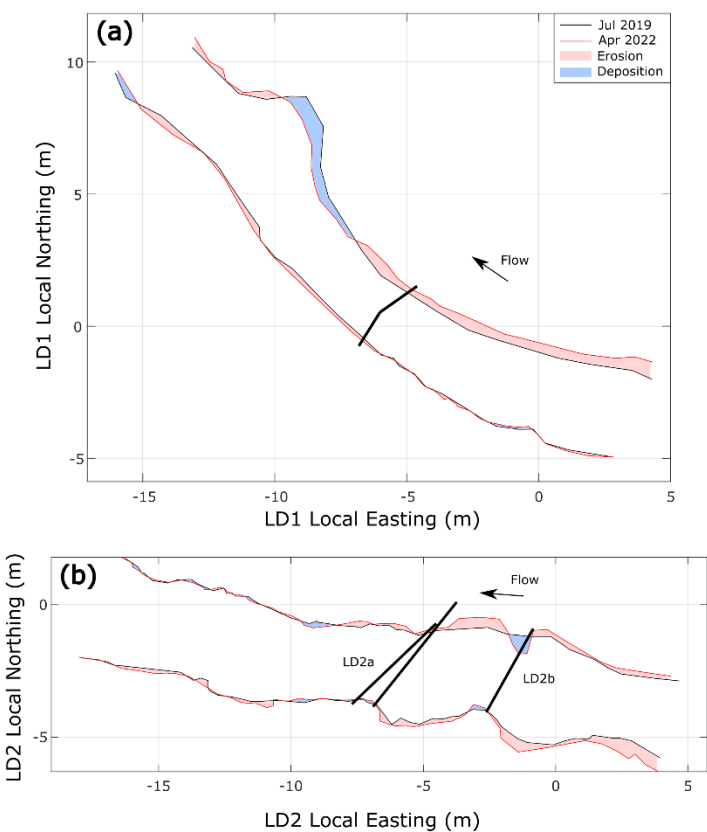
Figure 9: Bank erosion and deposition for LD1 (a) and LD2 (b). Leaky wooden dams are represented as thick black lines.

The banks at LD1 (Fig. 9a) predominantly exhibited erosion upstream of the LD and deposition downstream. The true right bank experienced 2.4 m² of bank erosion and 4.8 m² of deposition, with a net areal change of 2.4 m² (Table 3). In contrast the true left bank at LD1 predominantly exhibited erosion, experiencing -1.9 m² of bank loss, 0.41 m² of deposition and -1.5 m² of net areal change. Overall net planform area change at LD1 was 0.90 m². The channel at the site is relatively straight, and there was no clear influence from LD1 on bank erosion since the true right bank had a similar magnitude of planform change both above and below the LD.

LD2 (Fig. 9b) predominantly exhibited erosion, with a net planform area change of -1.10 m² but with greater spatial variability near the LD sequence. Immediately downstream of LD2b on the true right bank was an area of deposition, followed by approximately 0.50 m² of bank erosion, flanking LD2b. A similar pattern was observed on the true left bank, with an area of erosion upstream of LD2b, and a small area of deposition downstream. Often during high flows, the river would exceed the riverbanks — as highlighted above — and flank the true right bank of LD2b. This clearly resulted in localised scour downstream of LD2b on the true right bank. LD2a appeared to have had little impact on the banks, despite retaining water. Deposition mainly occurred in the mid-structure, preceded and succeeded by bank erosion. There was less

365 apparent impact from LD2a downstream (Fig. 9b) as, despite having increased structural complexity, the structure engaged with deeper flows less frequently than LD2b.
