Localised geomorphic response to channel-spanning leaky wooden dams

Joshua M. Wolstenholme^{1,2}, Christopher J. Skinner^{3,2}, David Milan⁴, Robert E. Thomas² and Daniel R. Parsons¹

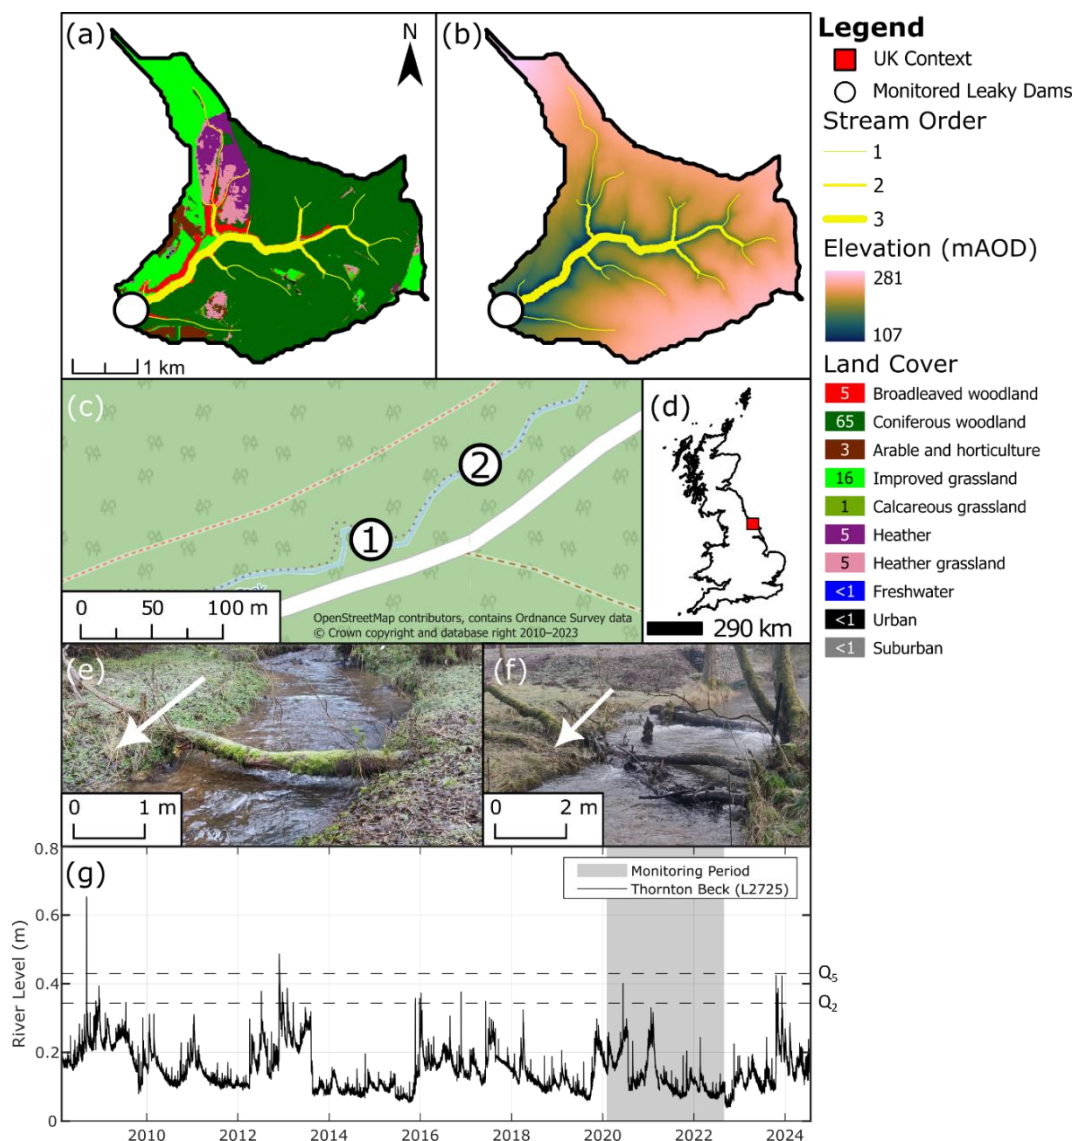
Figure 1: Location of studied leaky wooden dams in relation to the Dalby Forest catchment. (a) 2021 Land cover map with percentage cover shown in the legend (Marston et al., 2022). (b) Stream network generated from terrain data showing Strahler stream order and elevation (Ordnance Survey, 2020). Note same scale as (a). (c) Location of LD1 and LD2. (d) UK context for site location. (e) & (f) LD1 and LD2 respectively, flow direction denoted by white arrow. (g) River level record 2008–2024 for Thornton Beck, Thornton Le Dale (Grid Reference: SE 83681 83418; Station ID: L2725) approximately 7 km downstream of study area (from Environment Agency) including estimated return period (Q_n) as described in the supplementary material.

The catchment is characterised by woodland (70%), with grassland (17%) and heather (10%) the other principle land use types (Marston et al., 2022) as shown in Fig. 1a. It has a mean annual precipitation of 980 mm with monthly averages ranging from 55.6–118.9 mm (1991–2020 mean, Fylingdales weather station at 262 mAOD, 11.2 km NE; Met Office, 2020). The catchment contains 60.2 km of river corridor, with a mixture of first (9.9 km), second (3.6 km) and third-order (3.5 km) streams following the Strahler (1957) stream order notation (Fig. 1a, b). The channels are between 1 and 4 m wide, widening towards the catchment outlet.

LD1 (Fig. 1e) is a 6.2 m wide channel spanning LD with a 0.28 m average vertical gap across its width at the time of installation. The channel was 2.7 m wide where the LD was installed. It was anchored *in situ* with a wooden stake on the true right bank to reduce the likelihood of displacement during high flows and was embedded into the surface on the true left bank. The structure was comprised of a single log which was fully separated from a tree trunk, with some thin branches attached facing upwards. As this LD is fully channel spanning and thus does not interact with baseflow. Thus, it is a “Type 1” LD (fully channel spanning, not interacting with baseflows) following the classification of Lo et al. (2021). The LD extends onto the floodplain by approximately 1.5 metres either side of the channel.

LD2 (Fig. 1f) was felled and left in situ, remaining attached to its stump to enable growth (a “living” LD). The LD itself was composed of two sub-sections, furthest downstream (LD2a) was an 8.55 m long section spanning a 3.85 m wide channel. The structure was partially submerged with a minimum gap height of 0.14 m, and a maximum of 0.43 m at the time of installation. LD2a was classified as a “Type 2” LD (fully channel spanning, interacting with baseflows but not touching the stream bed; Lo et al., 2021). LD2 was more complex than LD1 due to the presence of a pre-existing walkway that formed a secondary sub-structure LD2b, that was fixed with wooden anchors. LD2b was a “Type 1” LD (fully channel spanning, not interacting with baseflows at all; Lo et al., (2021). LD2b was installed above the average water depth, was 3.83 m wide, spanned a 3.25 m wide channel and had a 0.41 m gap. LD2a extended approximately 1.5 metres either side of the channel, whereas LD2b extended less than 0.5 m either side of the channel banks.

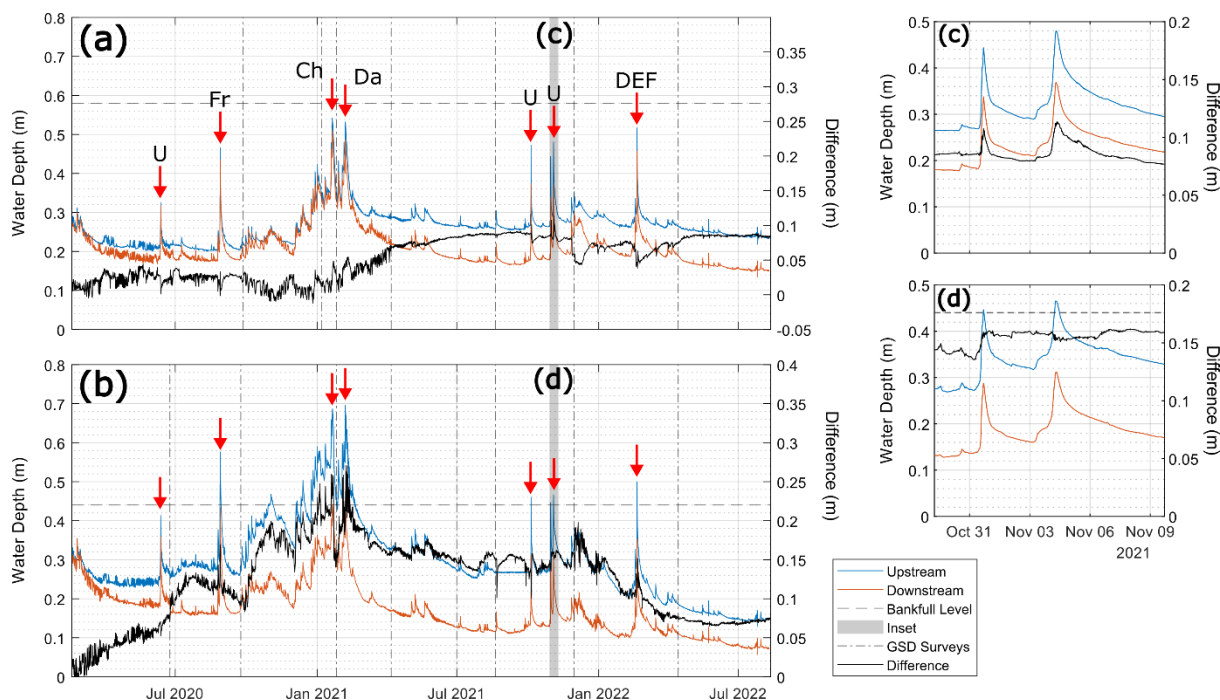
280 **Figure 2:** Temporal variations of water depth for LD1 (a) and LD2 (b) with difference between upstream and downstream recordings shown, as well as key peaks and storms (U=unnamed, Fr=Francis, Ch=Christoph, Da=Darcy, DEF=Dudley, Eunice & Franklin). Also shown are dates of GSD surveys and bankfull level. Note different y-axis scale. (c) and (d) show variations in water depth throughout time between the two sites.

265 monitoring period, denoted by red arrows on Fig. 2 linked to key storms identified in Table 1, that resulted in near
exceedance or exceedance of bankfull stage at site 2, in addition to increased average water depth throughout winter 2020/21
observed at both sites.

Initially, water depths at LD1 covaried, averaging 0.21 m downstream and 0.22 m upstream between February 2020 and
November 2020, increasing to 0.31 m and 0.32 m, respectively, until February 2021, when the upstream depth diverged from
the downstream. Throughout the monitoring period, there was an average difference of 0.05 m and a maximum difference of
270 0.11 m between the two depths, with the upstream depth ranging from 0.20 m to 0.54 m, and the downstream depth ranging
from 0.13 m to 0.51 m.

In contrast, the upstream and downstream water depths quickly diverged at LD2, with an average difference of 0.12 m
between the upstream and downstream depths. Downstream peaks were generally shorter in duration than upstream (Fig.
2b). Additionally, once the LD was fully engaged with the river, there was a near constant difference between the
275 downstream and upstream depths of up to 0.27 m. This difference decreased to less than 0.10 m following the last notable
storm of the monitoring record in February 2022 (Dudley, Eunice and Franklin). Upstream and downstream depths ranged
from 0.13 m to 0.70 m and from 0.06 m to 0.44 m, respectively.

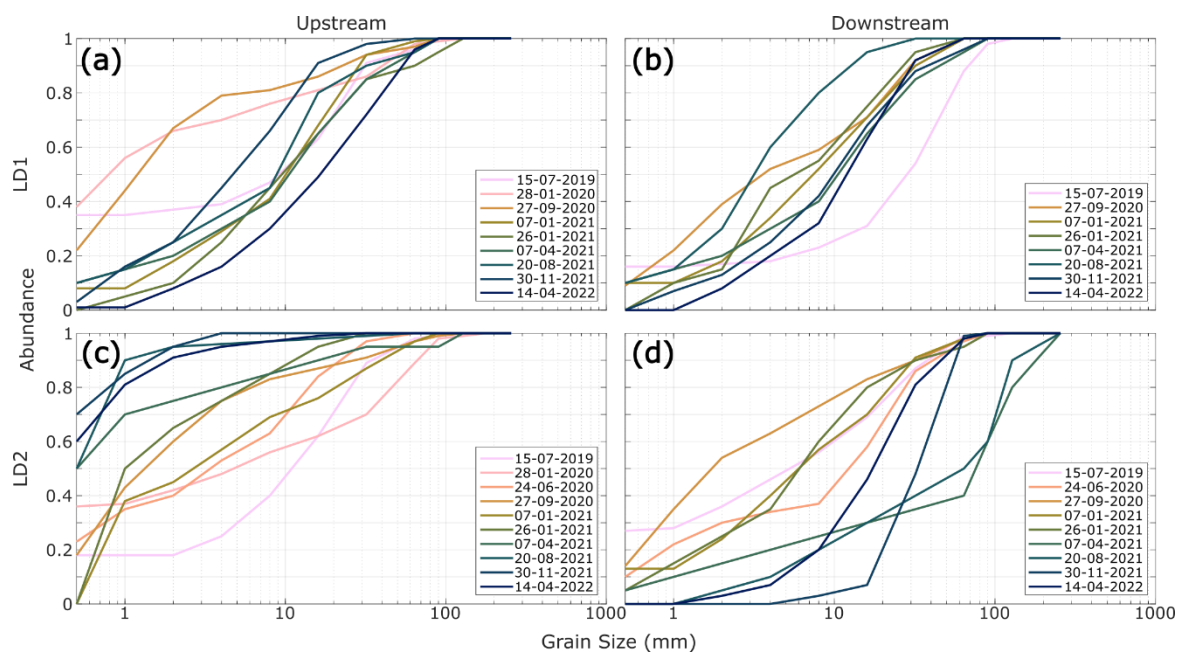
Figure 3: Cumulative density functions of Wolman pebble count data at LD1 (a) & (b) and LD2 (c) & (d). Sites are separated into upstream (a) & (c) and downstream (b) & (d) observations.

When comparing the upstream and downstream GSDs, except for an initial increase of the sand and fine gravel fractions upstream of the structure immediately following installation and until September 2020, the between-event variability is greater than any consistent change to the GSD at LD1 during the monitoring period, although there is some evidence of slight coarsening over the longer record (Fig. 3a, b). In contrast, the GSD at LD2 showed a consistent fining trend upstream of the structure post-installation, resulting in a decrease of D_{50} from 10 mm to < 1 mm (Fig. 3c) and a consistent coarsening trend downstream of the structure, resulting in an increase of D_{50} from 5 mm to 30 mm (Fig. 3d).

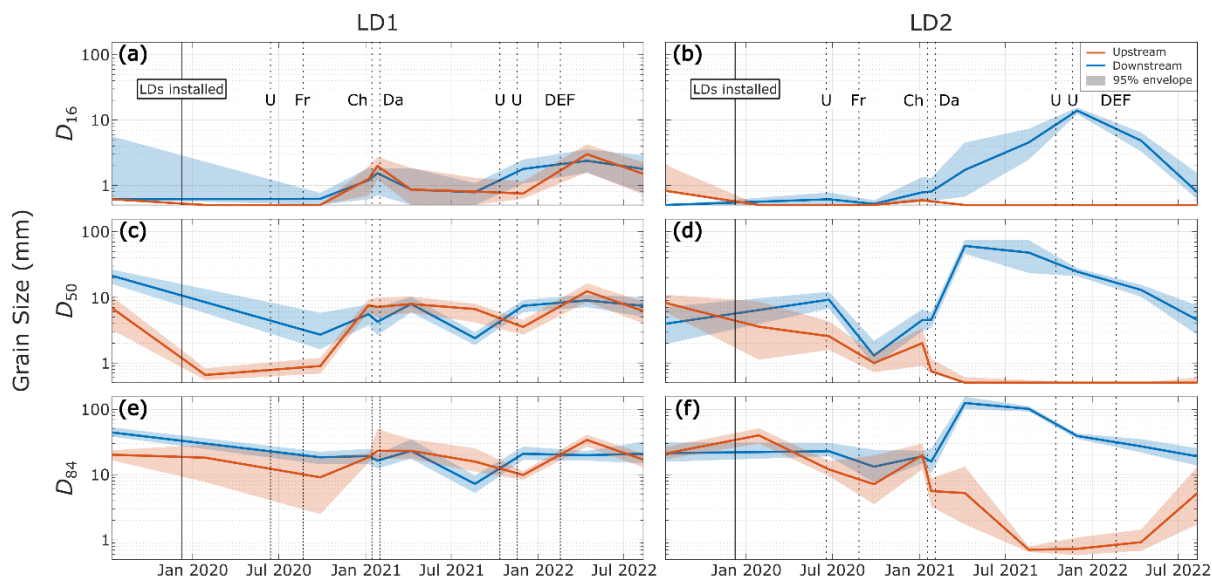
Figure 4: GSD metrics for upstream (orange) and downstream (blue) of the LD structures, with the 95% error envelope shown. Key storms are indicated by dashed lines.

D_{50} and D_{84} highlight the variability between the two sites as well as upstream and downstream of the LD structures as shown in Fig. 4. LD1 showed little difference for all metrics, with upstream and downstream matching closely throughout the monitoring period, often within the calculated 95% confidence interval of the measurements themselves, as such this aligns with the more detailed GSD overview presented in Fig. 3. In contrast, metrics for LD2 diverge notably from January 2021 onwards following the wet 2020/21 winter and storms Christoph (RI=2.3) and Darcy (RI=1.6), with a maximum range of 59 mm for D_{50} April 2021, 98 mm for D_{84} in August 2021 and 10 mm for D_{16} in November 2021. At the end of the monitoring period, all grain size metrics converged, most notably upstream of LD2 where D_{84} coarsened to 5.5 mm following winter 2021/22, while D_{16} and D_{50} downstream of the LD both fined to < 1 mm and 5 mm respectively from peaks of 10.5 mm and 60 mm.

downstream induced through disconnectivity may result in increased stream power downstream of the leaky wooden dam intervention both conceptually as shown by Kondolf (1997), and in this study through the grain size disparity (Fig. 4). Check dams that were historically installed to regulate flow conditions are similar (albeit larger) to leaky wooden dams by creating static points that induce disconnectivity have been shown to exacerbate incision downstream due to sediment starvation (Lo et al., 2022; Wohl and Beckman, 2014; Wyzga et al., 2021). There is therefore the potential risk that leaky wooden dams installed near to critical infrastructure may result in increased erosion (e.g., Nisbet et al., 2015), therefore careful consideration of placement of these structures is required, especially in a wood-supply poor area. Additionally, if the structures do not provide an effective conduit between the active channel and the floodplain, there is potential for the sediment stored to reduce the efficacy of the leaky wooden dam for flood risk management, however will likely provide water quality benefits (Quinn et al., 2013). Stored sediment will likely reduce the porosity of the structure (Lo et al., 2022), thereby further increasing longitudinal disconnectivity, similar to that of organic material (Schalko et al., 2018).

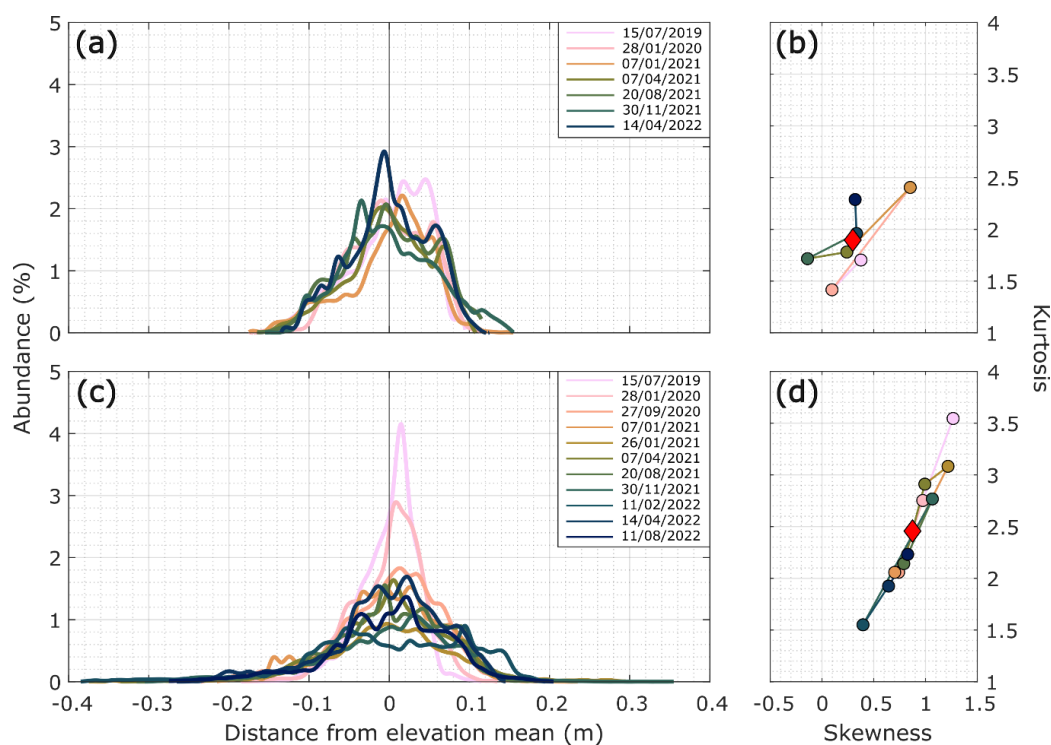
Figure 5: Detrended surface elevations relative to the mean for each bathymetric survey for LD1 (a) and LD2 (c). Associated skewness and kurtosis for each date is also shown with the mean shown as a red diamond (b) & (d) respectively.

325 between survey dates. There was a clear relationship between skewness and kurtosis with time, with surveys becoming moderately positively skewed (0.5–1) with increasing geomorphic variability (decreasing kurtosis). Both skewness and kurtosis fell between January and August 2021 when there were no substantial changes to stage—as shown in Fig. 2—and no storm events, but increased following storms Dudley, Eunice and Franklin towards winter 2022. The overall negative trend of the kurtosis indicates that the LD has increased internal topographic variability compared to the baseline observation, while fluctuating skewness generally identifies periods of accretion and erosion throughout the reach.

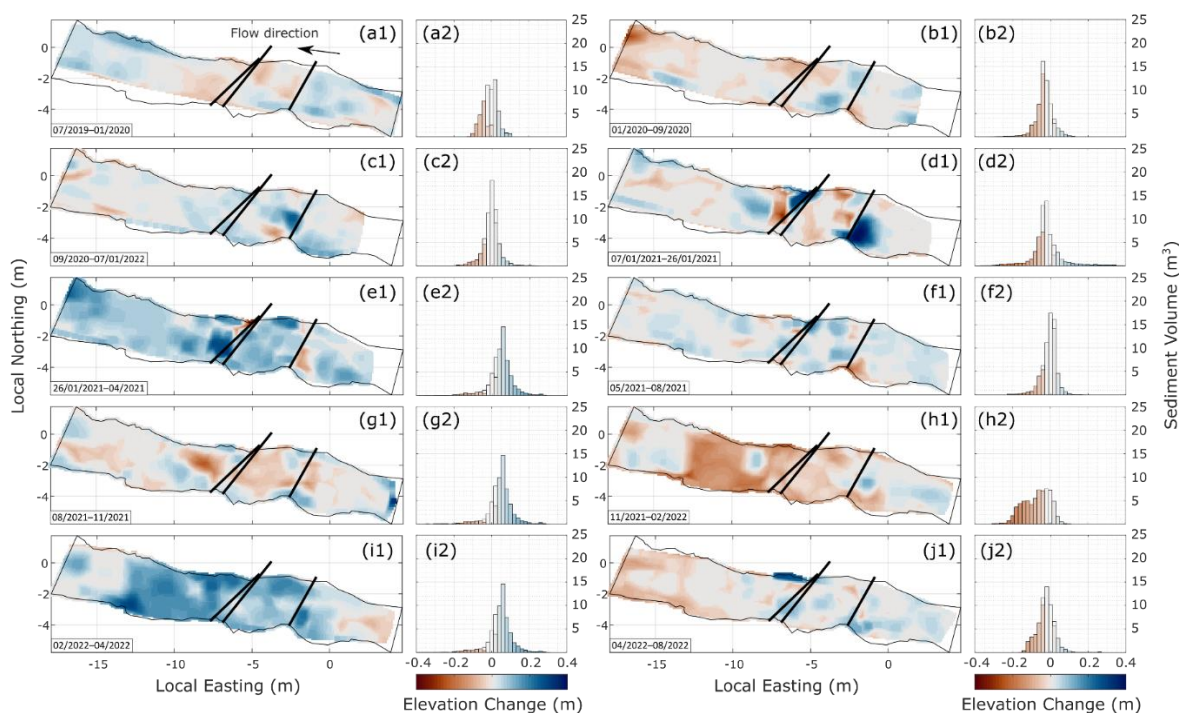
Figure 7: DoDs for LD2 (1) and histograms of elevation change (2). Significant elevation change ($\alpha < 0.05$) denoted by colour (red is erosion, blue is deposition), with insignificant change shown in grey. The channel boundary is shown as a black outline, with the planar view of the LD represented as a thick black line. Flow direction denoted by black arrow.

LD2, which was formed by two linked structures, had a maximum scour depth of 0.38 m between 26/01/2021 and April
345 2021 (Fig. 7e2), and a maximum deposition depth of 0.4 m (07/01/2021–26/01/2021; Fig. 7d2). The range of elevation
change fluctuated throughout time from -0.14–0.12 m immediately after LD installation (July 2019–January 2020; Fig. 7a2)
to reported maximum values. Additionally, the DoDs were highly spatially variable, with evidence of pool formation
downstream of the lower LD (Fig. 7a, b) which experiences periodic infilling (Fig. 7c, d) and scour (Fig. 7e, h) throughout
the monitoring period. Immediately downstream of the upstream LD, a secondary pool formed that exhibited similar scour
350 and fill cycles. The upstream LD stored sediment during the monitoring period, most clearly illustrated by Fig. 7d1
(07/01/2021–26/01/2021 following Storm Christoph), where a substantial area of the DoD exhibited change greater than the

LoD. The depositional zone also fluctuated over time, infilling and scouring on the true left bank of the upper LD.

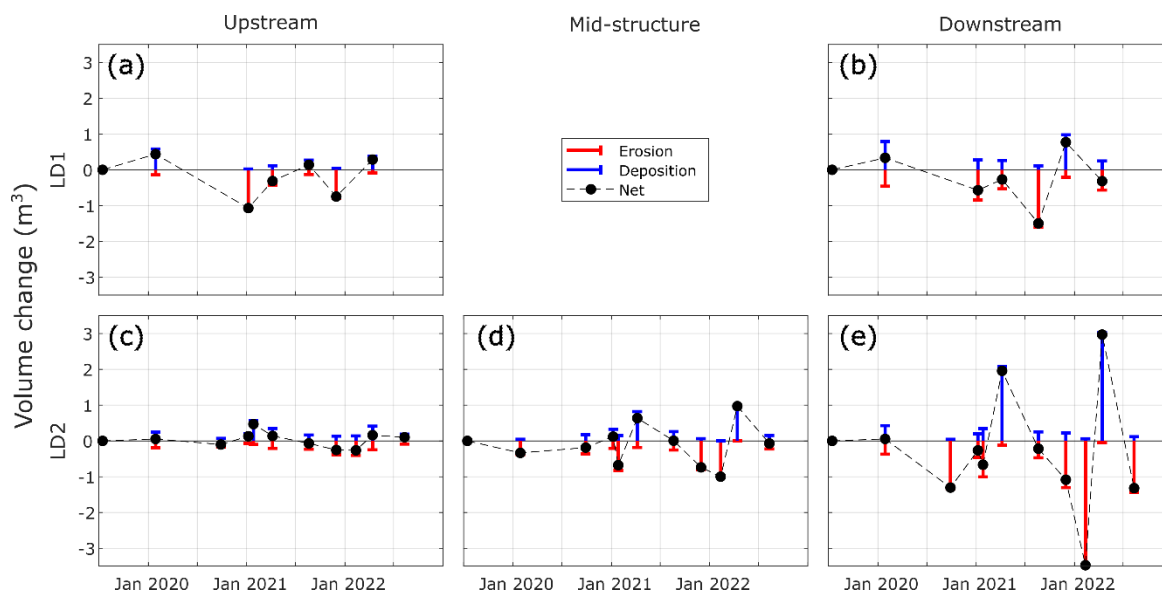
380 **Figure 8:** Volumetric change split into erosion and deposition for LD1 upstream (a) and downstream (b), and LD2 (c–e) separated into upstream of LD2b (c), mid-structure (i.e., between LD2a and LD2b; d) and downstream of LD2a (e).

Upstream of LD1 (Fig. 8a) volumetric change was highly variable, with no greater than 0.6 m^3 of deposition immediately after LD installation and 1.1 m^3 of erosion in January 2020. Upstream net change fluctuated throughout the monitoring period, with increased scour following higher flows in winter, and increased deposition across summer period lower flows. Downstream of LD1 (Fig. 8b) exhibited a similar pattern but there was increased erosion (maximum of 1.6 m^3 in August 2021) and deposition (up to 1 m^3 in November 2021).

periods were less variable as there was reach-wide erosion and deposition, however there were localised areas 1 m downstream of the LD that exhibited little elevation change.

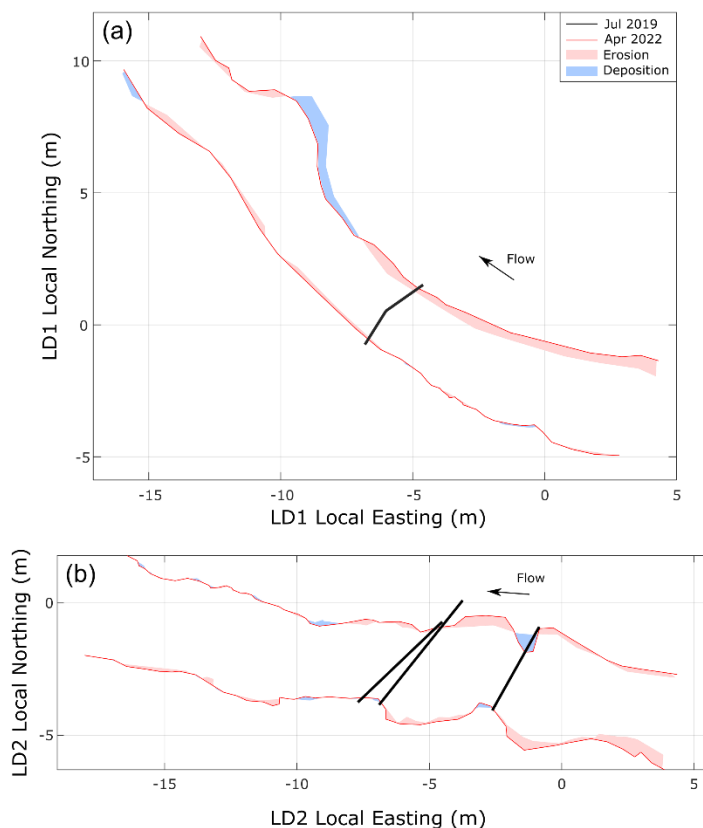
Figure 9: Bank erosion and deposition for LD1 (a) and LD2 (b). Leaky wooden dams are represented as thick black lines.

LD2 (Fig. 9b) predominantly exhibited erosion, with a net planform area change of -1.10 m² but with greater spatial variability near the LD sequence. Immediately downstream of the LD2b on the true right bank was an area of deposition, followed by approximately 0.50 m² of bank erosion, flanking LD2b. A similar pattern was observed on the true left bank, with an area of erosion upstream of LD2b, and a small area of deposition downstream. Often during high flows the river would exceed the river banks as highlighted above—and flank the true right bank of LD2b. This has clearly resulted in localised scour downstream of LD2b on the true right bank. LD2a appeared to have had little impact on the banks.

395 Deposition mainly occurred in the mid-structure, preceded and succeeded by bank erosion. There was less apparent impact from LD2a downstream, as shown in Fig. 9b.
