Experimental study on granite weathered crust landslides with different residual layer thicknesses under heavy rainfall

Jingye Chen^{1,2}, Qinghua Gong², Jun Wang², and Shaoxiong Yuan²

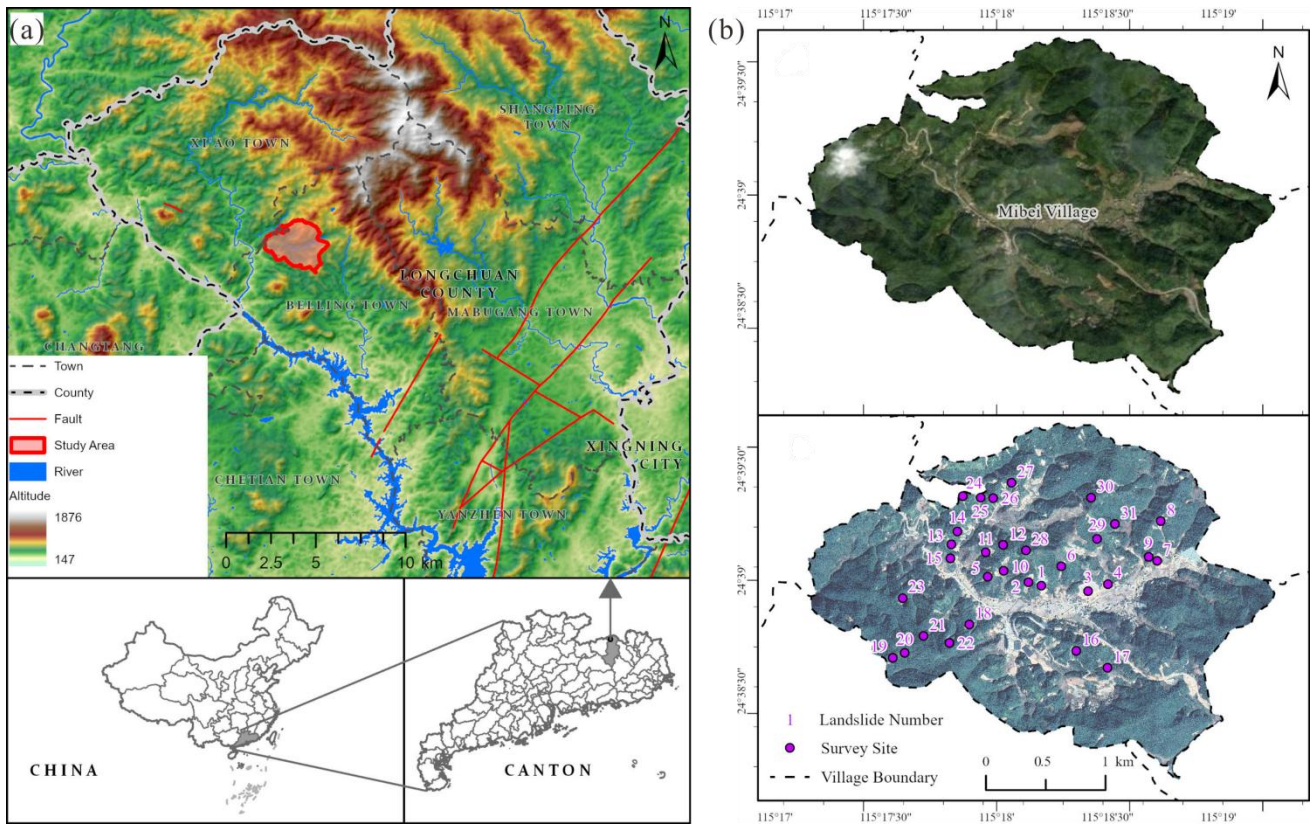
Figure 1. Map showing the background of study area. (a) geographical location. (b) satellite images before and after disaster (sourced from Google Earth).

Longchuan County, Guangdong Province, is located in the subtropical monsoon climate zone of China. The area experiences a high level of precipitation, with an average annual rainfall of 1621.79 mm. The distribution of rainfall across the region is uneven, with the majority of precipitation occurring between April and July each year. These months account for 52% of the annual rainfall, with the majority of this occurring as heavy rainfall. A total of 95.35% of geohazards occurred during periods of concentrated rainfall (Jia et al., 2024). There is a strong correlation between periods of heavy rainfall and periods of high incidence of geohazards. From June 10 to 13, 2019, persistent rainfall occurred in Longchuan County. One of the heavy rainfalls from 14:00 to 19:00 on June 11 resulted in mass landslides throughout the Mibei Village. Following the disaster, we surveyed the geological and geographic environment of Mibei Village, focusing on the 31 larger landslide sites in this event (Fig. 1b). The study area is hilly and mountainous landform, with simple geological conditions. There are no discernible faults or folds, and the groundwater table is deep. The bedrock consists of Lower Paleozoic granite. The outcrops on the surface expose the thick weathered crust formed by the weathering of granite. A distinct boundary can be seen in the profile of the stratum (Fig. 2a), showing a typical dual structure. The upper part of the weathered crust is the residual layer formed in situ after the weathering of granite. It is unevenly exposed at different locations and has a thickness of 1.00-10.40 m. The residual soil is hard plastic, slightly wet, and yellowish-brown in color. Quartz grains are visible to the naked eye. The lower part consists of the completely weathered layer, where the original rock structure remains discernible. The lower part of the weathered crust is the completely weathered layer, where the original rock structure remains recognizable. The completely weathered granite is hard and grayish-brown in color. All minerals, except for quartz, have been weathered (Fig. 2b). The basic geotechnical properties of the weathered crust are shown in Table 1. According to engineering classification, the residual soil belongs to sandy clay. The lower completely weathered layer is more compact and less susceptible to water seepage than the upper residual layer. The survey statistics of 31 landslide points show that the slope gradient of the landslides ranges from 31° to 45°, with the transverse width from 36 to 135 m, and the longitudinal length from 40 to 88 m. The sliding surface depth ranges from 1.5 to 4.3 m, all of which are shallow landslides. The material composition of the landslide mass is mainly residual soil. The water content of the landslide mass is considerable, and some of the landslides exhibit fluidization.

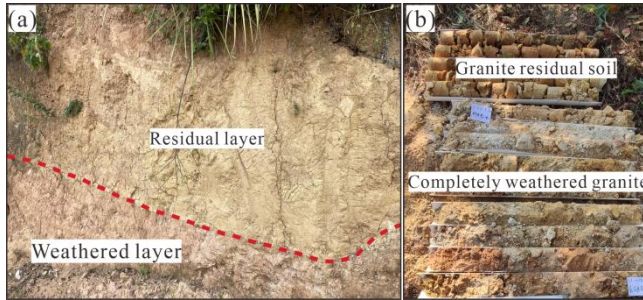
Figure 2. Geological condition of the study area. (a) stratigraphic structure. (b) drill core samples.

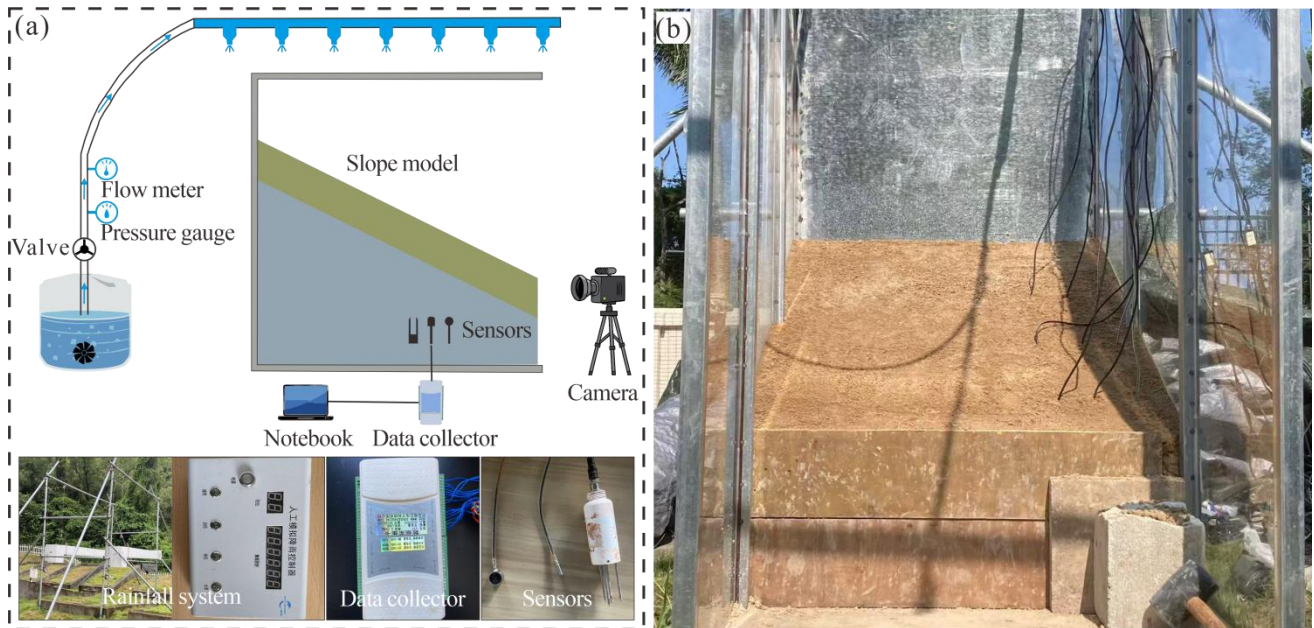
Figure 3. (a) slope model test platform. (b) constructed slope model.

The slope physical model test platform is comprised of model box, rainfall system, and data acquisition system (Fig. 3a). The dimension of the model box is 2 m×1 m×1.8 m (Length×Width×Height), and it is constructed with plexiglass and steel columns. Grid lines have been drawn on the plexiglass sidewalls to provide coordinate reference and datum control. The EL-RS3/5 mobile artificial rainfall simulation system produced by Beijing ECO-LEADER company that consists of rainfall machine, water supply system, control system. Its effective rainfall area is 5 m×3 m (Length×Width), with the rainfall uniformity coefficient greater than 0.9. The data acquisition system mainly consists of water content sensor, pore

water pressure sensor, soil pressure sensor and data collector, which are produced by Xi'an Weizheng Electronic Technology Company. Two layers of sensors were buried at the foot, middle and top of the slope, respectively and specific location is shown in Fig. 4. The sensor data are transferred to the notebook at a frequency of 3 min via the data collector. The deformation damage characteristics of slopes are recorded using the camera.

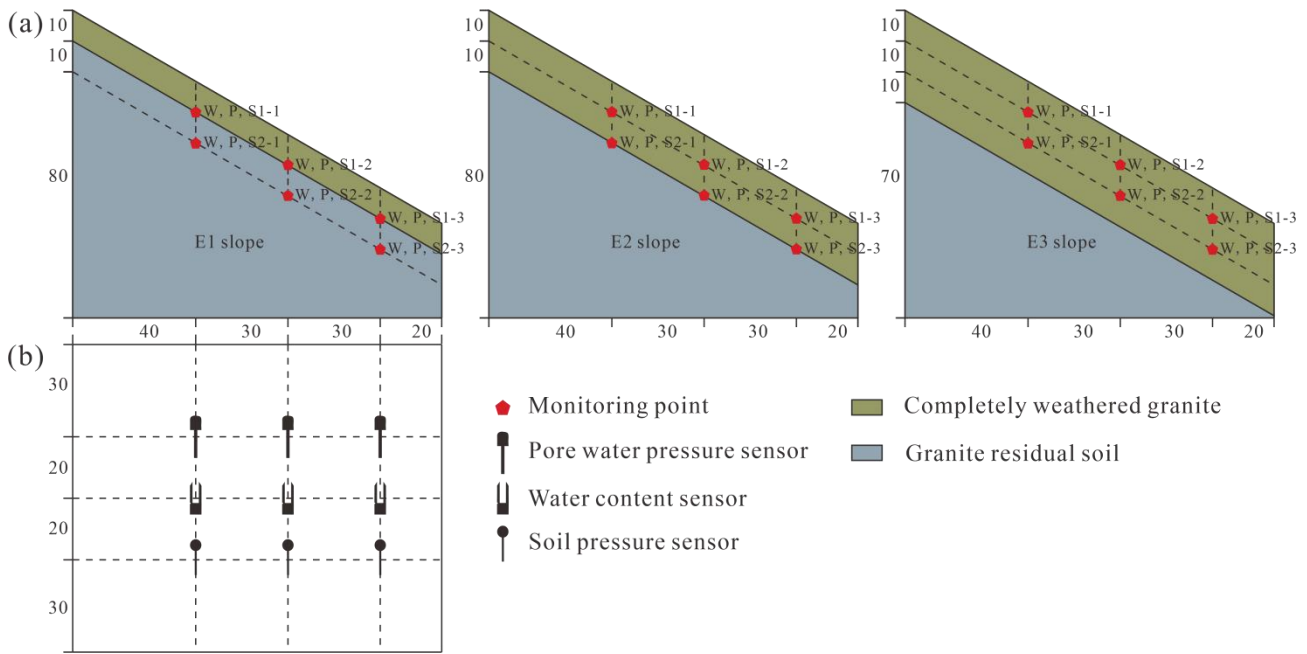
Figure 4. Schematic diagram of slope dimension and sensor buried position (unit: cm). **(a)** side view. **(b)** top view.

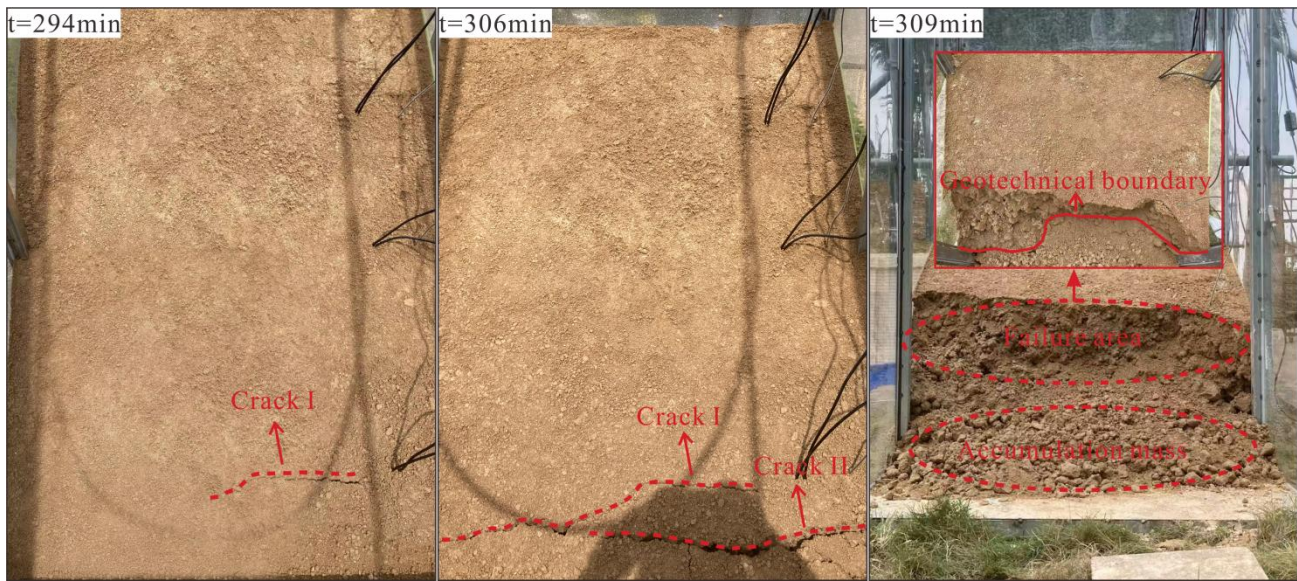
Figure 6. Deformation and failure process of E2 slope.

Figure 6 shows the failure process of the E2 slope. As illustrated in Figure, at test 294 min, the transverse crack I was observed at the foot of the slope. The formation of the crack is attribute to the continuous flow of rainwater towards the foot of the slope, thereby weakening the soil's resistance to deformation. At test 306 min, the soil body at the foot of the slope exhibited horizontal movement, resulting in uneven settlement of approximately 3 cm of downward misalignment and transverse crack II. The crack II ran almost from the middle to the right border, and the crack I had extended to the left border. These two cracks almost traversed the whole slope. At test 309 min, the slope slid along the crack I and crack II. The trailing edge of the landslide was located at the foot of the slope, and the sliding surface was positioned at the soil-rock interface. It took only 15 min for happening landslide after the appearance of the crack at the foot of slope. This landslide exhibited sudden sliding characteristics.

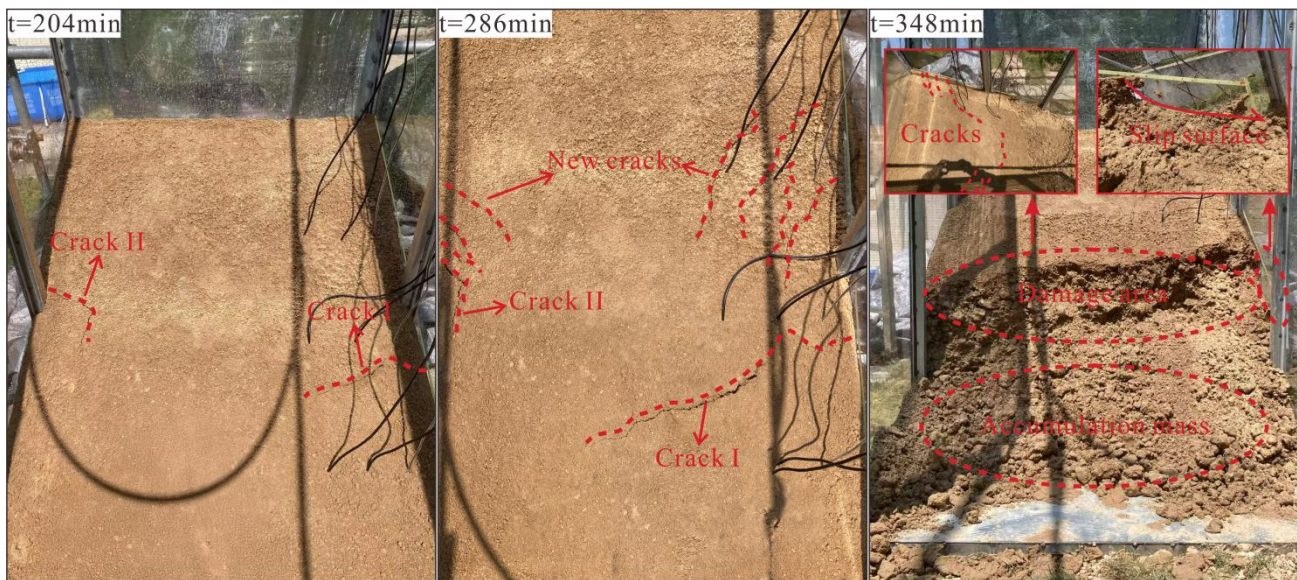
Figure 7. Deformation and failure process of E3 slope.

Figure 7 shows the failure process of the E3 slope. As illustrated in Figure, at test 204 min, the crack I and crack II were observed at the middle of the slope. These are the tensile cracks caused by uneven settlement of slope caused by rainfall infiltration. With the infiltration of rainfall, the overall downward deformation of the slope increased, and the slope underwent a shear and tension effect. At test 286 min, the crack I was extended and expanded in the lower left direction. New cracks appeared at the top of the slope, arranged in a feathery pattern. At test 348 min, the slope slid along the crack I. The sliding surface exhibited a circular arc shape, and the depth of the landslide was about 23 cm. There were multiple cracks appearing on the slope during the process.

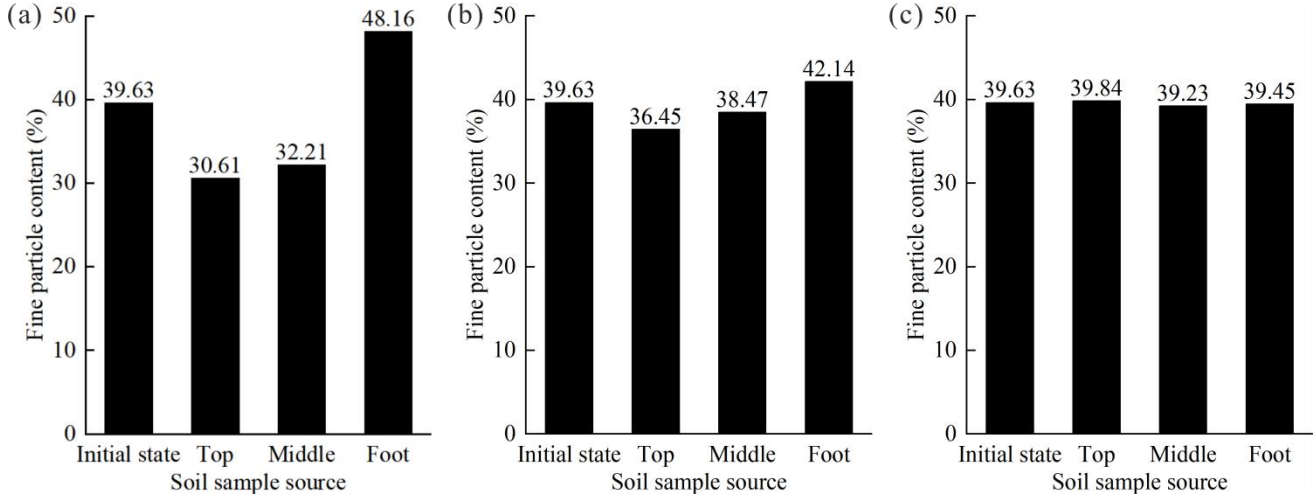
Figure 8. Fine particle content at different positions of slopes with different tests. (a) E1 slope. (b) E2 slope. (c) E3 slope.

In the case of rainfall-induced landslides, it is common for turbid runoff to carry sediment downhill and pile up at the foot of the slope. The phenomenon is essentially particle migration (Lu et al. 2011; Cui et al. 2014). The residual soil lacks intermediate particle size. The coarse particles form the skeleton of the soil, and the fine particles are attached to the skeleton particles as cement-like substance (Liu et al. 2021). This makes the fine particles can be carried by water flow and move through the skeleton pore. It is difficult to make direct observation inside the slope without the aid of specialized equipment. In this study, Samples were obtained from the top, middle, and foot of slope of the three groups using cutting ring. The locations of the samples were correspond with the depth of the sliding surface. The fine particles (particle size less than 0.075 mm) in the soil were measured by the particle gradation test, which was then compared with the initial fine particle content. The fine particle content at each location of the slopes at the end of the tests is shown in Fig. 8. It can be seen that there is a large difference in the fine particle content at each location of E1 slope. The loss of fine particles was most severe at the top of the slope, with a reduction from an initial 39.63% to 30.61%. The loss of fine particle content in the middle of slope was then 7.42%. Concurrently, the fine particle content at the foot of the slope increased by 8.53% (Fig. 8a). This indicates that the interior of the slope was undergoing a process of fine particle loss, with the lost portion undergoing longitudinal migration and eventual accumulation at the foot of the slope. The fine particle content of E2 slope exhibited a 3.18% decrease at the top of the slope, a 1.16% decrease at the middle of the

slope, and a 2.51% increase at the foot of the slope (Fig. 8b). E2 slope have been observed to exhibit a substantial reduction in fine particle loss in comparison to E1 slope. The fine particle content is nearly identical at all locations in the E3 slope (Fig. 8c). The movement of fine particles in soils of the same type is primarily influenced by in-slope seepage (Wang et al. 2024). It can be seen that seepage is most pronounced on the E1 slope, with no observable seepage on the E3 slope. The loss of fine particles destroys the soil structure, which has a greater impact on slope stability. The gradual increase in pore size between coarse particles within the slope will in turn exacerbate the loss of fine particles, leading to a reduction in the strength of slopes and their susceptibility to damage.

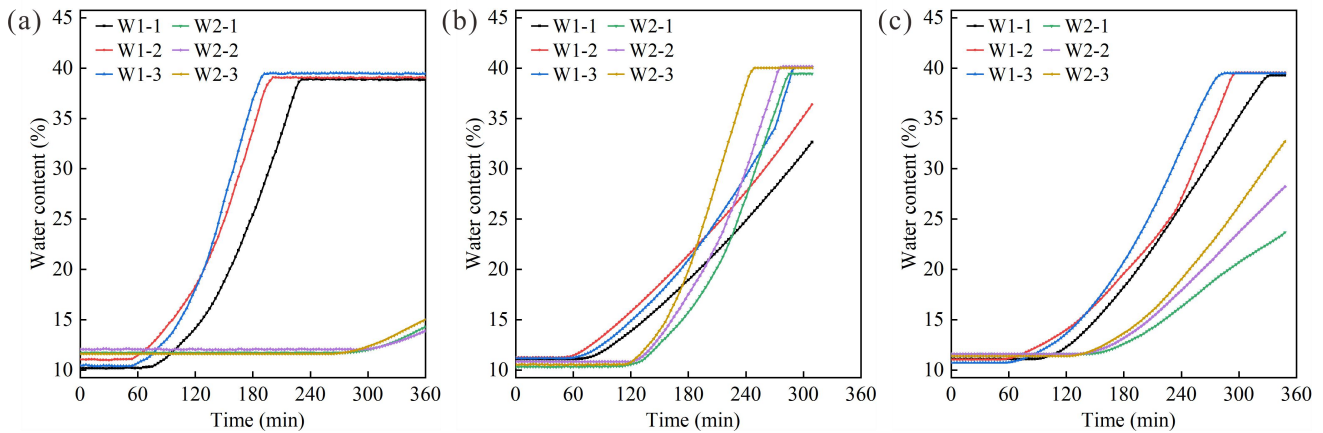
Figure 9. Water content-time curves. (a) E1 slope. (b) E2 slope. (c) E3 slope.

The water content-time curves are presented in Fig. 10. (1) For E1 slope, at test 57 min, the values of W1-2 and W1-3 increased first, followed by W1-1, indicating that the rainfall had infiltrated to the soil-rock interface and that the water content of the soil near the interface began to increase. Subsequently, the growth rate of W1-1, W1-2, and W1-3 values continued to increase. The values increased sharply and peaked within 135-159 min. This indicates that the soil water content at the soil-rock interface rises rapidly and the soil becomes saturated in a short period of time. The sensors within the weathered layer did not begin to respond until test 267 min, and the rate of increase in W2-1, W2-2, and W2-3 values was consistently low. At the end of the test, the largest increase in sensor value was only 3.38%. This suggests that rainfall has a minimal impact on the weathered layer. (2) For E2 slope, at test 54 min, the values of W1-3, W1-2 and W1-1 commenced an incremental ascent in turn, signifying that the rainfall infiltration had reached 10 cm depth at that moment. At test 111 min, the W2-3 value began to increase, followed by W2-2 and W2-1. This indicates that the rainfall had infiltrated at the soil-rock interface. The values of W2-1, W2-2 and W2-3 increased sharply, and their growth rate was much higher than that of the sensors buried at the 10 cm depth within the slope. The values of W1-1, W1-2, and W1-3 remained stable after 285 min, 279 min, and 249 min, respectively. This indicates that the soil at 20 cm depth had reached saturation. At test 273 min, the W1-3 value showed a pronounced increase, suggesting that the rate of soil water content increase at the 10 cm depth at the foot of slope was considerably more rapid. This is due to the fact that rainwater continues to collect at the slope toe under the influence of seepage within the slope. As the rainfall continued, the soil water content at the foot of the slope eventually became significantly higher than that at the top and middle of the slope, reaching saturation at test 291 min. (3) For E3 slope, at test 60 min, the infiltration of rainwater into the 10 cm depth resulted in a sequential increase in the values of W1-1, W1-3, and W1-2. At test 138 min, the W2-3 value began to increase, indicating that rainwater infiltrated to the 20 cm depth at the foot of the slope. This was followed by a sequential increase in the values of W2-1 and W2-2. At test 258 min, the W1-2 value showed a significant increasing trend, indicating a swift rise in soil water content at 10 cm depth at middle of the slope. The reason for this phenomenon is that the crack at the middle of slope provide easy access for rainfall infiltration, and rainwater infiltrates rapidly in the form of crack-preferential flow. The peak values of W1-3, W1-1, and W1-2 were observed at 288, 303, and 321 min of test, respectively, indicating that the soil was nearly saturated at 10 cm depth.

The response time of the water content at 10 cm depth was similar for three slopes. This is due to the fact that at the early stage of rainfall, rainwater mainly infiltrated vertically into the shallow surface layer of the slope in the form of homogenous flow. The rate of increase in water content at 10 cm depth was significantly greater on the E1 slope than on the E2 and E3 slopes. The phenomenon is attributed to the infiltration of rainwater into the weathered layer, which has a low permeability. Moisture is prevented from entering the weathered layer due to the effect of capillary force (Wu and

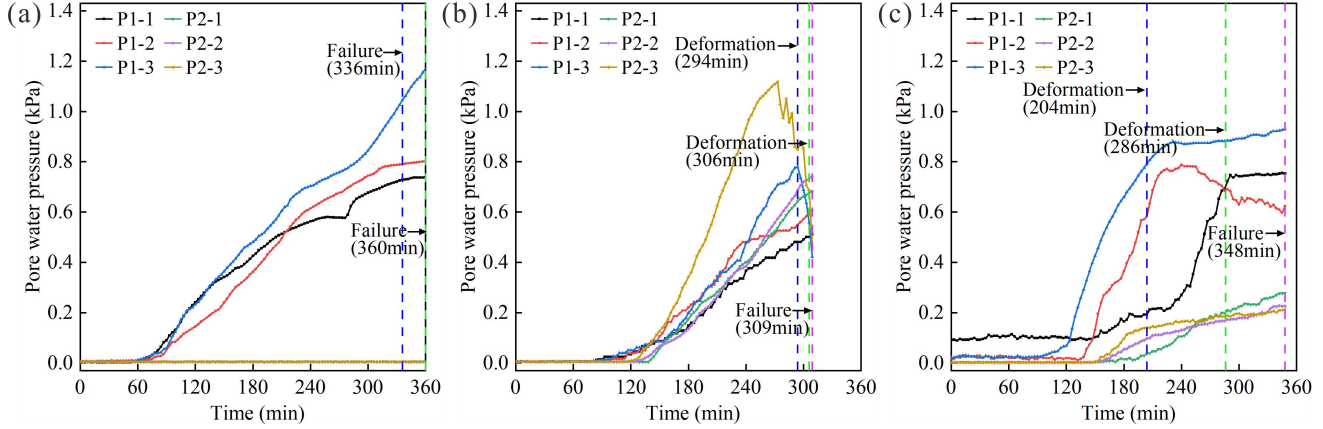
Figure 10. Pore water pressure-time curves. (a) E1 slope. (b) E2 slope. (c) E3 slope.

The pore water pressure-time curves are presented in Fig.10. In general, the pore water pressure change curves exhibit a similar overall trend to the water content change curves. This is due to the fact that the change in pore water pressure is primarily influenced by the soil water content. Furthermore, partial asynchrony stage has been observed in the changes in pore water pressure and water content, and this has been attributed to the influence of soil deformation on the change in pore water pressure (Iverson et al. 1997). (1) For E1 slope, the P1-1 value exhibited a slight decline at test 261 min, followed by a rapid increase at test 273 min. This phenomenon may be attributed to the loss of fine particles in soil at the top of the slope, which results in the hollowing out of the soil skeleton, composed of coarse particles. The reclosure of the pore subsequent to the collapse of the skeleton resulted in a sudden increase in pore water pressure. The P1-3 value continued to rise. This is due to the fact that the accumulation of fine particles at the foot of the slope, which results in the pore obstruction, thereby impeding drainage at this location. Consequently, the pore water pressure continues to increase, resulting in damage failure at the foot of the slope. (2) For E2 slope, the P2-3 value decreased significantly at test 273 min, preceding the deformation observed, indicating that significant deformation damage occurred at 20 cm depth of the foot of the slope first. At test 294 min, the P1-3 decreased significantly, indicating that the crack has developed upwards to 10 cm depth of the foot of the slope. Subsequently, there is a sharp decrease in values of E1-3 and E2-3, indicating that the foot of the slope is approaching instability. (3) For E3 slope, the P1-2 value continued to increase at test 204 min, when the slope had deformed. This may be due to the fact that granite residual soil in the area exhibit negative dilatancy (Chen et al. 2024). When shear damage occurring on the slope, the pores within the soil became smaller in size, thereby the pore water pressure continued to increase. At test 255 min, the P1-2 value began to decrease, indicating deformation at 10 cm depth at the middle of the slope. The P1-2 curve exhibited frequent fluctuations, with the value first increasing and subsequently decreasing. It's a sign of slow deformation. The creation of cracks within the slope leads to a decrease in pore water pressure, which is then restored by rainfall infiltration, a cycle that is repeated repeatedly.

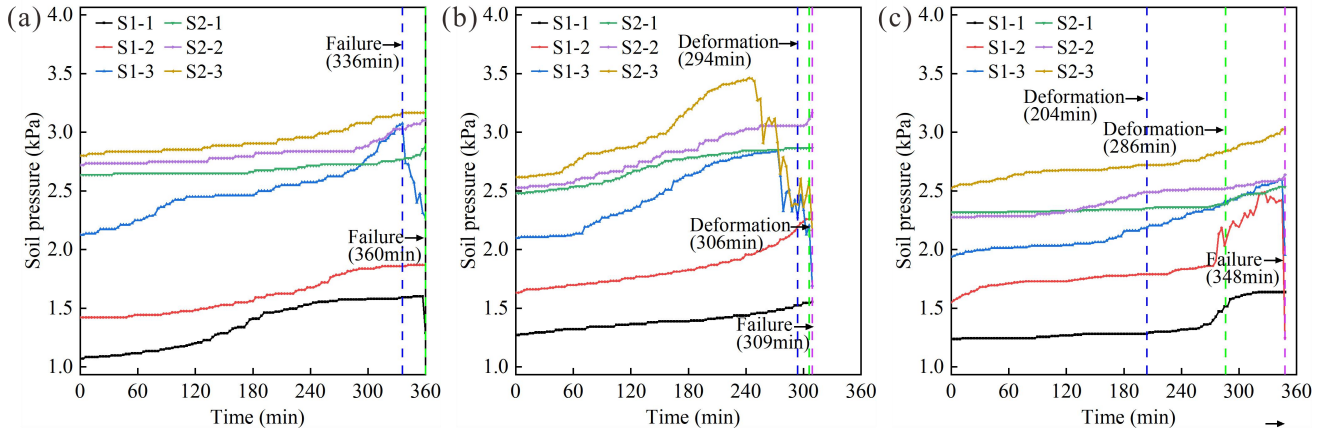
Figure 11. Soil pressure-time curves. (a) E1 slope. (b) E2 slope. (c) E3 slope.

In this test, the soil pressure sensor probe was placed perpendicular to the soil surface upward. This embedding method

can monitor the change in the sliding thrust of the upper rock and soil mass (Nian et al. 2023). Rainfall infiltration increases the slope self-weight, leading to an increase in the sliding thrust. Therefore, the soil pressure-time curves show an overall increasing trend. (1) For E1 slope, the largest increase in the S1-3 value indicates that the landslide thrust increases the most at 10 cm depth at the foot of the slope, and that the slope is most vulnerable to damage at that location. The S1-3 value continued to decrease after the damage occurred, indicating that the deformation damage at 10 cm depth at the foot of the slope still continued. (2) For E2 slope, the trend of the soil pressure curve responds to the slope deformation and damage characteristics consistent with the pore water pressure, which will not be repeated here. Notably, the decrease in S2-3 value is greater than that of S1-3, indicating that the sliding thrust at a depth of 20 cm at the foot of the slope decreases more. This suggests that the degree of deformation of the deeper soils at the foot of the slope is greater than that of the shallower soils. (3) For E3 slope, the S1-2 value increased significantly at test 273 min. This is due to the fact that water starts to fill in the crack, thereby exerting a hydrostatic pressure on the slope that significantly increases the sliding thrust. When the sliding thrust reaches a certain magnitude, landslide will occur.

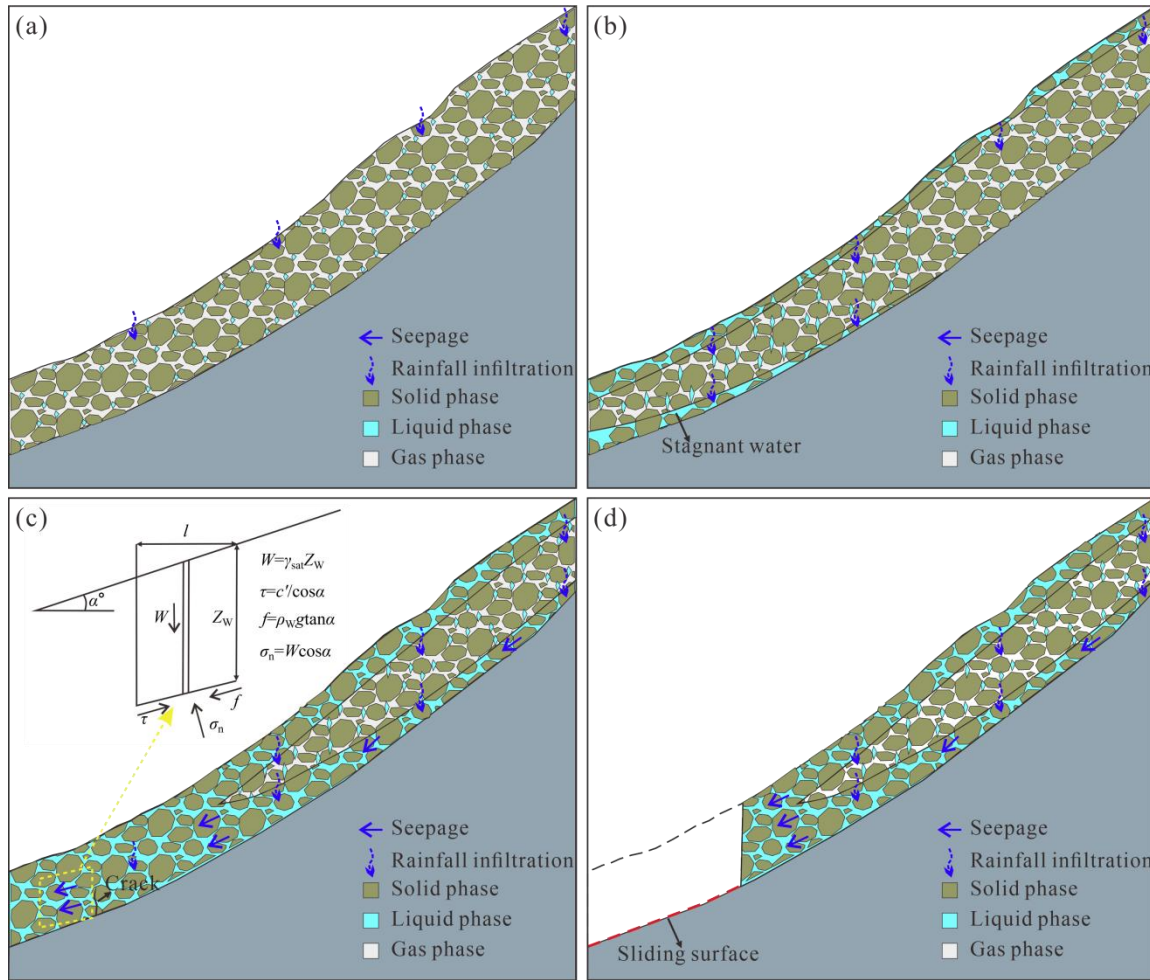
Figure 13. Schematic diagram of E2 slope instability. (a) rainfall infiltration. (b) stagnant water. (c) critical sliding. (d) landslide occurrence.

a. *rainfall infiltration*. At the beginning of rainfall, rainfall infiltration into the slope increases the soil water content. There is no evident deformation damage and surface runoff occurred on the slope.

b. *stagnant water*. As rainfall continues, shallow soil water content gradually increases and becomes saturated, and a saturated zone occurs. When rainfall infiltrates into the soil-rock interface, the underlying weathered layer has weak water permeability and is easy to form a relatively impermeable layer. Rainwater accumulates at the soil-rock interface, forming a saturated zone. The diffusion rate of this saturated zone is greater than that of the shallow surface layer. The soil is softened at this location, thus forming a plane of weakness.

c. *critical sliding*. Rainwater always flow towards the foot of the slope under gravity, saturating the residual layer at this location. Due to the large difference in permeability between the residual layer and the weathered layer, it is easy to generate strong seepage along the soil-rock interface. At this time, the sliding mode of the slope is traction and drag, and deformation tends to occur first at the soil-rock interface. Considering the role of hydrodynamic pressure, The calculation formula for the slope stability factor can be expressed as follows:

d. *landslide occurrence*. When the driving force is greater than the resisting force, the slope occurs generally in a translational slide at the soil-rock interface.

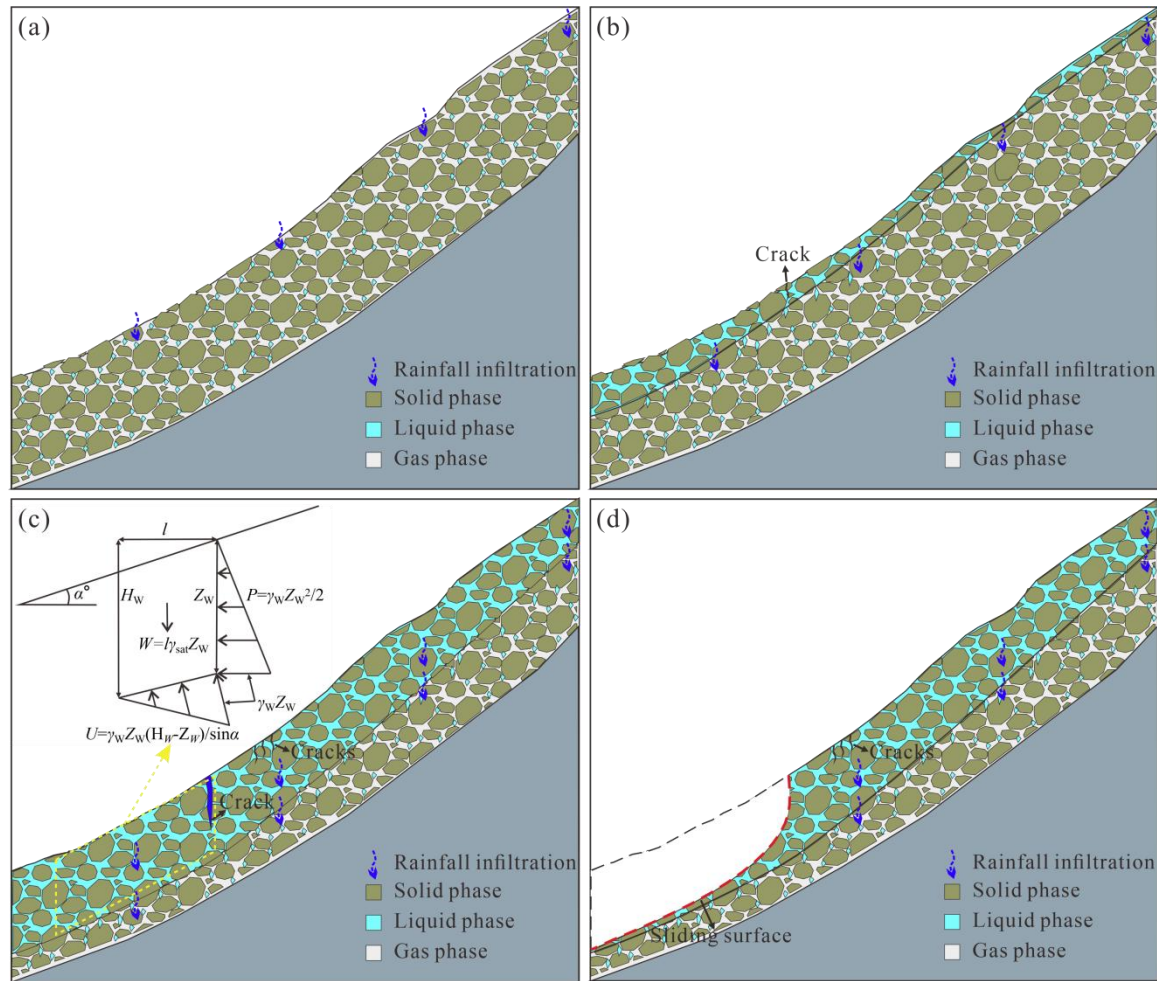
Figure 14. Schematic diagram of E3 slope instability. (a) rainfall infiltration. (b) crack generation. (c) critical sliding. (d) landslide occurrence.

a. *rainfall infiltration*. At the beginning of rainfall, rainfall infiltration into the slope increases the soil water content. There is no evident deformation damage and surface runoff occurred on the slope.

b. *crack generation*. As rainfall continues, shallow soil water content gradually increases and becomes saturated, and a saturated zone occurs. The increase in water content results in a softening of the soil, thereby reducing its strength. Meanwhile, rainfall infiltration increases the driving force on the slope, causing downward creep. Uneven distribution of soil strength leads to crack generation.

c. *critical sliding*. Crack provides easy access for rainfall infiltration. The accumulation of rainwater within the crack exerts a pressure on the slope, which contributes to the expansion of the cracks. When rainfall is sufficiently adequate, the crack fills with water creating hydrostatic pressure. At this time, the sliding mode of the slope is characterized by the coexistence of traction and thrust. The source of force that prompts the deformation and damage of the slope mainly comes from the slope self-weight and hydrostatic pressure. The calculation formula for the slope stability factor can be expressed as follows:

d. *Landslide occurrence*. When the driving force is greater than the resisting force, the slope occurs generally in a rotational slide within the residual layer.
