# Experimental study on granite weathered crust landslides with different residual layer thicknesses under heavy rainfall

**Abstract.** Landslides are frequent in the granite areas during rainfall. The hydrological response and deformation damage mechanisms of granite weathered crust slopes were investigated by physical model tests. The variability of the material with respect to the thickness of the residual layer was taken into account. The results show that the three types of slopes exhibit distinct disaster mechanisms. For the E1 slope (10 cm residual layer), the residual layer was rapidly saturated, and seepage was formed. The residual soil was susceptible to severe suffosion, and an overall flow-slip failure occurred with no obvious sliding surface. For the E2 slope (20 cm residual layer), rainfall infiltrated the soil-rock interface, forming a temporary water table at this location. The slope tended to slide along the soil-rock interface at the foot of the slope under the traction and drag of water flow. For the E3 slope (30 cm residual layer), rainfall failed to infiltrate the interface, and no seepage was observed within the slope. The slope gradually slides within the re

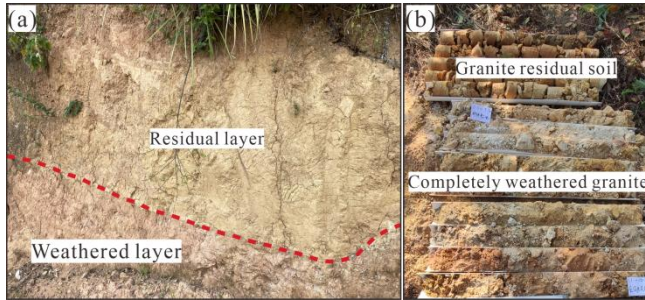
**Figure 2.** Geological condition of the study area. (a) Stratigraphic structure. (b) Drill core samples.

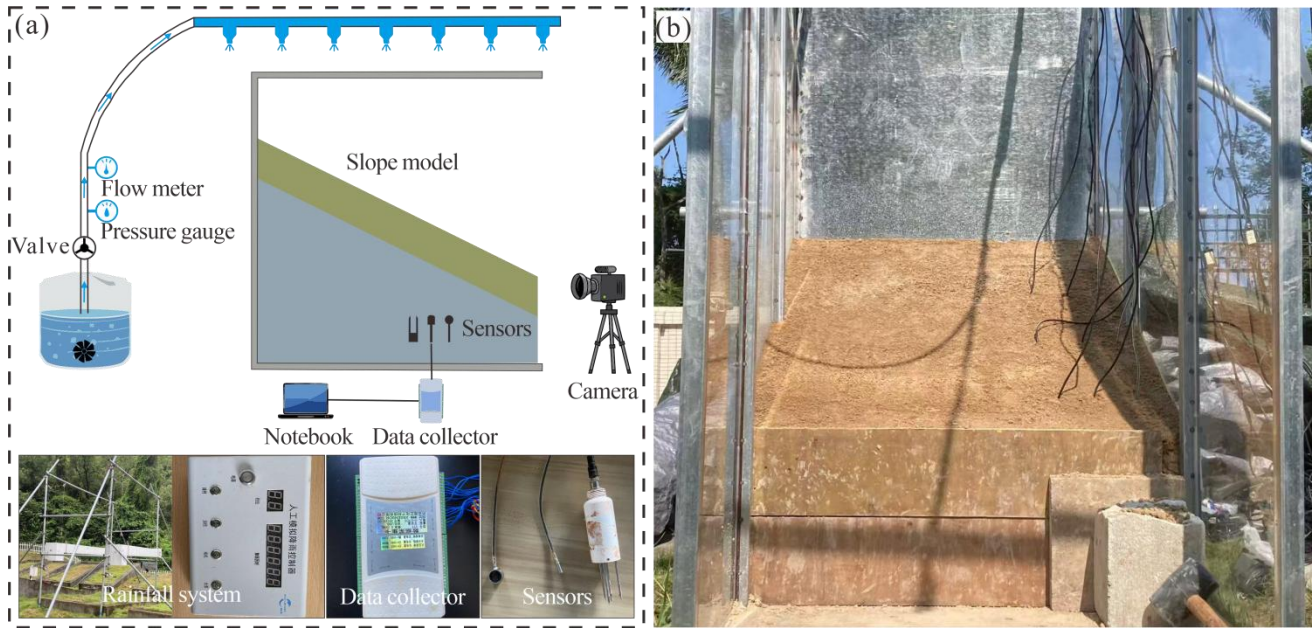
The slope physical model test platform is comprised of a model box, a rainfall system, and a data acquisition system (Fig. 3a). The dimension of the model box is 2 m × 1 m × 1.8 m (length × width × height), and it is constructed with Plexiglas and steel columns. Grid lines have been drawn on the Plexiglas sidewalls to provide coordinate reference and datum control. The EL-RS3/5 mobile artificial rainfall simulation system produced by the Beijing ECO-LEADER company consists of a rainfall machine, a water supply system, and a control system. Its effective rainfall area is 5 m × 3 m (length × width), with the rainfall uniformity coefficient greater than 0.9. The data acquisition system mainly consists of water

content sensors, pore water pressure sensors, soil pressure sensors, and a data collector, which are produced by Xi'an Weizheng Electronic Technology Company. Two layers of sensors were buried at the foot, middle, and top of the slope, respectively, and the specific location is shown in Fig. 4. The sensor data are transferred to the notebook at a frequency of 3 min via the data collector. The deformation damage characteristics of slopes are recorded using the camera.

**Figure 3. (a) Slope model test platform. (b) Constructed slope model.**

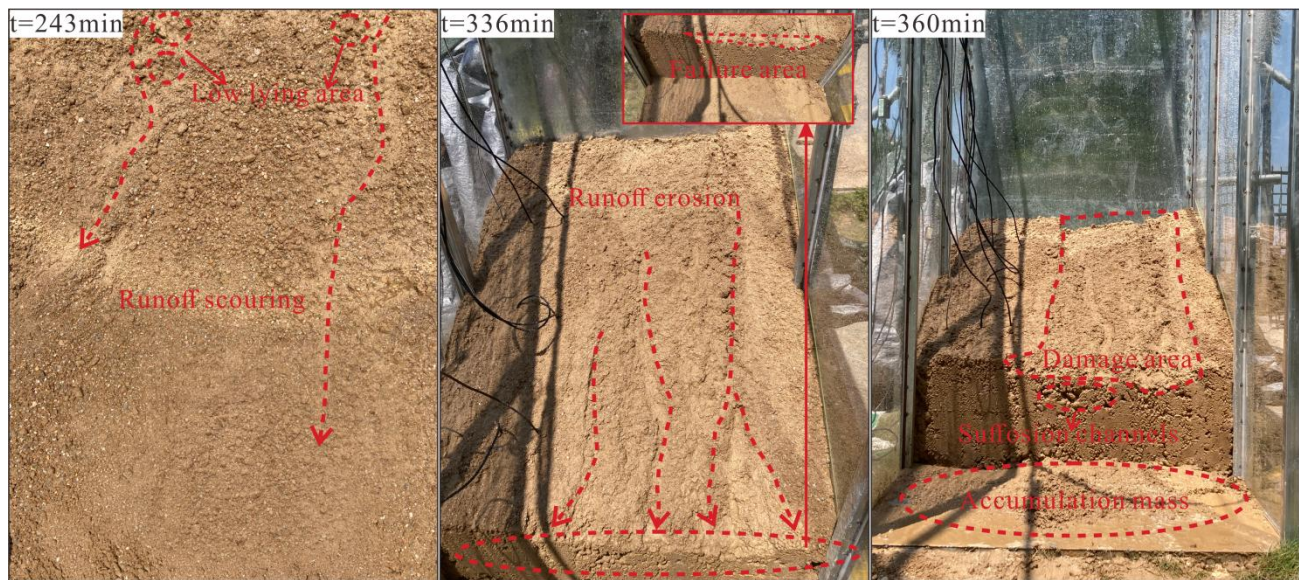
Figure 5 shows the failure process of the E1 slope. As illustrated in the figure, at test 243 min, a small range of low-lying areas was observed on the slope. As rainfall persisted, the residual layer gradually became saturated, and runoff was generated on the slope. The low-lying areas on the slope surface gradually developed into fine gullies as a result of runoff scouring. At test 336 min, the phenomenon of slip-collapse was observed at the foot of the slope. The initial fine gullies, subjected to the continuous action of seepage and erosion, ultimately evolved into erosion trenches of a certain depth and width. At test 360 min, extensive damage occurred at the top of the slope, with soil moving with the water flow and eventually accumulating at the foot of the slope. The accumulation mass exhibited looseness, high water content, and mobility. The slope showed an overall flow-slip damage with no obvious sliding surface. The suffusion channels were observed at the foot of the slope.

Figure 5. Deformation and failure process of the E1 slope.

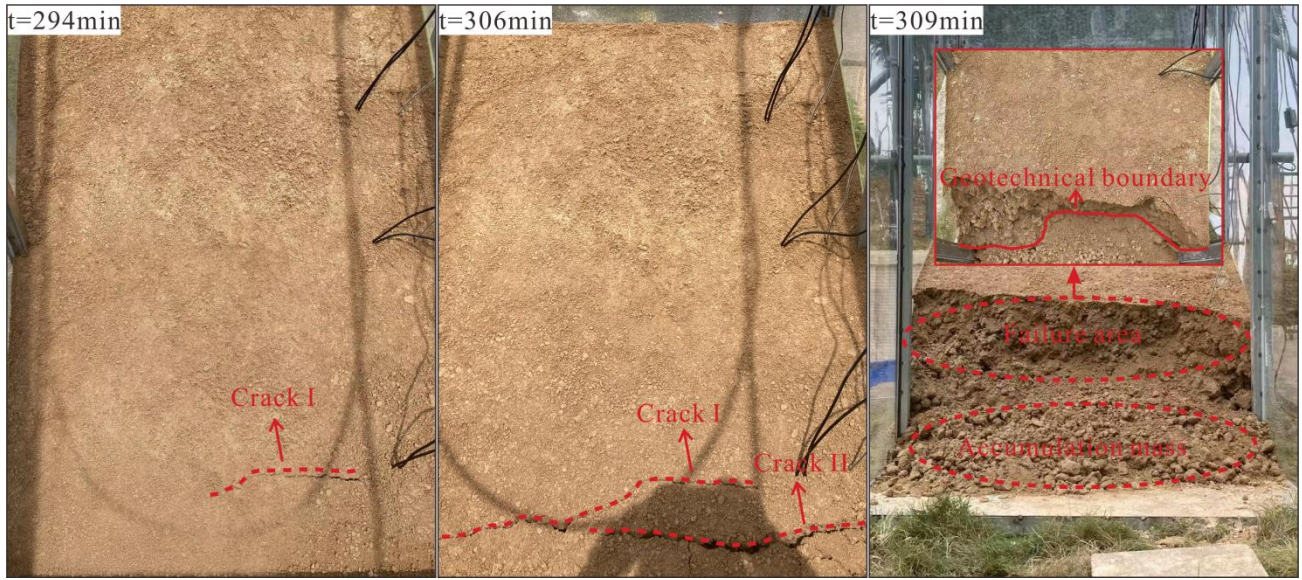
Figure 6 shows the failure process of the E2 slope. As illustrated in the figure, at test 294 min, the transverse crack I was observed at the foot of the slope. The formation of the crack is attributed to the continuous flow of rainwater towards the foot of the slope, thereby weakening the soil's resistance to deformation. At test 306 min, the soil body at the foot of the slope exhibited horizontal movement, resulting in uneven settlement of approximately 3 cm of downward misalignment and transverse crack II. The crack II ran almost from the middle to the right border, and the crack I had extended to the left border. These two cracks almost traversed the whole slope. At test 309 min, the slope slid along crack I and crack II. The trailing edge of the landslide was located at the foot of the slope, and the sliding surface was positioned at the soil-rock interface. It took only 15 min for the landslide to happen after the appearance of the crack at the foot of the slope. This landslide exhibited sudden sliding characteristics.

**Figure 6.** Deformation and failure process of the E2 slope.

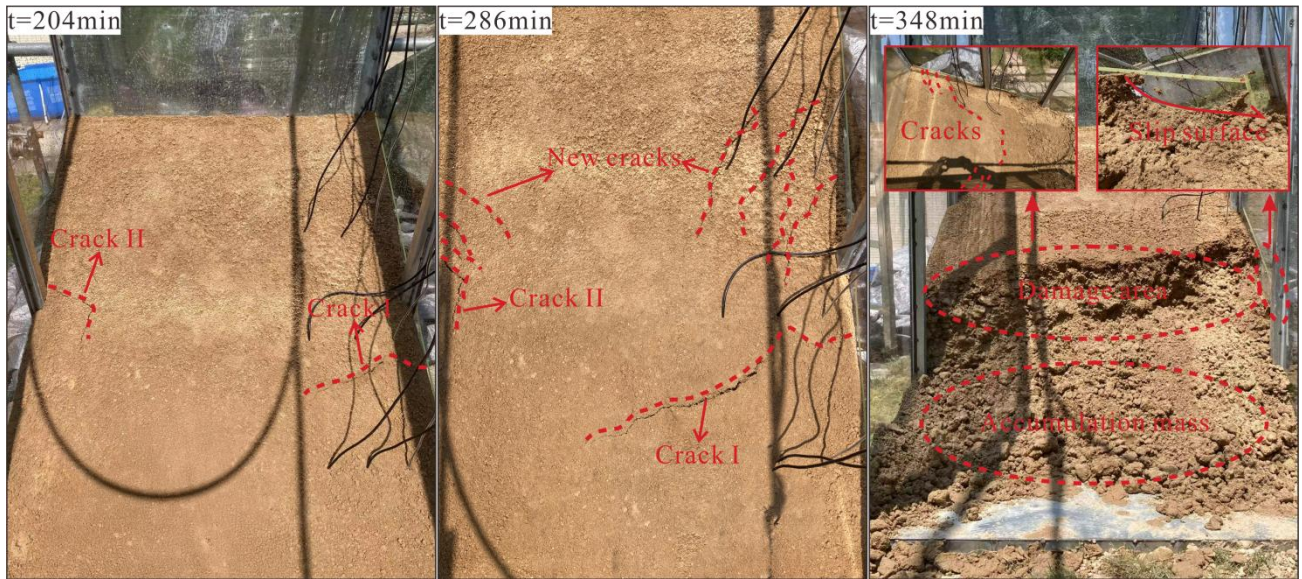
Figure 7 shows the failure process of the E3 slope. As illustrated in the figure, at test 204 min, crack I and crack II were observed at the middle of the slope. These are the tensile cracks caused by uneven settlement of the slope caused by rainfall infiltration. With the infiltration of rainfall, the overall downward deformation of the slope increased, and the slope underwent a shear and tension effect. At test 286 min, crack I was extended and expanded in the lower left direction. New cracks appeared at the top of the slope, arranged in a feathery pattern. At test 348 min, the slope slid along the crack I. The sliding surface exhibited a circular arc shape, and the depth of the landslide was about 23 cm. There were multiple cracks appearing on the slope during the process.

**Figure 7.** Deformation and failure process of the E3 slope.

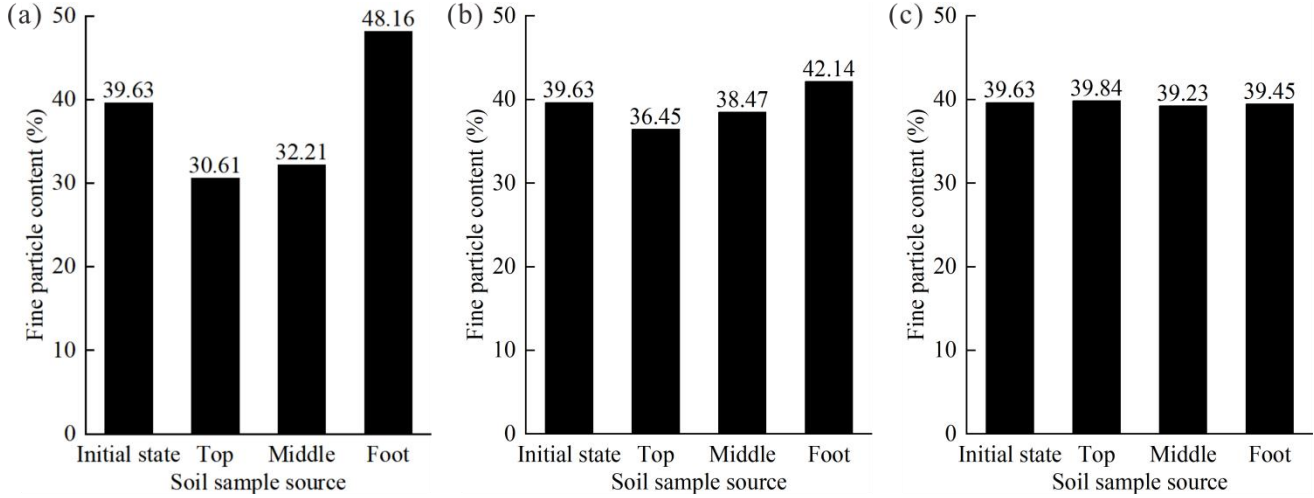
In the case of rainfall-induced landslides, it is common for turbid runoff to carry sediment downhill and pile up at the foot of the slope. The phenomenon is essentially particle migration (Lu et al. 2011; Cui et al. 2014). The residual soil lacks intermediate particle size. The coarse particles form the skeleton of the soil, and the fine particles are attached to the skeleton particles as a cement-like substance (Liu et al. 2021). This makes the fine particles able to be carried by water flow and move through the skeleton pore. It is difficult to make direct observations inside the slope without the aid of specialized equipment. In this study, samples were obtained from the top, middle, and foot of the slope of the three groups using a cutting ring. The locations of the samples correspond with the depth of the sliding surface. The fine particles (particle size less than 0.075 mm) in the soil were measured by the particle gradation test, which was then compared with the initial fine particle content. The fine particle content at each location of the slopes at the end of the tests is shown in Fig. 8. It can be seen that there is a large difference in the fine particle content at each location of the E1 slope. The loss of fine particles was most severe at the top of the slope, with a reduction from an initial 39.63% to 30.61%. The loss of fine particle content in the middle of the slope was then 7.42%. Concurrently, the fine particle content at the foot of the slope increased by 8.53% (Fig. 8a). This indicates that the interior of the slope was undergoing a process of fine particle loss, with the lost portion undergoing longitudinal migration and eventual accumulation at the foot of the slope. The fine particle content of the E2 slope exhibited a 3.18% decrease at the top of the slope, a 1.16% decrease at the middle of the

slope, and a 2.51% increase at the foot of the slope (Fig. 8b). The E2 slope has been observed to exhibit a substantial reduction in fine particle loss in comparison to the E1 slope. The fine particle content is nearly identical at all locations in the E3 slope (Fig. 8c). The movement of fine particles in soils of the same type is primarily influenced by in-slope seepage (Wang et al. 2024). It can be seen that seepage is most pronounced on the E1 slope, with no observable seepage on the E3 slope. The loss of fine particles destroys the soil structure, which has a greater impact on slope stability. The gradual increase in pore size between coarse particles within the slope will in turn exacerbate the loss of fine particles, leading to a reduction in the strength of slopes and their susceptibility to damage.

**Figure 8.** Fine particle content at different positions of slopes with different tests. (a) E1 slope. (b) E2 slope. (c) E3 slope.

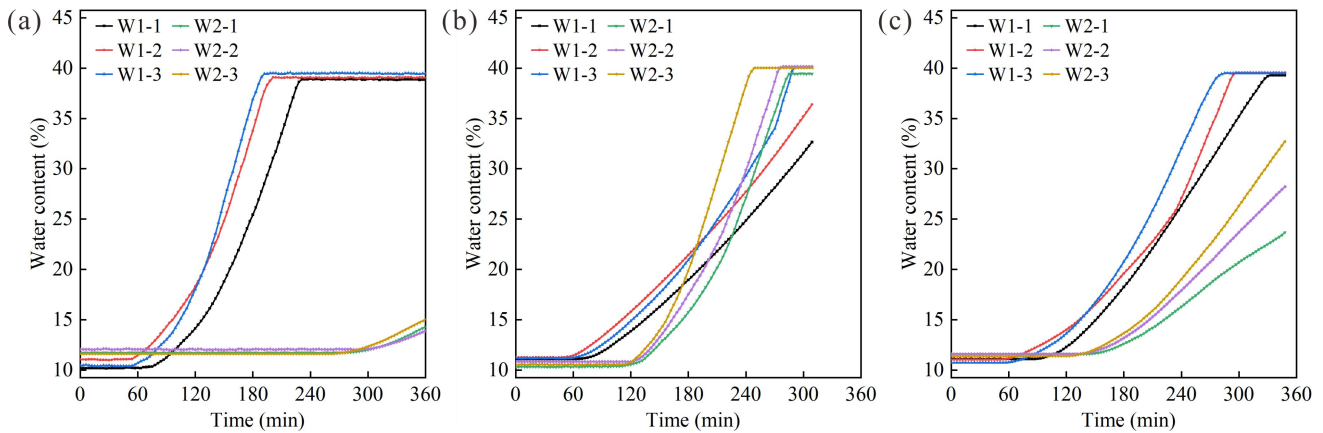
The water content-time curves are presented in Fig. 10. (1) For the E1 slope, at test 57 min, the values of W1-2 and W1-3 increased first, followed by W1-1, indicating that the rainfall had infiltrated to the soil-rock interface and that the water content of the soil near the interface began to increase. Subsequently, the growth rate of W1-1, W1-2, and W1-3 values continued to increase. The values increased sharply and peaked within 135-159 min. This indicates that the soil water content at the soil-rock interface rises rapidly and the soil becomes saturated in a short period of time. The sensors within the weathered layer did not begin to respond until test 267 min, and the rate of increase in W2-1, W2-2, and W2-3 values was consistently low. At the end of the test, the largest increase in sensor value was only 3.38%. This suggests that rainfall has a minimal impact on the weathered layer. (2) For the E2 slope, at test 54 min, the values of W1-3, W1-2, and W1-1 commenced an incremental ascent in turn, signifying that the rainfall infiltration had reached 10 cm depth at that moment. At test 111 min, the W2-3 value began to increase, followed by W2-2 and W2-1. This indicates that the rainfall had infiltrated at the soil-rock interface. The values of W2-1, W2-2, and W2-3 increased sharply, and their growth rate was much higher than that of the sensors buried at the 10 cm depth within the slope. The values of W1-1, W1-2, and W1-3 remained stable after 285 min, 279 min, and 249 min, respectively. This indicates that the soil at 20 cm depth had reached saturation. At test 273 min, the W1-3 value showed a pronounced increase, suggesting that the rate of soil water content increase at the 10 cm depth at the foot of the slope was considerably more rapid. This is due to the fact that rainwater continues to collect at the slope toe under the influence of seepage within the slope. As the rainfall continued, the soil water content at the foot of the slope eventually became significantly higher than that at the top and middle of the slope, reaching saturation at test 291 min. (3) For the E3 slope, at test 60 min, the infiltration of rainwater into the 10 cm depth resulted in a sequential increase in the values of W1-1, W1-3, and W1-2. At test 138 min, the W2-3 value began to increase, indicating that rainwater infiltrated to the 20 cm depth at the foot of the slope. This was followed by a sequential increase in the values of W2-1 and W2-2. At test 258 min, the W1-2 value showed a significant increasing trend, indicating a swift rise in soil water content at 10 cm depth at the middle of the slope. The reason for this phenomenon is that the crack at the middle of the slope provides easy access for rainfall infiltration, and rainwater infiltrates rapidly in the form of crack-preferential flow. The peak values of W1-3, W1-1, and W1-2 were observed at 288, 303, and 321 min of the test, respectively, indicating that the soil was nearly saturated at 10 cm depth.

**Figure 9.** Water content-time curves. (a) E1 slope. (b) E2 slope. (c) E3 slope.

The response time of the water content at 10 cm depth was similar for three slopes. This is due to the fact that at the early stage of rainfall, rainwater mainly infiltrated vertically into the shallow surface layer of the slope in the form of homogenous flow. The rate of increase in water content at 10 cm depth was significantly greater on the E1 slope than on the E2 and E3 slopes. The phenomenon is attributed to the infiltration of rainwater into the weathered layer, which has a low permeability. Moisture is prevented from entering the weathered layer due to the effect of capillary force (Wu and

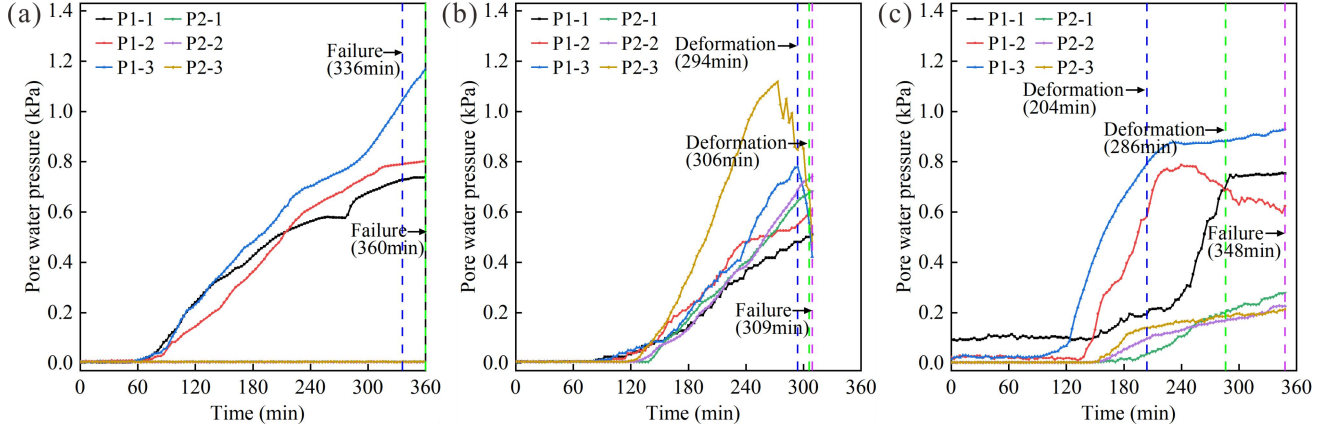
The pore water pressure-time curves are presented in Fig. 10. In general, the pore water pressure change curves exhibit a similar overall trend to the water content change curves. This is due to the fact that the change in pore water pressure is primarily influenced by the soil water content. Furthermore, a partial asynchrony stage has been observed in the changes in pore water pressure and water content, and this has been attributed to the influence of soil deformation on the change in pore water pressure (Iverson et al. 1997). (1) For the E1 slope, the P1-1 value exhibited a slight decline at test 261 min, followed by a rapid increase at test 273 min. This phenomenon may be attributed to the loss of fine particles in soil at the top of the slope, which results in the hollowing out of the soil skeleton, composed of coarse particles. The reclosure of the pore subsequent to the collapse of the skeleton resulted in a sudden increase in pore water pressure. The P1-3 value continued to rise. This is due to the fact that the accumulation of fine particles at the foot of the slope results in pore obstruction, thereby impeding drainage at this location. Consequently, the pore water pressure continues to increase, resulting in damage failure at the foot of the slope. (2) For the E2 slope, the P2-3 value decreased significantly at test 273 min, preceding the deformation observed, indicating that significant deformation damage occurred at 20 cm depth of the foot of the slope first. At test 294 min, the P1-3 decreased significantly, indicating that the crack has developed upwards to 10 cm depth of the foot of the slope. Subsequently, there is a sharp decrease in values of E1-3 and E2-3, indicating that the foot of the slope is approaching instability. (3) For the E3 slope, the P1-2 value continued to increase at test 204 min, when the slope had deformed. This may be due to the fact that granite residual soil in the area exhibits negative dilatancy (Chen et al. 2024). When shear damage occurred on the slope, the pores within the soil became smaller in size, thereby the pore water pressure continued to increase. At test 255 min, the P1-2 value began to decrease, indicating deformation at 10 cm depth at the middle of the slope. The P1-2 curve exhibited frequent fluctuations, with the value first increasing and subsequently decreasing. It's a sign of slow deformation. The creation of cracks within the slope leads to a decrease in pore water pressure, which is then restored by rainfall infiltration, a cycle that is repeated repeatedly.

**Figure 10.** Pore water pressure-time curves. (a) E1 slope. (b) E2 slope. (c) E3 slope.

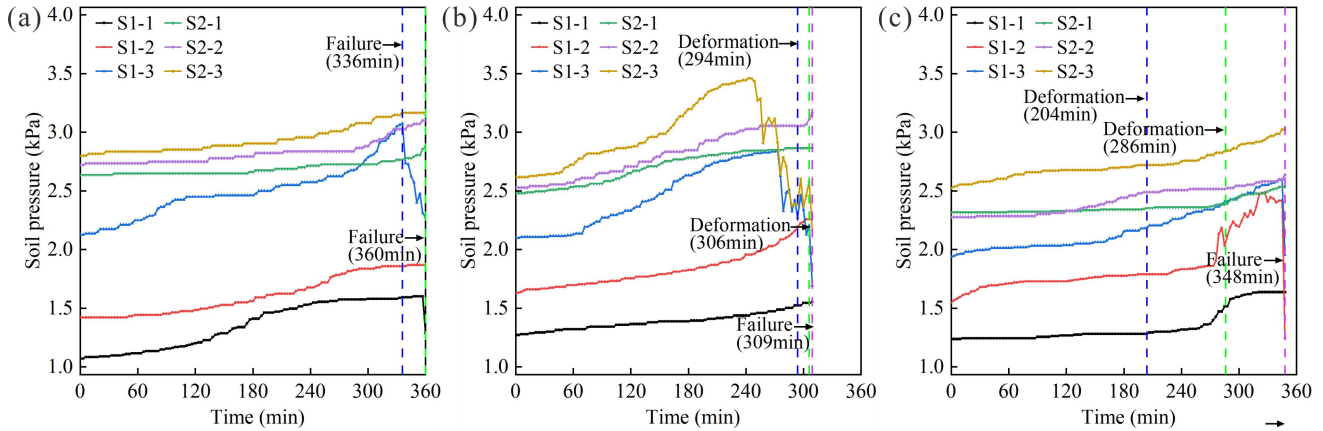
In this test, the soil pressure sensor probe was placed perpendicular to the soil surface upward. This embedding method

can monitor the change in the sliding thrust of the upper rock and soil mass (Nian et al. 2023). Rainfall infiltration increases the slope's self-weight, leading to an increase in the sliding thrust. Therefore, the soil pressure-time curves show an overall increasing trend. (1) For the E1 slope, the largest increase in the S1-3 value indicates that the landslide thrust increases the most at 10 cm depth at the foot of the slope and that the slope is most vulnerable to damage at that location. The S1-3 value continued to decrease after the damage occurred, indicating that the deformation damage at 10 cm depth at the foot of the slope still continued. (2) For the E2 slope, the trend of the soil pressure curve responds to the slope deformation and damage characteristics consistent with the pore water pressure, which will not be repeated here. Notably, the decrease in S2-3 value is greater than that of S1-3, indicating that the sliding thrust at a depth of 20 cm at the foot of the slope decreases more. This suggests that the degree of deformation of the deeper soils at the foot of the slope is greater than that of the shallower soils. (3) For the E3 slope, the S1-2 value increased significantly at test 273 min. This is due to the fact that water starts to fill in the crack, thereby exerting a hydrostatic pressure on the slope that significantly increases the sliding thrust. When the sliding thrust reaches a certain magnitude, a landslide will occur.

**Figure 11.** Soil pressure-time curves. (a) E1 slope. (b) E2 slope. (c) E3 slope.

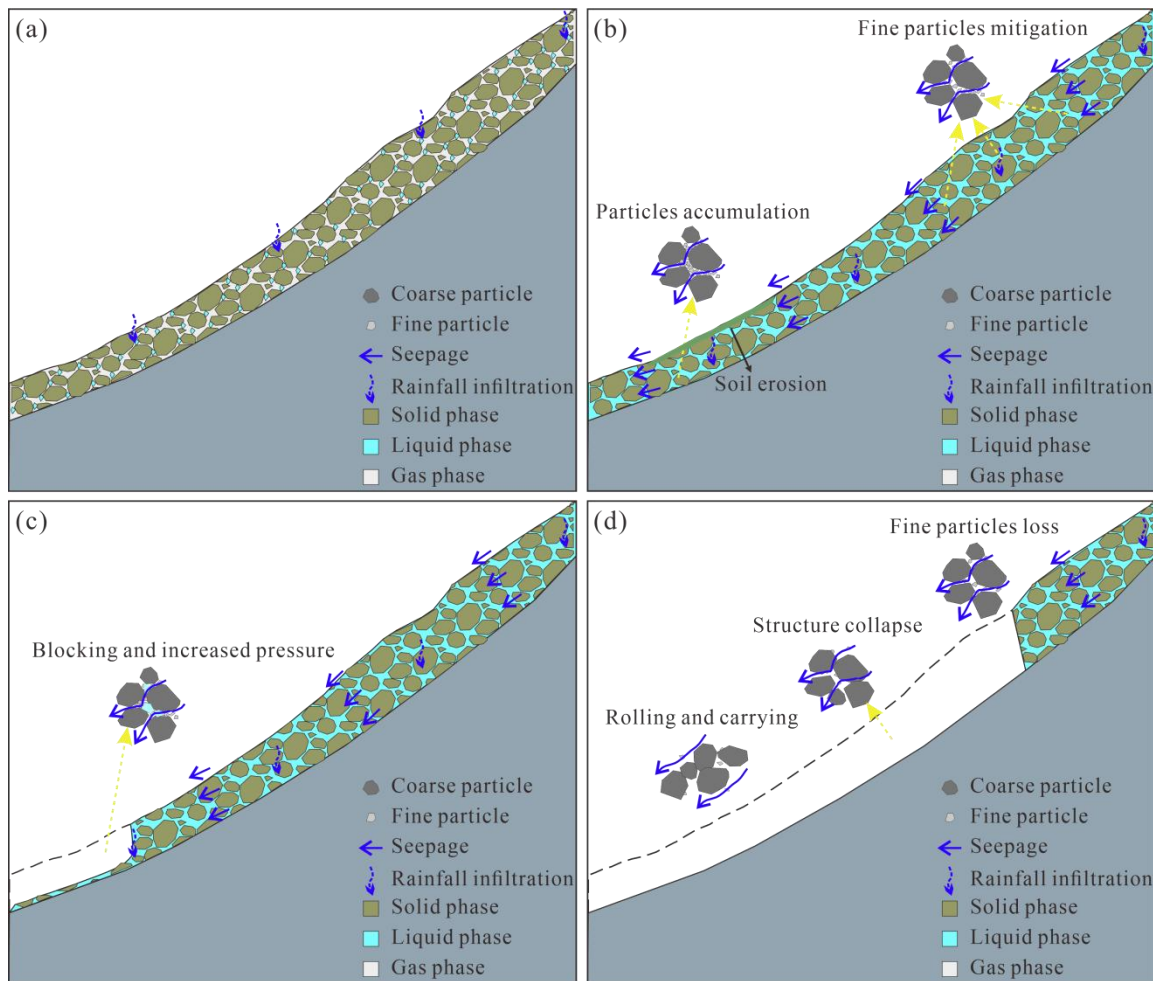
a. *Rainfall infiltration.* At the beginning of rainfall, rainfall infiltration into the slope increases the soil water content. There is no evident deformation damage, and surface runoff occurred on the slope.

b. *runoff and seepage.* As rainfall continues, the soil water content of the residual layer gradually increases and reaches saturation. Concurrently, the weathered layer impedes the rainwater infiltration. At this point the rainfall infiltration

capacity is reduced, and a proportion of the rainfall is converted into surface runoff. Low-lying areas and gullies are generated by the erosion of surface runoff and splash erosion of rainfall. Erosion damage is most severe at the foot and middle of the slope. Seepage occurs within the residual layer, with the water flow creating seepage force within the soil. Granite residual soil is poorly graded and susceptible to suffosion under seepage. Fine particles in the soil are transported with the water flow and accumulate at the foot of the slope.

c. *Localized Failure*. As fine particles continue to collect at the foot of the slope, the pores in the soil are blocked. This will make drainage at the foot of the slope difficult, and excess pore water pressure occurs at this location. The effective stress in the soil is lost, leading to a reduction in its resistance to deformation and localized damage at the foot of the slope.

d. *Overall failure*. As the soil continues to be subjected to suffosion, the fine particles in the soil are continuously lost. It is difficult for the soil to maintain its structure, and in turn the soil skeleton collapses. Soils with lost structure are prone to disintegration under seepage. At this time, the support at the foot of the slope has been lost, and the soil of the disintegration moves downslope under water flow, showing a wide range of flow-slip failure without an obvious sliding surface.

**Figure 12.** Schematic diagram of E1 slope instability. (a) Rainfall infiltration. (b) Runoff and seepage. (c) Local failure. (d) Overall failure.

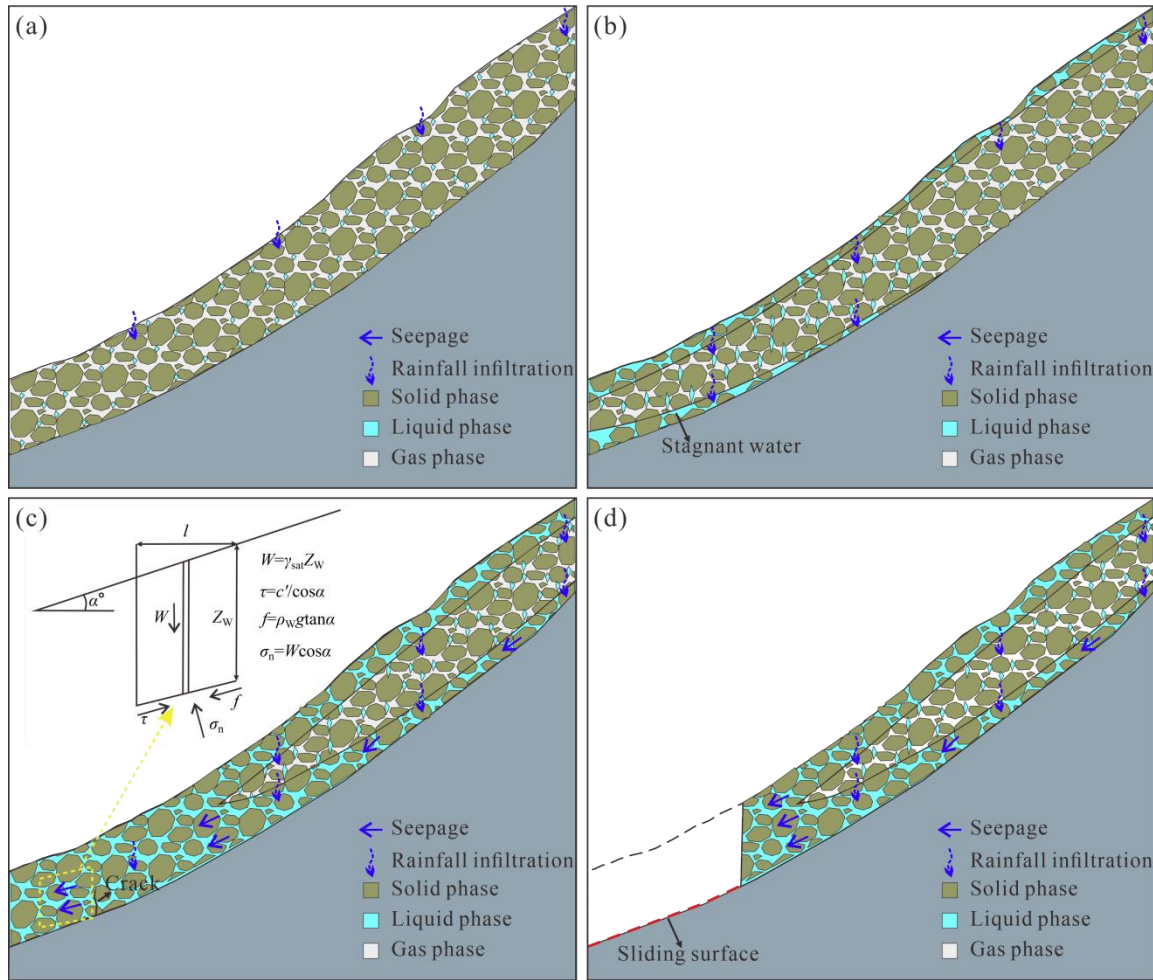
a. *rainfall infiltration*. At the beginning of rainfall, rainfall infiltration into the slope increases the soil water content. There is no evident deformation damage, and surface runoff occurred on the slope.

b. *stagnant water*. As rainfall continues, shallow soil water content gradually increases and becomes saturated, and a saturated zone occurs. When rainfall infiltrates into the soil-rock interface, the underlying weathered layer has weak water permeability and is easy to form a relatively impermeable layer. Rainwater accumulates at the soil-rock interface, forming a saturated zone. The diffusion rate of this saturated zone is greater than that of the shallow surface layer. The soil is softened at this location, thus forming a plane of weakness.

c. *critical sliding*. Rainwater always flows towards the foot of the slope under gravity, saturating the residual layer at this location. Due to the large difference in permeability between the residual layer and the weathered layer, it is easy to generate strong seepage along the soil-rock interface. At this time, the sliding mode of the slope is traction and drag, and deformation tends to occur first at the soil-rock interface. Considering the role of hydrodynamic pressure, the calculation formula for the slope stability factor can be expressed as follows:

d. *landslide occurrence*. When the driving force is greater than the resisting force, the slope occurs generally in a translational slide at the soil-rock interface.

**Figure 13.** Schematic diagram of E2 slope instability. (a) Rainfall infiltration. (b) Stagnant water. (c) Critical sliding. (d) Landslide occurrence.

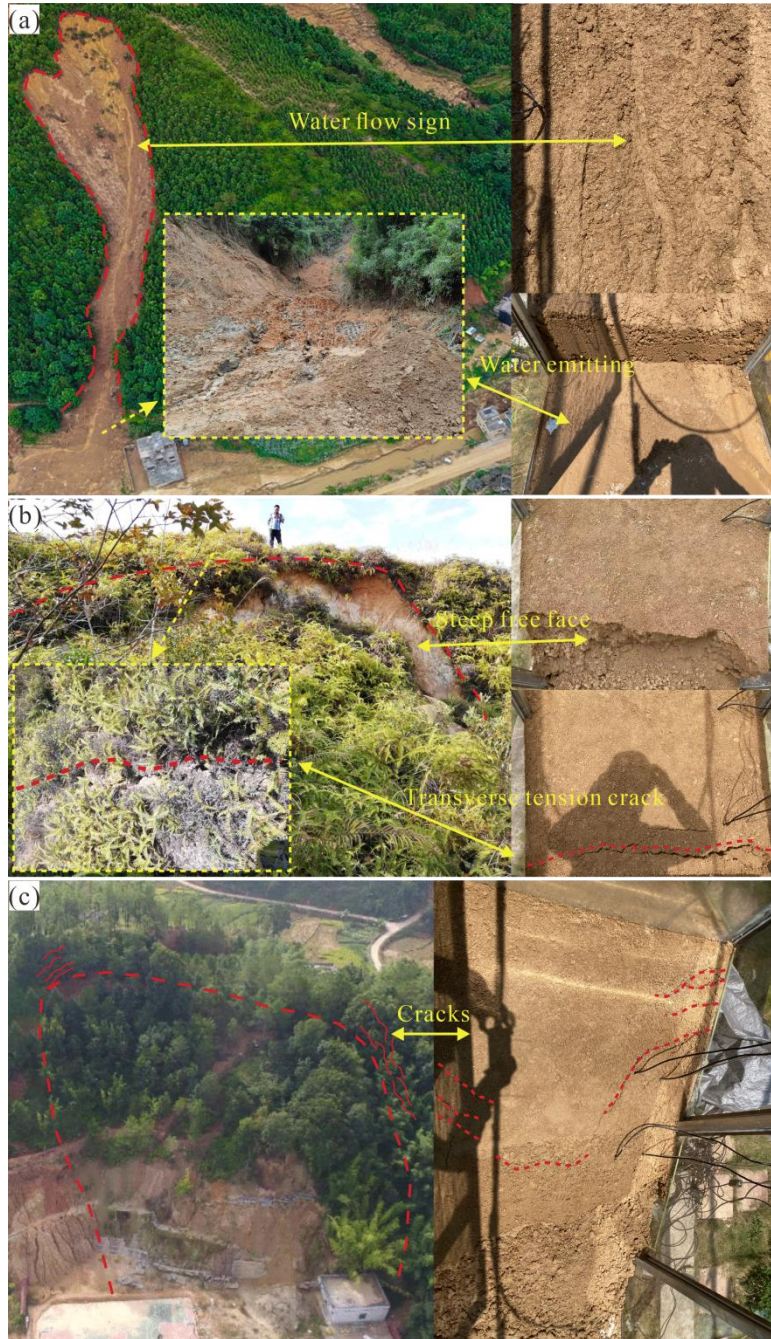
This study was conducted based on model tests, and the model materials utilized were collected in the field and are considered to be remodeled samples. It should be noted that the constructed slope model may differ somewhat from the actual situation, which may result in limited practical usability of the results of this research. Consequently, this study investigated the correspondence between the actual residual layer thickness and landslides, as well as analyzed the consistency between the findings and the model test results. (1) For the E1 slope, the slopes show clear water flow signs.

The water content of the landslide accumulation mass is very high, essentially saturated with water-emitting phenomena. (2) For the E2 slope, the trailing edge of landslides has no cracks other than the transverse tension cracks, which is because the slope deformation starts from a deeper layer. The landslides generate steep free faces due to traction-stagger deformation. (3) For the E3 slope, the number and distribution of tensile cracks at the trailing edge of the landslides are large, which are formed during the downward deformation of the slopes. It is evident that this test accurately replicates the destabilization of granite weathered crust slopes with different residual layer thicknesses.

**Figure 15.** Comparison of Mibei landslides deformation with model tests. (a) E1 slope. (b) E2 slope. (c) E3 slope.
