# Experimental study on granite weathered crust landslides with different residual layer thicknesses under heavy rainfall

**Abstract.** Landslides are frequent in the granite areas during rainfall. The hydrological response and deformation damage mechanisms of granite weathered crust slopes were investigated by physical model tests. The variability of the material with respect to the thickness of the residual layer was taken into account. The results show that the three types of slopes exhibit distinct disaster mechanisms. For the E1 slope (10 cm residual layer), the residual layer was rapidly saturated, and seepage was formed. The residual soil was susceptible to severe suffosion, and an overall flow-slip failure occurred with no obvious sliding surface. For the E2 slope (20 cm residual layer), rainfall infiltrated the soil-rock interface, forming a temporary water table at this location. The slope tended to slide along the soil-rock interface at the foot of the slope under the traction and drag of water flow. For the E3 slope (30 cm residual layer), rainfall failed to infiltrate the interface, and no seepage was observed within the slope. The slope gradually slides within the re

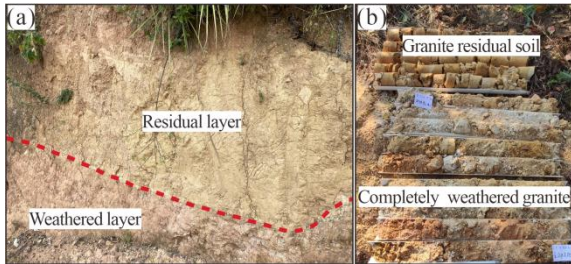
**Figure 2.** Geological condition of the study area. (a) Stratigraphic structure. (b) Drill core samples.

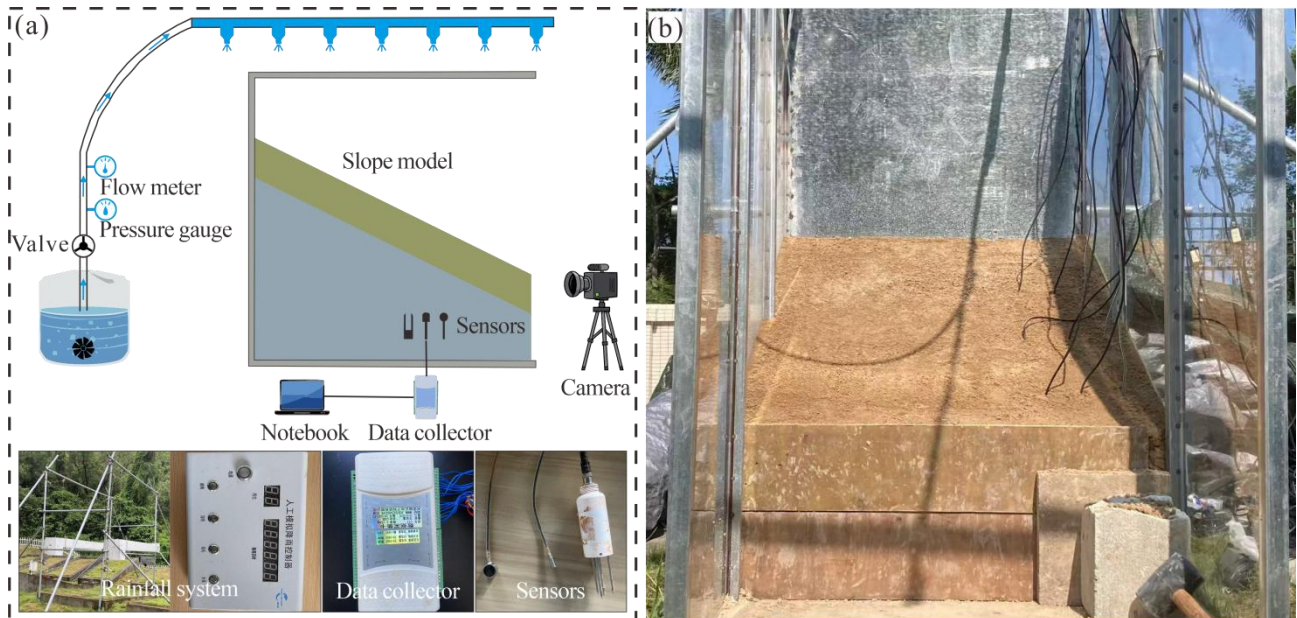
**Figure 3. (a) Slope model test platform. (b) Constructed slope model.**

The slope physical model test platform is comprised of a model box, a rainfall system, and a data acquisition system (Fig. 3a). The dimension of the model box is 2 m × 1 m × 1.8 m (length × width × height), and it is constructed with Plexiglas and steel columns. Grid lines have been drawn on the Plexiglas sidewalls to provide coordinate reference and datum control. The EL-RS3/5 mobile artificial rainfall simulation system produced by the Beijing ECO-LEADER company consists of a rainfall machine, a water supply system, and a control system. Its effective rainfall area is 5 m × 3 m (length × width), with the rainfall uniformity coefficient greater than 0.9. The data acquisition system mainly consists of water content sensors, pore water pressure sensors, soil pressure sensors, and a data collector, which are produced by Xi'an

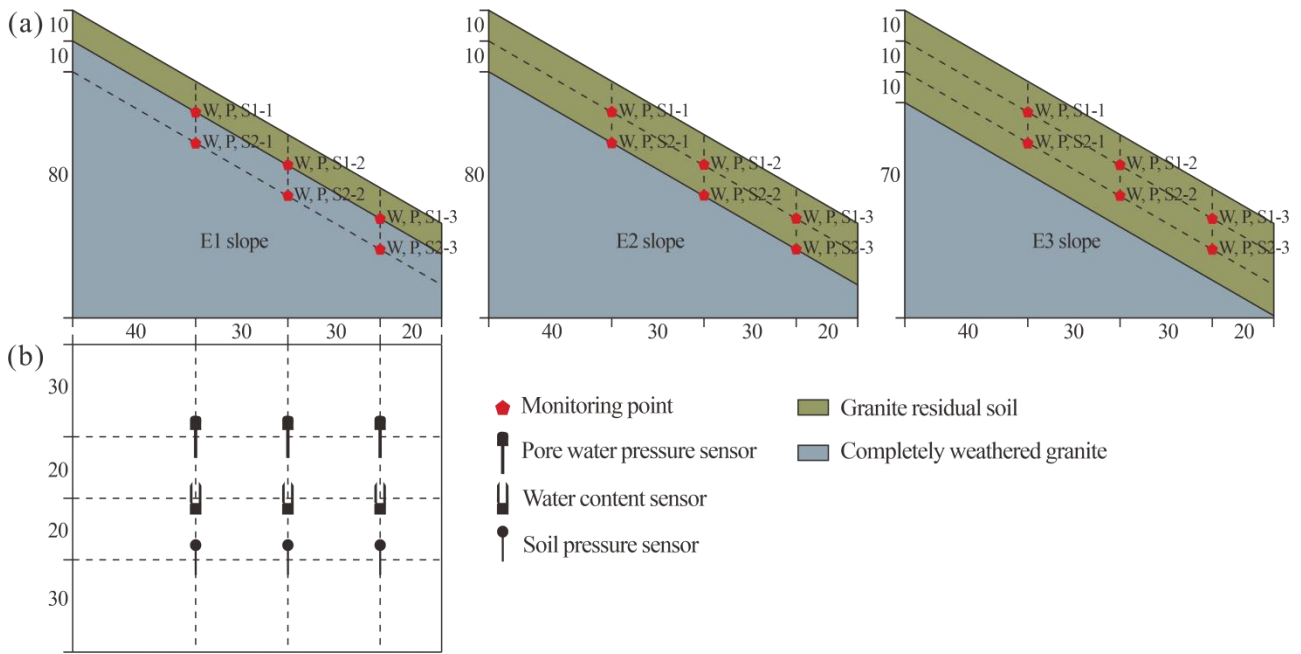
**Figure 4.** Schematic diagram of slope dimension and sensor buried position (unit: cm). **(a)** Side view. **(b)** Top view.

Weizheng Electronic Technology Company. Two layers of sensors were buried at the foot, middle, and top of the slope, respectively, and the specific location is shown in Fig. 4. The sensor data are transferred to the notebook at a frequency of 3 min via the data collector. The deformation damage characteristics of slopes are recorded using the camera.

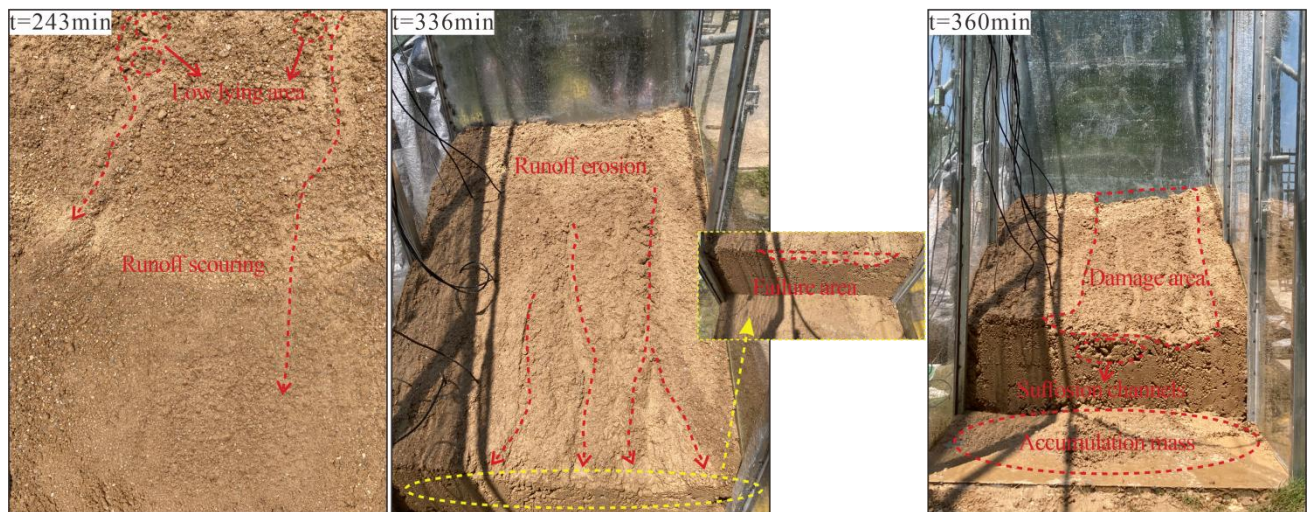
Figure 5. Deformation and failure process of the E1 slope.

Figure 5 shows the failure process of the E1 slope. As illustrated in the figure, at test 243 min, a small range of low-lying areas was observed on the slope. As rainfall persisted, the residual layer gradually became saturated, and runoff was generated on the slope. The low-lying areas on the slope surface gradually developed into fine gullies as a result of runoff scouring. At test 336 min, the phenomenon of slip-collapse was observed at the foot of the slope. The initial fine gullies, subjected to the continuous action of seepage and erosion, ultimately evolved into erosion trenches of a certain depth and width. At test 360 min, extensive damage occurred at the top of the slope, with soil moving with the water flow and eventually accumulating at the foot of the slope. The accumulation mass exhibited looseness, high water content, and mobility. The slope showed an overall flow-slip damage with no obvious sliding surface. The suffusion channels were observed at the foot of the slope.

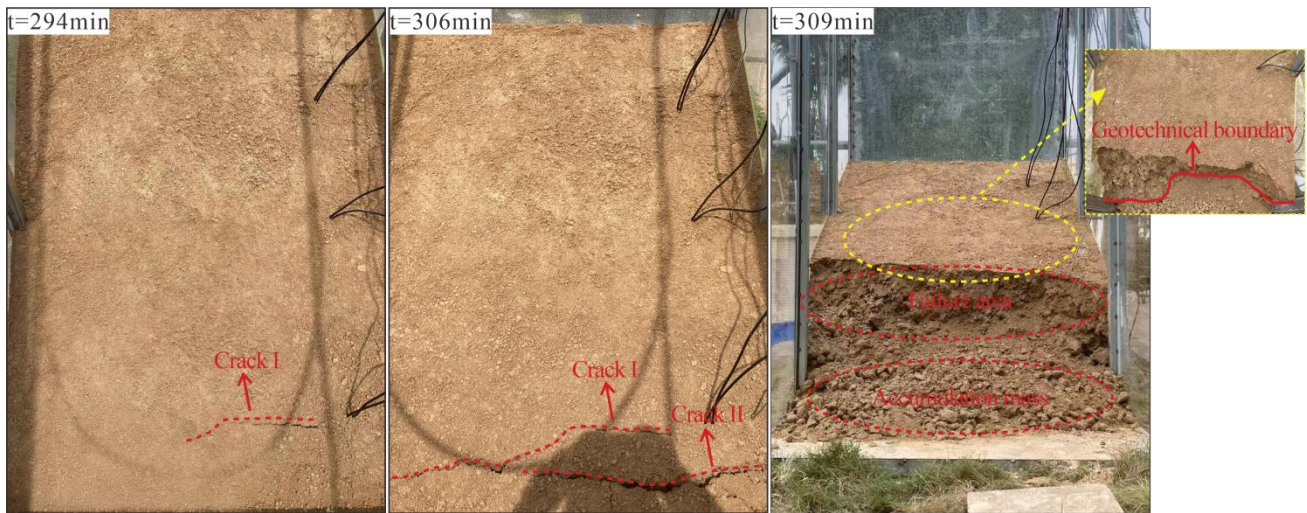
**Figure 6.** Deformation and failure process of the E2 slope.

Figure 6 shows the failure process of the E2 slope. As illustrated in the figure, at test 294 min, the transverse crack I was observed at the foot of the slope. The formation of the crack is attributed to the continuous flow of rainwater towards the foot of the slope, thereby weakening the soil's resistance to deformation. At test 306 min, the soil body at the foot of the slope exhibited horizontal movement, resulting in uneven settlement of approximately 3 cm of downward misalignment and transverse crack II. The crack II ran almost from the middle to the right border, and the crack I had extended to the left border. These two cracks almost traversed the whole slope. At test 309 min, the slope slid along crack I and crack II. The trailing edge of the landslide was located at the foot of the slope, and the sliding surface was positioned at the soil-rock interface. It took only 15 min for the landslide to happen after the appearance of the crack at the foot of the slope. This landslide exhibited sudden sliding characteristics.

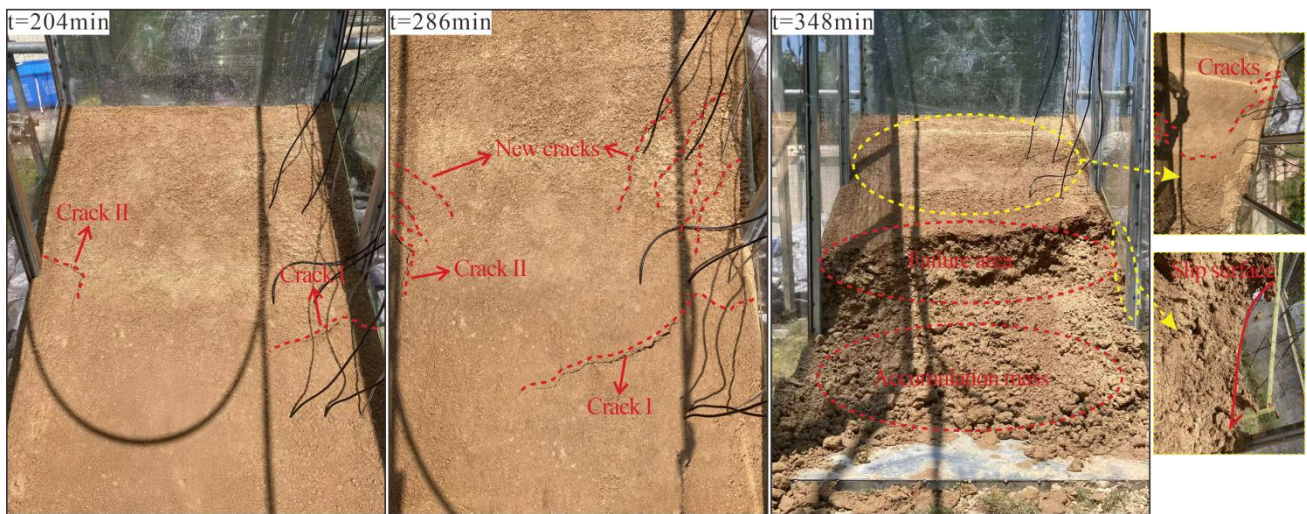
**Figure 7.** Deformation and failure process of the E3 slope.

Figure 7 shows the failure process of the E3 slope. As illustrated in the figure, at test 204 min, crack I and crack II were observed at the middle of the slope. These are the tensile cracks caused by uneven settlement of the slope caused by rainfall infiltration. With the infiltration of rainfall, the overall downward deformation of the slope increased, and the slope underwent a shear and tension effect. At test 286 min, crack I was extended and expanded in the lower left direction. New cracks appeared at the top of the slope, arranged in a feathery pattern. At test 348 min, the slope slid along the crack I. The sliding surface exhibited a circular arc shape, and the depth of the landslide was about 23 cm. There were multiple cracks appearing on the slope during the process.

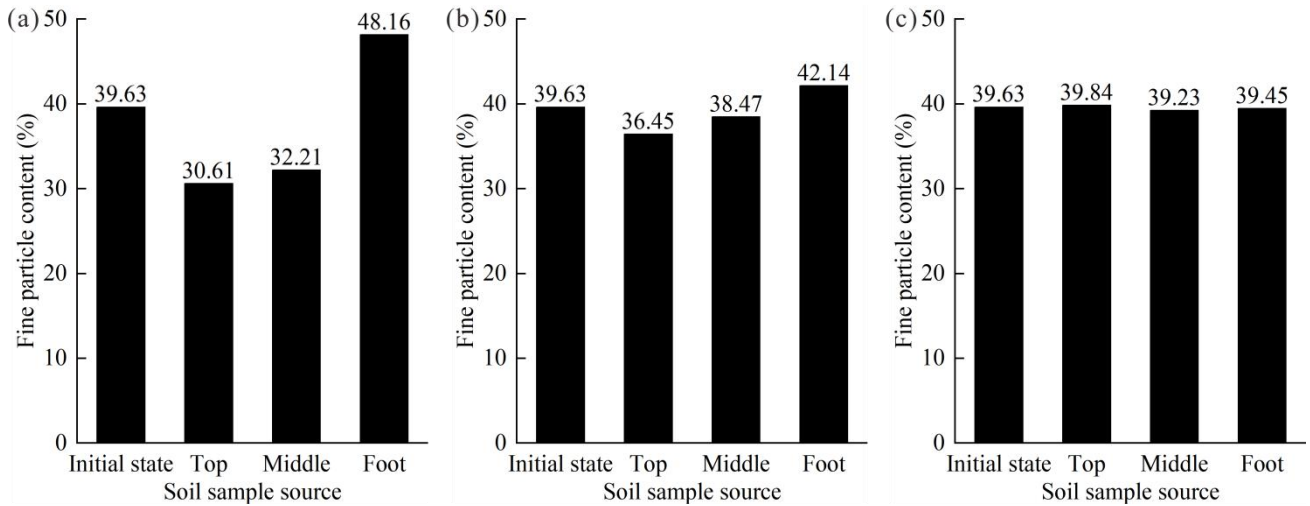
**Figure 8.** Fine particle content at different positions of slopes with different tests. (a) E1 slope. (b) E2 slope. (c) E3 slope.

In the case of rainfall-induced landslides, it is common for turbid runoff to carry sediment downhill and pile up at the foot of the slope. The phenomenon is essentially particle migration (Lu et al. 2011; Cui et al. 2014). The residual soil lacks intermediate particle size. The coarse particles form the skeleton of the soil, and the fine particles are attached to the skeleton particles as a cement-like substance (Liu et al. 2021). This makes the fine particles able to be carried by water flow and move through the skeleton pore. It is difficult to make direct observations inside the slope without the aid of specialized equipment. In this study, samples were obtained from the top, middle, and foot of the slope of the three groups using a cutting ring. The locations of the samples correspond with the depth of the sliding surface. The fine particles (particle size less than 0.075 mm) in the soil were measured by the particle gradation test, which was then compared with the initial fine particle content. The fine particle content at each location of the slopes at the end of the tests is shown in Fig. 8. It can be seen that there is a large difference in the fine particle content at each location of the E1 slope. The loss of fine particles was most severe at the top of the slope, with a reduction from an initial 39.63% to 30.61%. The loss of fine particle content in the middle of the slope was then 7.42%. Concurrently, the fine particle content at the foot of the slope increased by 8.53% (Fig. 8a). This indicates that the interior of the slope was undergoing a process of fine particle loss, with the lost portion undergoing longitudinal migration and eventual accumulation at the foot of the slope. The fine particle content of the E2 slope exhibited a 3.18% decrease at the top of the slope, a 1.16% decrease at the middle of the slope, and a 2.51% increase at the foot of the slope (Fig. 8b). The E2 slope has been observed to exhibit a substantial reduction in fine particle loss in comparison to the E1 slope. The fine particle content is nearly identical at all locations in the E3 slope (Fig. 8c). The movement of fine particles in soils of the same type is primarily influenced by in-slope seepage (Wang et al. 2024). It can be seen that seepage is most pronounced on the E1 slope, with no observable seepage

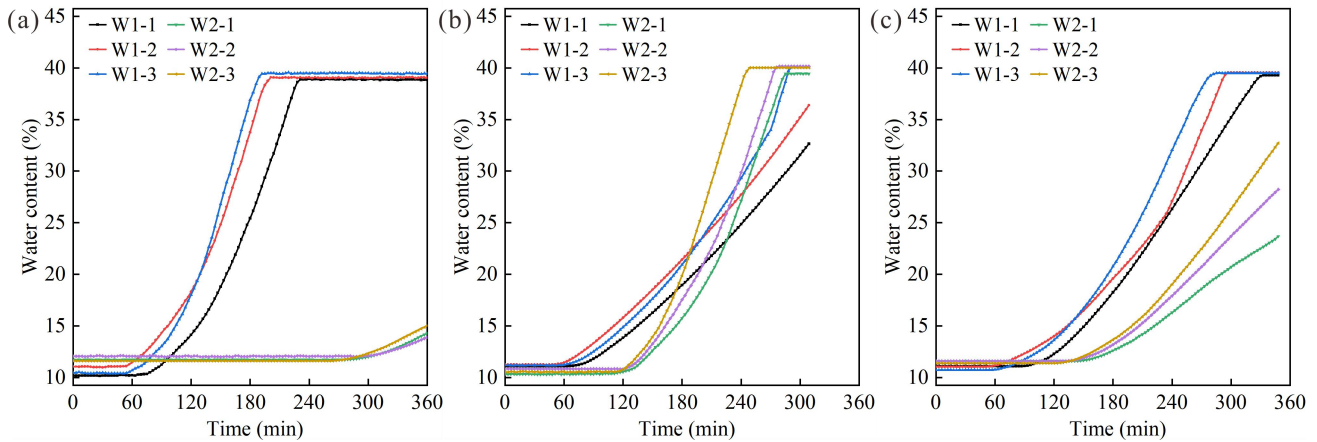
**Figure 9.** Water content-time curves. (a) E1 slope. (b) E2 slope. (c) E3 slope.

The water content-time curves are presented in Fig. 10. (1) For the E1 slope, at test 57 min, the values of W1-2 and W1-3 increased first, followed by W1-1, indicating that the rainfall had infiltrated to the soil-rock interface and that the water content of the soil near the interface began to increase. Subsequently, the growth rate of W1-1, W1-2, and W1-3 values continued to increase. The values increased sharply and peaked within 135-159 min. This indicates that the soil water content at the soil-rock interface rises rapidly and the soil becomes saturated in a short period of time. The sensors within the weathered layer did not begin to respond until test 267 min, and the rate of increase in W2-1, W2-2, and W2-3 values was consistently low. At the end of the test, the largest increase in sensor value was only 3.38%. This suggests that rainfall has a minimal impact on the weathered layer. (2) For the E2 slope, at test 54 min, the values of W1-3, W1-2, and W1-1 commenced an incremental ascent in turn, signifying that the rainfall infiltration had reached 10 cm depth at that moment. At test 111 min, the W2-3 value began to increase, followed by W2-2 and W2-1. This indicates that the rainfall had infiltrated at the soil-rock interface. The values of W2-1, W2-2, and W2-3 increased sharply, and their growth rate was much higher than that of the sensors buried at the 10 cm depth within the slope. The values of W1-1, W1-2, and W1-3 remained stable after 285 min, 279 min, and 249 min, respectively. This indicates that the soil at 20 cm depth had reached saturation. At test 273 min, the W1-3 value showed a pronounced increase, suggesting that the rate of soil water content increase at the 10 cm depth at the foot of the slope was considerably more rapid. This is due to the fact that rainwater continues to collect at the slope toe under the influence of seepage within the slope. As the rainfall continued, the soil water content at the foot of the slope eventually became significantly higher than that at the top and middle of the slope, reaching saturation at test 291 min. (3) For the E3 slope, at test 60 min, the infiltration of rainwater into the 10 cm depth resulted in a sequential increase in the values of W1-1, W1-3, and W1-2. At test 138 min, the W2-3 value began to increase, indicating that rainwater infiltrated to the 20 cm depth at the foot of the slope. This was followed by a sequential increase in the values of W2-1 and W2-2. At test 258 min, the W1-2 value showed a significant increasing trend, indicating a swift rise in soil water content at 10 cm depth at the middle of the slope. The reason for this phenomenon is that the crack at the middle of the slope provides easy access for rainfall infiltration, and rainwater infiltrates rapidly in the form of crack-preferential flow. The peak values of W1-3, W1-1, and W1-2 were observed at 288, 303, and 321 min of the test, respectively, indicating that the soil was nearly saturated at 10 cm depth.

The response time of the water content at 10 cm depth was similar for three slopes. This is due to the fact that at the early stage of rainfall, rainwater mainly infiltrated vertically into the shallow surface layer of the slope in the form of homogenous flow. The rate of increase in water content at 10 cm depth was significantly greater on the E1 slope than on the E2 and E3 slopes. The phenomenon is attributed to the infiltration of rainwater into the weathered layer, which has a low permeability. Moisture is prevented from entering the weathered layer due to the effect of capillary force (Wu and Wang 2025). Besides, the permeability coefficient of the residual soil is an order of magnitude higher than that of the completely weathered granite. It is very easy for violent horizontal seepage to occur at the geotechnical interface with large permeability differences (Wang et al. 2019). Consequently, the rainwater infiltration rate at the soil-rock interface is greatly reduced, resulting in the stagnant water phenomenon. Rainwater tends to flow along the interface. The above

phenomenon has also been observed when the rainfall infiltrates to the 20 cm depth within the E2 slope. Notably, the rate of increase in water content was greater at 20 cm depth than at 10 cm depth, which is related to the nature of the residual soil. The residual soil in the study area is weathered from monzonitic granite and contains significant amounts of clay minerals. When saturated with water, clay minerals tend to form a water film of a certain thickness on their surface, thereby reducing the soil permeability (Ma et al. 2025). The rate of rainfall infiltration on the slope will be greatly reduced, resulting in a lower amount of infiltration than discharge. Rainwater accumulates at the soil-rock interface along the penetrating seepage channels, thus forming a temporary water table. The water table gradually rises, and the soil water content in the vicinity of the interface increases at a faster rate than that of soil above the interface. Rainfall on the E3 slope continued to infiltrate downward, and the growth range of sensor values buried at 20 cm depth was slower than that at 10 cm depth. This shows that the rate of water content growth at 20 cm depth was significantly slower than that at 10 cm depth. It is because the transport of infiltrating rainwater to greater depths is affected by the unsaturated permeability of the soil at the wetting front, where the soil is still in the state of initial matrix suction and hinders the vertical downward movement of water (Rahardjo et al. 2005).

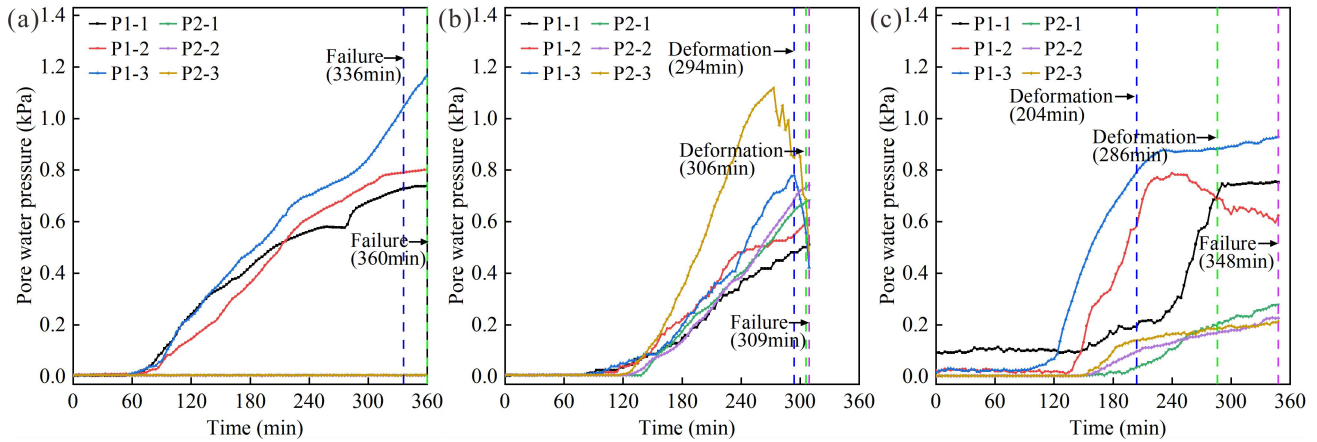
**Figure 10.** Pore water pressure-time curves. (a) E1 slope. (b) E2 slope. (c) E3 slope.

The pore water pressure-time curves are presented in Fig. 10. In general, the pore water pressure change curves exhibit a similar overall trend to the water content change curves. This is due to the fact that the change in pore water pressure is primarily influenced by the soil water content. Furthermore, a partial asynchrony stage has been observed in the changes in pore water pressure and water content, and this has been attributed to the influence of soil deformation on the change in pore water pressure (Iverson et al. 1997). (1) For the E1 slope, the P1-1 value exhibited a slight decline at test 261 min, followed by a rapid increase at test 273 min. This phenomenon may be attributed to the loss of fine particles in soil at the top of the slope, which results in the hollowing out of the soil skeleton, composed of coarse particles. The reclosure of the pore subsequent to the collapse of the skeleton resulted in a sudden increase in pore water pressure. The P1-3 value continued to rise. This is due to the fact that the accumulation of fine particles at the foot of the slope results in pore obstruction, thereby impeding drainage at this location. Consequently, the pore water pressure continues to increase, resulting in damage failure at the foot of the slope. (2) For the E2 slope, the P2-3 value decreased significantly at test 273 min, preceding the deformation observed, indicating that significant deformation damage occurred at 20 cm depth of the foot of the slope first. At test 294 min, the P1-3 decreased significantly, indicating that the crack has developed upwards to 10 cm depth of the foot of the slope. Subsequently, there is a sharp decrease in values of E1-3 and E2-3, indicating that the foot of the slope is approaching instability. (3) For the E3 slope, the P1-2 value continued to increase at test 204 min, when the slope had deformed. This may be due to the fact that granite residual soil in the area exhibits negative dilatancy (Chen et al. 2024). When shear damage occurred on the slope, the pores within the soil became smaller in size, thereby the pore water pressure continued to increase. At test 255 min, the P1-2 value began to decrease, indicating deformation at 10 cm depth at the middle of the slope. The P1-2 curve exhibited frequent fluctuations, with the value first increasing and subsequently decreasing. It's a sign of slow deformation. The creation of cracks within the slope leads to a decrease in pore water pressure, which is then restored by rainfall infiltration, a cycle that is repeated repeatedly.

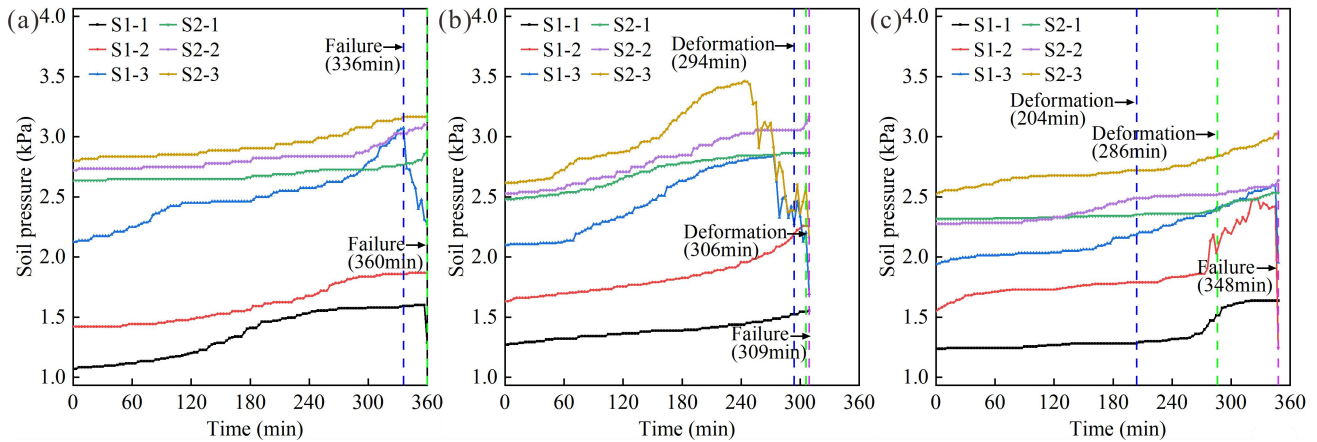
**Figure 11.** Soil pressure-time curves. (a) E1 slope. (b) E2 slope. (c) E3 slope.

In this test, the soil pressure sensor probe was placed perpendicular to the soil surface upward. This embedding method can monitor the change in the sliding thrust of the upper rock and soil mass (Nian et al. 2023). Rainfall infiltration increases the slope's self-weight, leading to an increase in the sliding thrust. Therefore, the soil pressure-time curves show an overall increasing trend. (1) For the E1 slope, the largest increase in the S1-3 value indicates that the landslide thrust increases the most at 10 cm depth at the foot of the slope and that the slope is most vulnerable to damage at that location.

The S1-3 value continued to decrease after the damage occurred, indicating that the deformation damage at 10 cm depth at the foot of the slope still continued. (2) For the E2 slope, the trend of the soil pressure curve responds to the slope deformation and damage characteristics consistent with the pore water pressure, which will not be repeated here. Notably, the decrease in S2-3 value is greater than that of S1-3, indicating that the sliding thrust at a depth of 20 cm at the foot of the slope decreases more. This suggests that the degree of deformation of the deeper soils at the foot of the slope is greater than that of the shallower soils. (3) For the E3 slope, the S1-2 value increased significantly at test 273 min. This is due to the fact that water starts to fill in the crack, thereby exerting a hydrostatic pressure on the slope that significantly increases the sliding thrust. When the sliding thrust reaches a certain magnitude, a landslide will occur.

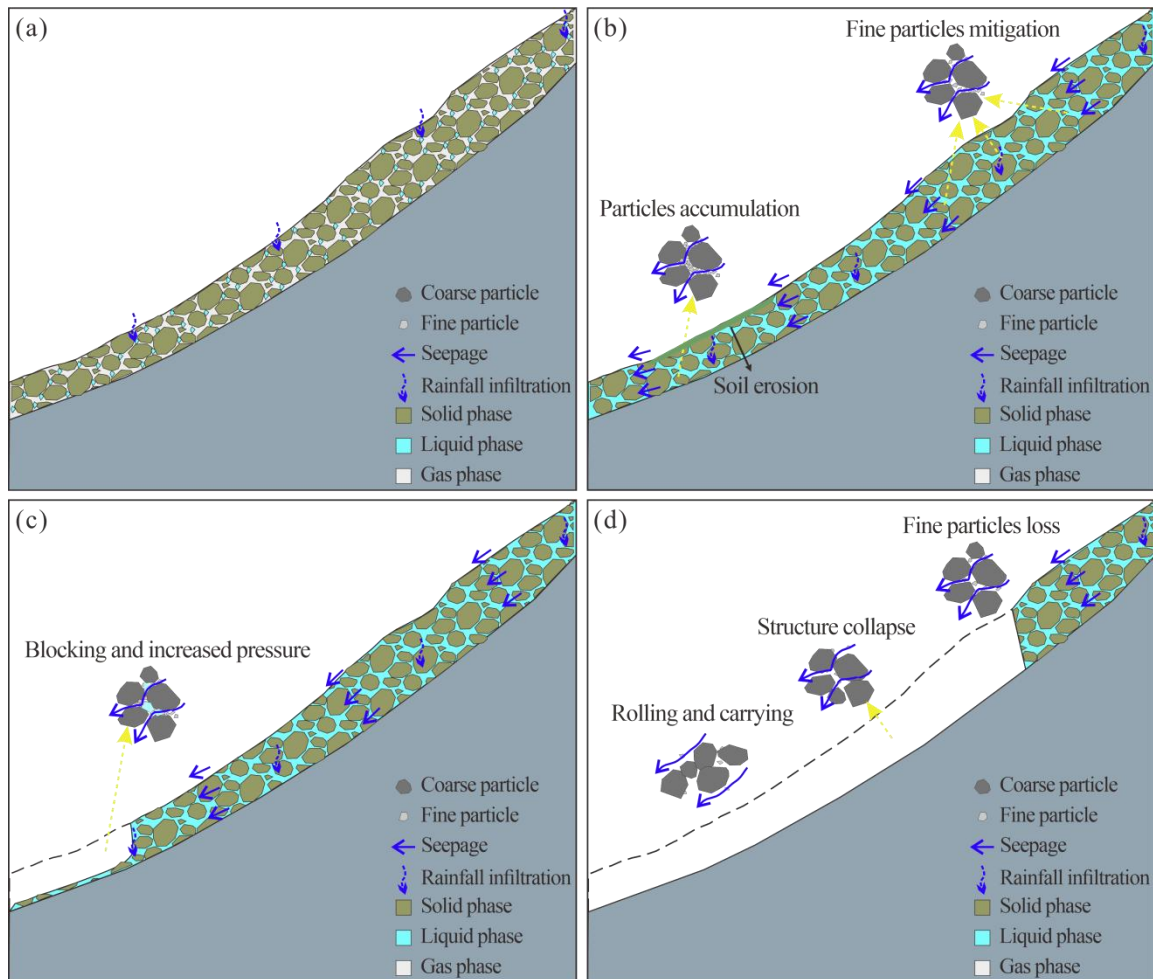
**Figure 12.** Schematic diagram of E1 slope instability. (a) Rainfall infiltration. (b) Runoff and seepage. (c) Local failure. (d) Overall failure.

a. *Rainfall infiltration.* At the beginning of rainfall, rainfall infiltration into the slope increases the soil water content. There is no evident deformation damage, and surface runoff occurred on the slope.

b. *Runoff and seepage.* As rainfall continues, the soil water content of the residual layer gradually increases and reaches saturation. Concurrently, the weathered layer impedes the rainwater infiltration. At this point the rainfall infiltration capacity is reduced, and a proportion of the rainfall is converted into surface runoff. Low-lying areas and gullies are generated by the erosion of surface runoff and splash erosion of rainfall. Erosion damage is most severe at the foot and middle of the slope. Seepage occurs within the residual layer, with the water flow creating seepage force within the soil.

Granite residual soil is poorly graded and susceptible to suffosion under seepage. Fine particles in the soil are transported with the water flow and accumulate at the foot of the slope.

c. *Localized Failure*. As fine particles continue to collect at the foot of the slope, the pores in the soil are blocked. This will make drainage at the foot of the slope difficult, and excess pore water pressure occurs at this location. The effective stress in the soil is lost, leading to a reduction in its resistance to deformation and localized damage at the foot of the slope.

d. *Overall failure*. As the soil continues to be subjected to suffosion, the fine particles in the soil are continuously lost. It is difficult for the soil to maintain its structure, and in turn the soil skeleton collapses. Soils with lost structure are prone to disintegration under seepage. At this time, the support at the foot of the slope has been lost, and the soil of the disintegration moves downslope under water flow, showing a wide range of flow-slip failure without an obvious sliding surface.

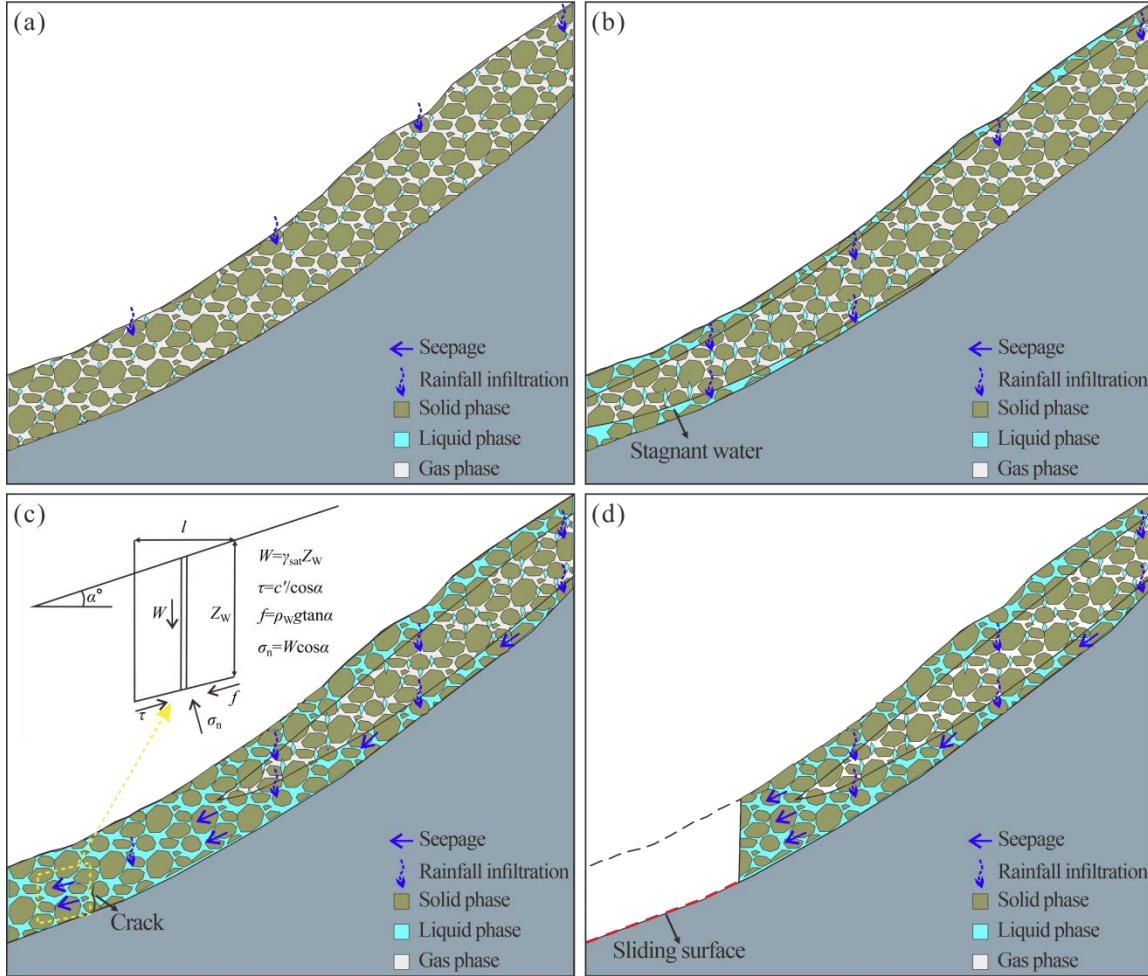
**Figure 13.** Schematic diagram of E2 slope instability. (a) Rainfall infiltration. (b) Stagnant water. (c) Critical sliding. (d) Landslide occurrence.

a. *Rainfall infiltration*. At the beginning of rainfall, rainfall infiltration into the slope increases the soil water content. There is no evident deformation damage, and surface runoff occurred on the slope.

b. *Stagnant water*. As rainfall continues, shallow soil water content gradually increases and becomes saturated, and a saturated zone occurs. When rainfall infiltrates into the soil-rock interface, the underlying weathered layer has weak water permeability and is easy to form a relatively impermeable layer. Rainwater accumulates at the soil-rock interface, forming a saturated zone. The diffusion rate of this saturated zone is greater than that of the shallow surface layer. The soil is softened at this location, thus forming a plane of weakness.

c. *Critical sliding*. Rainwater always flows towards the foot of the slope under gravity, saturating the residual layer at this location. Due to the large difference in permeability between the residual layer and the weathered layer, it is easy to generate strong seepage along the soil-rock interface. At this time, the sliding mode of the slope is traction and drag, and

d. *Landslide occurrence.* When the driving force is greater than the resisting force, the slope occurs generally in a translational slide at the soil-rock interface.

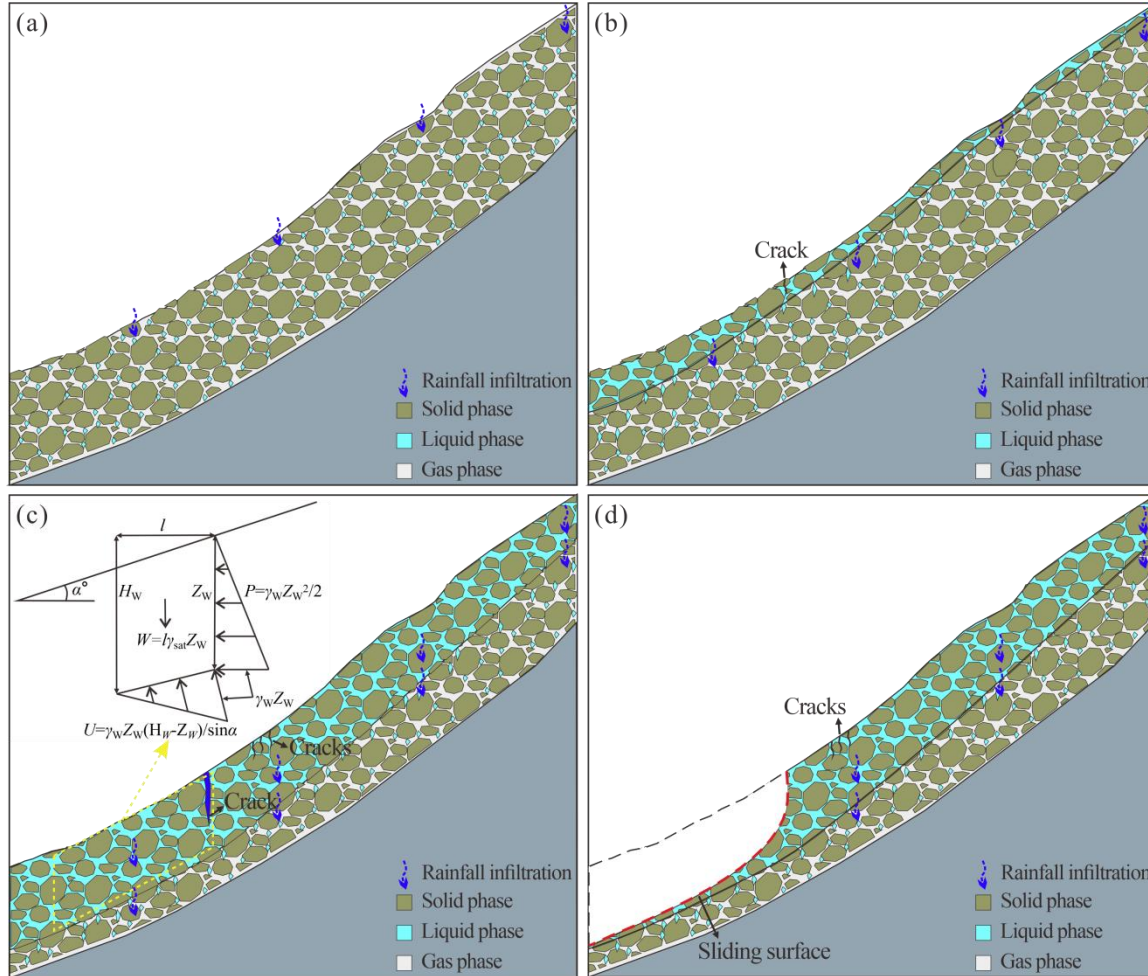
**Figure 14.** Schematic diagram of E3 slope instability. (a) Rainfall infiltration. (b) Crack generation. (c) Critical sliding. (d) Landslide occurrence.

a. *Rainfall infiltration.* At the beginning of rainfall, rainfall infiltration into the slope increases the soil water content. There is no evident deformation damage, and surface runoff occurred on the slope.

b. *Crack generation.* As rainfall continues, shallow soil water content gradually increases and becomes saturated, and a saturated zone occurs. The increase in water content results in a softening of the soil, thereby reducing its strength. Meanwhile, rainfall infiltration increases the driving force on the slope, causing downward creep. Uneven distribution of soil strength leads to crack generation.

c. *Critical sliding.* The crack provides easy access for rainfall infiltration. The accumulation of rainwater within the crack exerts a pressure on the slope, which contributes to the expansion of the cracks. When rainfall is sufficiently adequate, the crack fills with water, creating hydrostatic pressure. At this time, the sliding mode of the slope is characterized by the

d. *Landslide occurrence*. When the driving force is greater than the resisting force, the slope occurs generally in a rotational slide within the residual layer.

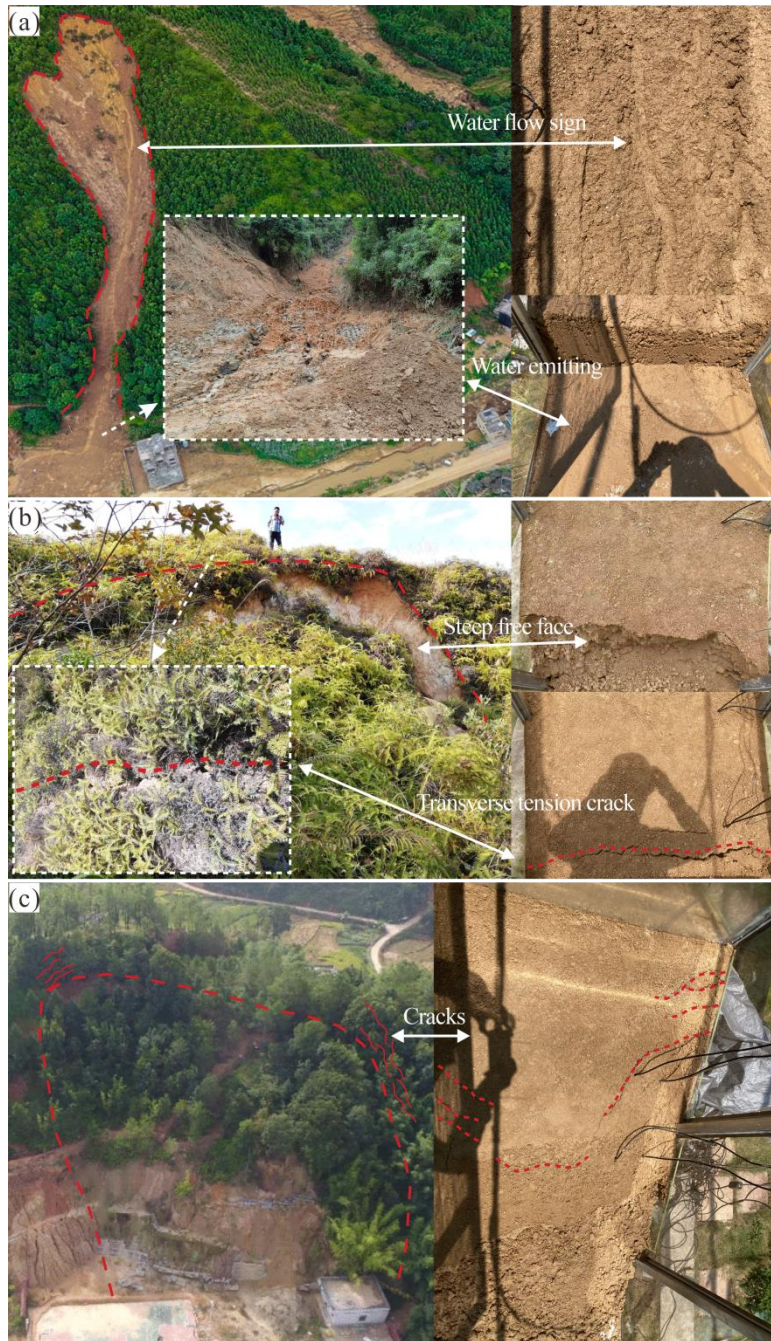
**Figure 15.** Comparison of Mibei landslides deformation with model tests. (a) E1 slope. (b) E2 slope. (c) E3 slope.

This study was conducted based on model tests, and the model materials utilized were collected in the field and are considered to be remodeled samples. It should be noted that the constructed slope model may differ somewhat from the actual situation, which may result in limited practical usability of the results of this research. Consequently, this study investigated the correspondence between the actual residual layer thickness and landslides, as well as analyzed the consistency between the findings and the model test results. (1) For the E1 slope, the slopes show clear water flow signs. The water content of the landslide accumulation mass is very high, essentially saturated with water-emitting phenomena. (2) For the E2 slope, the trailing edge of landslides has no cracks other than the transverse tension cracks, which is because the slope deformation starts from a deeper layer. The landslides generate steep free faces due to traction-stagger

deformation. (3) For the E3 slope, the number and distribution of tensile cracks at the trailing edge of the landslides are large, which are formed during the downward deformation of the slopes. It is evident that this test accurately replicates the destabilization of granite weathered crust slopes with different residual layer thicknesses.
