Supplementary figures

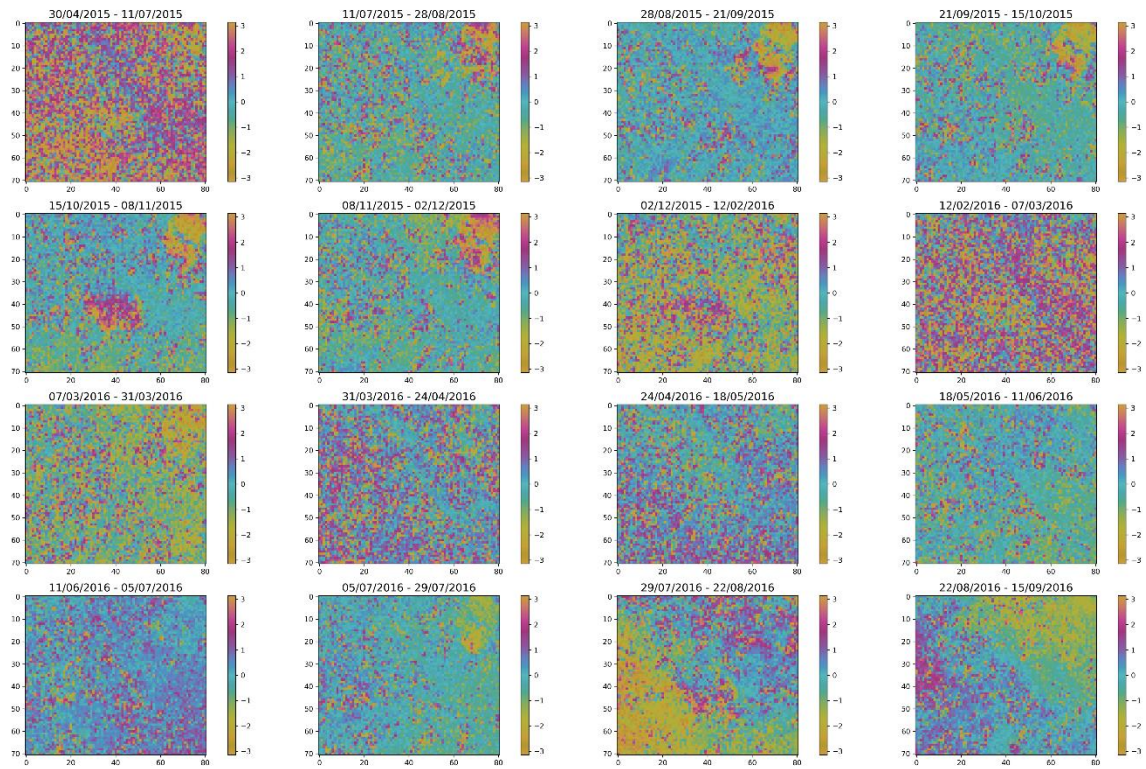
Supplementary Figure 1. Corrected wrapped interferograms from 30/04/2015 to 15/09/2016.

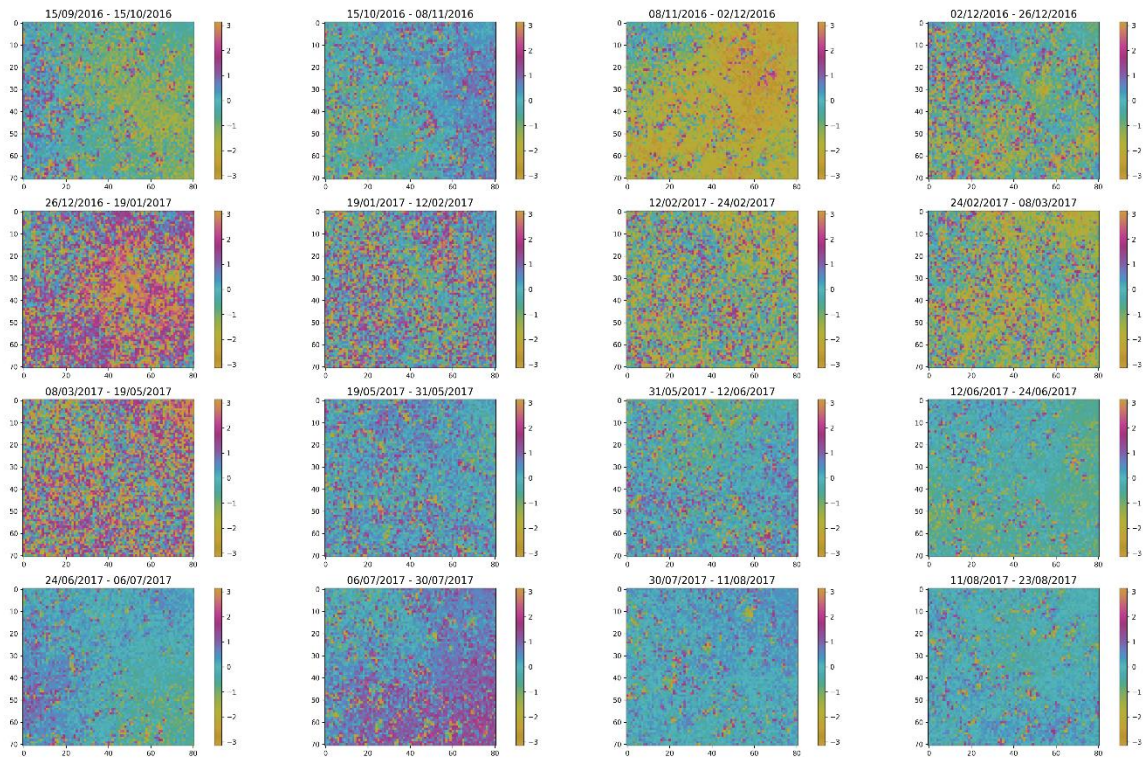
Supplementary Figure 2. Corrected wrapped interferograms from 15/09/2016 to 23/08/2017.

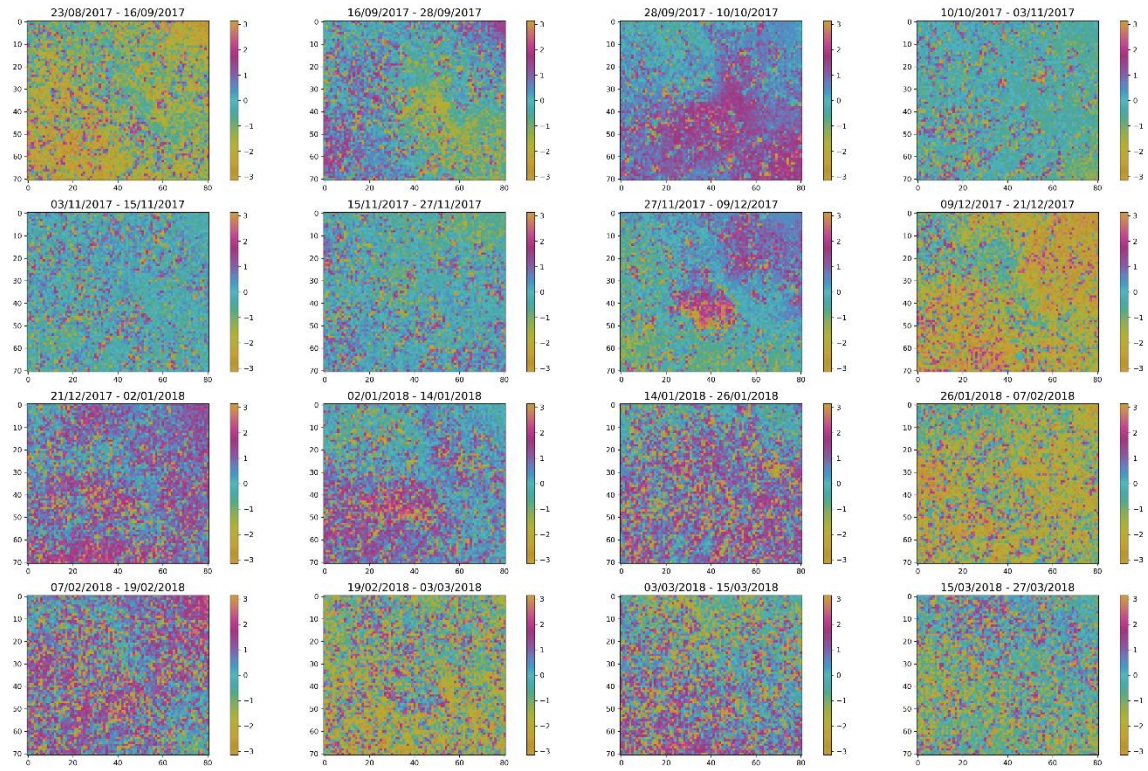
Supplementary Figure 3. Corrected wrapped interferograms from 23/08/2017 to 27/03/2018.

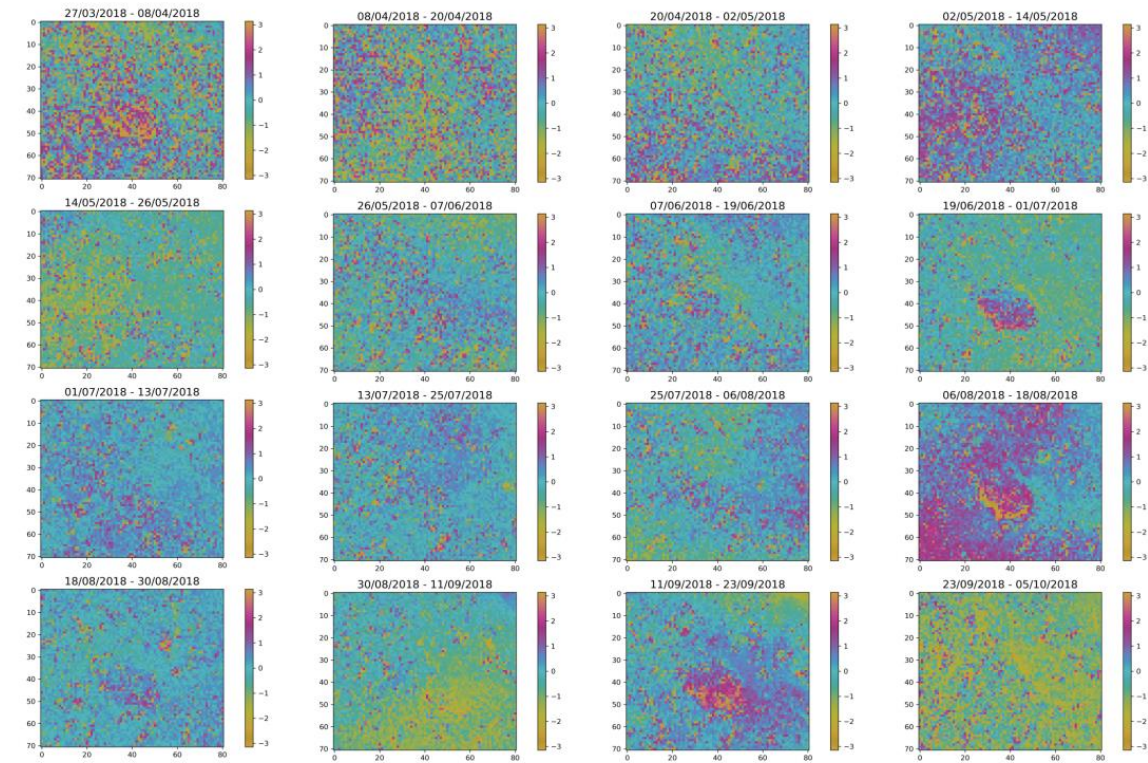
Supplementary Figure 4. Corrected wrapped interferograms from 27/03/2018 to 05/10/2018.

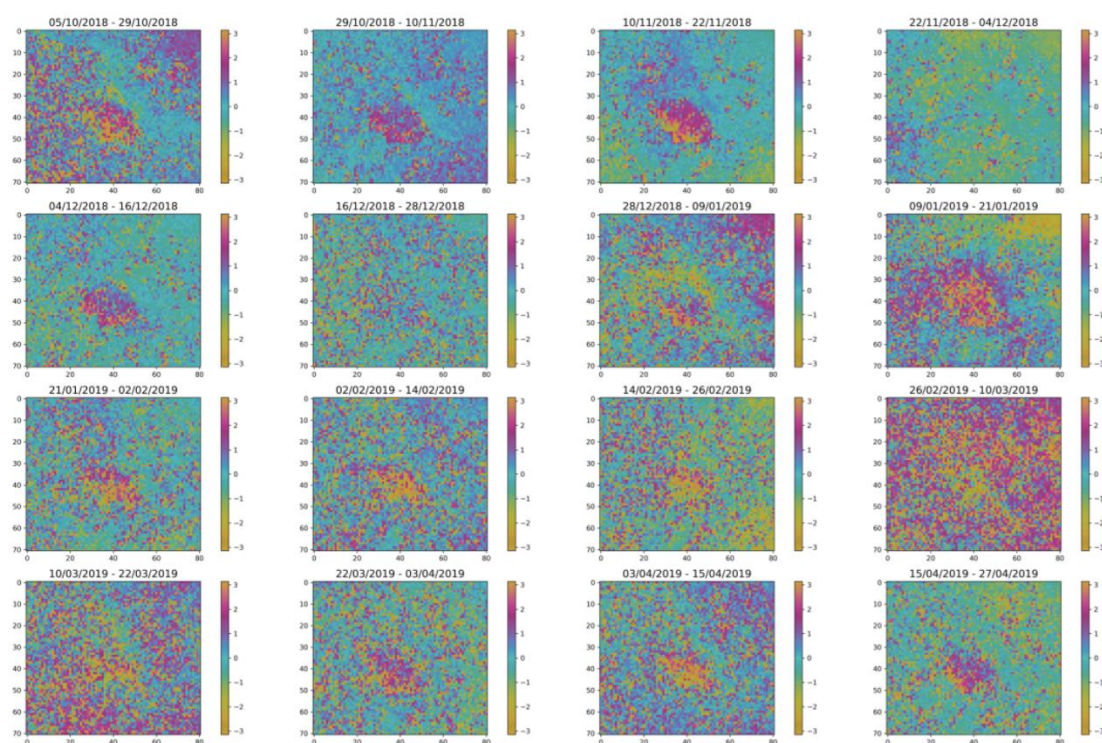
Supplementary Figure 5. Corrected wrapped interferograms from 05/10/2018 to 27/04/2019.

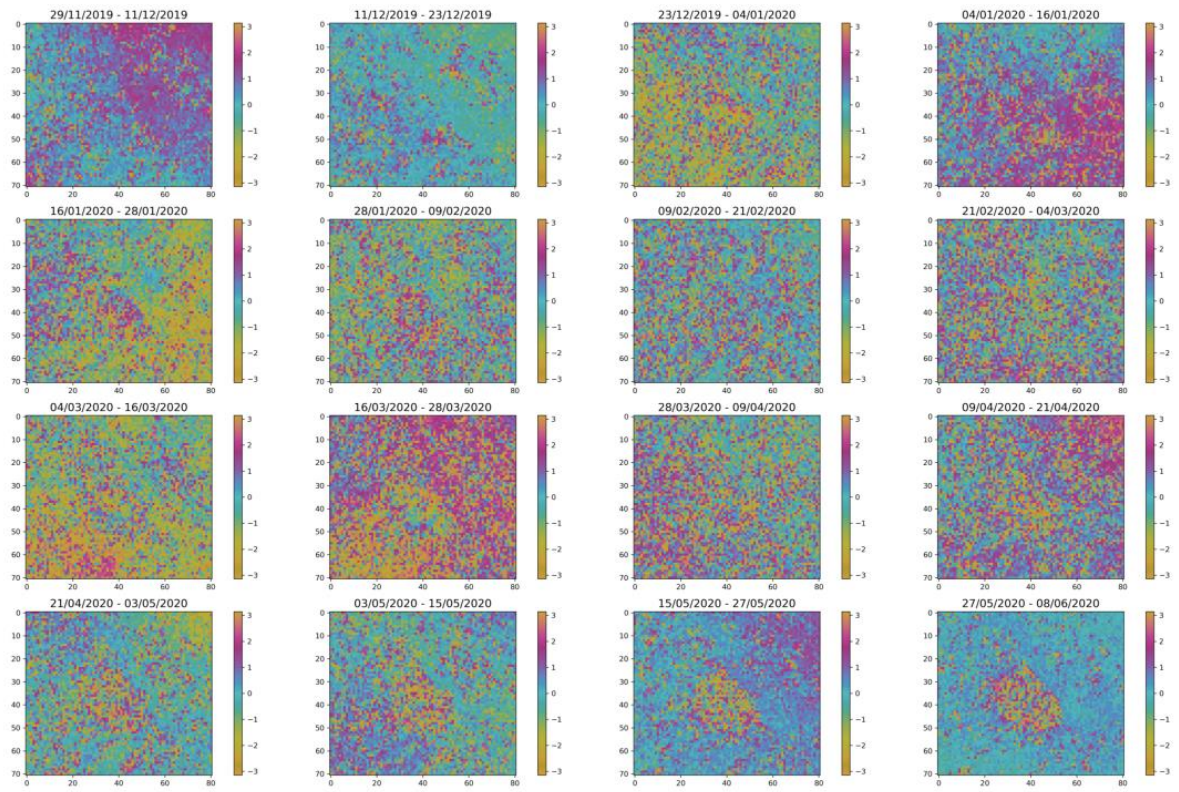
Supplementary Figure 7. Corrected wrapped interferograms from 29/11/2019 to 08/06/2020.

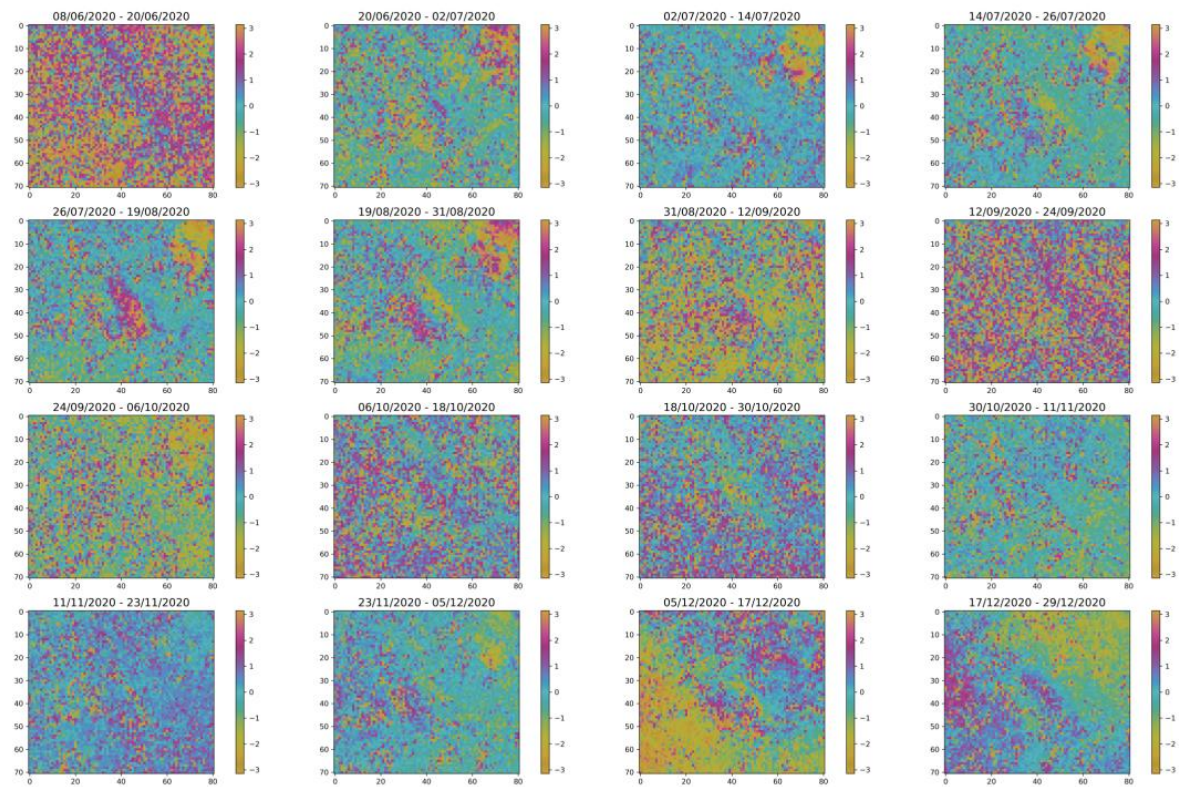
Supplementary Figure 8. Corrected wrapped interferograms from 08/06/2020 to 29/12/2020.

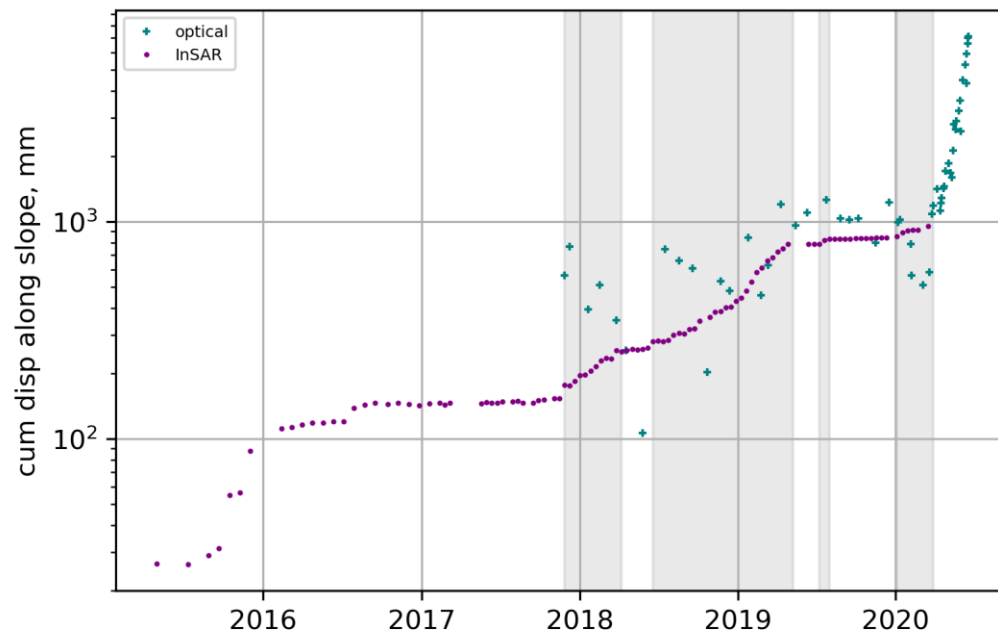
Supplementary Figure 9. Semilog plot of cumulative displacements on the Achoma landslide, showing the complementarity of InSAR and optical image correlation.
