1 **Bedrock ledges, colluvial wedges, and ridgeline water towers:**
2 **Characterizing geomorphic and atmospheric controls on the 2023**
3 **Wrangell landslide to inform landslide assessment in Southeast**
4 **Alaska, USA**

6 Joshua J. Roering^{*1}, Margaret M. Darrow², Annette I. Patton³, Aaron Jacobs⁴

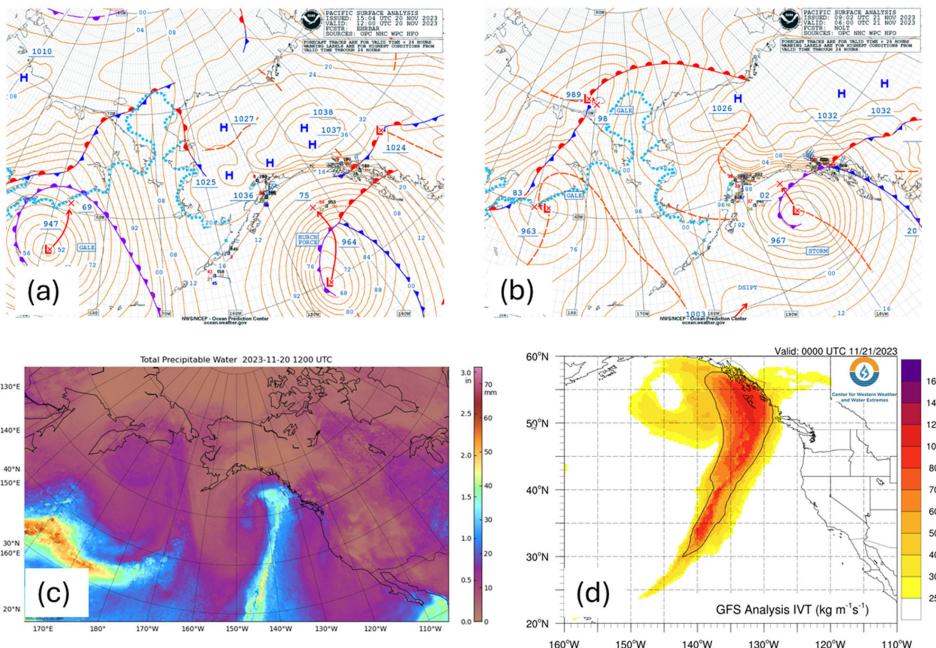
167 **Figure 3.** The November 20, 2023 atmospheric river event: (a) NOAA surface analysis from imagery from November 20 at
 168 4am Alaska Standard Time, (b) NOAA surface analysis from imagery from November 20 at 10pm Alaska Standard Time, (c)
 169 Total Precipitable Water from the Cooperative Institute for Meteorological Satellite Studies (CIMSS) Morphed Integrated

170 Microwave Total Precipitable Water (MIMIC-TPW) for November 20 at 4am Alaska Standard Time, (d) Integrated Water
171 Vapor Transport (IVT) from Center for Western Weather and Water Extremes (C3WE) from November 20 at 4pm.

159 A hurricane-force 964 mb low pressure system lifted out of the North Pacific into the Gulf of Alaska during the early morning
 160 hours of November 20, 2023 (Figure 3a). This low-pressure system proceeded along a north-northwest track, with the warm
 161 front moving over southern and central SE Alaska before the front pushed north through the evening hours (Fig. 3b). A cold
 162 air mass over northern SE Alaska and the Yukon produced a zone of high pressure and a strong pressure gradient across SE
 163 Alaska. This colder air likely produced ~~some~~ snowfall at higher elevations prior to the arrival of warm, moist air. This weather
 164 system included significant subtropical moisture and additional AR characteristics evident in satellite imagery (Fig. 3c). At 3
 165 PM on November 20, the CIMMS Model analysis of Integrated Water Vapor Transport (IVT), a commonly used indicator of
 166 ARs, indicated very high IVT over the southern half of SE Alaska (Fig. 3d).

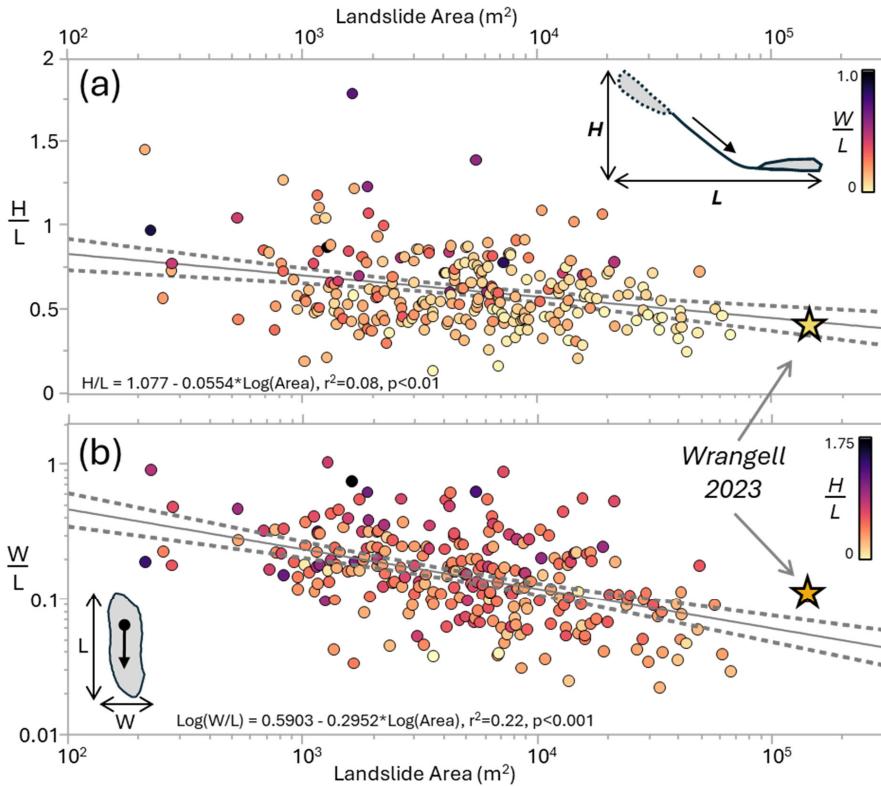
277 **Figure 7.** Plots of landslide characteristics for Wrangell landslides in the TNFLI. (a) Variation of mobility (H/L) with area,
278 and (b) variation of landslide aspect ratio with area. Note that the star indicates the MP 11.2 landslide in a and b. The solid
279 black and dashed grey lines denote the regression fits and 95% confidence intervals for the equations indicated in a and b.
280 Individual points are coloured by W/L in a and H/L in b.

260 and fitted a logarithmic trend, such that H/L decreases slightly with area (Fig. 7a). In this context, the MP11.2 landslide is
261 situated on the trend and thus does not appear notable for its mobility relative to its area. Because the MP11.2 landslide is
262 maintained a relatively wide footprint along most of its path, we also plotted W/L versus area (Fig. 7b) and noted a robust
263 power-law trend indicating that slides tend to become increasingly elongate as they get bigger. In this context, the MP11.2
264 landslide is anomalous for its large W/L value relative to its area. Specifically, the landslide plots well above the trend and
265 only one of the 25 next largest landslides has a similar positive deviation above the area-W/L curve (Fig. 7b). In summary, the
266 landslide did not appear to exhibit uncommon mobility as defined by H/L values, but rather it attained a large area while also

552 anomalous (Fig. 7a), we interpret its low deposit angle, and thus outsized and tragic impact, to result from highly efficient
553 entrainment and volumetric growth, which resulted in a large [volume and inundation area-and volume](#). Experimental and
554 theoretical investigations of debris flow runout emphasize that pore pressures generated as wet bed sediment is overridden and
555 progressively entrained, can reduce friction and facilitate increases in flow momentum (Iverson et al., 2011; Reid, 2011). These
556 studies emphasize that local slope and volumetric water content are highly sensitive factors that determine the extent of
557 entrainment during landslide runout (Iverson and Ouyang, 2015). Furthermore, because the colluvial stores on the slope were
558 emplaced by rockfall activity and soil transport, they may exist in a contractive state such that deformation and shearing
559 facilitate pore pressure development and volumetric growth.

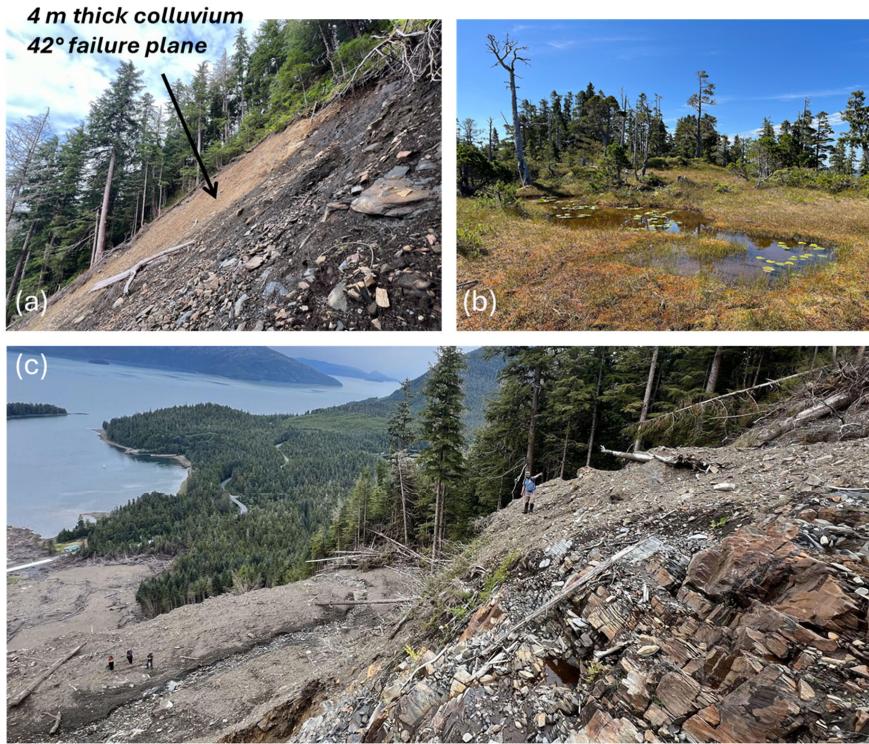
314 **Figure 9.** Photographs of key features identified in the field: (a) view to the north across the head scarp, exposing thick (~4m)
 315 colluvial wedge in lateral margin, (b) ridgeline wetland or muskeg that drains to the head scarp, and (c) oblique view of mid-
 316 slope location (~1,000 m on transect; see Fig. 11) depicting high relief and resistant cliff-forming unit and patch of live
 317 blueberry bushes just below the top of the bedrock cliff. Note person for scale.

305 In exposures along the landslide flanks, we observed colluvium as discontinuous “wedges” at the base of bedrock cliffs,
306 including a ~4 m thick deposit that constitutes the initiation zone (Fig. 9a). The matrix of the colluvium was brown, organic
307 silty sand to silty sand with gravel (SM), similar to displaced landslide material observed downslope. The material properties
308 of the colluvium imply moderate frictional strength, minimal weathering or alteration, and relatively high permeability. All of
309 the samples tested were non-plastic (supplementary materials). In an area scoured by the landslide in its depositional zone, we
310 also observed a deposit of sand and subrounded, imbricated gravel characteristic of coastal marine sediments. The deposit is
311 exposed just below the USFS road at approximately 100 m elevation, which is consistent with estimated glacial isostatic
312 adjustment documented for the region (Baichtal et al., 2021).

390 In the field, we also observed a live blueberry patch growing on a subvertical bedrock face at ~1000 m along the transect (Fig.
391 9c, 11c). This observation implies negligible erosion, and perhaps projectile behaviour of the landslide runout.
