Development of flood vulnerability functions for cultural heritage buildings and artworks for damage assessment in art cities

Claudia De Lucia¹, Chiara Arrighi¹

¹Department of Civil and Environmental Engineering, Università degli Studi di Firenze, Florence, Italy
Correspondence to: Chiara Arrighi (chiara.arrighi@unifi.it)

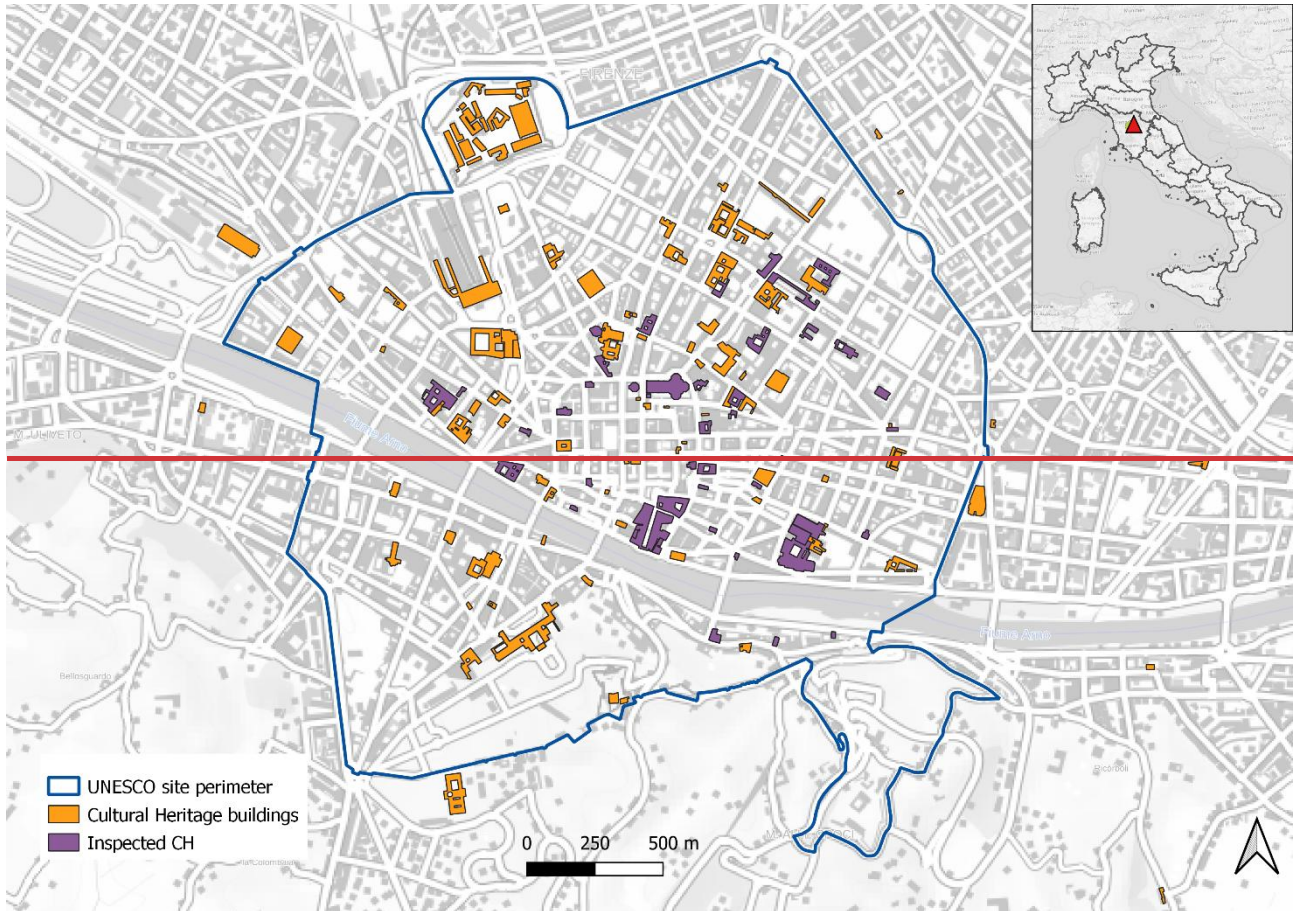
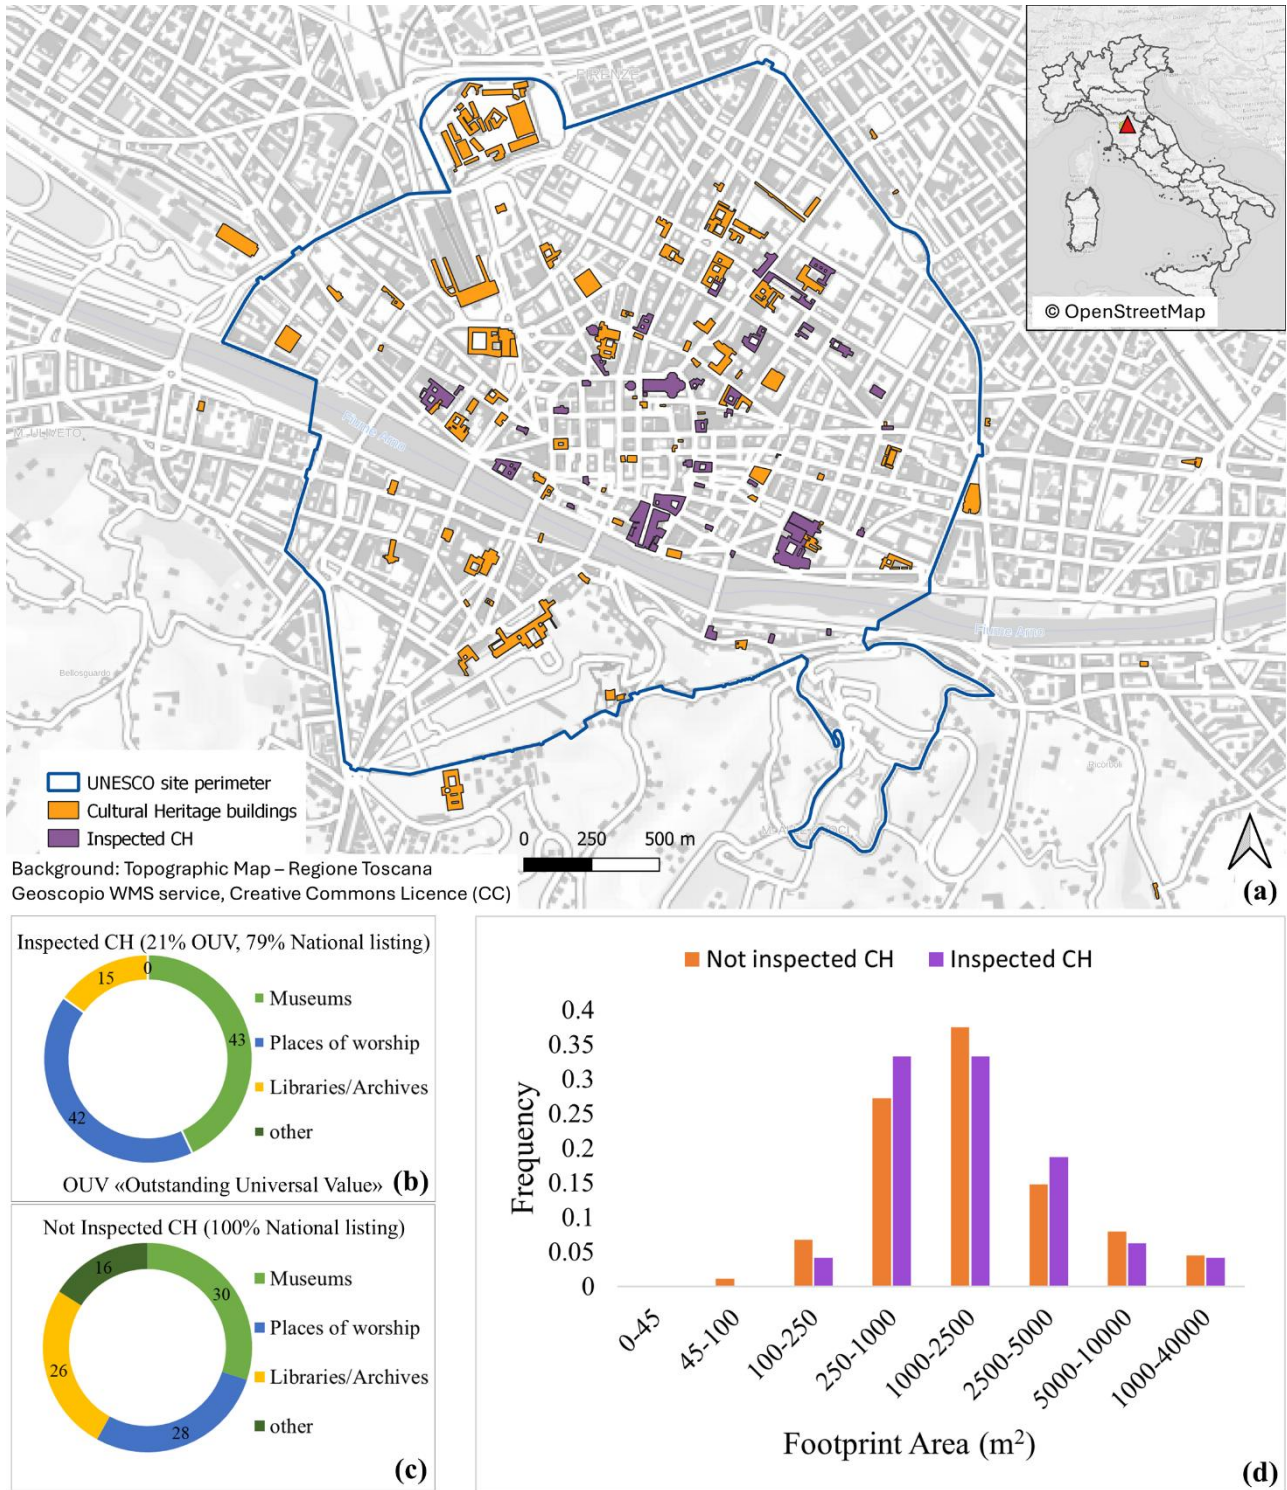
Fig. 2 Florence study area, cultural heritage buildings and those inspected for the development of vulnerability functions **(a)**. **Characteristics of inspected vs not inspected CH in terms of typology and protection status (b, c) and distribution of footprint area (d)**. Background map is based on data from OpenStreetMap. © OpenStreetMap contributors, licensed under the Open Database License (ODbL).

This method is applied to the CH of the historical city center of Florence (Fig.2.a), located in central Italy, which has been recognized as a UNESCO World Heritage since 1982. The UNESCO World Heritage Committee has acknowledged that the Historic Centre of Florence is the result of long-lasting creativity, whose influence has profoundly shaped architecture and fine arts of Italy and Europe (<https://whc.unesco.org/en/list/174/>).

Libraries and archives, although subject to different accessibility and regulatory conditions, are grouped together due to their similar storage systems (i.e., shelving) and the nature of their collections, which are primarily paper-based. Places of worship, by contrast, constitute a separate group for vulnerability analysis despite their internal diversity. They share several key features, including the presence of frescoes and wall decorations, similar types of artworks (e.g., panel paintings and wooden sculptures), and comparable display arrangements. The surveyed sample of places of worship includes 15 churches, 2 oratories, 1 baptistry, and 1 Jewish temple. The percent distribution of CH types in the surveyed sample, reflects pretty well the types not included in our detailed analysis (30% museums, 28% places of worship, 26% libraries/archives, 16% other, e.g., theatres or train stations) (Fig. 2 b,c). Moreover, the mean and median statistics of the footprint area of the CH building align well in the two samples (mean=2250 m², median=1292 m², mean=2652 m², median=1433 m², in the surveyed and not surveyed samples respectively) (Fig. 2 d).-

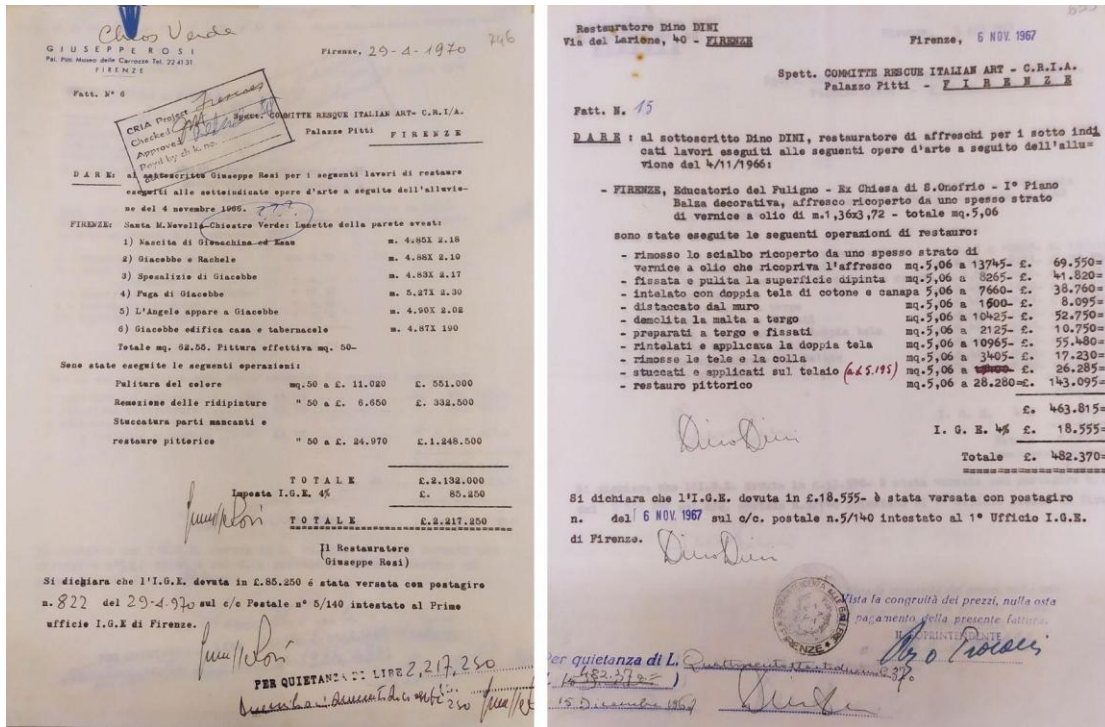
Fig. 4 An example of invoices issued by restorers after flooding 1966, stored in CRIA archive

Following the field investigations, the research focused on a detailed analysis of damage caused by historical flood events. The CRIA archive (Committee to Rescue Italian Art) contains extensive documentation on the 1966 flood in Florence, including photographs (over 900), videos, and written records. Restoration invoices issued after the event were examined and categorized by artwork type—primarily paintings on canvas, paintings on wooden panels, and wooden sculptures. *Figure 4* provides an example of these invoices related to restoration work carried out post-flood. The list of restoration activities documented for flood-damaged artworks was used to update restoration costs to present-day values, enabling the estimation of contemporary repair costs based on historical data.

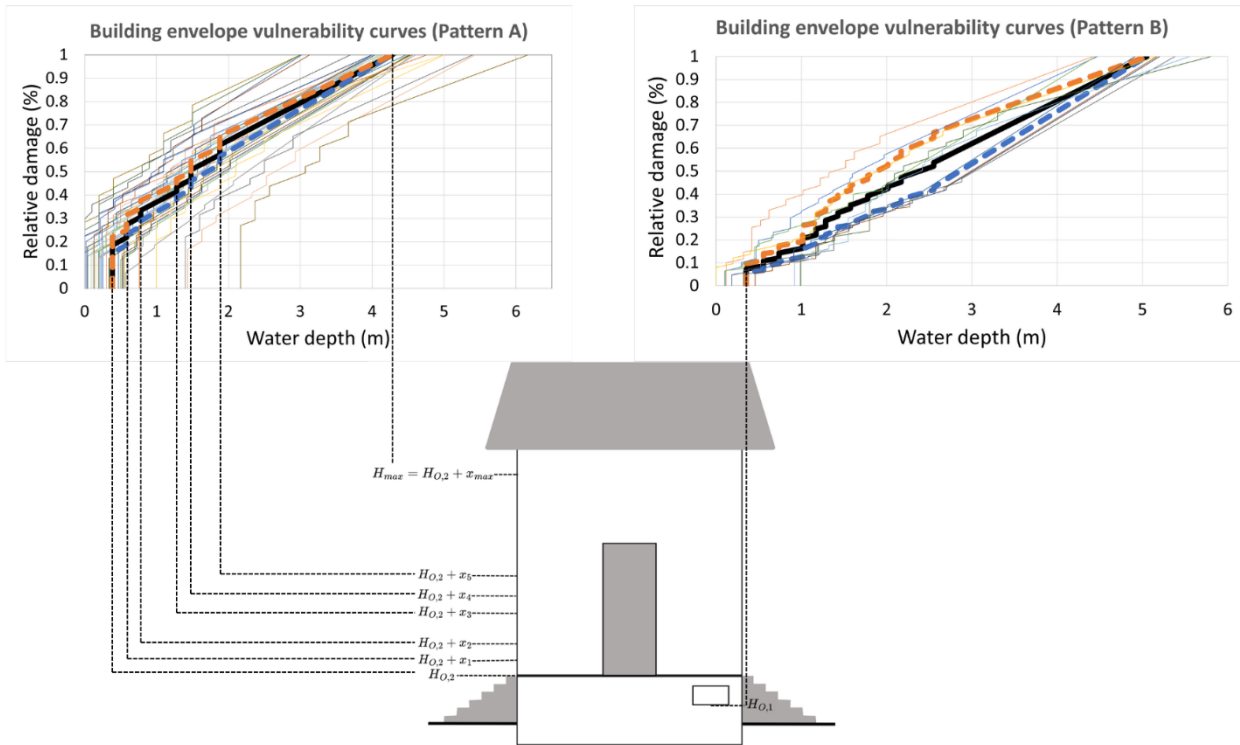
Fig. 5 CH Building vulnerability functions: Pattern A (on the left) and Pattern B (on the right). The bold black, orange and blue curves are the average, 75th and 25th percentile vulnerability functions.

The building analysis yields a specific vulnerability function for each CH building. These functions typically exhibit a combination of two growth patterns: a linear progression, reflecting damage to finishes and plaster, and a stepwise increase, associated with damage to floors and utility systems. Two vulnerability patterns, independent of CH types, are identified in the study area. These patterns reflect different inundation behaviors depending on the presence of a basement and its hydraulic connectivity to the road surface, along which the flood propagates. Figure 5 presents the two distinct vulnerability patterns, each accompanied by an average function (solid black line), the 25th percentile (orange dashed line), and the 75th percentile (blue dashed line). Pattern A (left) is characterized by six steps and represents damage scenarios for buildings either without basements or with basements that flood simultaneously with the ground floor. This occurs when basement openings are either absent or positioned above the elevation of the main entrance—typically in buildings with multi-level ground floors. The first step of the function corresponds to the point at which floodwaters reach the lowest opening, thereby affecting the floor. On average, this occurs at a water depth of 0.39 m, resulting in approximately 18% relative damage to the building. The extent of damage at this initial stage tends to increase with the building's surface area.

Subsequent steps in Pattern A correspond to progressive damage to electrical and plumbing systems. When the electrical system is fully compromised—typically at an average water depth of $w = H_{0,2} + x_s = 1.88$ m—the relative damage reaches approximately 62%.

In contrast, Pattern B (right) corresponds to buildings where the basement floods before the ground floor due to basement openings located below the elevation of the main entrance or any ground-floor openings. In this scenario, damage is assumed to occur equally at each level. Accordingly, Pattern B functions are derived by summing two identical stepwise curves, each shifted along the x-axis by $w = H_{0,2} - H_{0,1}$, representing the elevation difference between ground-floor and basement openings. As a result, the vulnerability curve for Pattern B includes twelve steps—six for each level.

As shown in Figure 5, buildings following Pattern B begin to sustain damage when water reaches the lowest basement opening, at an average depth of 0.36 m. Typically, when water depth reaches 2.55 m, the electrical systems on both levels are entirely compromised, and approximately 54% of the interior finishes of the building is damaged.

Only 10 CH buildings fall under Pattern B. Due to the low elevation of their basement openings relative to the street level, the first damage step for most of these buildings occurs at water depths below 0.5 m. The sole exception is the National Library of Florence, where the basement windows are located 0.99 m above street level, requiring a greater flood depth to trigger initial damage. The average and percentile vulnerability functions for the CH building are also displayed as supplementary materials of the manuscript.

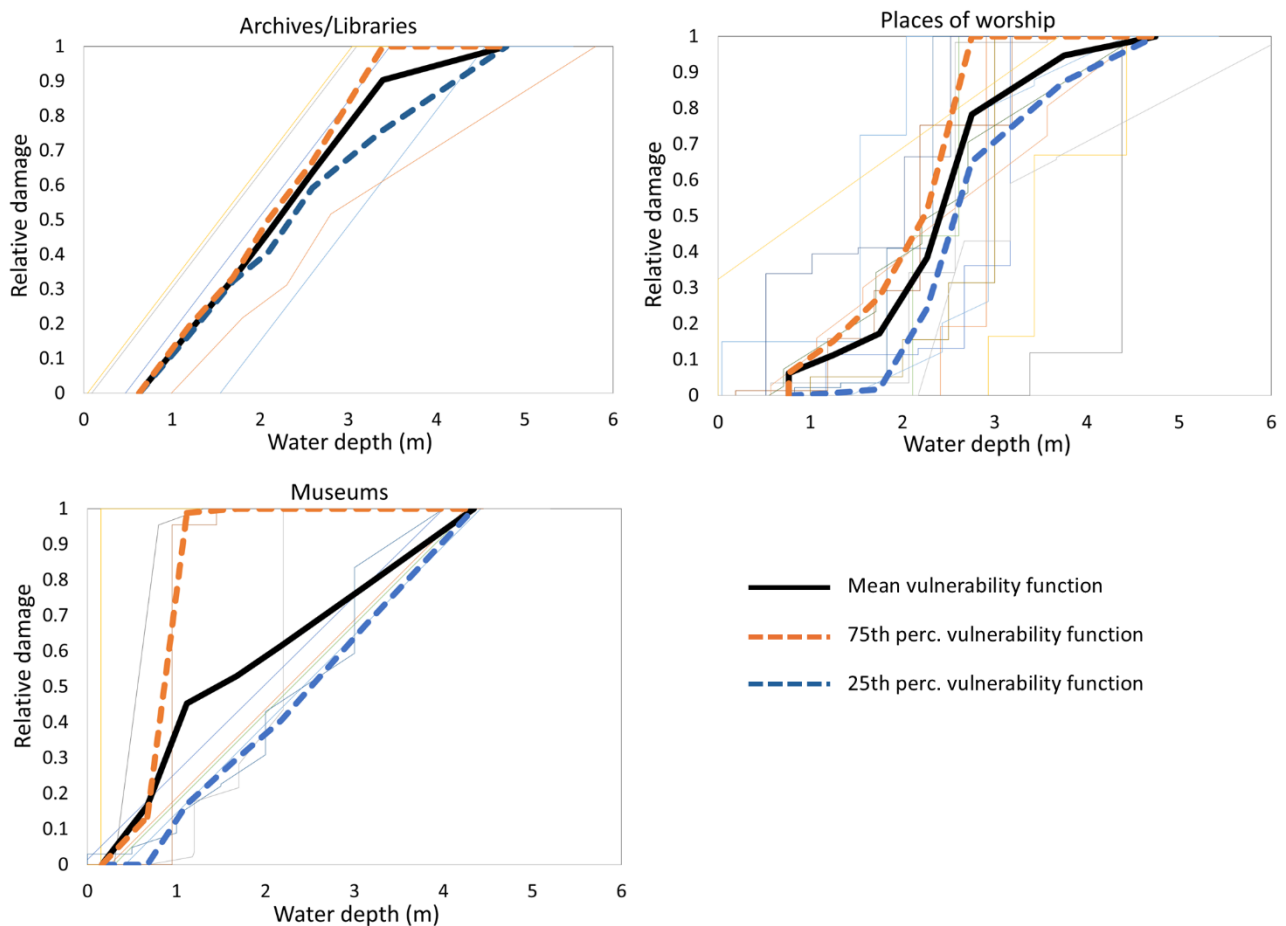
490 **Fig. 6 Artworks vulnerability functions for libraries/archives (top left), places of worship (top right) and museums (bottom left). The bold black, orange and blue curves are the average, 75th and 25th percentile vulnerability functions.**

The vulnerability assessment of artworks, as described in Section 2.4, yields a vulnerability function for each cultural site. These functions account for both movable and immovable artworks, illustrating how damage increases with rising water depth. Figure 6 groups the resulting vulnerability functions into three categories based on asset type: archives/libraries, places of worship, and museums. In each graph, the black line represents the average vulnerability curve, while the blue dashed line and orange dashed line represent the 25th and 75th percentiles, respectively. Only cultural site with a Cost Reliability Index (CRI) value below 0.3 are included in the figure.

Figure 6 (top right panel) presents the vulnerability curves for places of worship in the city of Florence. Approximately 69% of these curves exhibit a stepwise growth pattern, while the remaining curves display a combined trend of linear progression and stepwise increase. This mixed behavior reflects the coexistence of large-scale artworks, such as frescoes, and smaller movable objects, including paintings on canvas and sculptures. On average, no damage is recorded until the external water depth reaches approximately 0.77 m, after which the relative damage increases rapidly to 6.2%. A significant inflection occurs at around 1.75 m, where the damage rate increases sharply—from 0.12 to nearly 0.4. Complete damage is observed at a water depth of approximately 4.7 m. This depth–damage behavior aligns with the field data collected and supports findings from previous studies (Salazar et al., 2023; Figueiredo et al., 2021). Initially, elevated ground floors help delay damage; however, once floodwaters breach the entrances, ground-level artworks—such as marble fonts and wooden pews—are immediately affected. When internal water depth reaches around 1 m, artworks located at higher elevations, such as altar paintings, are also impacted, significantly increasing restoration costs.

510 In the museum category, multiple vulnerability patterns are observed, reflecting the diversity of museum types. This category includes sites ranging from galleries, which display large numbers of paintings or sculptures, to cenacles and historic palaces entirely decorated with frescoes. In galleries, the vulnerability function typically shows a stepwise pattern, while fresco-covered spaces often follow a linear progression. A particularly notable case is represented by the yellow curve, which shows a single-step transition from zero to 100% relative
515 damage. This curve corresponds to the “Cappelle Medicee” museum, which houses the Medici Crypt, the burial site of the Grand Dukes and their families. Due to the exceptional historical and evidential value of the marble gravestones covering the crypt’s floor, the museum is considered completely damaged as soon as floodwaters infiltrate the building (Historic England, 2008). An analysis of average vulnerability functions across the museum category reveals that relative damage increases rapidly up to a water depth of approximately

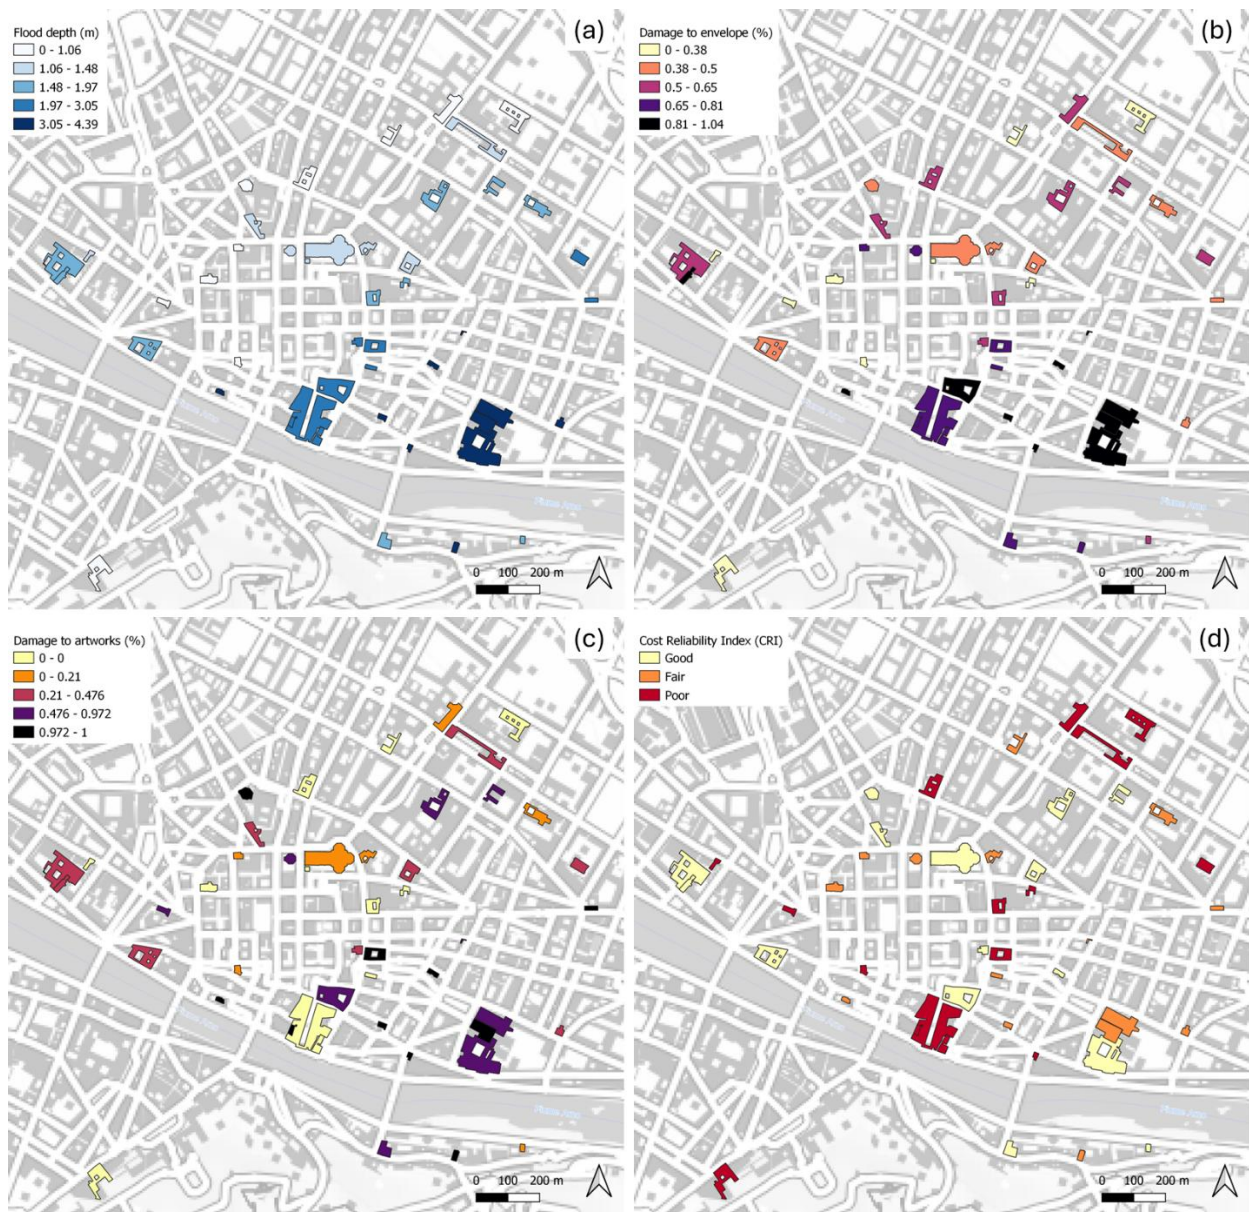
555 **Fig. 7** Flood depths for the 500 years return period scenario (a), relative damage to the building envelope (b), relative damage to the artworks (c), Cost Reliability Index for artworks (d). Background maps are based on data from OpenStreetMap. © OpenStreetMap contributors, licensed under the Open Database License (ODbL).

The 2D hydraulic simulation developed by Arrighi et al. (2022) provides flood maps for various scenarios, enabling the estimation of water depth at each CH building. For demonstrative purposes, the 500-year return period scenario is used to assess flood damage. Figure 7 (panel a) illustrates the flood depth in proximity to
530 buildings. It is evident that cultural heritage (CH) buildings located near the river experience the greatest flood depths—on the order of 3–4 meters above the road pavement in the S. Croce district (lower right area of panel a). Conversely, moving downstream and away from the river, flood depths at CH buildings decrease significantly.

The relative damage to building is shown in Figure 7 (panel b). The most exposed assets, depicted in black and purple, exhibit losses exceeding 65% under the analyzed flood scenario. Notably, the pattern of damage
535 to building does not decrease in direct correlation with flood depth. This discrepancy arises from variations in architectural features, particularly the elevation of openings (see also Figure 3 for comparison). This observation underscores the importance of on-site inspections to better determine the zero-damage thresholds of such historically unique buildings. For instance, many buildings close to the river possess elevated ground floors, mitigating damage, while those farther from the river often have entrances at or below road level,
540 increasing their vulnerability.

Regarding the relative damage to artworks (Figure 7, panel c), the results are more variable due to the heterogeneous distribution of artworks, differences in material susceptibility, and their positioning within CH buildings. Notably, artworks in four cultural buildings—whose ground floors are elevated above street level—remain unaffected, despite their location in flooded areas under the 500-year return period scenario.

545 Nevertheless, the S. Croce district, which hosts libraries, museums, and small churches, emerges as a significant cluster of potential artwork damage.

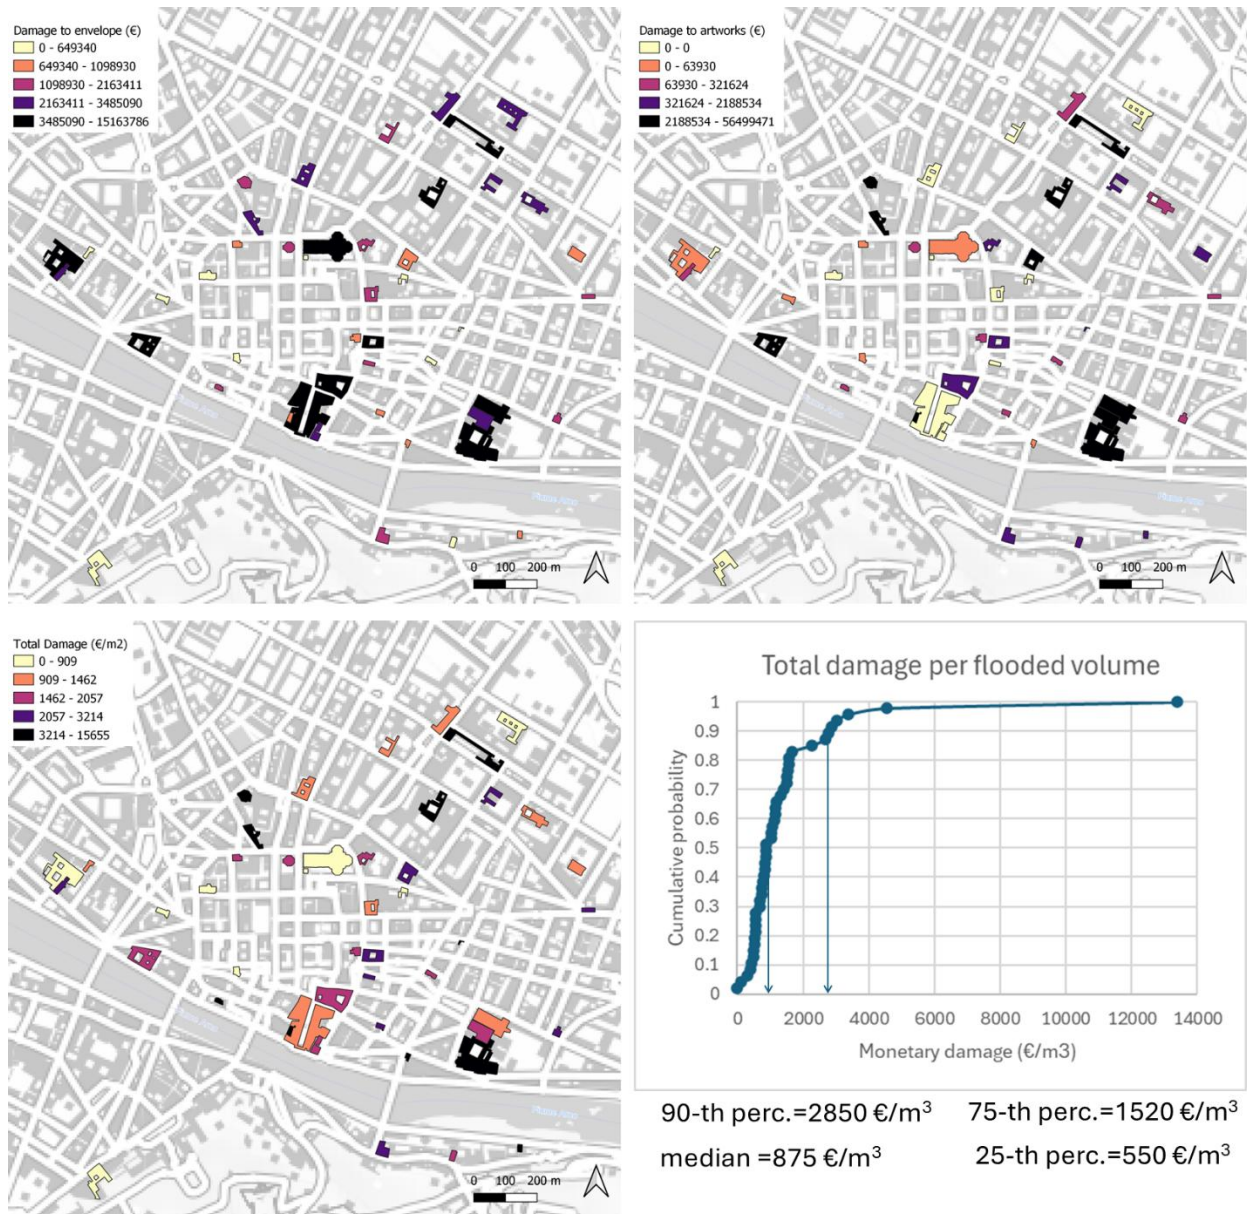
Fig. 8 Monetary damage to CH envelope (a), artworks (b), unitary surface damage (c) and unitary volume damage (d). Background maps are based on data from OpenStreetMap. © OpenStreetMap contributors, licensed under the Open Database License (ODbL).

560 Monetary damages are presented in Figure 8 for buildings (panel a) and artworks (panel b). Damage to the buildings is primarily driven by the larger cultural heritage (CH) buildings in the study area, with the five most affected assets each exceeding €5 million in estimated losses. The average monetary damage to buildings is approximately €2.5 million per building, corresponding to around €1,400 per square meter. The total estimated damage to buildings across the 48 assessed buildings amounts to approximately €120 million.

565 Artwork-related damages are predominantly concentrated in libraries and certain museums, with the three most affected institutions—the National Library, the Archaeological Museum, and the university library—each incurring losses exceeding €10 million. The Archaeological Museum, in addition to its vast collection of artefacts, houses, within its flood exposed levels, an extensive archive of books, as well as papyrus and parchment manuscripts (nearly 100,000 items), and photographs documenting archaeological campaigns since the 19th century (over 2 million, according to the museum manager). Therefore, all three of the most affected
570 institutions contain paper-based materials, which are highly susceptible to water damage. The average monetary damage to artworks in CH buildings is estimated at €3 million per asset, corresponding to approximately €1,110 per square meter. The total estimated monetary damage for artworks is approximately €150 million.

575 Figure 8 (panel c) illustrates the combined damage (building and artworks) expressed as unit cost per square meter. Unitary total damages range from approximately €500–700/m² to €2,000–4,000/m², with localized peaks exceeding €10,000/m², thus spanning two orders of magnitude. By dividing the unitary total damage by the flood depth, a unit monetary damage per flooded volume of CH is obtained. The cumulative probability distribution of this metric is shown in Figure 8 (panel d). The median and 75th percentile values for monetary damage per cubic meter of flooded volume are €875/m³ and €1,520/m³, respectively.
