Development of flood vulnerability functions for cultural heritage buildings and artworks for damage assessment in art cities

Claudia De Lucia¹, Chiara Arrighi¹

¹Department of Civil and Environmental Engineering, Università degli Studi di Firenze, Florence, Italy
Correspondence to: Chiara Arrighi (chiara.arrighi@unifi.it)

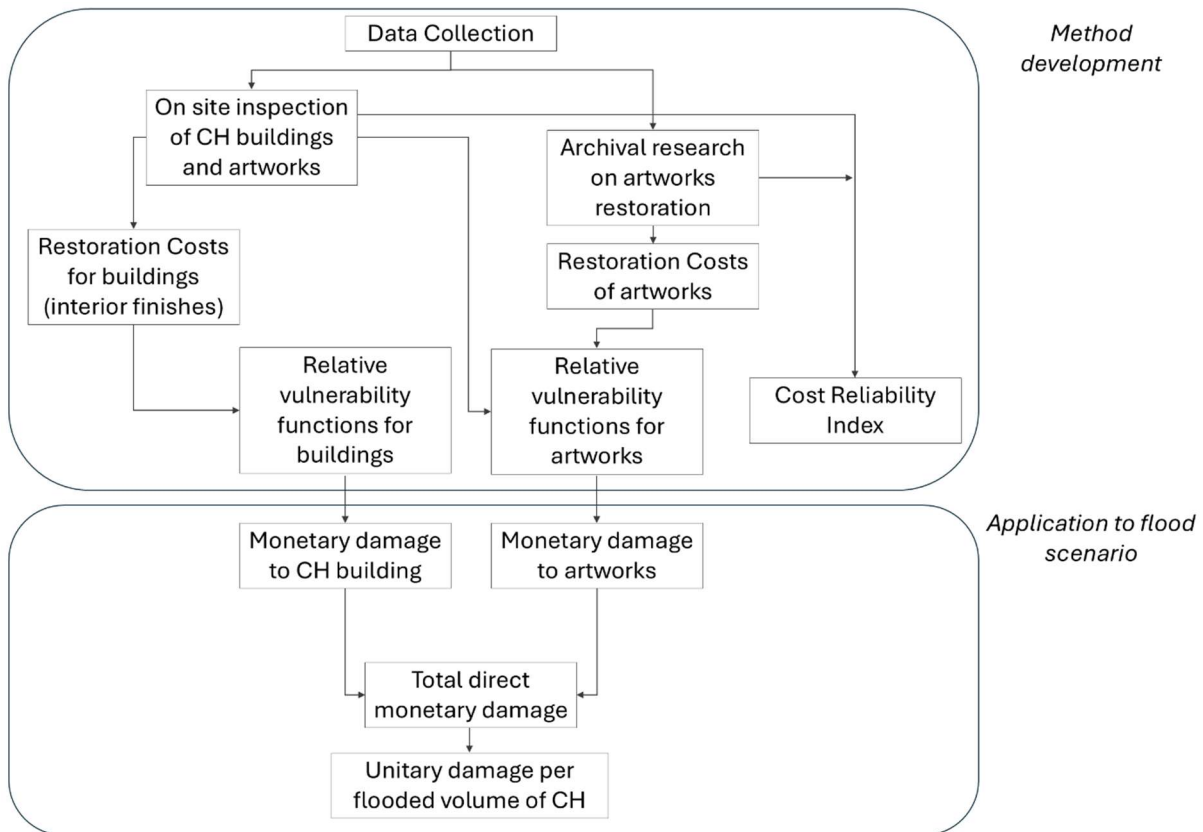
Fig. 1 Methodological scheme of the work.

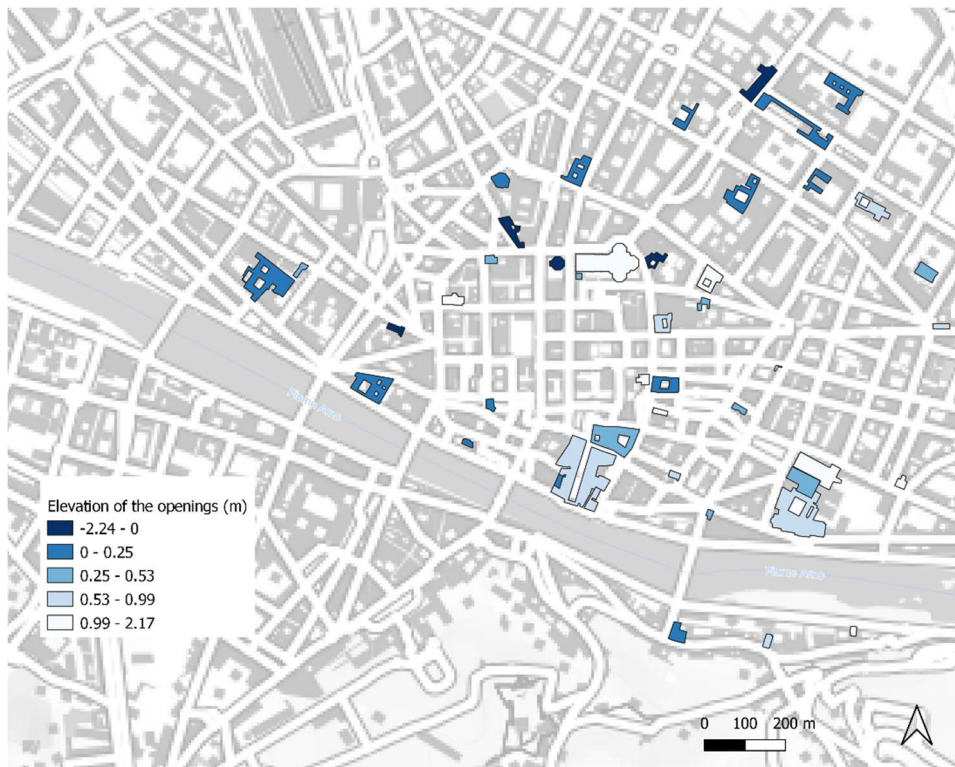
405 **Fig. 3 Elevation of the cultural heritage building openings HO above the road pavement after on-site measurements. Background map is based on data from OpenStreetMap. © OpenStreetMap contributors, licensed under the Open Database License (ODbL).**

The elevation of these openings is a critical factor in determining flood exposure, as it directly influences the flood depth threshold used to define zero-damage levels in vulnerability functions.

architectural features, particularly the elevation of openings (see also Figure 3 for comparison). This observation underscores the importance of on-site inspections to better determine the zero-damage thresholds of such historically unique buildings. For instance, many buildings close to the river possess elevated ground floors, mitigating damage, while those farther from the river often have entrances at or below road level, increasing their vulnerability.

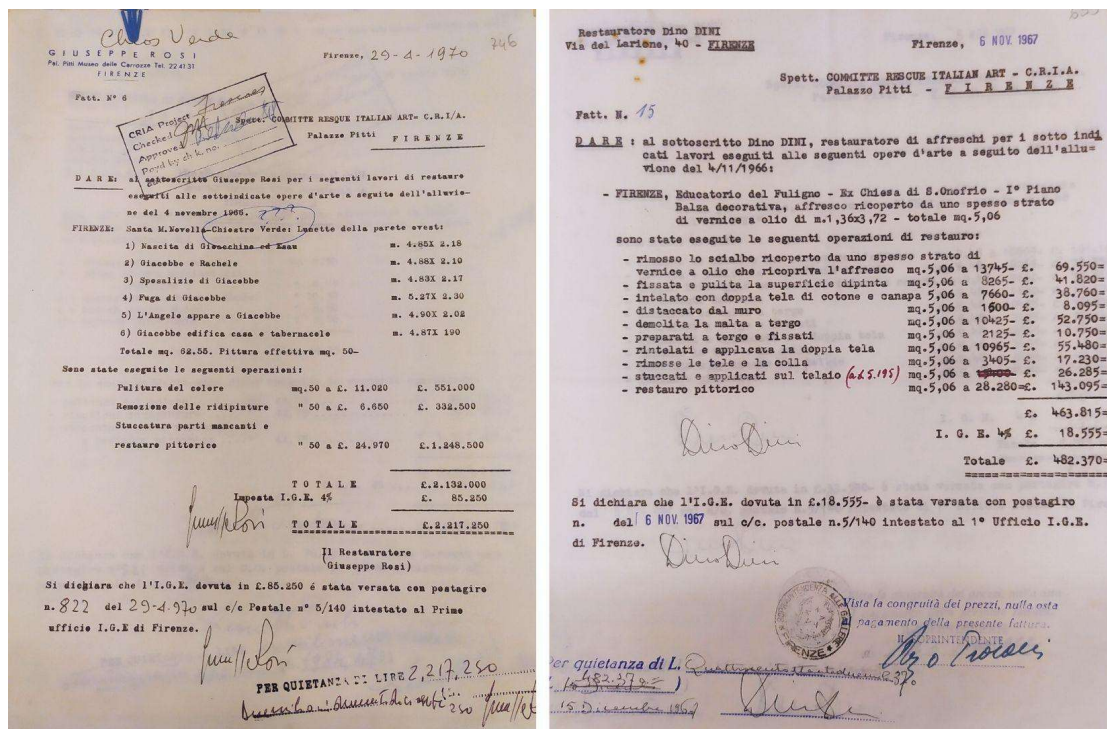
425 Fig. 4 An example of invoices issued by restorers after flooding 1966, stored in CRIA archive

Following the field investigations, the research focused on a detailed analysis of damage caused by historical flood events. The CRIA archive (Committee to Rescue Italian Art) contains extensive documentation on the 1966 flood in Florence, including photographs (over 900), videos, and written records. Restoration invoices issued after the event were examined and categorized by artwork type—primarily paintings on canvas,
420 paintings on wooden panels, and wooden sculptures. Figure 4 provides an example of these invoices related to restoration work carried out post-flood. The list of restoration activities documented for flood-damaged artworks was used to update restoration costs to present-day values, enabling the estimation of contemporary repair costs based on historical data.

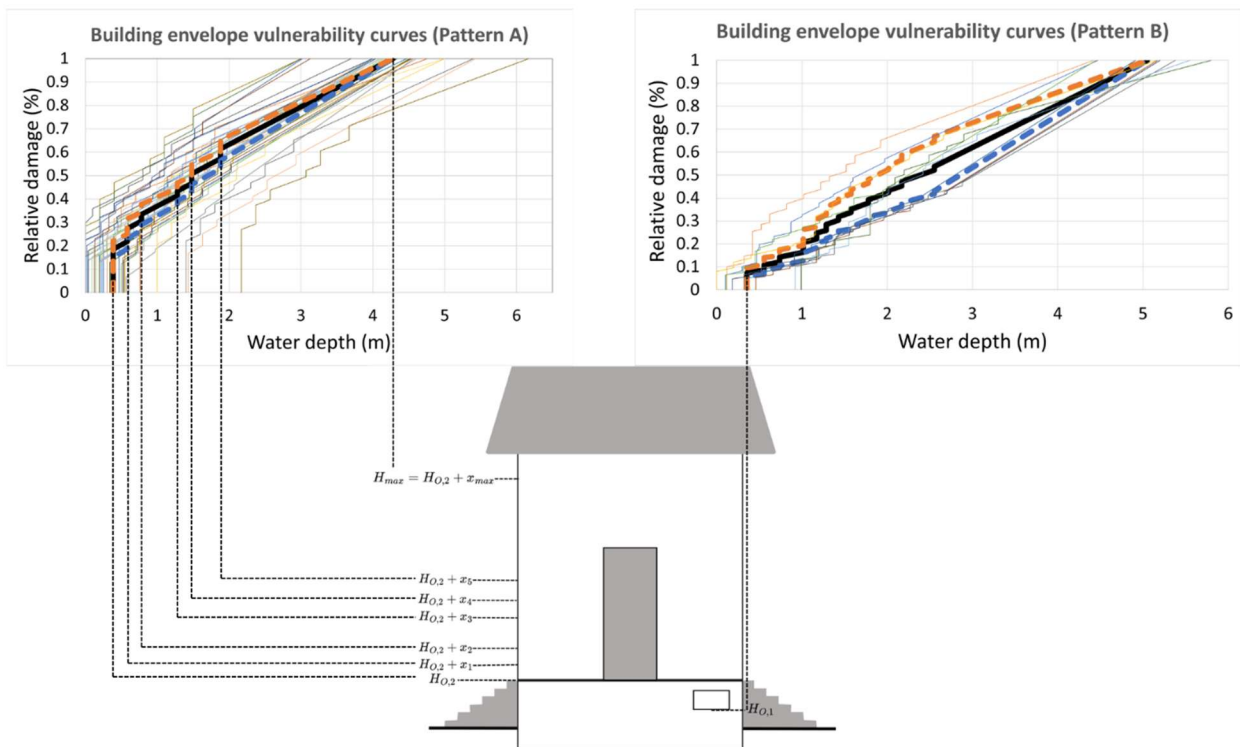
445 flood propagates. Figure 5 presents the two distinct vulnerability patterns, each accompanied by an average function (solid black line), the 25th percentile (orange dashed line), and the 75th percentile (blue dashed line). Pattern A (left) is characterized by six steps and represents damage scenarios for buildings either without basements or with basements that flood simultaneously with the ground floor. This occurs when basement openings are either absent or positioned above the elevation of the main entrance—typically in buildings with

Fig. 5 CH Building vulnerability functions: Pattern A (on the left) and Pattern B (on the right). The bold black, orange and blue curves are the average, 75th and 25th percentile vulnerability functions.

in approximately 18% relative damage to the building. The extent of damage at this initial stage tends to increase with the building's surface area.

Subsequent steps in Pattern A correspond to progressive damage to electrical and plumbing systems. When the electrical system is fully compromised—typically at an average water depth of $w = H_{O,2} + x_5 = 1.88$ m—the relative damage reaches approximately 62%.

In contrast, Pattern B (right) corresponds to buildings where the basement floods before the ground floor due to basement openings located below the elevation of the main entrance or any ground-floor openings. In this scenario, damage is assumed to occur equally at each level. Accordingly, Pattern B functions are derived by summing two identical stepwise curves, each shifted along the x-axis by $w = H_{O,2} - H_{O,1}$, representing the elevation difference between ground-floor and basement openings. As a result, the vulnerability curve for Pattern B includes twelve steps—six for each level.

As shown in Figure 5, buildings following Pattern B begin to sustain damage when water reaches the lowest basement opening, at an average depth of 0.36 m. Typically, when water depth reaches 2.55 m, the electrical systems on both levels are entirely compromised, and approximately 54% of the interior finishes of the building is damaged.

Only 10 CH buildings fall under Pattern B. Due to the low elevation of their basement openings relative to the street level, the first damage step for most of these buildings occurs at water depths below 0.5 m. The sole exception is the National Library of Florence, where the basement windows are located 0.99 m above street level, requiring a greater flood depth to trigger initial damage. The average and percentile vulnerability functions for the CH building are also displayed as supplementary materials of the manuscript.

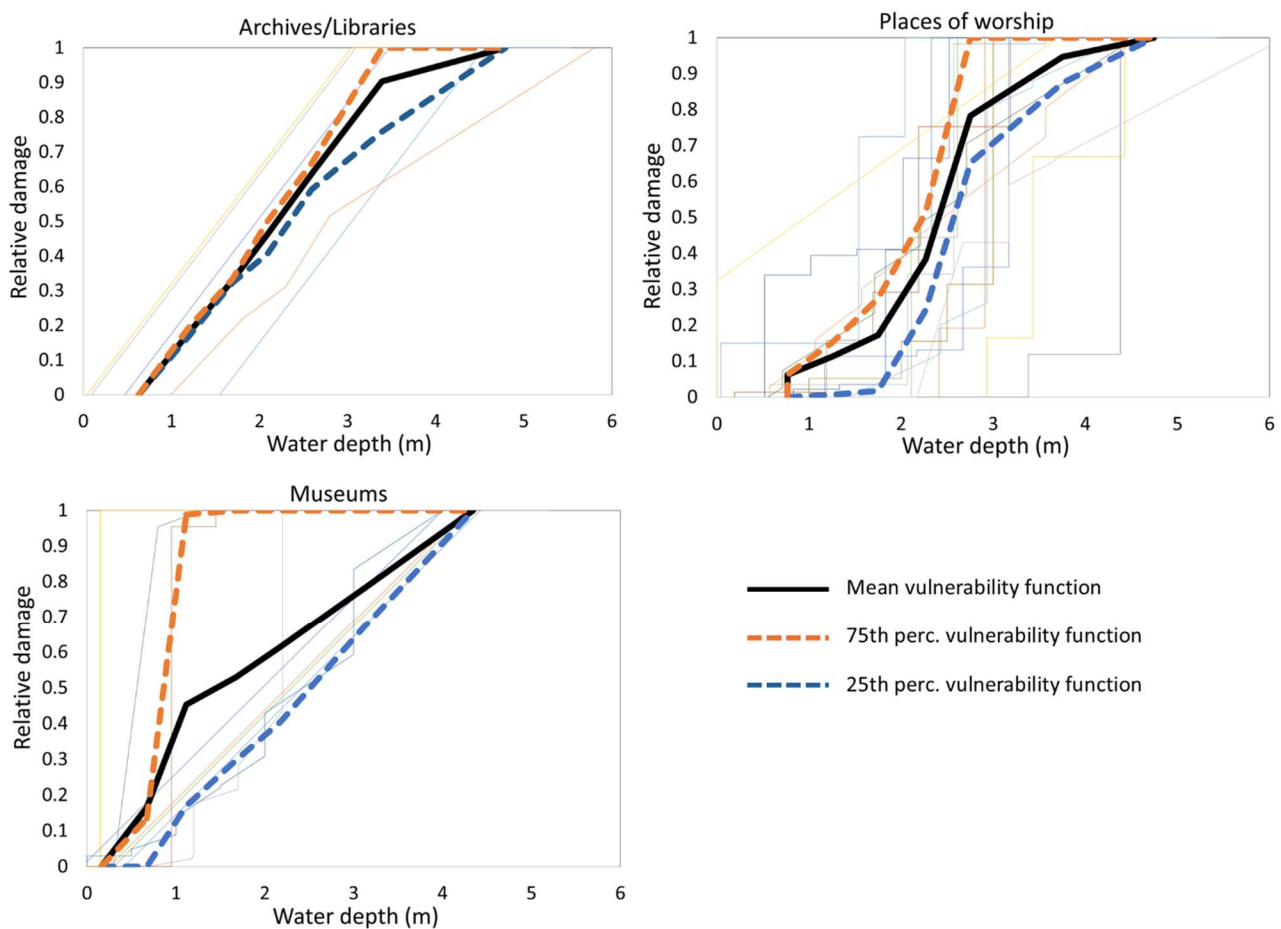
485 **Fig. 6 Artworks vulnerability functions for libraries/archives (top left), places of worship (top right) and museums (bottom left). The bold black, orange and blue curves are the average, 75th and 25th percentile vulnerability functions.**

Figure 6 (top right panel) presents the vulnerability curves for places of worship in the city of Florence. Approximately 69% of these curves exhibit a stepwise growth pattern, while the remaining curves display a combined trend of linear progression and stepwise increase. This mixed behavior reflects the coexistence of large-scale artworks, such as frescoes, and smaller movable objects, including paintings on canvas and sculptures. On average, no damage is recorded until the external water depth reaches approximately 0.77 m, after which the relative damage increases rapidly to 6.2%. A significant inflection occurs at around 1.75 m, where the damage rate increases sharply—from 0.12 to nearly 0.4. Complete damage is observed at a water

495 depth of approximately 4.7 m. This depth–damage behavior aligns with the field data collected and supports
findings from previous studies (Salazar et al., 2023; Figueiredo et al., 2021). Initially, elevated ground floors
help delay damage; however, once floodwaters breach the entrances, ground-level artworks—such as marble
fonts and wooden pews—are immediately affected. When internal water depth reaches around 1 m, artworks
500 costs.

In the museum category, multiple vulnerability patterns are observed, reflecting the diversity of museum types.
This category includes sites ranging from galleries, which display large numbers of paintings or sculptures, to
cenacles and historic palaces entirely decorated with frescoes. In galleries, the vulnerability function typically
shows a stepwise pattern, while fresco-covered spaces often follow a linear progression. A particularly notable
510 case is represented by the yellow curve, which shows a single-step transition from zero to 100% relative
damage. This curve corresponds to the “Cappelle Medicee” museum, which houses the Medici Crypt, the
burial site of the Grand Dukes and their families. Due to the exceptional historical and evidential value of the
marble gravestones covering the crypt’s floor, the museum is considered completely damaged as soon as
floodwaters infiltrate the building (Historic England, 2008). An analysis of average vulnerability functions

515 across the museum category reveals that relative damage increases rapidly up to a water depth of approximately
1.12 meters, after which the rate of increase slows, as indicated by a decrease in the average slope of the
function.

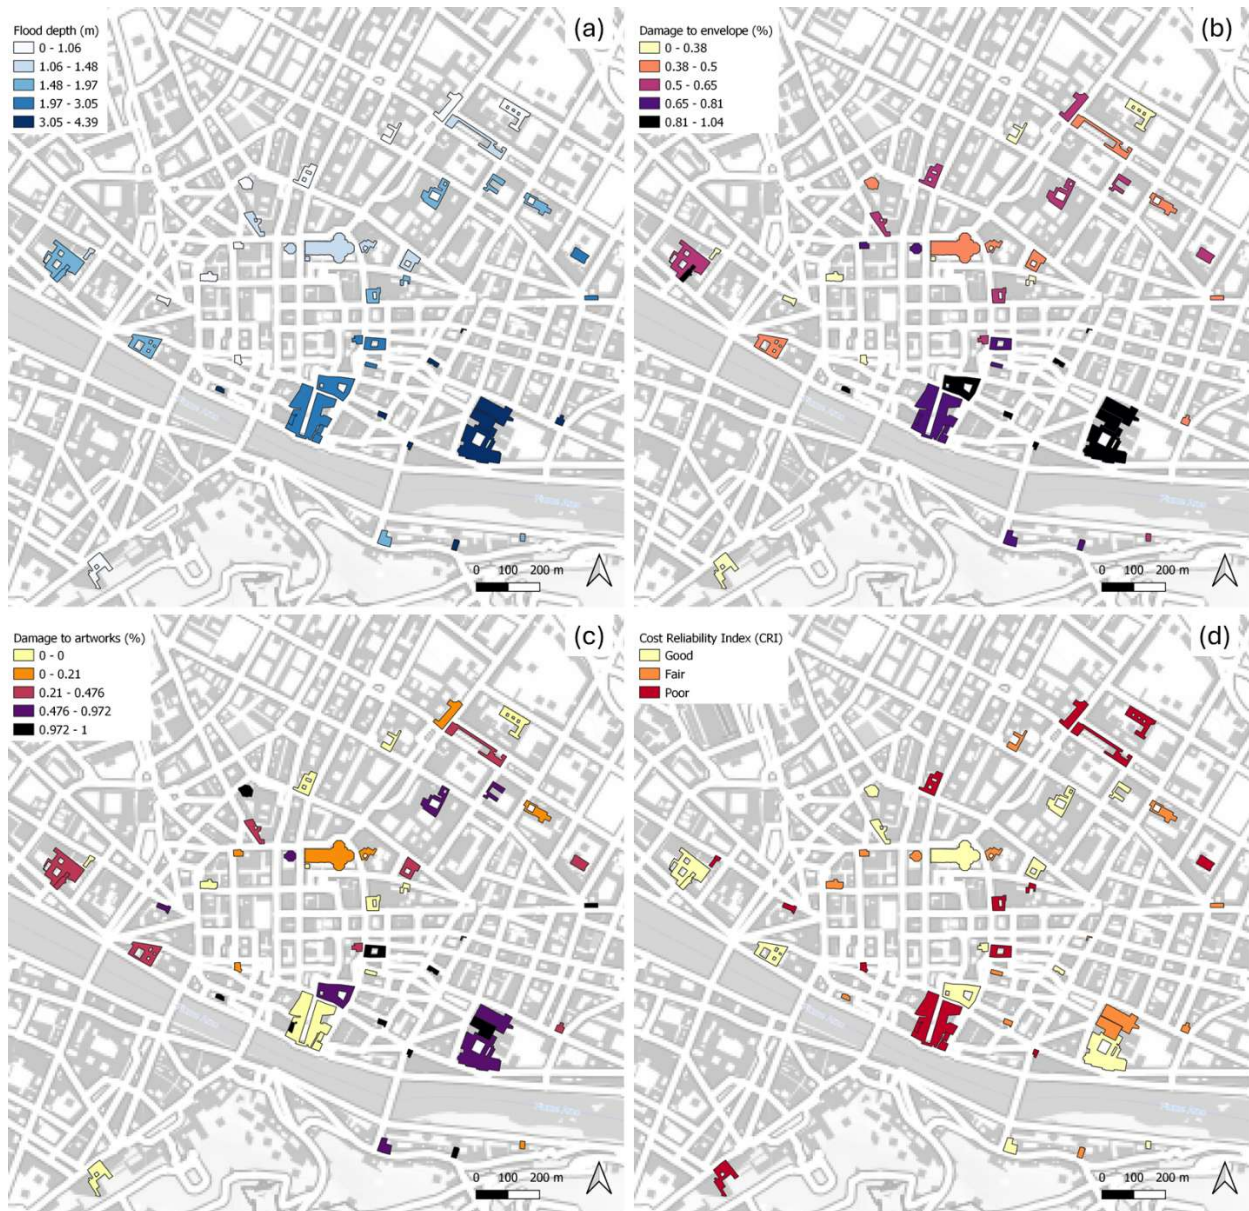
Fig. 7 Flood depths for the 500 years return period scenario (a), relative damage to the building envelope (b), relative damage to the artworks (c), Cost Reliability Index for artworks (d). Background maps are based on data from OpenStreetMap. © OpenStreetMap contributors, licensed under the Open Database License (ODbL).

The 2D hydraulic simulation developed by Arrighi et al. (2022) provides flood maps for various scenarios,
enabling the estimation of water depth at each CH building. For demonstrative purposes, the 500-year return
period scenario is used to assess flood damage. Figure 7 (panel a) illustrates the flood depth in proximity to
525 buildings. It is evident that cultural heritage (CH) buildings located near the river experience the greatest flood
depths—on the order of 3–4 meters above the road pavement in the S. Croce district (lower right area of panel
a). Conversely, moving downstream and away from the river, flood depths at CH buildings decrease
significantly.

The relative damage to building is shown in Figure 7 (panel b). The most exposed assets, depicted in black
530 and purple, exhibit losses exceeding 65% under the analyzed flood scenario. Notably, the pattern of damage
to building does not decrease in direct correlation with flood depth. This discrepancy arises from variations in

Regarding the relative damage to artworks (Figure 7, panel c), the results are more variable due to the heterogeneous distribution of artworks, differences in material susceptibility, and their positioning within CH buildings. Notably, artworks in four cultural buildings—whose ground floors are elevated above street level—remain unaffected, despite their location in flooded areas under the 500-year return period scenario. Nevertheless, the S. Croce district, which hosts libraries, museums, and small churches, emerges as a significant cluster of potential artwork damage.

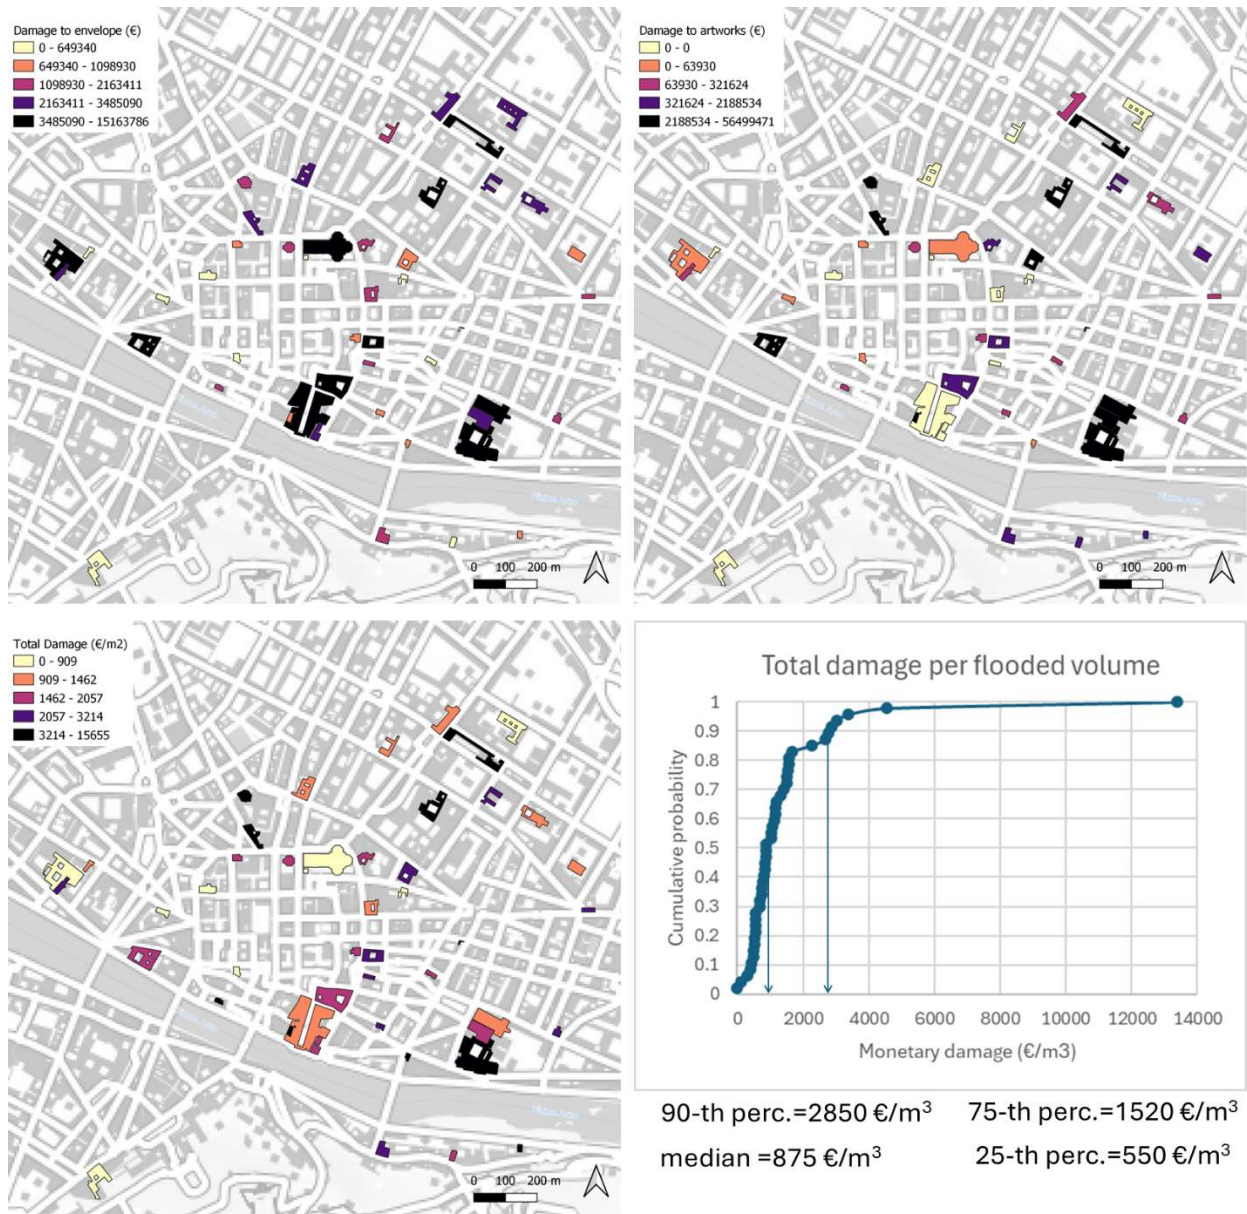
Fig. 8 Monetary damage to CH envelope (a), artworks (b), unitary surface damage (c) and unitary volume damage (d).
 585 Background maps are based on data from OpenStreetMap. © OpenStreetMap contributors, licensed under the Open Database License (ODbL).

Monetary damages are presented in Figure 8 for buildings (panel a) and artworks (panel b). Damage to the buildings is primarily driven by the larger cultural heritage (CH) buildings in the study area, with the five most affected assets each exceeding €5 million in estimated losses. The average monetary damage to buildings is approximately €2.5 million per building, corresponding to around €1,400 per square meter. The total estimated damage to buildings across the 48 assessed buildings amounts to approximately €120 million.

Artwork-related damages are predominantly concentrated in libraries and certain museums, with the three most affected institutions—the National Library, the Archaeological Museum, and the university library—each incurring losses exceeding €10 million. The Archaeological Museum, in addition to its vast collection of artefacts, houses, within its flood exposed levels, an extensive archive of books, as well as papyrus and

565 parchment manuscripts (nearly 100,000 items), and photographs documenting archaeological campaigns since the 19th century (over 2 million, according to the museum manager). Therefore, all three of the most affected institutions contain paper-based materials, which are highly susceptible to water damage. The average monetary damage to artworks in CH buildings is estimated at €3 million per asset, corresponding to approximately €1,110 per square meter. The total estimated monetary damage for artworks is approximately €150 million.

570 Figure 8 (panel c) illustrates the combined damage (building and artworks) expressed as unit cost per square meter. Unitary total damages range from approximately €500–700/m² to €2,000–4,000/m², with localized peaks exceeding €10,000/m², thus spanning two orders of magnitude. By dividing the unitary total damage by the flood depth, a unit monetary damage per flooded volume of CH is obtained. The cumulative probability distribution of this metric is shown in Figure 8 (panel d). The median and 75th percentile values for monetary damage per cubic meter of flooded volume are €875/m³ and €1,520/m³, respectively.
