Development of flood vulnerability functions for cultural heritage buildings and artworks for damage assessment in art cities

Claudia De Lucia¹, Chiara Arrighi¹

¹Department of Civil and Environmental Engineering, Università degli Studi di Firenze, Florence, Italy

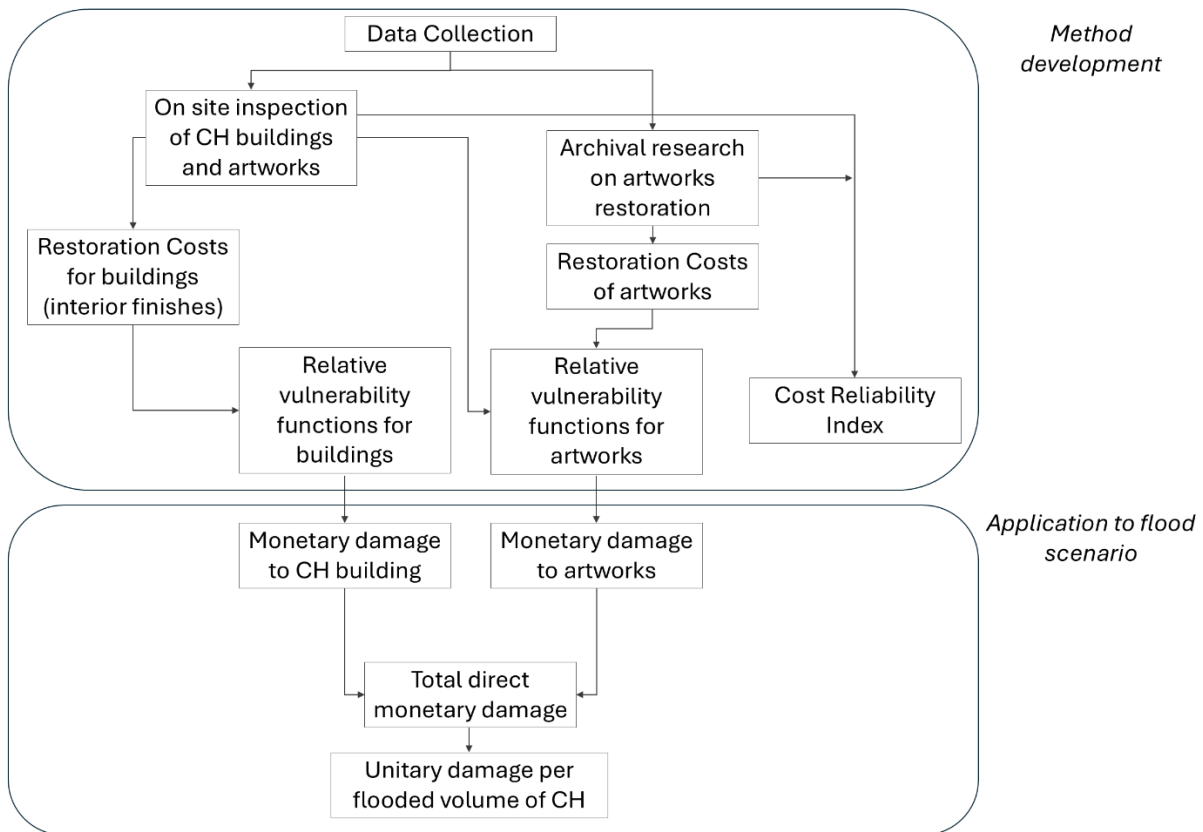
Fig. 1 Methodological scheme of the work.

This section outlines the materials and methods employed in this study to develop vulnerability functions for
90 cultural heritage and to apply them to the selected study area. In this work, we use the term *CH site* as a general designation for all types of cultural heritage, including both buildings and artworks. When referring to these specific components individually, we use the terms *building* and *artwork*, respectively. The methodological workflow is summarized in Fig. 1. Section 2.1 presents the essential data collected through field surveys, geospatial analysis, and archival research, which are necessary for assessing the flood vulnerability of cultural
95 heritage sites. Section 2.2 details the investigation carried out to estimate restoration costs for both CH buildings and artworks. Sections 2.3 and 2.4 constitute the core of the paper, as they present the development of vulnerability functions for the CH buildings and the artworks housed within them. Finally, Section 2.5 describes the method used to assess city-scale damage based on the previously developed vulnerability functions.

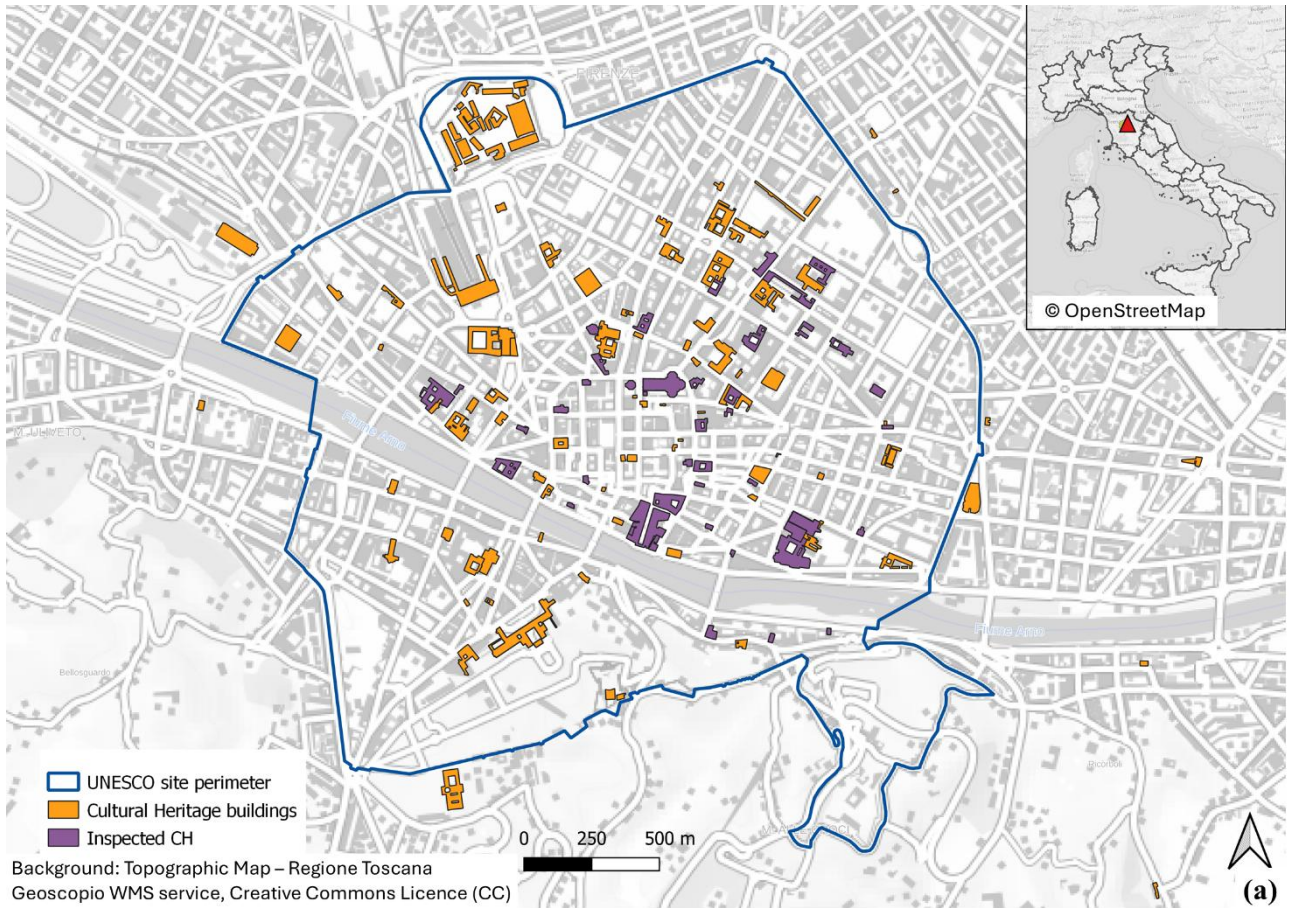
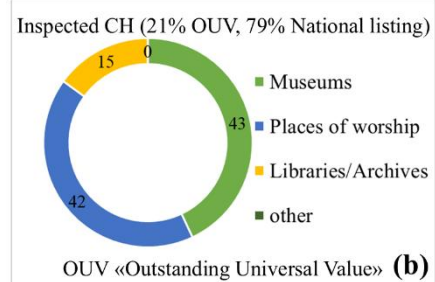
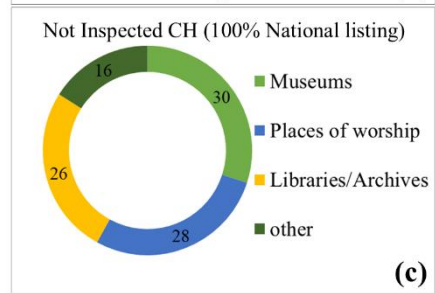
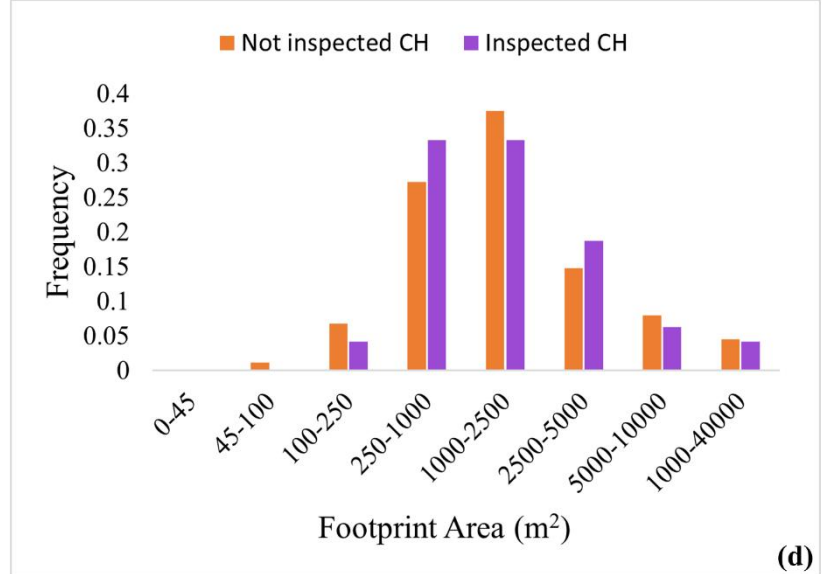
Fig. 2 Florence study area, cultural heritage buildings and those inspected for the development of vulnerability functions (a). Characteristics of inspected vs not inspected CH in terms of typology and protection status (b, c) and distribution of footprint area (d). Background map is based on data from OpenStreetMap. © OpenStreetMap contributors, licensed under the Open Database License (ODbL).

This method is applied to the CH of the historical city center of Florence (Fig.2, a), located in central Italy, which has been recognized as a UNESCO World Heritage since 1982. The UNESCO World Heritage Committee has acknowledged that the Historic Centre of Florence is the result of long-lasting creativity, whose influence has profoundly shaped architecture and fine arts of Italy and Europe (<https://whc.unesco.org/en/list/174/>).

Libraries and archives, although subject to different accessibility and regulatory conditions, are grouped together due to their similar storage systems (i.e., shelving) and the nature of their collections, which are primarily paper-based. Places of worship, by contrast, constitute a separate group for vulnerability analysis despite their internal diversity. They share several key features, including the presence of frescoes and wall decorations, similar types of artworks (e.g., panel paintings and wooden sculptures), and comparable display arrangements. The surveyed sample of places of worship includes 15 churches, 2 oratories, 1 baptistery, and 1 Jewish temple. The percent distribution of CH types in the surveyed sample, reflects pretty well the types not included in our detailed analysis (30% museums, 28% places of worship, 26% libraries/archives, 16% other, e.g., theatres or train stations) (Fig. 2 b,c). Moreover, the mean and median statistics of the footprint area of the CH building align well in the two samples (mean=2250 m², median=1292 m², mean=2652 m², median=1433 m², in the surveyed and not surveyed samples respectively) (Fig. 2 d).

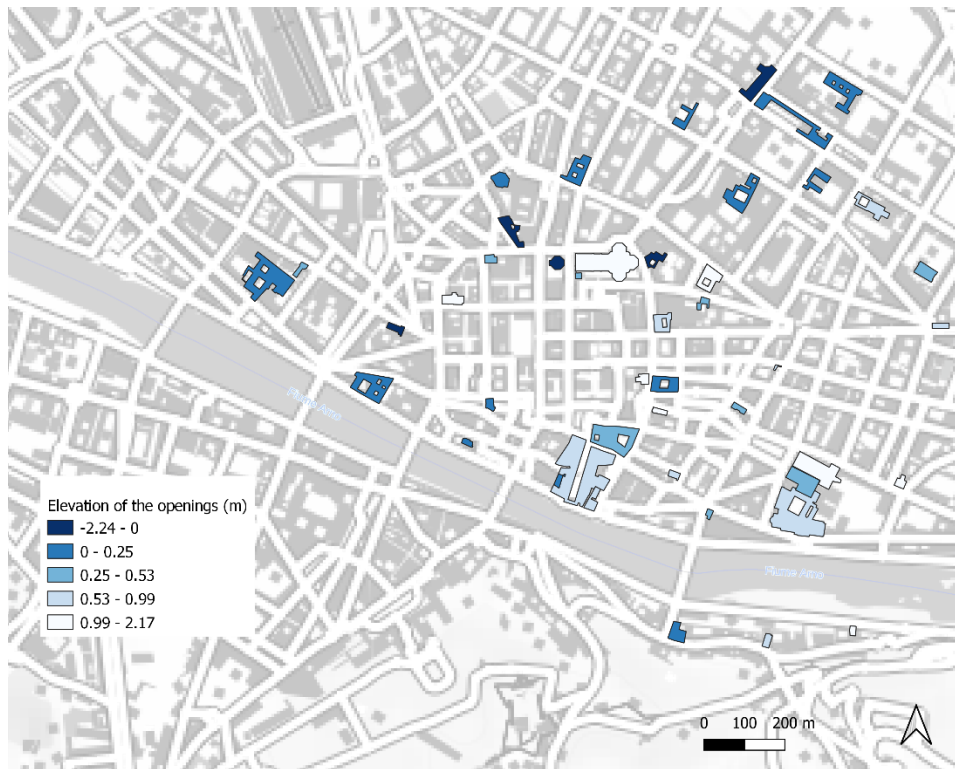
Fig. 3 Elevation of the cultural heritage building openings HO above the road pavement after on-site measurements. Background map is based on data from OpenStreetMap. © OpenStreetMap contributors, licensed under the Open Database License (ODbL).

395 Among the 48 cultural heritage sites examined, 42% are places of worship, 43% are museums, and 15% are libraries. A majority of these sites (41 out of 48) have a basement, 34% of which are used to store artworks. Notably, some museums—such as the Marino Marini Museum—are located in former places of worship, where crypts have been repurposed to house parts of the permanent collection or temporary exhibitions. In most cases, however, museum basements are used to store artworks that are not part of the public display. By 400 contrast, only 4 out of 20 places of worship and 2 out of 7 libraries utilize their basements for artwork storage. In the majority of the inspected cultural heritage buildings, the ground floor is elevated above street level. On average, the elevation of the main entrance is approximately 0.54 meters. This average increases to 0.72 meters for places of worship and decreases to 0.33 meters for museums. The highest recorded elevation among the surveyed sites is 2.17 meters, observed at the Santa Croce Church. *Figure 3* presents the measured elevations 405 of building openings above road pavement for the inspected sites.

The elevation of these openings is a critical factor in determining flood exposure, as it directly influences the flood depth threshold used to define zero-damage levels in vulnerability functions.

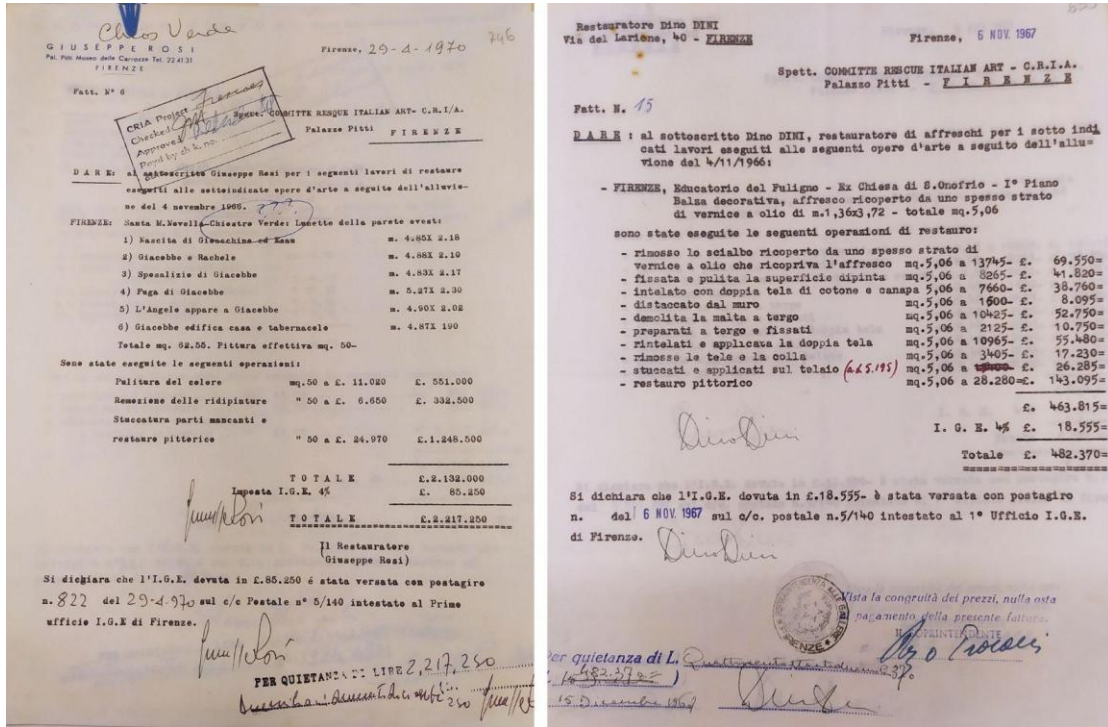
Fig. 4 An example of invoices issued by restorers after flooding 1966, stored in CRIA archive

Following the field investigations, the research focused on a detailed analysis of damage caused by historical flood events. The CRIA archive (Committee to Rescue Italian Art) contains extensive documentation on the 1966 flood in Florence, including photographs (over 900), videos, and written records. Restoration invoices issued after the event were examined and categorized by artwork type—primarily paintings on canvas, paintings on wooden panels, and wooden sculptures. *Figure 4* provides an example of these invoices related to restoration work carried out post-flood. The list of restoration activities documented for flood-damaged artworks was used to update restoration costs to present-day values, enabling the estimation of contemporary repair costs based on historical data.

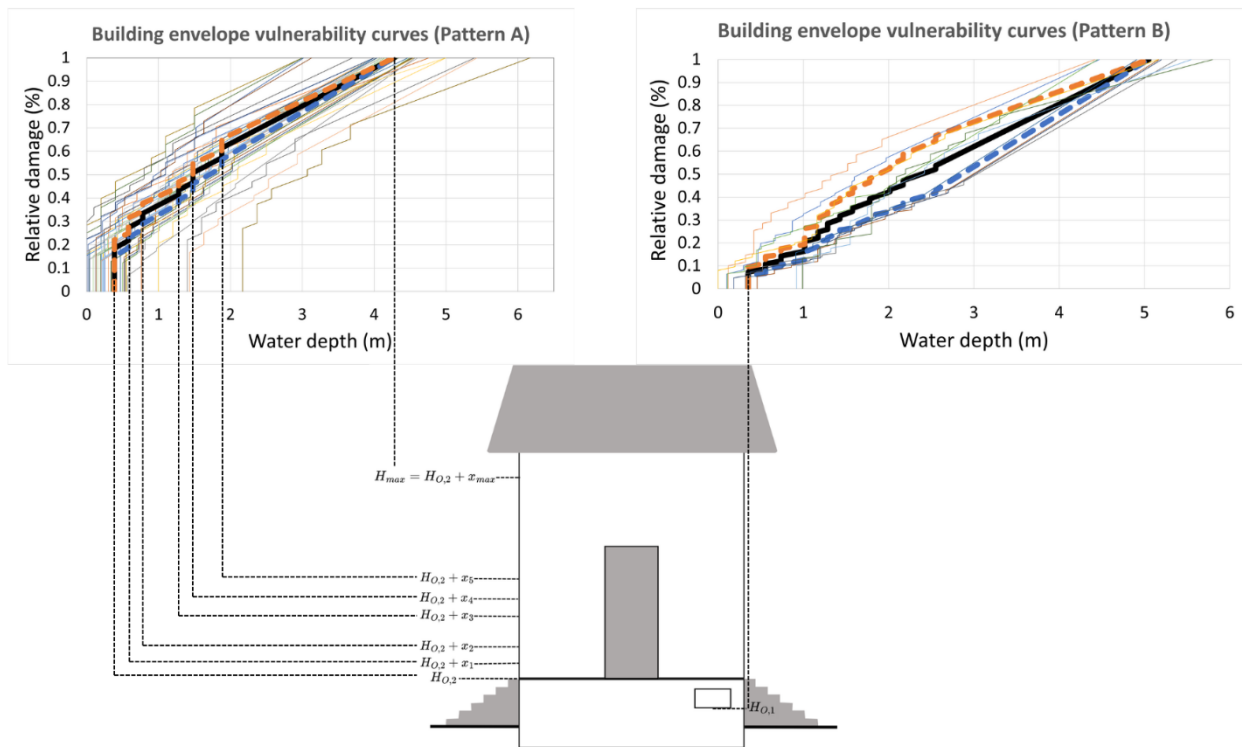
Fig. 5 CH Building vulnerability functions: Pattern A (on the left) and Pattern B (on the right). The bold black, orange and blue curves are the average, 75th and 25th percentile vulnerability functions.

The building analysis yields a specific vulnerability function for each CH building. These functions typically exhibit a combination of two growth patterns: a linear progression, reflecting damage to finishes and plaster, and a stepwise increase, associated with damage to floors and utility systems. Two vulnerability patterns, independent of CH types, are identified in the study area. These patterns reflect different inundation behaviors depending on the presence of a basement and its hydraulic connectivity to the road surface, along which the flood propagates. Figure 5 presents the two distinct vulnerability patterns, each accompanied by an average function (solid black line), the 25th percentile (orange dashed line), and the 75th percentile (blue dashed line). Pattern A (left) is characterized by six steps and represents damage scenarios for buildings either without basements or with basements that flood simultaneously with the ground floor. This occurs when basement openings are either absent or positioned above the elevation of the main entrance—typically in buildings with multi-level ground floors. The first step of the function corresponds to the point at which floodwaters reach the lowest opening, thereby affecting the floor. On average, this occurs at a water depth of 0.39 m, resulting in approximately 18% relative damage to the building. The extent of damage at this initial stage tends to increase with the building's surface area.

Subsequent steps in Pattern A correspond to progressive damage to electrical and plumbing systems. When the electrical system is fully compromised—typically at an average water depth of $w = H_{O,2} + x_s = 1.88$ m—the relative damage reaches approximately 62%.

In contrast, Pattern B (right) corresponds to buildings where the basement floods before the ground floor due to basement openings located below the elevation of the main entrance or any ground-floor openings. In this scenario, damage is assumed to occur equally at each level. Accordingly, Pattern B functions are derived by summing two identical stepwise curves, each shifted along the x-axis by $w = H_{O,2} - H_{O,1}$, representing the elevation difference between ground-floor and basement openings. As a result, the vulnerability curve for Pattern B includes twelve steps—six for each level.

As shown in Figure 5, buildings following Pattern B begin to sustain damage when water reaches the lowest basement opening, at an average depth of 0.36 m. Typically, when water depth reaches 2.55 m, the electrical systems on both levels are entirely compromised, and approximately 54% of the interior finishes of the building is damaged.

Only 10 CH buildings fall under Pattern B. Due to the low elevation of their basement openings relative to the street level, the first damage step for most of these buildings occurs at water depths below 0.5 m. The sole

exception is the National Library of Florence, where the basement windows are located 0.99 m above street level, requiring a greater flood depth to trigger initial damage. The average and percentile vulnerability functions for the CH building are also displayed as supplementary materials of the manuscript.

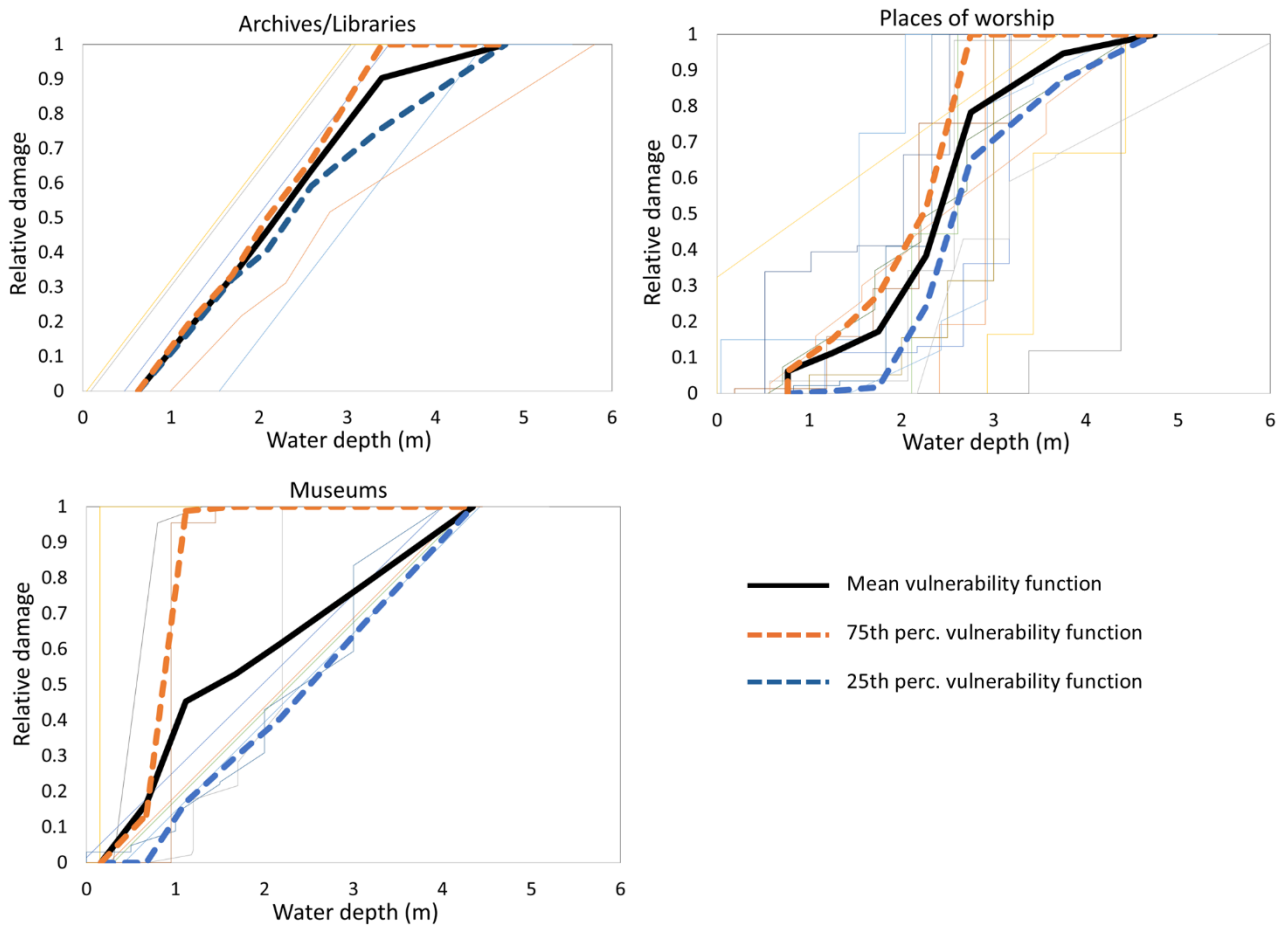
Fig. 6 Artworks vulnerability functions for libraries/archives (top left), places of worship (top right) and museums (bottom left). The bold black, orange and blue curves are the average, 75th and 25th percentile vulnerability functions.

The vulnerability assessment of artworks, as described in Section 2.4, yields a vulnerability function for each cultural site. These functions account for both movable and immovable artworks, illustrating how damage increases with rising water depth. Figure 6 groups the resulting vulnerability functions into three categories based on asset type: archives/libraries, places of worship, and museums. In each graph, the black line represents the average vulnerability curve, while the blue dashed line and orange dashed line represent the 25th and 75th percentiles, respectively. Only cultural site with a Cost Reliability Index (CRI) value below 0.3 are included in the figure.

Figure 6 (top right panel) presents the vulnerability curves for places of worship in the city of Florence. Approximately 69% of these curves exhibit a stepwise growth pattern, while the remaining curves display a combined trend of linear progression and stepwise increase. This mixed behavior reflects the coexistence of large-scale artworks, such as frescoes, and smaller movable objects, including paintings on canvas and sculptures. On average, no damage is recorded until the external water depth reaches approximately 0.77 m, after which the relative damage increases rapidly to 6.2%. A significant inflection occurs at around 1.75 m, where the damage rate increases sharply—from 0.12 to nearly 0.4. Complete damage is observed at a water depth of approximately 4.7 m. This depth–damage behavior aligns with the field data collected and supports findings from previous studies (Salazar et al., 2023; Figueiredo et al., 2021). Initially, elevated ground floors help delay damage; however, once floodwaters breach the entrances, ground-level artworks—such as marble fonts and wooden pews—are immediately affected. When internal water depth reaches around 1 m, artworks located at higher elevations, such as altar paintings, are also impacted, significantly increasing restoration costs.

In the museum category, multiple vulnerability patterns are observed, reflecting the diversity of museum types.

510 This category includes sites ranging from galleries, which display large numbers of paintings or sculptures, to cenacles and historic palaces entirely decorated with frescoes. In galleries, the vulnerability function typically shows a stepwise pattern, while fresco-covered spaces often follow a linear progression. A particularly notable case is represented by the yellow curve, which shows a single-step transition from zero to 100% relative damage. This curve corresponds to the “Cappelle Medicee” museum, which houses the Medici Crypt, the
515 burial site of the Grand Dukes and their families. Due to the exceptional historical and evidential value of the marble gravestones covering the crypt’s floor, the museum is considered completely damaged as soon as floodwaters infiltrate the building (Historic England, 2008). An analysis of average vulnerability functions across the museum category reveals that relative damage increases rapidly up to a water depth of approximately 1.12 meters, after which the rate of increase slows, as indicated by a decrease in the average slope of the
