The 15 September 2022 floods in northern Marche (Central Italy): disaster analysis, case studies and mitigation strategies for ~~geomorphological–hydraulic risk~~ hydro-geomorphological hazard

Abstract. On September 15th and 16th, 2022, a large area of the Marche region in central Italy experienced an exceptionally heavy rainfall event, with nearly 420 mm/m² of rain falling in just six hours. The intense rains, in addition to causing 13 fatalities, triggered a large number of landslides in the mountain areas and flood events, mainly concentrated along the valleys of the hydrographic basins of the Metauro, Cesano, Misa, and Esino Rivers. The physiographic setting of the territory and the poor maintenance of both the main and secondary hydrographic network, often insufficient or entirely absent, exacerbated an already exceptional event. Although extraordinary, the natural event ~~affected an area already hit by intense meteoric events in the past, the most recent of which occurred~~ occurred in an area already affected by intense meteoric events in the past, the most recent of which had taken place just eight years earlier, in 2014.

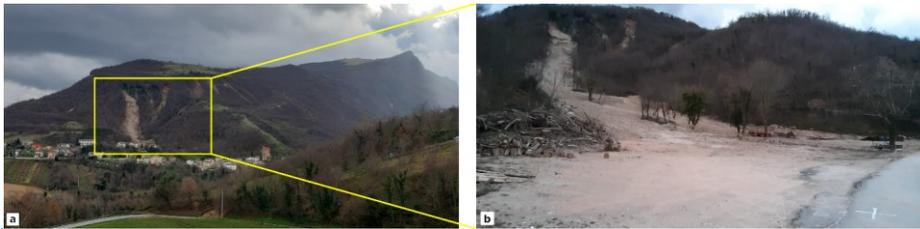
[2014\).](#) **Figure 1: a) the scars of landslide events along the northern slopes of Mt. Calvello, activated during the rainfall event in question and involving the hamlet of Leccia, municipality of Serra Sant'Abbondio (PU); b) detail of the frame in picture a).**

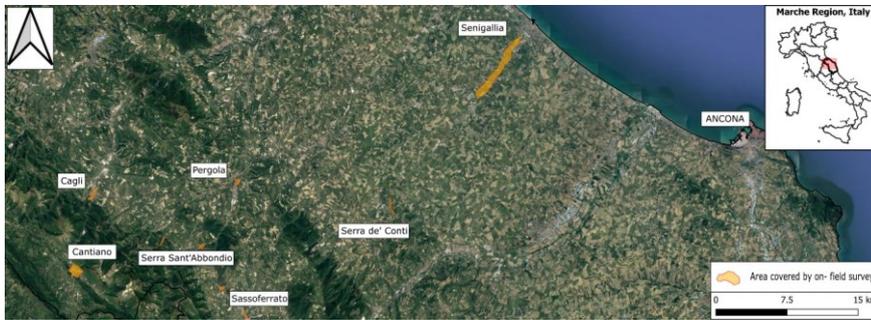
Figure 514: the surveyed locations in the provinces of Ancona and Pesaro Urbino, with the effective surveyed areas superimposed to the @Google Earth image and highlighted in orange.

As mentioned before, the study was conducted in some test areas which include some of the inhabited centres most severely affected by the flood event. The surveyed localities correspond to the most affected towns: Cantiano (PU), Cagli (PU), Serra Sant'Abbondio (PU), Pergola (PU), Sassoferrato (AN), Serra de' Conti (AN), Ostra (AN) and Senigallia (AN) (fig. 145).

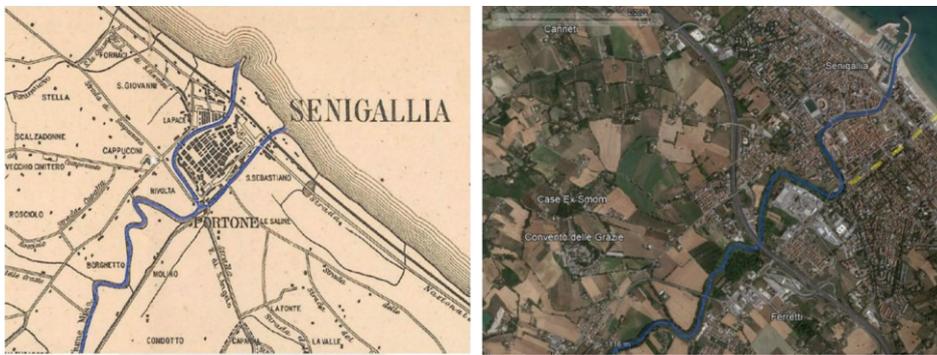
325 Figure 327: The comparison between the Misa River, highlighted in blue near Senigallia in an ancient map of 1889 (Santoni G.,
& Morici R., 2021) on the left and in a @Google Maps image of 2023 on the right, with the preexisting “Penna channel” dashed in
yellow, subsequently occluded about a century ago.

The case study of Senigallia represents a very didactic example of studying anthropogenic modifications of the territory.
Looking at the comparison between the ancient cartography of the Geographical Institute “De Agostini Novara” of 1889 and
the aerial image of 2023 (Fig. 327), it appears evident how the Misa River, at that time, had two channels, both flowing into
the Adriatic Sea. Within them, the ancient castle of the town was built, defended with imposing walls to protect against sieges
320 and floods.

In the past, floods came very frequently in Senigallia. For this reason, over the years, the farmers built the embankments along
the Misa River to protect field crops and livestock. At the same time, the municipal administrations built the so-called “cavo
Penna”, an artificial channel which flowed below the actual IV November Street and reached the sea, where today there is the

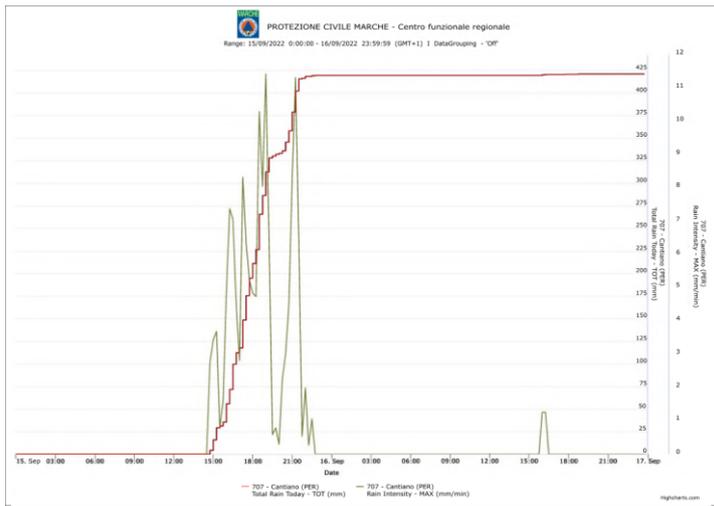
Figure 612: Cumulative and intensity of precipitation recorded by the rain gauge of Cantiano (redraw from Civil Protection of the Marche region, 2022). Times in the graph refer to standard time.

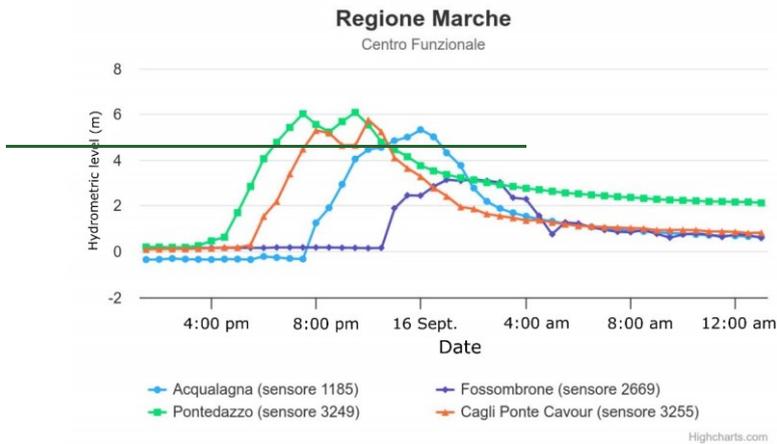
Figure 9: The hydrometric levels of the mountain portion of the Metauro River basin from Pontedazzo (Cantiano) to Fossombrone, from 1:00 p.m. of Sept. 15th, 2022, to 1:00 p.m. of Sept. 16th, 2022. Italian time (SIRMIP 2022).

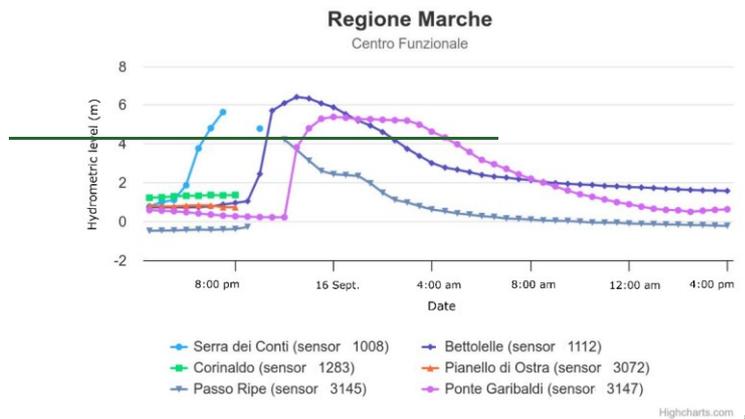
Looking at the hydrometric comparison between the hydrometers along the catchment area of the Misa River, it is immediately apparent how the hydrometers of Serra de' Conti, Corinaldo, Passo Ripe and Pianello di Ostra stopped because they were broken, temporarily disabled, or washed away as the flood arrived. The difference between Bettolle (municipality of Ostra) sensor 1112 and, downstream, Ponte Garibaldi sensor 3147 (Senigallia city centre). From Serra de' Conti in the mountain area to Garibaldi Bridge in Senigallia, the peak of the flood wave took presumably about three hours and a half.

Figure 10: The hydrometric levels of the Misa River basin between Serra de Conti (AN) and Senigallia (Garibaldi Bridge), from 4:00 p.m. of Sept. 15th, 2022, to 4:00 p.m. of Sept. 16th, 2022, Italian time (SIRMIP 2022).

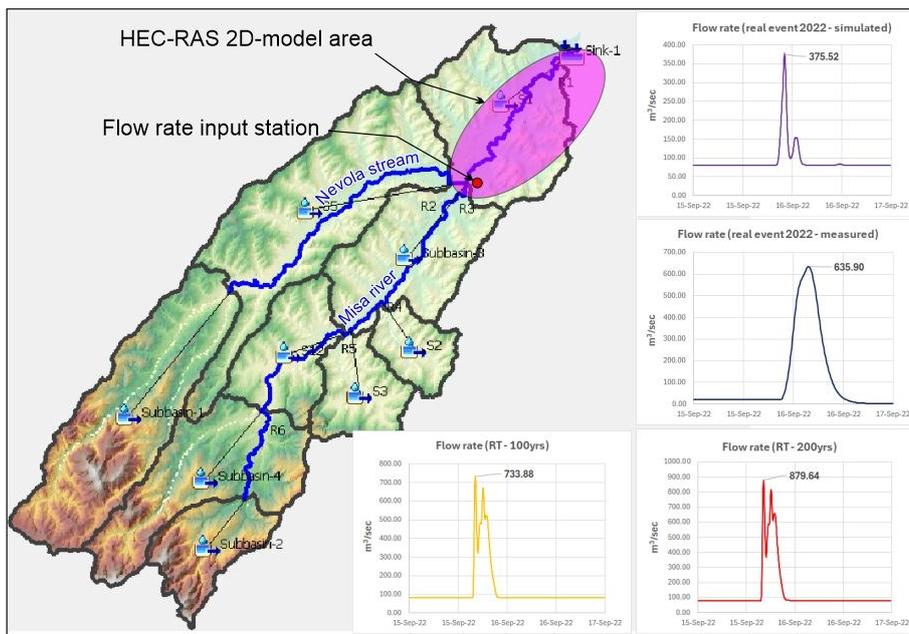
Fig. 14: HEC-HMS model results.

For the actual 2022 event, precipitation data were entered into the model with a relatively low average Curve Number (CN = 49), typical of dry conditions; the rainfall event had, in fact, been preceded by weeks of virtually no precipitation. Flow rate

550 calculation gives a value of approximately 375 m³/sec, a value significantly lower than that recorded at the Bettollele hydrometer (around 640 m³/sec). In the simulations estimating maximum flood discharges for 100- and 200-year return periods, on the other hand, an average Curve Number of 64 was used; this value is typical of "saturated" conditions, as required by legislation, which mandates consideration of the most unfavorable event scenario. Flow rates calculated for both scenarios give values of 733 and 879 m³/sec respectively.

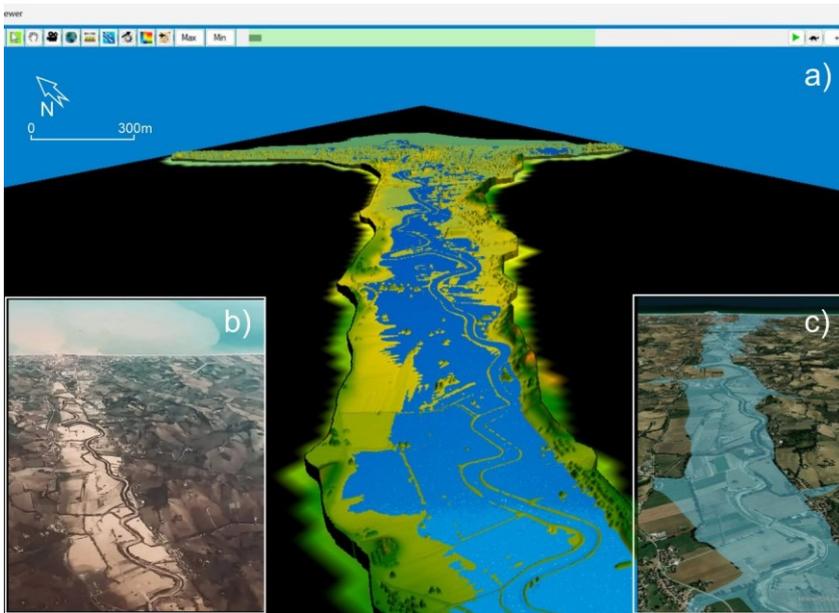
560 Fig. 15: Comparison between potentially floodable areas in relation to different event scenarios and the areas actually flooded during the September 2022 event in correspondence of the final stretch of the Misa River valley. (a) Flooded area using a flow rate of 640 m³/sec; (b) the flooded plain of the Misa River seen from an aircraft flying from Ancona to the United Kingdom on 16th September 2022 at 11.08 a.m. Italian time, with the well-recognisable flooded area, the main localities in yellow and the plume of

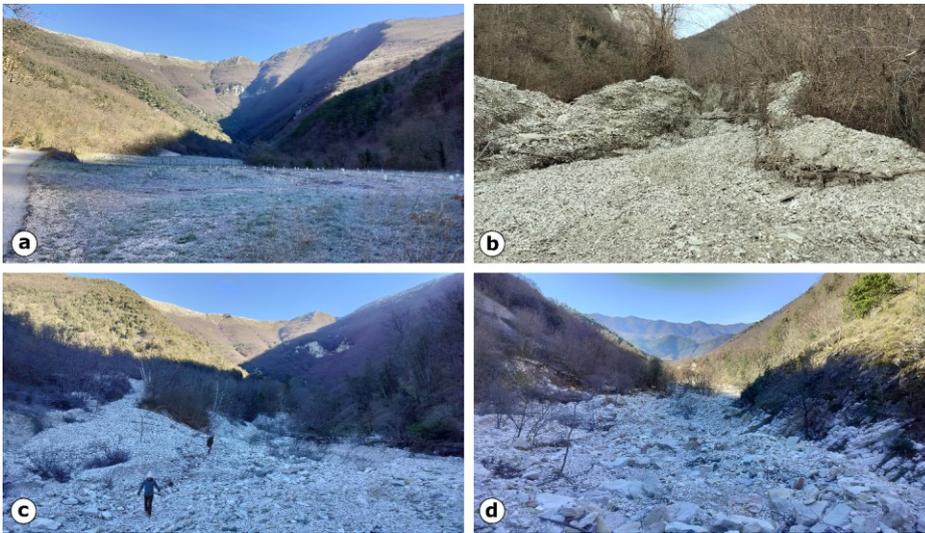
Figure 16: geomorphological criticalities detected along the Tenetra valley in the municipality of Cantiano: a) panoramic view of the valley seen from downstream; b) debris flow channel in the hydrographic right portion of Tenetra ditch; c) debris flow deposits of the channel in picture b) in the valley bottom side; d) the flat bottom of Tenetra Stream valley seen from upstream filled with debris flows sediments.

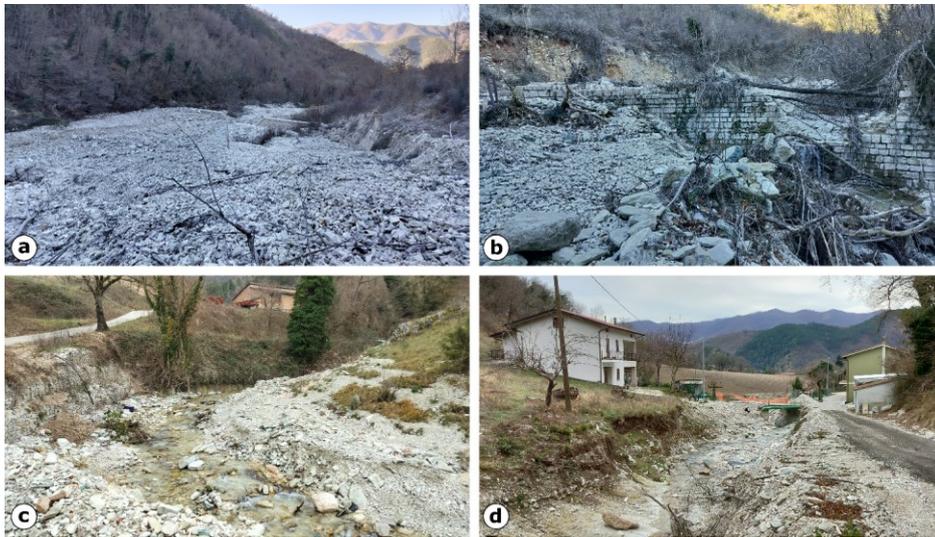
645 The on-field survey mapped different criticalities, also from the anthropic point of view. Along the watercourse, three hydraulic weirs were present, and they were entirely filled (fig. 17a) and damaged (fig. 17b) by the event, compromising their functionality. Some riverbank protection works were also damaged, such as the gabion wall (fig. 17c) protecting the municipal road. Another criticality was represented by the undersized bridge in the hamlet of Tenetra (fig. 17d), which was obstructed and overtopped during the flood so much that it separated the two dwellings on either side of it.

650 **Figure 17: Critical issues represented by the anthropic structures: a) a filled and buried hydraulic weir seen from upstream; b) a damaged hydraulic weir; c) damaged gabion wall; d) undersized bridge in the hamlet of Tenetra.**

hydraulic weirs (resulting damaged and filled) placed upstream with respect to the town counteracted the erosive potential of the stream, preventing major damage to downstream structures.

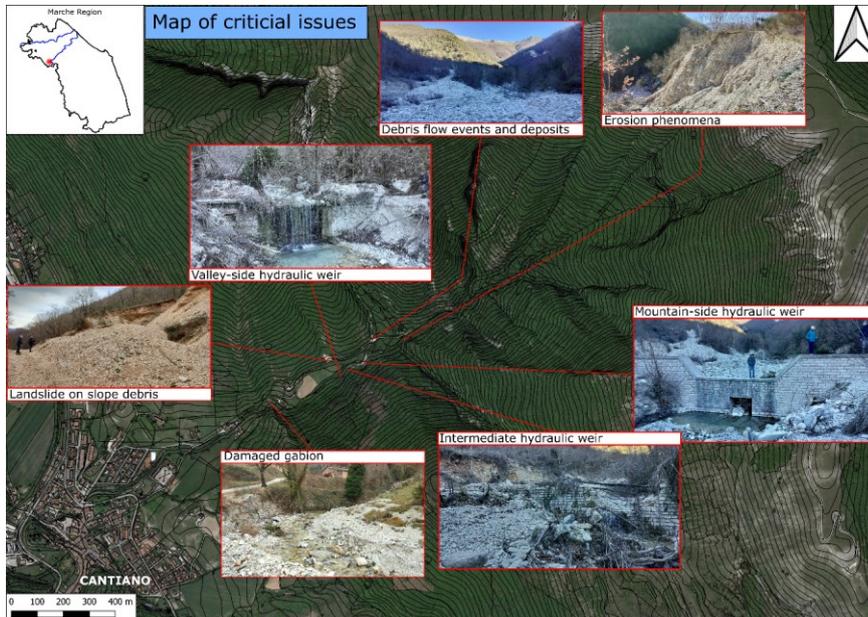
Figure 18: Map of critical issues in the Tenetra valley. The extent rectangle shows in black the boundaries of the Marche Region with Cantiano (in red) and the catchment area of the Metauro River (in blue). Cartographic layers from Regione Marche, n.d.

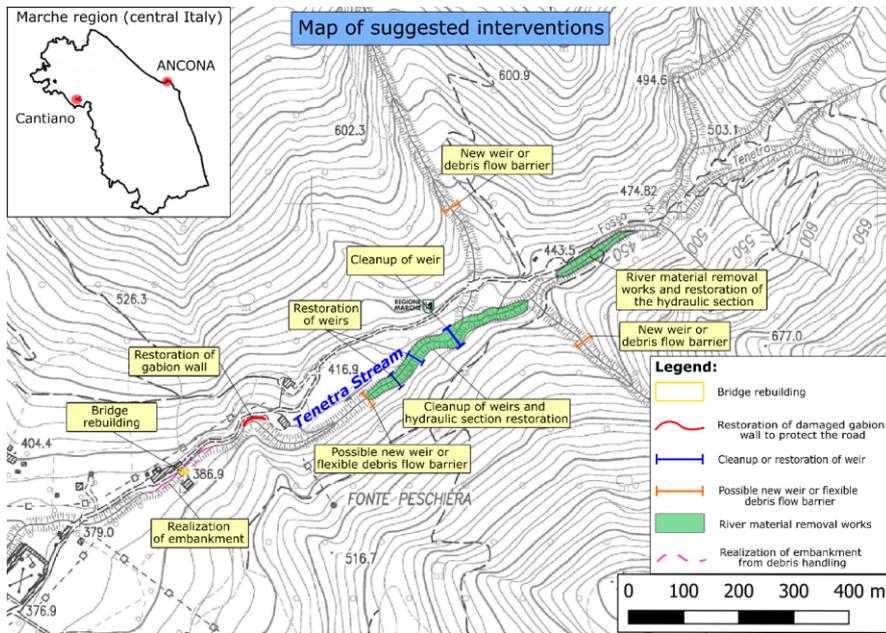
Figure 19: map of the suggested intervention in the Tenetra Valley. The extent rectangle shows in black the boundaries of the Marche Region with Cantiano (in red) and the catchment area of the Metauro River (in blue). Cartographic layers from Regione Marche, n.d.

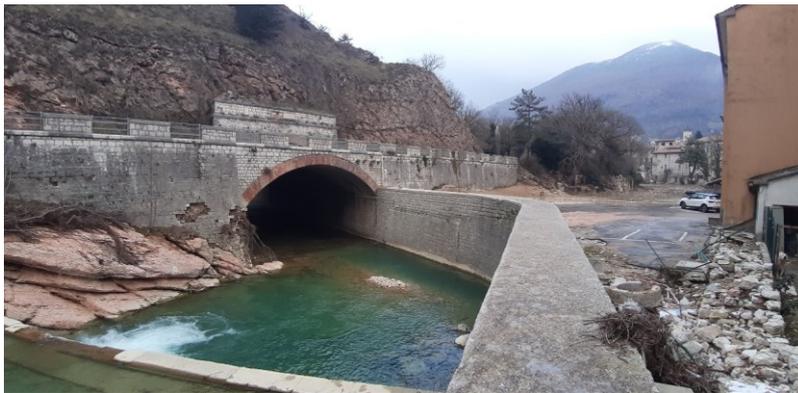
720 Figure 21: The 65-meter tunnel of the Burano River below the calcareous mountain ridge, with the anthropogenic embankment behind which the alluvial plain, the parking and the historical centre are recognizable.

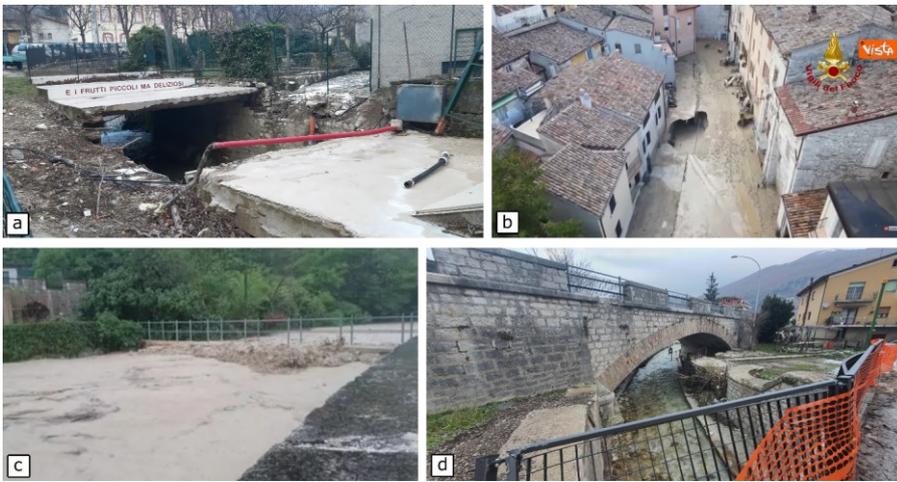
725 Figure 22: a) collapse of the tombed sections in Tumiati Street, Tenetra Creek; b) explosion of the buried sections in Fiorucci Street, Bevano Creek (courtesy of National Fire Department); c) undersized footbridge reached by the water level, subsequently washed away, Burano River; d) narrowing of bridge arch partially occluded by sediment and anthropogenic material, Bevano Creek.

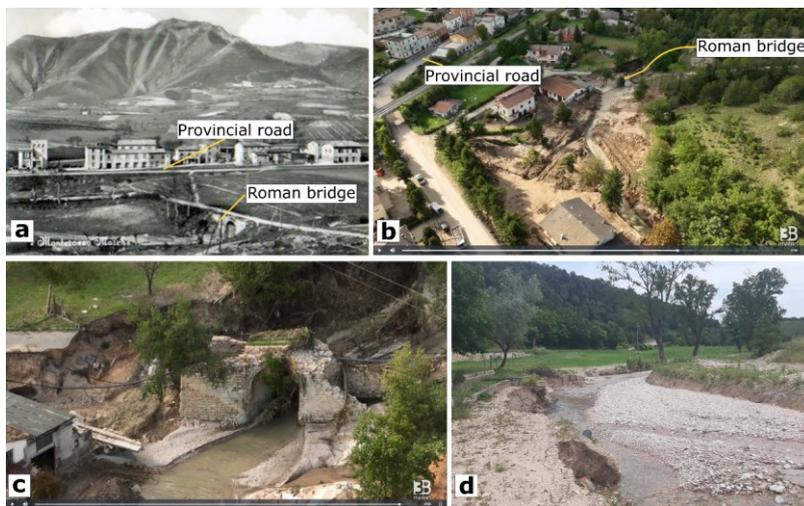
755 Figure 23: a) the Roman bridge at Monterosso Stazione above the Sanguerone Creek in a historical photo, with the eastern foothills
of Mt. Strega in the background (scanning from a postcard, then modified); b) the post-event situation for comparisons with image
a (also related to urbanisation). Note that in the past, the alluvial valley was not urbanised; c) the Roman bridge after the event
viewed from downstream, with the collapsed abutments; d) the unnamed ditch in Sassoferrato Stazione after the flood, with the
waterbed filled with gravel and raised about two meters compared to the pre-event situation. Images b) and c) come from

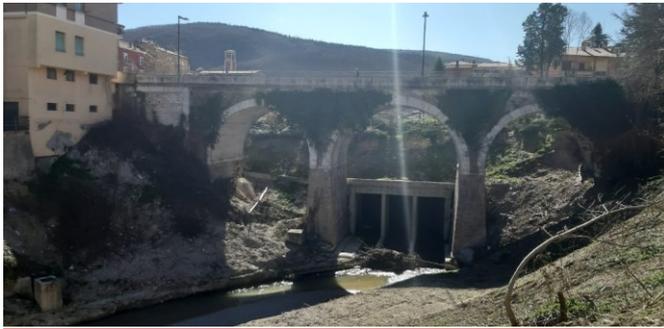
785 **Figure 25: The Garibaldi Street Bridge saw from upstream with the evident, extreme reduction of the original flow section with a box-like structure (the markers on the wall on the left mark the hydrometric levels reached).**

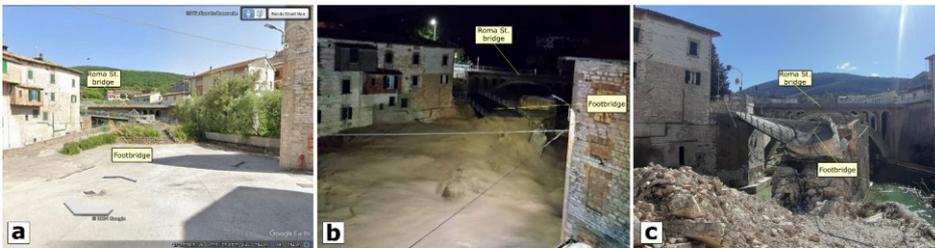
795 **Figure 26: The area exiting the tombed section of Sanguerone Stream under the Castellucci parking a) before, b) during and c) after the event.**

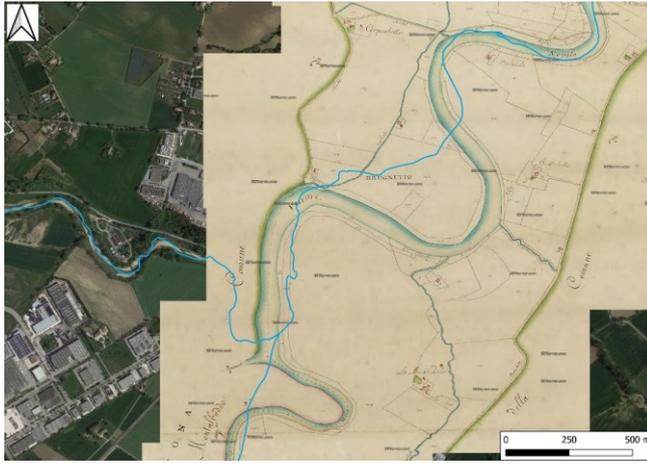
825 **Figure 27: The ancient map of the Gregorian cadastre (Archivio di Stato di Roma, n.d.) with the superimposed actual watercourses of the Nevola and Misa rivers (light blue lines). The modifications of the hydrographic network are well recognisable.**

The area is close to the Adriatic coastline and, from a topographic point of view, is almost exclusively flat, as it is the floodable area of the Nevola and Misa Rivers. During the time many anthropic modifications to the hydrographic network have been made to manage the watercourse and allocate as much land as possible for agricultural, industrial, or urban development purposes. The spatiotemporal analysis conducted through the comparison of historical cartographies highlighted a widespread discrepancy between actual and ancient maps (Fig. 27). The Gregorian cadastre of 1835 shows the area at the confluence between the Nevola and Misa rivers, coming from the West and South, and shows significant modifications made to the hydrographic network during that time.

Nowadays, this final portion of the Misa River appears completely channelled between artificial earthen embankments. On-field surveys and mapping also regarded these structures and identified their main criticalities.

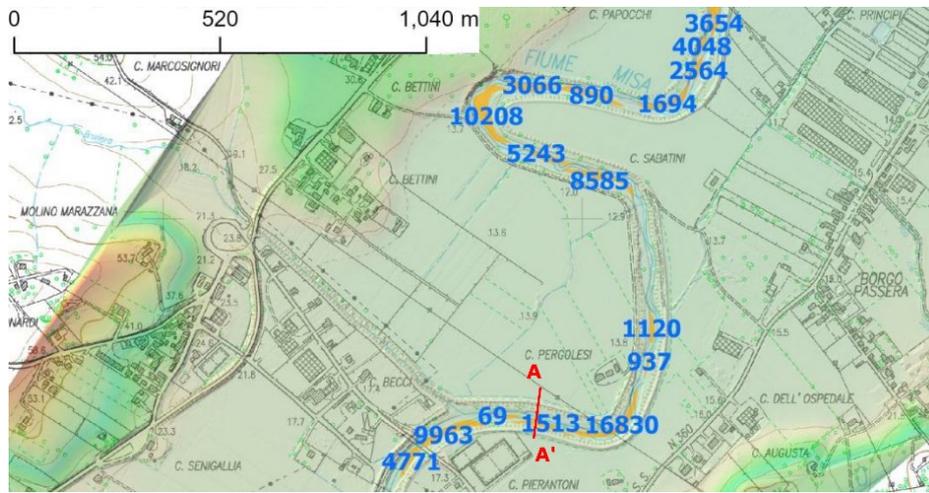
850 Figure 35: A stretch of the lidar image of the Misa River around Molino Marazzana (Senigallia). The blue numbers refer to the single volume of each river point bar (in orange) to be dredged to widen the river section. The red line indicates the section trace from which the river cross-sectional topographic profile (shown in the next image) was obtained through LiDAR data. The colour shades refer to the elevations.

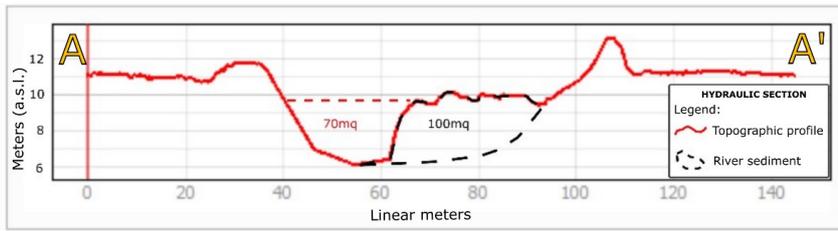
865 **Figure 29: The topographic profile of a representative stretch of the Misa River in Molino Marazzana (Senigallia) acquired through lidar survey after the flood event.**

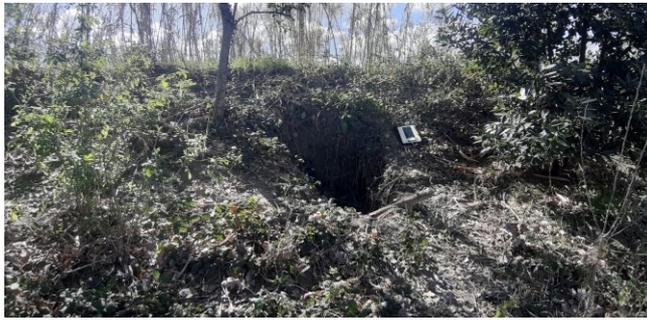
875 **Figure 30: The burrow of fossorial animals along the right embankment of Misa River in the hamlet of Borgo Catena (Senigallia), with A4 block notes for scale.**

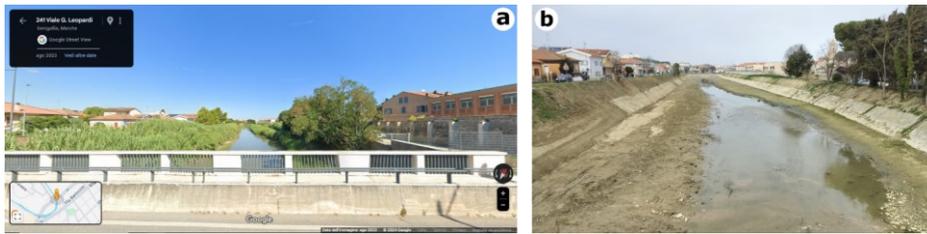
900 Figure 31: Two images of the same stretch of Misa River caught from Portone Bridge along Leopardi Street: a) in August 2023 (Google Earth image); b) in February 2024, after the works of the hydraulic section widening with the removal of sediments and vegetation, which exposed the concrete embankments constructed by the "Consorzio di bonifica del Misa" a century ago.

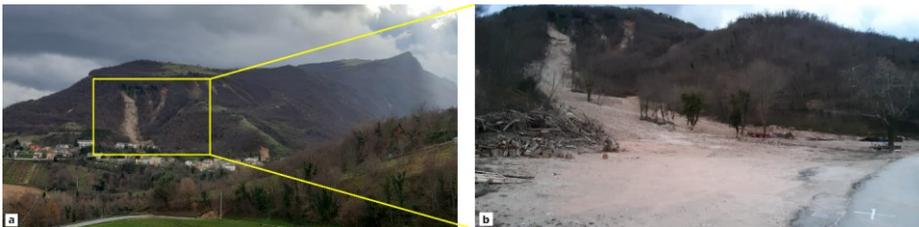
Figure 2: a) the scars of landslide events along the northern slopes of Mt. Calvello, activated during the rainfall event in question and involving the hamlet of Lecceia, municipality of Serra Sant'Abbondio (PU); b) detail of the frame in picture a).

925 During the events of the present study, along the mountain territories, very intense erosion phenomena were recorded along the slopes, with erosion gullies concentrated where surface runoff was most intense and the triggering of many gravitational events (see also Donnini et al., 2023; Santangelo et al., 2023). The geomorphological conformation of the Apennine territory predisposed the formation of different typologies of landslides. In many cases, the presence of an elevation gradient sometimes even of one thousand meters, the stratigraphic condition of the material and the disruptive action inferred by the meteoric processes, acted originating a large quantity of debris flow phenomena (fig. 2 a, b), involving coarse grained material with

930 gravel sizes ranging from cobbles to boulders, according to Udden, 2014 and Wentworth, 1922.

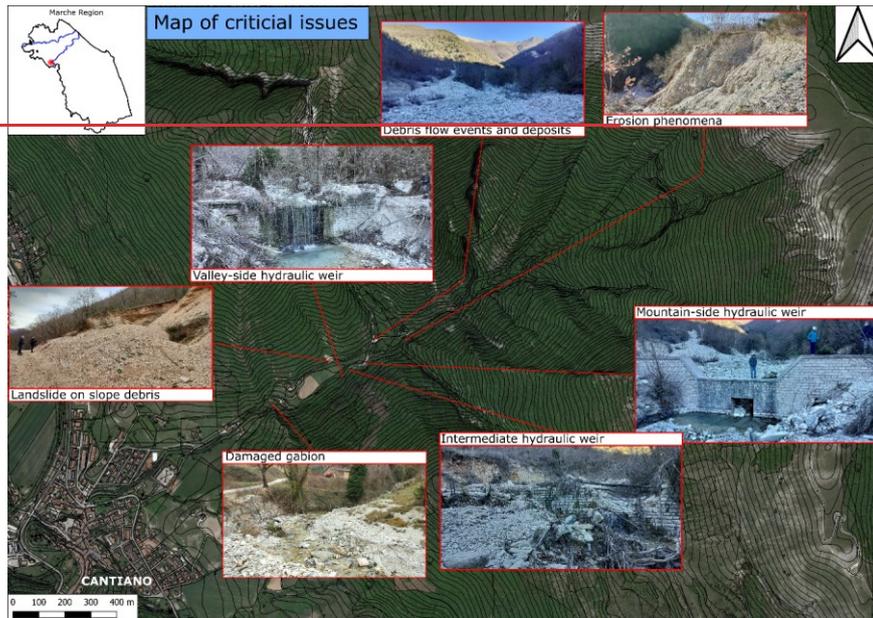
Figure 18: Map of critical issues in the Tenetra valley. The extent rectangle shows in black the boundaries of the Marche Region with Cantiano (in red) and the catchment area of the Metauro River (in blue). Cartographic layers from Regione Marche, n.d.

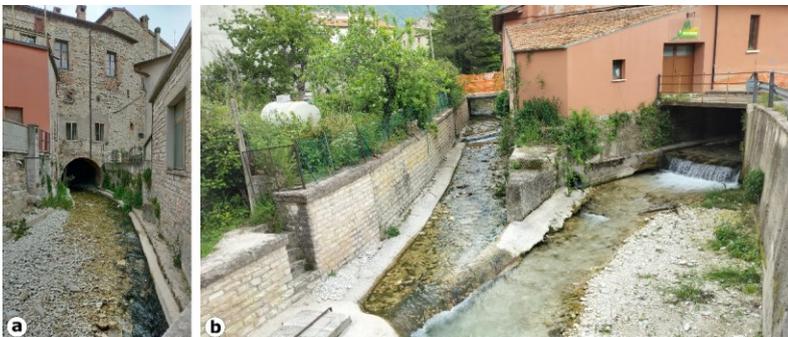
Figure 21: a) the Tenetra ditch channelled below a dwelling in the historical centre of Cantiano; b) the confluence between Tenetra (left) and Bevano creeks (right) in the historical centre of Cantiano with the channelled watercourses.

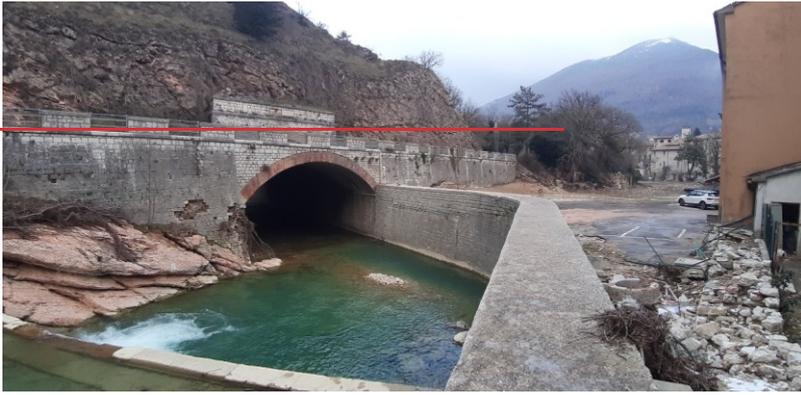
285 **Figure 22:** The 65-meter tunnelling of the Burano River below the calcareous mountain ridge, with the anthropogenic embankment behind which the alluvial plain, the parking and the historical centre are recognizable.

diverting it below a rocky ridge with a tunnel of about 65 meters (fig. 22). In this way, the river was supposed to abandon its floodplain, allowing humans to cultivate it and, in recent decades, create a parking space above it. This practice certainly proved to be a gamble because, during the flood of September 15th, 2022, Burano River in the proximity of Fiorucci Street was able to overflow above the artificial embankments built for its channelization (fig. 10), flooding the entire floodplain, the parking, Fiorucci street and to arrive at the historic city centre inundating all Luceoli square (fig. 23) with two main events, at 7:00 pm with a water level of 0.5 meters and at 10:00 pm raising 2.35 m. (hydrometric levels recorded in front of the town hall). Effectively, the Bevano Creek originally flowed through Luceoli Square, as evidenced by the Gregorian cadastre cartography of 1835 consulted as an indispensable tool supporting the present work (fig. 24). Even the most significant contribution was provided by the Burano River, the main responsible for the flood, also for its higher flood discharge. The swollen watercourses merely occupied and reclaimed their original spaces. For this paper, a map was produced showing the anthropogenic interventions that have forced the watercourses over time (fig. 12) greatly affecting the surface hydrological regime.

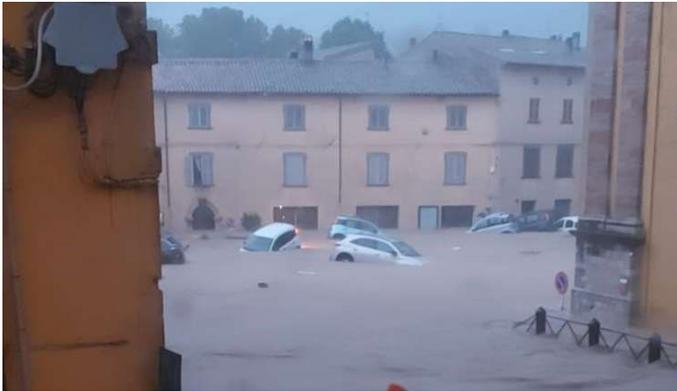
290 **Figure 23:** The entirely flooded Luccoli Square in the historical centre of Cantiano during the afternoon of 15th September 2022. Image from <https://www.vivereurbino.it/2022/09/16/alluvione-cantiano-interc-zone-isolate-impraticabili-le-statali-flaminia-c-della-contessa-scuole-chiuse/2100257772/#> (accessed on 09.09.2024).

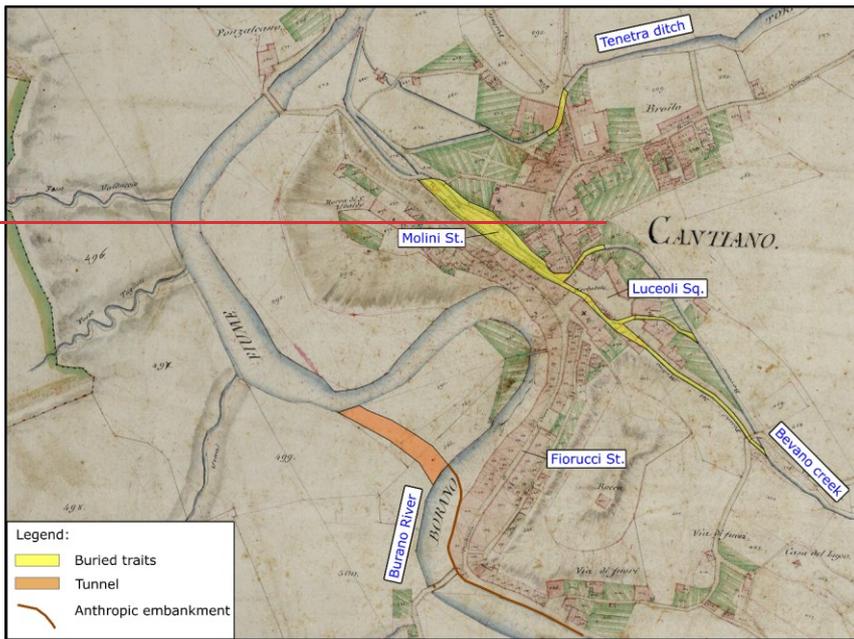
Figure 24: schematic map of the main anthropogenic surface-water regulation interventions superimposed on the Gregorian cadastre (Archivio di Stato di Roma, n.d.). It is easily recognisable that the abandoned meander is destined for human use.

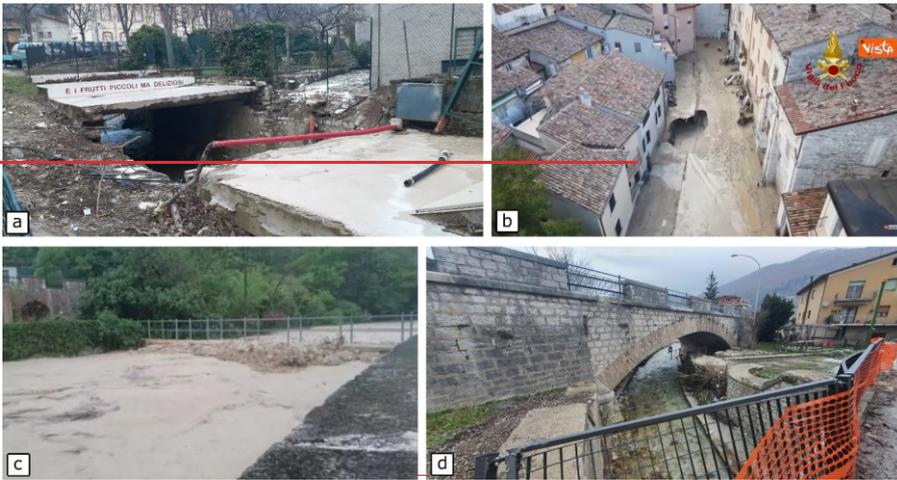
Figure 25: a) collapse of the tombed sections in Tumiati Street, Tenetra-Creek; b) explosion of the buried sections in Fiorucei Street, Bevano-Creek (courtesy of National Fire Department); c) undersized footbridge reached by the water level, subsequently washed away, Burano River; d) narrowing of bridge arch partially occluded by sediment and anthropogenic material, Bevano-Creek.

The culverts were undersized, both in size and construction details, because the covers did not withstand the hydraulic pressures set below them and they literally collapsed (fig. 25a and 25b). Moreover, during the on-field surveys, other critical issues were detected: undersized bridges with a limited height between intrados and riverbed (fig. 25e), partially occluded arches of the bridges (fig. 25d), absent river maintenance with the presence of vegetation and sediment that can reduce the hydraulic section during flood events:

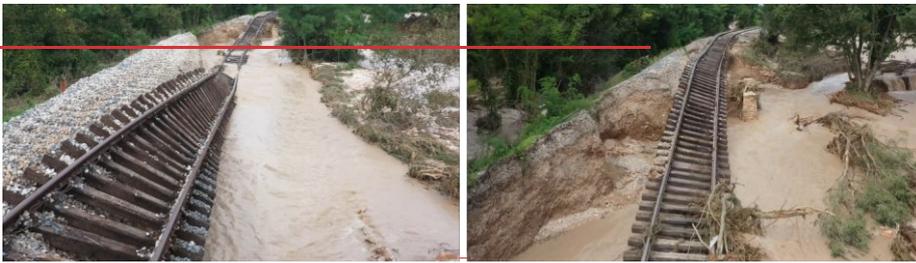
Figure 28: The railway upstream of Monterosso Stazione, completely damaged by the flood (images from <https://www.ilfattoquotidiano.it/2022/09/16/alluvione-nelle-marche-il-drone-sorvola-la-ferrovia-a-monterosso-stazione-binari-sommersi-e-massicciata-erosa/6806043/> (accessed on 12.11.2024).

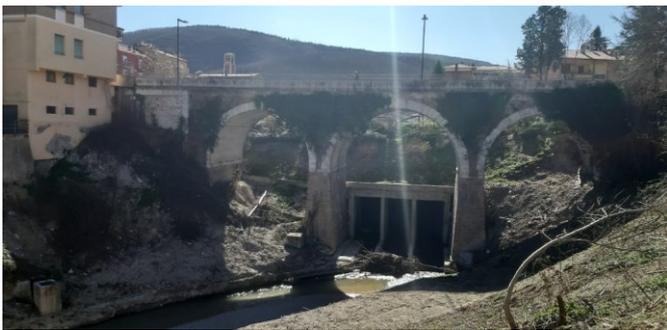
Figure 29: The Garibaldi Street Bridge saw from upstream with the evident, extreme reduction of the original flow section with a box-like structure (the markers on the wall on the left mark the hydrometric levels reached).

Starting from the bridge on Garibaldi Street, the entire riverbed of Sanguerone Stream was channelised with a three-segmented concrete box structure of about 200 meters in length, which reduces the original section of the ancient bridge built by the Italian Army General Staff (fig. 29). The watercourse returns to the open space only one hundred meters before its confluence into the Sentino Creek. The buried section was then covered with backfill material, above which the Castellucci parking was realised. The channelisation intervention, observed from upstream, shows how the original wide arches of Garibaldi Street Bridge were reduced to a box-like structure that greatly reduced the hydraulic section, making it undoubtedly undersized for the flow rates recorded during the September 15th, 2022, hydraulic event.

The flood eradicated and dragged trees and sediment along its course, which, once they met the narrowing imposed by the channelisation, obstructed the section, creating a lake in its upstream portion (markers on the wall in the left mark the hydrometric levels reached). Overpressures developed inside the buried section, the roof of which fortunately held up without being damaged. These overpressures, however, were released as they exited the channelized section, creating extensive erosions to structures located adjacent to it (fig. 30).

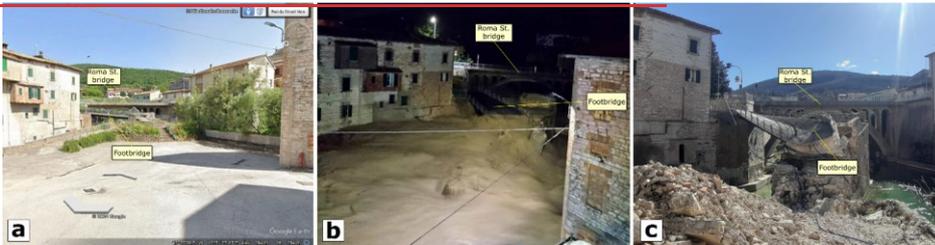
Figure 30: The area exiting the tombed section of Sanguerone Stream under the Castellucci parking a) before, b) during and c) after the event.

In Monterosso Stazione and Sassoferrato, it is evident how inadequate man-made structures, together with neglect of maintenance along the river network, contributed to amplifying the destructive effects of the flood.

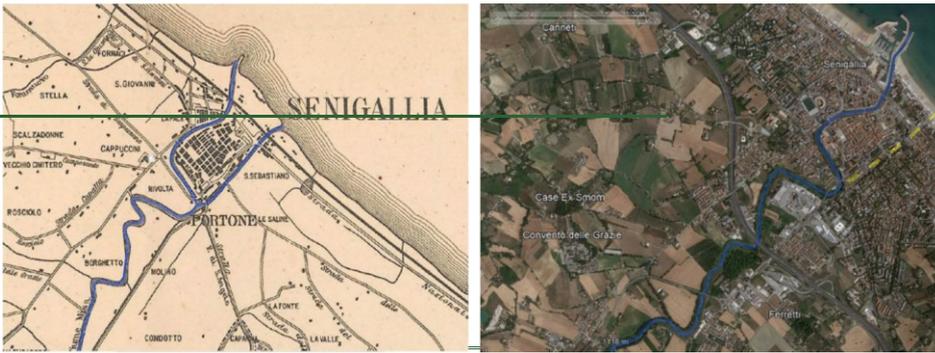
Figure 32: The comparison between the Misa River highlighted in blue near Senigallia. An ancient map of 1889 (Santoni G., & Morici R., 2021) on the left and a @Google Maps image of 2023 on the right, with the preexisting “Penna channel” dashed in yellow, subsequently occluded.

The case study of Senigallia represents a very didactic example of studying anthropogenic modifications of the territory. Looking at the comparison between the ancient cartography of the Geographical Institute “De Agostini Novara” of 1889 and the aerial image of 2023 (Fig. 32), it appears evident how the Misa River, at that time, had two channels, both flowing into the Adriatic Sea. Within them, the ancient castle of the town was built, defended with imposing walls to protect against sieges and floods.

In the past, floods came very frequently in Senigallia. For this reason, over the years, the farmers built the embankments along the Misa River to protect field crops and livestock. At the same time, the municipal administrations built the “cavo Penna”, an artificial channel which flowed below the actual IV November Street and reached the sea, where today there is the famous roundabout. Penna channel (fig. 33) was a sort of drainage ditch to protect the town from floods. Around 1920, after completing all the earthen embankments in the countryside and building the masonry embankments in the city, they decided to bar and fill the channel and urbanise the area above it abundantly.

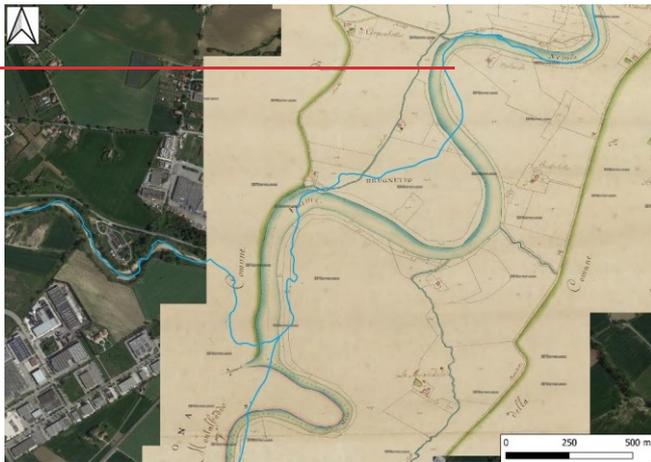
Figure 34: The ancient map of the Gregorian cadastre (Archivio di Stato di Roma, n.d.) with the superimposed actual watercourses of the Nevola and Misa rivers (light blue lines). The modifications of the hydrographic network are well recognisable.

The spatiotemporal analysis conducted through the comparison of historical cartographies highlighted a widespread discrepancy between actual and ancient maps (Fig. 34). The Gregorian cadastre of 1835 shows the area at the confluence between the Nevola and Misa rivers, coming from the West and South, and shows significant modifications made to the hydrographic network during that time.

Nowadays, this final portion of the Misa River appears completely channelled between artificial earthen embankments. On-field surveys and mapping also regarded these structures and identified their main criticalities.

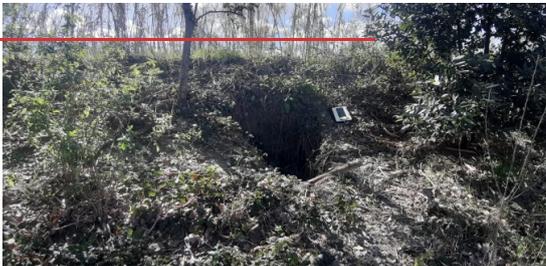
495 Furthermore, the on-field geomorphological-hydraulic survey identified the presence of widespread burrows of fossorial animals (Fig. 37), sometimes passing from one side to the other. During a flood, this can represent an important situation of weakness of the embankment and can therefore cause its erosion, piping and collapse. In addition to the embankment overflowing, this was one of the causes of the flooding of the Senigallia and Ostra area.

Figure 37: The burrow of fossorial animals along the right embankment of Misa River in the hamlet of Borgo Catena (Senigallia), with A4 block notes for scale.

Another of the most important actions is the embankment restoration and reinforcement. The burrows of fossorial fauna (fig. 37) must be filled in, the embankments consolidated and reinforced, and the height of the hydrographic left and right embankments levelled.

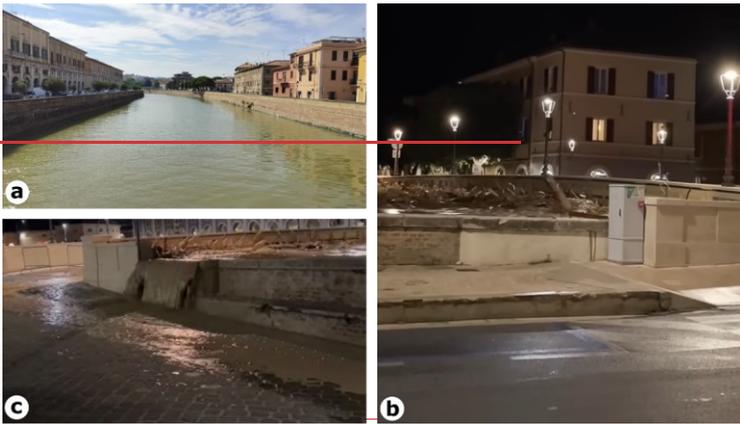
500 Within the historic centre of Senigallia, the Misa River is channelled through masonry embankments (Fig. 38a). The greatest criticalities are due to the large urbanization of this area, the ancient Penna channel that was eliminated and the presence of three bridges (Portone Bridge, Garibaldi Bridge and 2 June Bridge) that resulted undersized during the flood of 15 September 2022 that they were obstructed to the point of being obstructed by vegetation and causing the Misa to overflow from their sides (Fig. 38b, c). The Garibaldi Bridge was damaged, and it has been demolished. It will be rebuilt with a wider height.

Figure 38: Three situations close to the 2-June bridge: a) the masonry embankments of Misa River in Senigallia seen from the 2-June bridge after heavy rain; b) the 2-June bridge with the intrados occluded by vegetation carried by the river a few moments (11:30 p.m. of 15 September 2022, Italian time) before the flood (youtube page of Storm Chasers Marehe); c) the precise moment (00:05 a.m. of 16 September 2022, Italian time) of the beginning of the Misa flood in the centre of Senigallia (youtube page of Vivere Senigallia). Note the methodology of prohibiting access to the bridge and the non-perforated edge protection of the bridge.

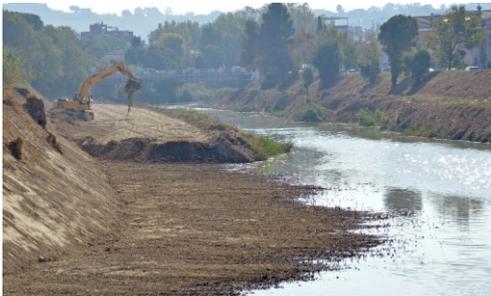
Figure 40: The works for the removal of river point bar sediments along the Misa River in Senigallia were executed in 2023. Image from <https://www.adriaceo.eu/2023/10/13/alluvione-2022-sopralluogo-a-senigallia-per-la-verifica-dello-stato-dei-lavori-sul-misa/> (accessed on 12.16.2024).

To avoid the accumulation of vegetation eradicated from the riverbed in the narrowings, it was proposed to act along the hydrographic network by removing dead vegetation present along the river that could create a potential obstacle to runoff (fig. 39a). Action was also taken by removing the material deposited in the river bars to widen the hydraulic section (fig. 39b).
