The 15 September 2022 floods in northern Marche (Central Italy): disaster analysis, case studies and mitigation strategies for hydro-geomorphological hazard

Abstract. On September 15th and 16th, 2022, a large area of the Marche region in central Italy experienced an exceptionally heavy rainfall event, with nearly 420 mm/m² of rain falling in just six hours. The intense rains, in addition to causing 13 fatalities, triggered a large number of landslides in the mountain areas and flood events, mainly concentrated along the valleys of the hydrographic basins of the Metauro, Cesano, Misa, and Esino Rivers. The physiographic setting of the territory and the poor maintenance of both the main and secondary hydrographic network, often insufficient or entirely absent, exacerbated an already exceptional event. Although extraordinary, the natural event occurred in an area already affected by intense meteoric events in the past, the most recent of which had taken place just eight years earlier, in 2014.

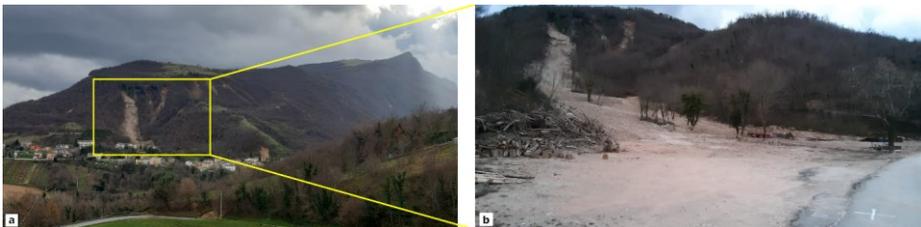
Figure 1: a) the scars of landslide events along the northern slopes of Mt. Calvello, activated during the rainfall event in question and involving the hamlet of Leccia, municipality of Serra Sant'Abbondio (PU); b) detail of the frame in picture a).

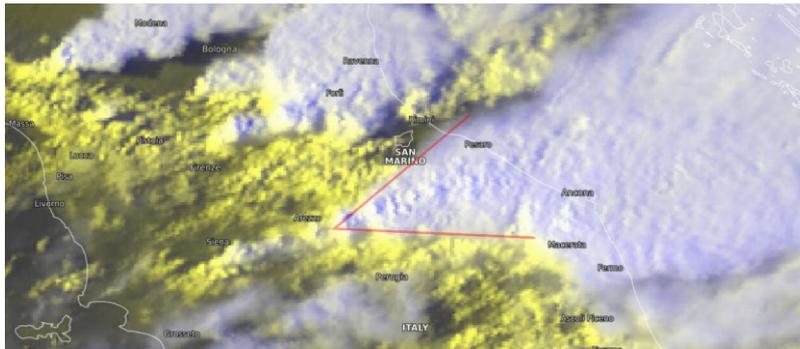
125 **Figure 3: The Central Italy satellite view of the thunderstorm at 3:00 pm UTC on 15th September 2022. MSG-SEVIRI HRV cloud composite with the characteristic and well-recognisable V-shape (drawn in red). Copyright Eumetsat. Image from <https://view.eumetsat.int/productviewer?v=61314> (last access 10.18.2024).**

because of its geometry, well recognizable in plain view (fig. 3). In general, V-shaped thunderstorms are not uncommon over
115 Italy, especially in the summer (Torcasio et al., 2023) and not all V-shaped thunderstorms result in floods or flash floods, as
their duration is short. However, when V-shaped thunderstorms are stationary for several hours over a specific area, they very
often result in floods or flash floods (Federico et al., 2019). The vertex of the V-shaped (sting) is the point where the fresh new
storm cells are continually regenerating, and it is there that the phenomena can take on an extraordinary character in terms of
rainfall and lightning. Geographically, during the event, this position was the inner territory of the Marche region, between
120 Pesaro Urbino and Ancona provinces. Comparing fig. 3 and 9, in fact, it appears clear the superimposition between the location
of the sting and the areas with the highest recorded rainfall.

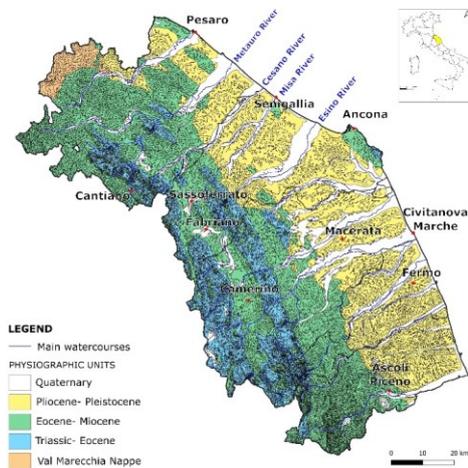
Figure 4: Physiographic setting of the Marche region (Farabollini & Bendia, 2022, modified) with elevation contour lines, main watercourses, and provincial boundaries. Cartographic layers from Regione Marche, n.d.

135 The Marche region exhibits a distinctive physiographic setting (Fig. 4), following an Apenninic N/NW–S/SE trend, because
it reflects the main tectonic lineaments ~~whose~~that acted in the landscape. The territory is characterised by an internal, western

portion constituted mainly by calcareous and marly rocks and a higher elevation, the Apennine ridge. Moving away from the mountainous sector, elevations progressively decrease eastward, reaching the terrigenous peri-Adriatic area, which is characterised by predominantly hilly landforms and mostly low-lying coastlines. The dominant direction of the watercourses is from west to east, up to the Adriatic Sea, with a comb-like arrangement orthogonal to the structure.

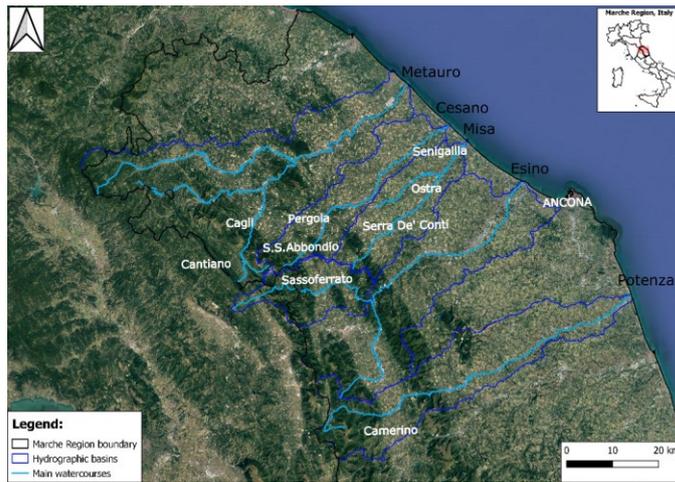
150 **Figure 5: The northern portion of the Marche Region with the hydrographic basins involved by the flood and the names of the main localities named in the article. Cartographic layers from Regione Marche, n.d.**

145 As mentioned before, the study was conducted in some test areas, which include some of the inhabited centres most severely affected by the flood event: Cantiano (~~PU~~), Cagli (~~PU~~), Serra Sant'Abbondio (~~PU~~), Pergola (~~PU~~), Sassoferrato (~~AN~~), Serra de' Conti (~~AN~~), Ostra (~~AN~~) and Senigallia (~~AN~~). The hydrographic basins involved were those of Metauro, Cesano, Misa, Esino and Potenza Rivers, although the last (southern) one was affected to a lesser extent (fig. 5).

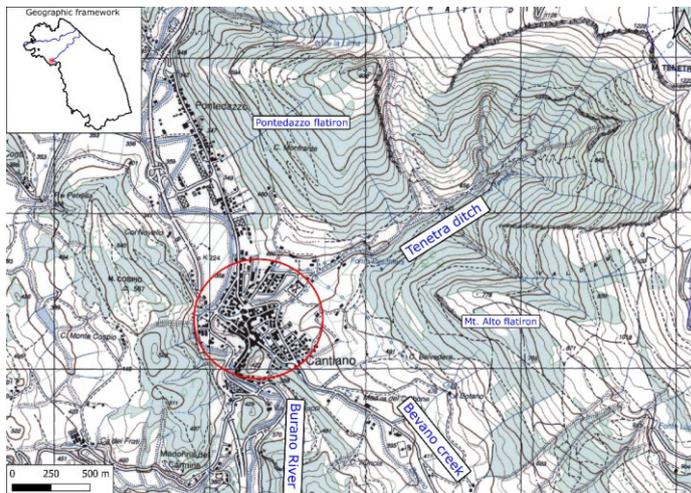
175 **Figure 6: Topographic map of the town of Cantiano (IGM 1:25,000) with the well-recognisable form of Mt. Tenetra amphitheatre and the three main watercourses. In the extent rectangle, the Marche region, the hydrographic basin of the Metauro River in blue and the town of Cantiano in red. Cartographic layers from Regione Marche, n.d.**

Tenetra released different debris flows (figures 6; 14a; 14b) along the pre-existing channels, in some cases stopped along the slope, in other cases able to reach the Tenetra mainstream at the bottom of the valley. Very likely, the presence of three hydraulic weirs (resulting damaged and filled) placed upstream with respect to the town counteracted the erosive potential of the stream, preventing major damage to downstream structures.

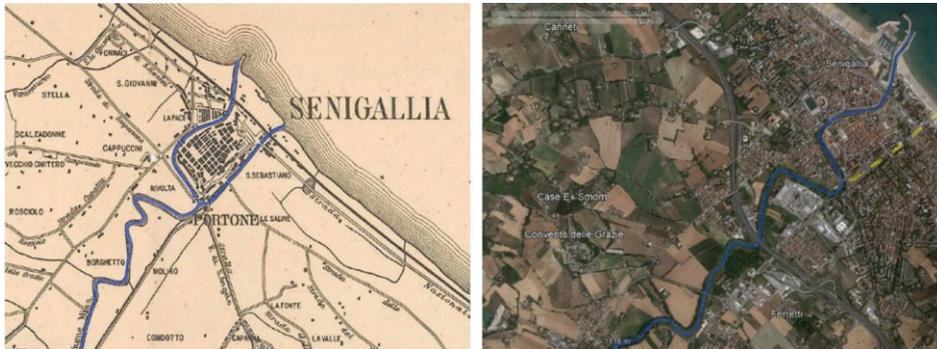
225 **Figure 7: The comparison between the Misa River, highlighted in blue near Senigallia in an ancient map of 1889 (Santoni G., & Morici R., 2021) on the left and in a © 2023 Google image of 2023 on the right, with the preexisting “Penna channel” dashed in yellow, subsequently occluded about a century ago.**

220 along the Misa River to protect field crops and livestock. At the same time, the municipal administrations built the so-called
“cavo Penna”, an artificial channel which flowed below the actual IV November Street and reached the sea, where today there
is the famous roundabout. The Penna channel was a sort of drainage ditch eigne-designed to protect the town from floodings.
Around 1920, after completing all the earthen embankments in the countryside and building the masonry embankments in the
city, they decided to bar and fill the channel and urbanise the area above it abundantly (fig. 7).

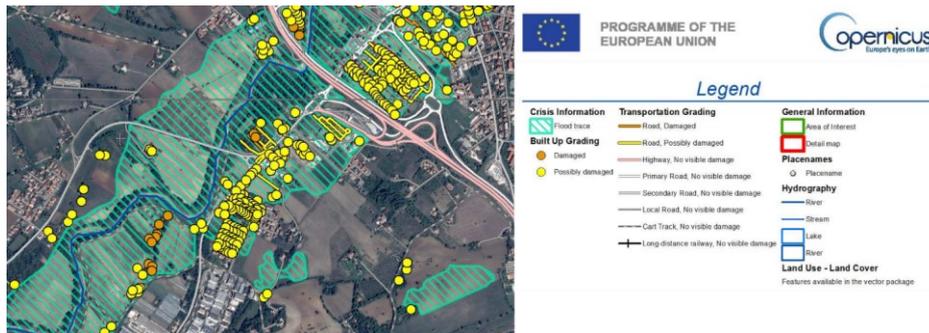
250 **Figure 8: An excerpt, modified, of Copernicus satellite mapping in the immediate aftermath of the Marche floods, with the well-recognisable flood trace and the damaged and possibly damaged buildings. South-West of Senigallia. Original image from <https://emergency.copernicus.eu/mapping/list-of-components/EMSR634> (Accessed on 12.16.2024).**

245 The availability of satellite data from the Copernicus European project was acquired during and in the immediate aftermath of the event (fig. 8). This project produced for each locality a map capable of investigating and defining the extent of the phenomenon. These remote sensing techniques, in addition to being useful to geologists in defining the flooded area immediately, can be considered essential in real time to provide Civil Protection with an idea of the extent of the event and to direct relief efforts to the most damaged areas, taking into account the expected level of damage and people involved.

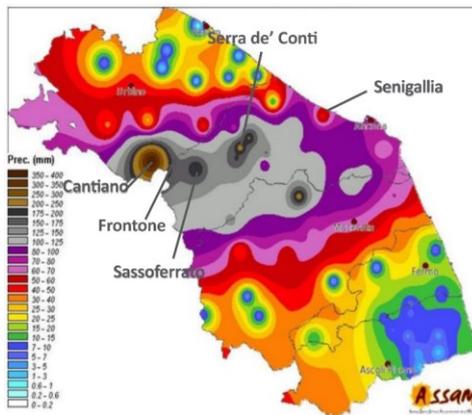
Figure 9: Cumulative rainfall distribution during the entire day of 15th September 2022 in the Marche region, modified, indicating the most represented localities treated in this work (Regional Agro- meteorological Service of AMAP Regione Marche, 2022; modified).

From the regional rainfall map (fig. 9), it is possible to recognize the areas most affected by rain during the meteorological event, such as the western Apennines area of the province of Pesaro Urbino and a large portion of Ancona province.

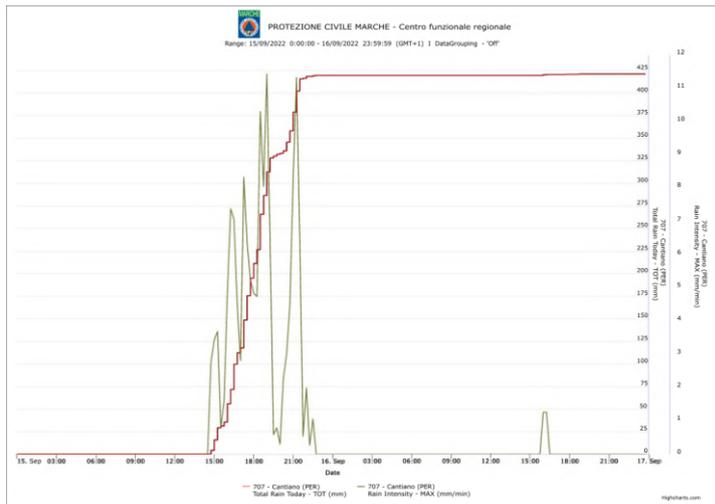
Figure 10: Cumulative and intensity of precipitation recorded by the rain gauge of Cantiano (redraw from Civil Protection of the Marche region, 2022). Times in the graph refer to standard time.

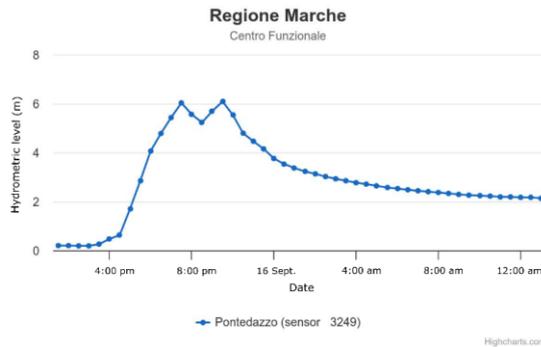
Figure 11: The hydrometric graph of sensor 3249 Pontedazzo about one km downstream of Cantiano from 1:00 p.m. of Sept. 15th, 2022, to 1:00 p.m. of Sept. 16th, 2022, Italian time (SIRMIP 2022).

The hydrometric analysis for the municipality of Cantiano (Fig. 11) confirms the testimonies collected from residents who narrated about two flood waves that affected Luceoli Square: the first, smaller, inundated the square with about 50 centimetres of water and the second, more extensive, reached a height of 2.35 meters. This is well recognizable in the two peaks corresponding to the two flood waves that reached Luceoli Square at 7:30 p.m. and 9:30 p.m.

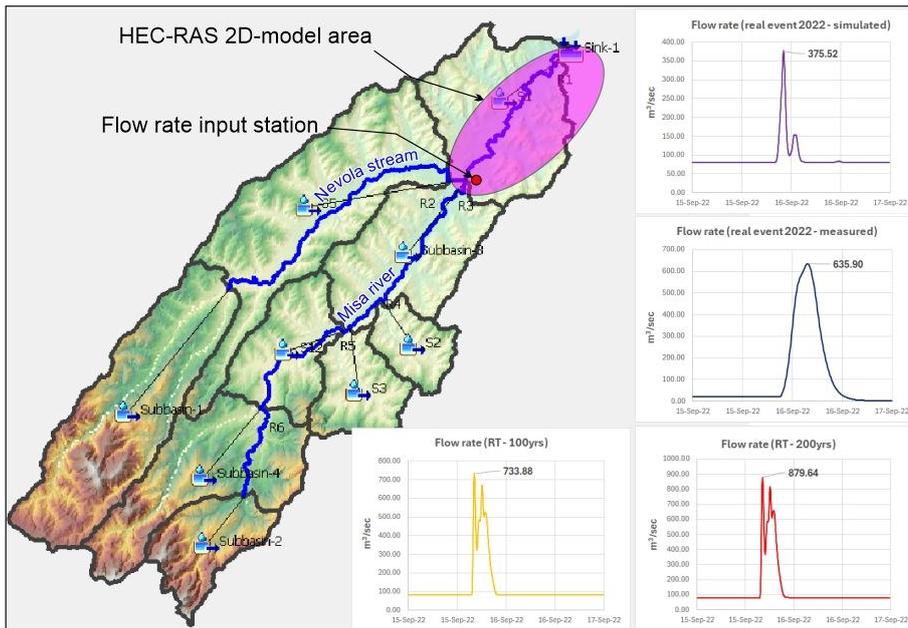
350 Fig. 12: HEC-HMS model results.

For the actual 2022 event, precipitation data were entered into the model with a relatively low average Curve Number (CN = 49), typical of dry conditions; the rainfall event had, in fact, been preceded by weeks of virtually no precipitation. Flow rate calculation gives a value of approximately 375 m³/sec, a value significantly lower than that recorded at the Bettollele hydrometer (around 640 m³/sec). In the simulations estimating maximum flood discharges for 100- and 200-year return periods, on the other hand, an average Curve Number of 64 was used; this value is typical of "saturated" conditions, as required by legislation, which mandates consideration of the most unfavorable event scenario. Flow rates calculated for both scenarios give values of **respectively** 733 and 879 m³/sec-**respectively**.

The results of the hydrological modelling (settings and parameters are shown in Table 1) are presented in Fig. 12.

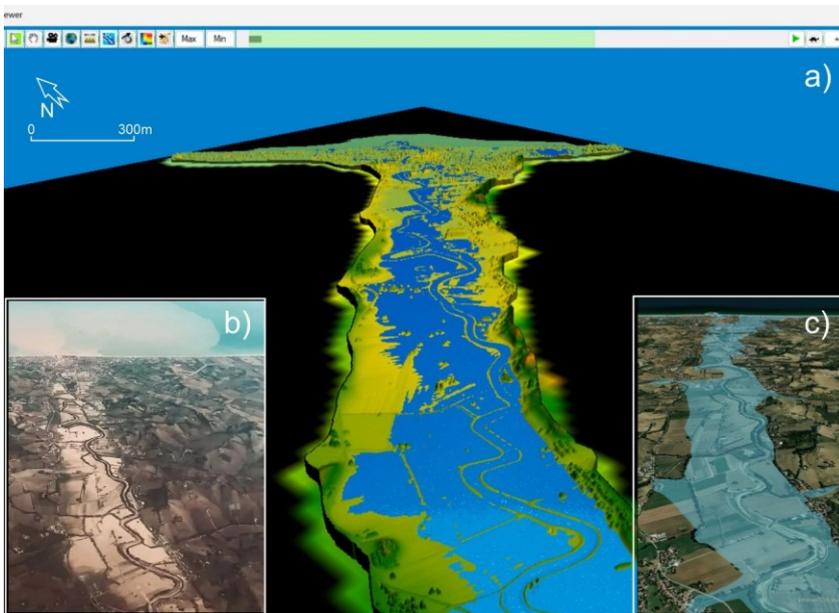
370 Fig. 13: Comparison between potentially floodable areas in relation to different event scenarios and the areas actually flooded during the September 2022 event in correspondence of the final stretch of the Misa River valley. (a) Flooded area using a flow rate of 640 m³/sec; (b) the flooded plain of the Misa River seen from an aircraft flying from Ancona to the United Kingdom on 16th September 2022 at 11.08 a.m. Italian time, with the well-recognisable flooded area, the main localities in yellow and the plume of sediments seaward. Image from <https://www.senigallianotizie.it/1327562338/dalla-foto-ad-alta-definizione-si-individuano-punti-di-fuoriuscita-e-rottura-argini-del-misa> (accessed on 12.11.2024); (c) flooded area for a return time of 100 yrs.

floodplain; iii) Fig. 13c illustrates the floodable area for a return period of 100 years, as defined by the Marche Region Civil
365 Protection Agency.

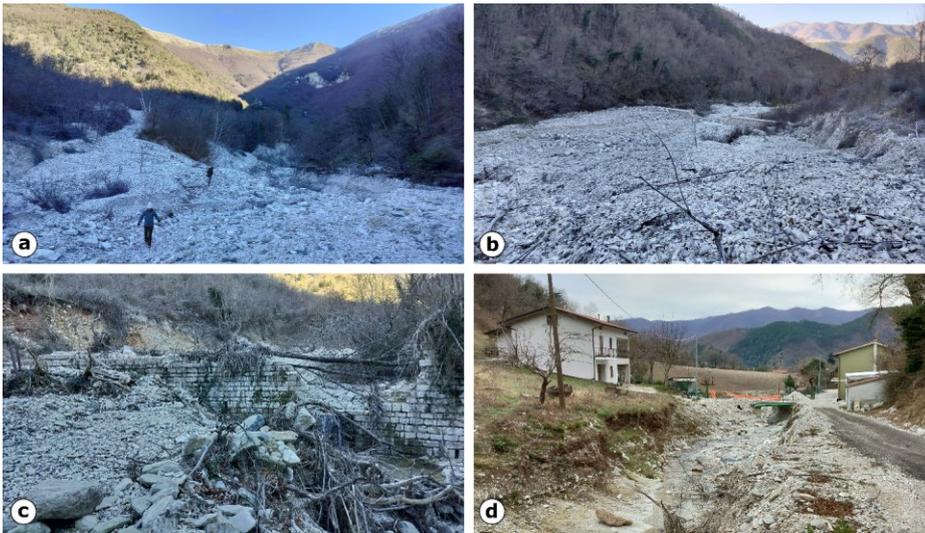
Figure 14: geomorphological criticalities detected along the Tenetra valley in the municipality of Cantiano: a) panoramic view of the valley seen from downstream; b) debris flow channel in the hydrographic right portion of Tenetra ditch; c) debris flow deposits of the channel in picture b) in the valley bottom side; d) the flat bottom of Tenetra Stream valley seen from upstream filled with debris flows sediments.

The on-field survey mapped different criticalities, also from the anthropic point of view. Along the watercourse, three hydraulic weirs were present, and they were entirely filled (fig. 14b) and damaged (fig. 14c) by the event, compromising their functionality. Some riverbank protection works were also damaged, such as the gabion wall protecting the municipal road. Another criticality was represented by the undersized bridge in the hamlet of Tenetra (fig. 14d), which was obstructed and overtopped during the flood so much that it separated the two dwellings on either side of it.

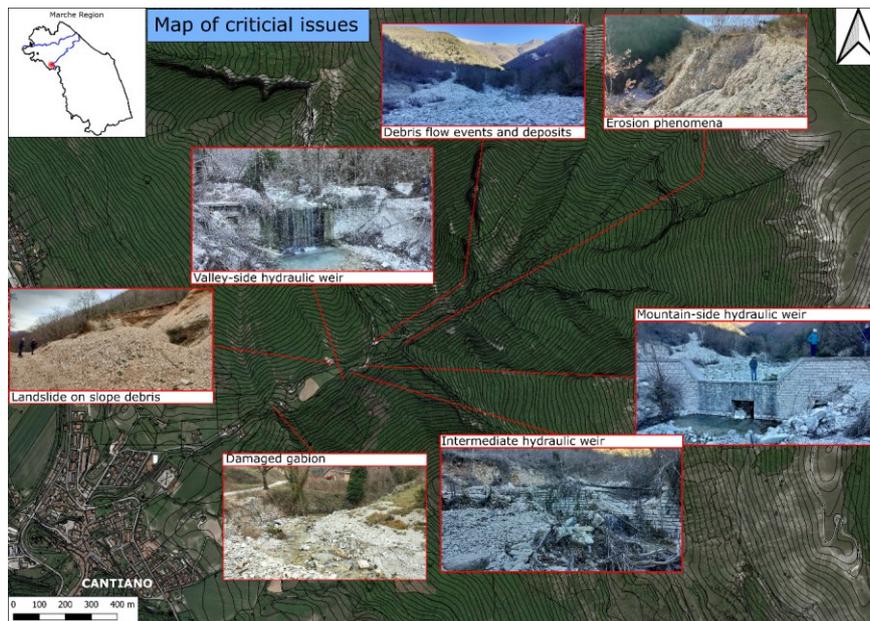
Figure 15: Map of critical issues in the Tenetra valley. The extent rectangle shows in black the boundaries of the Marche Region with Cantiano (in red) and the catchment area of the Metauro River (in blue). Cartographic layers from Regione Marche, n.d.

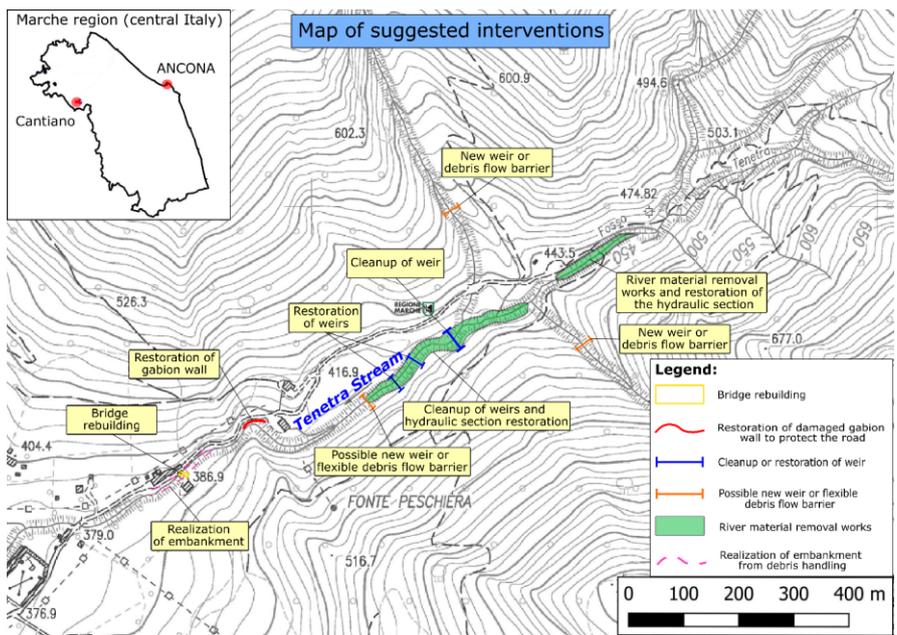
Figure 16: map of the suggested intervention in the Tenetra Valley. The extent rectangle shows in black the boundaries of the Marche Region with Cantiano (in red) and the catchment area of the Metauro River (in blue). Cartographic layers from Regione Marche, n.d. (Bendia et al., 2025).

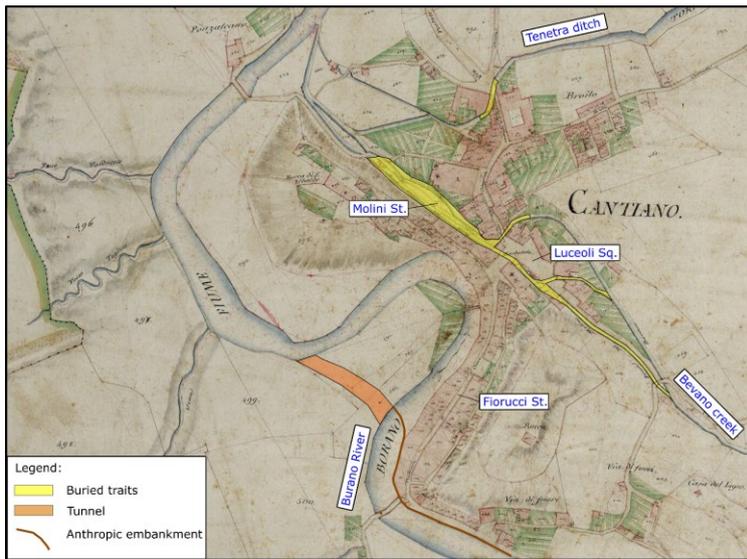
Figure 17: schematic map of the main anthropogenic surface water regulation interventions superimposed on the Gregorian cadastre (Archivio di Stato di Roma, n.d.). It is easily recognisable that the abandoned meander is destined for human use.

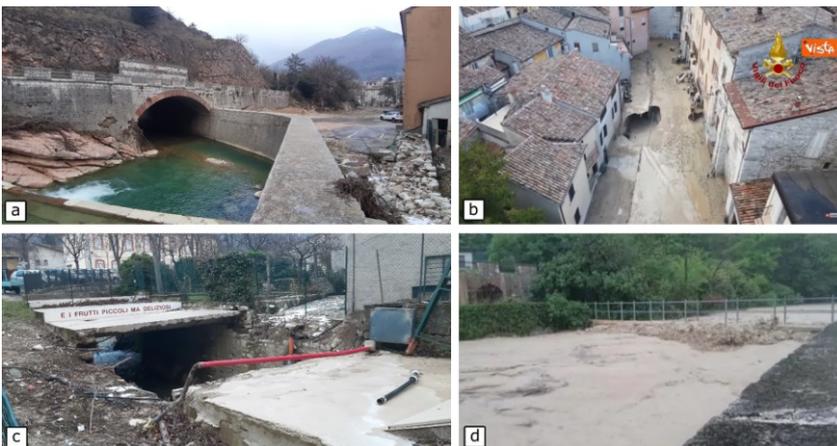
480 **Figure 18: a) The 65-meter tunnel of the Burano River below the calcareous mountain ridge, with the anthropogenic embankment behind which the alluvial plain, the parking and the historical centre are recognizable; b) collapse of the tombed sections in Tumiatì Street, Bevano Creek; c) explosion of the buried sections in Fiorucci Street, Bevano Creek (courtesy of National Fire Department); d) undersized footbridge reached by the water level, subsequently washed away, Burano River.**

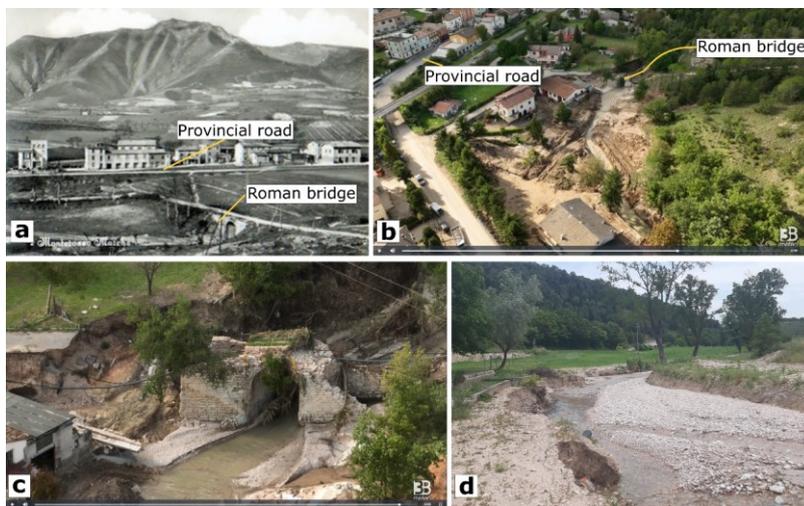
520 Figure 2319: a) the Roman bridge at Monterosso Stazione above the Sanguerone Creek in a historical photo, with the eastern foothills of Mt. Strega in the background (scanning from a postcard, then modified); b) the post-event situation for comparisons with image a (also related to urbanisation). Note that in the past, the alluvial valley was not urbanised; c) the Roman bridge after the event viewed from downstream, with the collapsed abutments; d) the unnamed ditch in Sassoferrato Stazione after the flood, with the waterbed filled with gravel and raised about two meters compared to the pre-event situation. Images b) and c) come from <https://www.3bmeteo.com/giornale-meteo/cronaca-meteo-alluvione-marche---monterosso-stazione-dal-drone---ponti-crollati-e-gravi-danni---video-643860> (accessed on 12.01.2026).

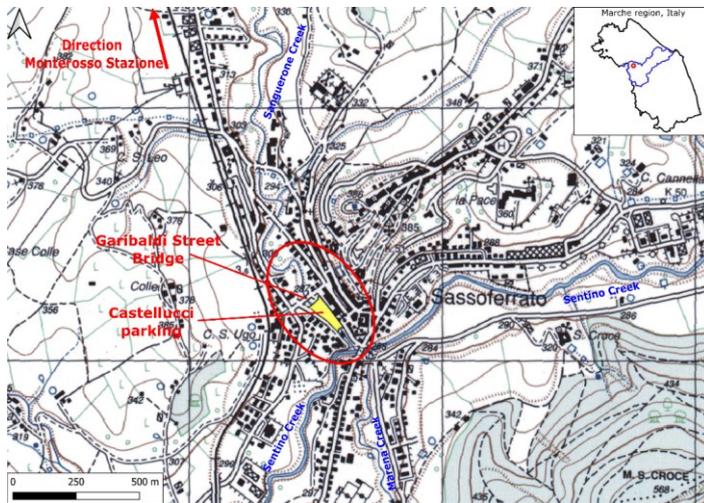
535 Figure 20: Topographic map of the Military Geographical Institute-IGM of Sassoferrato (AN) with the buried stretch of Sanguerone Creek below the Castellucci parking highlighted in yellow. In the extent rectangle, the Marche region (black border), the hydrographic basin of the Esino River in blue and the town of Sassoferrato in red. Cartographic layers from Regione Marche, n.d.

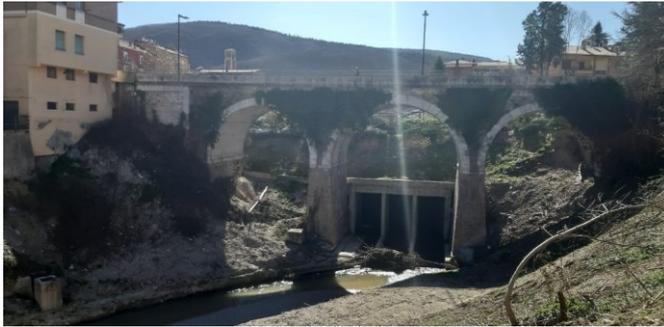
540 Starting from the bridge on Garibaldi Street, the entire riverbed of Sanguerone Stream was tunnelled with a three-segmented concrete box structure of about 200 meters in length, which reduces the original section of the ancient bridge built by the Italian Military Engineering Corps (fig. 21). The watercourse returns to the open space only one hundred meters before its confluence into the Sentino Creek. The buried section was then upward covered with backfill material, above which the Castellucci parking was realised. The channelisation intervention, observed from upstream, shows how the original wide arches of Garibaldi Street Bridge were reduced to a box-like structure that greatly reduced the hydraulic section, making it

545 undoubtedly undersized for the flow rates recorded during the September 15th, 2022, hydraulic event (fig. 21).

Figure 2521: The Garibaldi Street Bridge saw from upstream with the evident, extreme reduction of the original flow section with a box-like structure (the markers on the wall on the left mark the hydrometric levels reached).

The flood eradicated and dragged bushes, branches, trees and sediment along its course, which, once they met the narrowing imposed by the channelisation, obstructed the section, creating a lake in its upstream portion (markers on the wall on the left mark the hydrometric levels reached). Overpressures developed inside the buried section, the roof of which fortunately held up without being damaged. These overpressures, however, were released as they exited the channelized section, creating

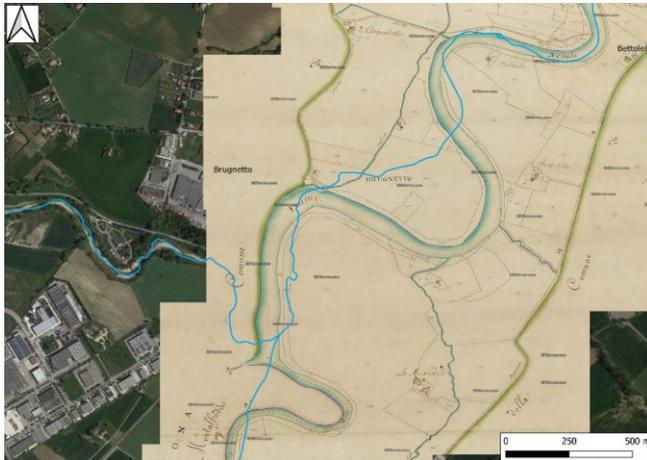
Figure 22: The ancient map of the Gregorian cadastre (Archivio di Stato di Roma, n.d.) with the superimposed actual watercourses of the Nevola and Misa rivers (light blue lines), with the modifications of the hydrographic network well recognisable (Bendia et al., 2025, [modif.](#)).

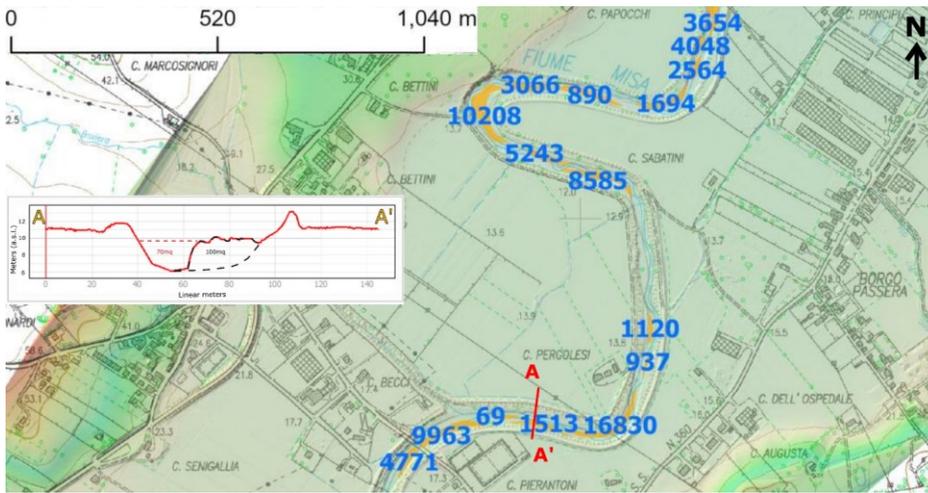
knowing their planimetric and cross-sectional dimensions, also obtained from the LiDAR-derived topographic profile (fig. 23), it was possible to calculate the volume of removable material to widen the section. Upstream of the town of Senigallia, field surveys and LiDAR mapping of the over-sedimentation areas made it possible to identify a total of 42 individual in-channel zones, located against the outer bends of the river with respect to its flow direction, for a total removable material volume of approximately 252,000 cubic meters. These calculations were useful to quantify the removable material from the riverbed according to profiles and cross-sections corresponding to the low-flow channel of that time, to enlarge the current flood discharge sections to the maximum extent available between the incised banks. These lidar images were also very useful for the identification of areas where the construction of flood attenuation basins could be recommended.

Figure 23: A stretch of the lidar image of the Misa River around Molino Marazzana (Senigallia). The blue numbers refer to the single volume of each river point bar (in orange) to be dredged to widen the river section. The red line indicates the section trace from which the river cross-sectional topographic profile (shown in the inset) was obtained through LiDAR data from the drone survey performed. The colour shades refer to the elevations. The smaller inset shows the topographic profile (red line) of a representative stretch of the Misa River in near Molino Marazzana (Senigallia) acquired through lidar survey after the flood event (river sediments dashed in black).

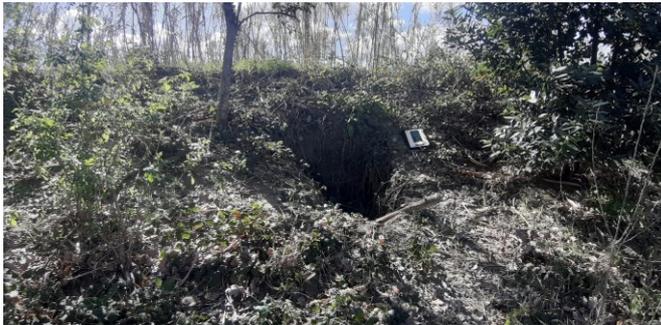
620 Furthermore, the on-field geomorphological-hydraulic survey identified the presence of widespread burrows of fossorial animals (Fig. 24), sometimes passing from one side to the other. During a flood, this can represent a serious situation of weakness of the embankment and can therefore cause its erosion, piping and collapse. In addition to the embankment overflowing, this was one of the causes of the flooding of the Senigallia and Ostra area.

625 **Figure 3024:** The burrow of fossorial animals along the right embankment of Misa River in the hamlet of Borgo Catena (Senigallia), with A4 block notes for scale.

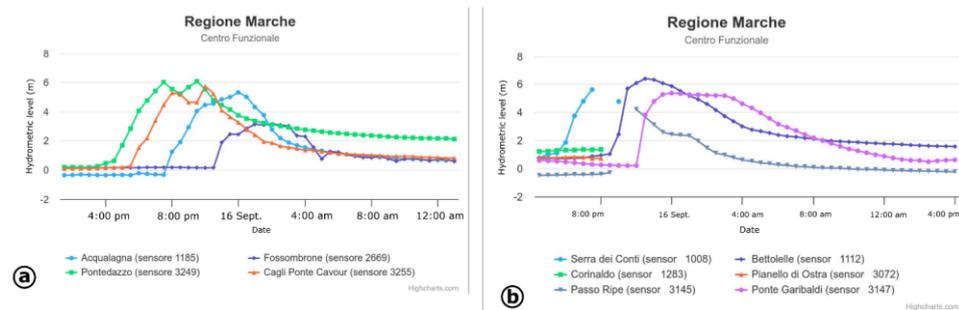
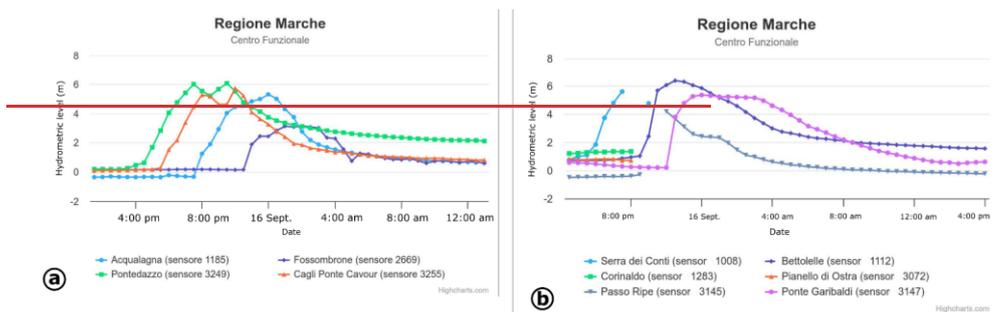
Several hydrometers were damaged or washed away during the flood (fig. 25b; tab. 4), preventing real-time monitoring at crucial moments. This operational fragility underscores the need to redesign and strengthen the regional hydro-meteorological network, particularly in catchments repeatedly affected by extreme events.

665 Looking at the comparison between the hydrometers along the catchment area of the Misa River (fig. 25b), it is immediately apparent how the hydrometers of Serra de' Conti, Corinaldo, Passo Ripe and Pianello di Ostra stopped because they were broken, temporarily disabled, or washed away as the flood arrived. The difference between Bettolelle (municipality of Ostra) sensor 1112 and, downstream, Ponte Garibaldi sensor 3147 (Senigallia city centre). From Serra de' Conti in the mountain area to Garibaldi Bridge in Senigallia, the peak of the flood wave took presumably about three and a half hours.

Figure 25: a) the hydrometric levels of the mountain portion of the Metauro River basin from Pontedazzo (Cantiano) to Fossombrone, from 1:00 p.m. of Sept. 15th, 2022, to 1:00 p.m. of Sept. 16th, 2022. Italian time (SIRMIP 2022); b) the hydrometric levels of the Misa River basin between Serra de Conti and Senigallia (Garibaldi Bridge), from 4:00 p.m. of Sept. 15th, 2022, to 4:00 p.m. of Sept. 16th, 2022. Italian time (SIRMIP 2022).
