The 15 September 2022 floods in northern Marche (Central Italy): disaster analysis, case studies and mitigation strategies for hydro-geomorphological hazard

Abstract. On September 15th and 16th, 2022, a large area of the Marche region in central Italy experienced an exceptionally heavy rainfall event, with nearly 420 mm/m² of rain falling in just six hours. The intense rains, in addition to causing 13 fatalities, triggered a large number of landslides in the mountain areas and flood events, mainly concentrated along the valleys
10 of the hydrographic basins of the Metauro, Cesano, Misa, and Esino Rivers. The physiographic setting of the territory and the poor maintenance of both the main and secondary hydrographic network, often insufficient or entirely absent, exacerbated an already exceptional event. Although extraordinary, the natural event occurred in an area already affected by intense meteoric events in the past, the most recent of which had taken place just eight years earlier, in 2014.

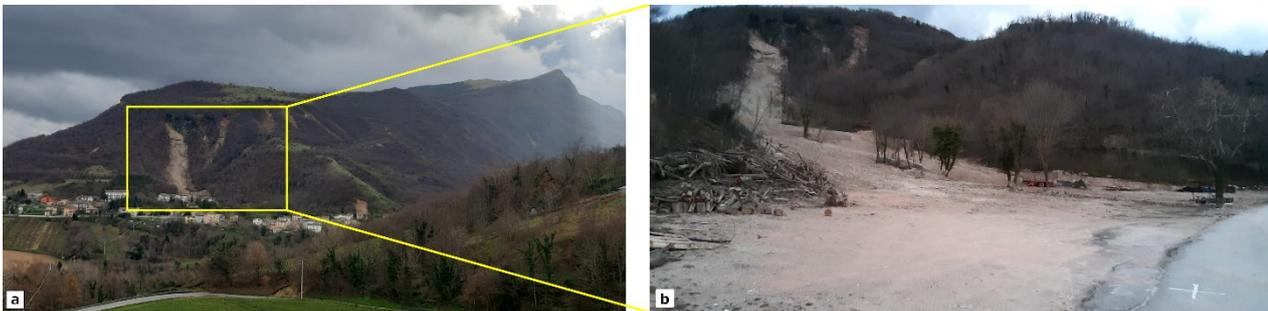
75 **Figure 1: a) the scars of landslide events along the northern slopes of Mt. Calvello, activated during the rainfall event in question and involving the hamlet of Leccia, municipality of Serra Sant'Abbondio (PU); b) detail of the frame in picture a).**

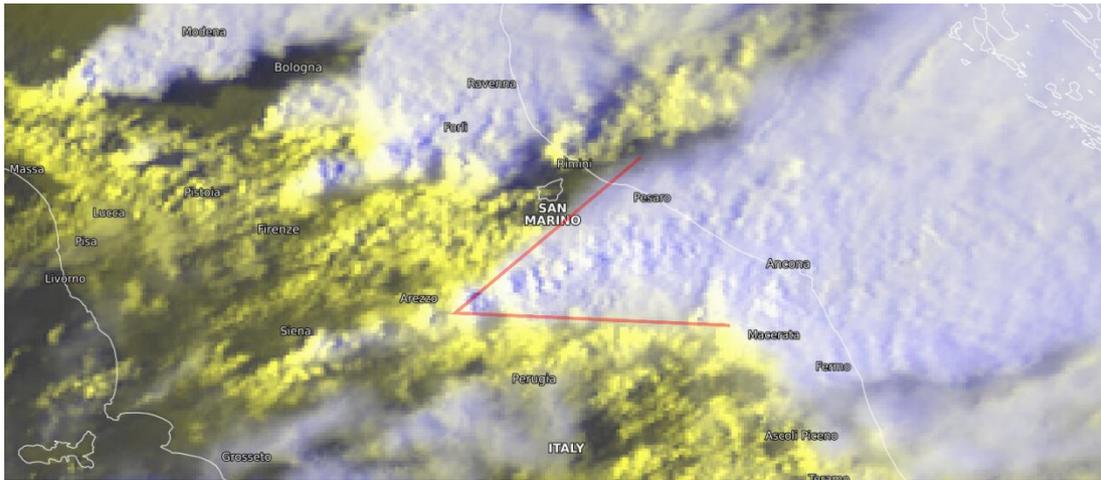
Figure 3: The Central Italy satellite view of the thunderstorm at 3:00 pm UTC on 15th September 2022. MSG-SEVIRI HRV cloud composite with the characteristic and well-recognisable V-shape (drawn in red). Copyright Eumetsat. Image from <https://view.eumetsat.int/productviewer?v=61314> (last access 10.18.2024).

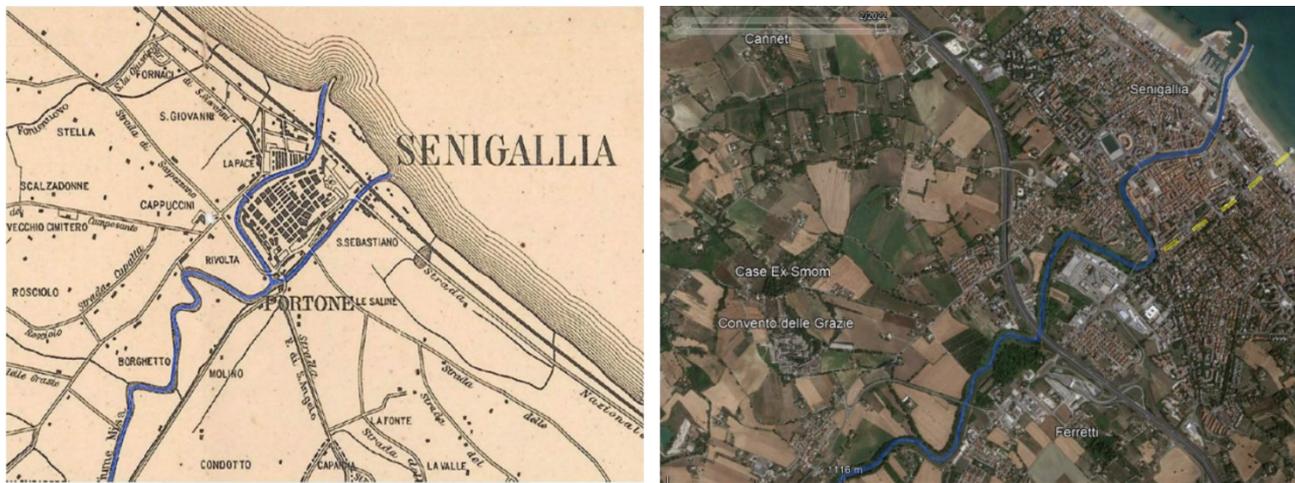
265 **Figure 7: The comparison between the Misa River, highlighted in blue near Senigallia in an ancient map of 1889 (Santoni G., & Morici R., 2021) on the left and in a © 2023 Google image of 2023 on the right, with the preexisting “Penna channel” dashed in yellow, subsequently occluded about a century ago.**

260 The case study of Senigallia represents a very didactic example of studying anthropogenic modifications of the territory. Looking at the comparison between the ancient cartography of the Geographical Institute “De Agostini Novara” of 1889 and the aerial image of 2023 (Fig. 7), it appears evident how the Misa River, at that time, had two channels, both flowing into the Adriatic Sea. Within them, the ancient castle of the town was built, defended with imposing walls to protect against sieges and floods.

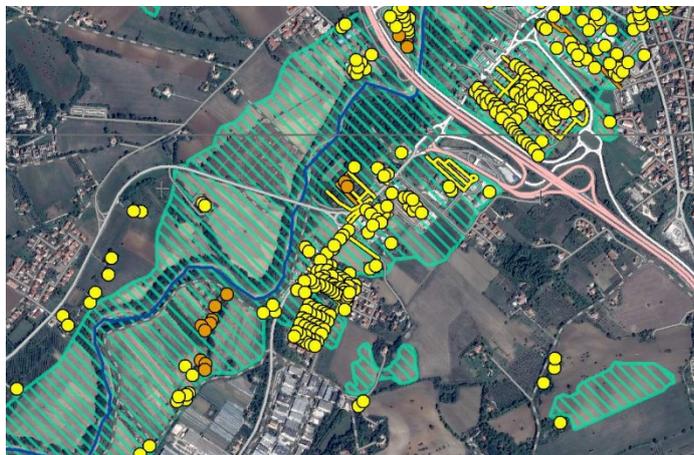
315 **Figure 9: An excerpt, modified, of Copernicus satellite mapping in the immediate aftermath of the Marche floods, with the well-recognisable flood trace and the damaged and possibly damaged buildings. South-West of Senigallia. Original image from <https://emergency.copernicus.eu/mapping/list-of-components/EMSR634> (Accessed on 12.16.2024).**

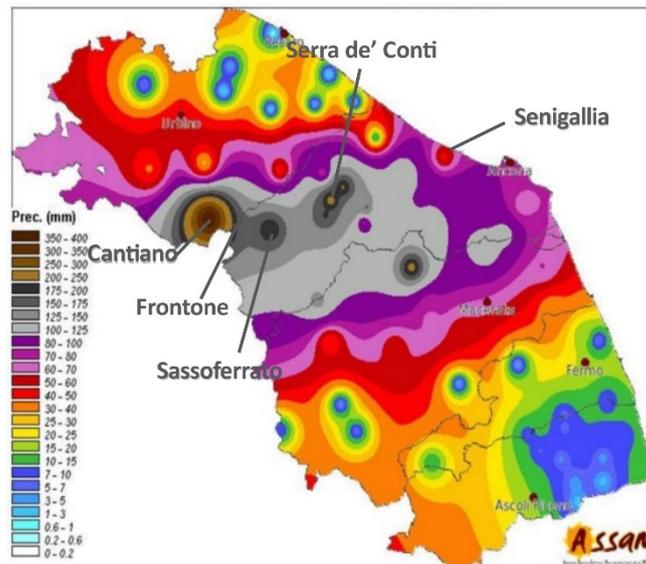
360 **Figure 10: Cumulative rainfall distribution during the entire day of 15th September 2022 in the Marche region, modified, indicating the most represented localities treated in this work (Regional Agro- meteorological Service of AMAP Regione Marche, 2022; modified).**

From the regional rainfall map (fig. 10), it is possible to recognize the areas most affected by rain during the meteorological event, such as the western Apennines area of the province of Pesaro Urbino and a large portion of Ancona province.

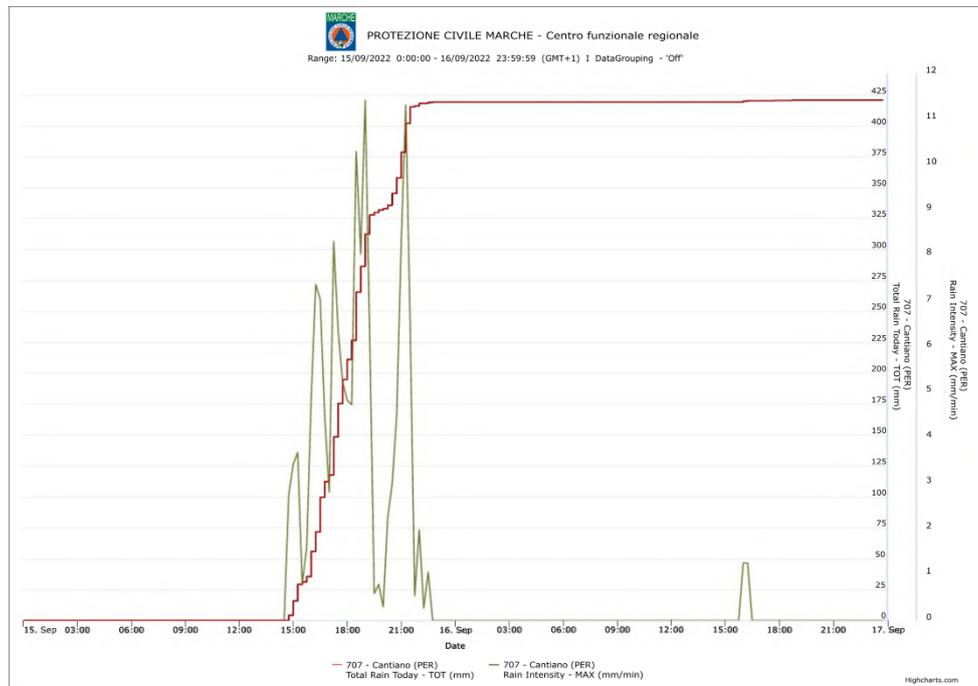
Figure 12: Cumulative and intensity of precipitation recorded by the rain gauge of Cantiano (redraw from Civil Protection of the Marche region, 2022). Times in the graph refer to standard time.

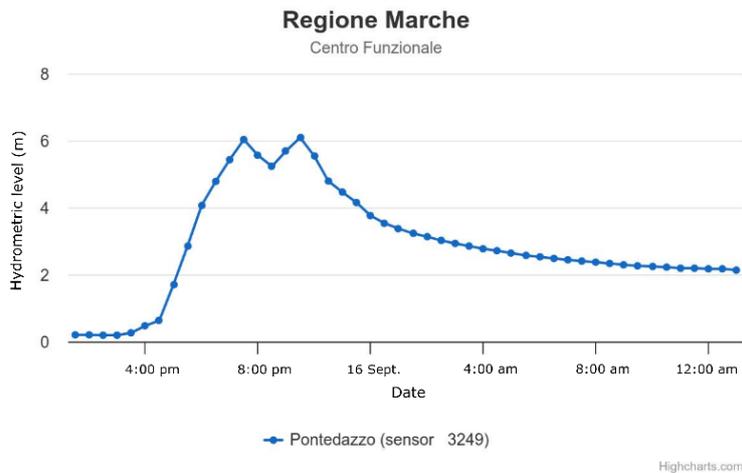
Figure 8: The hydrometric graph of sensor 3249 Pontedazzo about one km downstream of Cantiano from 1:00 p.m. of Sept. 15th, 2022, to 1:00 p.m. of Sept. 16th, 2022, Italian time (SIRMIP 2022).

The hydrometric analysis for the municipality of Cantiano (Fig. 13) confirms the testimonies collected from residents who narrated about two flood waves that affected Luceoli Square: the first, smaller, inundated the square with about 50 centimetres of water and the second, more extensive, reached a height of 2.35 meters. This is well recognizable in the two peaks
410 of water and the second, more extensive, reached a height of 2.35 meters. This is well recognizable in the two peaks corresponding to the two flood waves that reached Luceoli Square at 7:30 p.m. and 9:30 p.m.

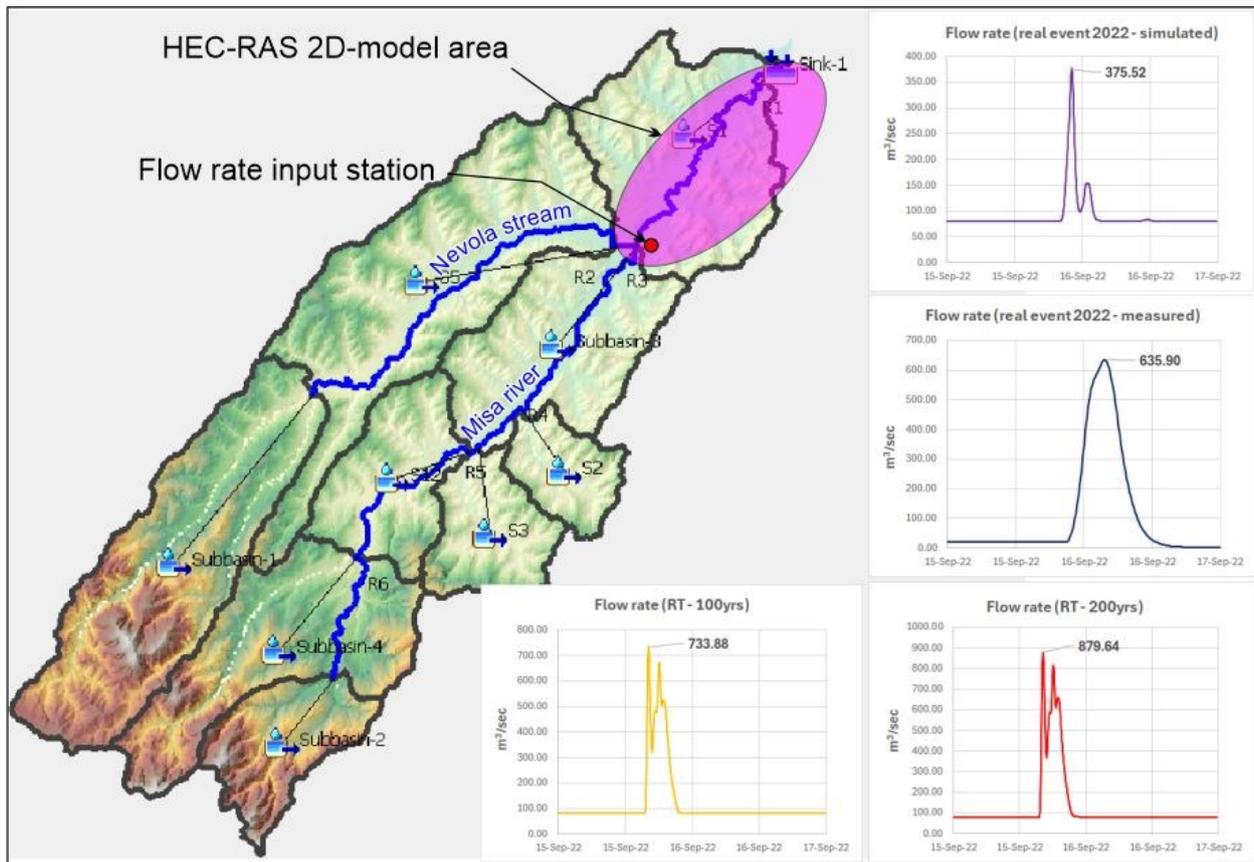
Fig. 14: HEC-HMS model results.

The results of the hydrological modelling (settings and parameters are shown in Table 1) are presented in Fig. 14.

For the actual 2022 event, precipitation data were entered into the model with a relatively low average Curve Number (CN = 49), typical of dry conditions; the rainfall event had, in fact, been preceded by weeks of virtually no precipitation. Flow rate calculation gives a value of approximately 375 m³/sec, a value significantly lower than that recorded at the Bettlelle hydrometer (around 640 m³/sec). In the simulations estimating maximum flood discharges for 100- and 200-year return periods, on the other hand, an average Curve Number of 64 was used; this value is typical of "saturated" conditions, as required by legislation, which mandates consideration of the most unfavorable event scenario. Flow rates calculated for both scenarios give values of 733 and 879 m³/sec respectively.

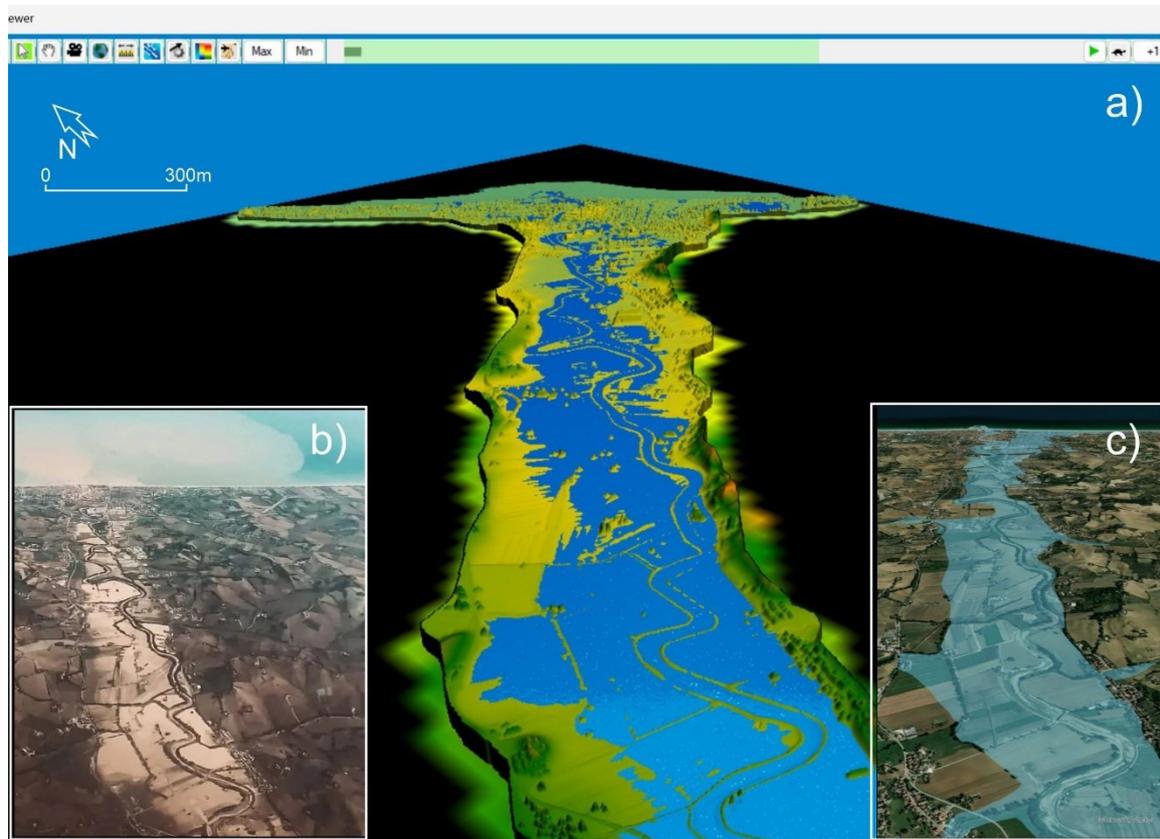
440 **Fig. 15: Comparison between potentially floodable areas in relation to different event scenarios and the areas actually flooded during the September 2022 event in correspondence of the final stretch of the Misa River valley. (a) Flooded area using a flow rate of 640 m³/sec; (b) the flooded plain of the Misa River seen from an aircraft flying from Ancona to the United Kingdom on 16th September 2022 at 11.08 a.m. Italian time, with the well-recognisable flooded area, the main localities in yellow and the plume of sediments seaward. Image from <https://www.senigallianotizie.it/1327562338/dalla-foto-ad-alta-definizione-si-individuano-punti-di-fuoriuscita-e-rottura-argini-del-misa> (accessed on 12.11.2024); (c) flooded area for a return time of 100 yrs.**

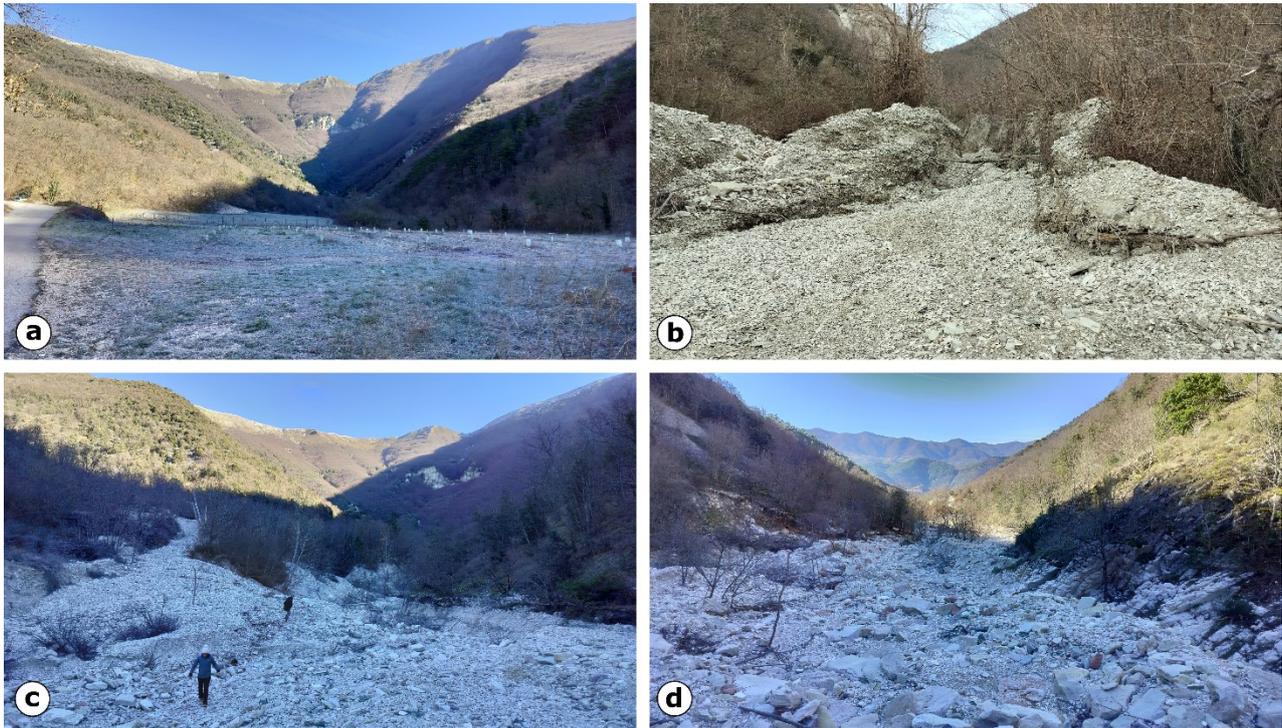
470 In many observations, along the slopes, the same channels have been filled with this coarse-grained sediment and subsequently incised during the tail of the event, remaining debris flow deposits in the form of embankments lateral attributable to a lateral overflow of the flow front (Johnson & Rodine, 1984) (fig. 16b). After the extreme event many deposits at the foot of the slopes (fig. 16c) and throughout the valley were recorded. The shape of the valley, in fact, resulted in steep slopes and a flat bottom filled with sediments (fig. 16d), spreading as flat blankets on alluvial fans (Aulitzky, 1980), indicating the overflowing 475 condition of the same.

Figure 16: geomorphological criticalities detected along the Tenetra valley in the municipality of Cantiano: a) panoramic view of the valley seen from downstream; b) debris flow channel in the hydrographic right portion of Tenetra ditch; c) debris flow deposits of the channel in picture b) in the valley bottom side; d) the flat bottom of Tenetra Stream valley seen from upstream filled with debris flows sediments.

- the lateral flatirons of Pontedazzo and Mt. Alto engrave the western slope of Mt. Tenetra by channelling possible debris flow events (fig. 6; 16b, 16c), which are triggered quite frequently in this area due to the high slopes often not covered by vegetation and litho-structural conditions of the rock masses, which present discontinuities and fractures because highly tectonized. Containing this material along the slopes is necessary to prevent debris flow phenomena from reaching the watercourse and the anthropogenic structures downstream. For this reason, the installation of anti-

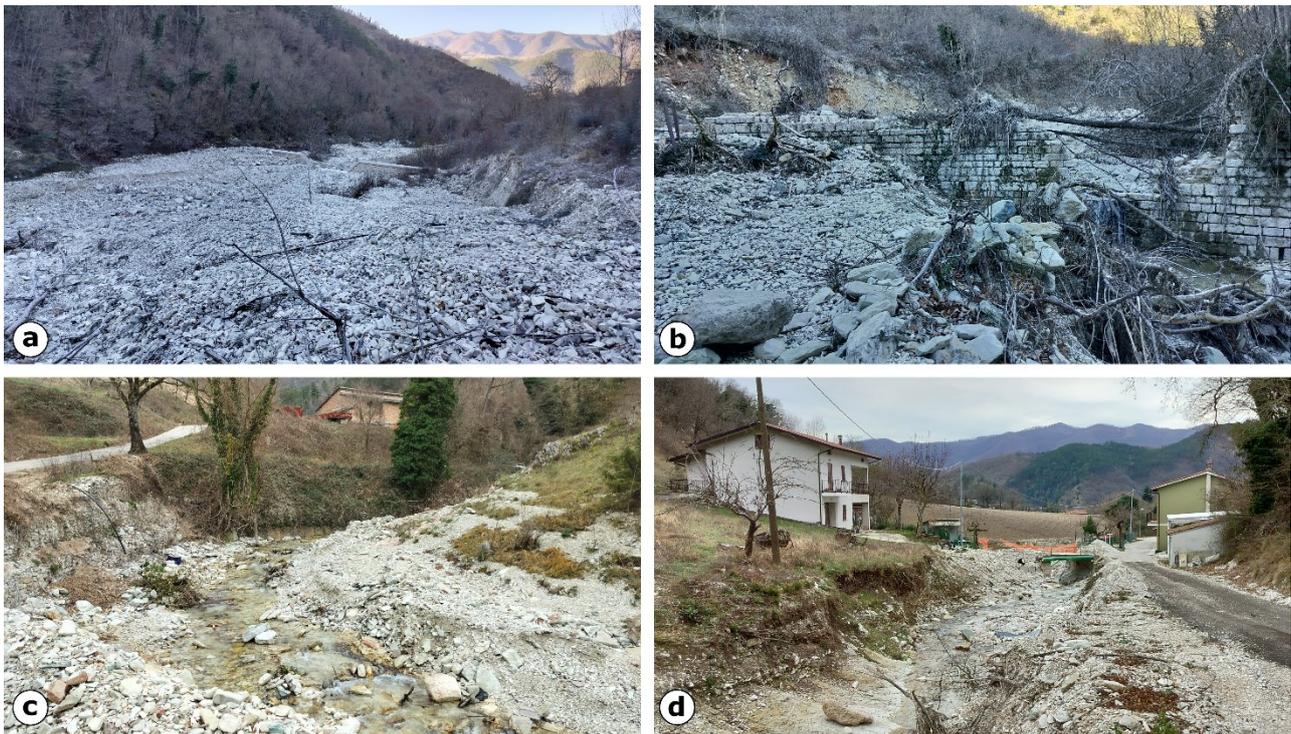
The on-field survey mapped different criticalities, also from the anthropic point of view. Along the watercourse, three hydraulic weirs were present, and they were entirely filled (fig. 17a) and damaged (fig. 17b) by the event, compromising their functionality. Some riverbank protection works were also damaged, such as the gabion wall (fig. 17c) protecting the municipal road. Another criticality was represented by the undersized bridge in the hamlet of Tenetra (fig. 17d), which was obstructed and overtopped during the flood so much that it separated the two dwellings on either side of it.

Figure 17: Critical issues represented by the anthropic structures: a) a filled and buried hydraulic weir seen from upstream; b) a damaged hydraulic weir; c) damaged gabion wall; d) undersized bridge in the hamlet of Tenetra.

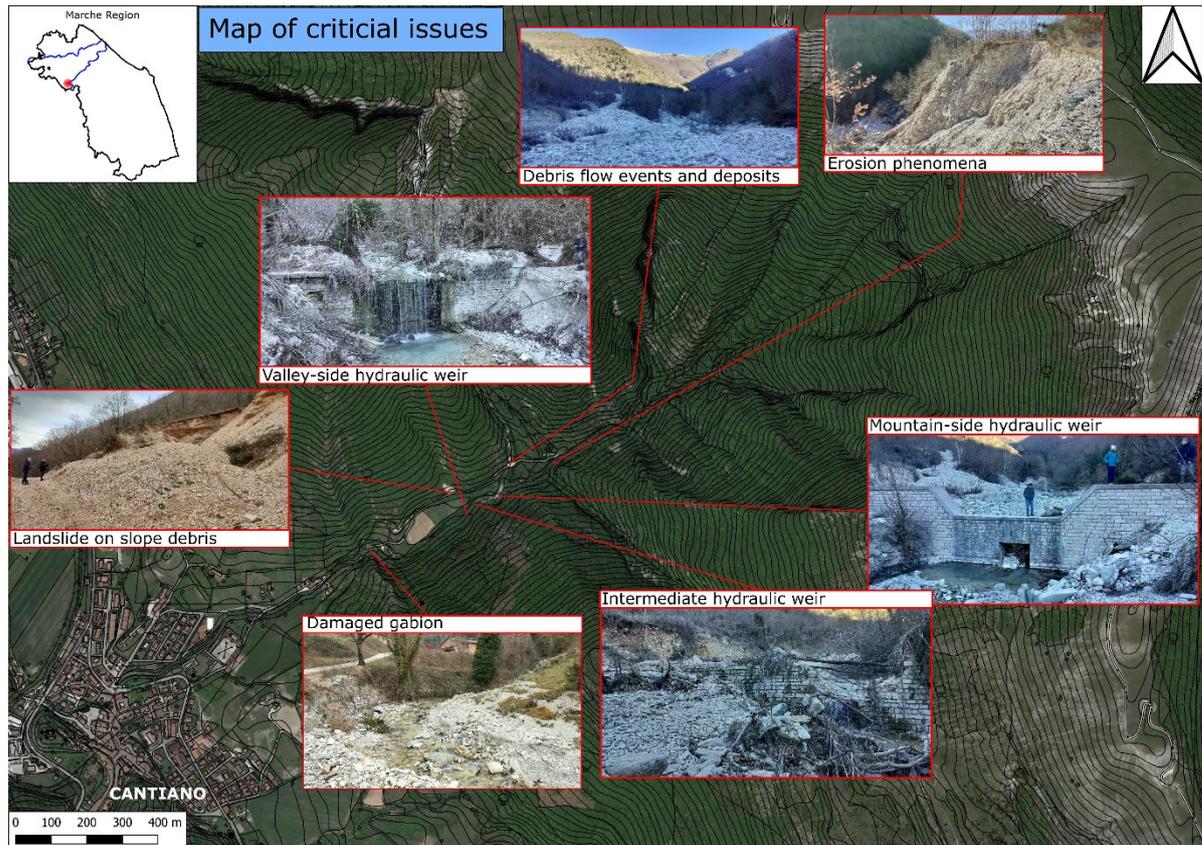
Figure 18: Map of critical issues in the Tenetra valley. The extent rectangle shows in black the boundaries of the Marche Region with Cantiano (in red) and the catchment area of the Metauro River (in blue). Cartographic layers from Regione Marche, n.d.

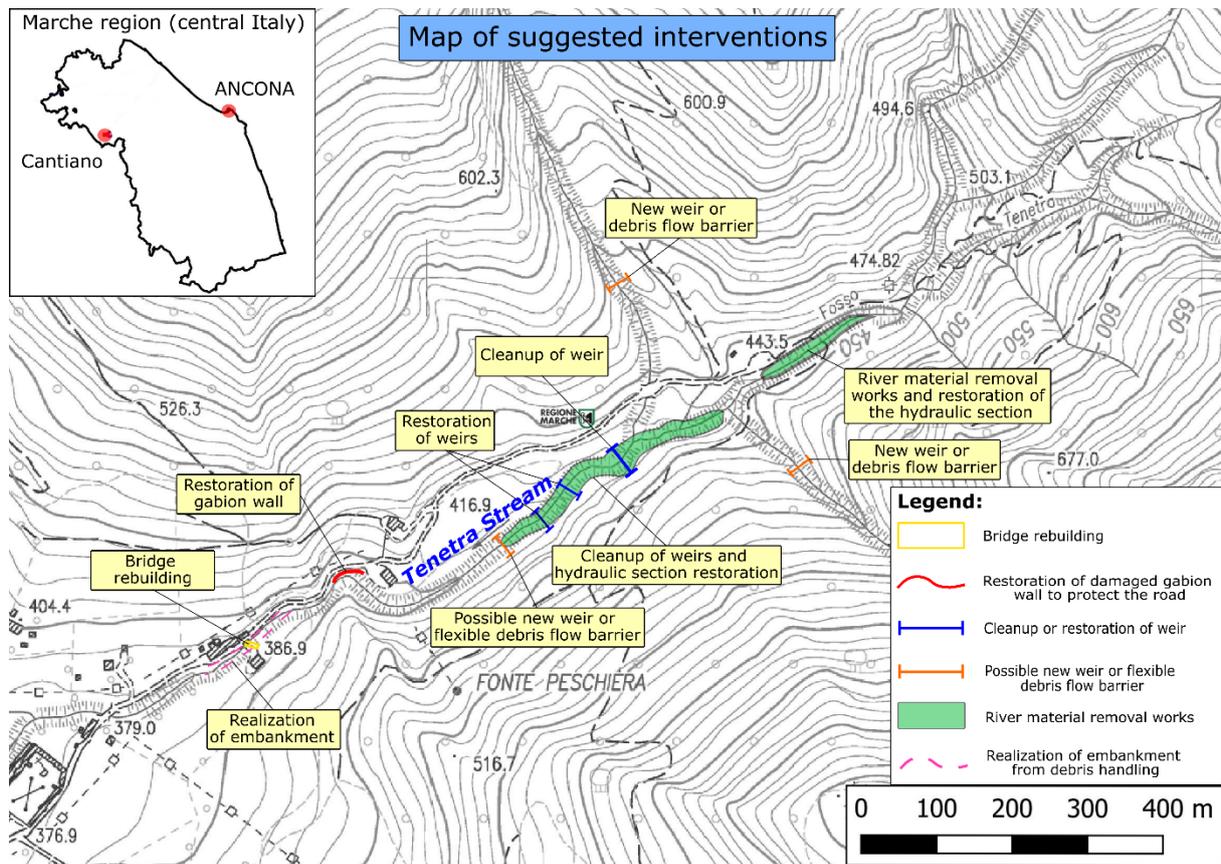
520 **Figure 19: map of the suggested intervention in the Tenetra Valley.** The extent rectangle shows in black the boundaries of the Marche Region with Cantiano (in red) and the catchment area of the Metauro River (in blue). Cartographic layers from Regione Marche, n.d.

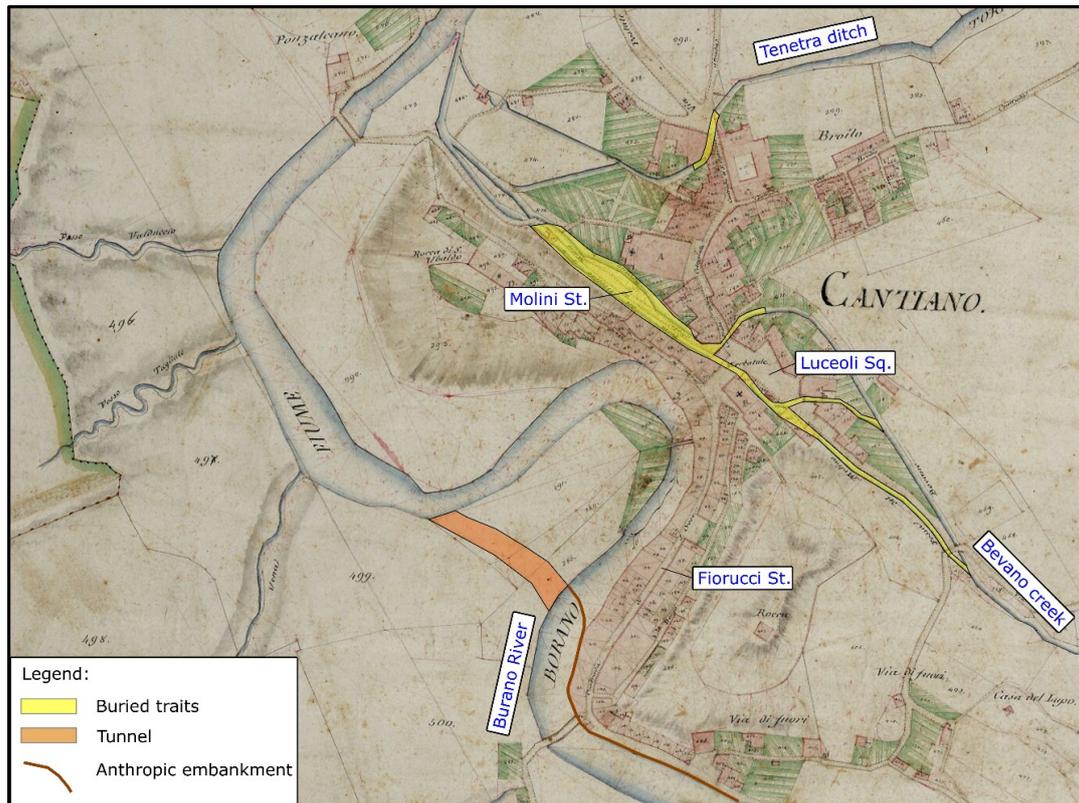
Figure 20: schematic map of the main anthropogenic surface water regulation interventions superimposed on the Gregorian cadastre (Archivio di Stato di Roma, n.d.). It is easily recognisable that the abandoned meander is destined for human use.

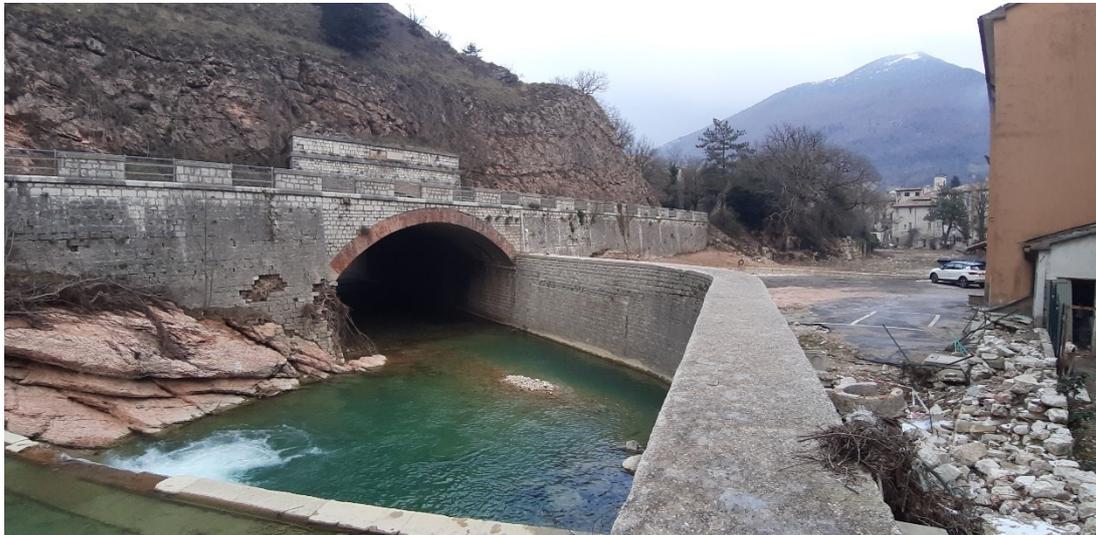
Figure 21: The 65-meter tunnel of the Burano River below the calcareous mountain ridge, with the anthropogenic embankment behind which the alluvial plain, the parking and the historical centre are recognizable.

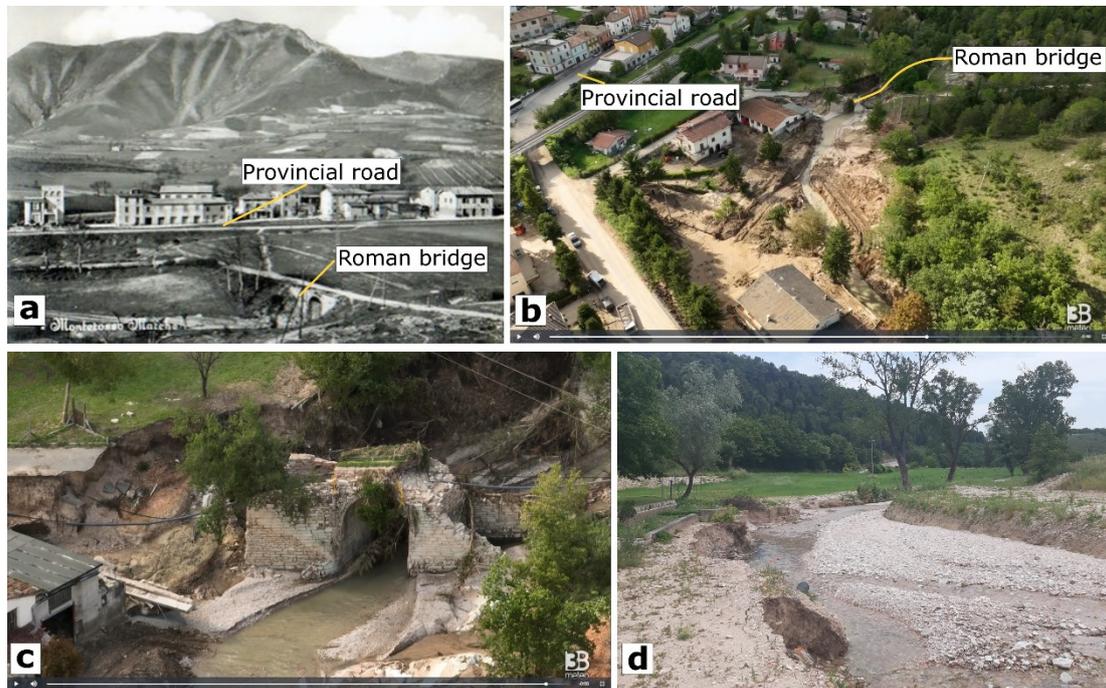
Figure 23: a) the Roman bridge at Monterosso Stazione above the Sanguerone Creek in a historical photo, with the eastern foothills
of Mt. Strega in the background (scanning from a postcard, then modified); b) the post-event situation for comparisons with image
a (also related to urbanisation). Note that in the past, the alluvial valley was not urbanised; c) the Roman bridge after the event
viewed from downstream, with the collapsed abutments; d) the unnamed ditch in Sassoferrato Stazione after the flood, with the
595 waterbed filled with gravel and raised about two meters compared to the pre-event situation. Images b) and c) come from
<https://www.3bmeteo.com/giornale-meteo/cronaca-meteo-alluvione-marche---monterosso-stazione-dal-drone--ponti-crollati-e-gravi-danni---video-643860> (accessed on 12.01.2026).

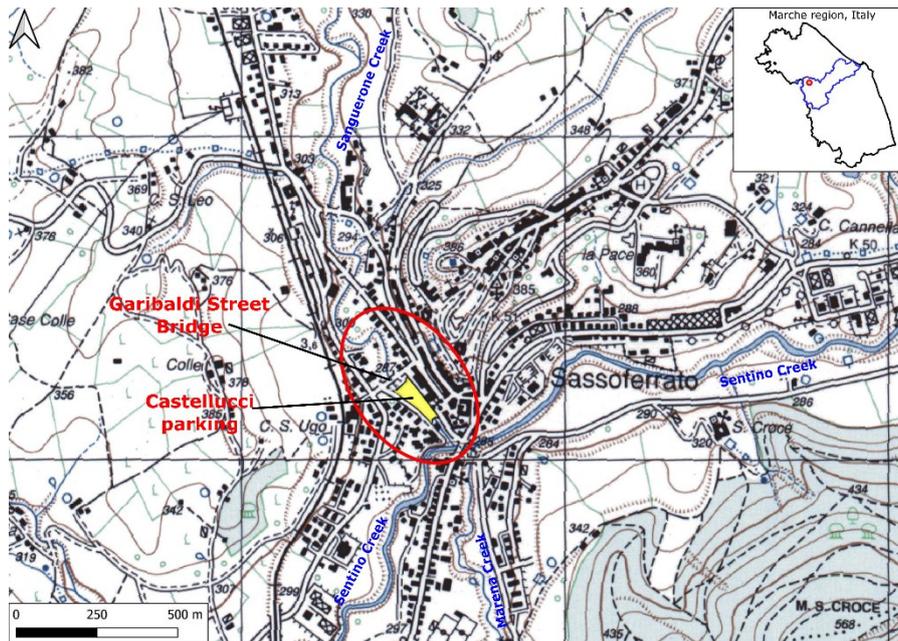
600 About seven kilometres downstream, the Sanguerone Stream reaches the town of Sassoferrato, where it flows between 280
and 290 meters above sea level with an approximately N-S direction (fig. 24). The watercourse flows through the
lithostratigraphic transition between the eastern more calcareous and marly-calcareous lithotypes on which the historic centre
of Sassoferrato was built, and the western hemipelagites with a more marly and marly-clay content. These sediments,
characterized by a greater aptitude for degradation by erosion, border the slope on the hydrographic right of the Sanguerone,
605 which is therefore distinguished by gentler morphologies and less steep slopes.
The Sanguerone Valley, upstream of the confluence with the Sentino Creek, presents a rather curvilinear course, with a variable
width of about 30- 50 linear meters. This amplitude is drastically reduced when the watercourse meets the Garibaldi Street

610 **Figure 24: Topographic map of the Military Geographical Institute- IGM of Sassoferrato (AN) with the buried stretch of Sanguerone
Creek below the Castellucci parking highlighted in yellow. In the extent rectangle, the Marche region (black border), the
hydrographic basin of the Esino River in blue and the town of Sassoferrato in red. Cartographic layers from Regione Marche, n.d.**

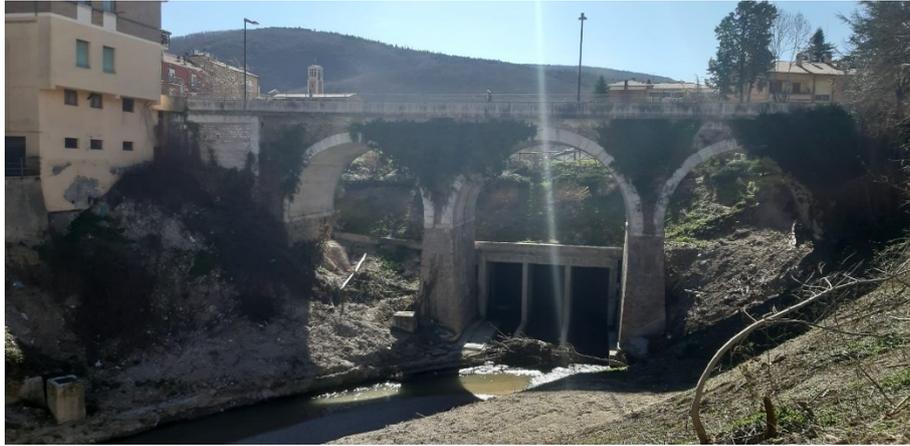
Starting from the bridge on Garibaldi Street, the entire riverbed of Sanguerone Stream was tunnelled with a three-segmented
615 concrete box structure of about 200 meters in length, which reduces the original section of the ancient bridge built by the
Italian Military Engineering Corps (fig. 25). The watercourse returns to the open space only one hundred meters before its
confluence into the Sentino Creek. The buried section was then covered with backfill material, above which the Castellucci
parking was realised. The channelisation intervention, observed from upstream, shows how the original wide arches of

Garibaldi Street Bridge were reduced to a box-like structure that greatly reduced the hydraulic section, making it undoubtedly undersized for the flow rates recorded during the September 15th, 2022, hydraulic event.

Figure 25: The Garibaldi Street Bridge saw from upstream with the evident, extreme reduction of the original flow section with a box-like structure (the markers on the wall on the left mark the hydrometric levels reached).

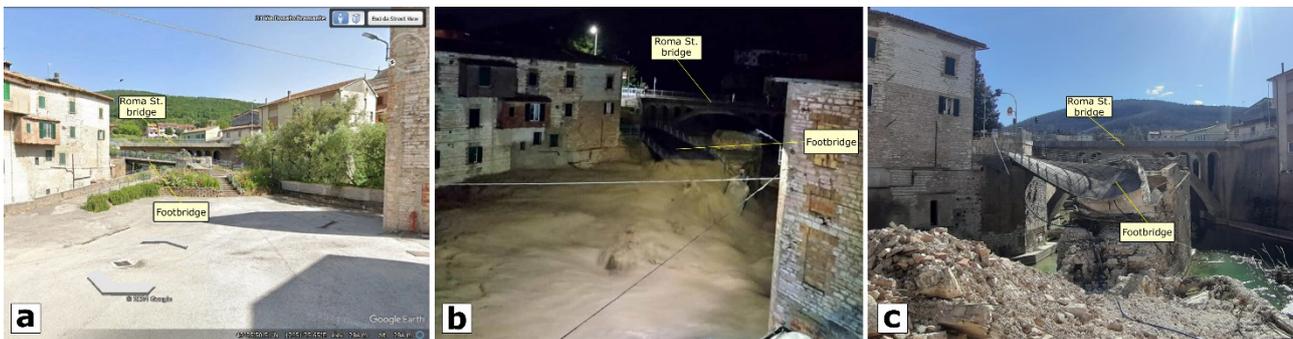
The flood eradicated and dragged trees and sediment along its course, which, once they met the narrowing imposed by the channelisation, obstructed the section, creating a lake in its upstream portion (markers on the wall in the left mark the hydrometric levels reached). Overpressures developed inside the buried section, the roof of which fortunately held up without being damaged. These overpressures, however, were released as they exited the channelized section, creating extensive erosions to structures located adjacent to it (fig. 26).

Figure 26: The area exiting the tombled section of Sanguerone Stream under the Castellucci parking a) before, b) during and c) after the event.

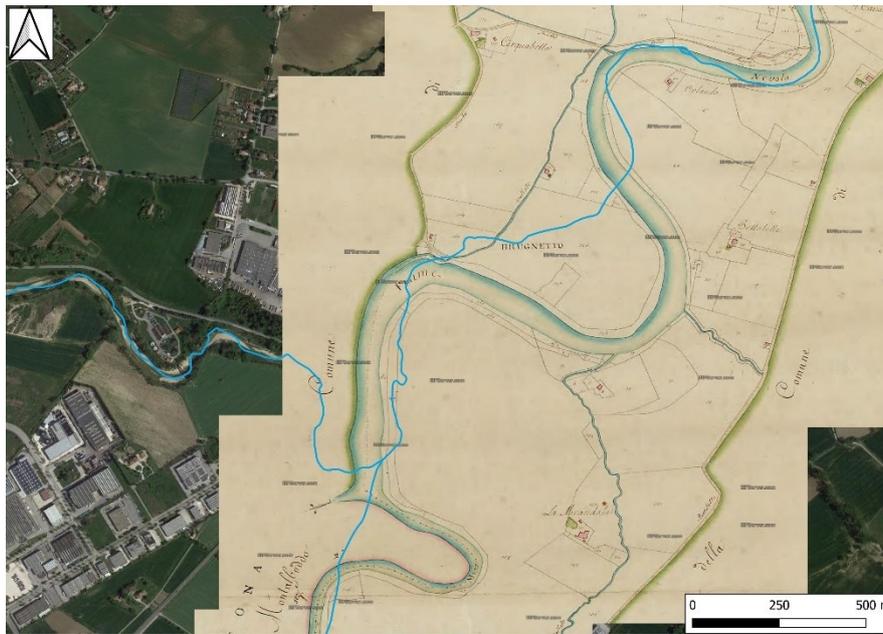
Figure 27: The ancient map of the Gregorian cadastre (Archivio di Stato di Roma, n.d.) with the superimposed actual watercourses of the Nevola and Misa rivers (light blue lines). The modifications of the hydrographic network are well recognisable.

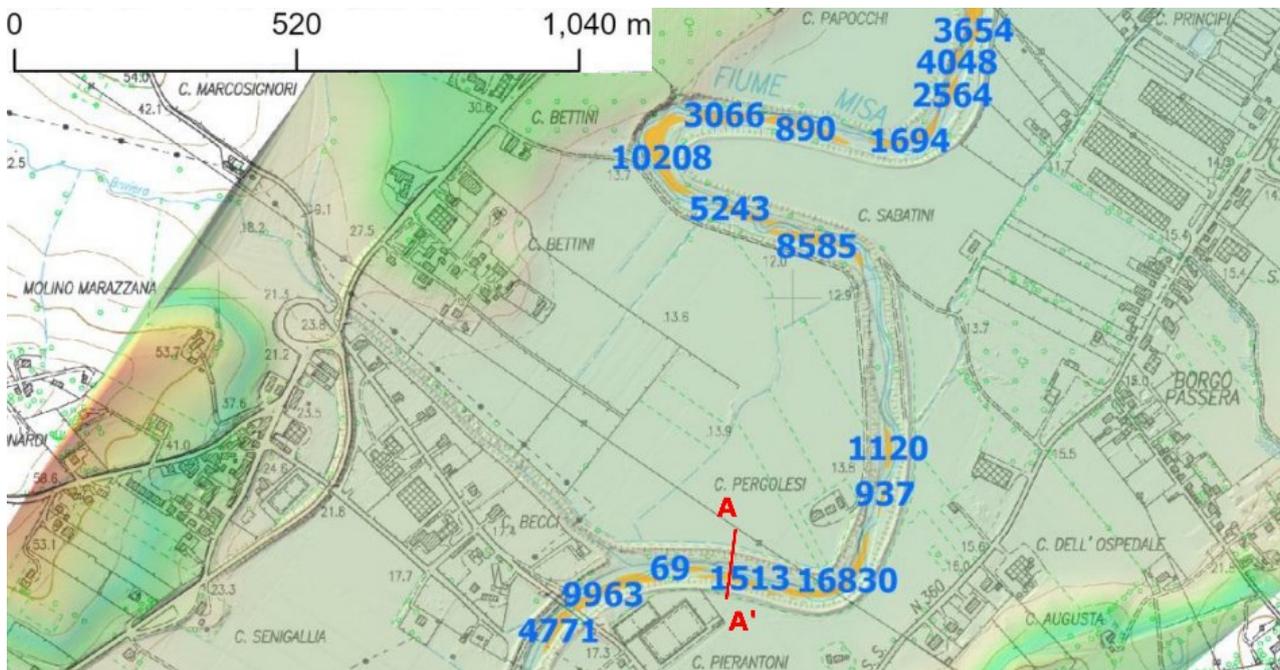
690 **Figure 28: A stretch of the lidar image of the Misa River around Molino Marazzana (Senigallia). The blue numbers refer to the single volume of each river point bar (in orange) to be dredged to widen the river section. The red line indicates the section trace from which the river cross-sectional topographic profile (shown in the next image) was obtained through LiDAR data. The colour shades refer to the elevations.**

685 These lidar images were also very useful for the identification of areas where the construction of flood attenuation basins could be recommended.

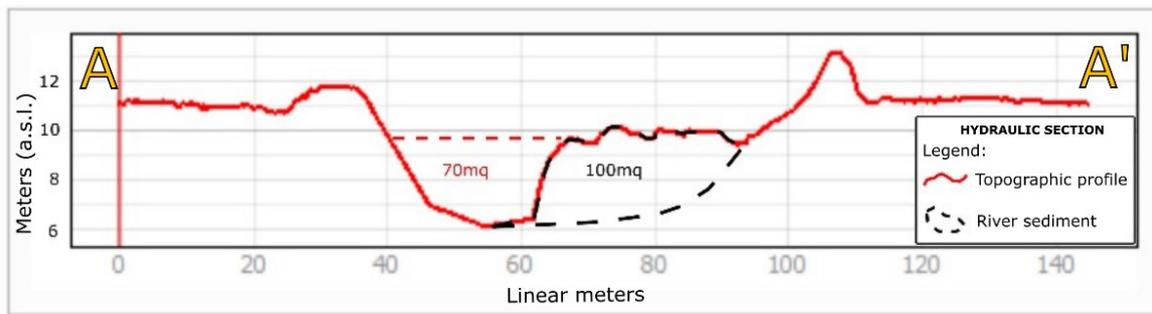
695 The main criticalities of the hydraulic section of the valley portion of the Misa River can be detected by observing the lidar acquisition. The topographic profile resulting from lidar acquisition acquired by our research group (fig. 29) highlighted the asymmetry of the two embankments, with differences in height and thickness. In addition to this, the hydraulic section appears partially occluded from the river point bar on the hydraulic right. From the examination of the typical cross-section derived from the LiDAR survey carried out by UNICAM, it is evident that the removal of the overbank sediment allows the recovery of an additional 100 m² of flood section, resulting in a total cross-sectional area more than twice the current one (70 m²), as
700 shown in fig. 29.

Figure 29: The topographic profile of a representative stretch of the Misa River in Molino Marazzana (Senigallia) acquired through lidar survey after the flood event.

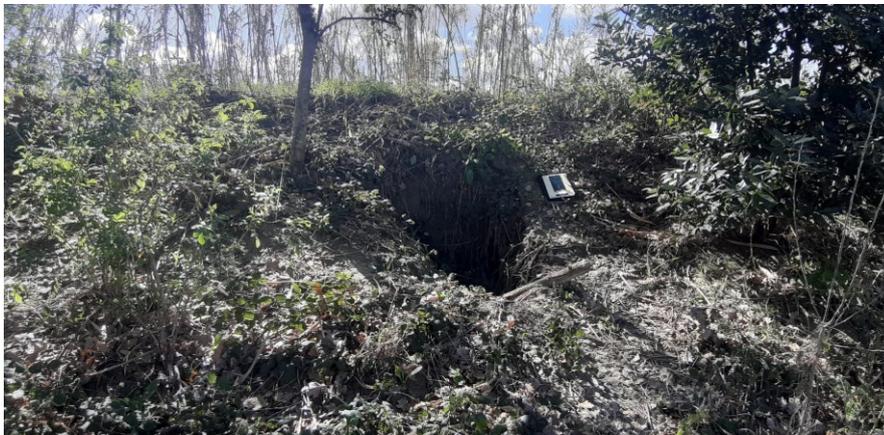
Furthermore, the on-field geomorphological-hydraulic survey identified the presence of widespread burrows of fossorial animals (Fig. 30), sometimes passing from one side to the other. During a flood, this can represent a serious situation of weakness of the embankment and can therefore cause its erosion, piping and collapse. In addition to the embankment overflowing, this was one of the causes of the flooding of the Senigallia and Ostra area.

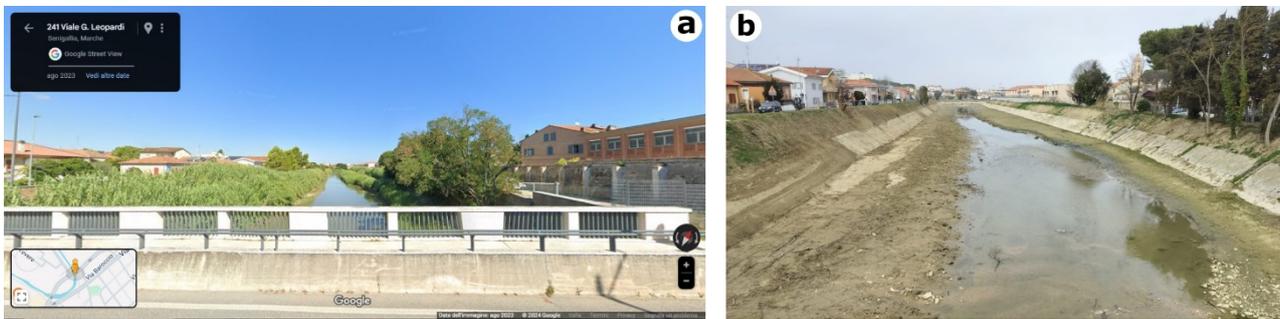
735 **Figure 31: Two images of the same stretch of Misa River caught from Portone Bridge along Leopardi Street: a) in August 2023 (© 2025 Google); b) in February 2024, after the works of the hydraulic section widening with the removal of sediments and vegetation, which exposed the concrete embankments constructed by the “Consorzio di bonifica del Misa” a century ago.**

To avoid the accumulation of vegetation eradicated from the riverbed in the narrowings, it was proposed to act along the hydrographic network by removing dead vegetation present along the river that could create a potential obstacle to runoff (fig. 31a). Action was also taken by removing the material deposited in the river bars to widen the hydraulic section (fig. 31b). Another of the most important actions is the embankment restoration and reinforcement. The burrows of fossorial fauna (fig. 30) must be filled in, the embankments consolidated and reinforced, and the height of the hydrographic left and right embankments levelled.

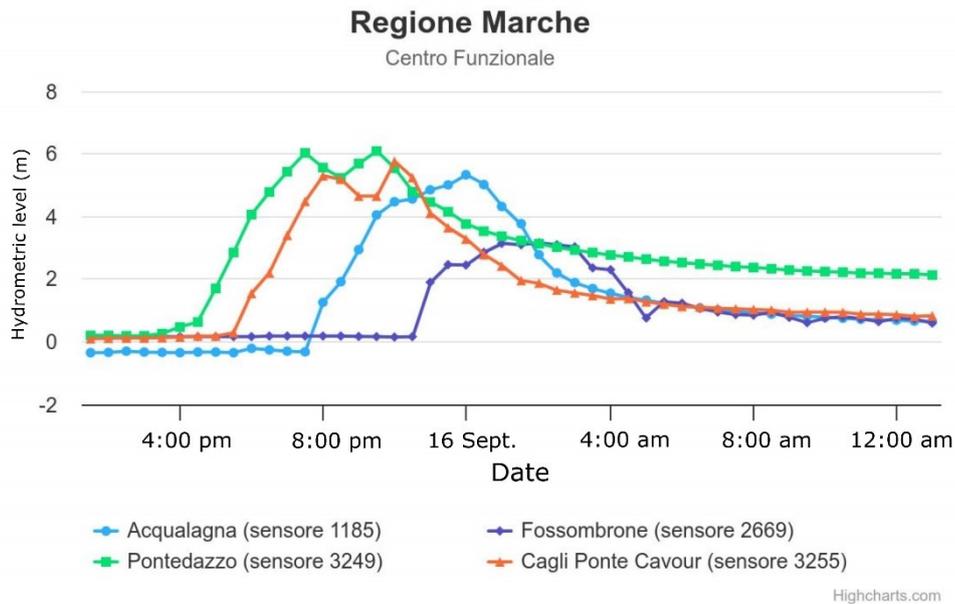
780 **Figure 32: The hydrometric levels of the mountain portion of the Metauro River basin from Pontedazzo (Cantiano) to Fossombrone, from 1:00 p.m. of Sept. 15th, 2022, to 1:00 p.m. of Sept. 16th, 2022. Italian time (SIRMIP 2022).**

Analysing the hydrometric graphs (fig. 13 and 32) along the catchment area of Metauro River from Cantiano (hamlet of Pontedazzo) to Fossombrone (PU) it is possible to recognize the two main peaks inherited from the Cantiano floods also reflected in the downstream municipality of Cagli (PU), which is another locality studied for this work. After the rain gauge in Cagli (Cavour Bridge of Flaminia Street), the Burano River reaches the water contributions of Bosso River, further on, those
775 of Candigliano River and, further on, in proximity of Fossombrone, those of Metauro River. It is precisely for these contributions that, from the town of Cagli on, we don't find the double peak in the flow. The downward trend in hydrometric levels is because the Metauro River has a SW-NE direction while the storm has moved to the south-east.

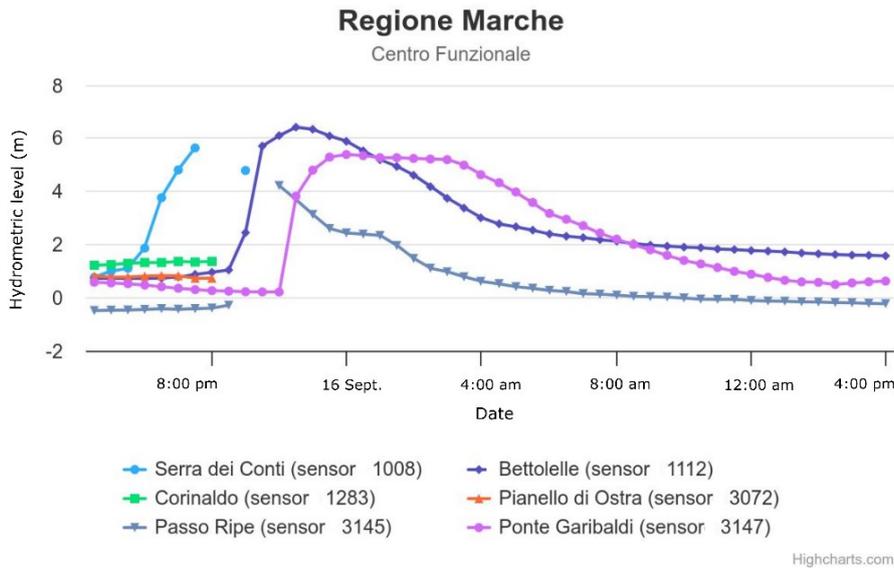
Figure 33: The hydrometric levels of the Misa River basin between Serra de Conti (AN) and Senigallia (Garibaldi Bridge), from 4:00 p.m. of Sept. 15th, 2022, to 4:00 p.m. of Sept. 16th, 2022. Italian time (SIRMIP 2022).

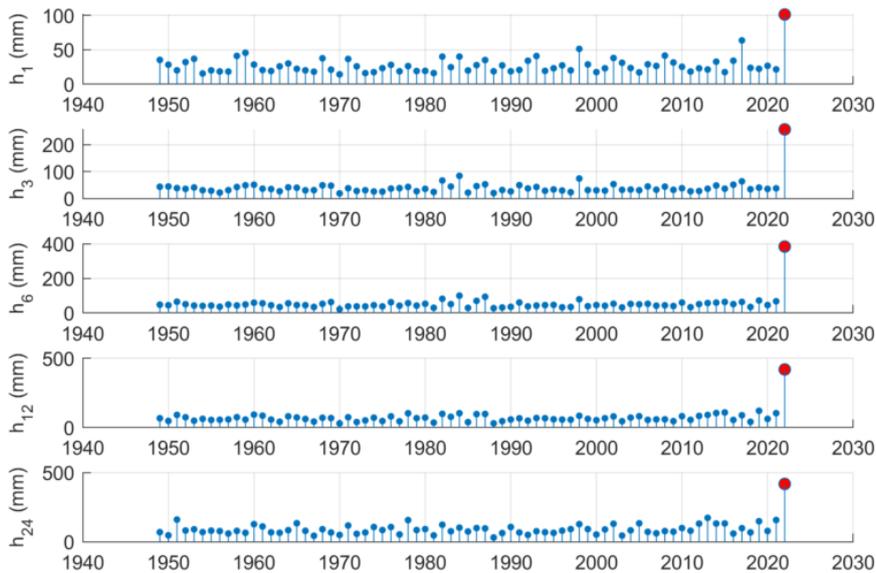
795 Figure 34: Historical series of annual precipitation maxima for 5 different durations (1, 3, 6, 12 and 24 hours) of the Cantiano rain gauge, showing the extremes recorded during the September 15th, 2022, event (Idrogeologia Polito, 2022).
