# The 15 September 2022 floods in northern Marche (Central Italy): disaster analysis, case studies and mitigation strategies for hydro-geomorphological hazard

**Abstract.** On September 15th and 16th, 2022, a large area of the Marche region in central Italy experienced an exceptionally heavy rainfall event, with nearly 420 mm/m<sup>2</sup> of rain falling in just six hours. The intense rains, in addition to causing 13 fatalities, triggered a large number of landslides in the mountain areas and flood events, mainly concentrated along the valleys  
10 of the hydrographic basins of the Metauro, Cesano, Misa, and Esino Rivers. The physiographic setting of the territory and the poor maintenance of both the main and secondary hydrographic network, often insufficient or entirely absent, exacerbated an already exceptional event. Although extraordinary, the natural event occurred in an area already affected by intense meteoric events in the past, the most recent of which had taken place just eight years earlier, in 2014.

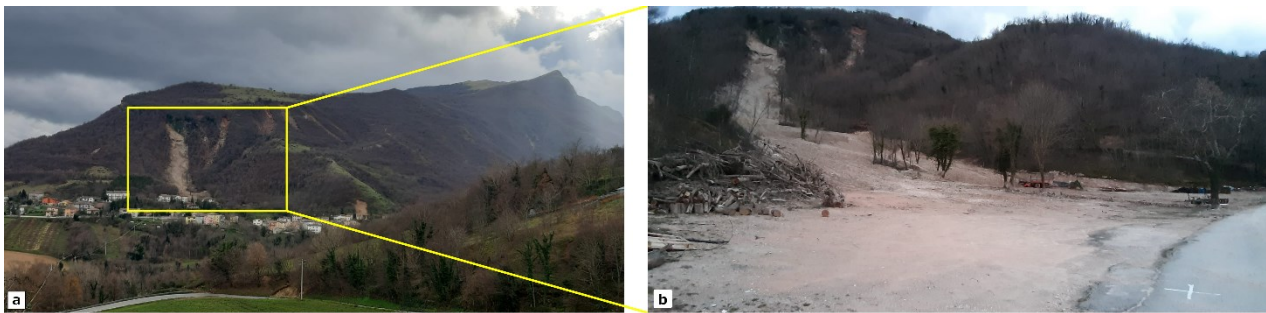
**Figure 1: a) the scars of landslide events along the northern slopes of Mt. Calvello, activated during the rainfall event in question and involving the hamlet of Leccia, municipality of Serra Sant'Abbondio; b) detail of the frame in picture a).**

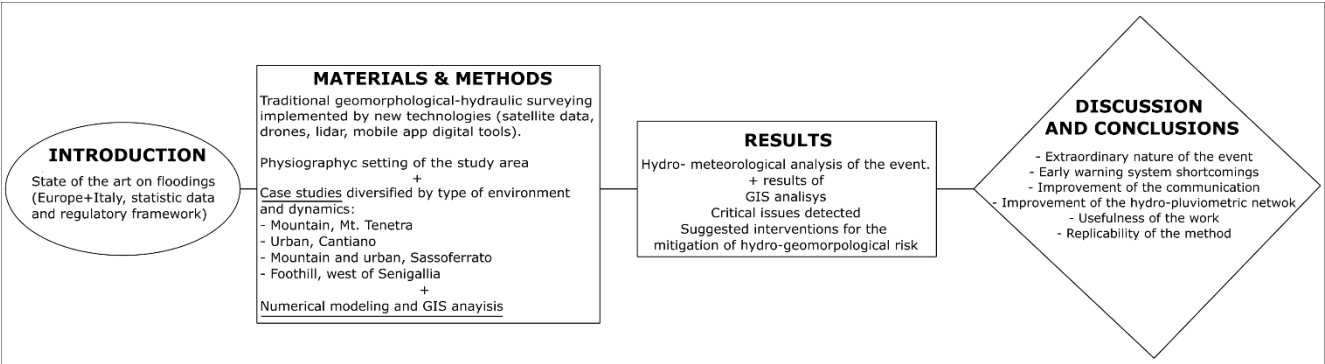
Figure 2: flow chart of the methodology used.

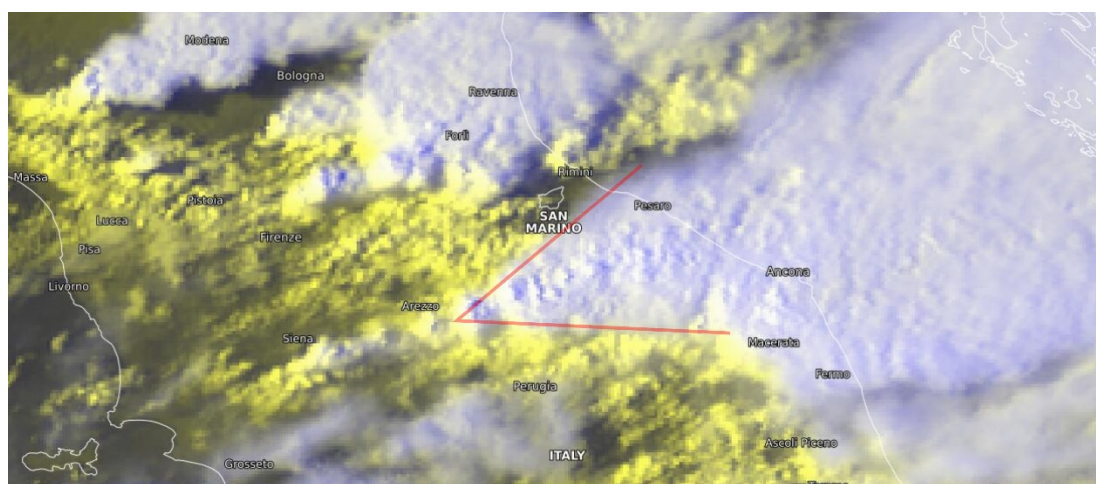
**Figure 3: The Central Italy satellite view of the thunderstorm at 3:00 pm UTC on 15th September 2022. MSG-SEVIRI HRV cloud composite with the characteristic and well-recognisable V-shape (drawn in red). Copyright Eumetsat. Image from <https://view.eumetsat.int/productviewer?v=61314> (last access 10.18.2024).**

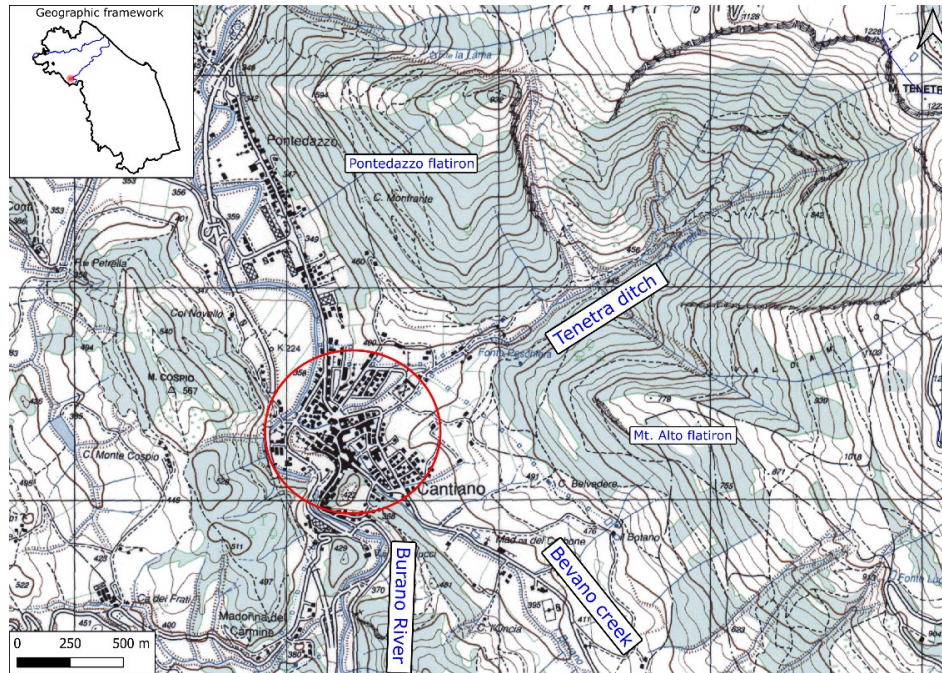
**Figure 6: Topographic map of the town of Cantiano (IGM 1:25,000) with the well-recognisable form of Mt. Tenetra amphitheatre and the three main watercourses. In the extent rectangle, the Marche region, the hydrographic basin of the Metauro River in blue and the town of Cantiano in red. Cartographic layers from Regione Marche, n.d.**

Tenetra released different debris flows (figures 6; 14a; 14b) along the pre-existing channels, in some cases stopped along the slope, in other cases able to reach the Tenetra mainstream at the bottom of the valley. Very likely, the presence of three  
440 hydraulic weirs (resulting damaged and filled) placed upstream with respect to the town counteracted the erosive potential of the stream, preventing major damage to downstream structures.

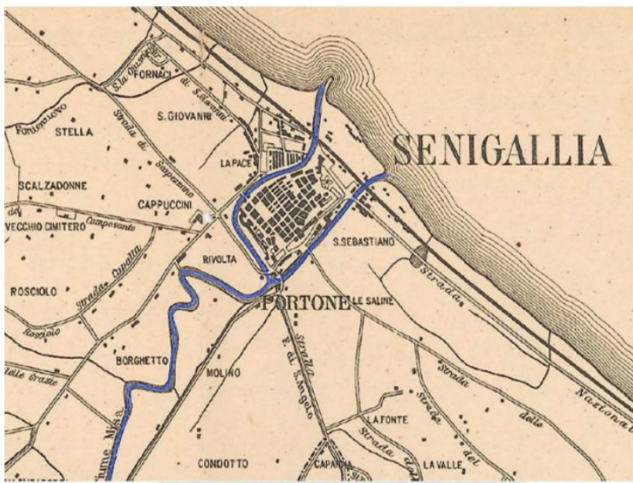
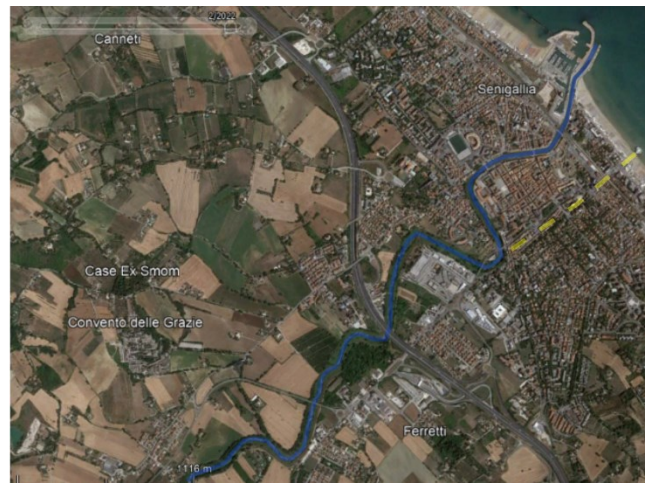
**Figure 7: The comparison between the Misa River, highlighted in blue near Senigallia in an ancient map of 1889 (Santoni G., & Morici R., 2021) on the left and in a © 2023 Google image of 2023 on the right, with the preexisting “Penna channel” dashed in yellow, subsequently occluded about a century ago.**

In the past, floods came very frequently in Senigallia. For this reason, over the years, the farmers built artificial embankments along the Misa River to protect field crops and livestock. At the same time, the municipal administrations built the so-called “cavo Penna”, an artificial channel which flowed below the actual IV November Street and reached the sea, where today there is the famous roundabout. The Penna channel was a sort of drainage ditch designed to protect the town from floodings. Around 1920, after completing all the earthen embankments in the countryside and building the masonry embankments in the city, they decided to bar and fill the channel and urbanise the area above it abundantly (fig. 7).

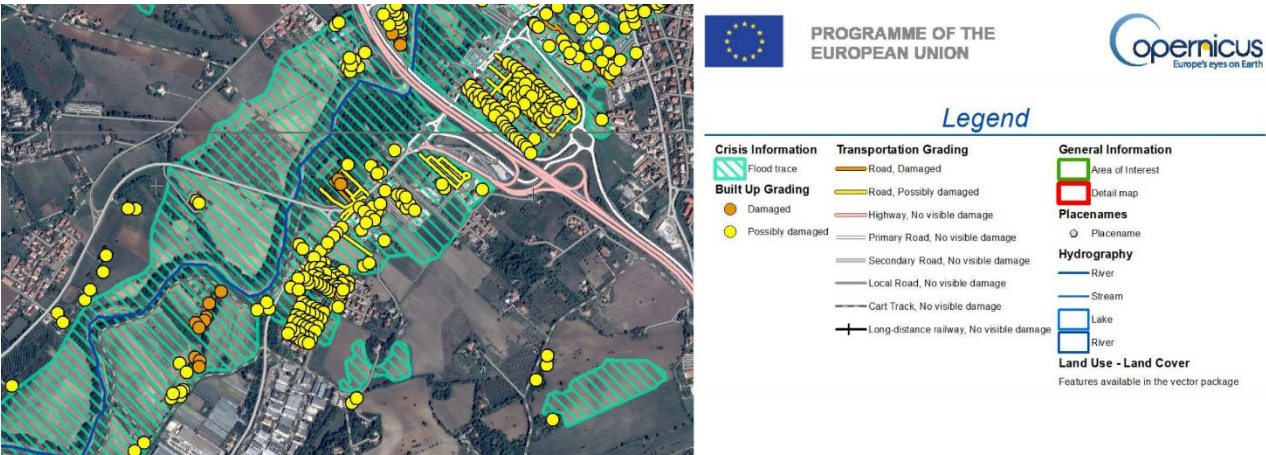
Figure 8: An excerpt, modified, of Copernicus satellite mapping in the immediate aftermath of the Marche floods, with the well-recognisable flood trace and the damaged and possibly damaged buildings. South-West of Senigallia. Original image from <https://emergency.copernicus.eu/mapping/list-of-components/EMSR634> (Accessed on 12.16.2024).

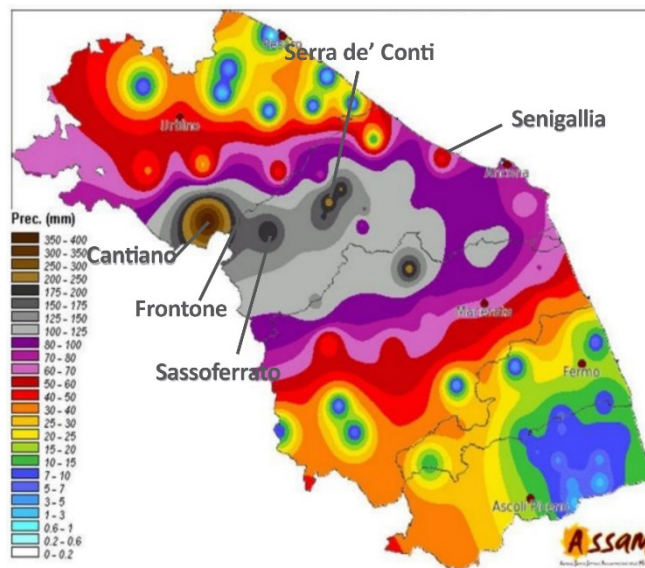
**Figure 9: Cumulative rainfall distribution during the entire day of 15th September 2022 in the Marche region, modified, indicating the most represented localities treated in this work (Regional Agro- meteorological Service of AMAP Regione Marche, 2022; modified).**

From the regional rainfall map (fig. 9), it is possible to recognize the areas most affected by rain during the meteorological event, such as the western Apennines area of the province of Pesaro Urbino and a large portion of Ancona province.

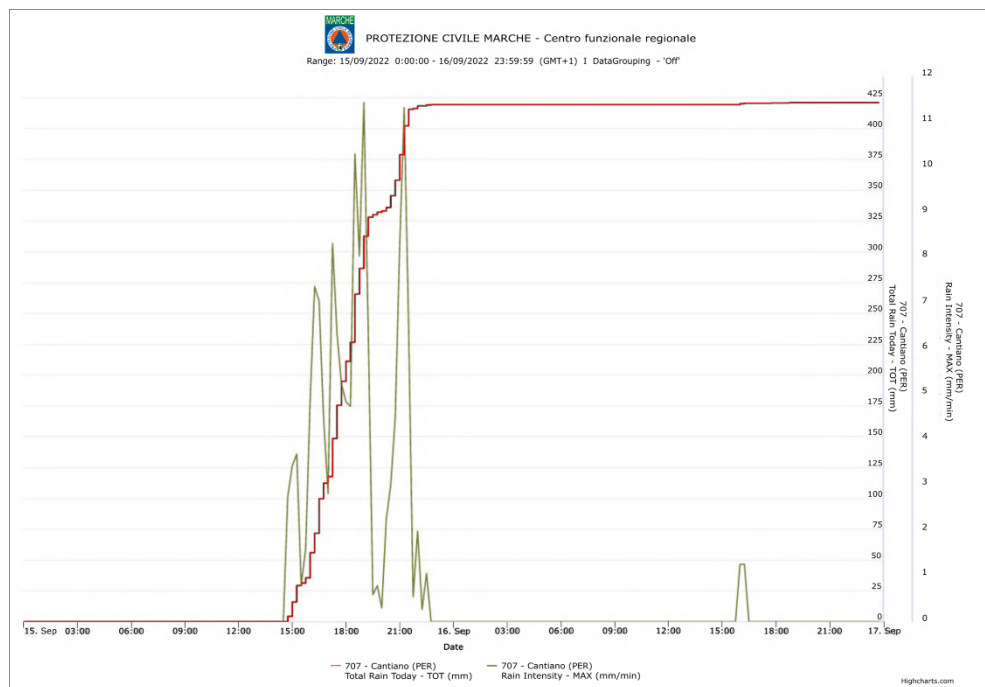
320 **Figure 10: Cumulative and intensity of precipitation recorded by the rain gauge of Cantiano (redraw from Civil Protection of the Marche region, 2022). Times in the graph refer to standard time.**

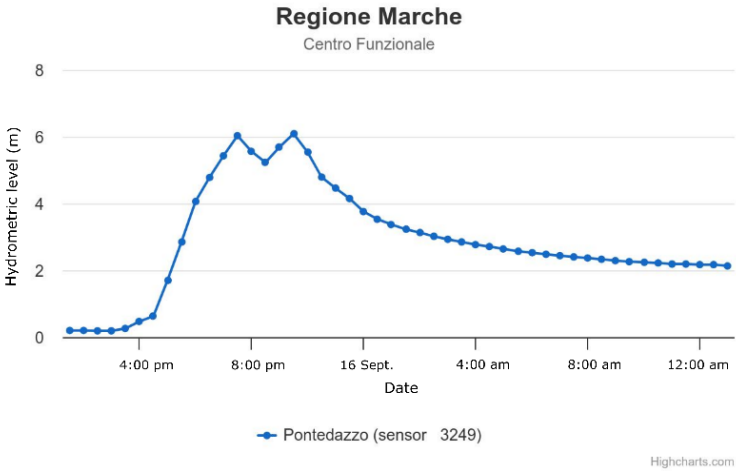
Figure 11: The hydrometric graph of sensor 3249 Pontedazzo about one km downstream of Cantiano from 1:00 p.m. of Sept. 15<sup>th</sup>, 2022, to 1:00 p.m. of Sept. 16<sup>th</sup>, 2022, Italian time (SIRMIP 2022).

The hydrometric analysis for the municipality of Cantiano (Fig. 11) confirms the testimonies collected from residents who narrated about two flood waves that affected Luceoli Square: the first, smaller, inundated the square with about 50 centimetres of water and the second, more extensive, reached a height of 2.35 meters. This is well recognizable in the two peaks corresponding to the two flood waves that reached Luceoli Square at 7:30 p.m. and 9:30 p.m.

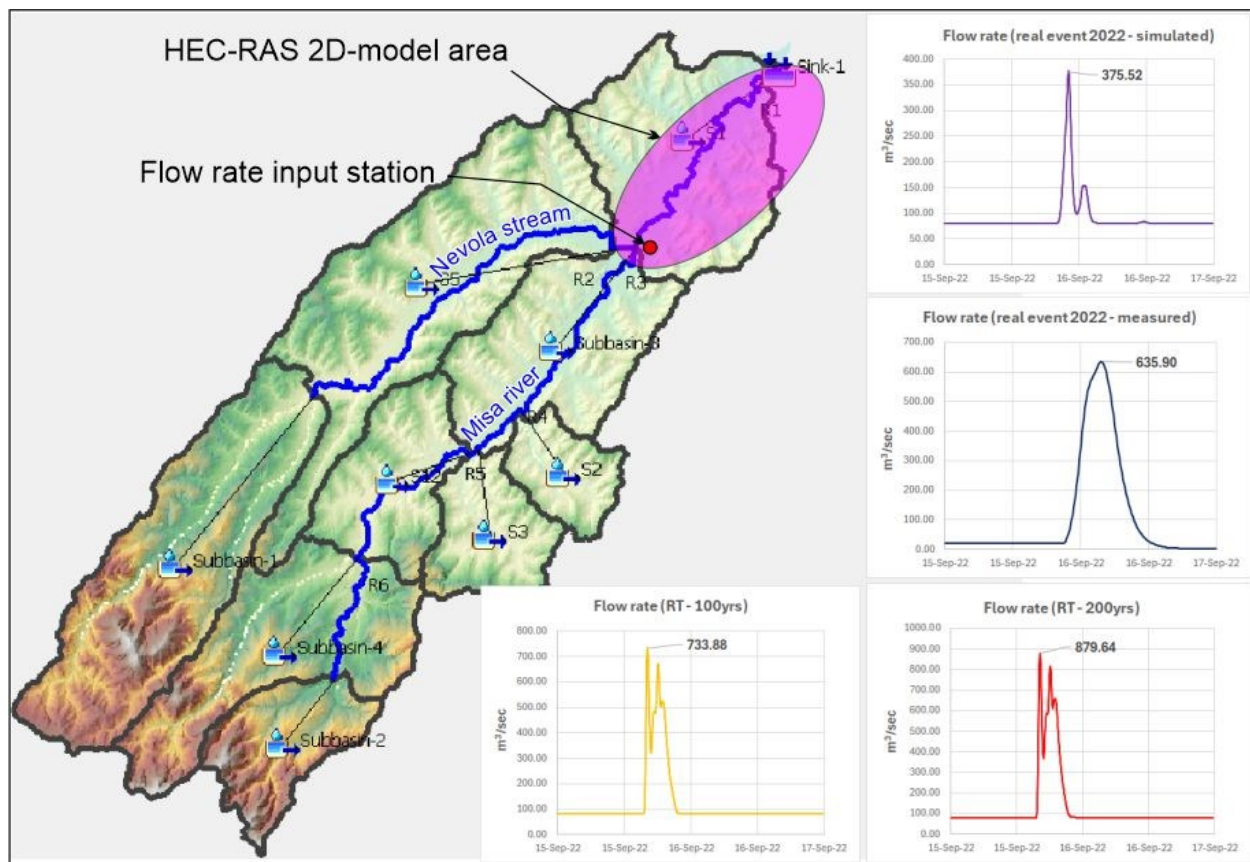
Fig. 12: HEC-HMS model results.

The results of the hydrological modelling (settings and parameters are shown in Table 1) are presented in Fig. 12.

For the actual 2022 event, precipitation data were entered into the model with a relatively low average Curve Number (CN = 49), typical of dry conditions; the rainfall event had, in fact, been preceded by weeks of virtually no precipitation. Flow rate calculation gives a value of approximately 375 m<sup>3</sup>/sec, a value significantly lower than that recorded at the Bettollele hydrometer (around 640 m<sup>3</sup>/sec). In the simulations estimating maximum flood discharges for 100- and 200-year return periods, on the other hand, an average Curve Number of 64 was used; this value is typical of "saturated" conditions, as required by legislation, which mandates consideration of the most unfavorable event scenario. Flow rates calculated for both scenarios give values of respectively 733 and 879 m<sup>3</sup>/sec.

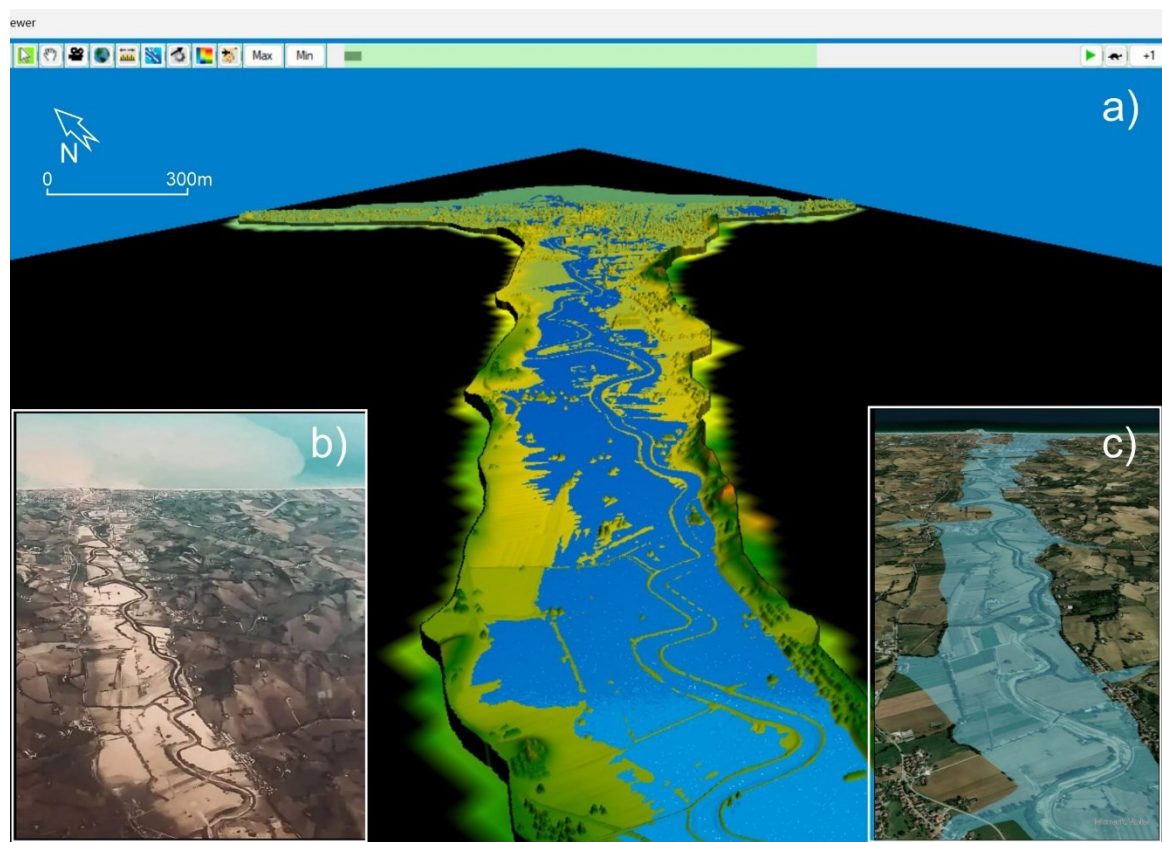
360 Fig. 13: Comparison between potentially floodable areas in relation to different event scenarios and the areas actually flooded during the September 2022 event in correspondence of the final stretch of the Misa River valley. (a) Flooded area using a flow rate of 640 m3/sec; (b) the flooded plain of the Misa River seen from an aircraft flying from Ancona to the United Kingdom on 16<sup>th</sup> September 2022 at 11.08 a.m. Italian time, with the well-recognisable flooded area, the main localities in yellow and the plume of sediments seaward. Image from <https://www.senigallianotizie.it/1327562338/dalla-foto-ad-alta-definizione-si-individuano-punti-di-fuoriuscita-e-rottura-argini-del-misa> (accessed on 12.11.2024); (c) flooded area for a return time of 100 yrs.

355 floodplain; iii) Fig. 13c illustrates the floodable area for a return period of 100 years, as defined by the Marche Region Civil Protection Agency.

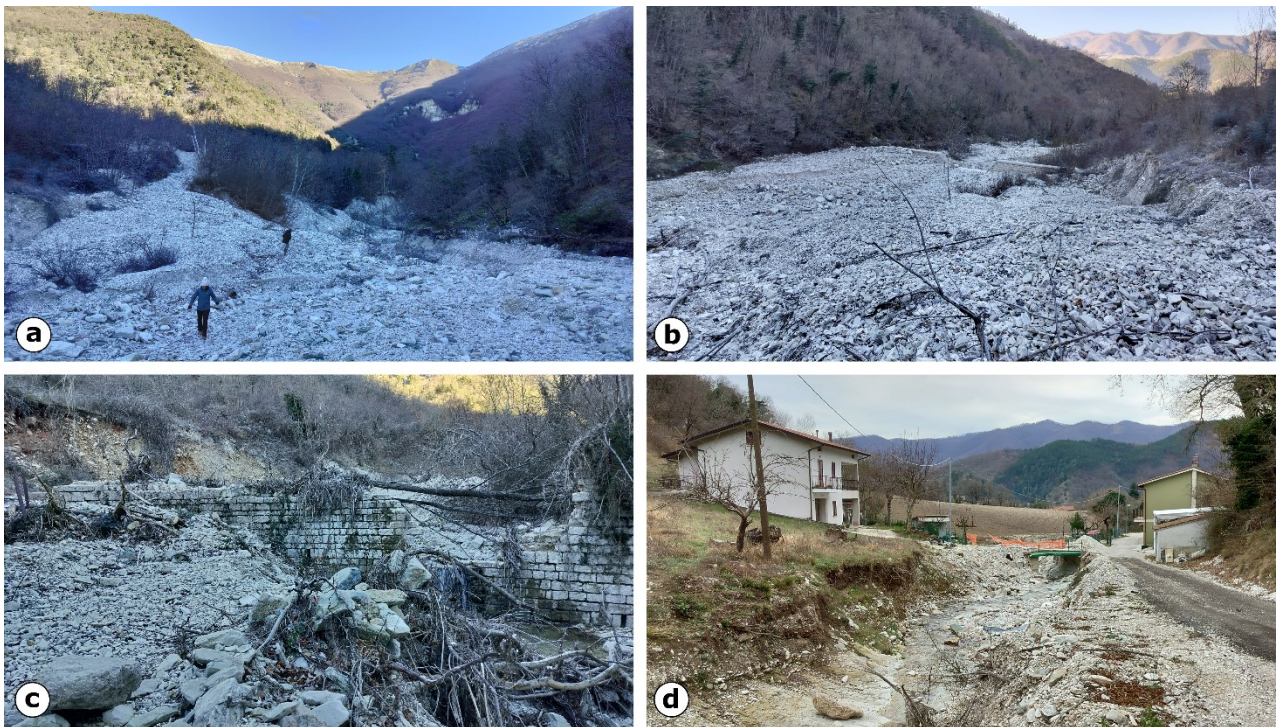
**Figure 14: geomorphological criticalities detected along the Tenetra valley in the municipality of Cantiano: a) panoramic view of the valley seen from downstream; b) debris flow channel in the hydrographic right portion of Tenetra ditch; c) debris flow deposits of the channel in picture b) in the valley bottom side; d) the flat bottom of Tenetra Stream valley seen from upstream filled with debris flows sediments.**

The on-field survey mapped different criticalities, also from the anthropic point of view. Along the watercourse, three hydraulic weirs were present, and they were entirely filled (fig. 14b) and damaged (fig. 14c) by the event, compromising their functionality. Some riverbank protection works were also damaged, such as the gabion wall protecting the municipal road. Another criticality was represented by the undersized bridge in the hamlet of Tenetra (fig. 14d), which was obstructed and overtopped during the flood so much that it separated the two dwellings on either side of it.

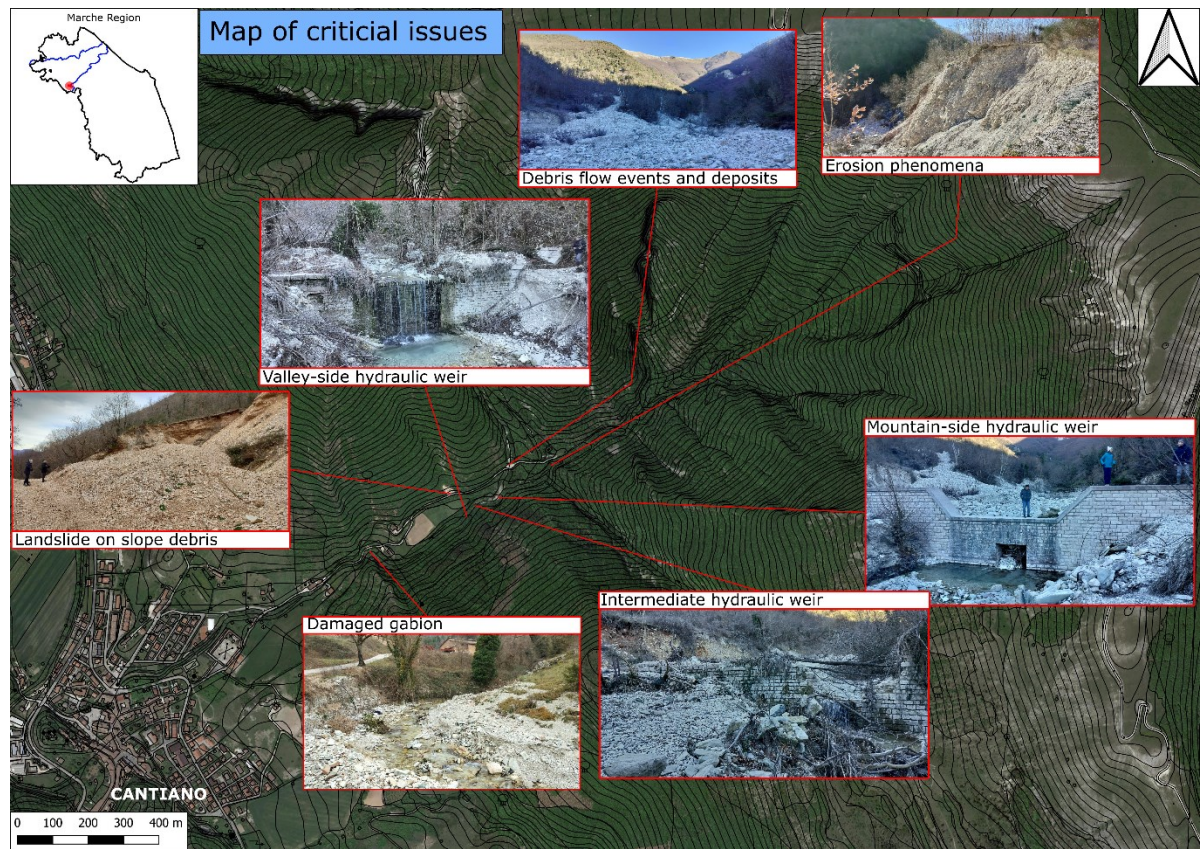
Figure 15: Map of critical issues in the Tenetra valley. The extent rectangle shows in black the boundaries of the Marche Region with Cantiano (in red) and the catchment area of the Metauro River (in blue). Cartographic layers from Regione Marche, n.d. (Bendia et al., 2025)

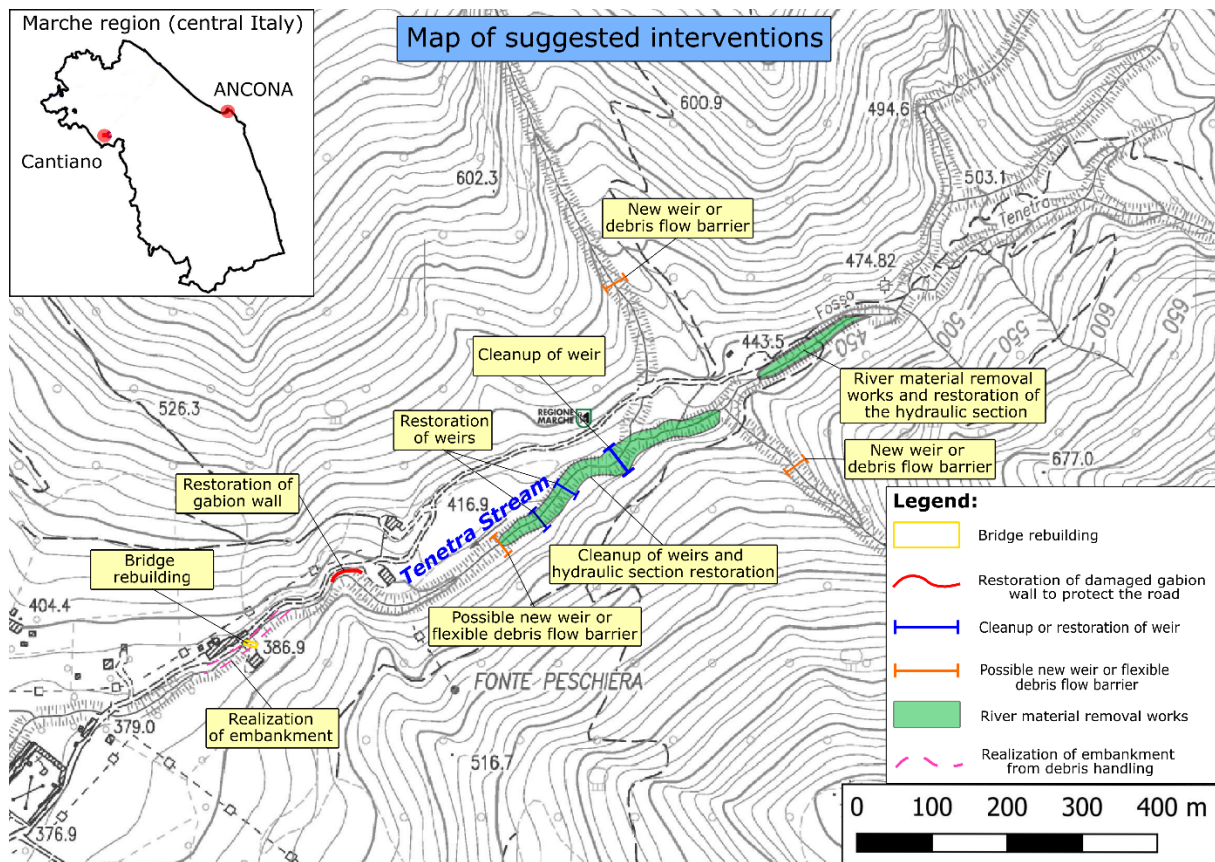
**Figure 16: map of the suggested intervention in the Tenetra Valley.** The extent rectangle shows in black the boundaries of the Marche Region with Cantiano (in red) and the catchment area of the Metauro River (in blue). Cartographic layers from Regione Marche, n.d. (Bendia et al., 2025).

of interventions along the Tenetra sub-basin is considered strategically important for managing water flow volumes and solid transport within Cantiano.

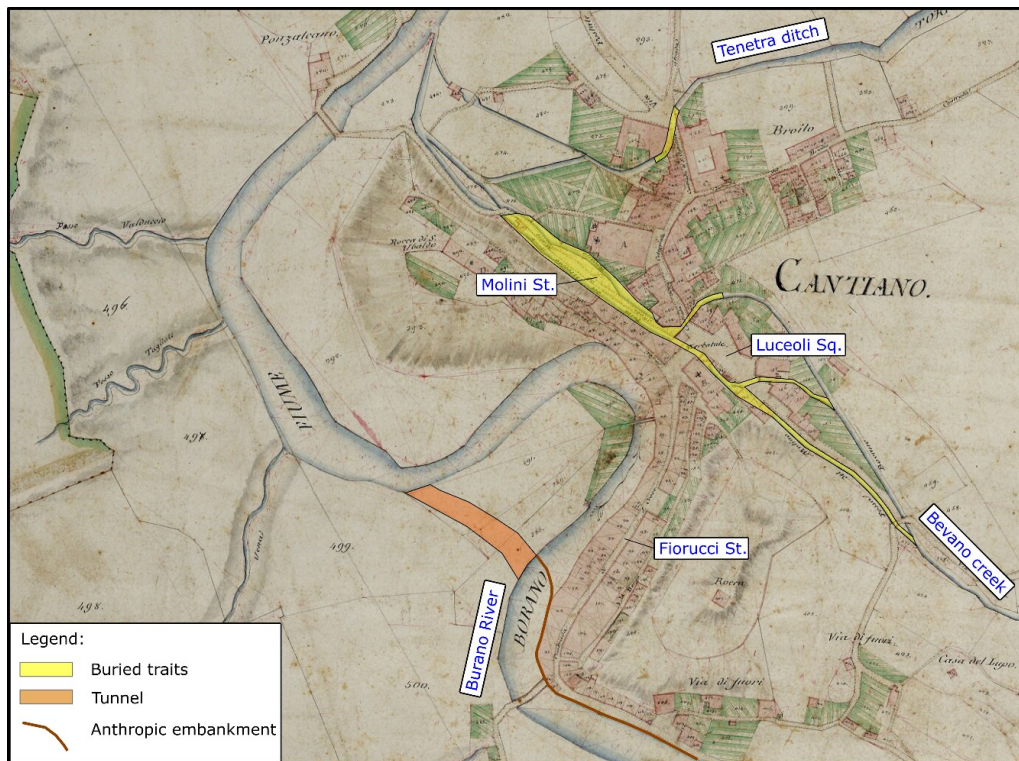
Figure 17: schematic map of the main anthropogenic surface water regulation interventions superimposed on the Gregorian cadastre  
 465 (Archivio di Stato di Roma, n.d.). It is easily recognisable that the abandoned meander is destined for human use.

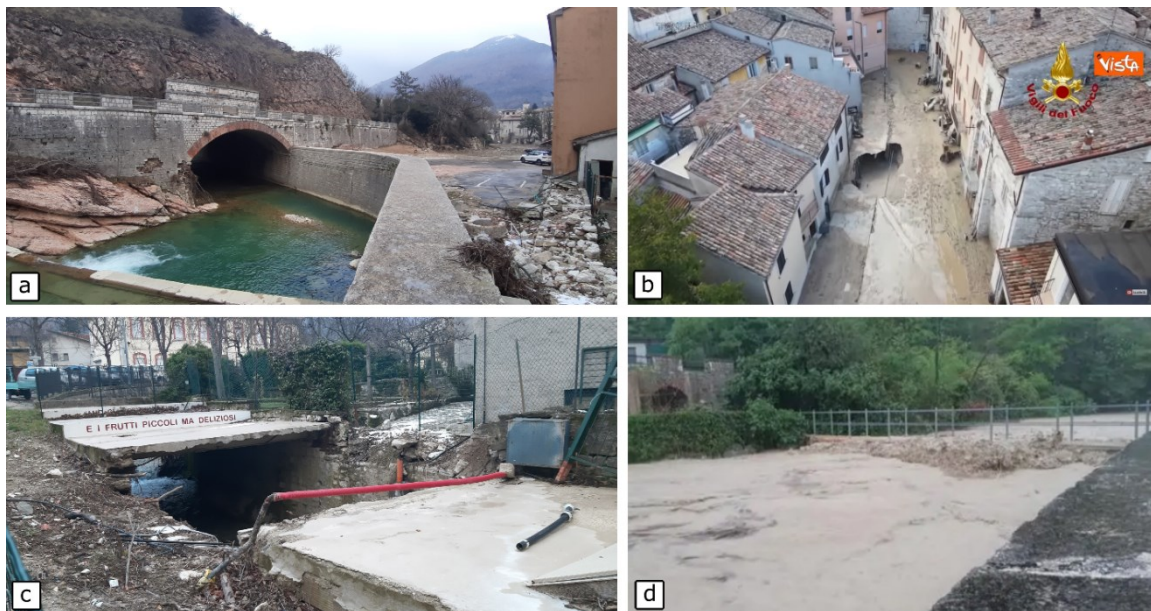
Figure 18: a) The 65-meter tunnel of the Burano River below the calcareous mountain ridge, with the anthropogenic embankment behind which the alluvial plain, the parking and the historical centre are recognizable; b) collapse of the tombed sections in Tumiat Street, Bevano Creek; c) explosion of the buried sections in Fiorucci Street, Bevano Creek (courtesy of National Fire Department); d) undersized footbridge reached by the water level, subsequently washed away, Burano River.

The culverts were undersized, both in size and construction details, because the covers did not withstand the hydraulic pressures set below them and they literally collapsed (fig. 18b and 18c). Moreover, during the on-field surveys, other critical issues were detected: undersized bridges with a limited height between intrados and riverbed (fig. 18d), partially occluded arches of the  
460 bridges and absent river maintenance with the presence of vegetation and sediment that can reduce the hydraulic section during flood events.

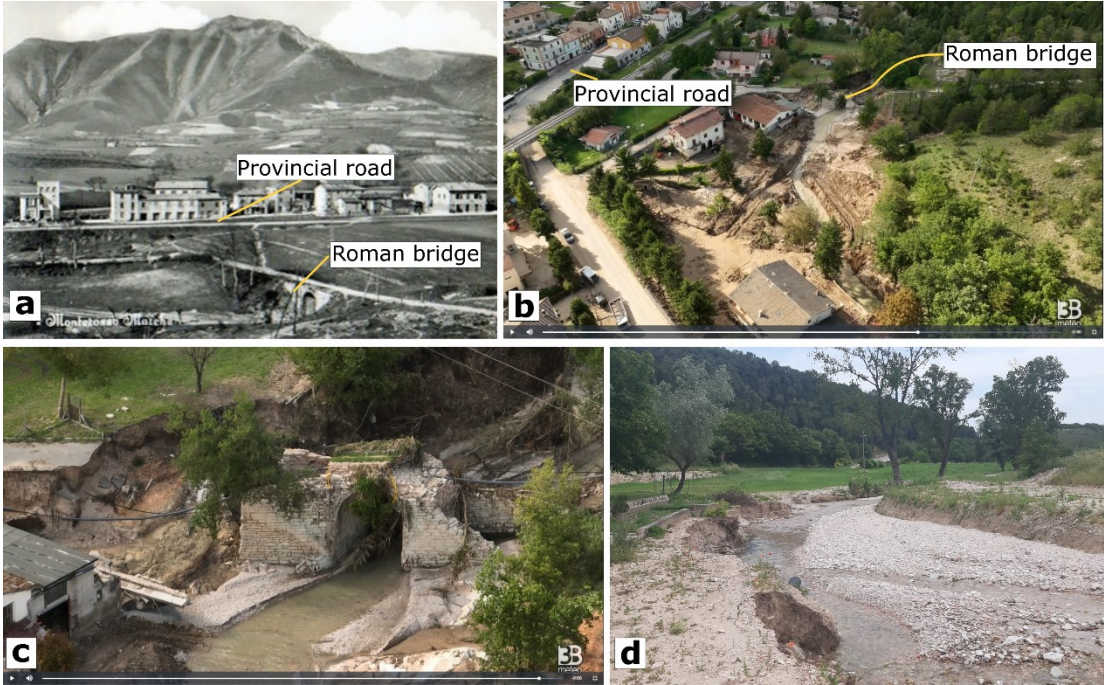
**Figure 19: a) the Roman bridge at Monterosso Stazione above the Sanguerone Creek in a historical photo, with the eastern foothills of Mt. Strega in the background (scanning from a postcard, then modified); b) the post-event situation for comparisons with image a (also related to urbanisation). Note that in the past, the alluvial valley was not urbanised; c) the Roman bridge after the event viewed from downstream, with the collapsed abutments; d) the unnamed ditch in Sassoferrato Stazione after the flood, with the waterbed filled with gravel and raised about two meters compared to the pre-event situation. Images b) and c) come from <https://www.3bmeteo.com/giornale-meteo/cronaca-meteo-alluvione-marche---monterosso-stazione-dal-drone--ponti-crollati-e-gravi-danni---video-643860> (accessed on 12.01.2026).**

After the flooding, the watercourses released their solid transport in the portions where hydraulic affinity allowed this. The riverbed of the unnamed ditch coming from the south behind the automobile repairs workshop was filled with gravel and raised about two meters (testimony from residents) compared to the pre-event situation (fig. 19d). This resulted in repeated new flooding of the forecourt of the building at each new rainfall event. This represented an important critical issue which required the emergency restoration of the original section of the watercourse.

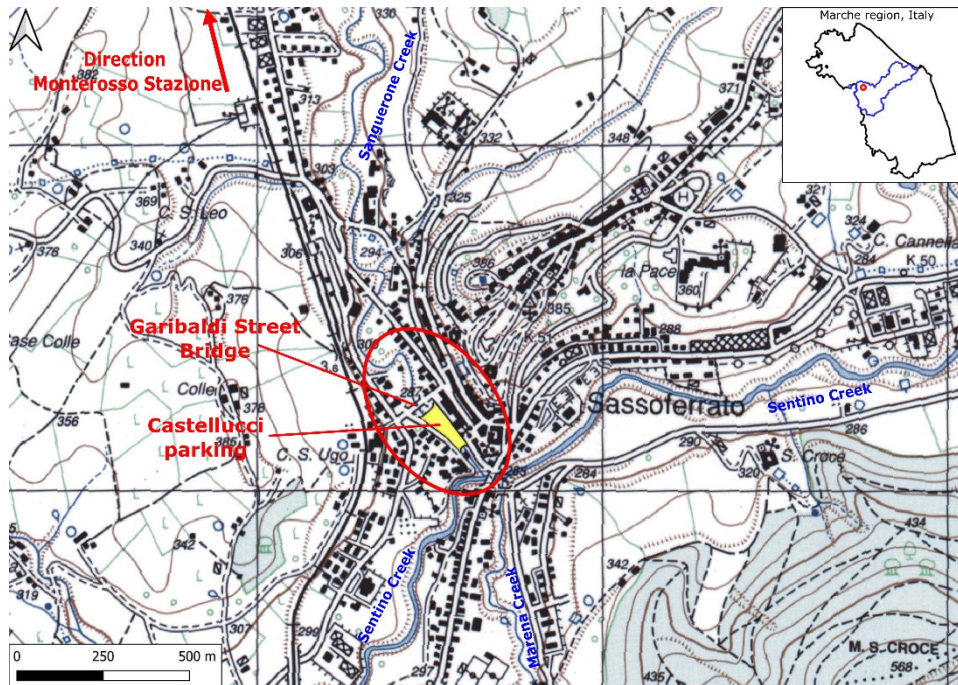
Figure 20: Topographic map of the Military Geographical Institute- IGM of Sassoferrato with the buried stretch of Sanguerone Creek below the Castellucci parking highlighted in yellow. In the extent rectangle, the Marche region (black border), the hydrographic basin of the Esino River in blue and the town of Sassoferrato in red. Cartographic layers from Regione Marche, n.d.

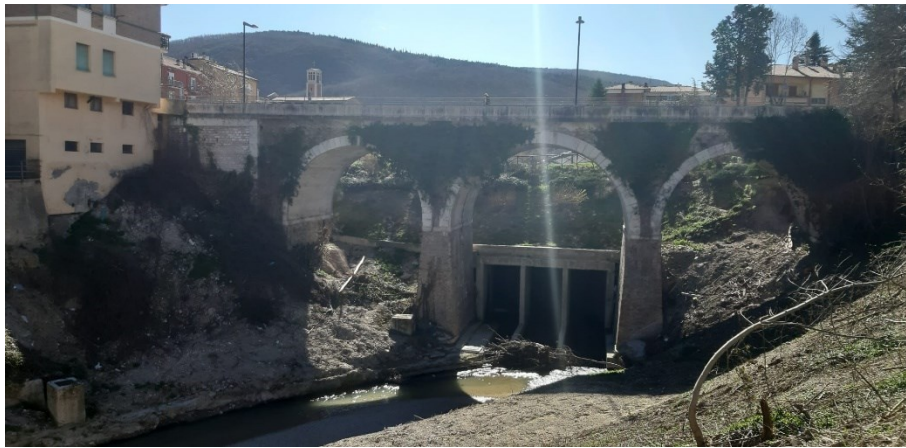
Starting from the bridge on Garibaldi Street, the entire riverbed of Sanguerone Stream was tunnelled with a three-segmented concrete box structure of about 200 meters in length, which reduces the original section of the ancient bridge built by the Italian Military Engineering Corps (fig. 21). The watercourse returns to the open space only one hundred meters before its confluence into the Sentino Creek. The buried section was then upward covered with backfill material, above which the Castellucci parking was realised. The channelisation intervention, observed from upstream, shows how the original wide arches of Garibaldi Street Bridge were reduced to a box-like structure that greatly reduced the hydraulic section, making it undoubtedly undersized for the flow rates recorded during the September 15<sup>th</sup>, 2022, hydraulic event (fig. 21).

**Figure 21: The Garibaldi Street Bridge saw from upstream with the evident, extreme reduction of the original flow section with a box-like structure (the markers on the wall on the left mark the hydrometric levels reached).**

- 535 The flood eradicated and dragged bushes, branches, trees and sediment along its course, which, once they met the narrowing imposed by the channelisation, obstructed the section, creating a lake in its upstream portion (markers on the wall on the left mark the hydrometric levels reached). Overpressures developed inside the buried section, the roof of which fortunately held up without being damaged. These overpressures, however, were released as they exited the channelized section, creating extensive erosions to structures located adjacent to it.

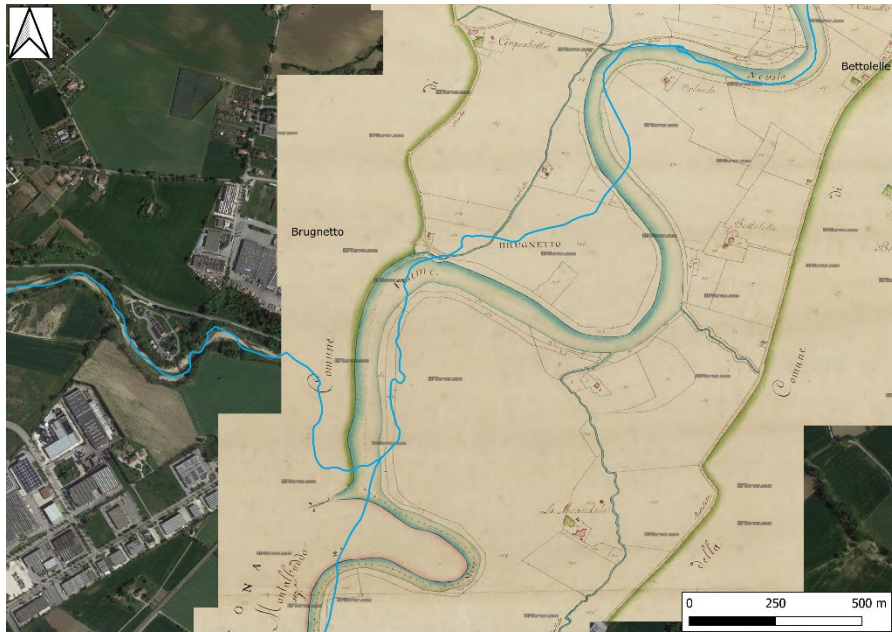
560 **Figure 22: The ancient map of the Gregorian cadastre (Archivio di Stato di Roma, n.d.) with the superimposed actual watercourses of the Nevola and Misa rivers (light blue lines), with the modifications of the hydrographic network well recognisable (Bendia et al., 2025, modif.).**

555 During the time many anthropic modifications to the hydrographic network have been made to manage the watercourse and allocate as much land as possible for agricultural, industrial, or urban development purposes. The spatiotemporal analysis conducted through the comparison of historical cartographies highlighted a widespread discrepancy between actual and ancient maps (Fig. 22). The Gregorian cadastre of 1835 shows the area at the confluence between the Nevola and Misa rivers, coming from the West and South, and shows significant modifications made to the hydrographic network during that time.

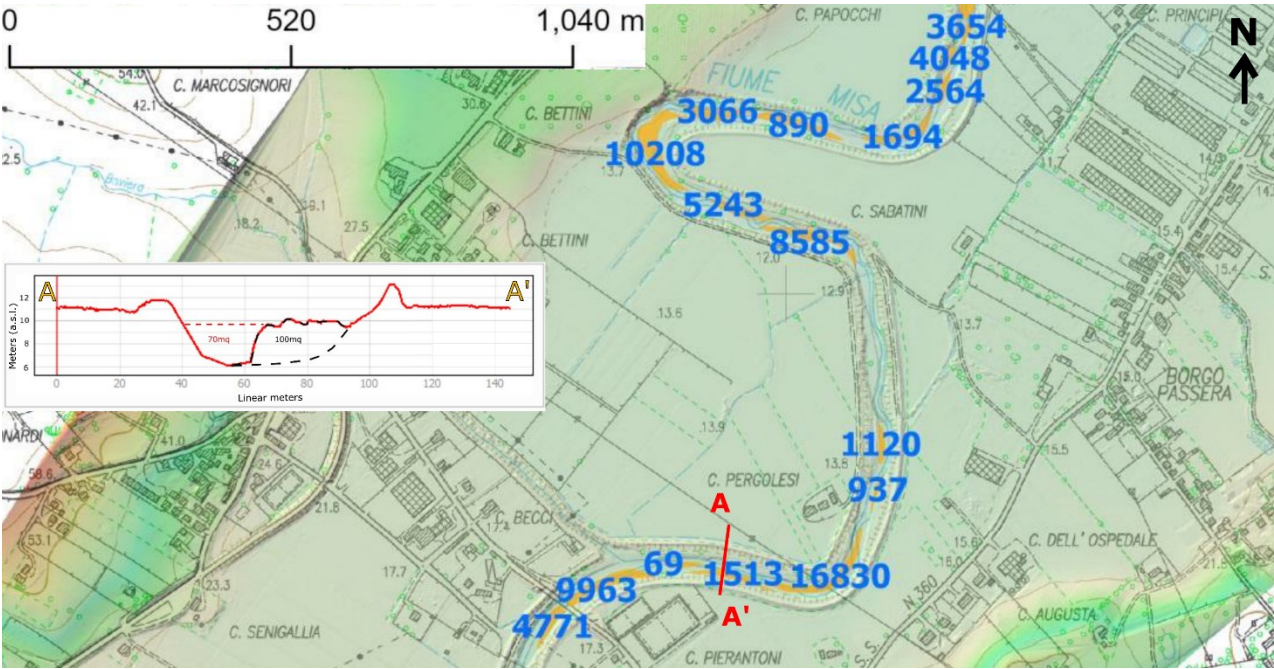
knowing their planimetric and cross-sectional dimensions, also obtained from the LiDAR-derived topographic profile (fig. 23), it was possible to calculate the volume of removable material to widen the section. Upstream of the town of Senigallia, field surveys and LiDAR mapping of the over-sedimentation areas made it possible to identify a total of 42 individual in-channel zones, located against the outer bends of the river with respect to its flow direction, for a total removable material volume of approximately 252,000 cubic meters. These calculations were useful to quantify the removable material from the riverbed according to profiles and cross-sections corresponding to the low-flow channel of that time, to enlarge the current flood discharge sections to the maximum extent available between the incised banks. These lidar images were also very useful for the identification of areas where the construction of flood attenuation basins could be recommended.

**Figure 23: A stretch of the lidar image of the Misa River around Molino Marazzana (Senigallia). The blue numbers refer to the single volume of each river point bar (in orange) to be dredged to widen the river section. The red line indicates the section trace from which the river cross-sectional topographic profile (shown in the inset) was obtained through LiDAR data from the drone survey performed. The colour shades refer to the elevations. The smaller inset shows the topographic profile (red line) of a representative stretch of the Misa River near Molino Marazzana (Senigallia) acquired through lidar survey after the flood event (river sediments dashed in black).**

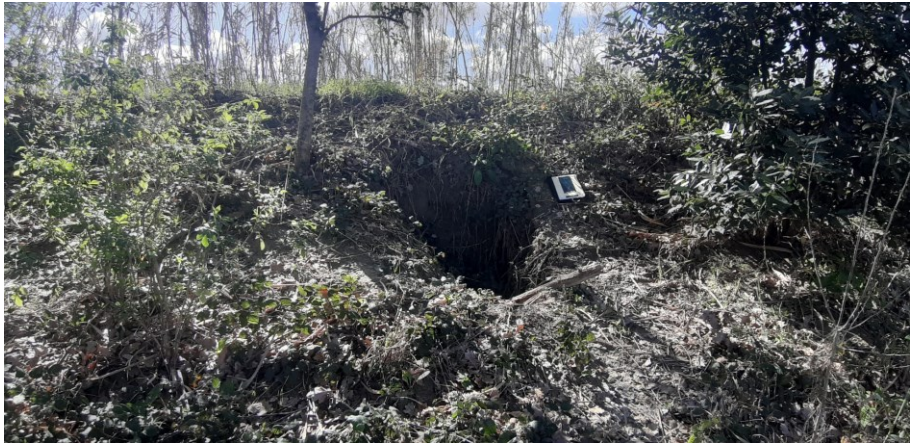
Furthermore, the on-field geomorphological-hydraulic survey identified the presence of widespread burrows of fossorial animals (Fig. 24), sometimes passing from one side to the other. During a flood, this can represent a serious situation of weakness of the embankment and can therefore cause its erosion, piping and collapse. In addition to the embankment overflowing, this was one of the causes of the flooding of the Senigallia and Ostra area.

**Figure 24: The burrow of fossorial animals along the right embankment of Misa River in the hamlet of Borgo Catena (Senigallia), with A4 block notes for scale.**

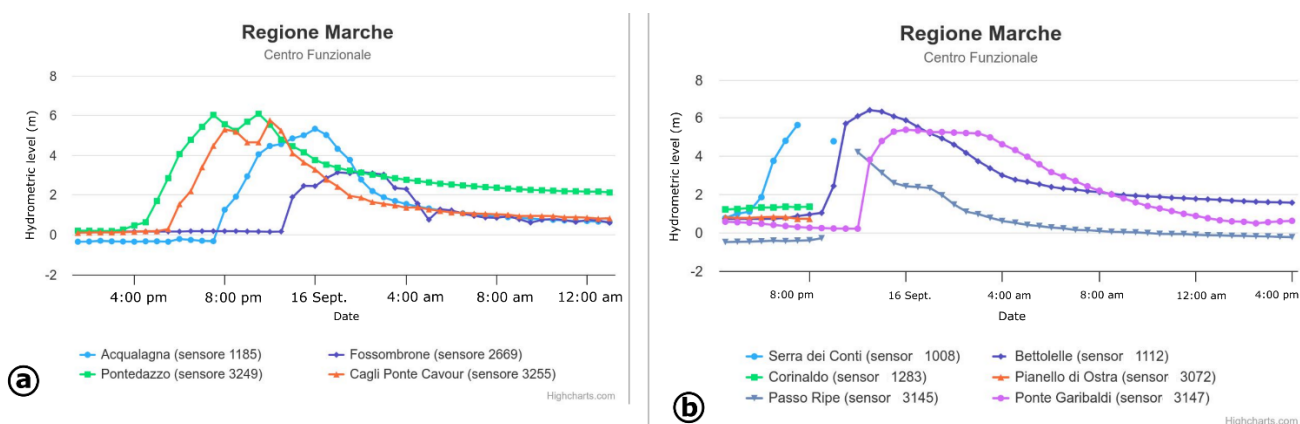
Several hydrometers were damaged or washed away during the flood (fig. 25b; tab. 4), preventing real-time monitoring at crucial moments. This operational fragility underscores the need to redesign and strengthen the regional hydro-meteorological network, particularly in catchments repeatedly affected by extreme events.

Looking at the comparison between the hydrometers along the catchment area of the Misa River (fig. 25b), it is immediately apparent how the hydrometers of Serra de' Conti, Corinaldo, Passo Ripe and Pianello di Ostra stopped because they were broken, temporarily disabled, or washed away as the flood arrived. The difference between Bettolle (municipality of Ostra) sensor 1112 and, downstream, Ponte Garibaldi sensor 3147 (Senigallia city centre). From Serra de' Conti in the mountain area to Garibaldi Bridge in Senigallia, the peak of the flood wave took presumably about three and a half hours.

**Figure 25: a) the hydrometric levels of the mountain portion of the Metauro River basin from Pontedazzo (Cantiano) to Fossombrone, from 1:00 p.m. of Sept. 15th, 2022, to 1:00 p.m. of Sept. 16th, 2022. Italian time (SIRMIP 2022); b) the hydrometric levels of the Misa River basin between Serra de Conti and Senigallia (Garibaldi Bridge), from 4:00 p.m. of Sept. 15<sup>th</sup>, 2022, to 4:00 p.m. of Sept. 16<sup>th</sup>, 2022. Italian time (SIRMIP 2022).**
