The multi-decadal hazard cascade of a tropical mountain wildfire

Abstract. Climate change is driving wildfires to higher elevations, yet the hazard cascades that follow the burning of pristine tropical mountain ecosystems remain largely unexplored. Here, we analyse the long-term cascade following a February 2012 wildfire that burned 31 km² of forest and wetland in Uganda's Rwenzori Mountains National Park. Combining remote sensing, humanitarian records, field surveys, and interviews, we document ten major floods since 2012, including two debris floods that required large-scale humanitarian responses. Post-fire increases in erosion and mass movement have widened the River Nyamwamba sevenfold since 2012, breaching copper-cobalt mine tailings and mobilising an estimated 744,000 tonnes of waste into the river. Slow vegetation recovery at high altitudes and positive feedbacks between hazards have prolonged this high-risk state, underscoring the susceptibility of tropical mountain ecosystems to long-term post-wildfire cascades. More monitoring and research are required to characterise key hazard interactions after tropical mountain fires, which can guide entry points for management seek

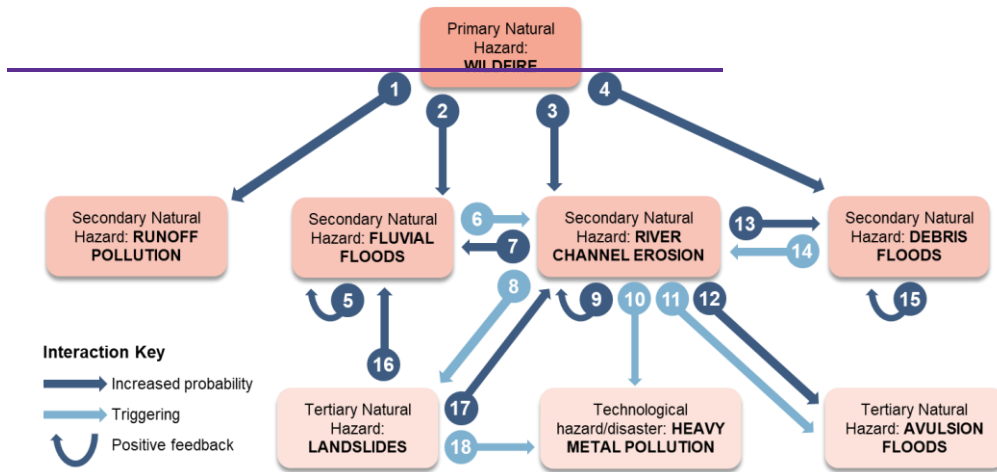
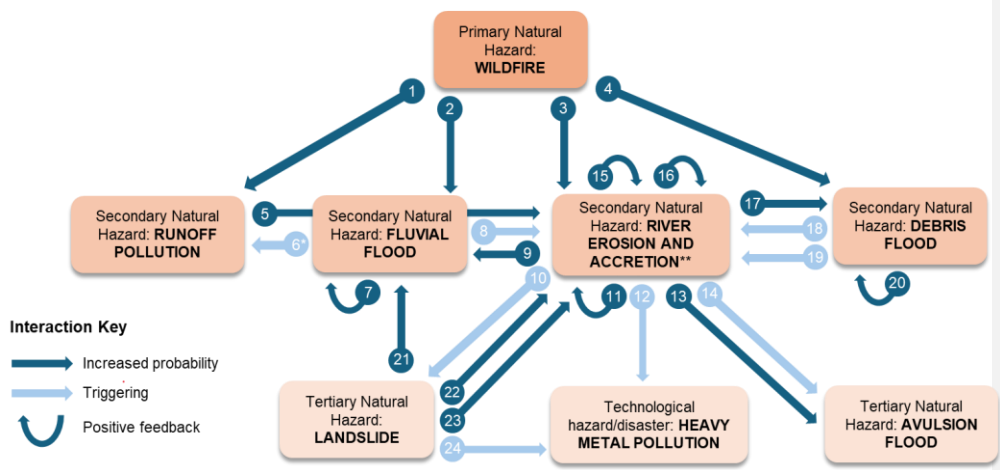
Figure 2: Conceptual model of the multi-hazard cascade following the Rwenzori National Park wildfire in February 2012. Interactions between hazards are classified as being (i) triggering, or (ii) probability increasing or (iii) catalysing/impeding, following Gill and Malamud's (2016) framework. As there, and (iii) positive feedbacks have been identified. There are numerous catalysing/impeding relationships in this context, which we omit these from the visualisation for simplicity but describe key examples in the analysis text. Table 1 describes each of the interactions shown.

179 We present the multi-hazard cascade caused by the 2012 Rwenzori National Park wildfire (Fig. 2). The following sections
180 describe each of the hazards involved and the interactions they drive, based on evidence from our mixed methods. Results are
181 structured by hazard type: wildfire (Sect. 3.1), flooding (3.2), landslides (3.3), erosion (3.4), and pollution (3.5). Identified
182 interactions highlight opportunities where management interventions can impede the cascade, for which we discuss practical
183 solutions at the local and global scales in Sect. 4 (Discussion). The hazard definitions follow the Hazard Information Profiles
184 (UNDRR, 2025) and are clarified in Table D1 (Appendix D). Importantly, here landslides refer to gravitational mass
185 movements directly connected to the river system as shown in Figures I1 and I2 (Appendix I).

Table 1: Description of the hazard cascade interactions in Fig. 2. The study evidence for each interaction is explained in the text and summarised in Table D+D2 (Appendix D).

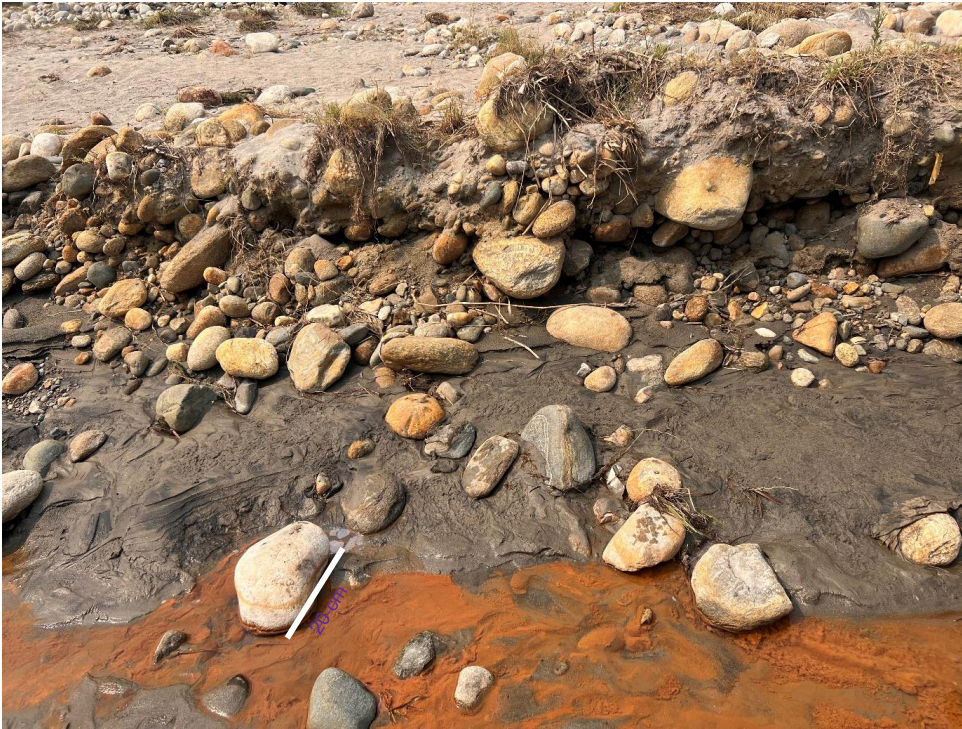
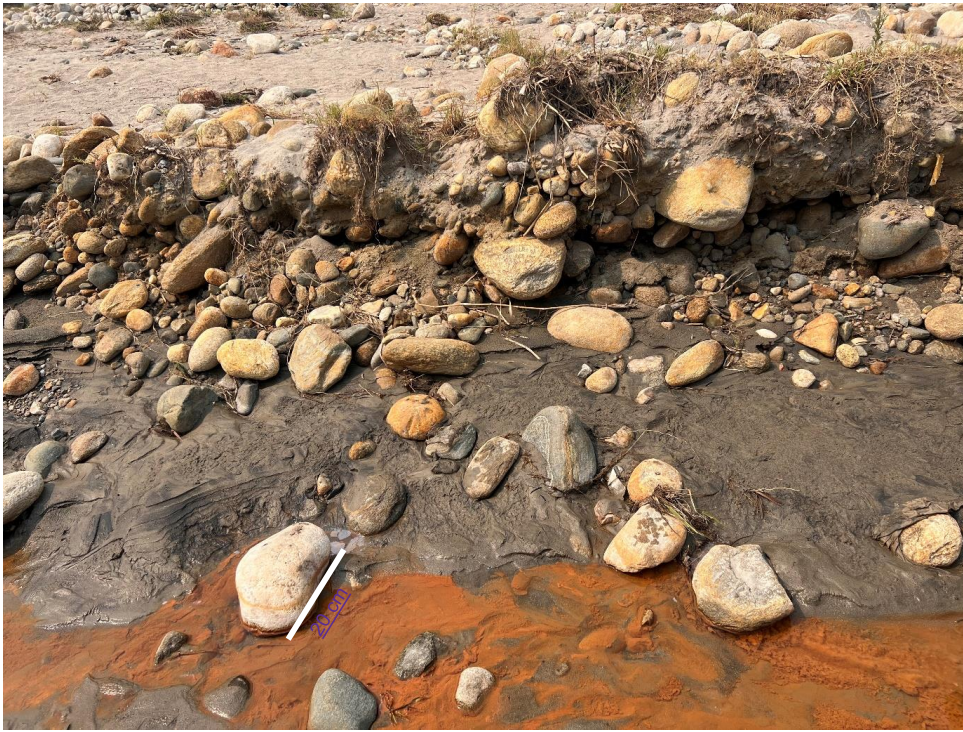
946
947 **Figure E1: Acid mine drainage at location 0.18599N, 30.01951E, 25 July 2024.**

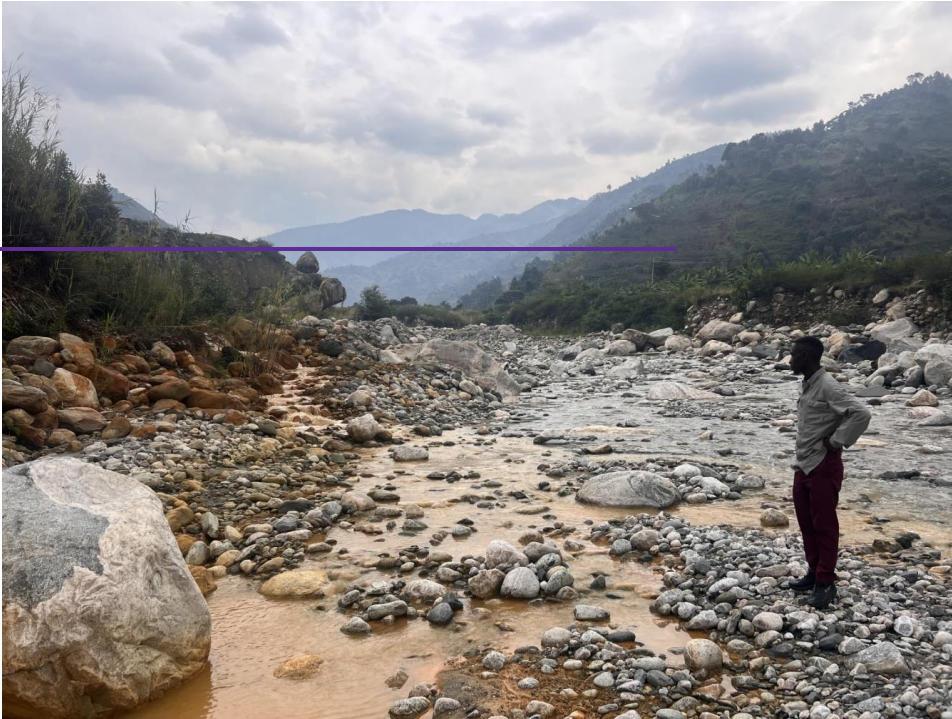
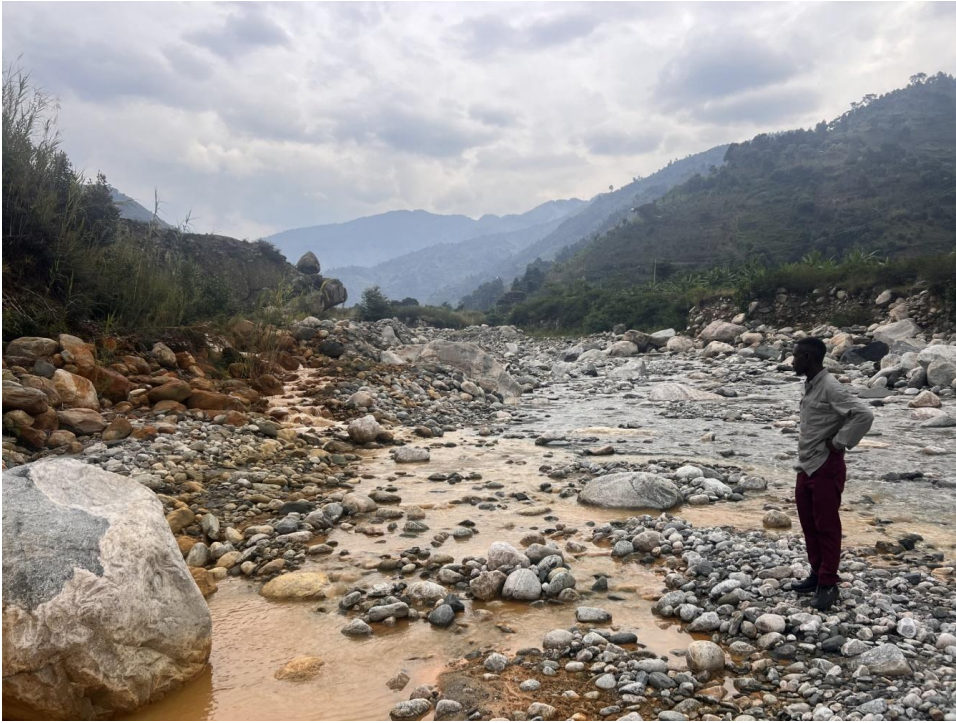
Figure E2: Acid mine drainage at location 0.19879N, 30.01139E, 3 August 2024.

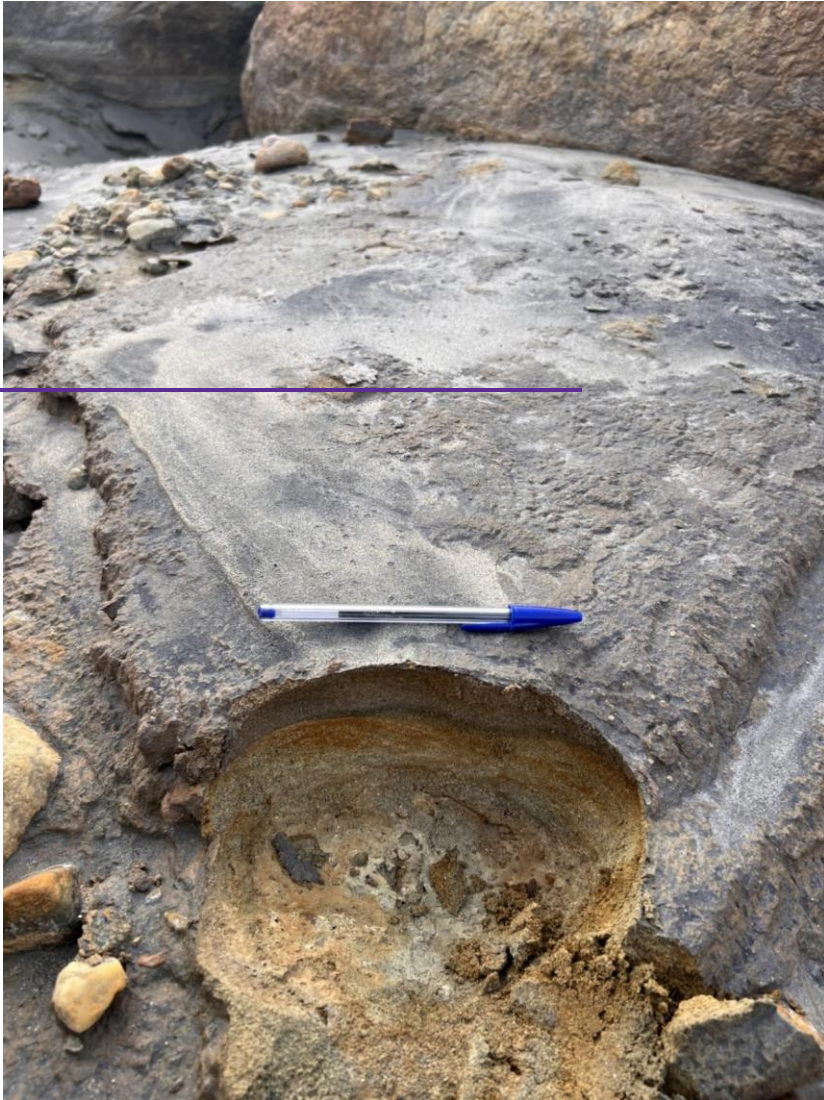
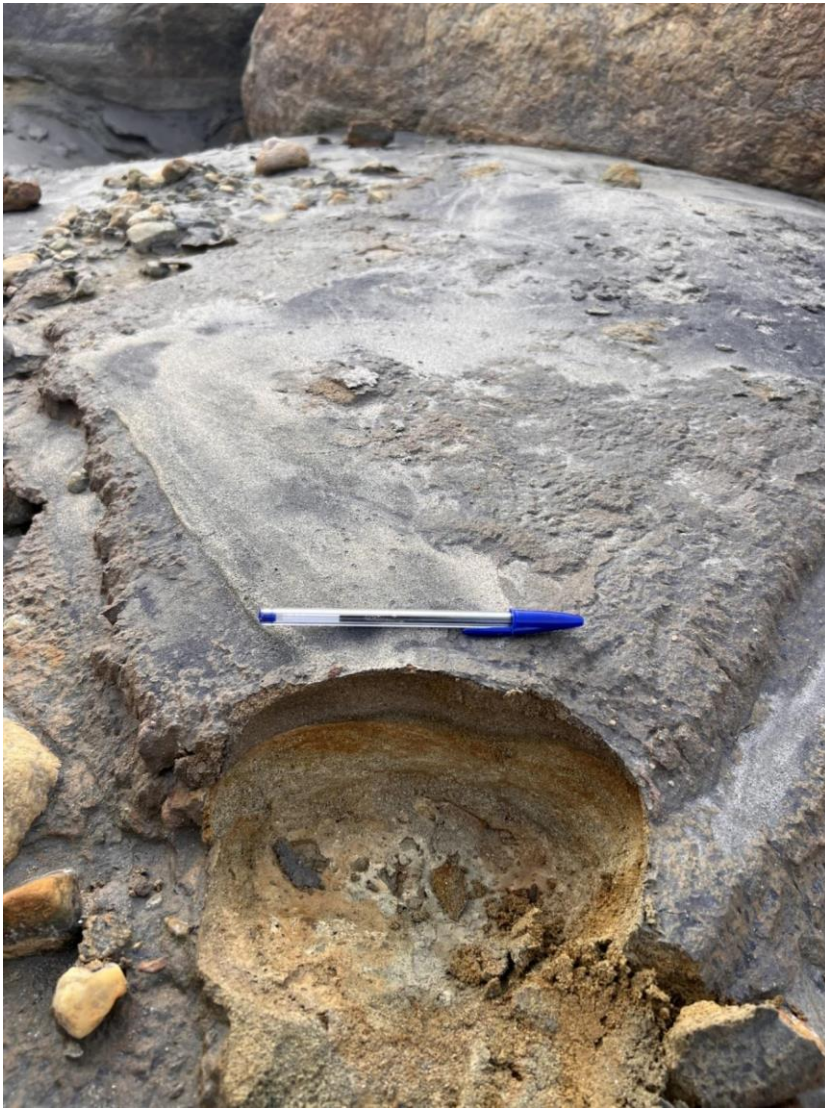
953 Figure E3: Tailings sedimentation in the Nyamwamba channel, 0.18652N, 30.01986E, 25 July 2024.

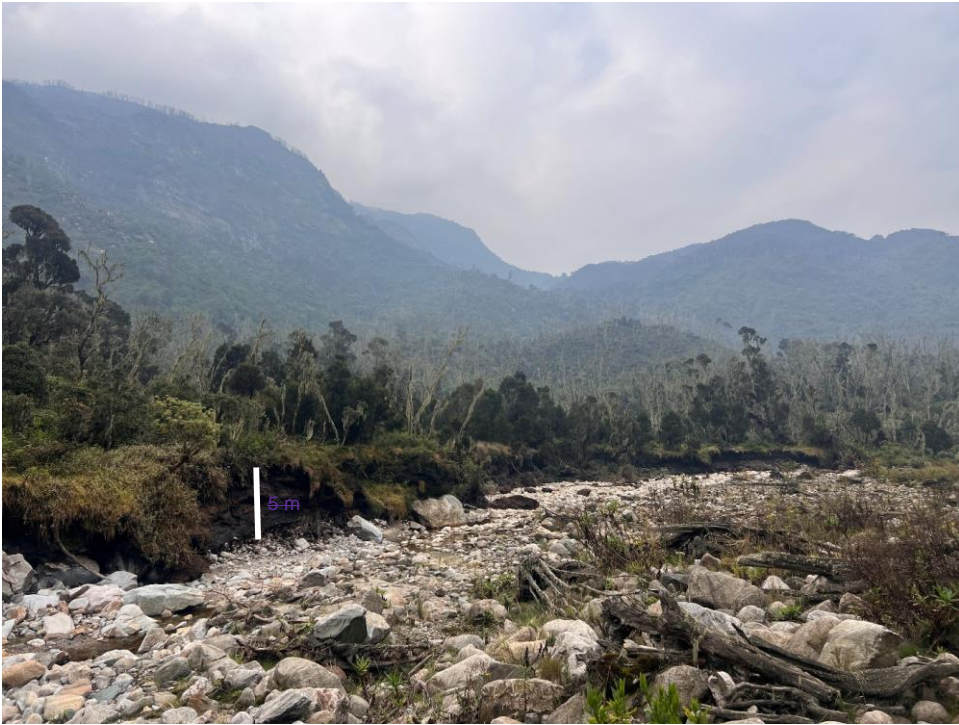
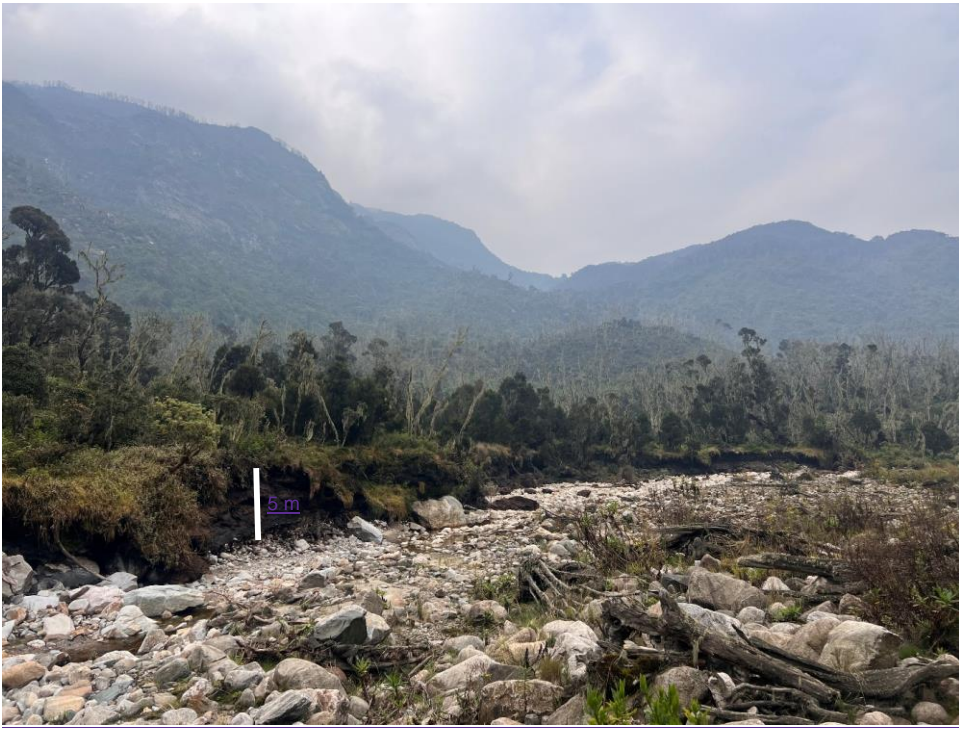
956
957 **Figure F1: River-cliffRiverbank exposure at 0.29291N, 29.93596E – 28 July 2024.**
958

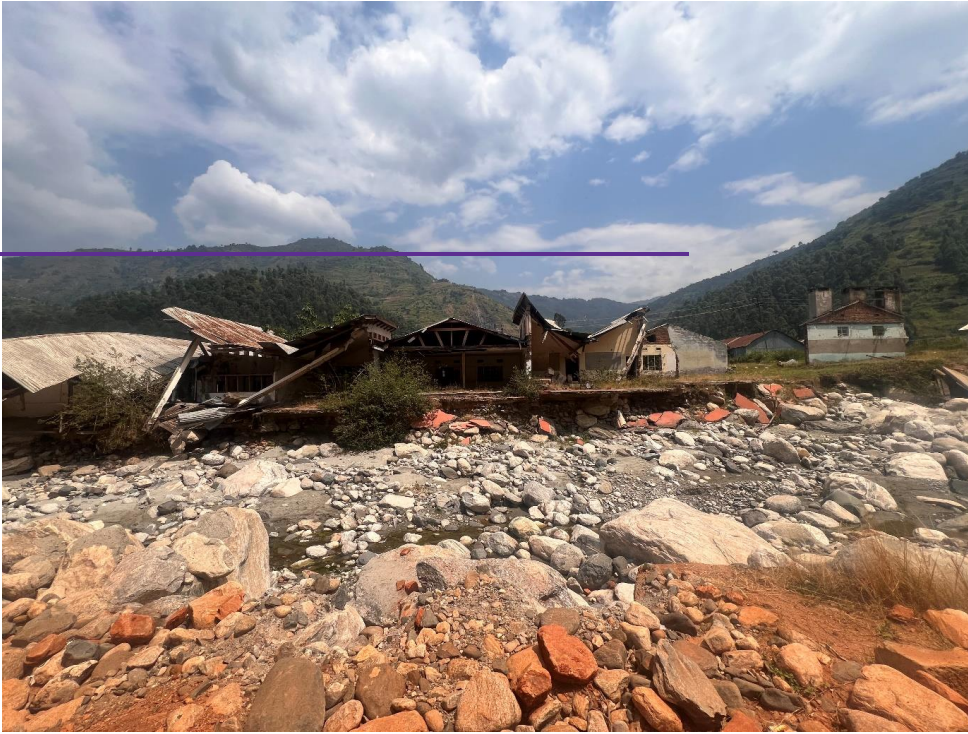
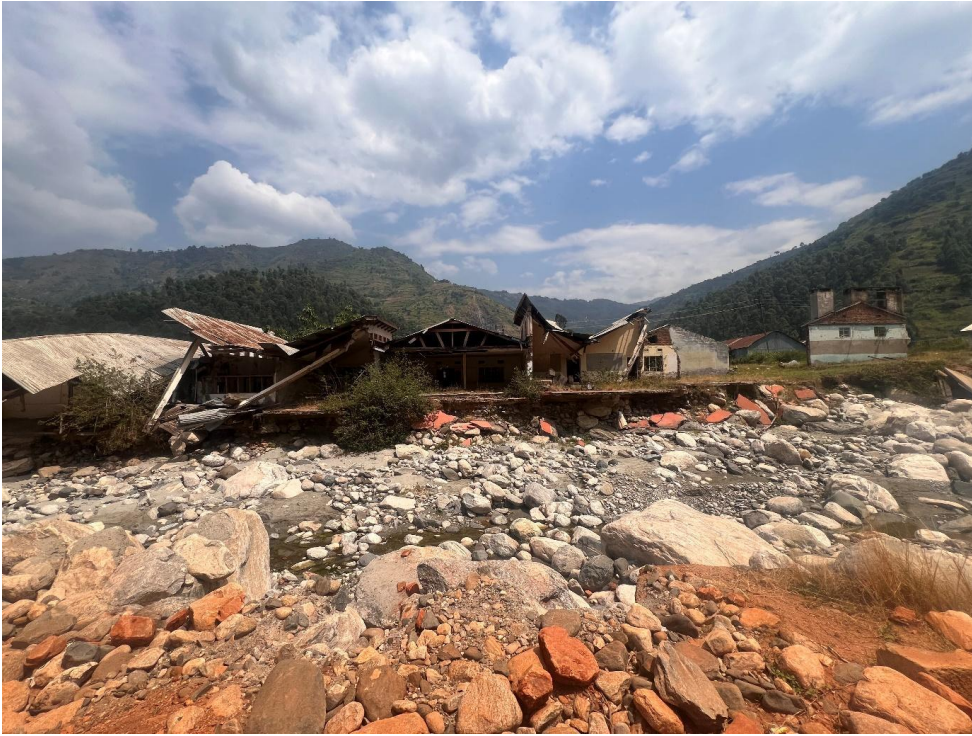
960
961 **Figure F2: River cliff style erosion of house foundations in Kilembe, 0.20603N, 30.00822E – 24 July 2024.**
962
963
964
965
966
967
968
969
970
971

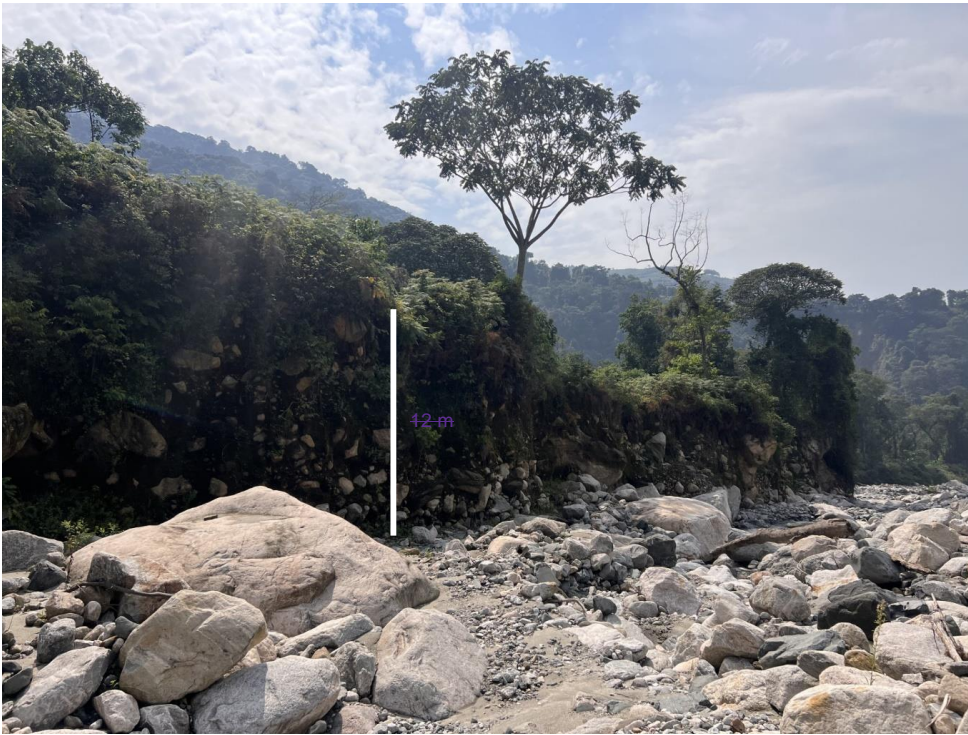
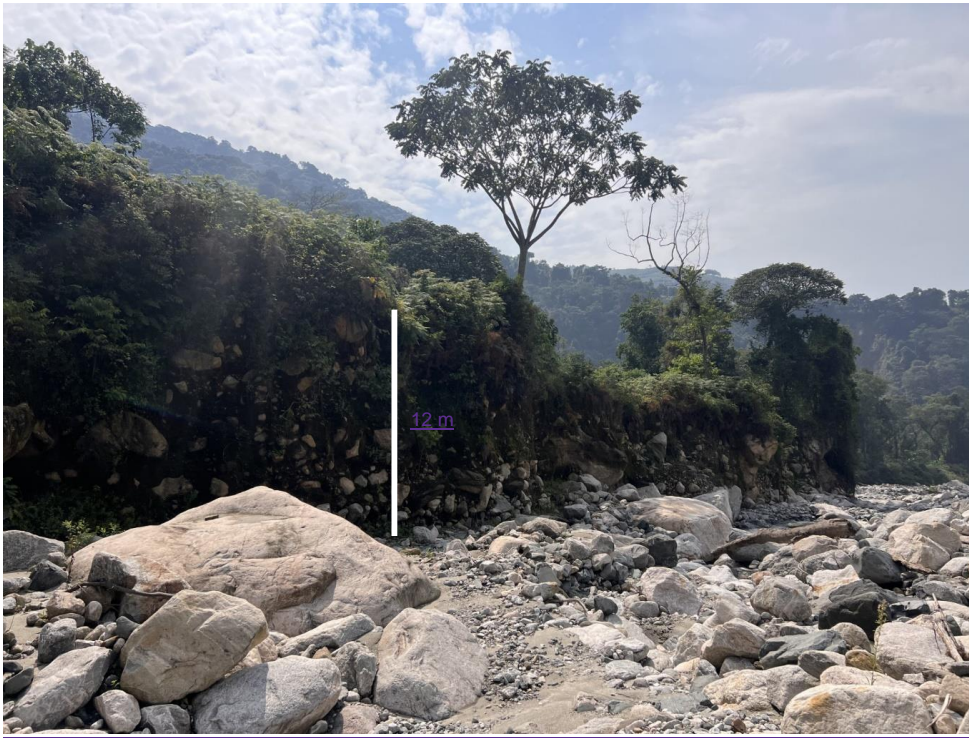
974
975 **Figure F3: River cliffRiverbank at 0.23742N, 23.97568E – 1 August 2024.**

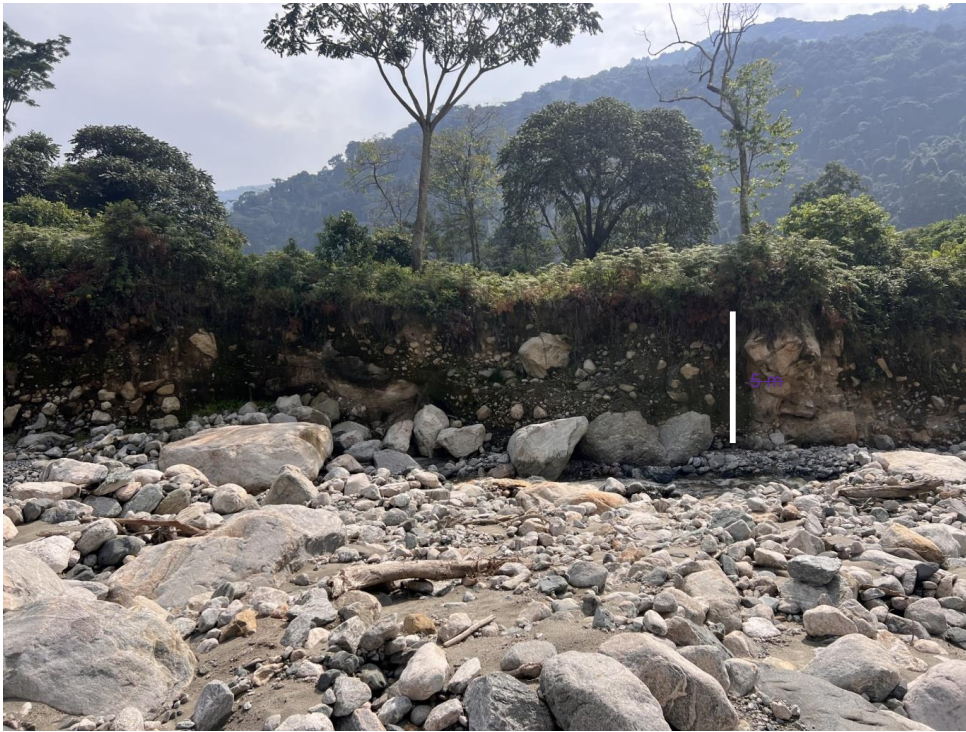
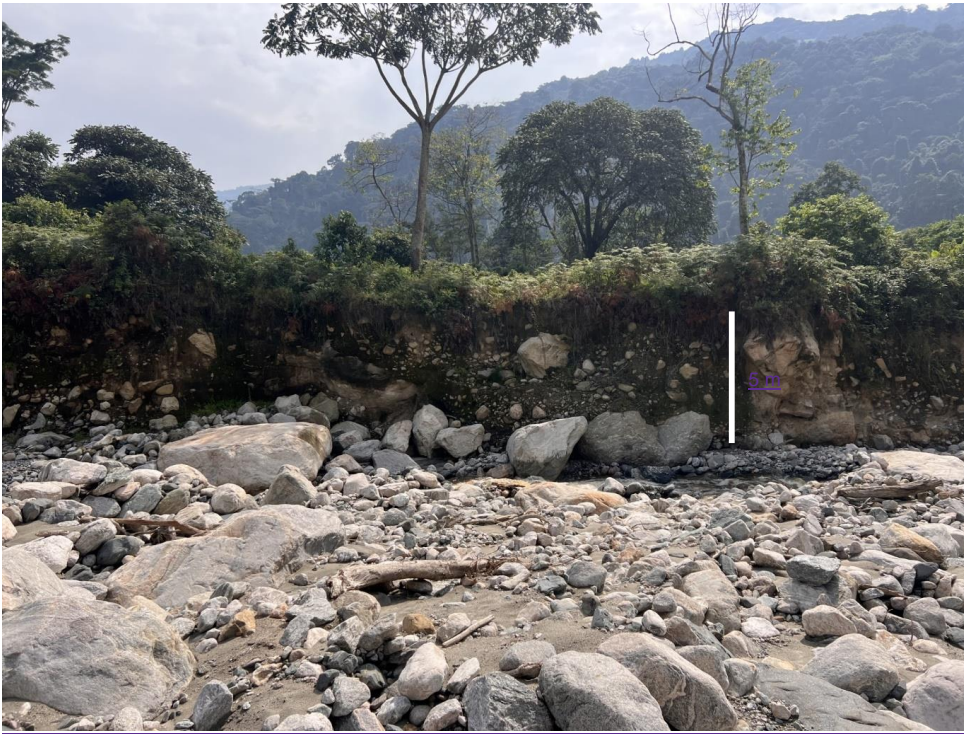
Figure F4: River cliffRiverbank at 0.23715N, 29.97601E – 1 August 2024.

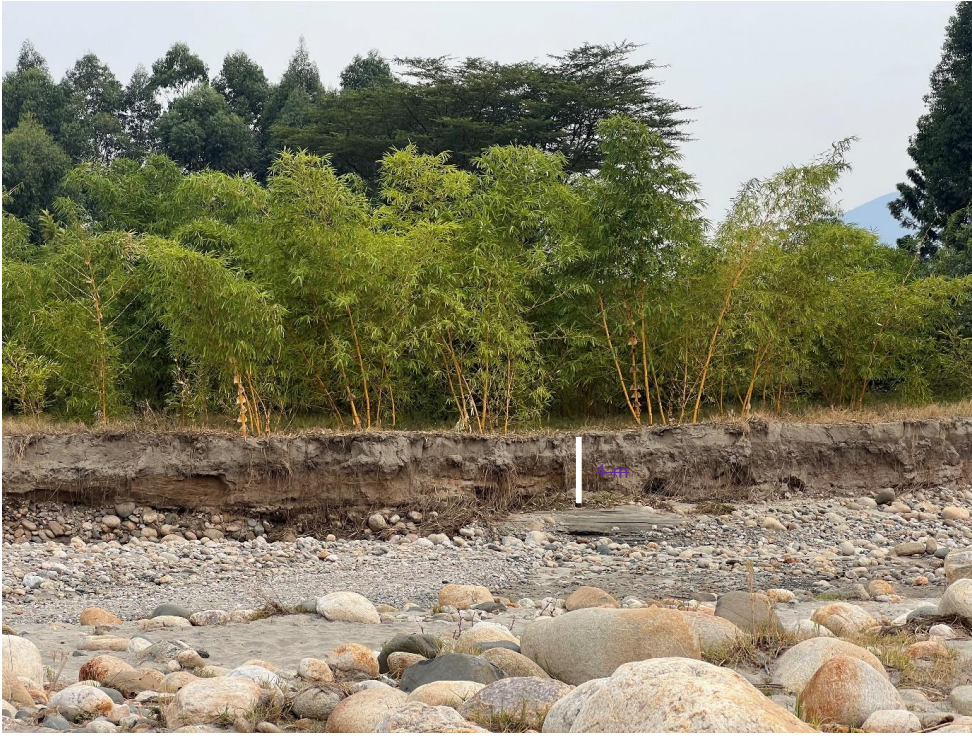
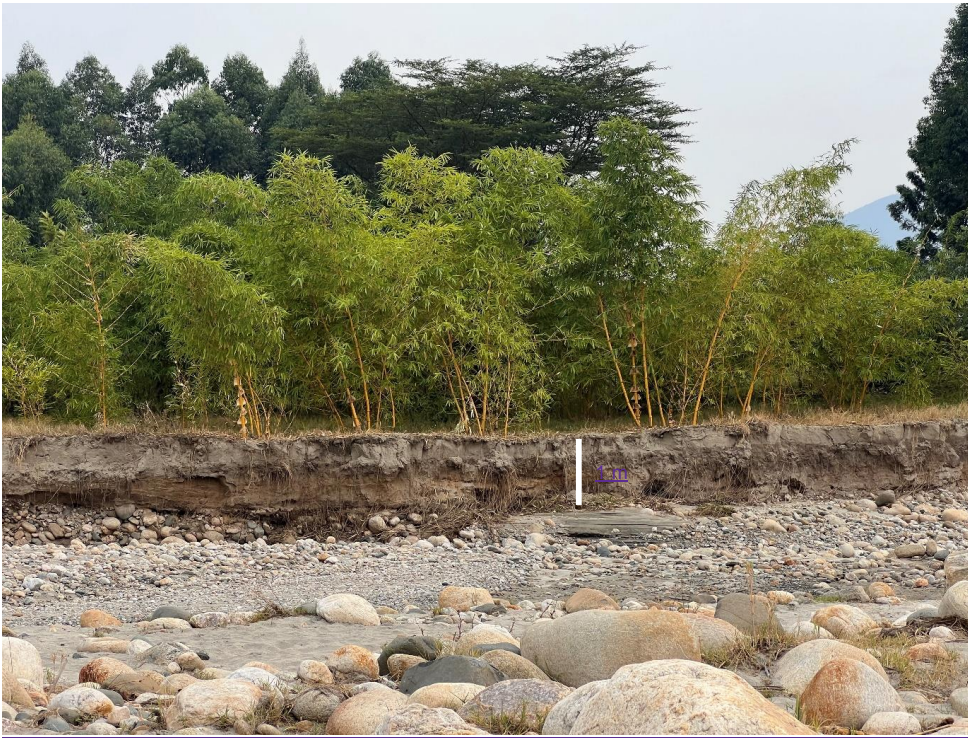
Figure H1: 0.18981N, 30.07408E, 26 July 2024 (damaged bamboo nature-based solution).

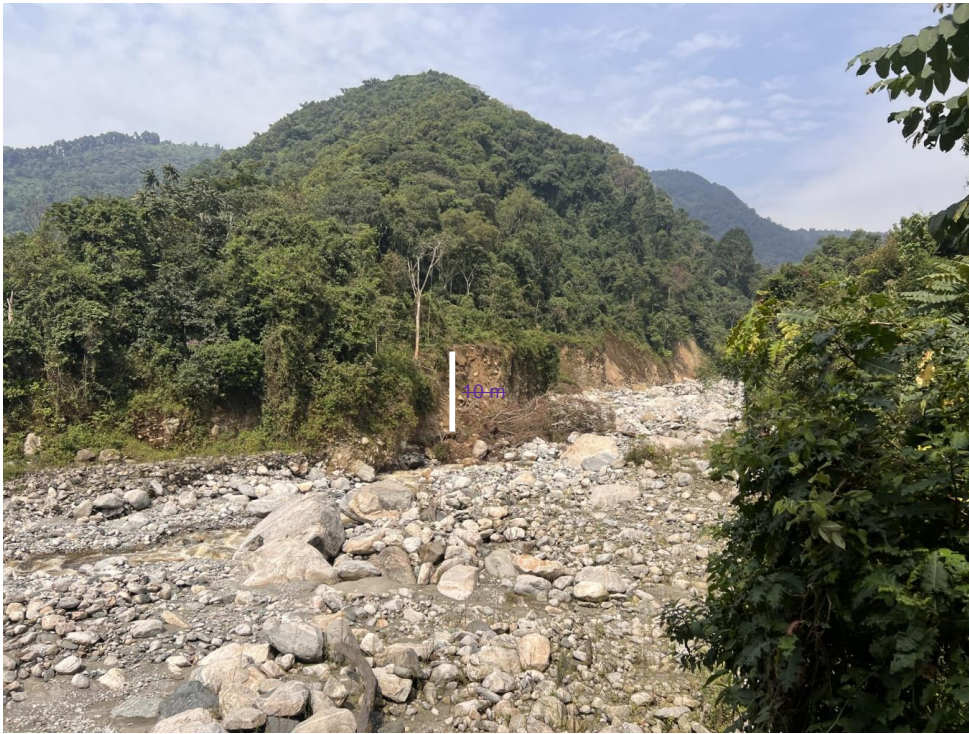
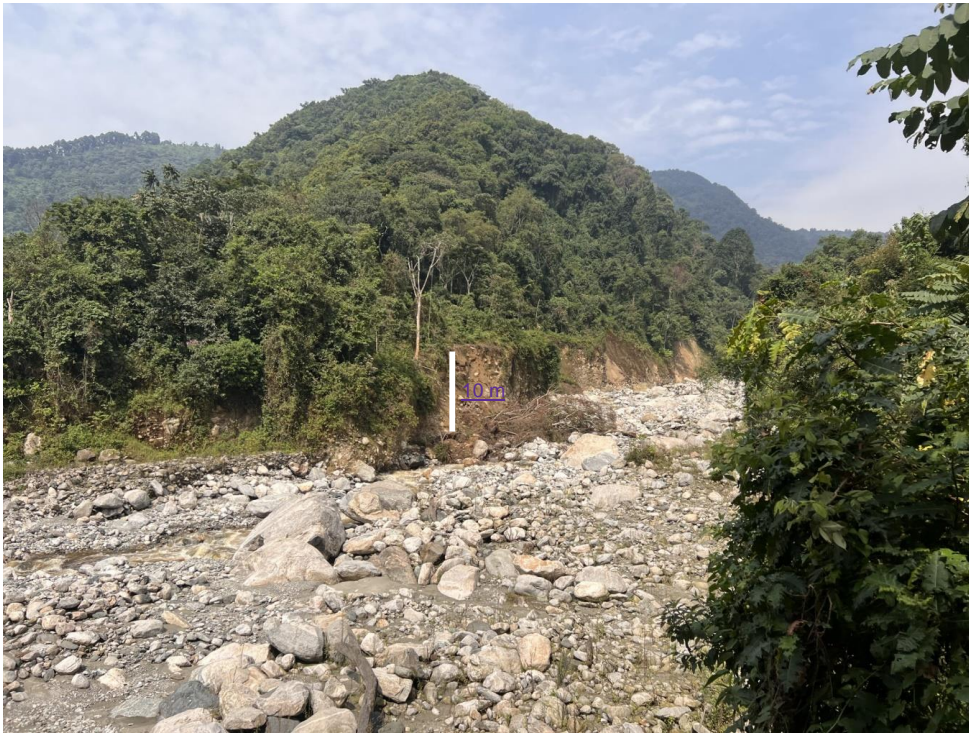
Figure I2: Landslide scar at 0.23758N, 29.97570E – 1 August 2024.

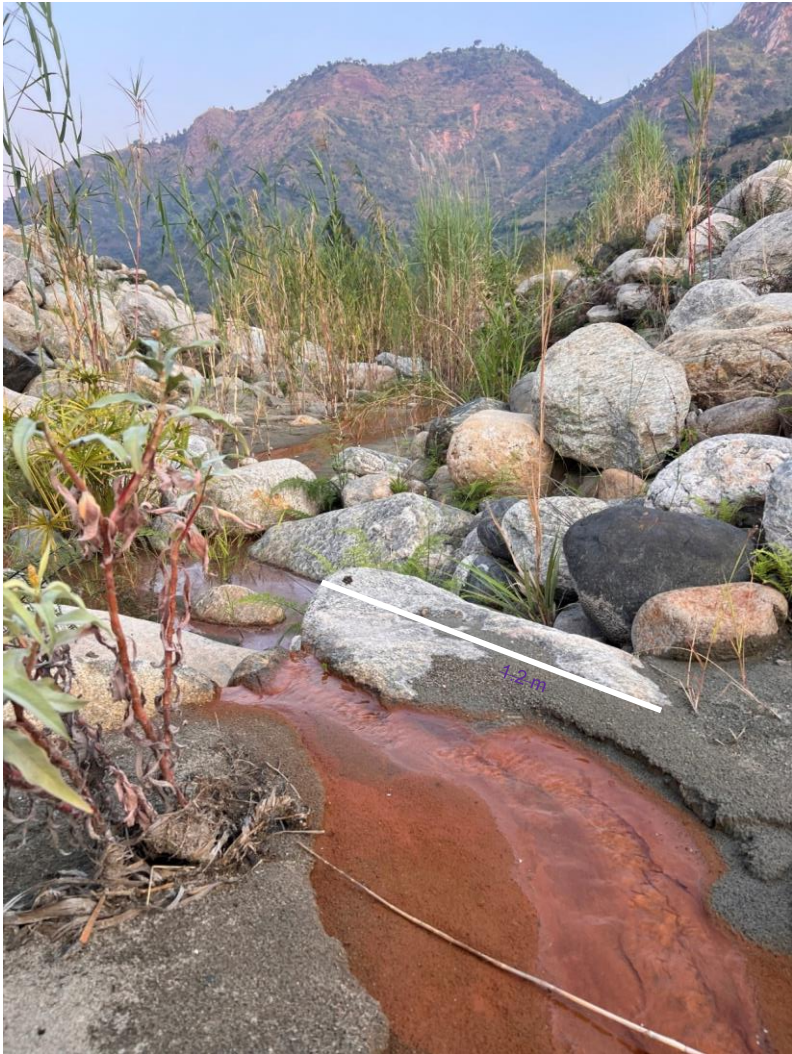
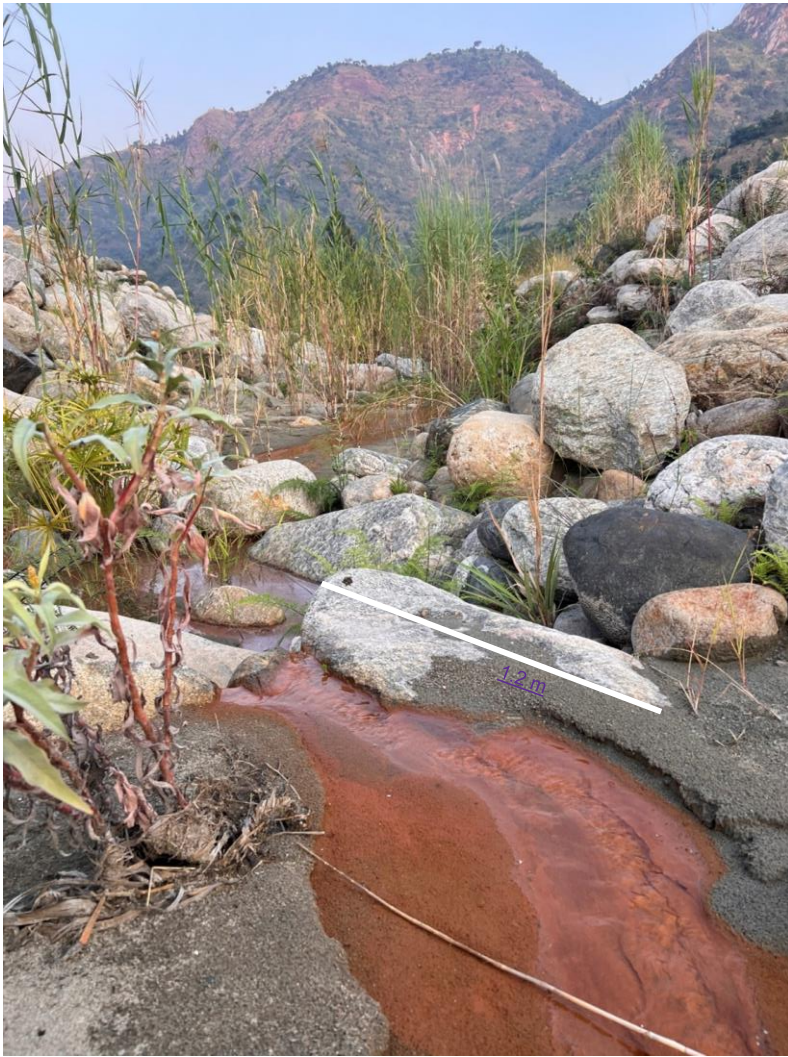
Figure J1: Deposition and acid mine drainage downstream of Kilembe Mines 0.19385N, 30.082355 E, 26 July 2024.

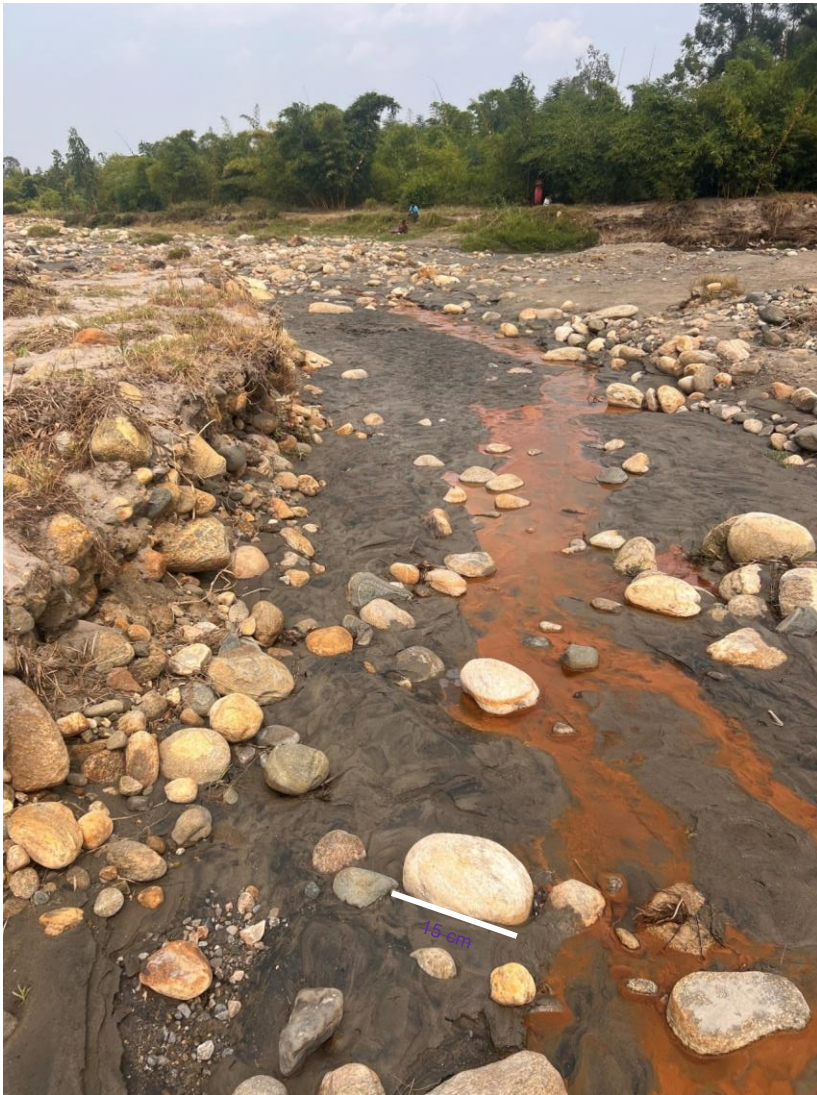
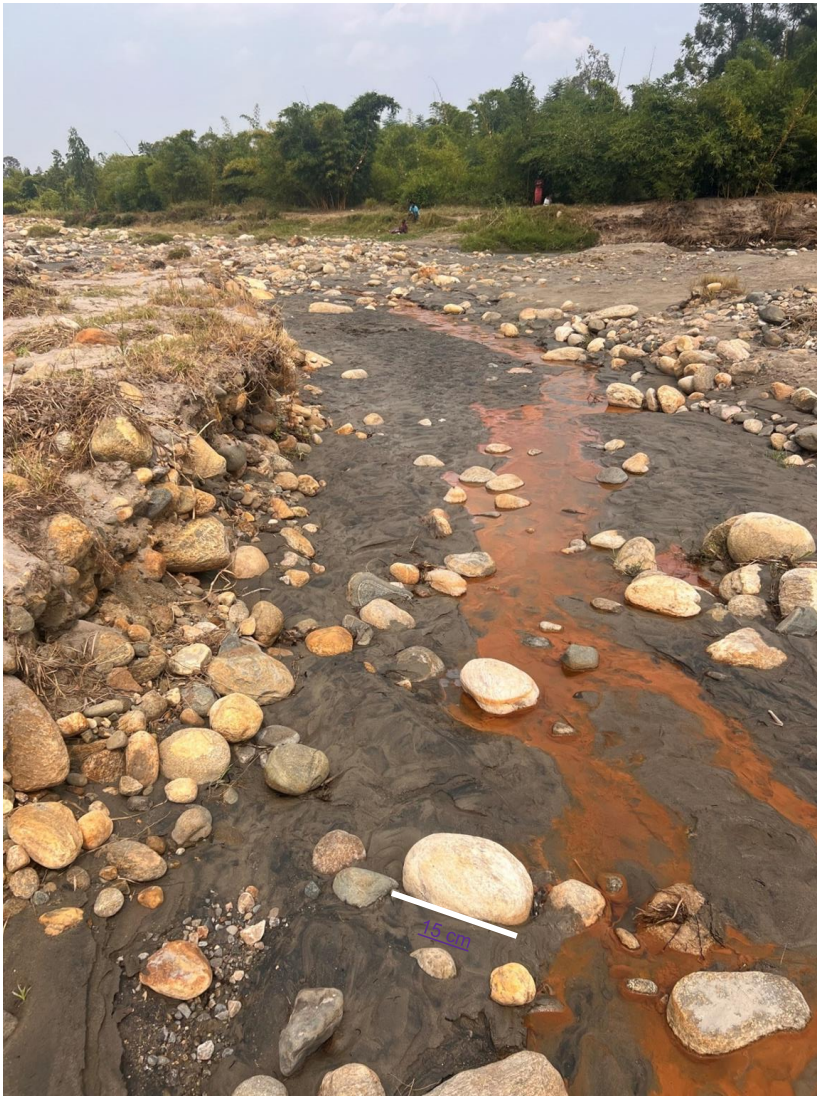
Figure J2: Acid mine drainage from deposited solid tailings at location adjacent to Kasese town, 26 July 2024.

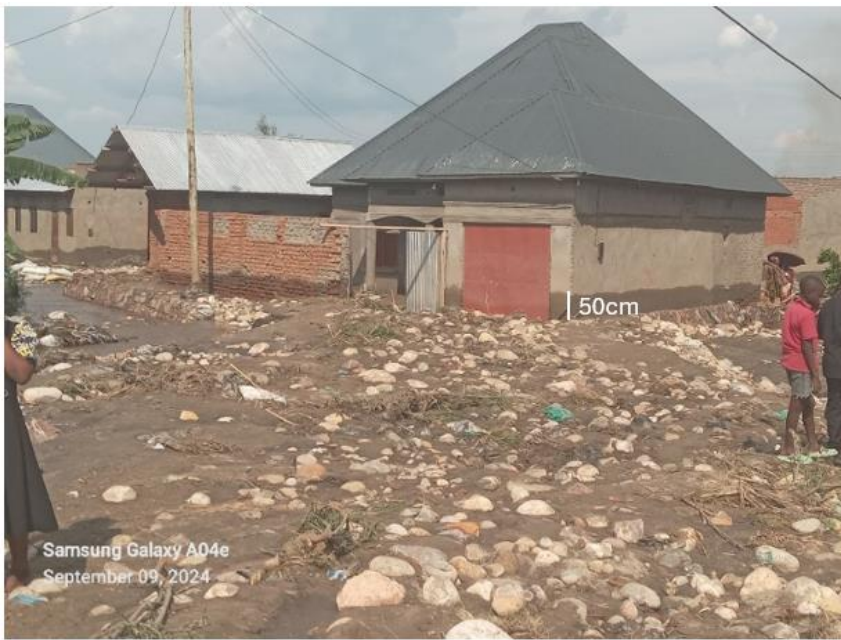
1028 **Figure L1: Photograph following flooding in Kasese town evidencing the inundation level and post-flood ground**
1029 **contamination. Photograph provided by the Ministry of Water and Environment.**

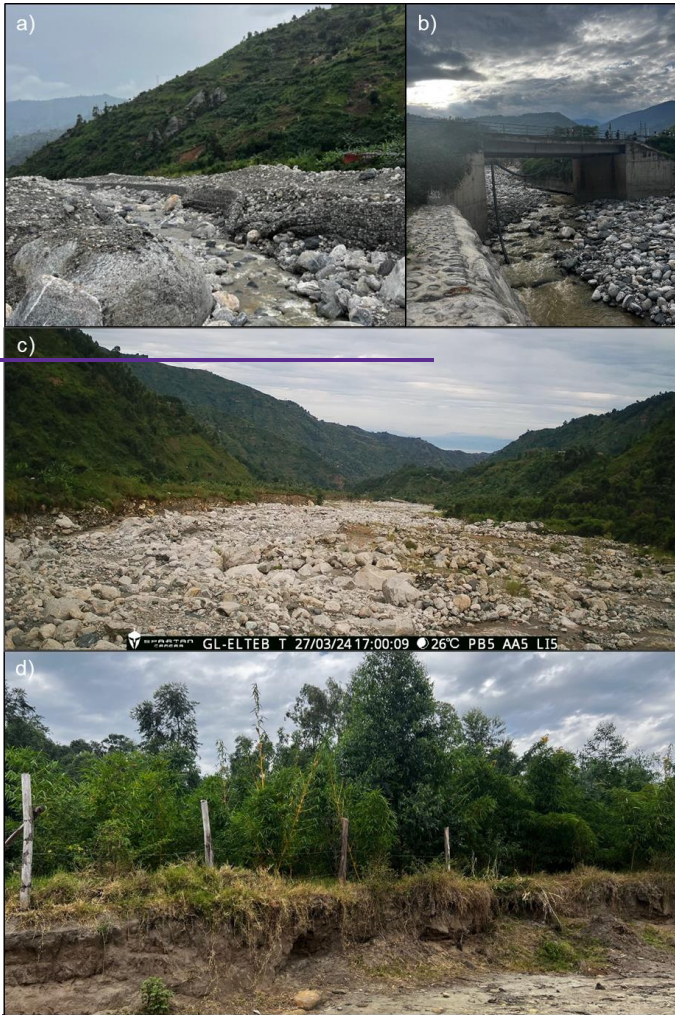
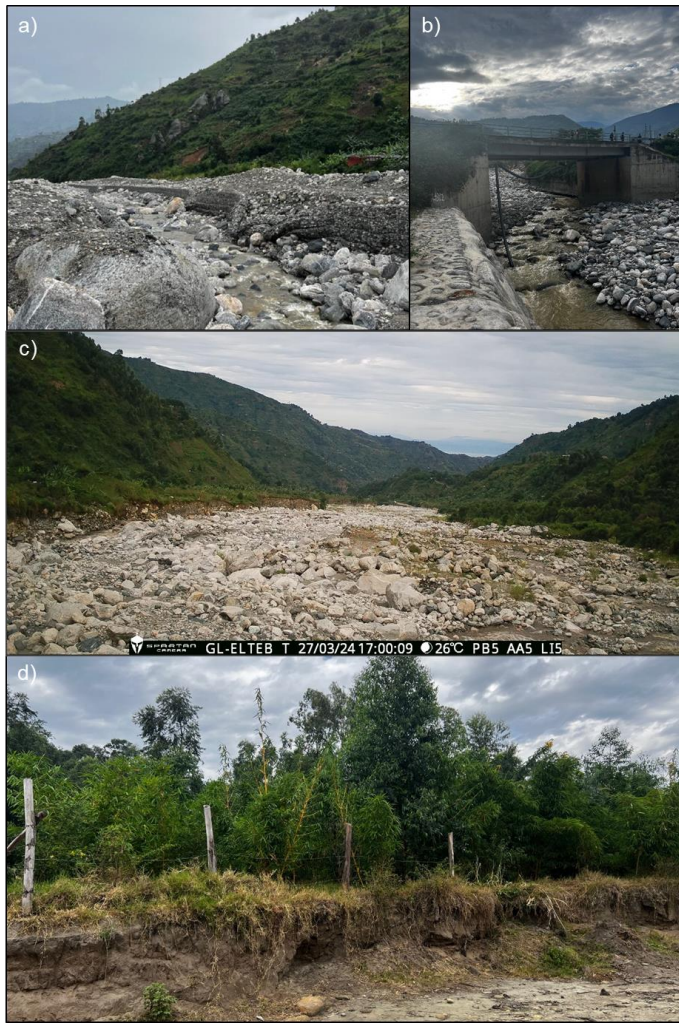
Figure L4MI – Photographs taken during June 2023 field reconnaissance: a) collapsed gabions adjacent to Kilembe town (for scale: 8 m channel width); b) channelisation using concrete embankments in Kilembe town centre (10 m channel width under bridge); c)
