The multi-decadal hazard cascade of a tropical mountain wildfire

Abstract. Climate change is driving wildfires to higher elevations, yet the hazard cascades that follow the burning of pristine tropical mountain ecosystems remain largely unexplored. Here, we analyse the long-term cascade following a February 2012 wildfire that burned 31 km² of forest and wetland in Uganda's Rwenzori Mountains National Park. Combining remote sensing, humanitarian records, field surveys, and interviews, we document ten major floods since 2012, including two debris floods that required large-scale humanitarian responses. Post-fire increases in erosion and mass movement have widened the River Nyamwamba sevenfold since 2012, breaching copper-cobalt mine tailings and mobilising an estimated 744,000 tonnes of waste into the river. Slow vegetation recovery at high altitudes and positive feedbacks between hazards have prolonged this high-risk state, underscoring the susceptibility of tropical mountain ecosystems to long-term post-wildfire cascades. More monitoring and research are required to characterise key hazard interactions after tropical mountain fires, which can guide entry points for management seek

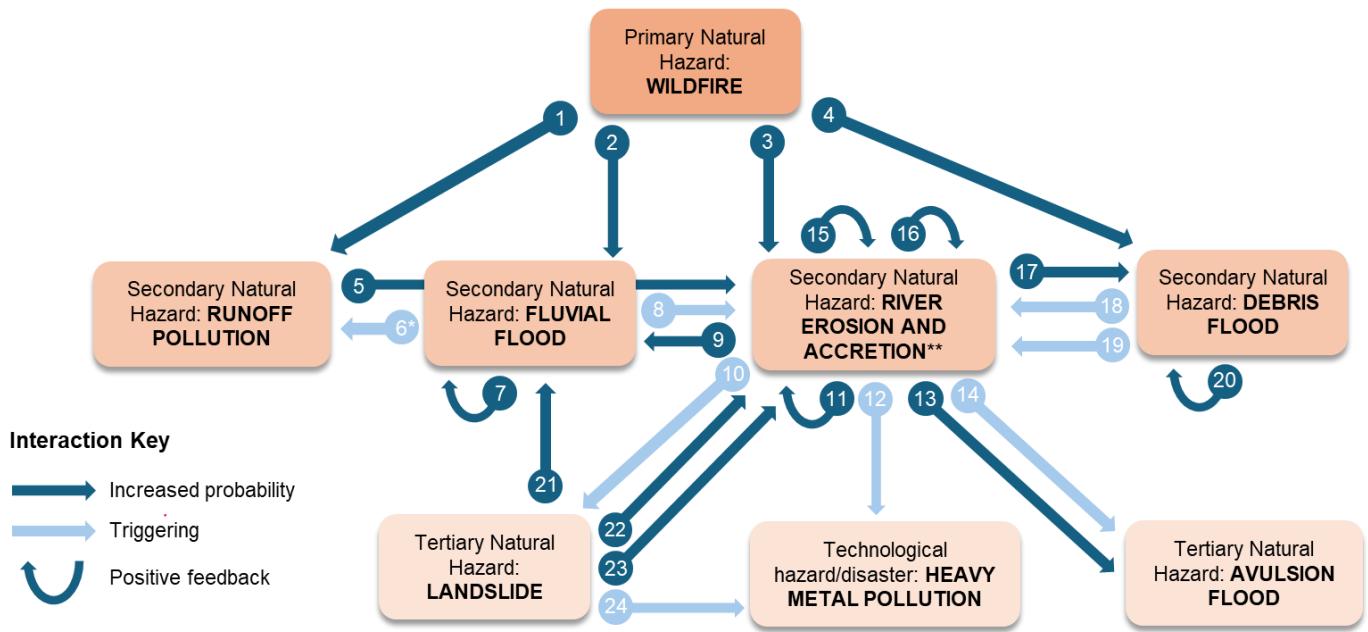
186 **Figure 2: Conceptual model of the multi-hazard cascade following the Rwenzori National Park wildfire in February 2012.**
 187 **Interactions between hazards are classified as being (i) triggering, or (ii) probability increasing, following Gill and Malamud’s**
 188 **(2016) framework, and (iii) positive feedbacks have been identified. There are numerous catalysing/impeding relationships in this**
 189 **context, which we omit from the visualisation for simplicity but describe key examples in the analysis text. Table 1 describes each**
 190 **of the interactions shown.**

191 ***Interaction (6) also applies for debris floods and avulsion floods as the driving hazard (Table 1), but they are grouped for**
 192 **simplicity in the visualisation.**

193 ****River channel erosion and accretion of eroded sediment are treated as one hazard in line with UNDRR’s Hazard Information**
 194 **Profiles (HIPs), with continuously interacting processes and positive feedbacks (15, 16) along the river’s reach (UNDRR, 2025).**

175 We present the multi-hazard cascade caused by the 2012 Rwenzori National Park wildfire (Fig. 2). The following sections
176 describe each of the hazards involved and the interactions they drive, based on evidence from our mixed methods. Results are
177 structured by hazard type: wildfire (Sect. 3.1), flooding (3.2), landslides (3.3), erosion (3.4), and pollution (3.5). Identified
178 interactions highlight opportunities where management interventions can impede the cascade, for which we discuss practical
179 solutions at the local and global scales in Sect. 4 (Discussion). The hazard definitions follow the Hazard Information Profiles
180 (UNDRR, 2025) and are clarified in Table D1 (Appendix D). Importantly, here landslides refer to gravitational mass
181 movements directly connected to the river system as shown in Figures I1 and I2 (Appendix I).

195 **Table 1: Description of the hazard cascade interactions in Fig. 2. The study evidence for each interaction is explained in the text and**
 196 **summarised in Table D2 (Appendix D).**

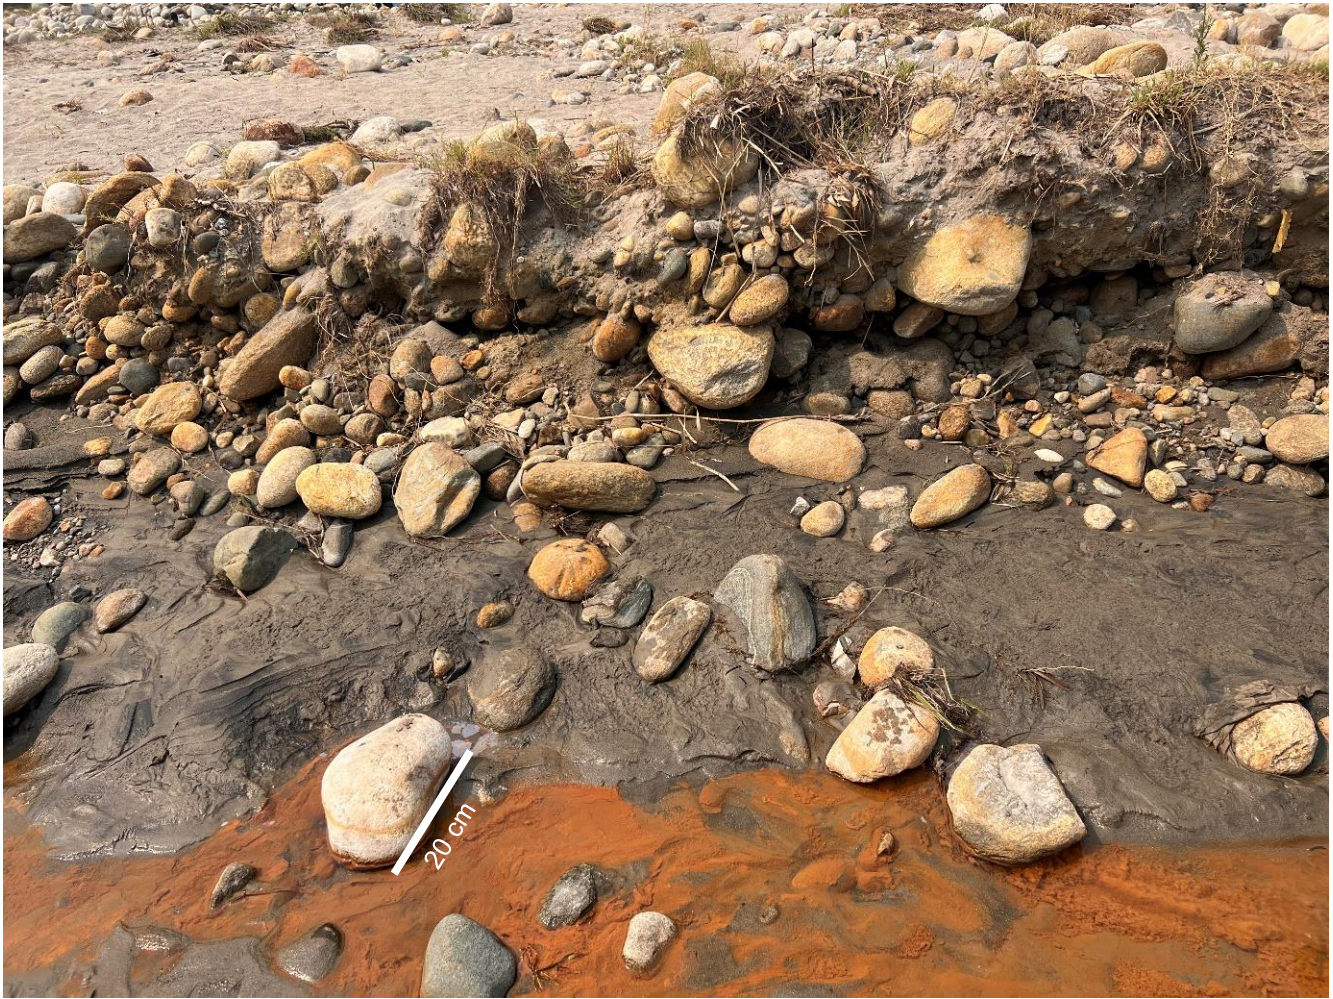
861 **Figure E1: Acid mine drainage at location 0.18599N, 30.01951E, 25 July 2024.**

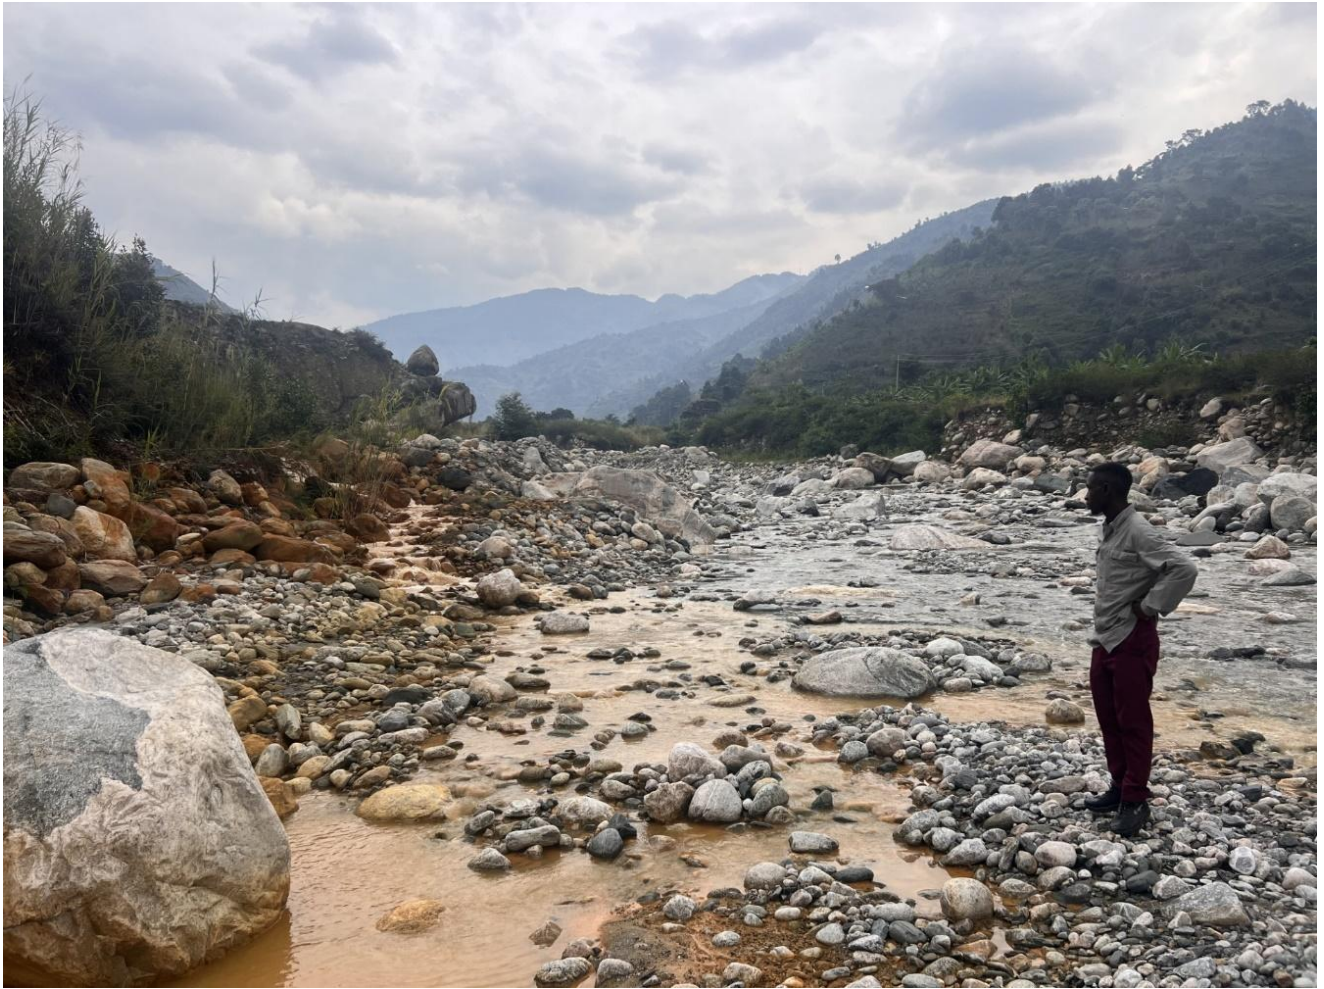
863 **Figure E2: Acid mine drainage at location 0.19879N, 30.01139E, 3 August 2024.**

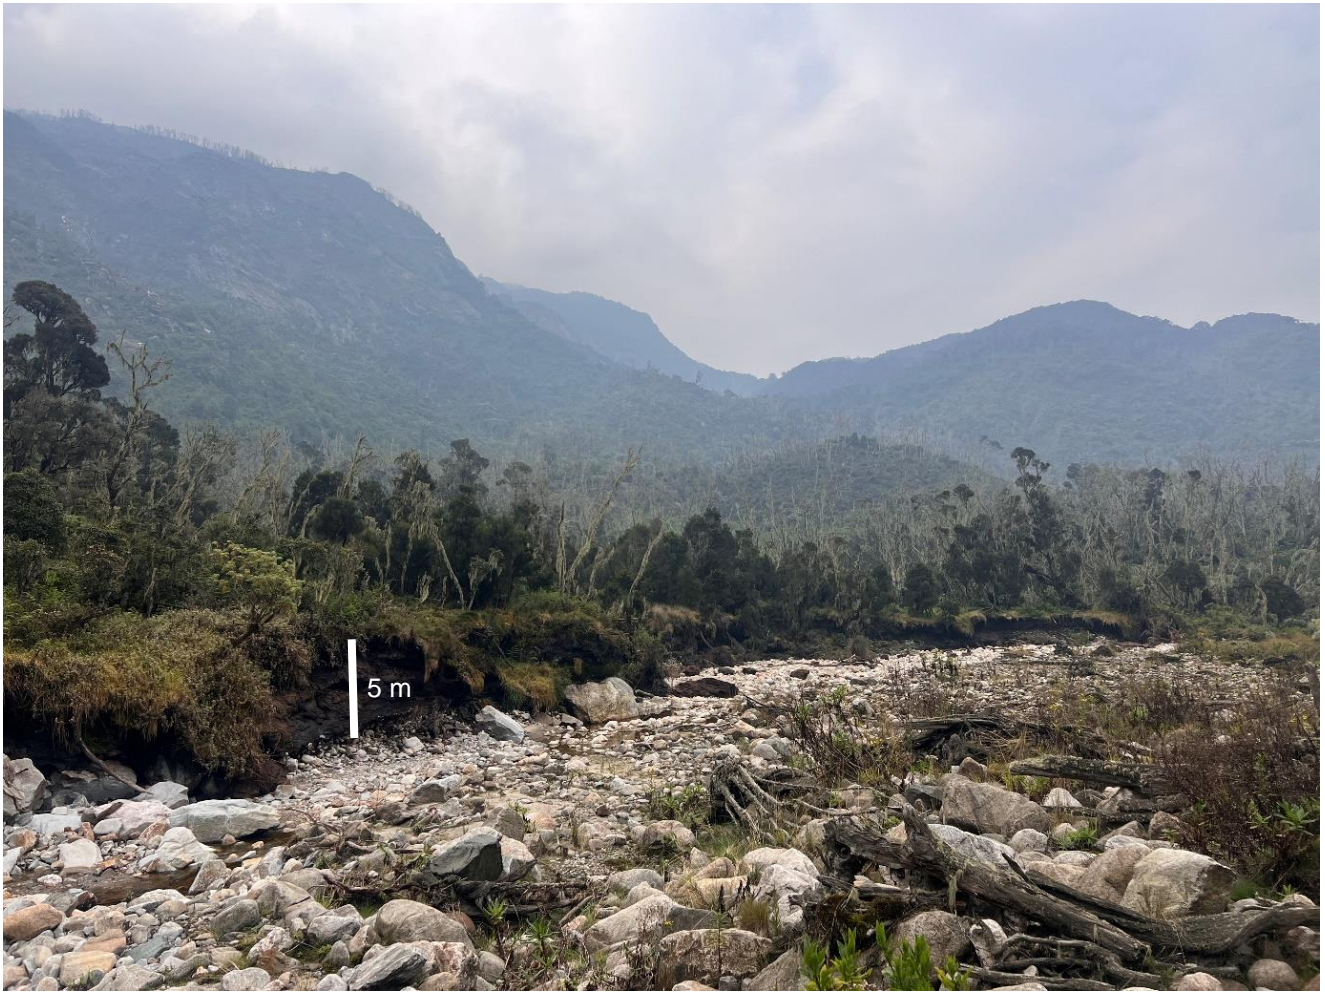
867
868 **Figure F1: Riverbank exposure at 0.29291N, 29.93596E – 28 July 2024.**
869

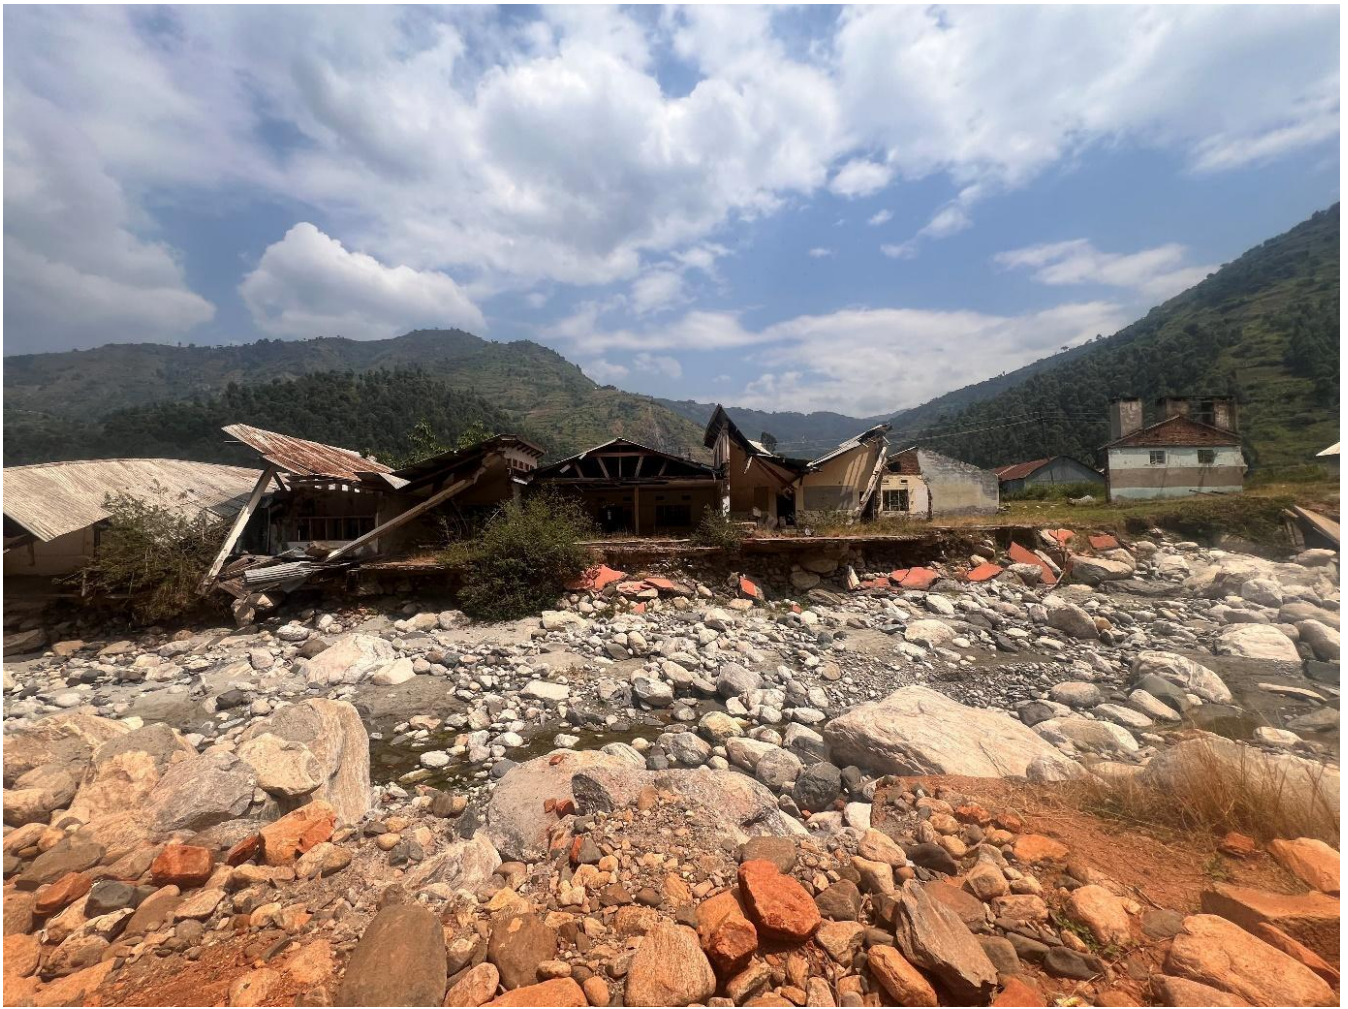
Figure F2: Riverbank style erosion of house foundations in Kilembe, 0.20603N, 30.00822E – 24 July 2024.

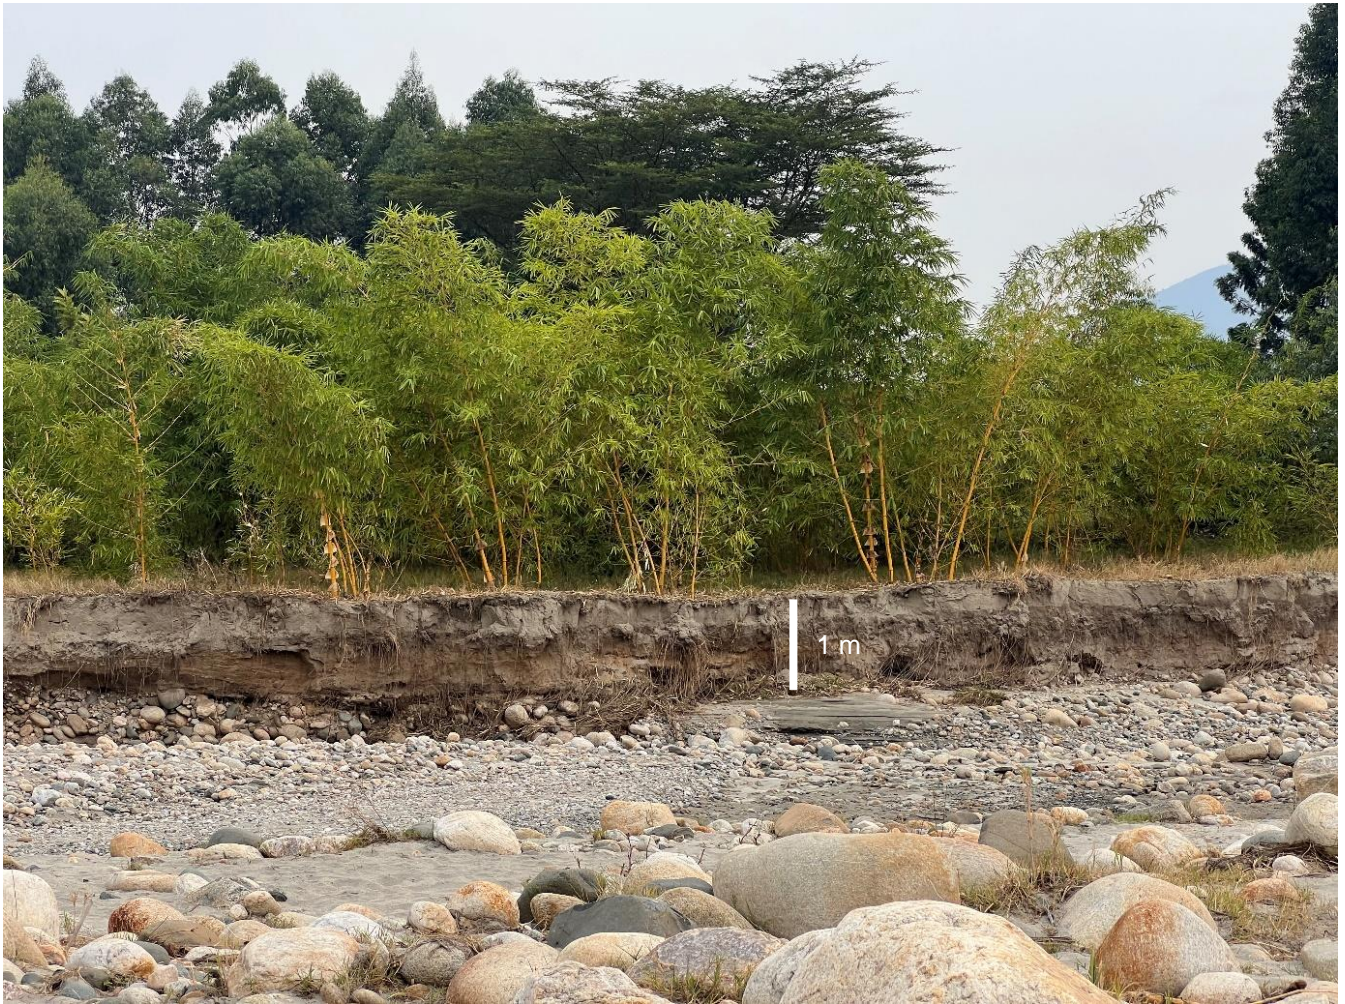
896 **Figure H1: 0.18981N, 30.07408E, 26 July 2024 (damaged bamboo nature-based solution).**

286 High flows during fluvial and debris floods damage engineered flood defences, increasing their own probabilities of future
287 breaches in self-perpetuating positive feedback (#7; #20; Appendix H). At the same time, their elevated velocities and
288 turbulence generate shear stress and hydraulic action that trigger river erosion and accretion (#8; #18, #19). GIS analysis
289 confirms that the years of greatest erosion (2013 and 2020) coincided with the largest debris flood events [M1; R1] (Sect. 3.4).

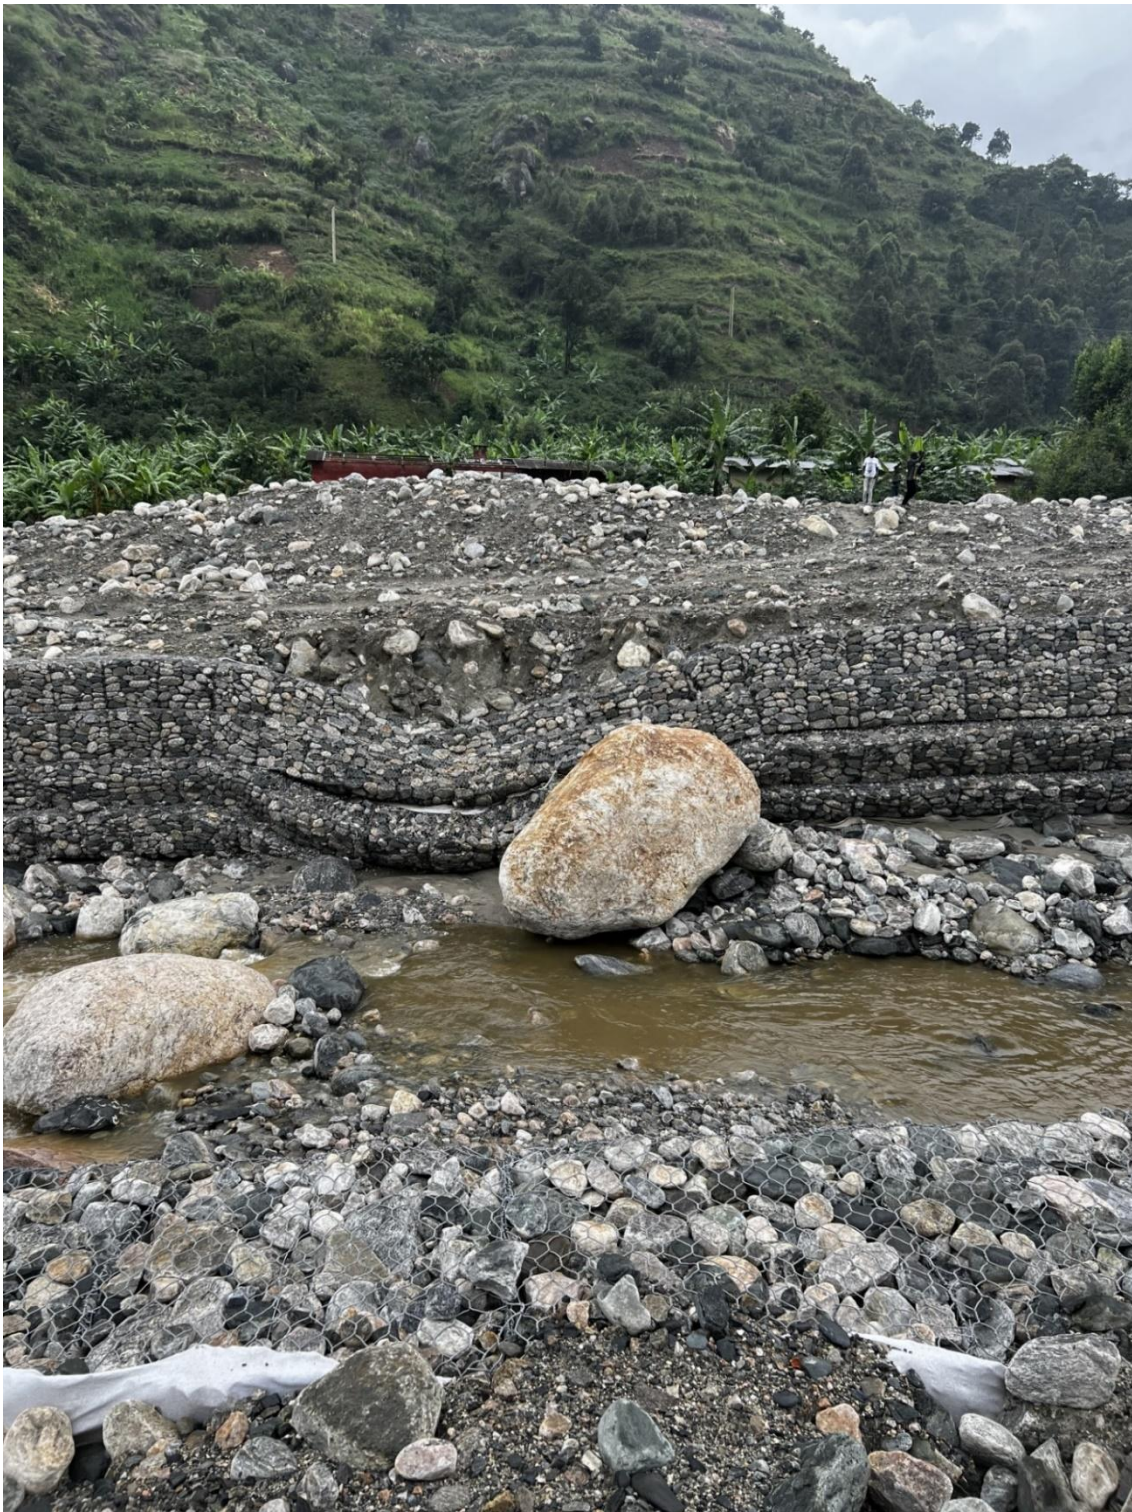
899 **Figure H2: 0.21387N, 30.00558E, 7 June 2023 (damaged gabions).**

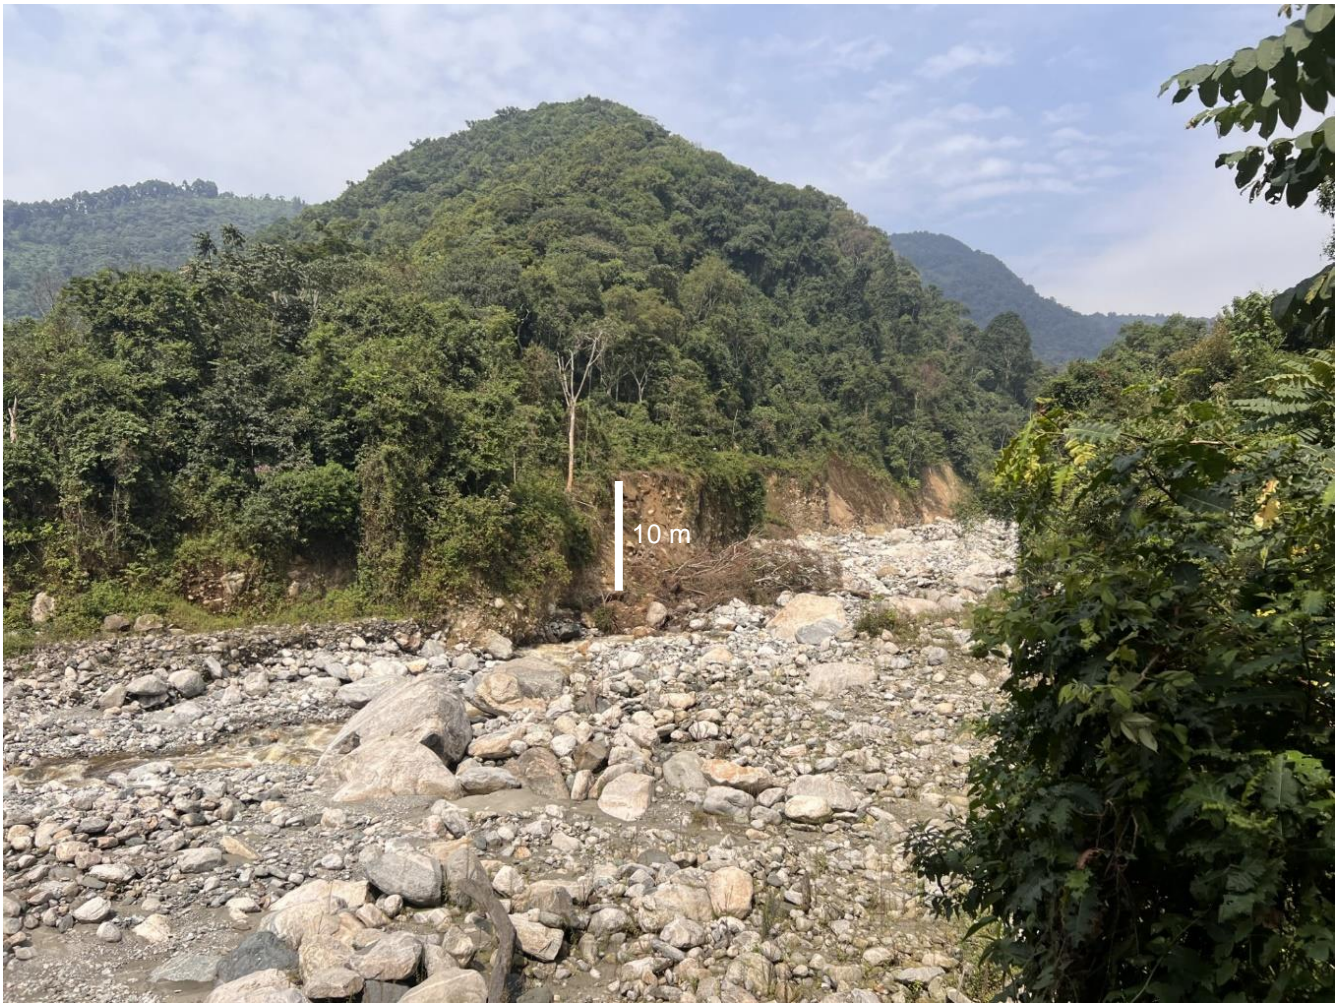
903
904 **Figure I2: Landslide scar at 0.23758N, 29.97570E – 1 August 2024.**
905
906
907
908
909
910
911
912
913

294 Landslides caused by lateral river erosion undercutting riverbanks and hillslopes (Jacobs et al., 2016) have accelerated since
295 the wildfire due to higher post-fire discharges and sediment loads [I1; M1; M2; R1]. In addition, the initial destruction and
296 exposure of formerly stable riverbanks during the wildfire and 2013 flood has worked to further increase the probability of
297 mass movement into the river [M1; G2]. Previously, graded banks of unconsolidated quaternary sediment were anchored by
298 climax vegetation. Now, vertical riverbanks are exposed to direct erosion and undercutting at sites throughout the river's long
299 profile. As one local government representative describes, "*when the floodwaters come down, they remove soil and grasses to*
300 *expose more boulders, and then you will have a landslide*" [G2]. This process is visible in Fig. 3c, where the riverbanks on
301 sections of the burned side are now steep, unvegetated banks of exposed and unconsolidated glacial till.

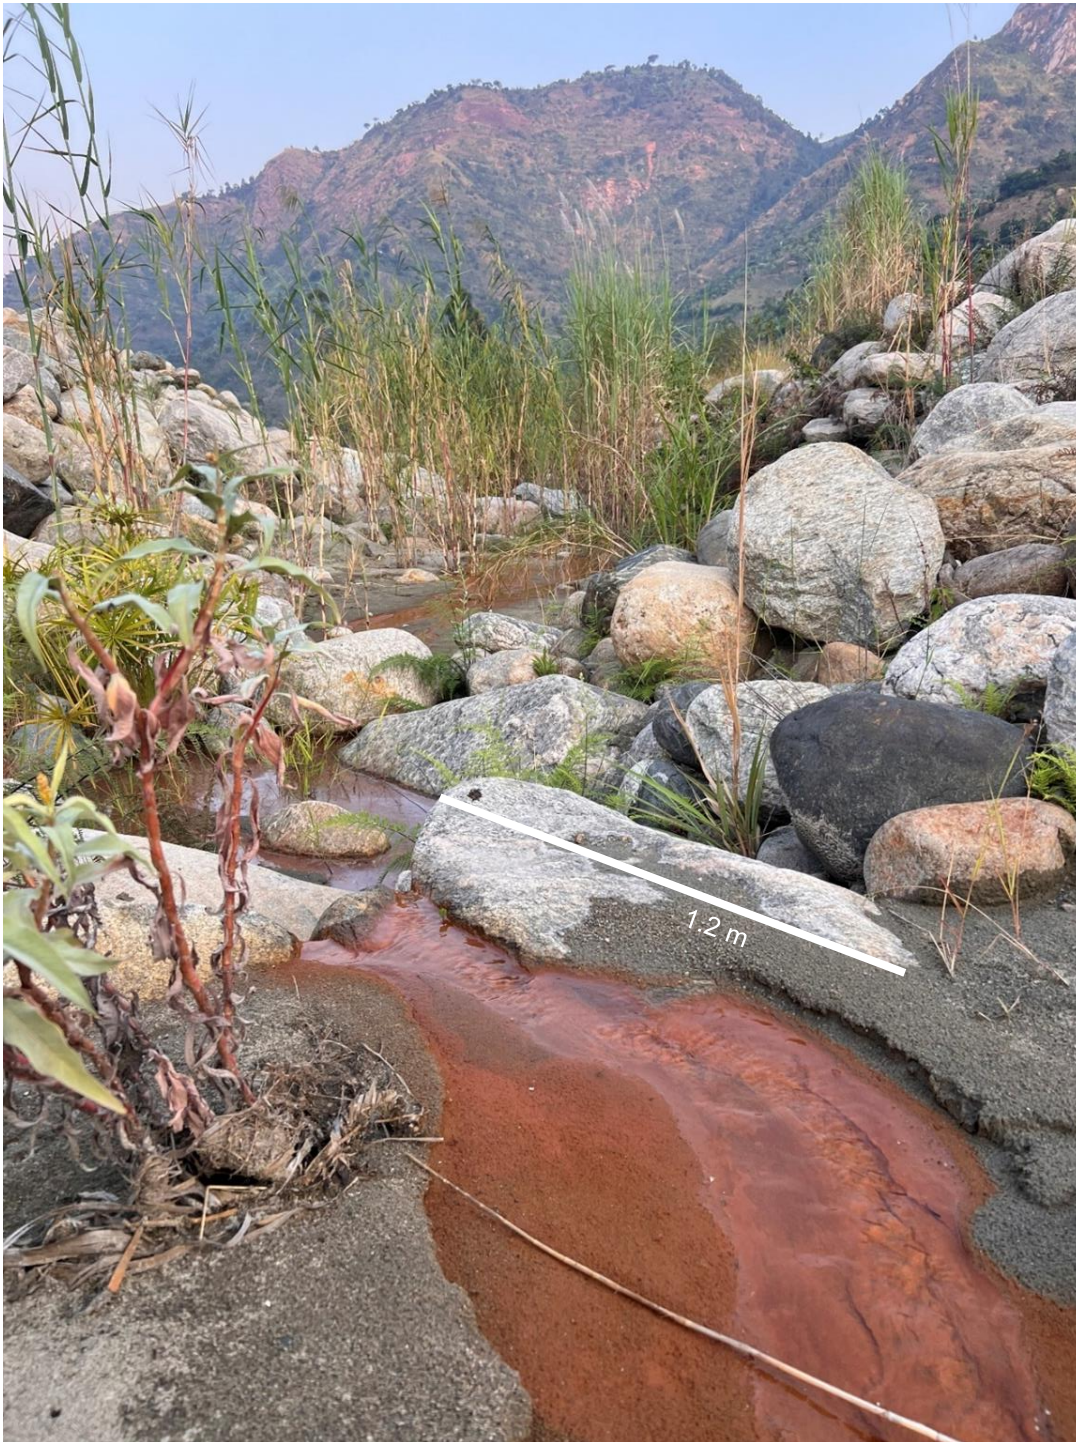
Figure J1: Deposition and acid mine drainage downstream of Kilembe Mines 0.19385N, 30.082355 E, 26 July 2024.

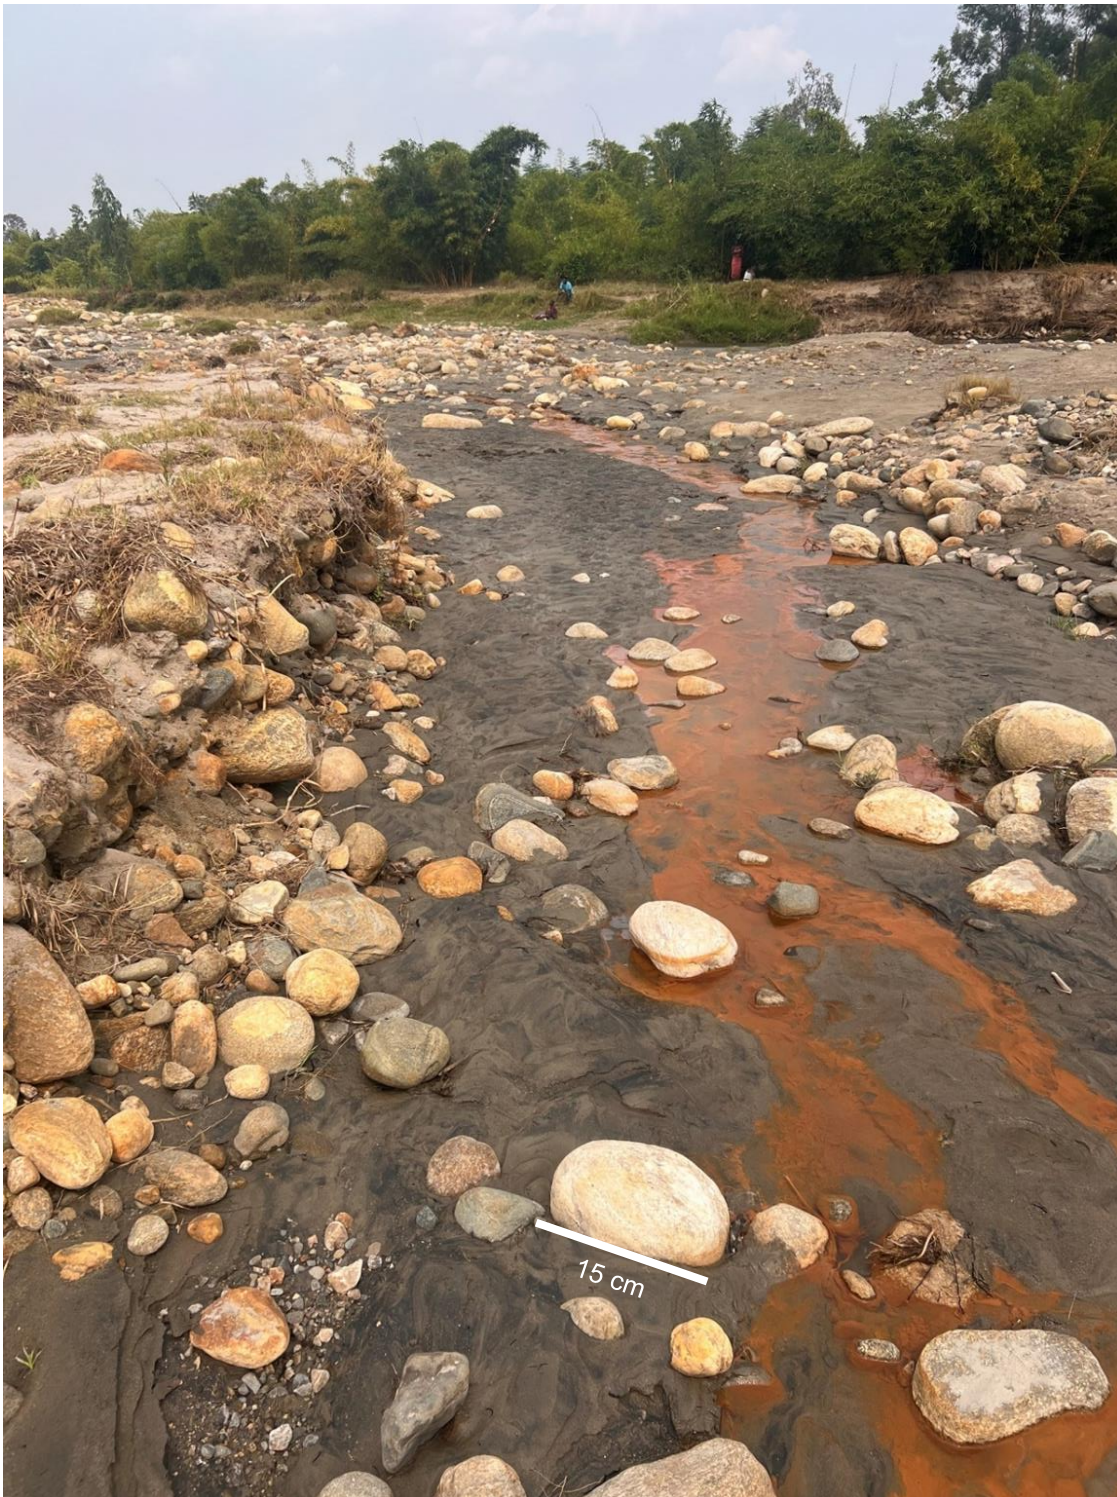
Figure J2: Acid mine drainage from deposited solid tailings at location adjacent to Kasese town, 26 July 2024.

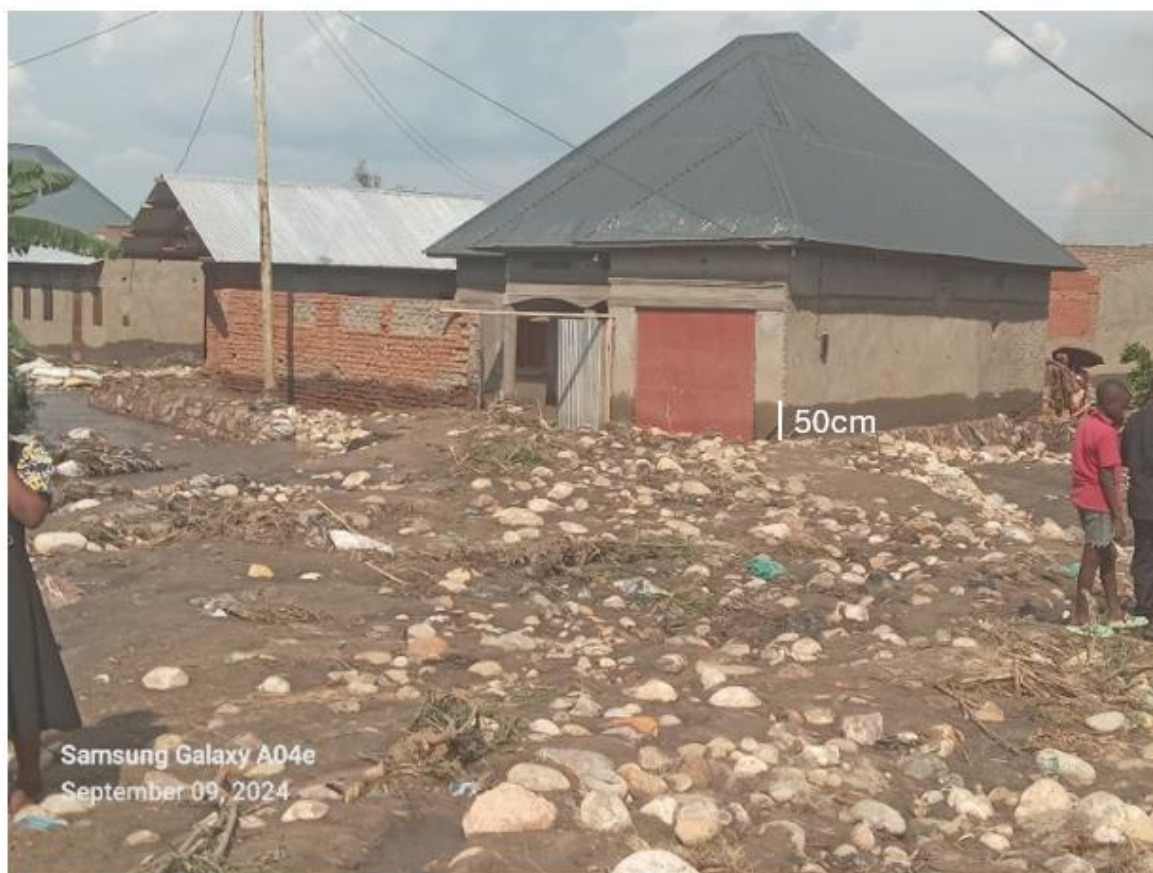
927
928 **Figure L1: Photograph following flooding in Kasese town evidencing the inundation level and post-flood ground**
929 **contamination. Photograph provided by the Ministry of Water and Environment.**

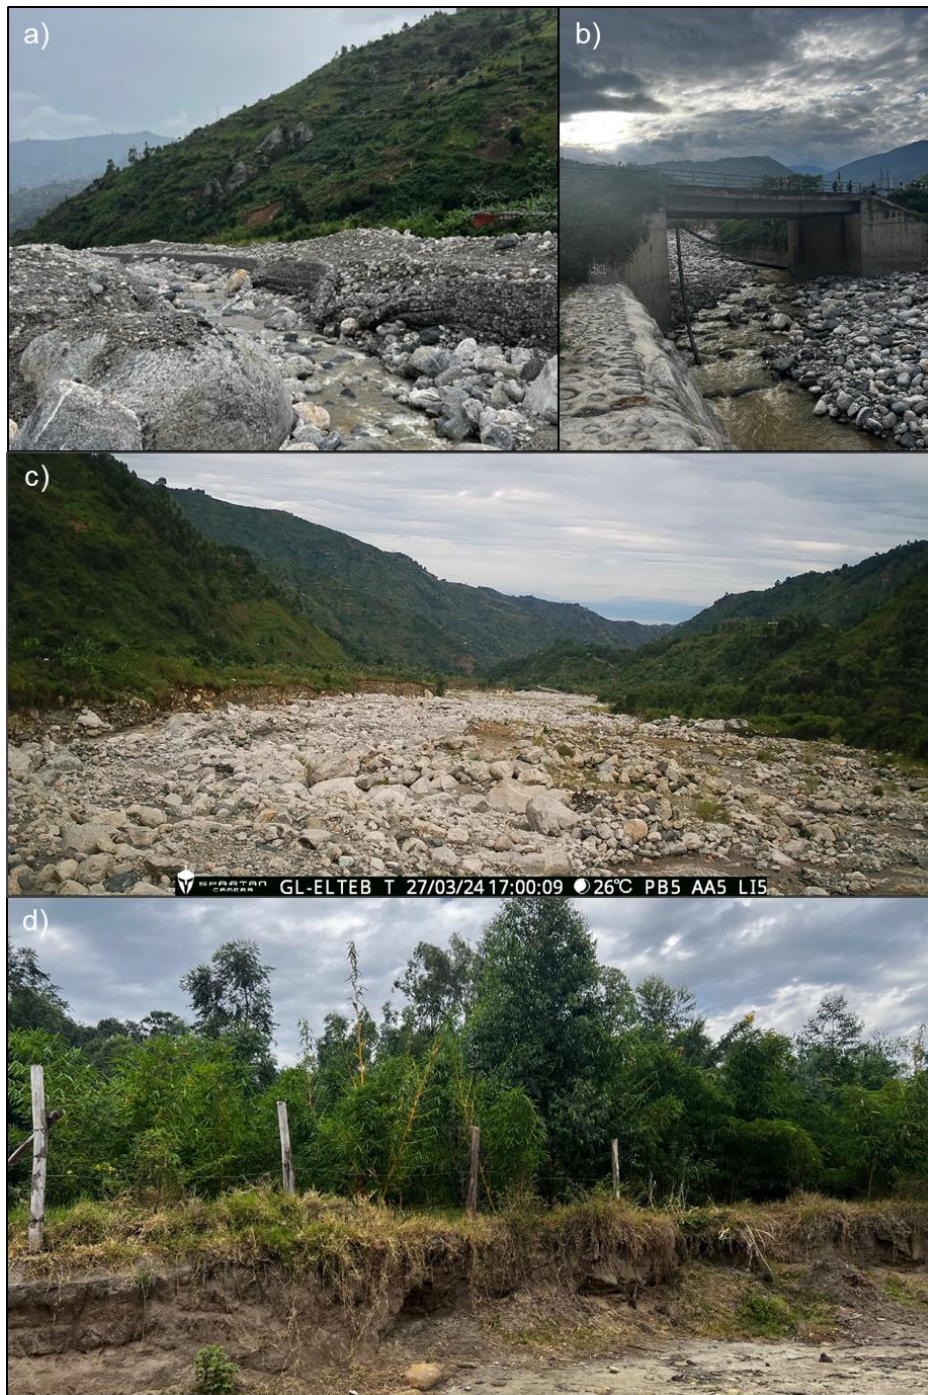
Figure M1 – Photographs taken during June 2023 field reconnaissance: a) collapsed gabions adjacent to Kilembe town (for scale: 8 m channel width); b) channelisation using concrete embankments in Kilembe town centre (10 m channel width under bridge); c) photo from a camera transmitting photos at 1-minute intervals 5 km upstream of Kilembe town centre for flood early warning; d) riverbank stabilisation adjacent to Kasese town including asper bamboo (4 m fencepost spacing).
