# The multi-decadal hazard cascade of a tropical mountain wildfire

**Abstract.** Climate change is driving wildfires to higher elevations, yet the hazard cascades that follow the burning of pristine  
tropical mountain ecosystems remain largely unexplored. Here, we analyse the long-term cascade following a February 2012  
wildfire that burned 31 km<sup>2</sup> of forest and wetland in Uganda's Rwenzori Mountains National Park. Combining remote sensing,  
humanitarian records, field surveys, and interviews, we document ten major floods since 2012, including two debris floods  
20 that required large-scale humanitarian responses. Post-fire increases in erosion and mass movement have widened the River  
Nyamwamba sevenfold since 2012, breaching copper-cobalt mine tailings and mobilising an estimated 744,000 tonnes of  
waste into the river. Slow vegetation recovery at high altitudes and positive feedbacks between hazards have prolonged this  
high-risk state, underscoring the susceptibility of tropical mountain ecosystems to long-term post-wildfire cascades. More

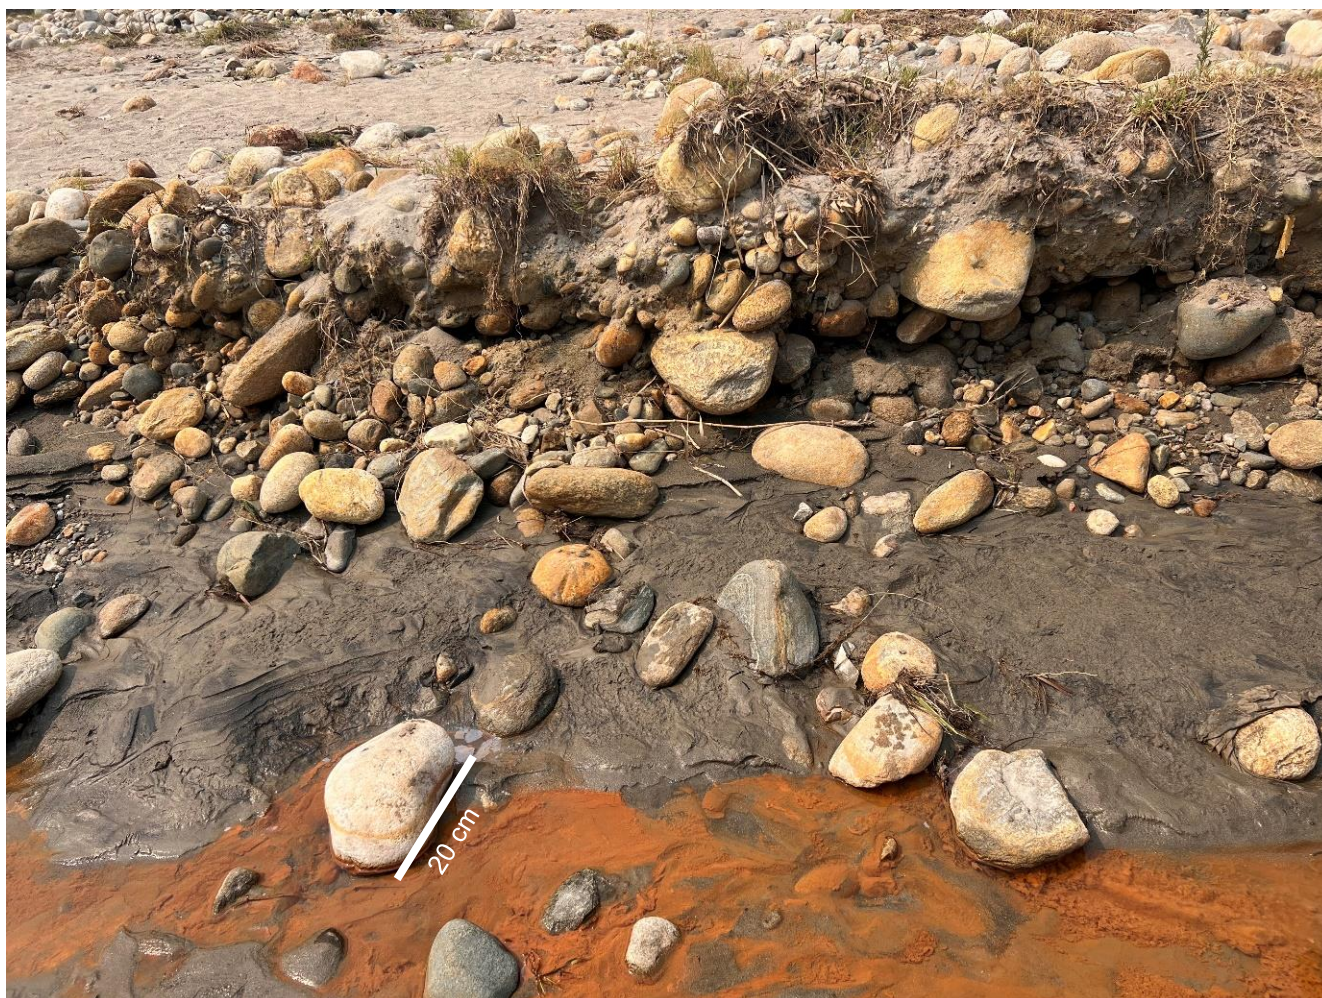
**Figure E1: Acid mine drainage at location 0.18599N, 30.01951E, 25 July 2024.**

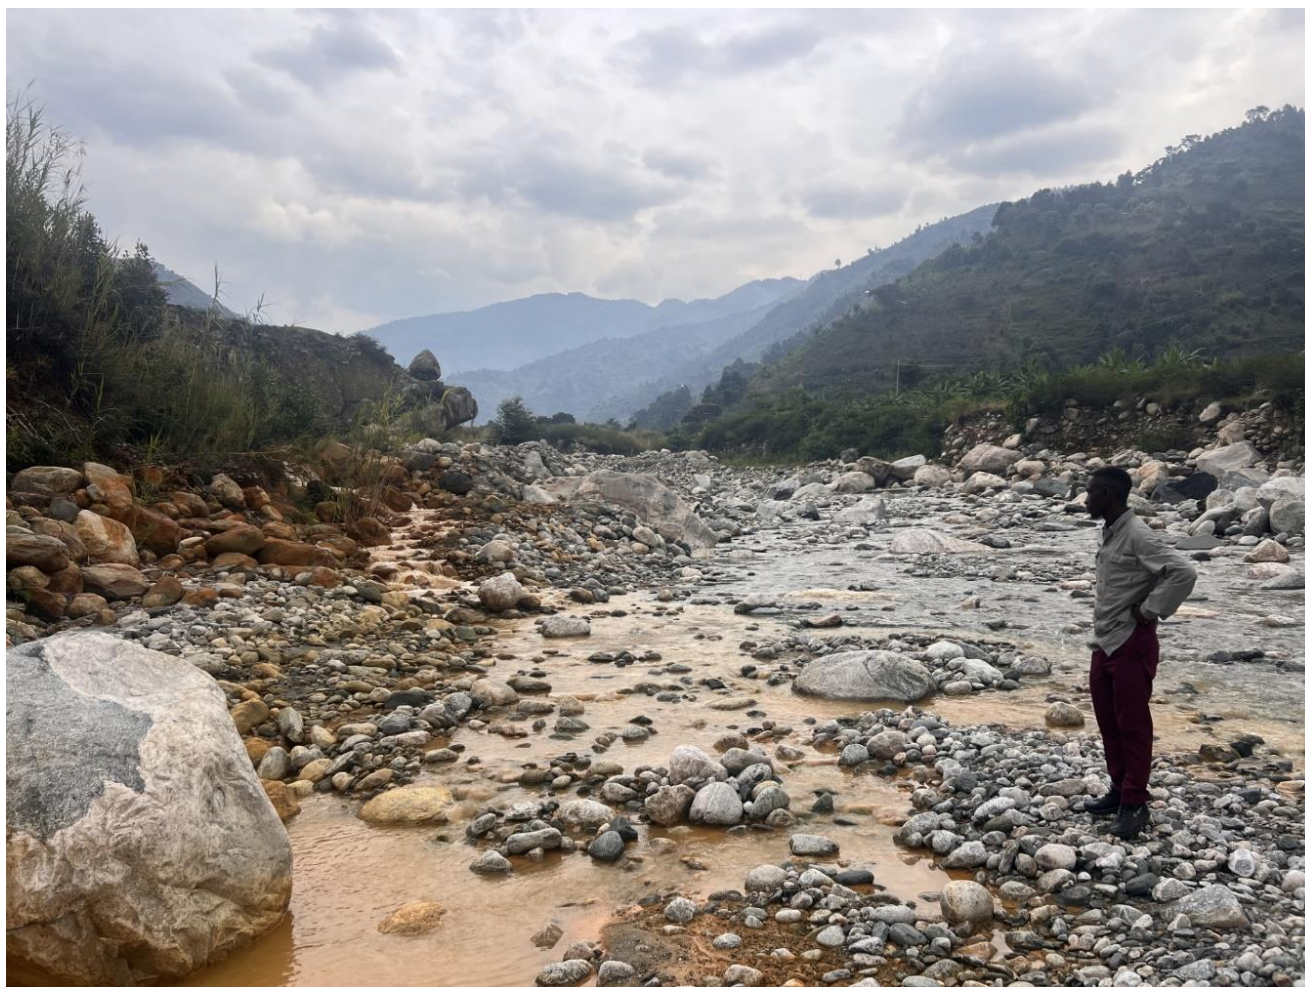
710 **Figure E2: Acid mine drainage at location 0.19879N, 30.01139E, 3 August 2024.**

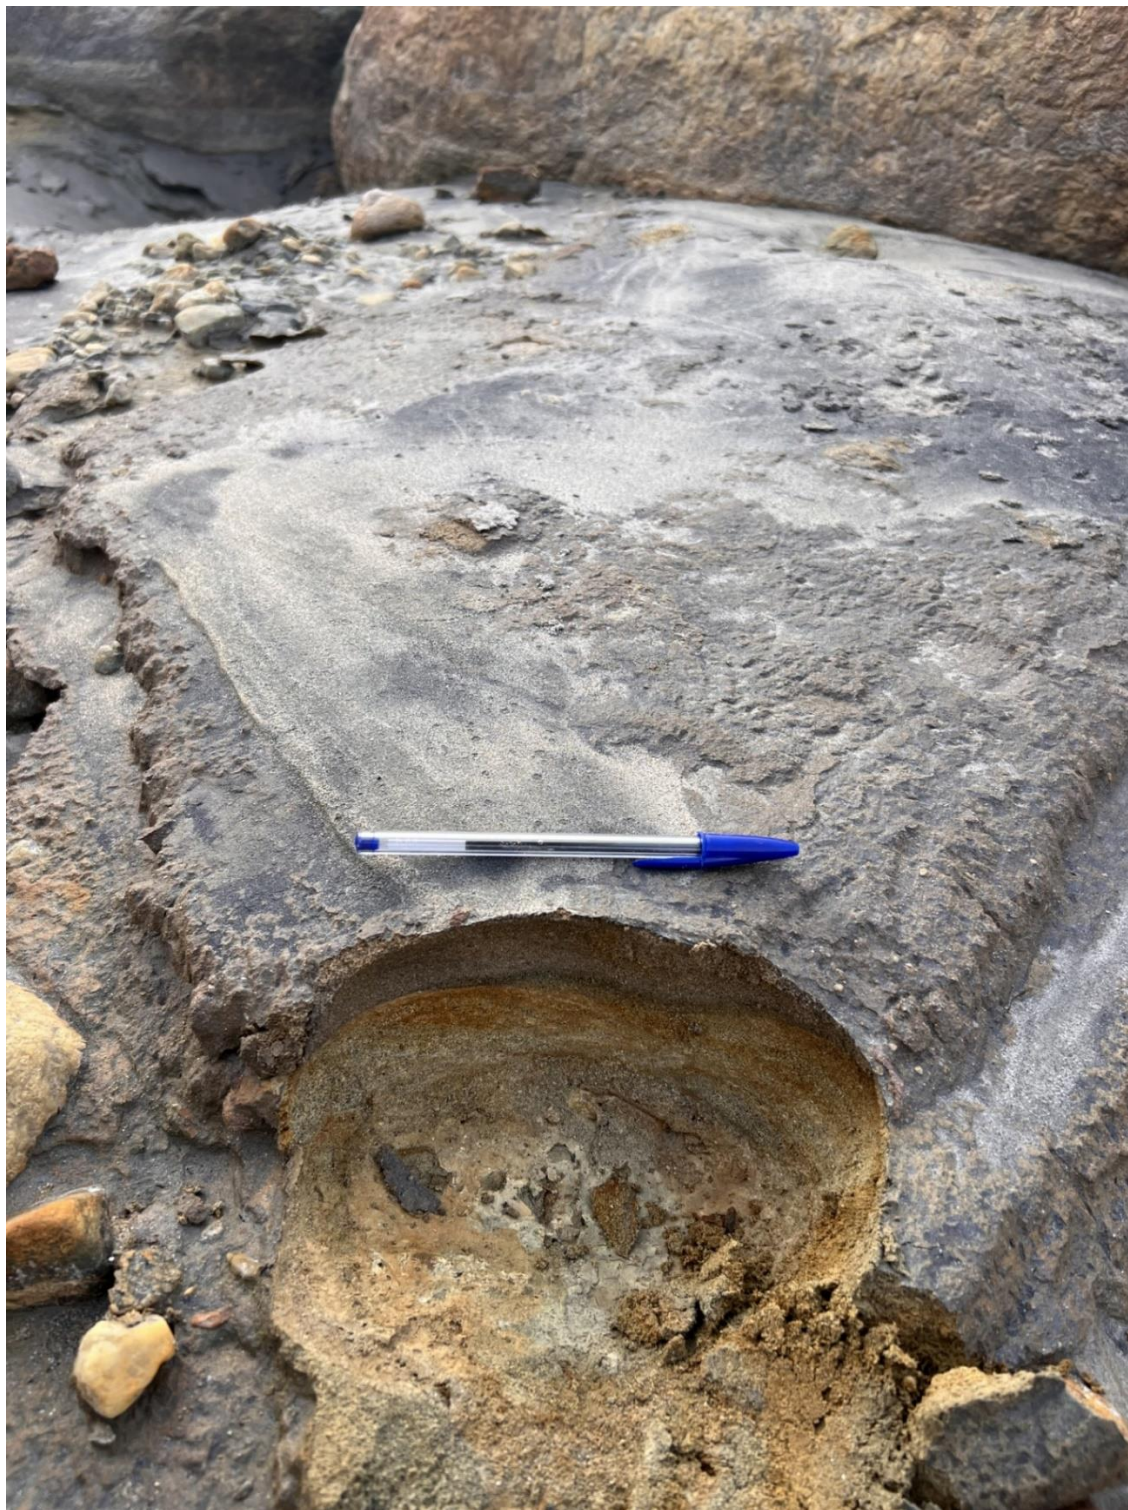
**Figure E3:** Tailings sedimentation in the Nyamwamba channel, 0.18652N, 30.01986E, 25 July 2024.

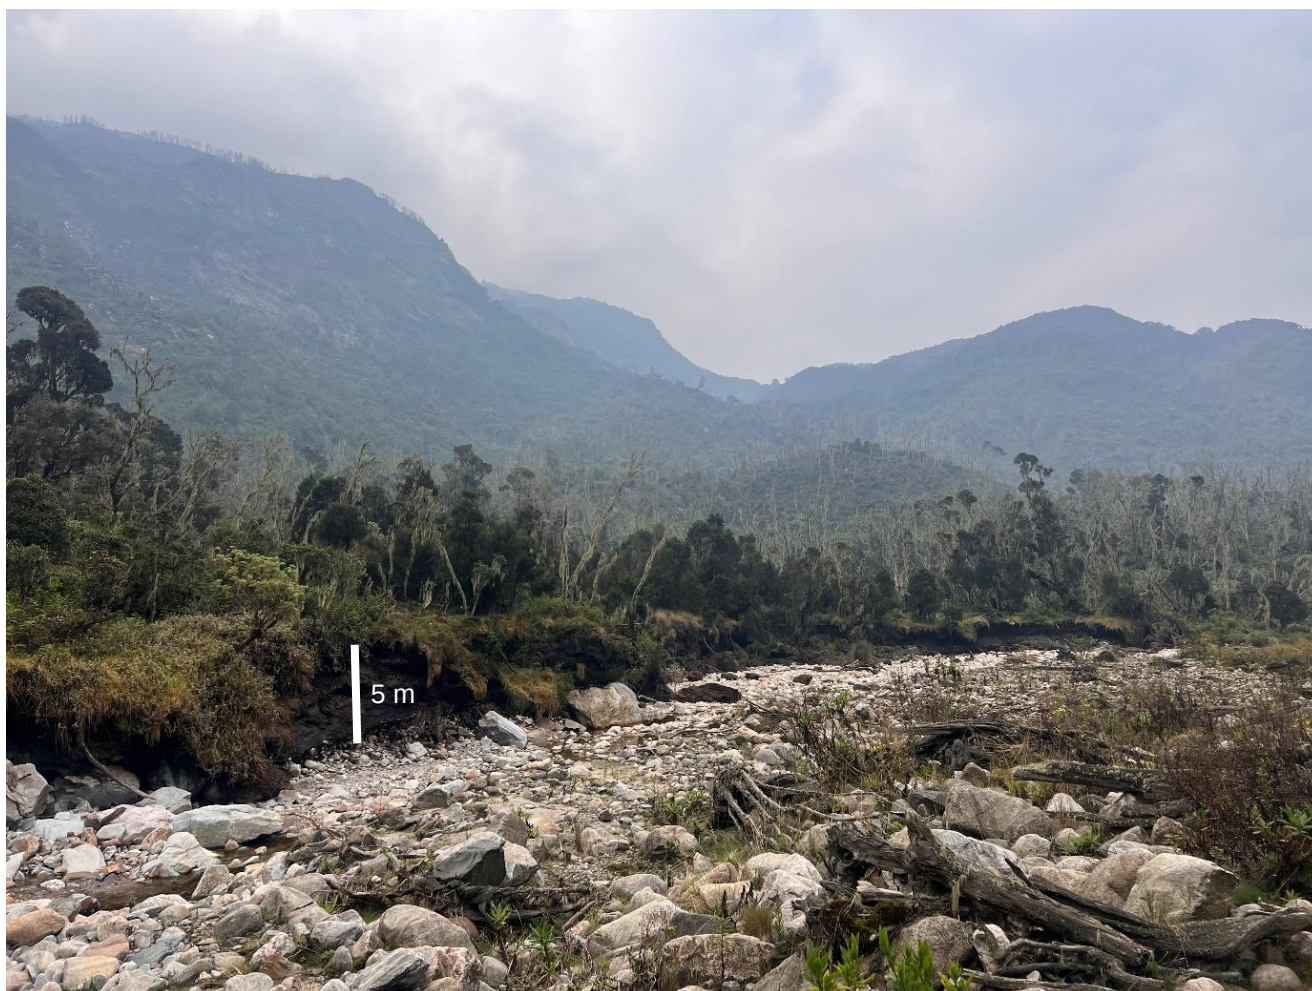
715 **Figure F1: River cliff exposure at 0.29291N, 29.93596E – 28 July 2024.**

| # | Initiating Hazard | Affected Hazard | Interaction Description | Evidence |
|---|---|---|---|---|
| 3 | Wildfire | River erosion | Increased probability. Wildfire’s burning of vegetation and erosion of soil has increased runoff, peak river discharge, and therefore the erosive power of the river. Initial erosion and mass movement also exposed river cliffs, which is increasing the probability of (and catalysing) further erosion in a positive feedback process. | GIS analysis calculating an erosion rate increase by a factor of 2.64 due to the wildfire (Fig. 4). Photographs of exposed river cliffs within wildfire affected areas (Fig. 3c and Appendix F). |

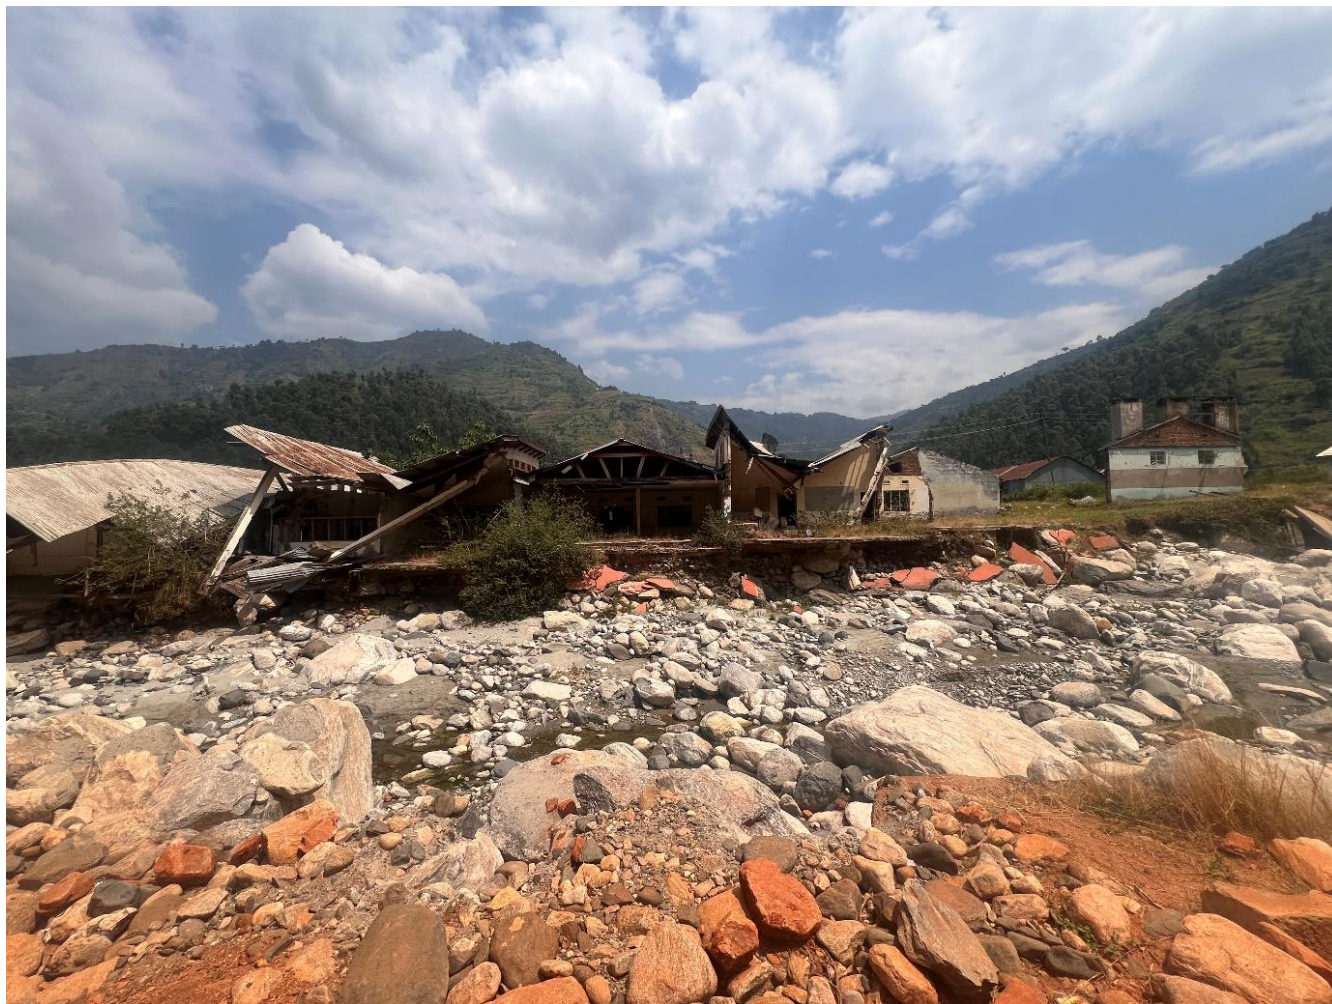
**Figure F2: River cliff style erosion of house foundations in Kilembe, 0.20603N, 30.00822E – 24 July 2024.**

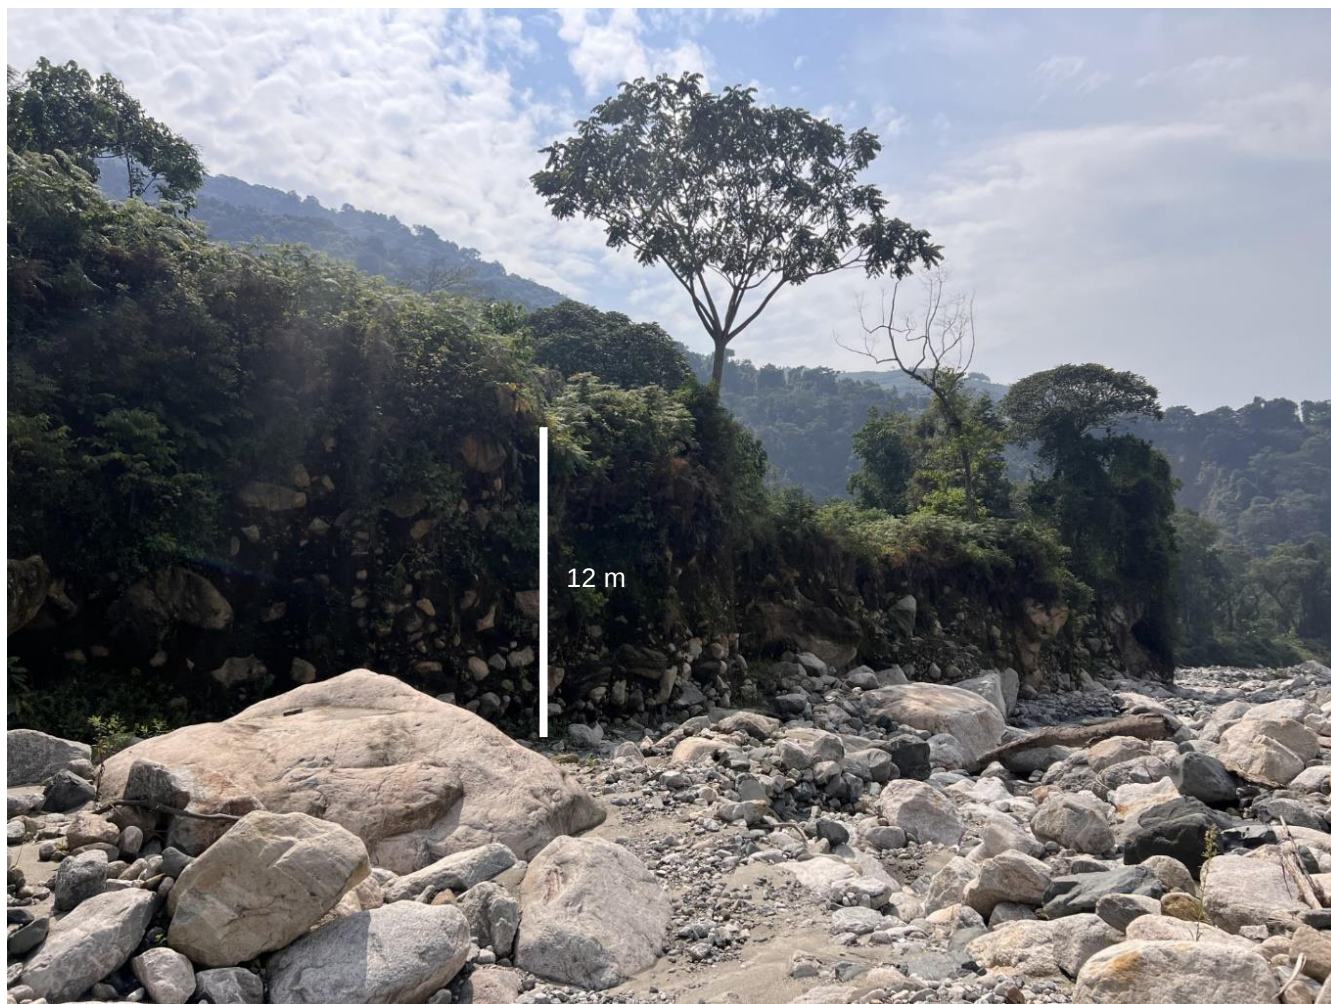
**Figure F3: River cliff at 0.23742N, 23.97568E – 1 August 2024.**

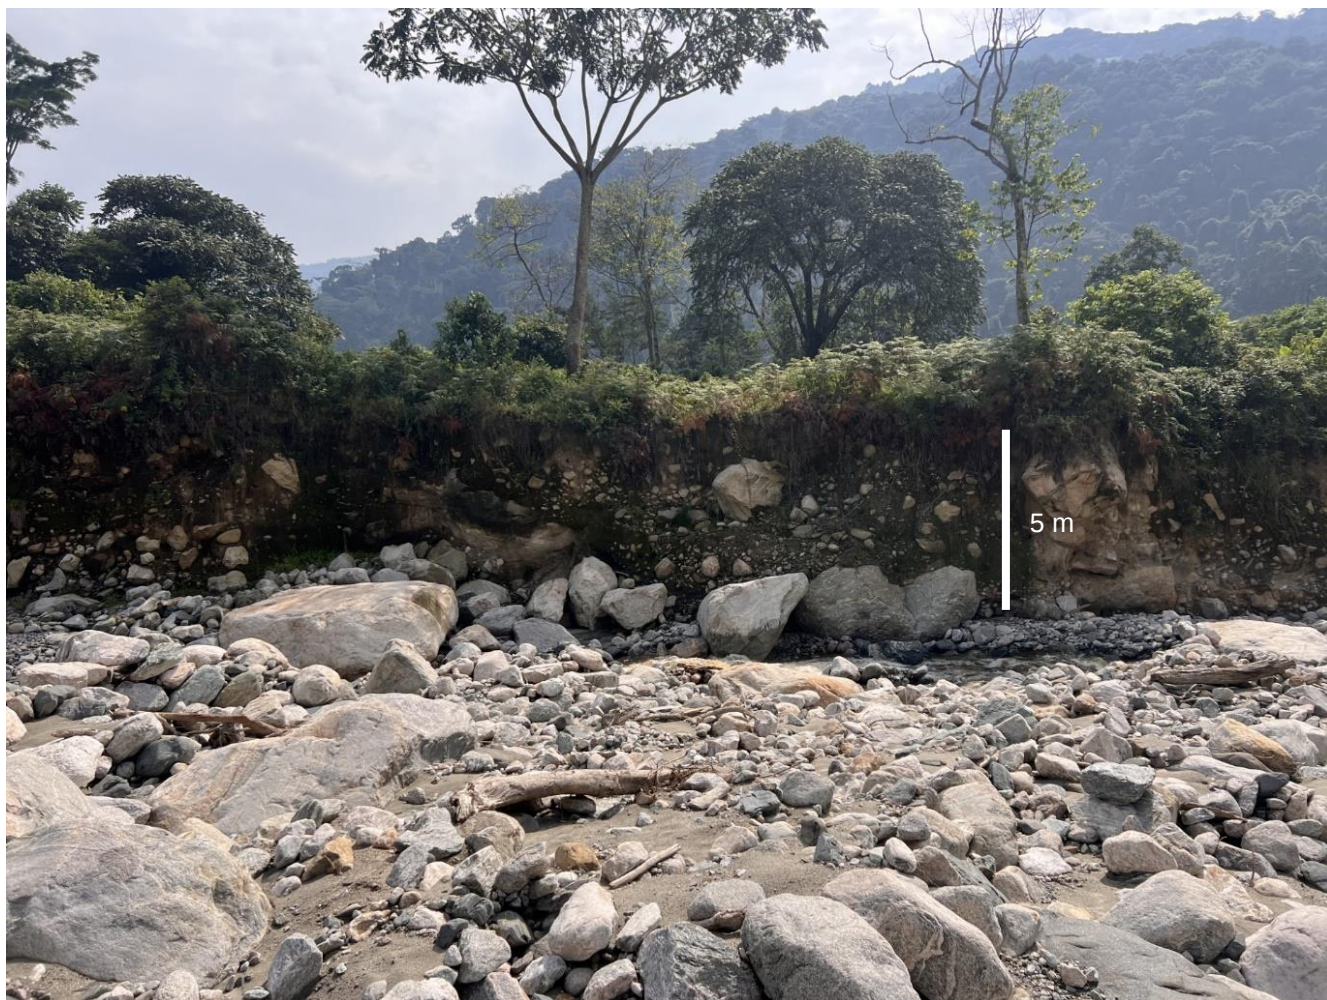
**Figure F4: River cliff at 0.23715N, 29.97601E – 1 August 2024.**

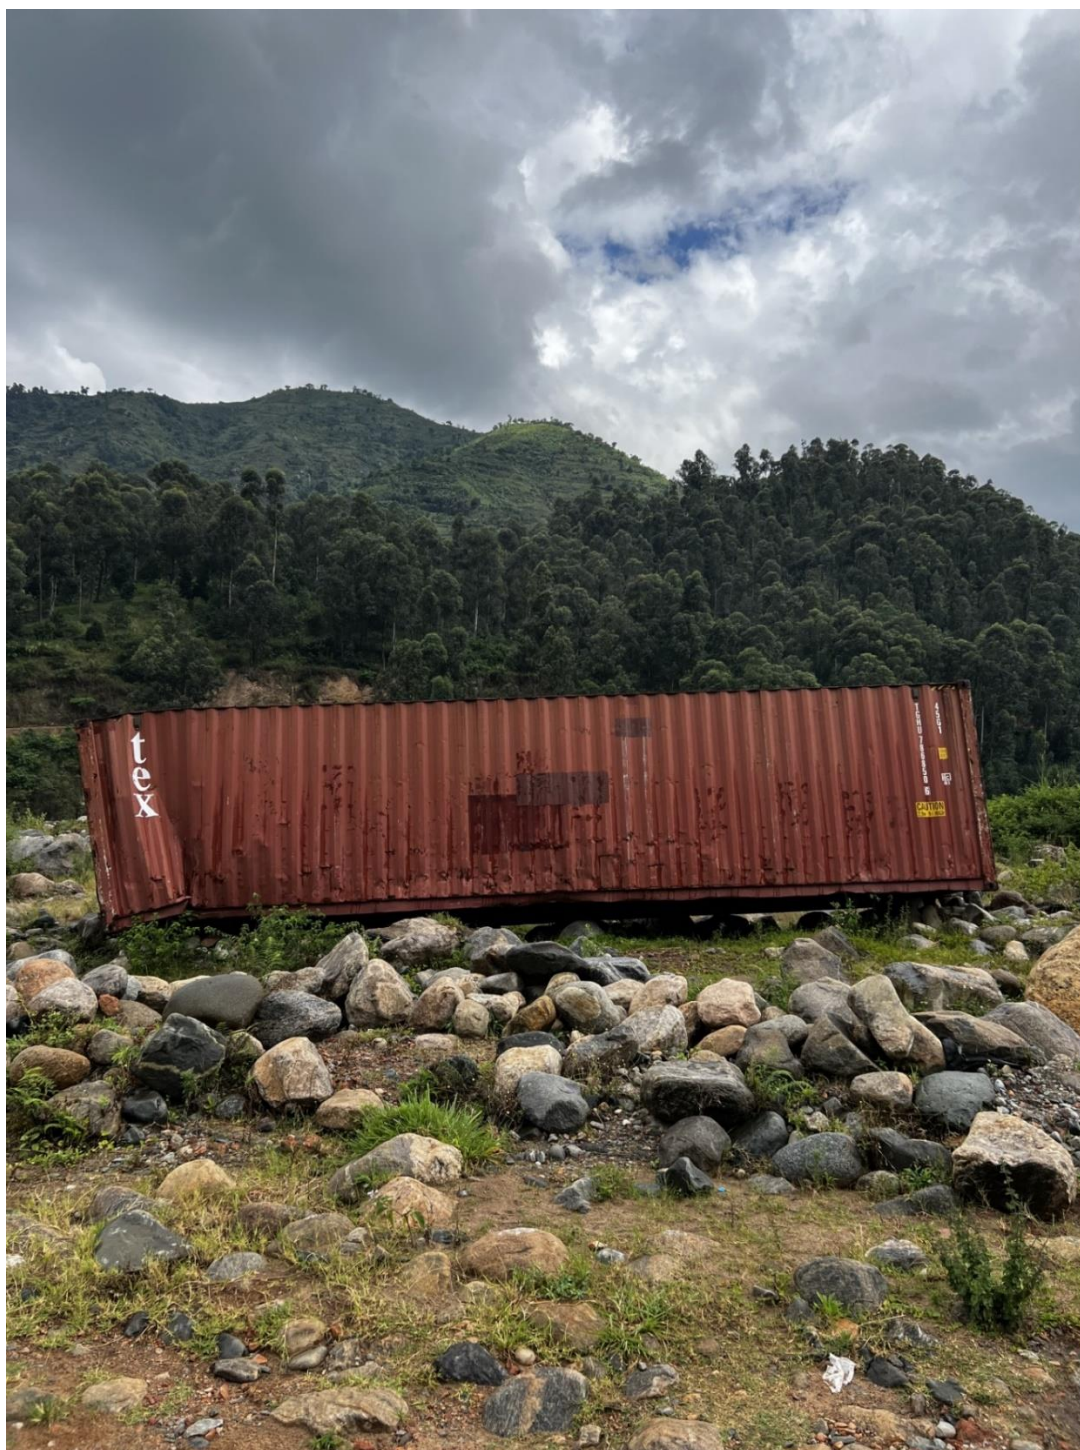
**Figure G1: 0.20285N, 30.00908E - 7 June 2023.**

735 **Appendix G: Flood Plain Boulder Deposition Photographs**

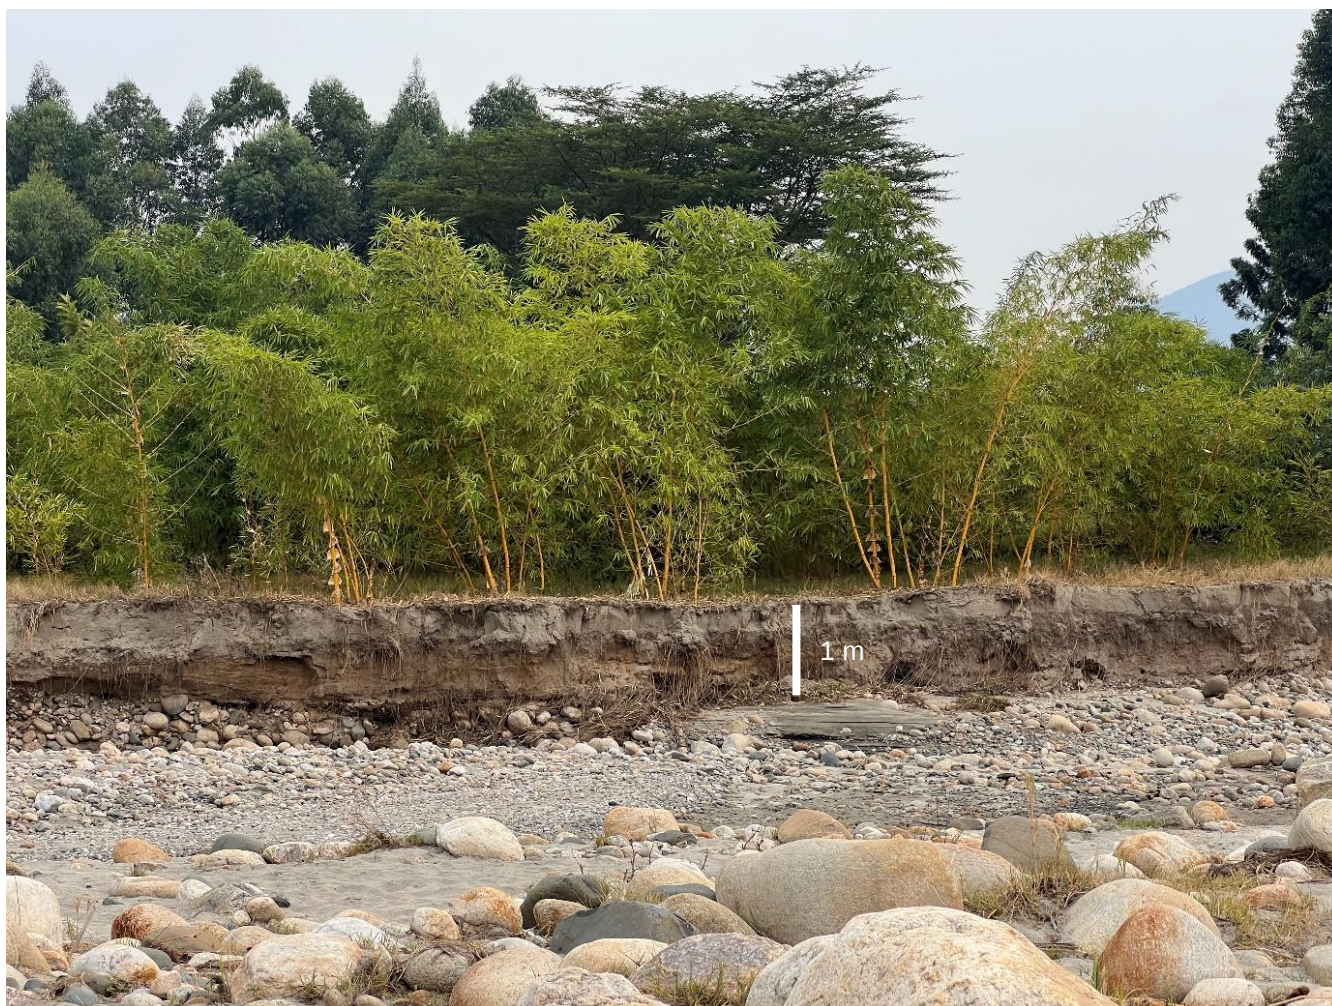
**Figure H1: 0.18981N, 30.07408E, 26 July 2024 (damaged bamboo nature-based solution).**

240 High flows during fluvial and debris floods damage engineered flood defences, increasing their own probabilities of future breaches in self-perpetuating positive feedback (#5; #14; Appendix H). At the same time, their elevated velocities and turbulence generate shear stress and hydraulic action that trigger river erosion (#6; #15). GIS analysis confirms that the years of greatest erosion (2013 and 2020) coincided with the largest flood events [M1; R1] (Sect. 3.4).

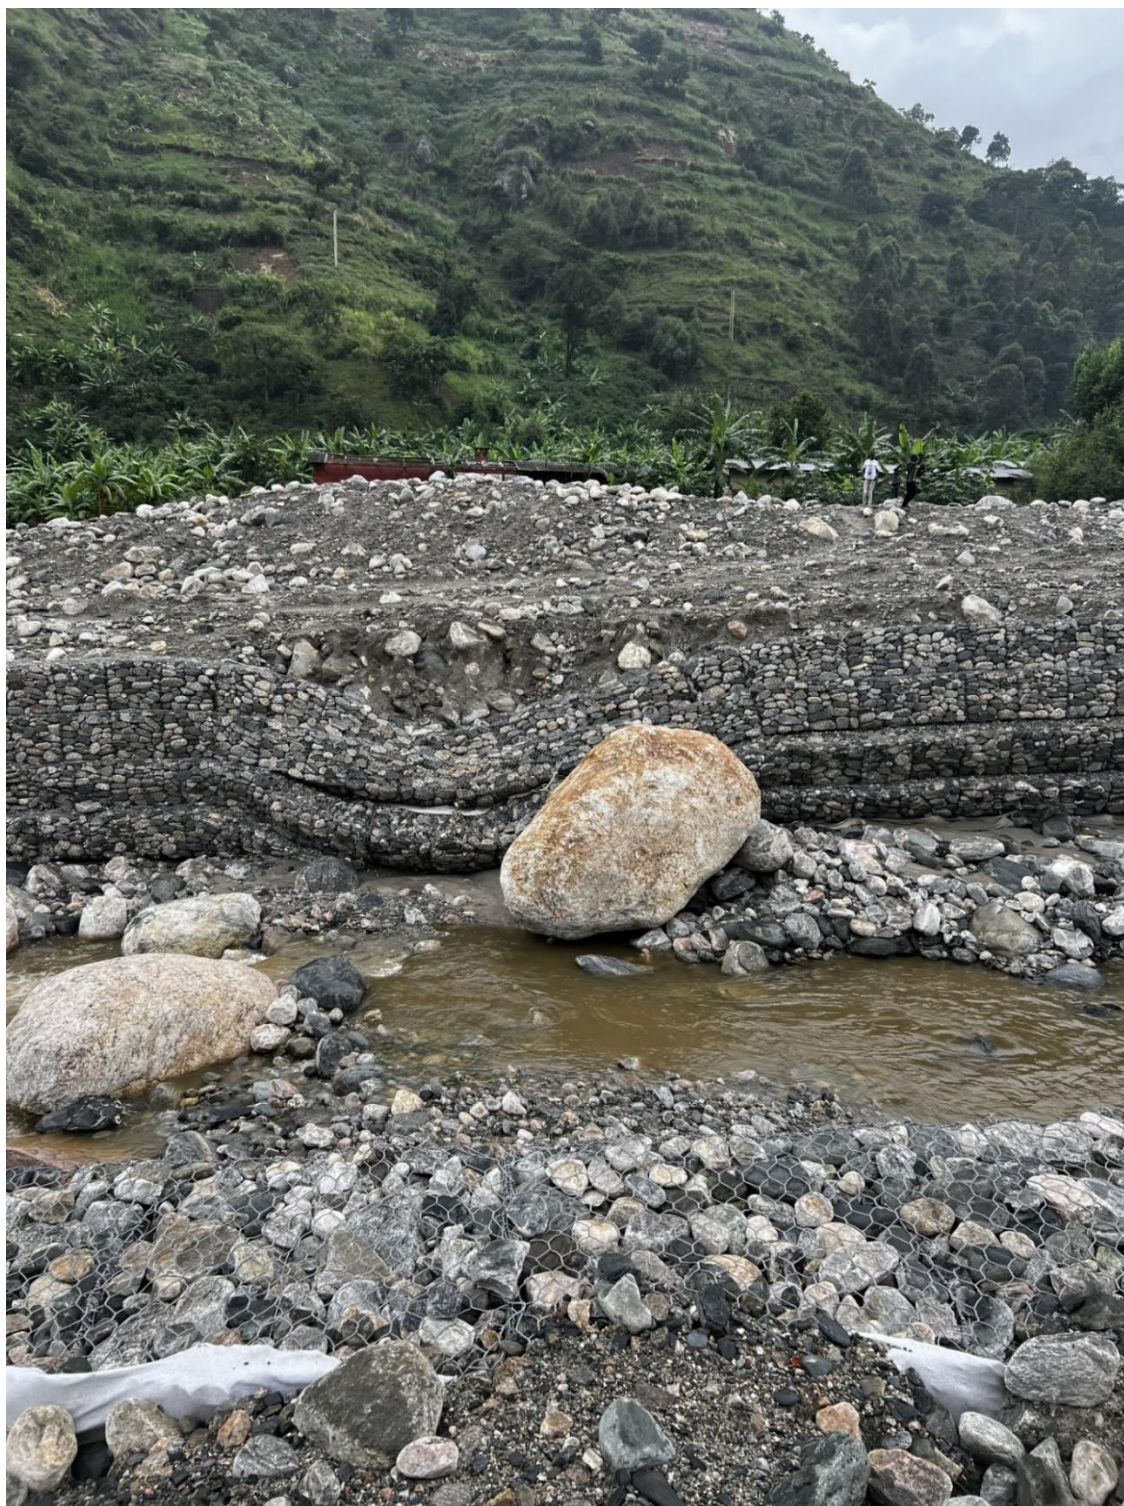
**Figure H2: 0.21387N, 30.00558E, 7 June 2023 (damaged gabions).**

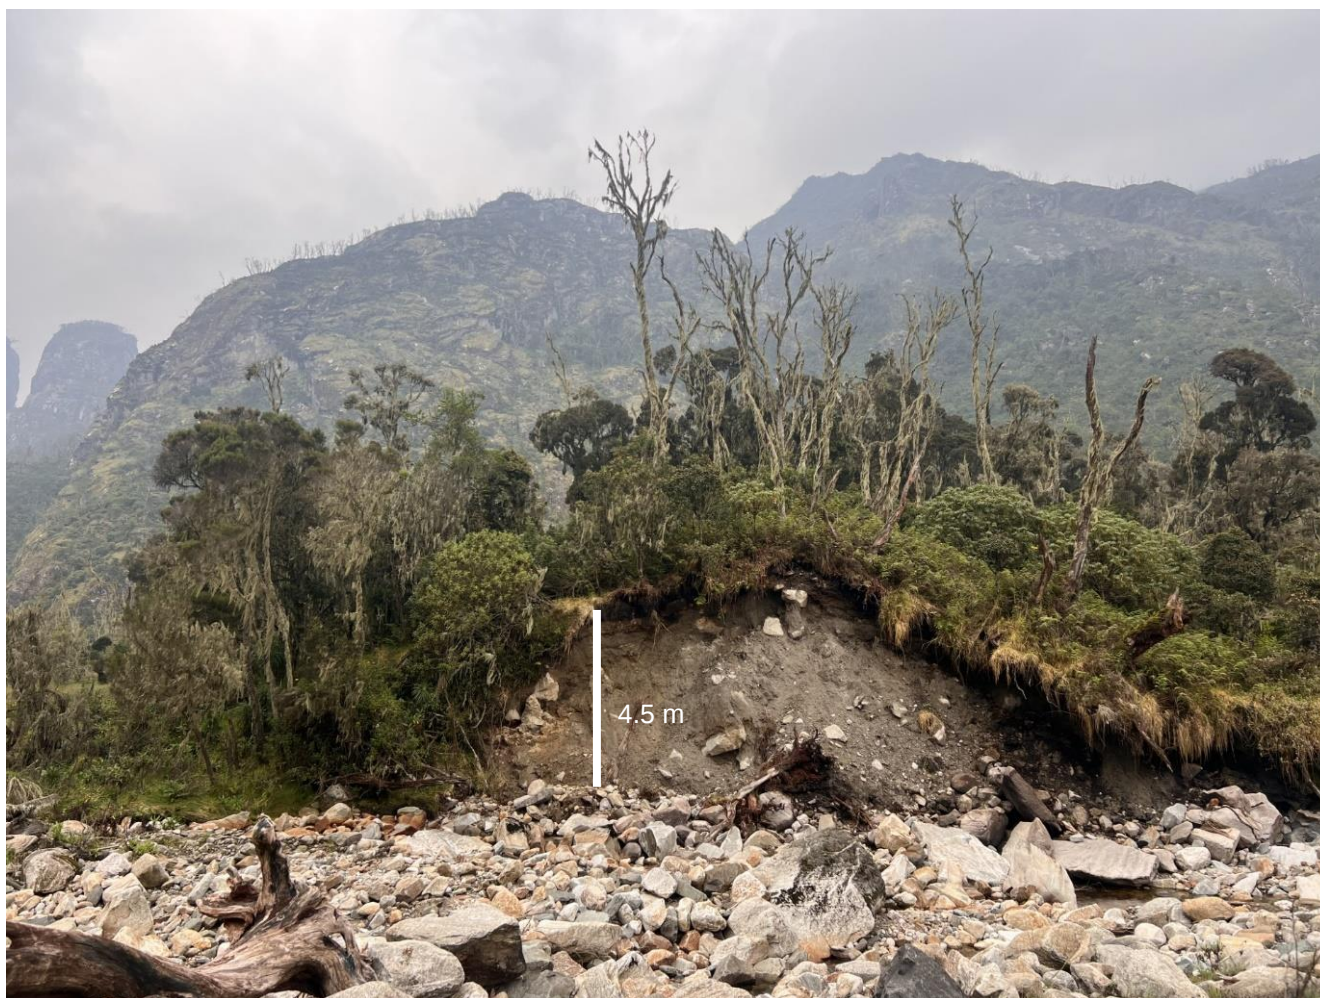
**Figure I1:** 0.29291N, 29.93596E – 28 July 2024.

## Appendix I: Landslide Talus Entering the River Photographs

Landslides caused by lateral river erosion undercutting riverbanks and hillslopes (Jacobs et al., 2016) have accelerated since the wildfire due to higher post-fire discharges and sediment loads [I1; M1; M2; R1]. In addition, the initial destruction and exposure of formerly stable riverbanks during the wildfire and 2013 flood has worked to further increase the probability of mass movement into the river [M1; G2]. Previously, graded banks of unconsolidated quaternary sediment were anchored by climax vegetation. Now, vertical river cliffs are exposed to direct erosion and undercutting at sites throughout the river's long profile. As one local government representative describes, "*when the floodwaters come down, they remove soil and grasses to expose more boulders, and then you will have a landslide*" [G2]. This process is visible in Fig. 3c, where the riverbanks on sections of the burned side are now steep, unvegetated cliffs of exposed and unconsolidated glacial till.

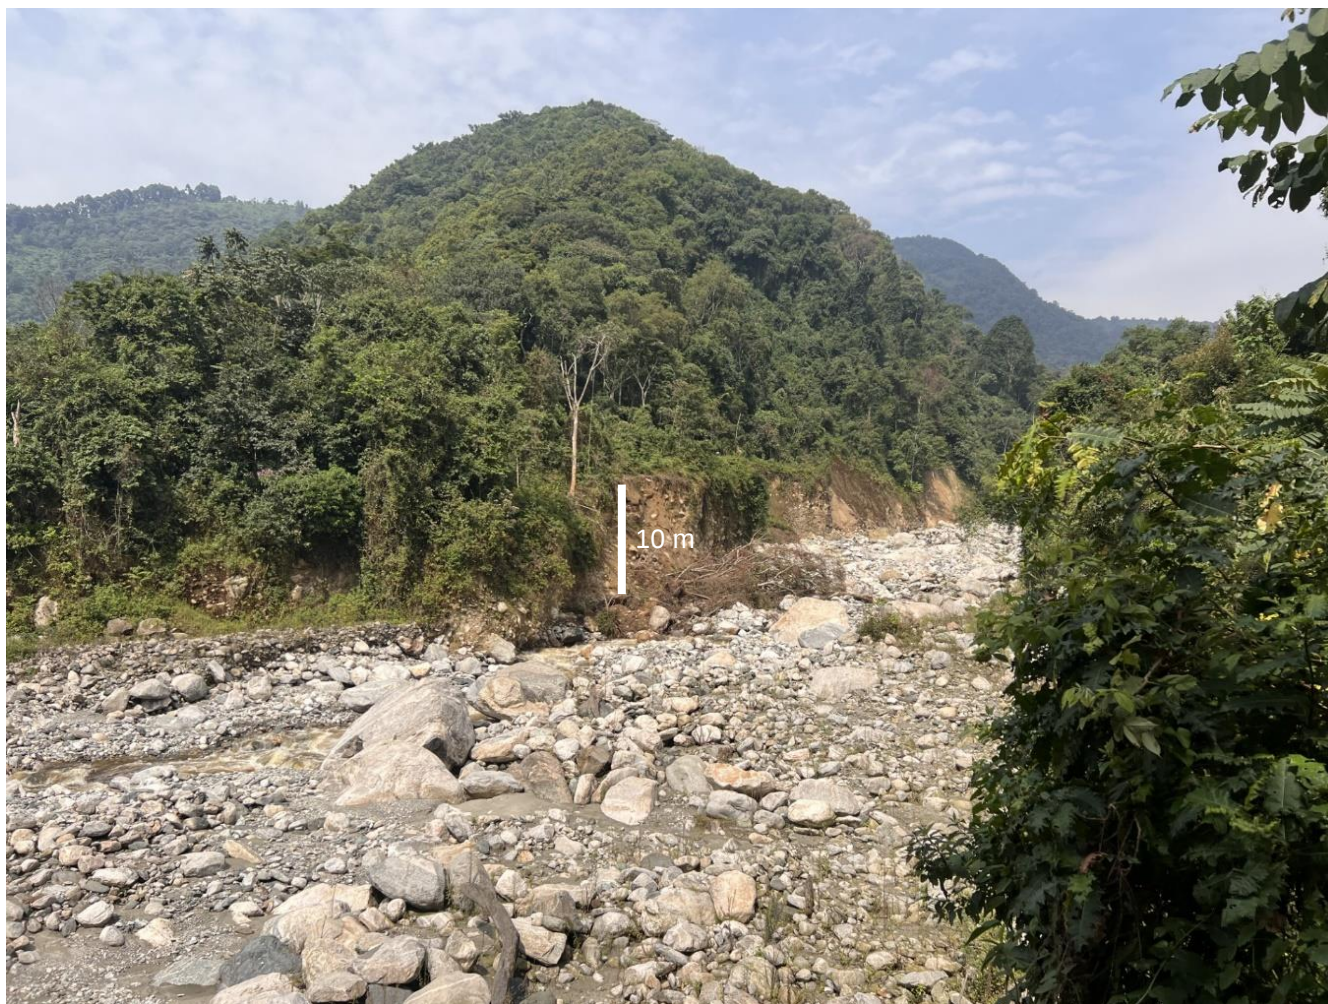
**Figure I2: Landslide scar at 0.23758N, 29.97570E – 1 August 2024.**

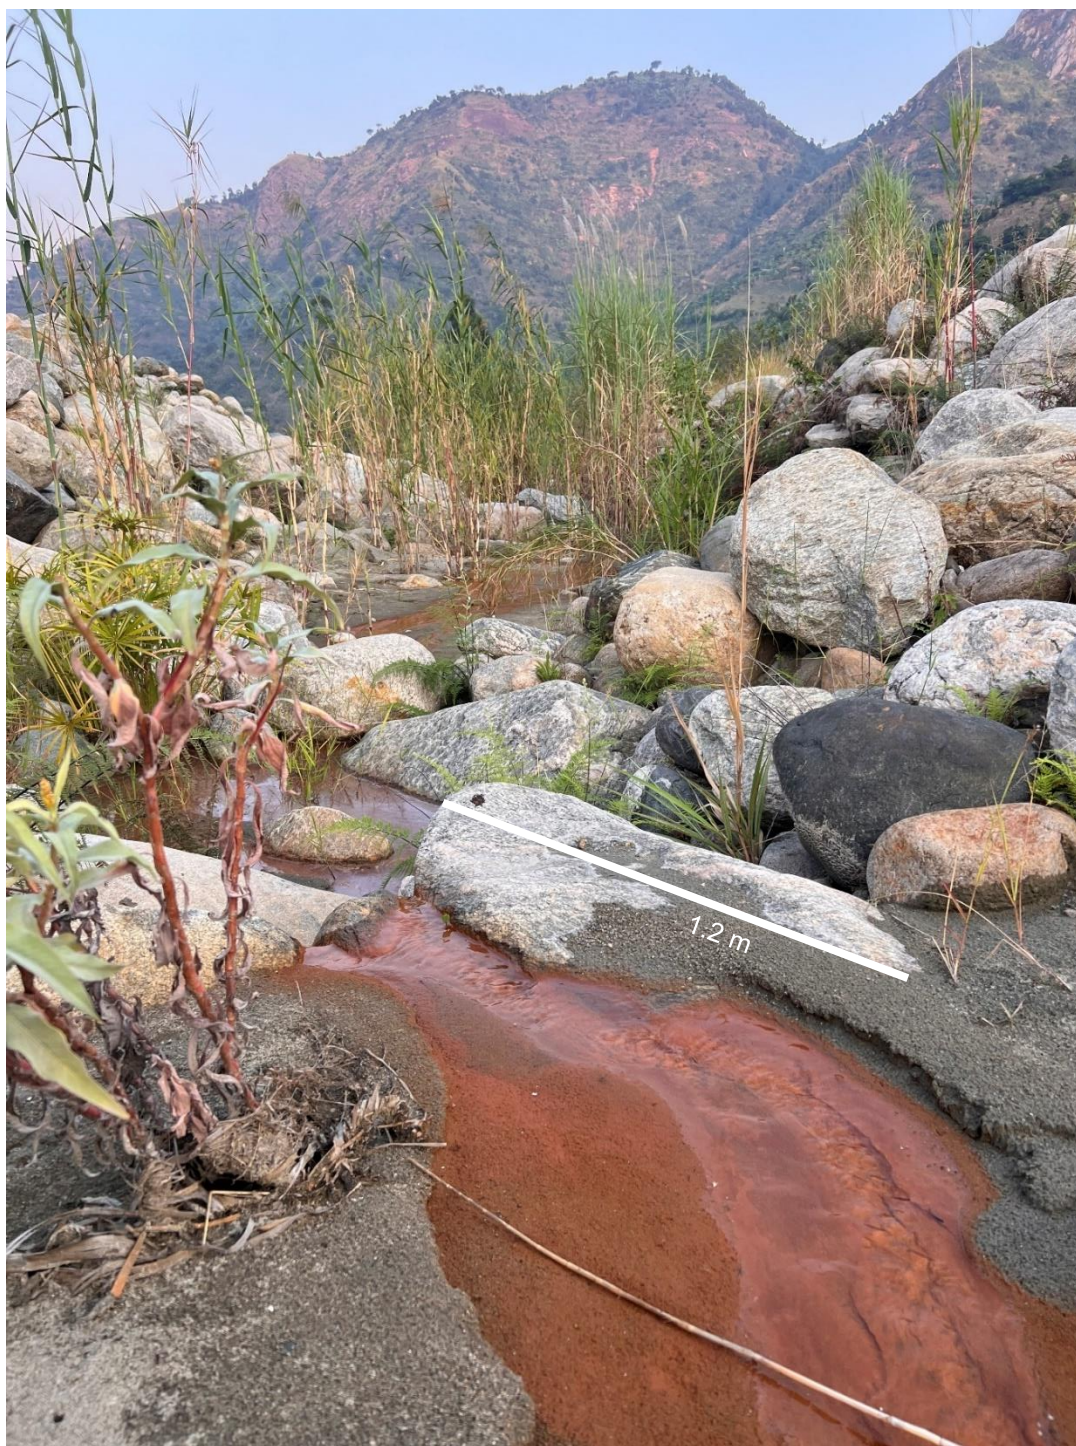
**Figure J1: Deposition and acid mine drainage downstream of Kilembe Mines 0.19385N, 30.082355 E, 26 July 2024.**

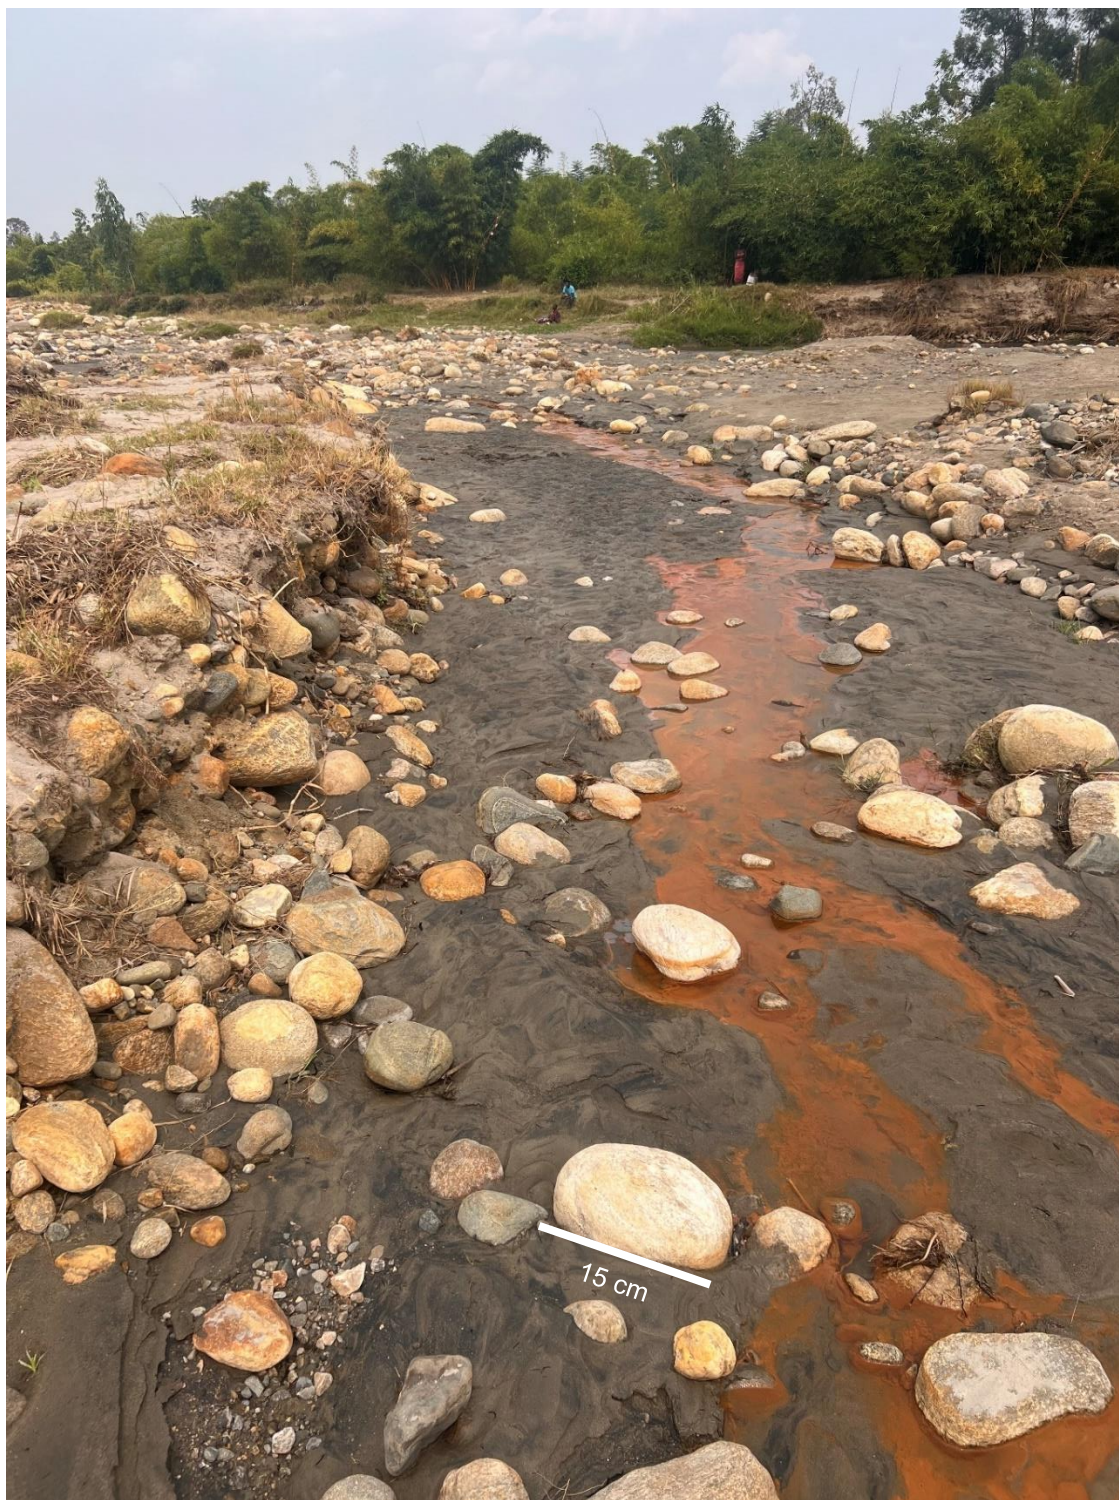
765 **Figure J2: Acid mine drainage from deposited solid tailings at location adjacent to Kasese town, 26 July 2024.**

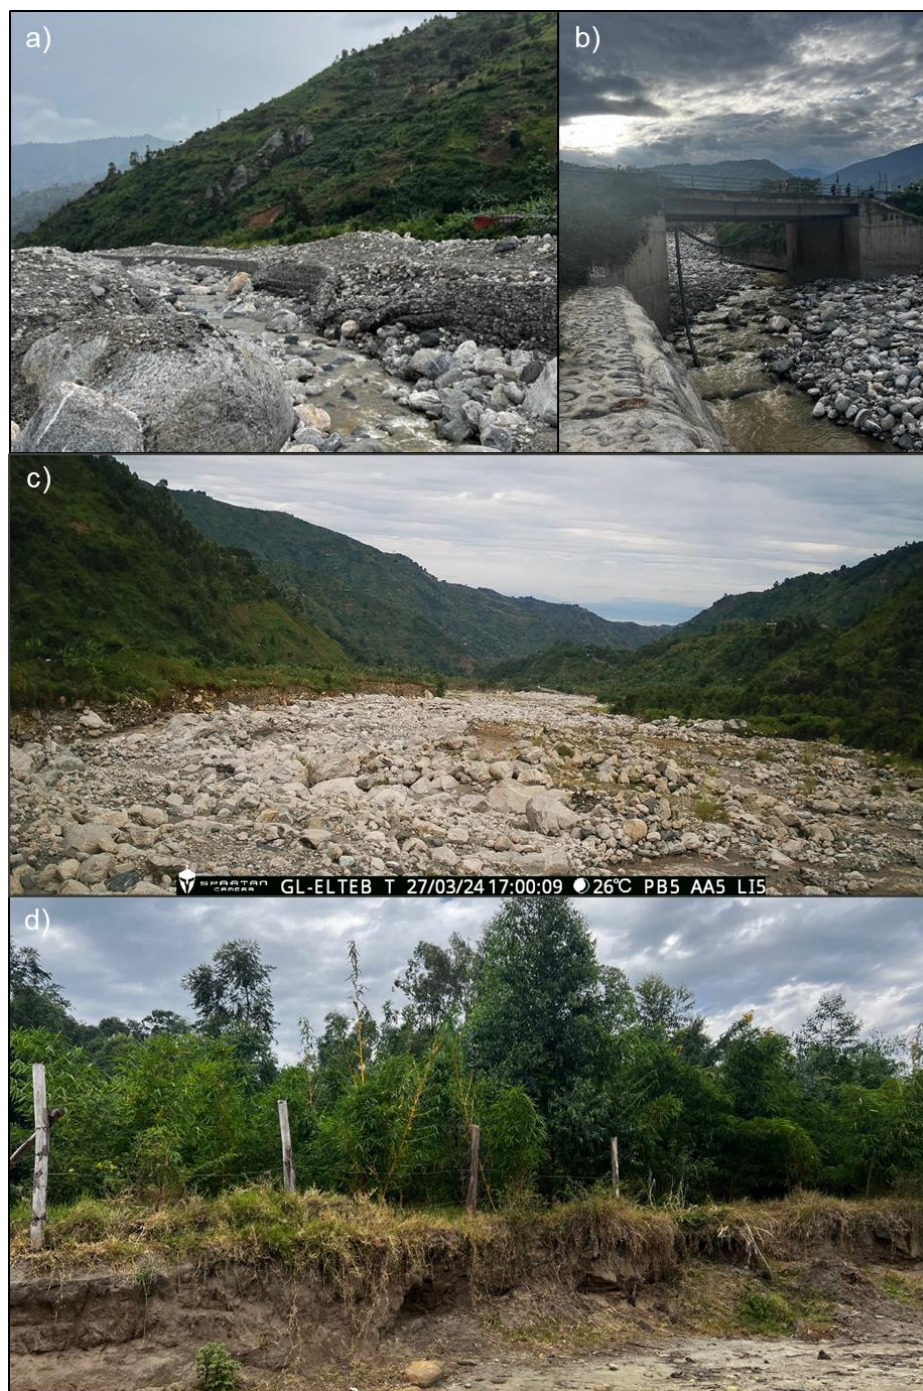
815 **Figure L1 – Photographs taken during June 2023 field reconnaissance: a) collapsed gabions adjacent to Kilembe town (for scale: 8 m channel width); b) channelisation using concrete embankments in Kilembe town centre (10 m channel width under bridge); c) photo from a camera transmitting photos at 1-minute intervals 5 km upstream of Kilembe town centre for flood early warning; d) river bank stabilisation adjacent to Kasese town including asper bamboo (4 m fencepost spacing).**

800 A project funded by the World Bank and implemented by the Ugandan Ministry of Water and Environment (MoWE) in 2021 – 2022 has installed a range of nature-based (NbS) and community-centred solutions (MoWE, 2022). The NbS of river bank stabilisation in Kasese is considered especially promising [R1, R3, W1, M1, M2], using 35,000 asper bamboo seedlings and other economic crops in buffer zones on the mid-catchment river banks to prevent erosion. Despite challenges with drought,  
805 flooding, termites and metal-contaminated soils during the early implementation [W1, M2, G2], a previous project successfully stabilising the Mubuku river banks for 20 years [M1] and observations of stable bamboo forests in the upper catchment [R1] provide optimism for the project. Respondents are more critical of other parts of the project, including soil-water conservation and participatory desilting of the river (Table L1), for focussing on the mid-catchment around Kasese town, when discharge and sediment generation is taking place higher in the mountains [R1, I2].
