### S1.1: Pisco-province informants

Description of the observations reported by interviewees during the 2007 Pisco earthquake

## S2. Annual NDVI and SAVI Temporal Trend

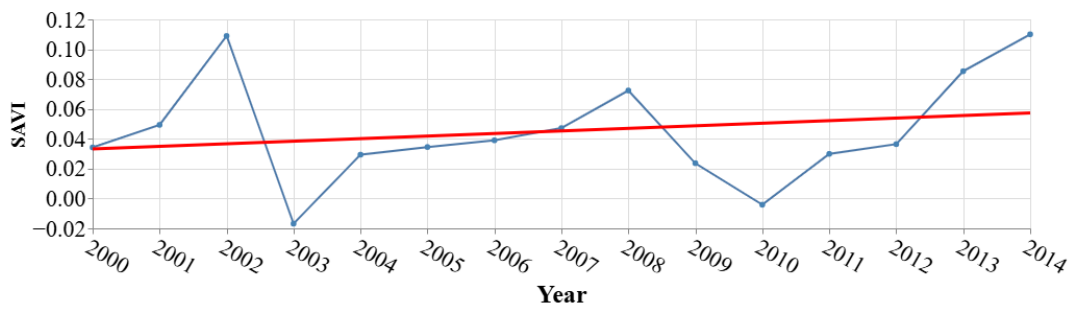
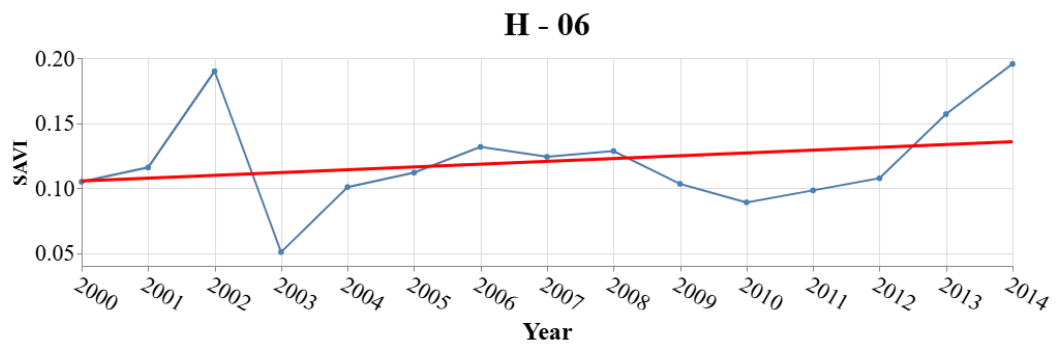
The results of the NDVI calculations and the extraction of time-series data from LandSat satellite imagery are presented through the following line graphs. These figures display the annual mean values derived from all available LandSat scenes between 2000 and 2014. The analysis covers six wetland sectors (H-01 to H-06). The X-axis represents the years 2000–2014 (annual NDVI averages), while the Y-axis shows the corresponding SAVI (Soil-Adjusted Vegetation Index) values. These temporal trends allow the identification of the marked vegetation anomaly observed after the 2007 event, highlighting spatially variable responses influenced by soil liquefaction processes as well as local anthropogenic disturbances.
