1 **Diagnostic and Recovery Method for Boot Failure in  
2 PC/104Based Geophysical Resistivity Instruments Following  
3 CMOS Configuration Loss: On the ABEM Terrameter SAS-  
4 1000/4000 Using the PFM-540I Platform**

5  
6 **Gideon Fosu Dwamena<sup>1</sup>, Benjamin Ekow Mensah<sup>2</sup>**

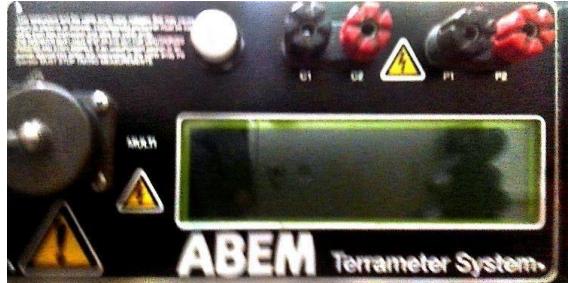
Figure 1: The SAS 1000 Terrometer with Dark screen

42 Following replacement of the CMOS battery, the Terrameter SAS-1000/4000 failed to initialize. Although the  
43 device powered on and the LCD contrast circuit behaved normally, the display remained black an expected result when  
44 the firmware cannot load, as documented in embedded measurement platforms where LCD controllers depend on  
45 system software rather than BIOS routines.

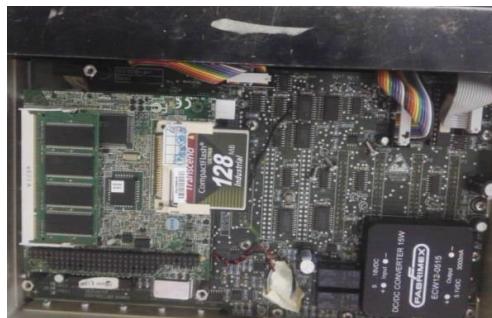
Figure 2: The Module-PFM-540I in the SAS 1000 Terrometer

55 The diagnostic procedure followed established embedded system recovery methods emphasizing hardware  
56 inspection, CMOS clearing, external interfacing and BIOS reconstruction. The PFM-540I board was removed from  
57 the Terrameter enclosure to expose its PC/104 headers. Custom VGA and PS-2 adapters were fabricated to interface  
58 with its non-standard pinouts, enabling access to BIOS configuration an approach consistent with repair procedures  
59 for sealed industrial instruments.

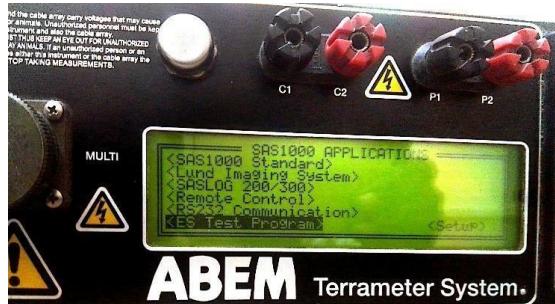
101 **Figure 6: The Resistivity meter with functioning LCD display after the restoration**

91 Prior to recovery, the BIOS consistently failed to detect the CompactFlash disk, matching known symptoms of  
92 CMOS related IDE timing failure in embedded systems. After jumper validation, CMOS clearing and BIOS  
93 reconstruction, CF detection succeeded on every attempt. The boot success rate increased from zero to full restoration,  
94 and the Terrameter firmware initialized properly each time.

95 Fifteen cold-boot cycles conducted across multiple days showed complete retention of BIOS settings, confirming  
96 battery integrity and stable CMOS behaviour. Similar multi-cycle validation is widely used to evaluate BIOS  
97 persistence in industrial x86 hardware. The Terrameter LCD previously black displayed its normal main menu  
98 immediately upon firmware initialization.

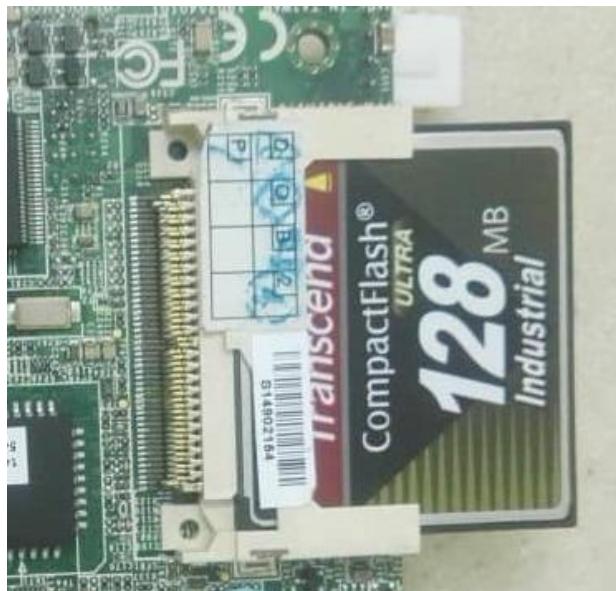
122 Figure A1: Close-up view of the PFM-540I PC/104-plus platform interface showcasing the industrial-grade Transcend  
123 128 MB CompactFlash (CF) card used for system boot and data storage.

124 The image illustrates the integration of the **Transcend Industrial 128 MB CompactFlash card** into the onboard CF  
125 socket of the **PFM-540I platform**. In the context of the ABEM Terrameter SAS-1000/4000, this storage medium acts  
126 as the primary IDE-compatible drive. During a CMOS configuration loss, the BIOS often reverts to default settings  
127 that may fail to recognize the specific geometry or boot priority of this CF card, leading to the boot failures analyzed  
128 in this study. This figure highlights the hardware dependency of the diagnostic recovery method, emphasizing the  
129 importance of the physical connection between the industrial flash memory and the embedded PC/104 architecture.  
130 The sticker on the CF socket indicates quality control/date tracking, which is essential for identifying the hardware  
131 revision of the geophysical instrument.
