# The 2022 Rainfall-Triggered Landslide-Tsunami Disaster in Pilar, Abuyog, Leyte, Philippines and its implications for coastal hazard assessment

10 <sup>1</sup>UP Resilience Institute and NOAH Center, University of the Philippines, Diliman, Quezon City, 1101, Philippines

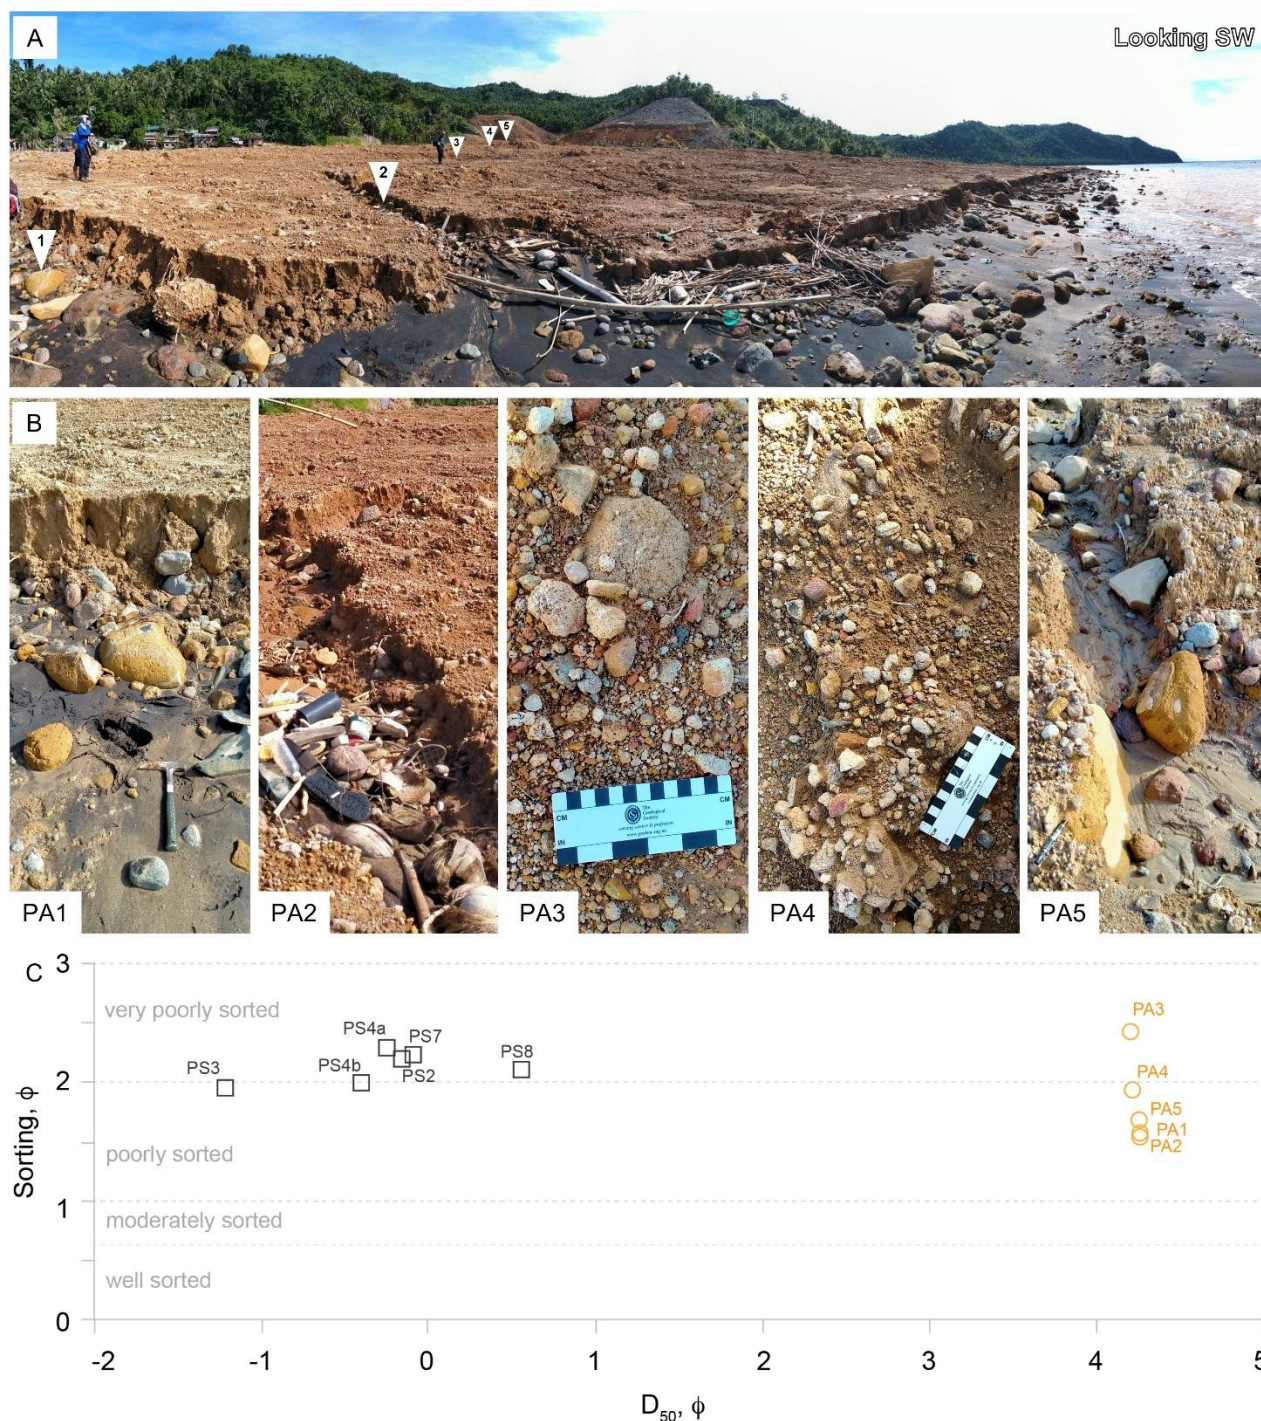
**Figure 8: Auger Sampling Stations (A1 to A5). A) Panoramic shot at the July 19, 2022 coast of Pilar; inverted triangles marking the Auger Sampling points. B) Surface of DF2 sample sites. C) Sediment Analysis of DF1 (gray squares) and DF2 (brown circles) samples.**

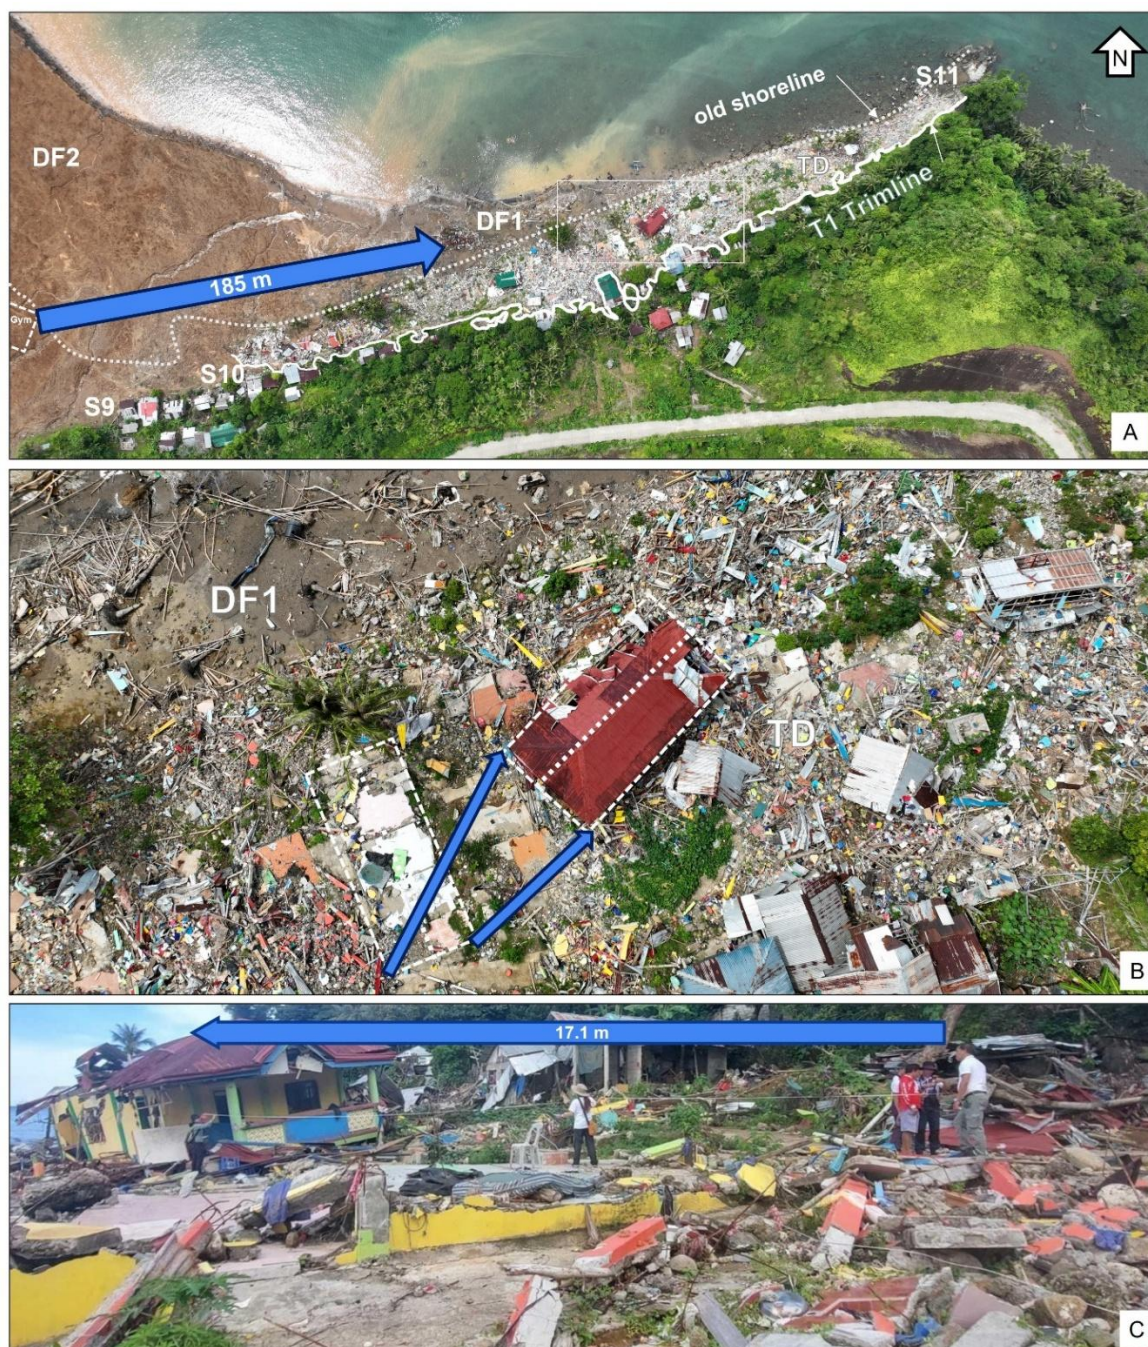
Videos of T2 (Fig. 7D, E, I and J) showed its wave spreading from the splash zone towards the coast. The near-field wave appeared white and had a rolling motion. Calculating based on the distance of the DF2 front to Punta (425m) and the 37 seconds that it took the wave to travel this distance, we estimate the near-field wave of T2 to have a velocity of 11.48 m/s. T2 was not reported to have reached Barangay Malaguicay.
