The 2022 Rainfall-Triggered Landslide-Tsunami Disaster in Pilar, Abuyog, Leyte, Philippines and its implications for coastal hazard assessment

³Mindanao State University at Naawan, Naawan, Misamis Oriental, 9023, Philippine (current affiliation)

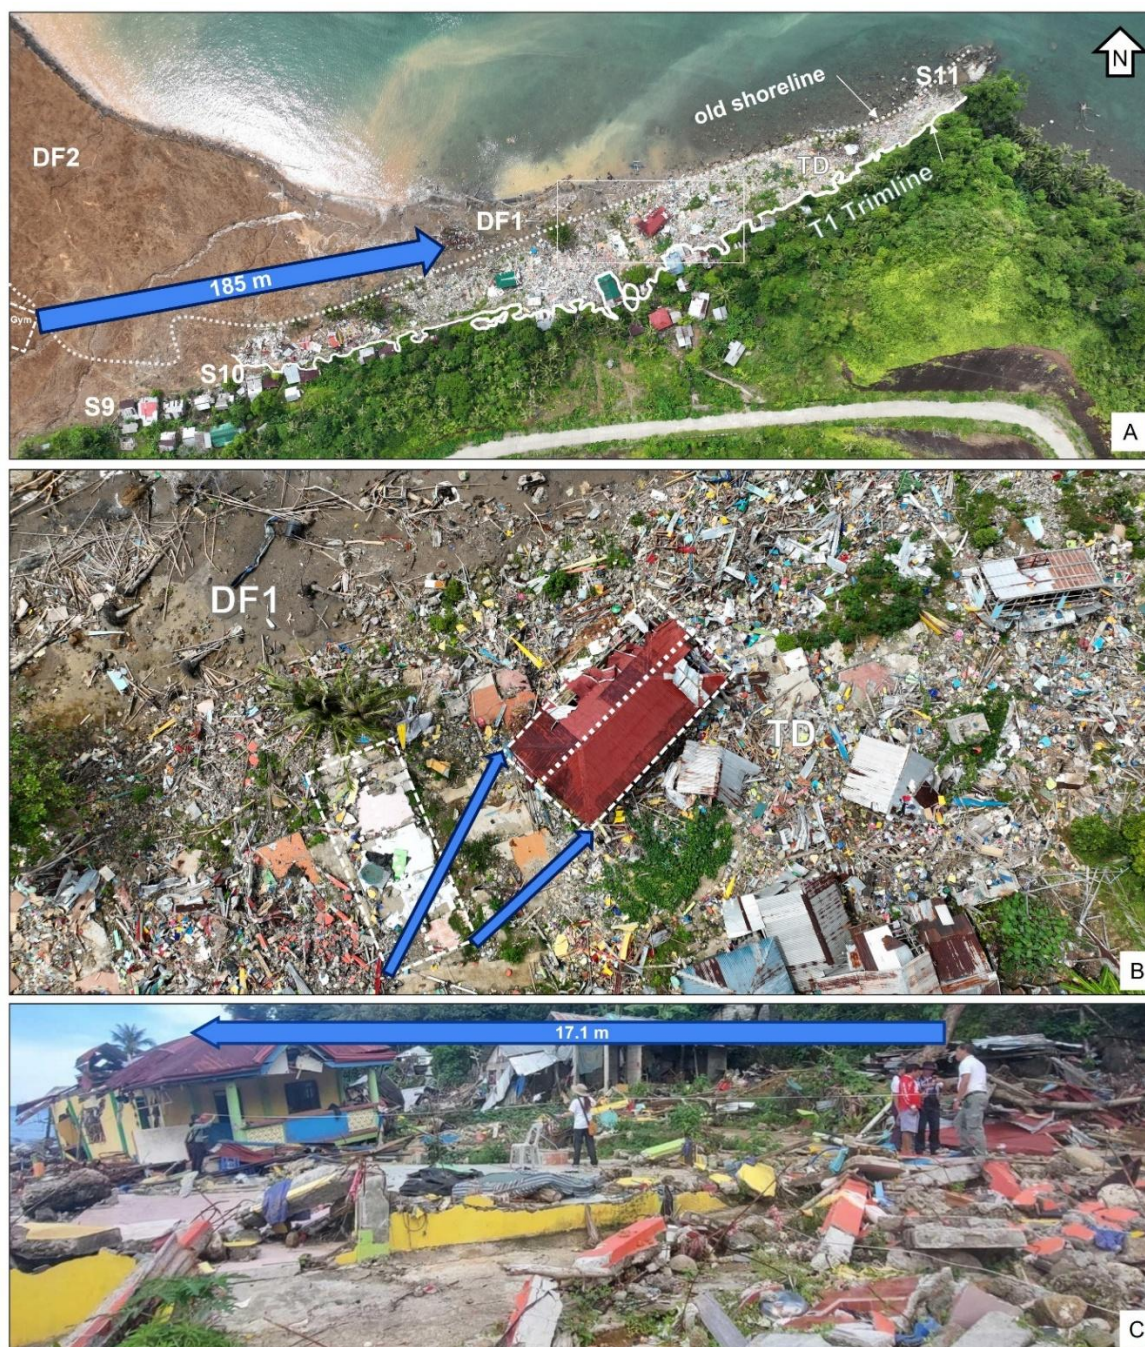
440 **Figure 10: Landslide-Tsunami impact in Pilar. A) Extent of the tsunami impact zone. The white rectangle marks the extent of the next photo. Blue arrow shows the displacement of the Barangay gym. B) UAV photo of the tsunami debris (TD) field. The dashed white rectangles outline the red-roofed house and its foundation. Blue arrow indicate the displacement direction of its southern corners. C) Destruction and displacement of structures caused by the tsunami (T1) as seen from the ground.**
