## Response to Reviewer 1

This study conducts systematic post-event field surveys and hydrodynamic numerical simulations for the storm surge disaster induced by Typhoon Hato in Guangdong Province. This work produces valuable ground truth data and model validation references for estuarine storm surge research. However, several aspects of the article require improvement.

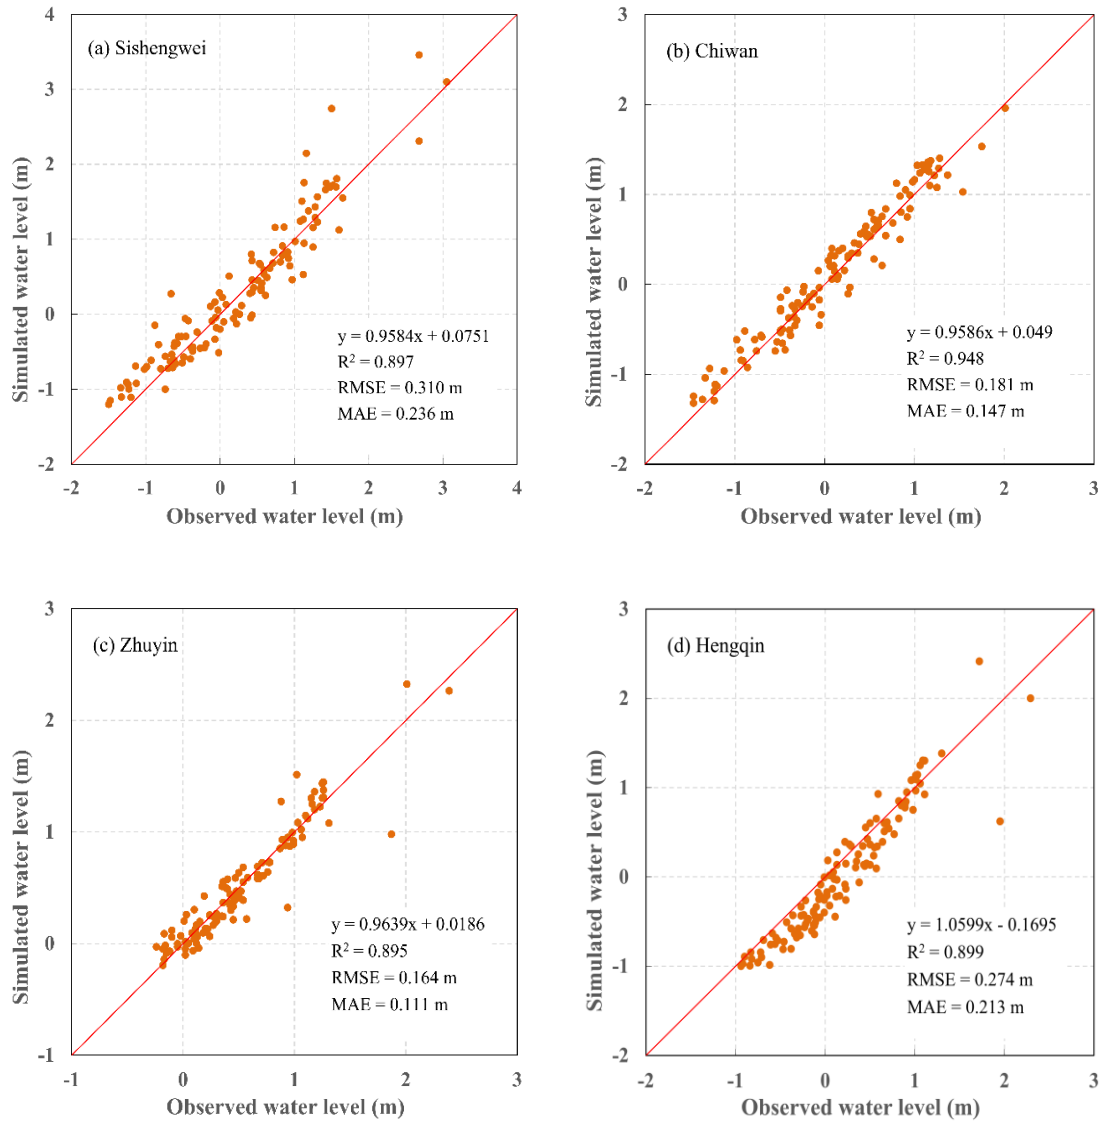
To quantitatively evaluate the performance of the hydrodynamic model in reproducing the temporal evolution of water levels during Typhoon Hato, simulated water levels were compared with hourly observations at four tidal stations (Figure 5). Overall, the simulated and observed water levels showed a strong linear correspondence

across all stations, with coefficients of determination ( $R^2$ ) ranging from 0.895 to 0.948. The relatively high  $R^2$  values indicate that the model successfully captured the temporal variability of water levels during the event, including the overall rising and falling patterns associated with tidal fluctuations and storm induced water level changes. The magnitude of the errors was generally moderate, with RMSE values ranging from 0.164 to 0.310 m and MAE values ranging from 0.111 to 0.236 m. The best agreement was obtained at Zhuyin, where the model achieved an  $R^2$  of 0.895, an RMSE of 0.164 m, and an MAE of 0.111 m, while Chiwan showed the highest  $R^2$  (0.948) and relatively low errors (RMSE = 0.181 m; MAE = 0.147 m). Sishengwei exhibited the largest deviations, with an RMSE of 0.310 m and an MAE of 0.236 m, suggesting greater uncertainty in reproducing the local water-level response. At Hengqin, the regression slope was slightly greater than unity (1.060), indicating a modest amplification of the simulated water-level variability relative to the observations, whereas the slopes at the other three stations were slightly below unity (0.958–0.964), suggesting a generally consistent but slightly compressed response amplitude. The close correspondence between simulated and observed water levels across the four stations demonstrates that the model reasonably reproduces the hydrodynamic response to Typhoon Hato and provides a reliable basis for subsequent assessment of inundation extent and depth. The model performance was therefore further evaluated by comparing the simulated inundation extent and depth with field observations. (Line 251-267 in the revised manuscript)

Figure 5. Comparison between the simulated and observed water levels during Typhoon Hato from 0:00 on August 20 to 0:00 on August 25.

Thank you for your valuable comment. To provide quantitative evidence for model validation, we have added a systematic comparison between the simulated and observed hourly water levels at four tidal stations. The model performance was quantitatively evaluated using the coefficient of determination ( $R^2$ ), root mean square error (RMSE), and mean absolute error (MAE). The results show strong agreement between the simulated and observed water levels, with  $R^2$  values ranging from 0.895 to 0.948, RMSE values from 0.164 to 0.310 m, and MAE values from 0.111 to 0.236 m. In addition, we have revised the structure and corresponding subsection titles of the Results section. A new subsection “3.4 Model Validation” has been introduced to integrate the water-level validation with the subsequent comparisons of inundation extent and inundation depth. Details of water-level validation are as follows:

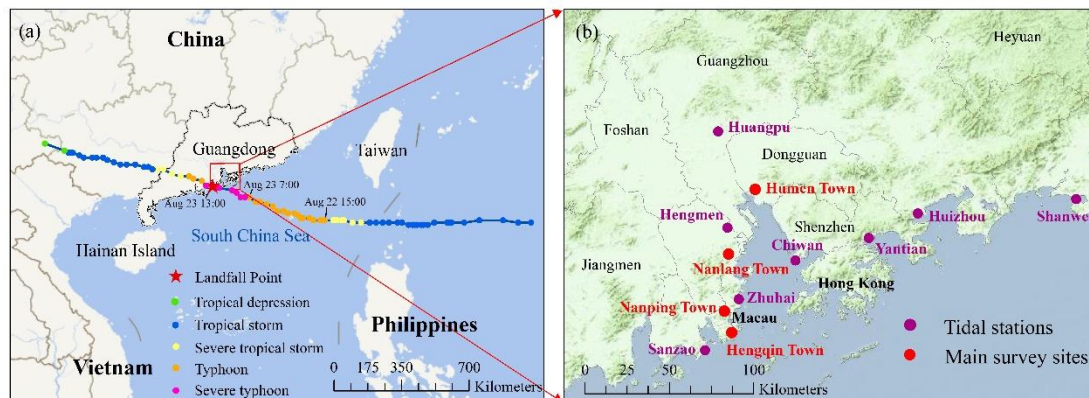
**Figure 1.** (a)Track and intensity variation of Typhoon Hato. (b) The spatial distribution of tidal stations (purple circles) and main field survey sites (red circles).

Thank you for your valuable comment. We have added the geographic locations of observation sites mentioned in Table 3 onto the study area map (Figure 1). The revised figure is as follows:
