# Seismic risk assessment of schools in Nepal for effective disaster risk reduction practices

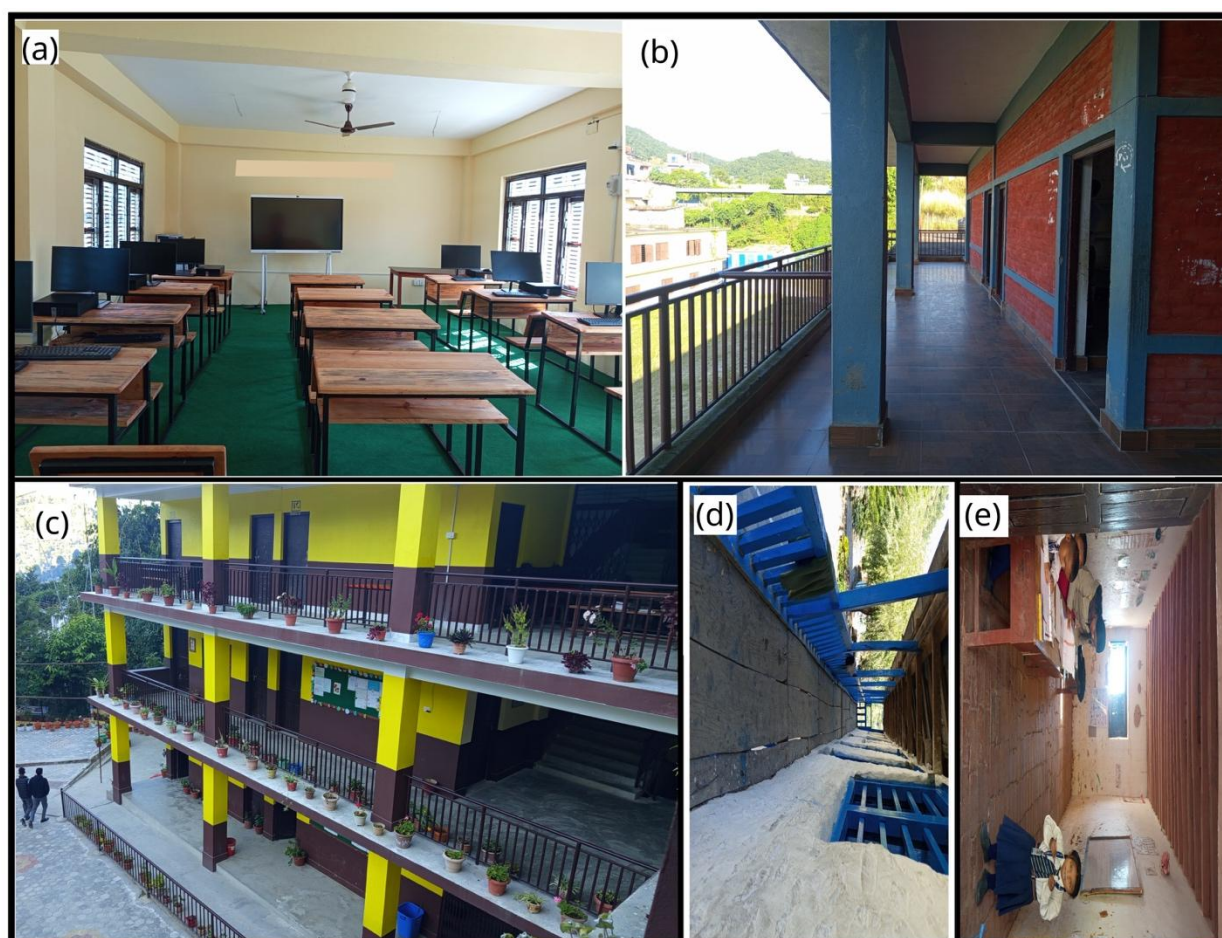
Some examples of good and bad practices are shown in Figure 5.

250 **Figure 5: Examples of good and bad practices observed during the risk assessments. (a): A smart classroom demonstrating good practice of space management and furniture quality. (b): Pillars provide additional support to the railing, representing a positive safety measure. (c): Unanchored flower vases placed on each floor, illustrating a non-structural hazard. (d): A narrow corridor constructed using mud, stone, and wood may impede safe evacuation. (e): A traditional classroom building illustrating a vulnerable construction type.**

In most of the schools, the absence of clearly marked evacuation routes were observed and a lack of designated open spaces for emergency assembly. Several evacuation paths were obstructed by various items, and in some cases, the routes themselves posed safety risks. Inside classrooms, unsecured furniture and objects increased the potential for injuries during shaking, and in principals' offices, unanchored items such as medals and display materials were found to be potential falling hazards. For each room assessed, practical and achievable measures were proposed to help mitigate these risks.

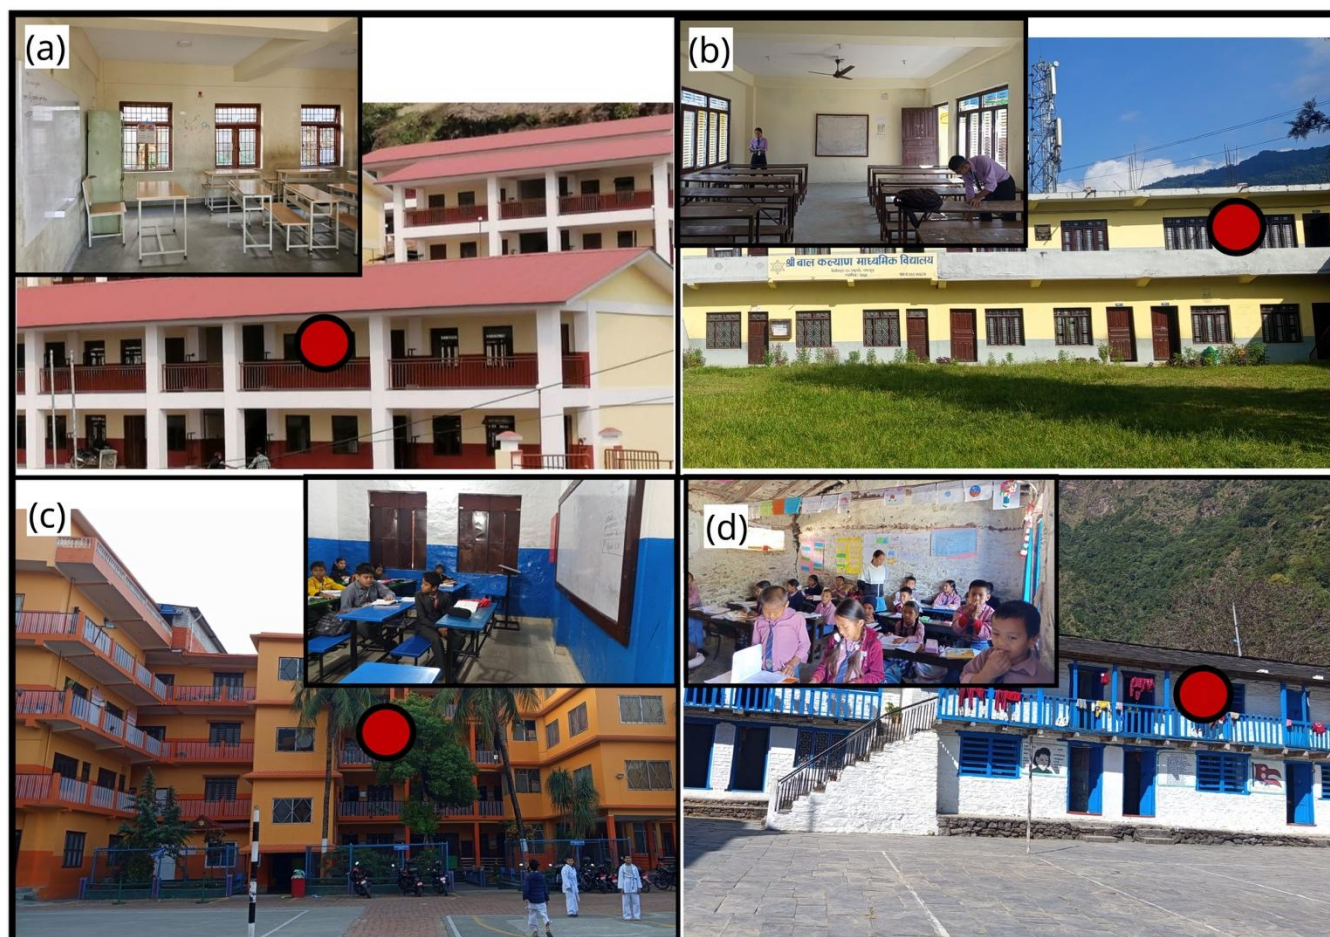
**Figure 7: Example of school buildings and classrooms associated with different risk levels. (a): low risk levels with earthquake-resistant buildings. (b): medium risk level with the RCC building, (c): high risk levels with the RCC building, (d): very highrisk levels with the traditional stone and mud building. The black-contoured red circle represents the location of the inset classroom images for each school building.**

Overall, earthquake-resistant buildings demonstrate the lowest proportion of high-risk rooms (~12%) and the highest proportion of low-risk rooms (~49%), indicating better preparedness against seismic hazards. In contrast, RCC buildings exhibit a considerable proportion of medium- and high-risk rooms (~68% combined), while brick masonry buildings are the most vulnerable, with all assessed rooms classified as high risk. Some images depicting the different structural types and risk levels among all the visited schools and their representative classrooms are shown in Figure 7.
