Study on the Biological Communities and Bioweathering of the Marble Surfaces of the Hall of Prayer for Good Harvests at the Temple of Heaven (Beijing, China)

Youping Tian *

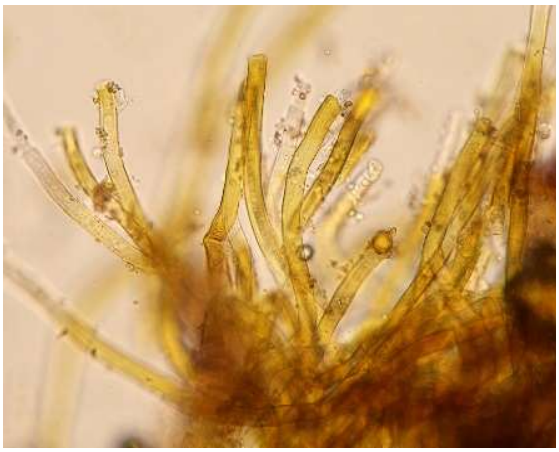
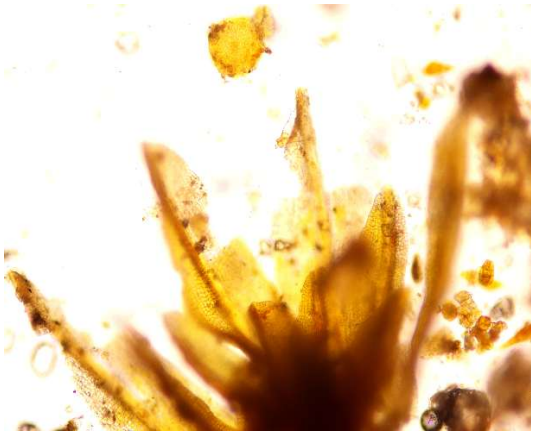
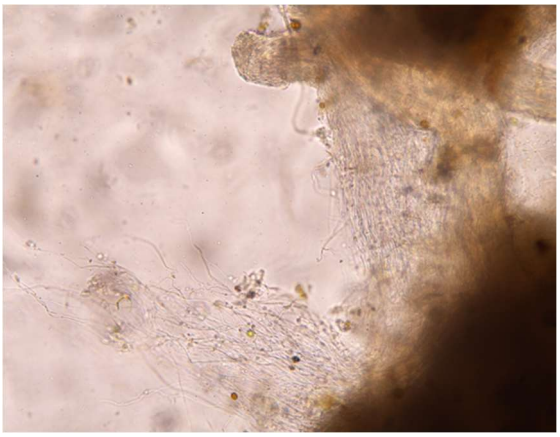
Fig. 9. Micrographs of biomes and some species on the west-facing marble surface of the altar of Prayer for Good Harvest in the Temple of Heaven, Beijing, China.

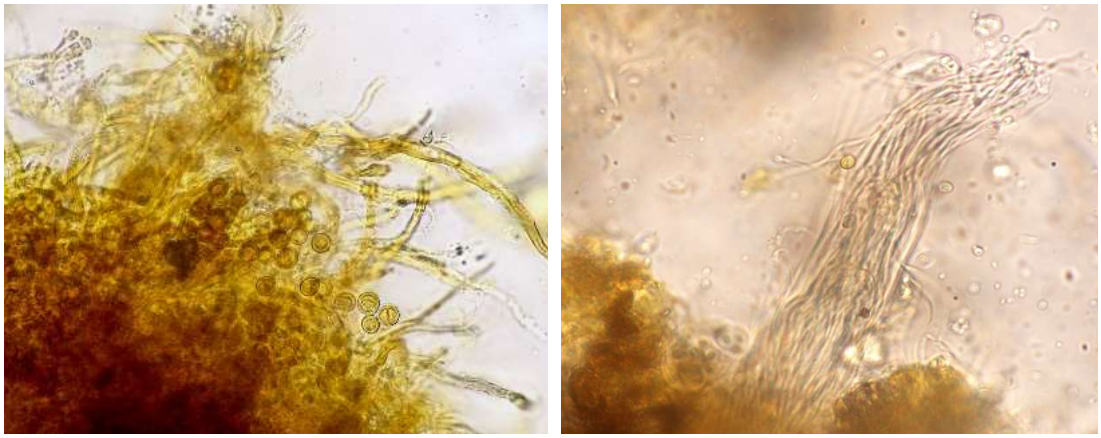
Fig. 11. Micrograph of biological communities and some species on the north facing marble surface of the altar of Prayer for Good Harvest in the Temple of Heaven, Beijing, China.

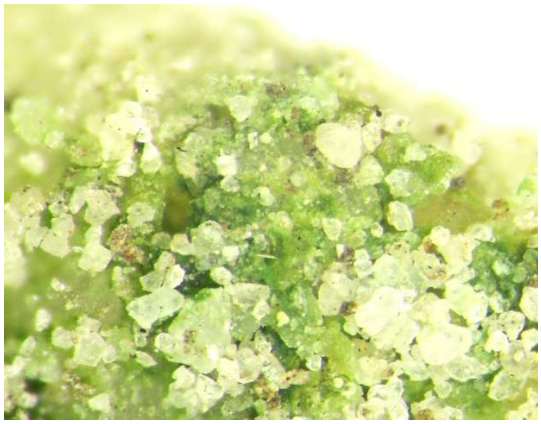
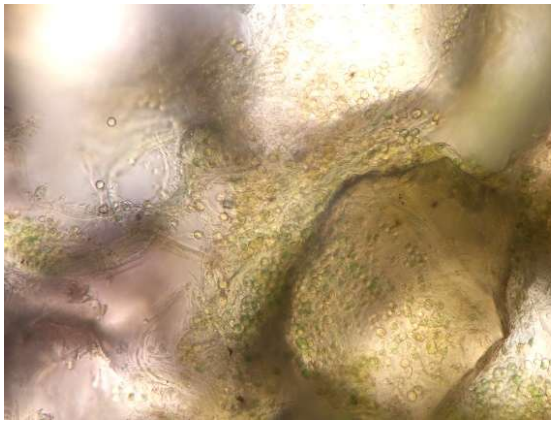
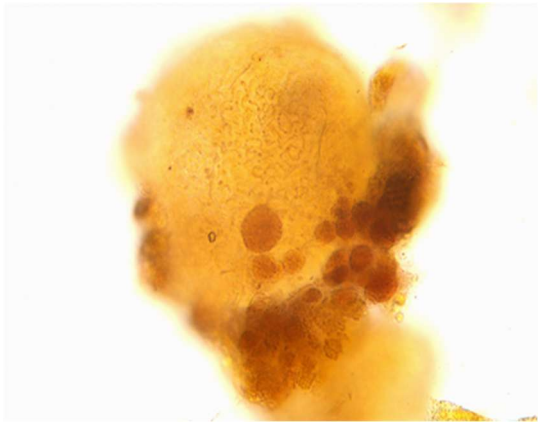
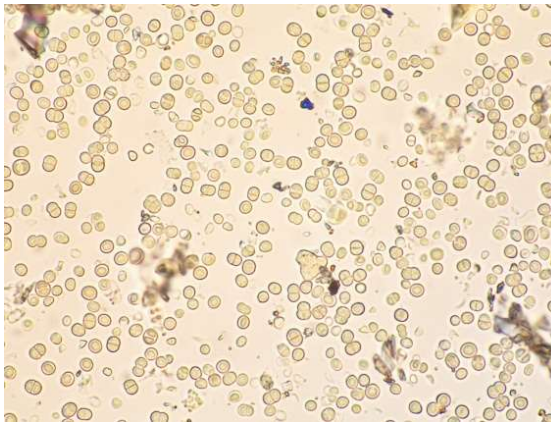
Fig. 14. Micrograph of biomes and some species on the south facing marble surface of the altar of Prayer for Good Harvest in the Temple of Heaven, Beijing, China.

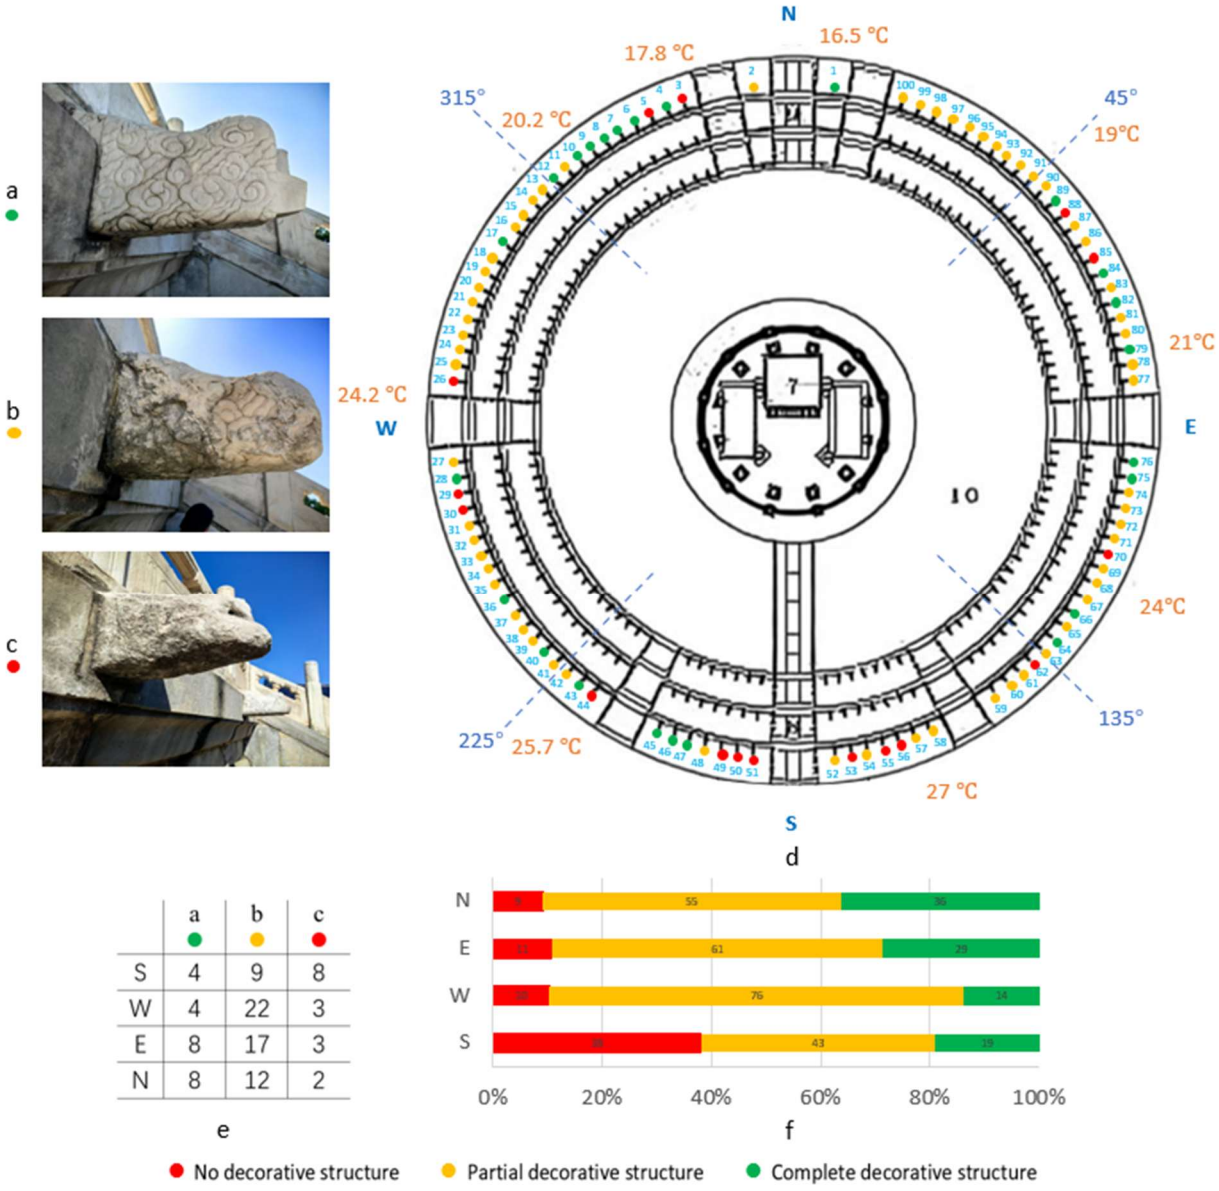
in relatively weaker weathering. The south-facing surface receives more sunlight and weathers faster, with the carved decorations on the rock surface completely destroyed (Fig. 13a). The matrix is highly loose, and even large filamentous cyanobacteria like *Nostoc*, which typically prefer to live in soil rather than on rock surfaces, are present. This indicates that the south-facing marble has weathered severely, forming a loose, soil-like thick weathering layer. Additionally, *Scytonema* sp.1, a species that thrives in sunny and dry environments and plays a significant role in bioweathering, is also present. Mosses are not found on the south-facing side because they prefer shady and moist environments. The orientation of the building, through differences in sunlight duration and evaporation rates, creates a unique gradient of microhabitats, which in turn drives the differential distribution of microbial communities and is accompanied by varying degrees of weathering depending on the direction.

Fig. 16 Rock surface temperatures and weathering conditions of the Cloud Chi Heads on the third layer of the Hall of Prayer for Good Harvests at the Temple of Heaven in Beijing, China, on a sunny afternoon in April.
