# Study on the Biological Communities and Bioweathering of the Marble Surfaces of the Hall of Prayer for Good Harvests at the Temple of Heaven (Beijing, China)

Youping Tian *

School of Earth Sciences and Resources, China University of Geosciences (Beijing), Beijing, China

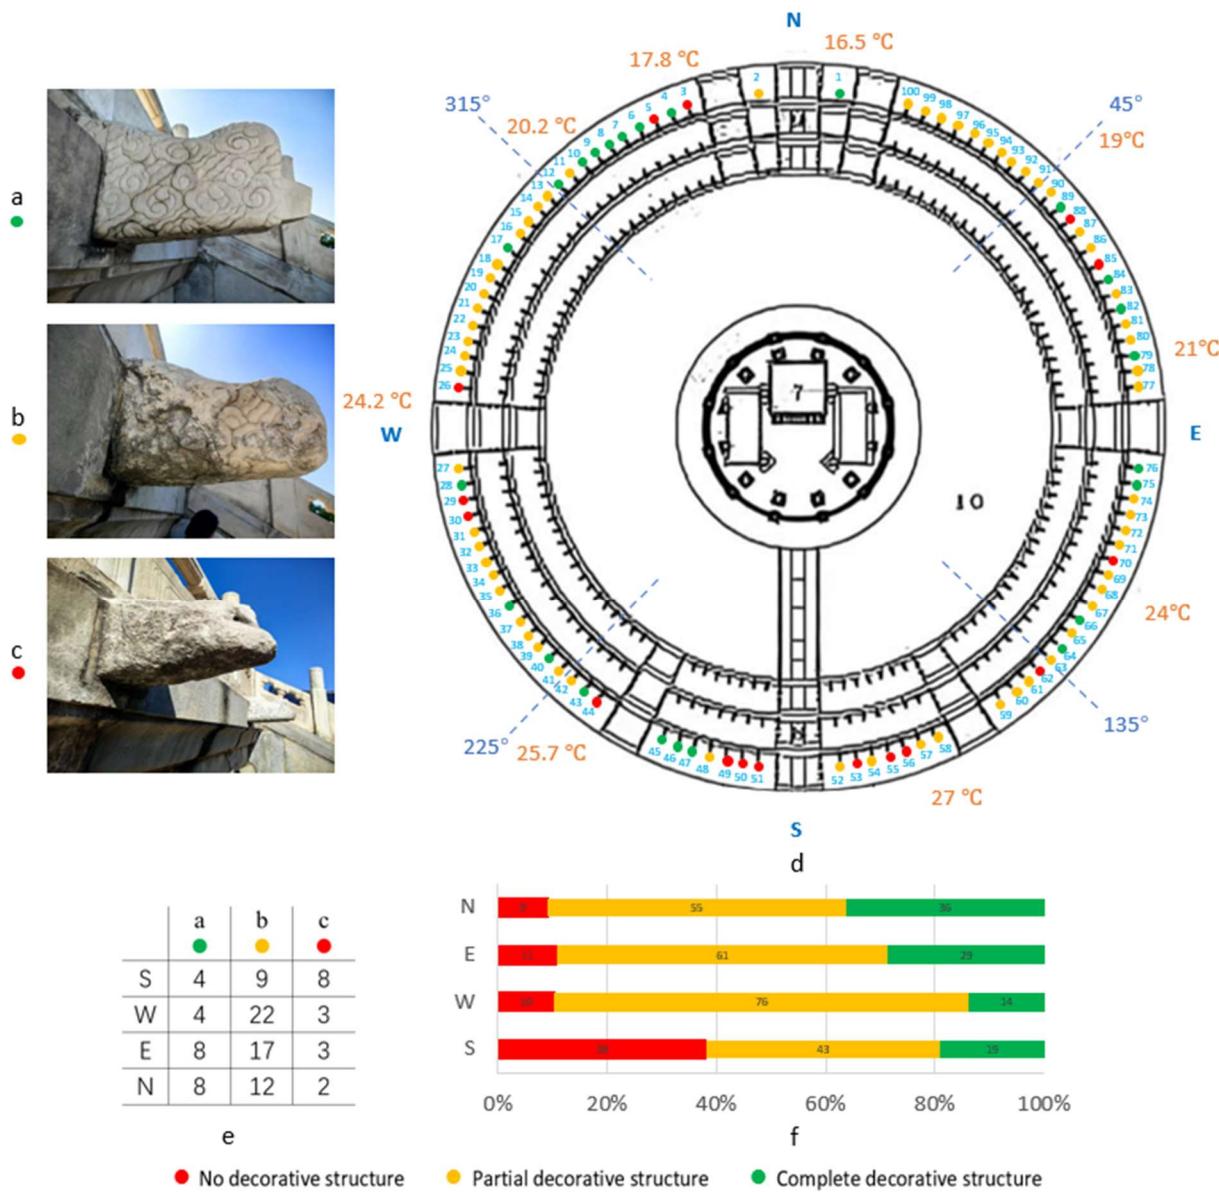
210  Fig. 4 Rock surface temperatures and weathering conditions of the Cloud Chi Heads on the third layer of the

Hall of Prayer for Good Harvests at the Temple of Heaven in Beijing, China, on a sunny afternoon in April.

To further understand the environmental differences and weathering conditions of the rock surfaces at the Hall of Prayer for Good Harvests in the Temple of Heaven, temperature measurements were taken on a sunny afternoon in April (Fig. 4). The rock surface temperatures were found to be highest in the southwest and lowest in the northwest. The Hall of Prayer for Good Harvests was divided into four natural sectors, each centered on a cardinal direction and covering 45° to either side: North (N): 315°-45°, centered on true north, covering from northwest to northeast; East (E): 45°-135°, centered on true east, covering from northeast to southeast; South (S): 135°-225°, centered on true south, covering from southeast to southwest; West (W): 225°-315°, centered on true west, covering from southwest to northwest. The weathering degree of 100 Cloud Chi Heads on the third layer was statistically analyzed in each sector. The results showed that 40% of the south-facing Cloud Chi Heads decorations were completely weathered, indicating the most severe weathering. The weathering degrees for the west, east, and north sectors decreased in that order. This pattern is consistent with the distribution of biological organisms on the rock surfaces, as shown in Table 1. The analysis of the weathering degree of 100 Cloud Chi Heads on the third layer showed that 40% of the south-facing Cloud Chi Heads decorations were completely weathered, indicating the most severe weathering. The weathering degrees for the west, east, and north directions decreased in that order. This pattern is consistent with the differences in weathering in different directions revealed by the distribution of biological organisms on the rock surfaces (Table 1).

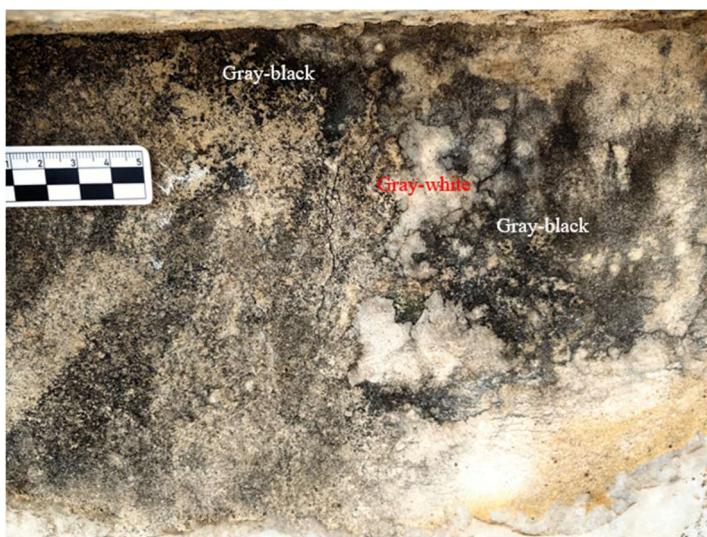
a. Gray-white, Gray-black

b. Gray-white, Gray-brown, Black-brown, White

**Fig. 8.** Micrographs of biological communities and some species on the east-facing marble surface of the Hall of Prayer for Good Harvests in the Temple of Heaven, Beijing, China.

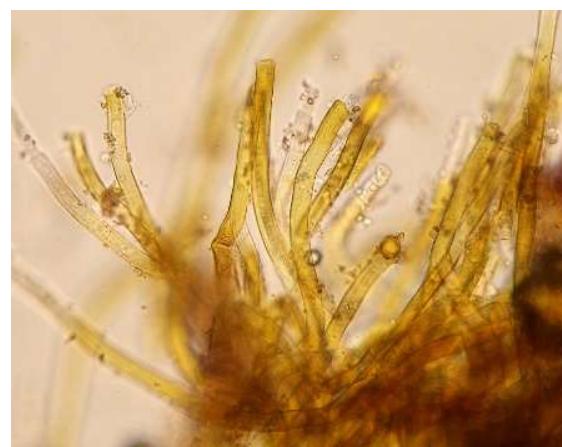
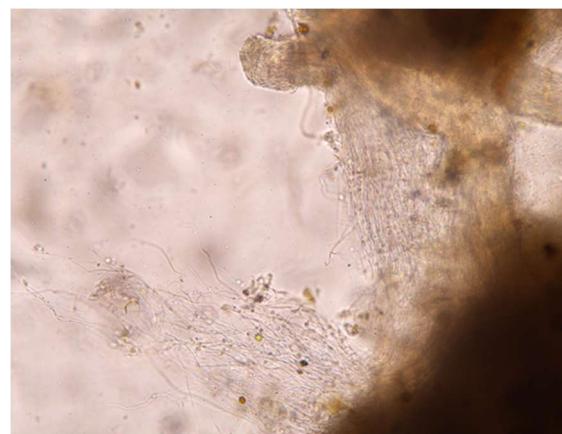
a. Gray-black leathery              b. Black hairy and membranous

c. Yellow-green, Gray-green, Brown

**Fig. 10.** Micrographs of biomes and some species on the west-facing marble surface of the altar of Prayer for Good Harvest in the Temple of Heaven, Beijing, China.

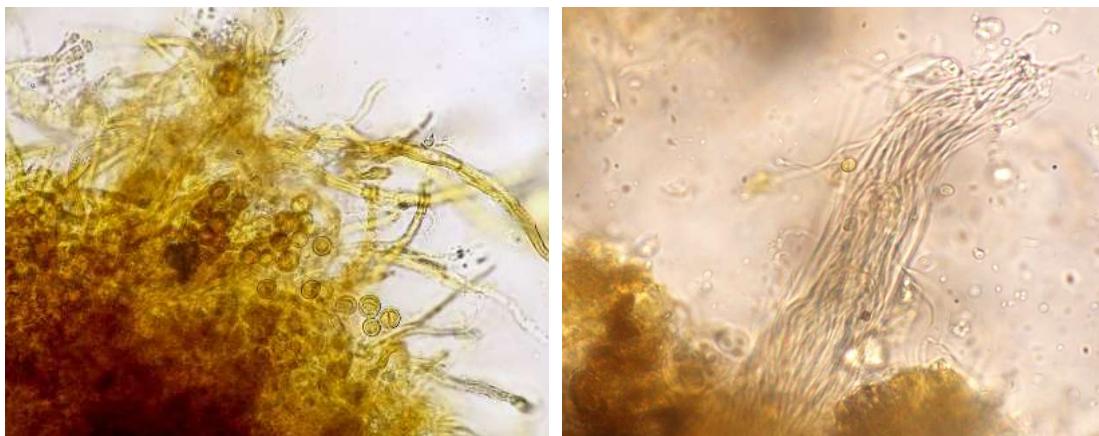
a. Gray-brown membranous            b. Gray-black

c. Yellow-green               d. Gray-white

**Fig. 12.** Micrograph of biological communities and some species on the north facing marble surface of the altar of

Prayer for Good Harvest in the Temple of Heaven, Beijing, China.

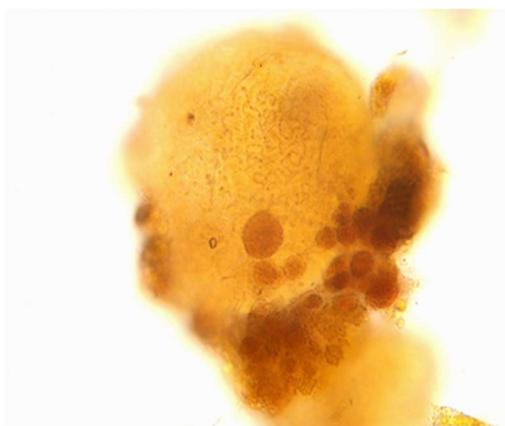
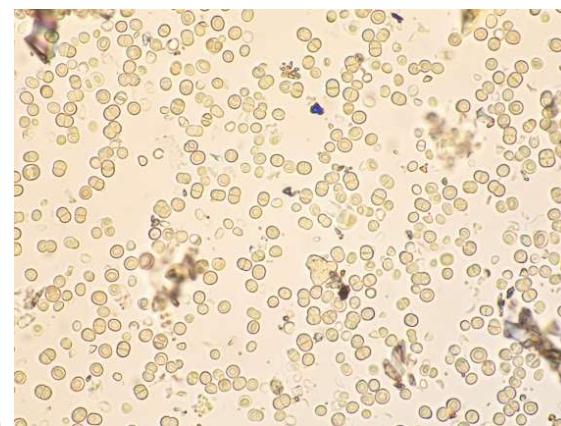
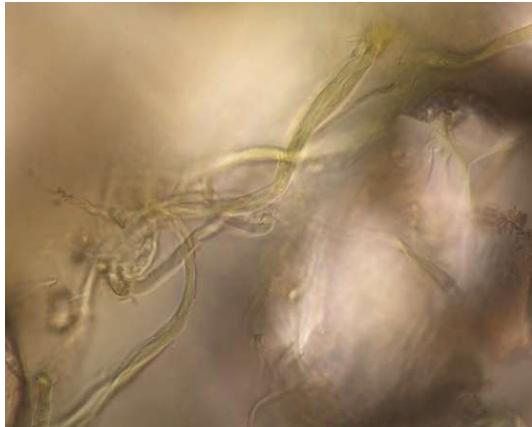
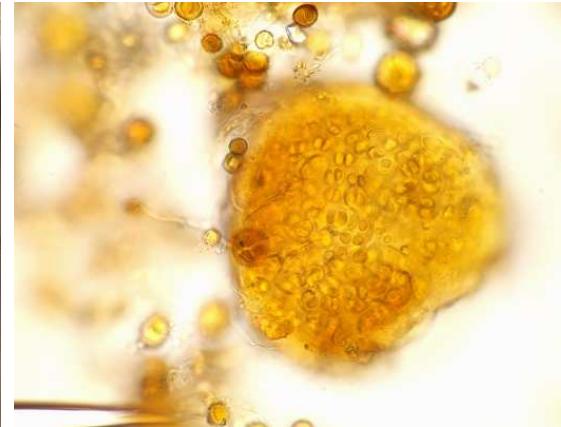
a. Green powdery layer magnified 60x

b. Green powdery layer magnified 400x

**Fig. 15.** Micrograph of biomes and some species on the south facing marble surface of the altar of Prayer for Good Harvest in the Temple of Heaven, Beijing, China.

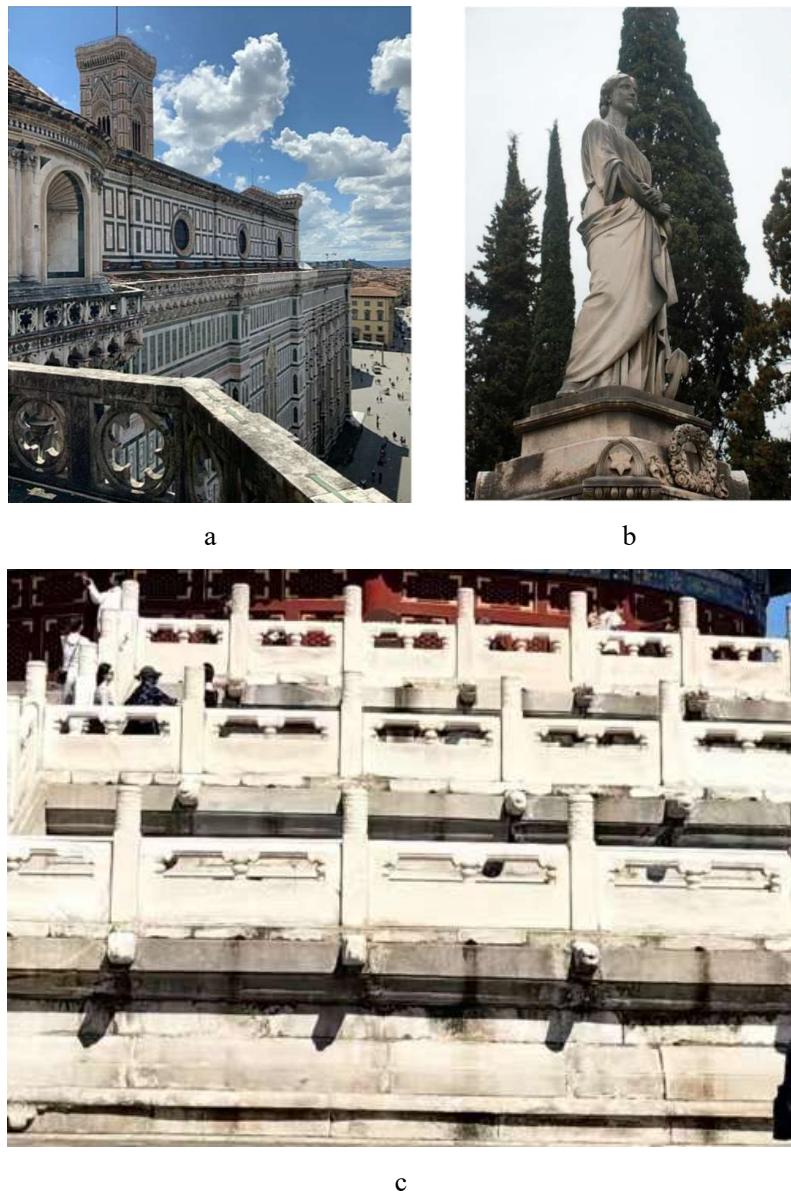
664                    Fig. 24: Comparison of Black Biofilm Growth on Marble Relics in Florence and Beijing

665    a. Cathedral of Santa Maria del Fiore in Florence (façade completed in 1887, 138 years old, using white, green, and pink marble), with a
