Geological-geotechnical analysis of a rock-toppling prone canyon in Furnas, Brazil, after a fatal event

Abstract. When a disaster related to a natural phenomenon occurs in areas dependent on Geotourism, restoring tourist confidence can be a challenge. An example is the rock-toppling event that occurred on January 2022 in one of the four canyons located in the Furnas reservoir in Brazil, which caused 10 fatalities. Visitation fear and their temporary closure severely impacted the economy of the surrounding municipalities that rely on tourism. To support a safer operation of the canyons to visitation, our study investigates the factors that can lead to landslide events in the region, based on the combination of field investigations, rock-mass quality evaluation (RMR14) and kinematic analysis. We hypothesize that the assessment of rock-mass quality can successfully identify specific areas in the bedrock that are prone to rockfall and rock toppling, supporting risk management strategies in tourist regions. Our results indicate that the 2022 rock-toppling event occurred due to the combination of different factors, such as rainfall infiltration in the unfavorably-oriented joints of the

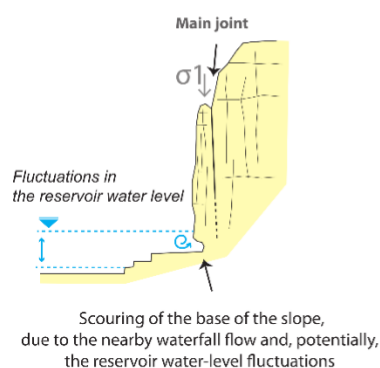
1. Erosion

STEPS THAT LED TO THE ROCK-TOPPLING EVENT

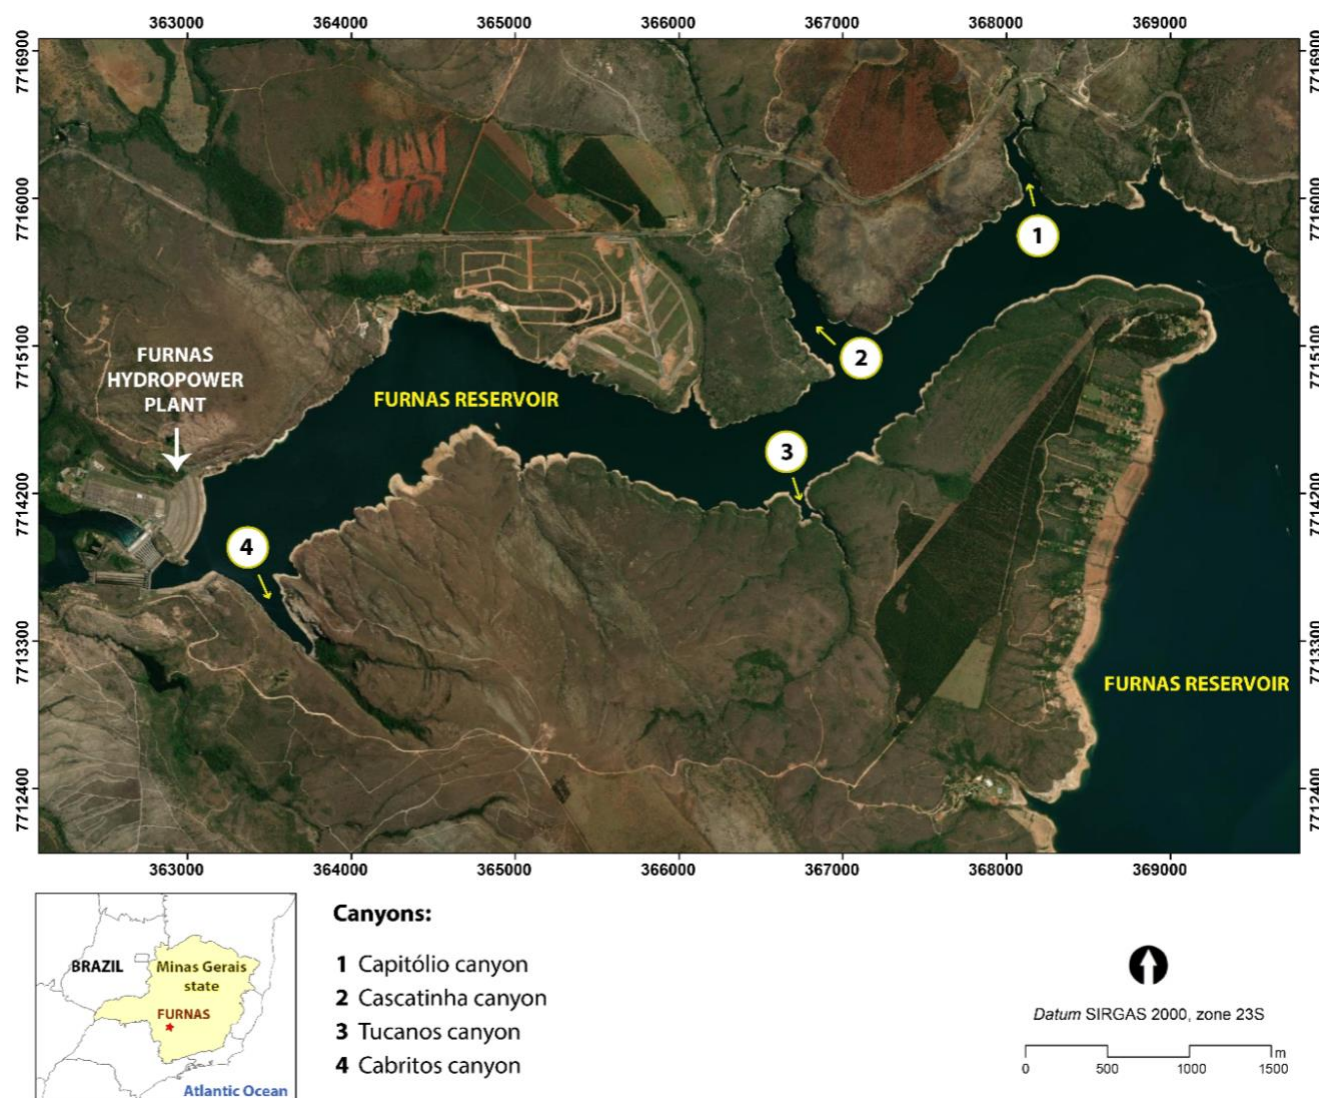
Rock toppling and rockfall are landform processes that naturally occur in the four canyons located in the region of Furnas (Minas Gerais state), denominated (1) Capitólio (where the fatal event occurred), (2) Cascatinha, (3) Tucanos and (4) Cabritos canyon (**Figure 1**). The “Furnas canyons” are a very popular tourist attraction in Brazil, as they are located in one of the largest reservoirs in the country (Machado et al., 2020), with an area of over 1,440 km². The reservoir was created due to the construction of the Furnas Hydropower plant in 1958 (Godoy, 2017), and, in 2020, the tourism related to the canyons and the reservoir represented over 65% of the total Gross Domestic Product (GDP) of the surrounding municipalities, with the population tripling during holidays (Machado et al. 2020).

105 **Figure 1: The four canyons located in the Furnas reservoir, state of Minas Gerais, Southeast Brazil. The fatal rock-toppling event occurred in the Capitório canyon (1). The Furnas Reservoir was created due to the construction of the Furnas hydropower plant. The source of the aerial image is from Google Maps ©.**

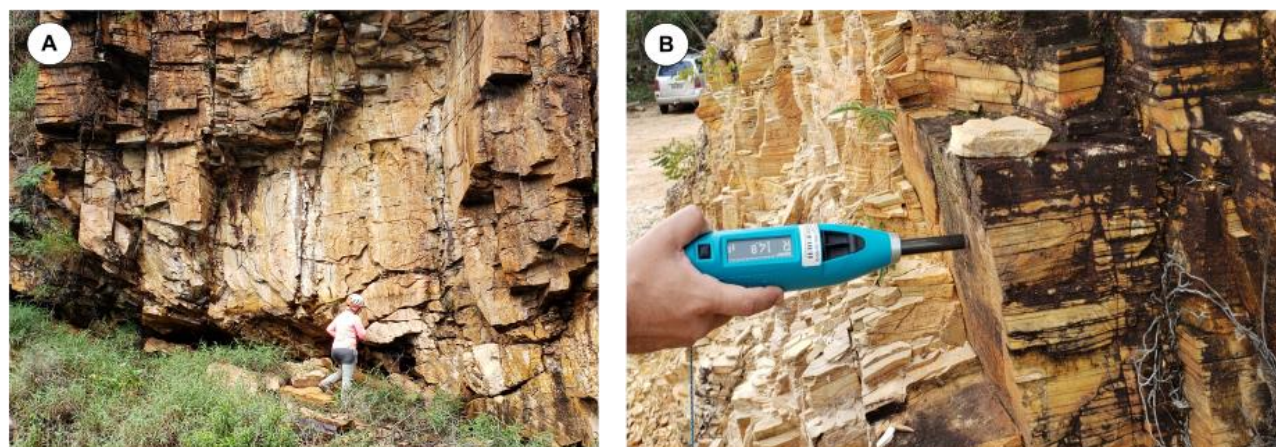
Two field campaigns were conducted in the canyons (February and March, 2022), in which an overview of the geology, geomorphology and rock-mass conditions was performed (**Figure 3A**). Structural measurements were also taken, as well as the physical properties of the bedrock were estimated using the Schmidt Hammer (**Figure 3B**).

Figure 3: Field investigations. A) Structural data measurements. B) Schimdt Hammer sampling.

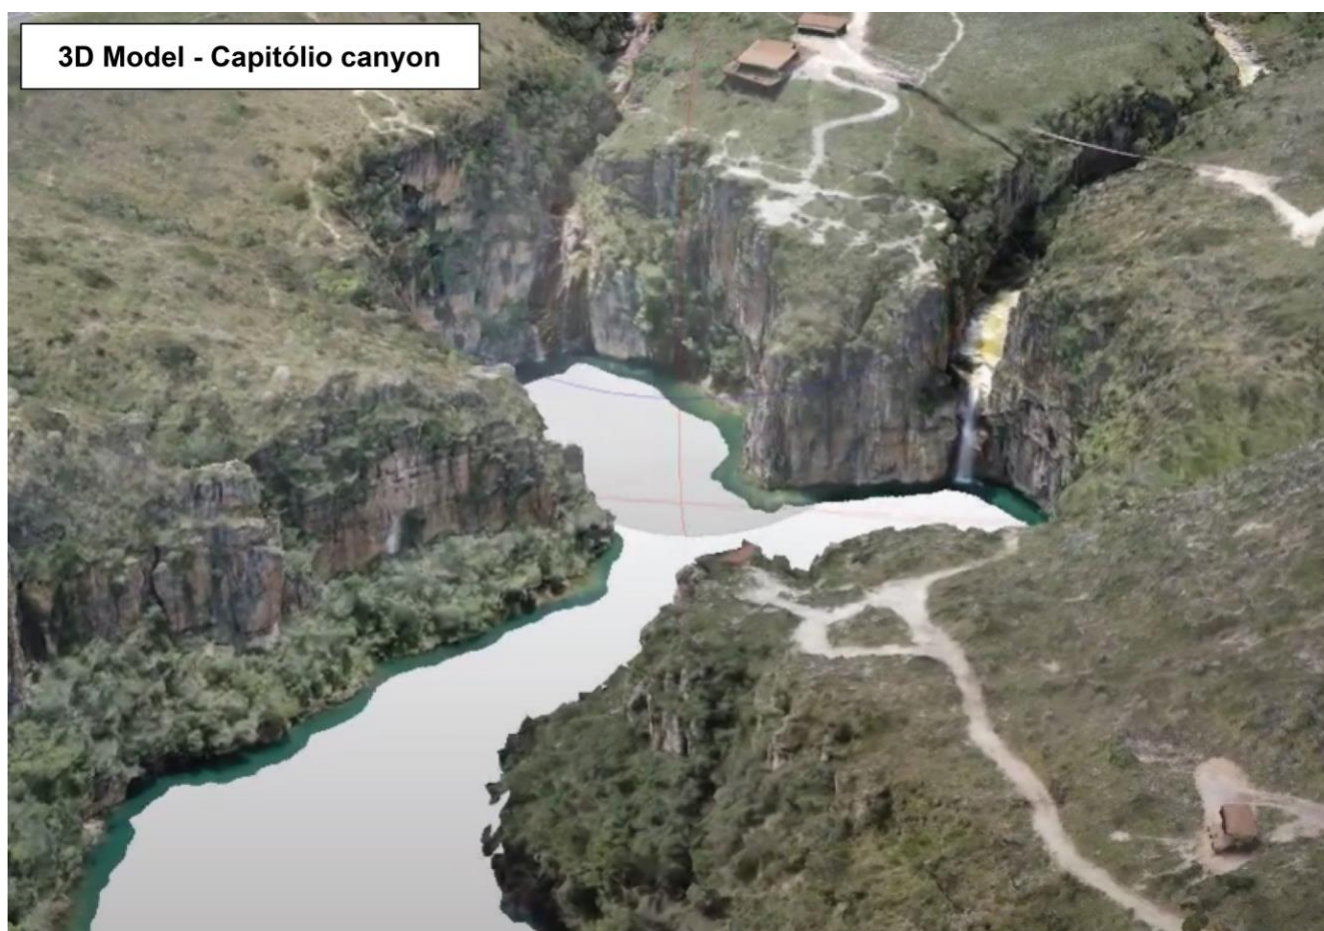
190 The main products that resulted from the UAV survey were the Digital Surface Model - DSM, the 3D model and the
orthophotos of the four canyons. We chose to employ the DSM instead of DTM (Digital Terrain Model) due to uncertainties
when generating the latter based on the UAV survey. Moreover, since no infrastructures were installed in the canyons and as
the vegetation on top of the slopes consist mainly of shrubs of up to 1 m (Cerrado Biome), they did not considerably impact
the rock-slope height estimation. The 3D model of the canyons (**Figure 4**) allowed a detailed reconstruction of the slope faces,
195 supporting *in-situ* observations.

Figure 4: The 3D model of the Capitólio canyon.
