# Post-wildfire sediment source and transport modeling, empirical observations, and applied mitigation: an Arizona USA case study

5 Edward R. Schenk<sup>1</sup>, Alex Wood<sup>2</sup>, Allen Haden<sup>2</sup>, Gabriel Baca<sup>2</sup>, Jake Fleishman<sup>2</sup>, and Joe Loverich<sup>3</sup>

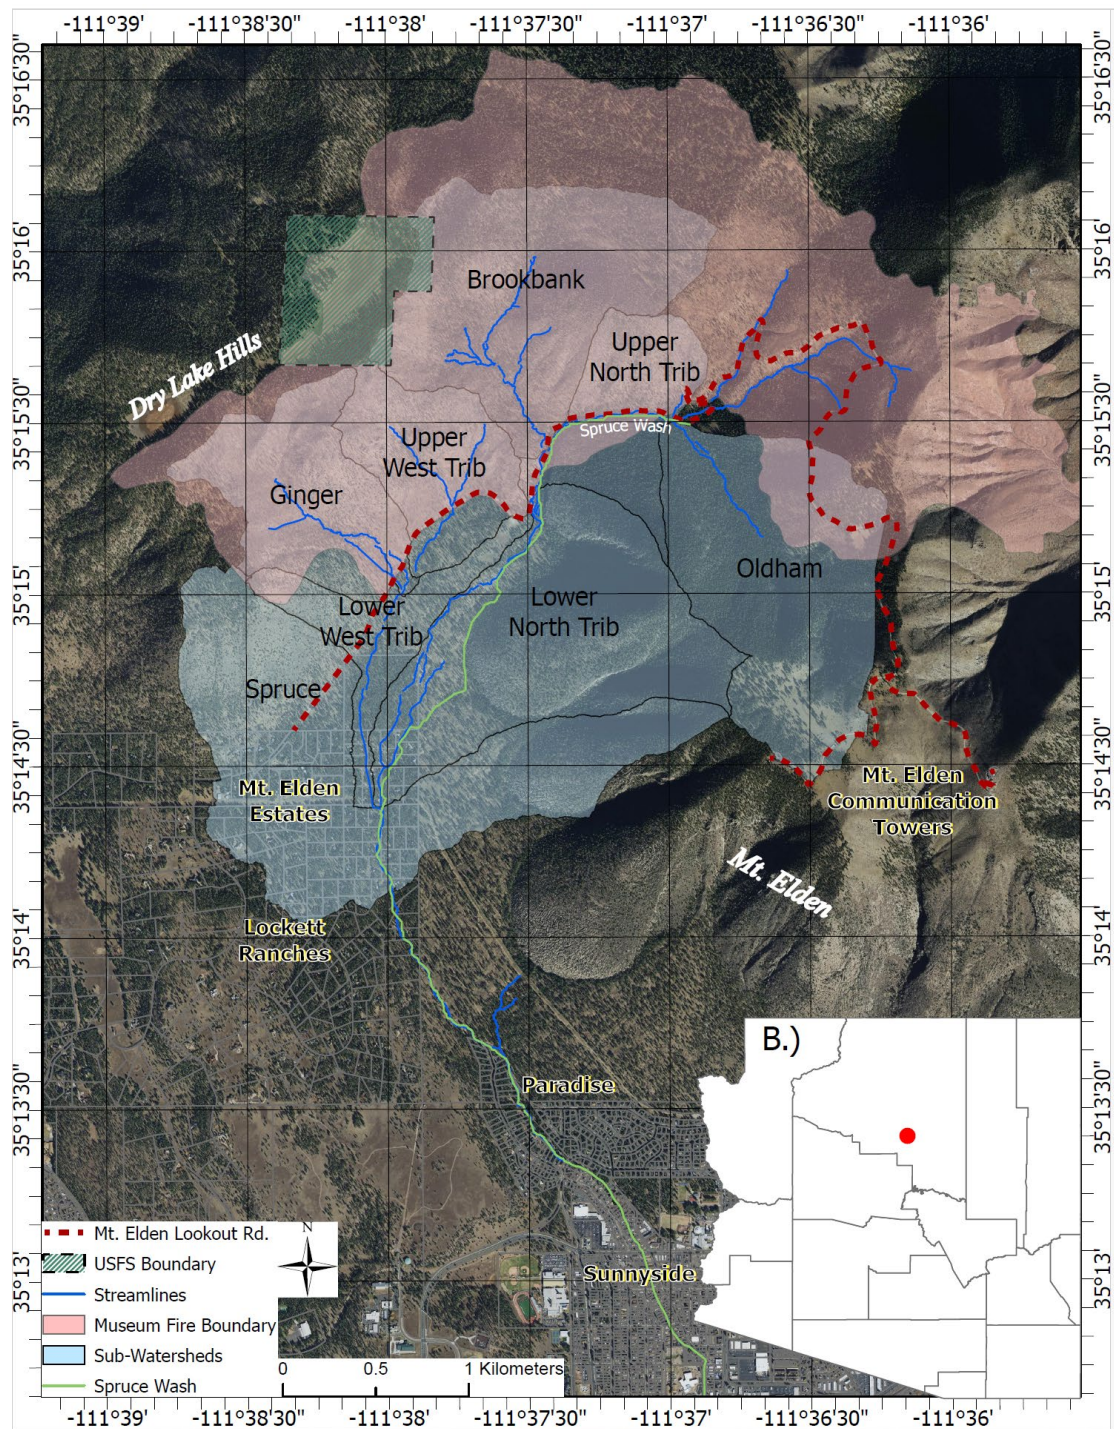
120 **Figure 1.** Overview map of the 2019 Museum Fire watershed (Spruce Wash), sub-tributary names, and locations of impacted neighborhoods. The City of Flagstaff is located in north-central Arizona on the edge of the Colorado Plateau and shown on the lower portion of this figure. Background aerial imagery is public domain (Coconino County 2015).

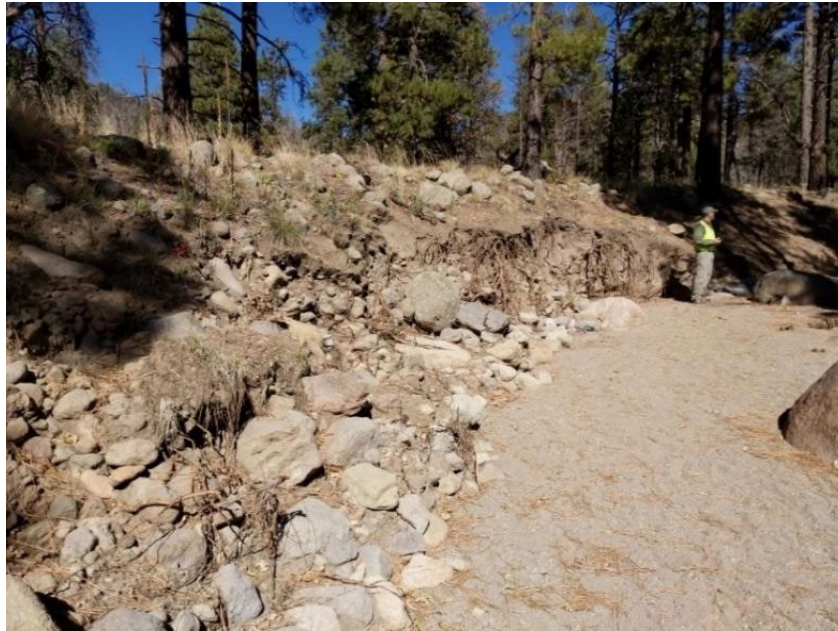
**Figure 2. Surveyors performing a BEHI analysis on a typical channel along Spruce Wash. Photo taken in fall 2021 approximately 500 m upstream of Mount Elden Estates.**

3.3.1. *BEHI data collection*- Bank erosion hazard index (BEHI) surveys were used to qualitatively evaluate all eroding channels within the Spruce Wash watershed, (Rosgen 2009; Figure 2). Collected data consisted of channel bank height, channel and bank material, length of channel, vegetation and root density, bank slope angle, valley and stream type classification (Rosgen 1996), and near bank stress (NBS).  
190

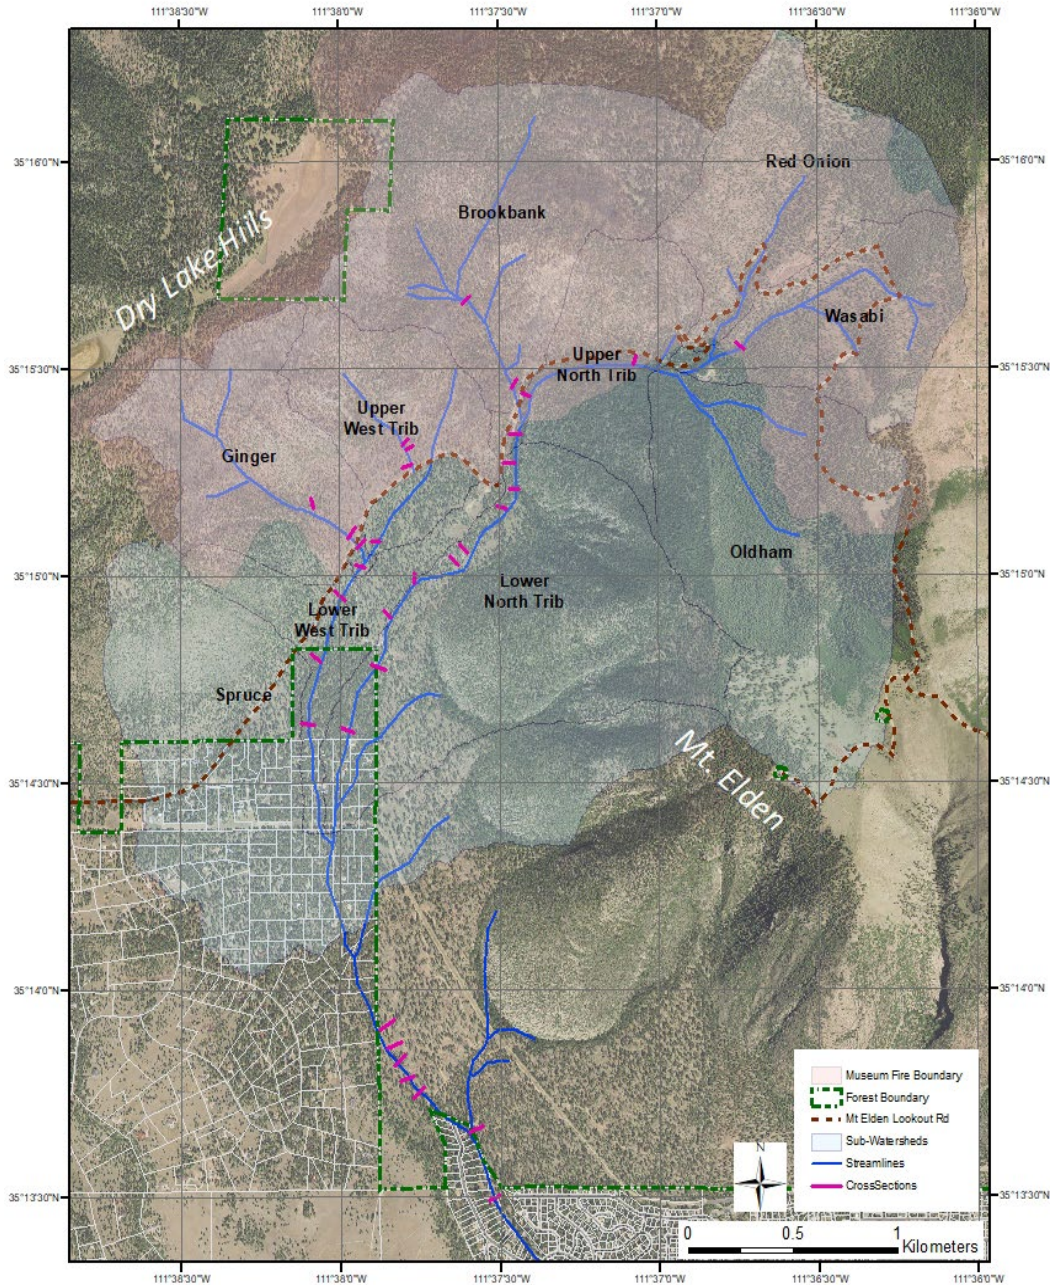
**Figure 3. Cross sections within the Spruce Wash watershed, the 2019 Museum Fire burn area is shown in light red. Background aerial imagery is public domain (Coconino County 2015).**

195 3.3.2. *Channel Surveys*- channel cross-sectional surveys were completed proximal to proposed work areas (i.e. flood mitigation capital improvements) to accurately model sediment transport through channels and assess channel characteristics. Twenty seven (27) cross sectional surveys (Figure 3), longitudinal channel profiles, and pebble counts were completed to evaluate the channel slope and characteristics of specific channel reaches.

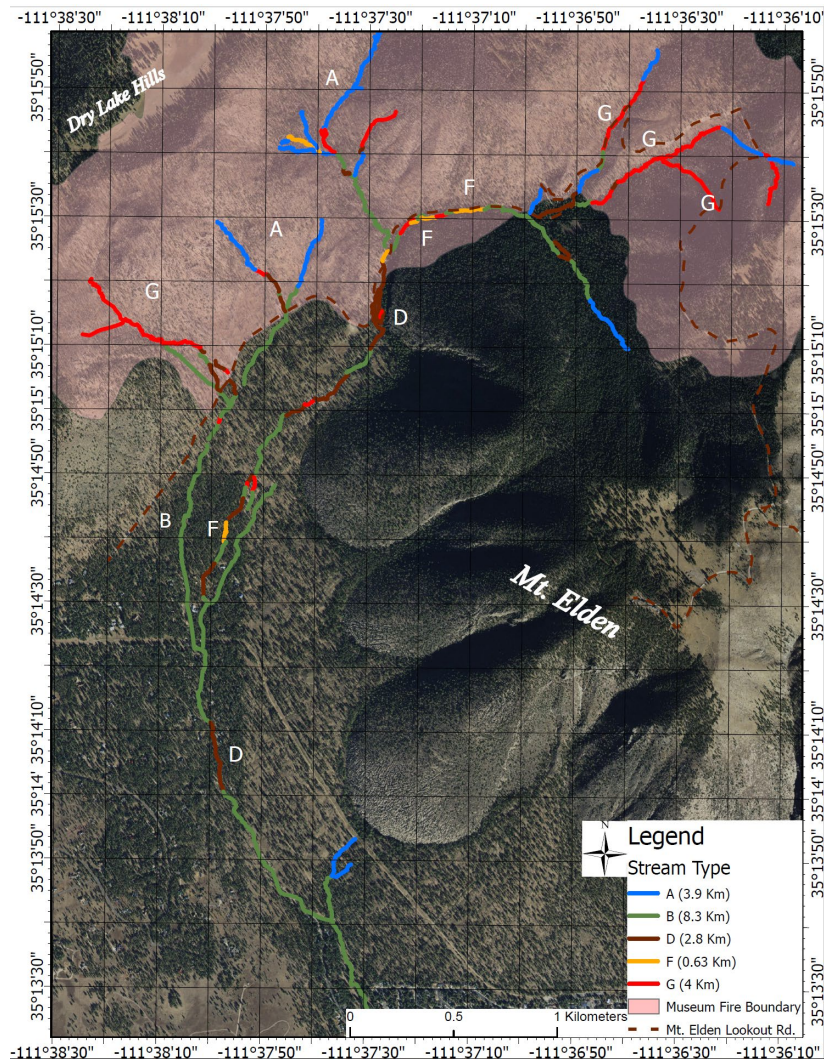
315 **Figure 4. Spruce Wash channel types based on the Rosgen classification system. "A" and "B" types are generally stable with low sediment contribution. "F" and "G" channel types are generally unstable and are sediment sources, "D" channel types tend to be aggradational (Rosgen 2009). Background aerial imagery is public domain (Coconino County 2015).**

Approximately 20% of the channels in the Museum Fire watershed are incised channels with high sediment contribution from channel and bank processes (“G” type channels in the Rosgen classification). G channels were found primarily in the burned, steep, upper reaches of the watershed;  
305 however, some were found in reactivated alluvial fans (Figure 4). Bank erosion from this type of channel can be an order of magnitude higher sediment contribution from bank and channel processes than other non-incised steep slope channels (Rosgen 2009). Aggrading, often braided, “D” type channels or valleys that can support aggrading alluvial fans, or riparian floodplains, are roughly 15% of the watershed. While these channels have the potential to store large amounts of sediment, many are  
310 gullied post-wildfire and now function as sediment sources rather than sediment sinks. The Rosgen channel type was determined visually during the BEHI surveys, and the results are shown in Figure 4.

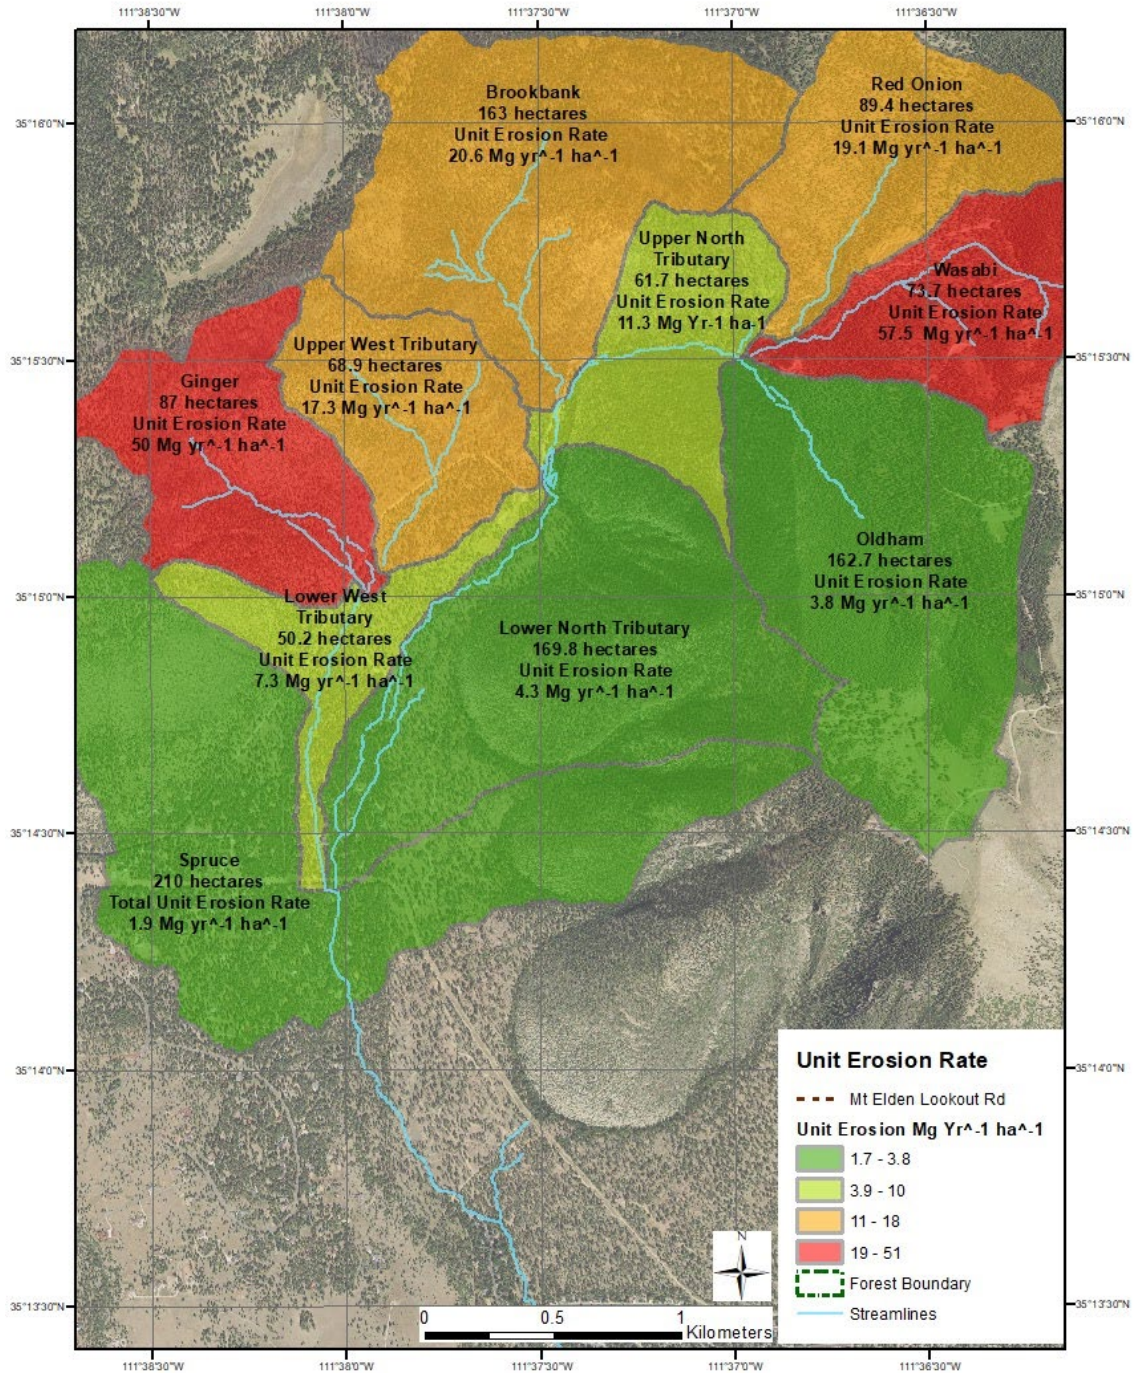
345 **Figure 5. Unit erosion rates for each sub-watershed based on the ERMiT model. Background aerial**  
**imagery is public domain (Coconino County 2015).**

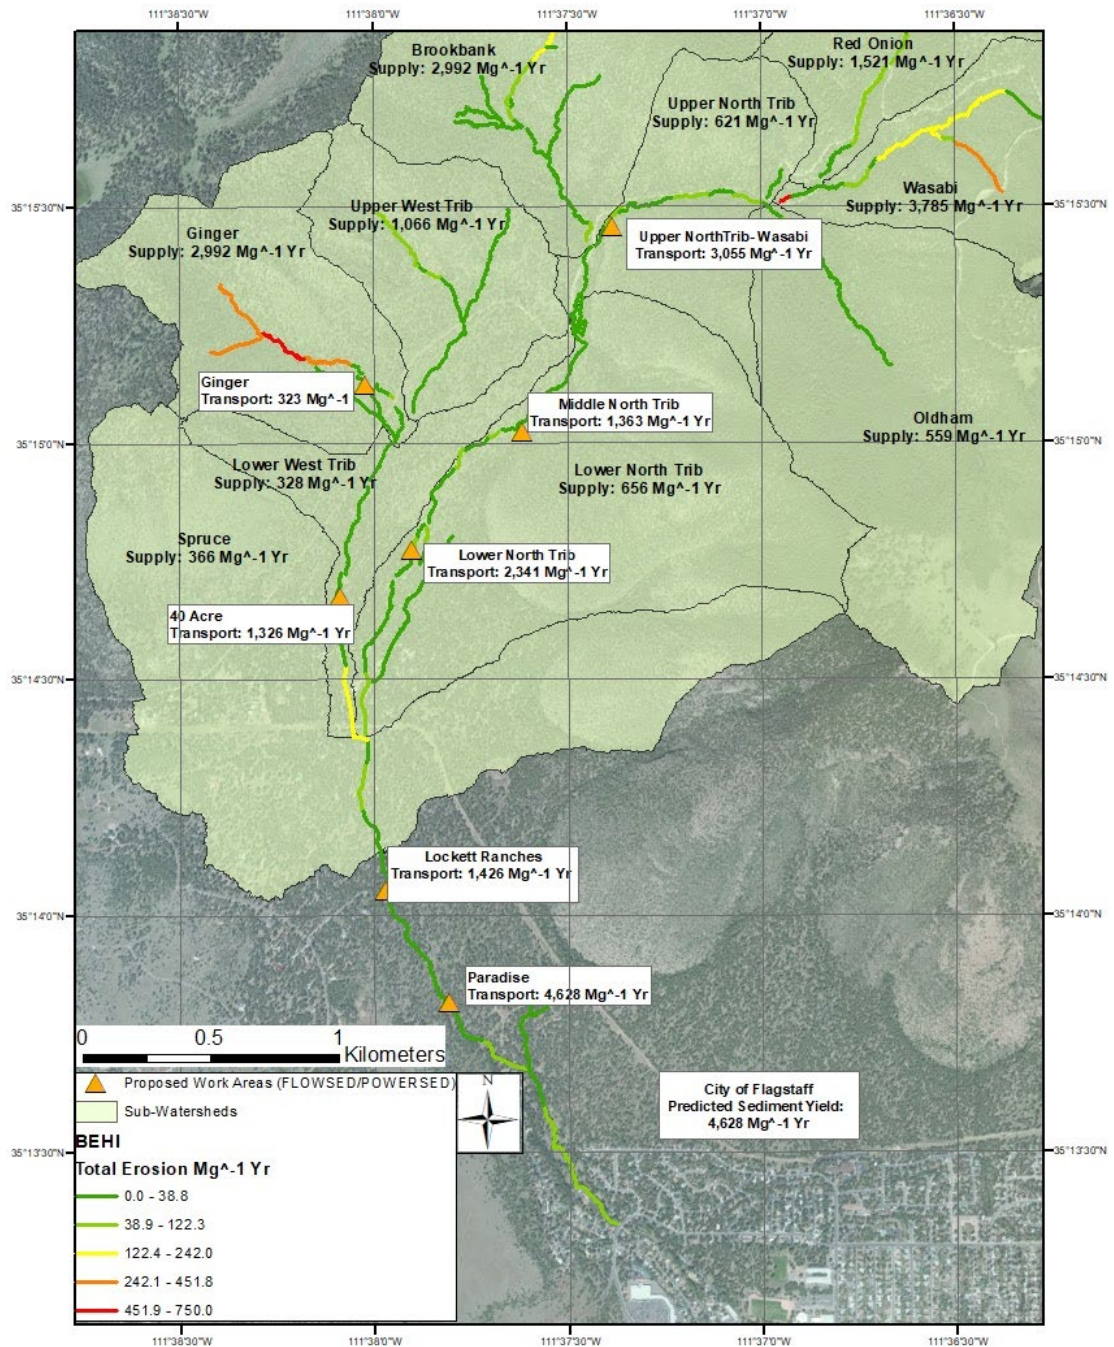
355 Figure 6. Sediment transport capacity for all work areas (constructed in 2022 and 2023) from the POWERSED/FLOWSED model. Background aerial imagery is public domain (Coconino County 2015).

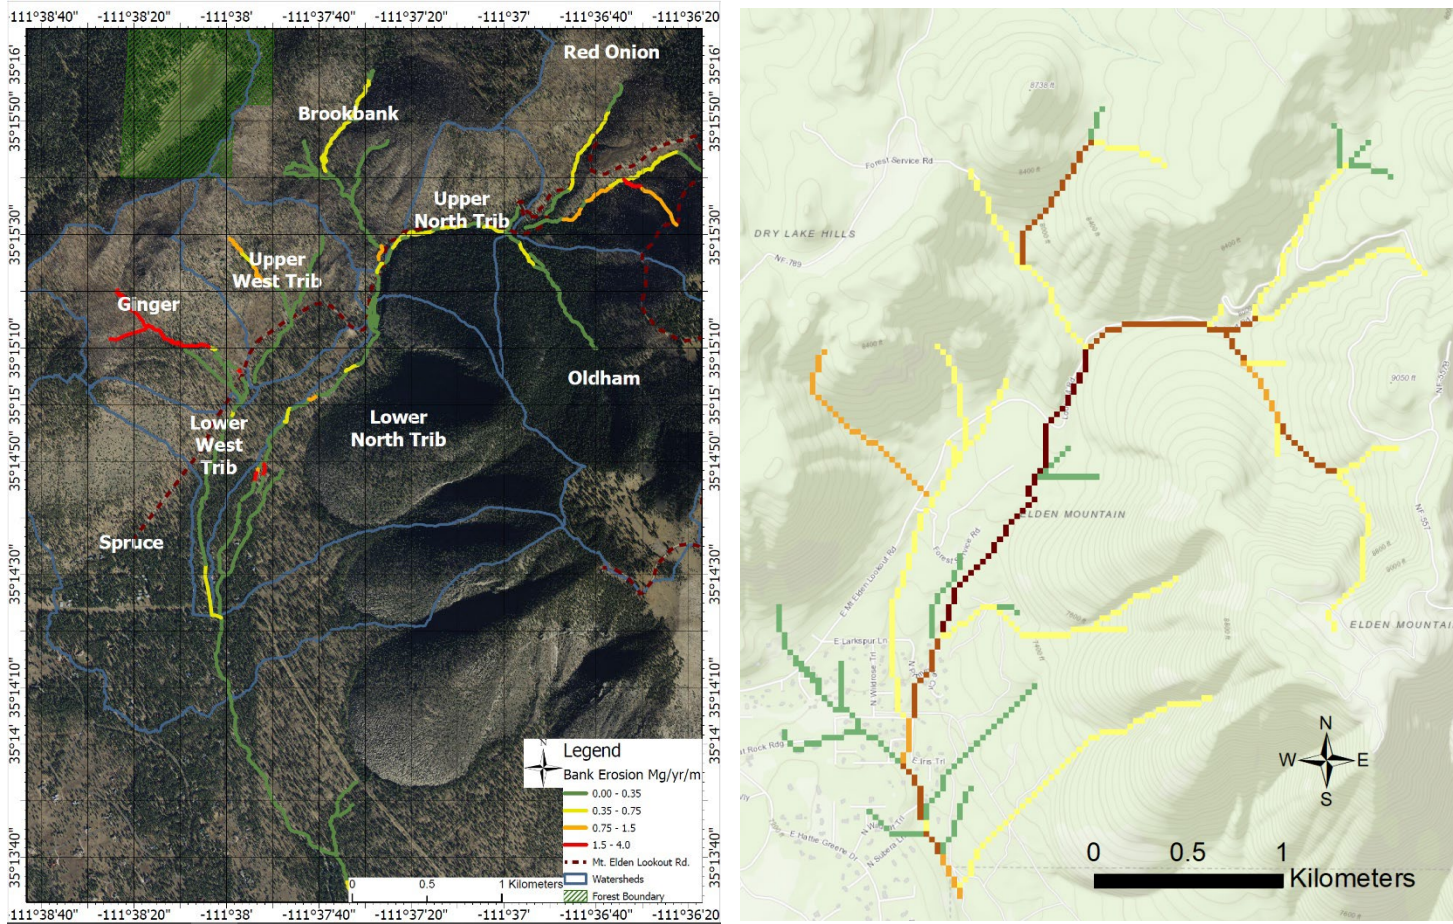
365 **Figure 7. A) BANCS modeled bank erosion rates for tributaries within the Spruce Wash watershed. B) WEPP modeled bank erosion, there is a similar spatial pattern for “Ginger”, “Brookbank”, and the unnamed tributary south of “Wasabi”, differences exist for the main-stem channel erosion prediction. Background aerial imagery is public domain (Coconino County 2015) for Figure 7a, background imagery for Figure 7b is public domain USGS NLCD data (Homer et al. 2012).**

330 The BANCS model also estimates the unit bank erosion rate which is the erosion rate per longitudinal length of channel (0.3m in this case). Figure 7 presents the unit bank erosion rate for channels in the Spruce Wash watershed, indicating the channels with the highest expected erosion rates. The Ginger and

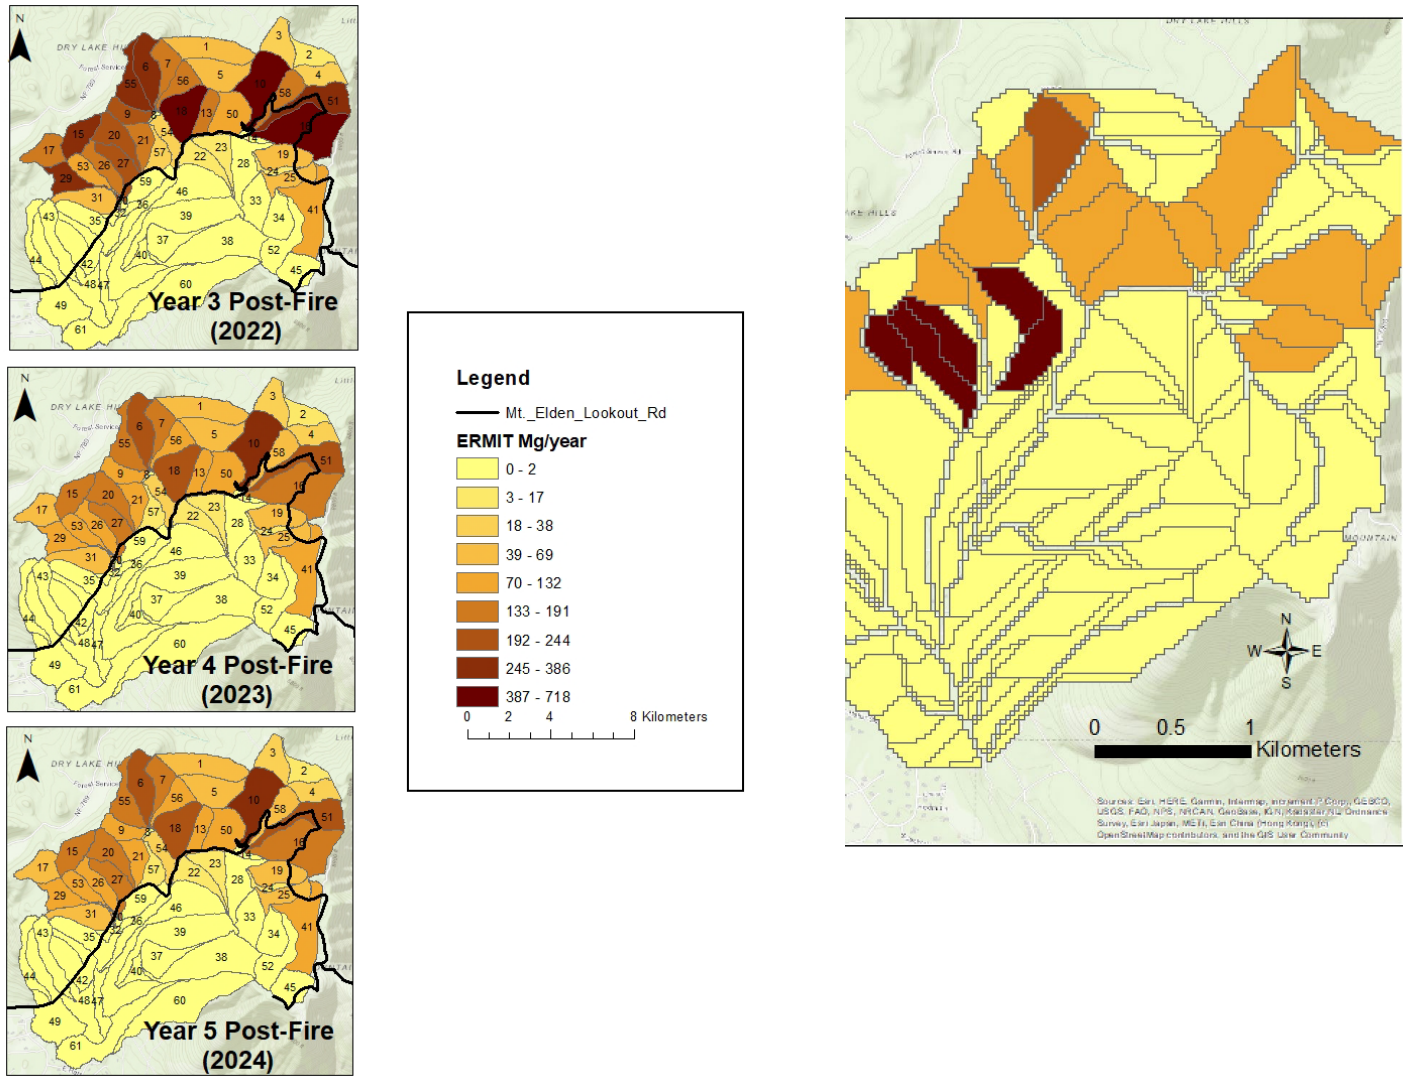
380 **Figure 8. Modeled hillslope erosion rates for 2022, 2023, and 2024 (A: ERMiT model) and 100 year forecasted annual hillslope annual yield (B: WEPP model). The WEPP model shading is to scale with the ERMiT model. Background imagery is USGS NLCD data in the public domain (Homer et al. 2012).**

335 Wasabi sub-watersheds, which are two steep watersheds in the burn area, have the highest unit bank erosion rates. The results of the ERMiT model showing the predicted hillslope erosion rates are presented in Figure 8 which generally show the highest hillslope erosion rates in the steeper, burned areas of the watershed.

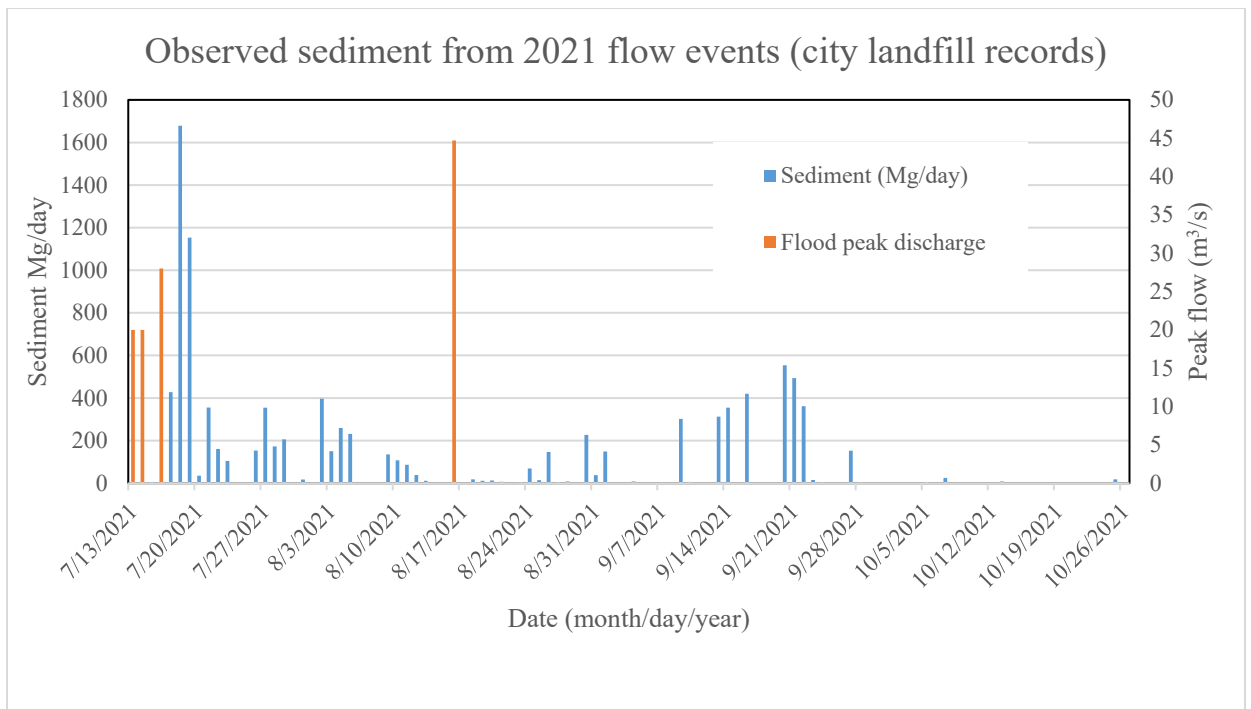
**Figure 9. Sediment and debris removed from channels and streets. Flood events occurred on July 13, 14, 16, and August 17th. Flood flows were predicted at the upstream entry to the CoF as 20, 20, 28, and 44.7 m<sup>3</sup>/s respectively (Schenk et al. 2023).**

Empirical results from in-city sediment removal, as measured at the Cinder Hills Landfill, are provided in Figure 9. The majority of sediment removed from the urban environment occurred after the first storms post-wildfire, during the July months (6260 Mg) with an additional 3760 Mg removed after the larger August flood event. All in-city sediment removed is downstream of the modeling regimes and act as an end-point for the study system.

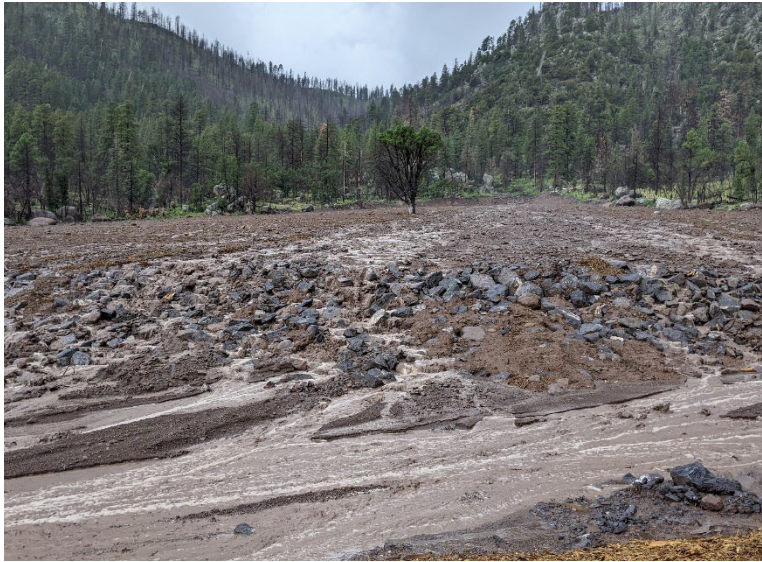
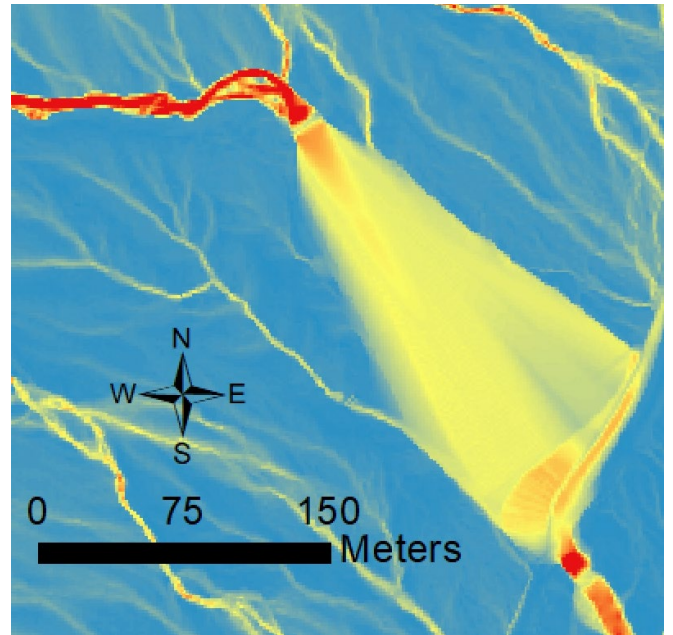
450 **Figure 10 A) Ginger alluvial fan work site ( $35^{\circ} 15' 10''$ ,  $-111^{\circ} 38' 0''$ , looking upstream) during a July 2022 flow event, note the spread of flow and subsequent drop in water velocity allowing sediment aggradation. B) Ginger alluvial fan work site including predicted velocities during a 25 year annual exceedance probability rain event. The dark red areas are approximately 3 m/s, the blue areas denote no flow (0 m/s). The photograph in Figure 10a was taken at the southeast corner of the fan looking northwest (upstream).**

535 The sediment mitigation structures, or “work areas”, consist of an upstream, single thread “feeder” channel and a multithread anastomosing “fan” channel supported by lateral harden grade control (e.g. rock sills) before constricting back to a single thread channel to feed into the existing drainage downstream (see Rosgen and Rosgen 2015 for more detail). Sediment output from the restored fans appears to be moderate (approximately half of upstream sediment input) over a multi-year average (authors’ field observations). However, the relatively steep fans will produce higher shear stresses at high, infrequent flows. For example, peak discharges modeled for a 2” (5 cm) per hour precipitation event over the whole watershed (~ 37 CMS, 4% annual exceedance probability) produce enough shear stress on the Paradise fan to move 30 cm diameter sediment. Consequently, these infrequent precipitation scenarios will have the potential to move large quantities of material through the fan system, even though most is retained on the fan.
