Larger lake outbursts despite glacier thinning at ice-dammed Desolation Lake, Alaska

Natalie Lützow¹, Bretwood Higman², Martin Truffer³, Bodo Bookhagen⁴, Friedrich Knuth⁵, Oliver Korup^{1,4}, Katie E. Hughes⁶, Marten Geertsema⁷, John J. Clague⁸, and Georg Veh¹

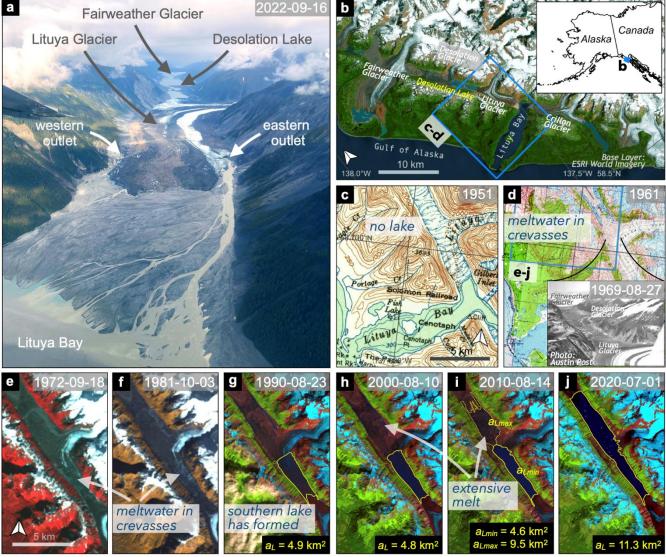
Fig 1.: Location and formation of Desolation Lake. a; Oblique aerial view into Desolation Valley from the head of Lituya Bay. Desolation Lake is only partially filled. White arrows indicate the location of the two flood outlets. b; Location map and glacial setting of Desolation

Lake. **c-j**; Time series of historic maps (**c,d**; U.S. Geological Survey, 1951, 1961) and Landsat images (**e-j**; derived from the USGS Earth Explorer and Google Earth Engine Data Catalog) showing the formation and growth of Desolation Lake between 1951 and 2020. The yellow outlines in **g-j** show the mapped lake areas (*a_L*). The photograph by Austin Post inset into **d** is a view into Desolation Valley and Lituya Glacier from the head of Lituya Bay in 1969, shortly before modern Desolation Lake formed.

seasonal snow cover. Desolation Lake is further bordered by Fairweather Glacier to the northwest and Desolation Glacier flowing into the valley from the northeast (**Fig. 1b**).

The lake axis follows that of Desolation Valley and the NW-SE-striking, tectonically active Fairweather Fault. In 1958, before modern Desolation Lake began to form (**Fig.1d-f**), a magnitude 7.9 earthquake triggered a landslide that entered Lituya Bay in front of Lituya Glacier, which was a tidewater glacier at that time (Miller, 1960; Lander, 1996; Mader and Gittings, 2002). The landslide triggered a tsunami that reached up to 524 m above sea level on the opposite hillslope and travelled the length of the bay and into the open Pacific Ocean. The run-up remains the highest of any reported tsunami worldwide (Mader and Gittings, 2002; Miller, 1960).

Desolation Lake is surrounded by steep valley walls with an average slope of ~32° (ArcticDEM 2020-09-11; **Table S1**). Field observations, satellite imagery, and elevation models show that frequent mass movements of different size occur on these slopes. Since the onset of the GLOF cycle, sediment carried to the terminus of Lituya Glacier has formed a rapidly advancing proglacial delta, which today separates the glacier from Lituya Bay. Accordingly, Lituya Glacier ceased to be a tidewater glacier and became a landlocked valley glacier between 1990 and 1992. Crillon Glacier flows into Lituya Bay south of the head of the bay. A lake dammed by Crillon Glacier ~10 km from its terminus (**Fig. 1a**) has had no reported outbursts.

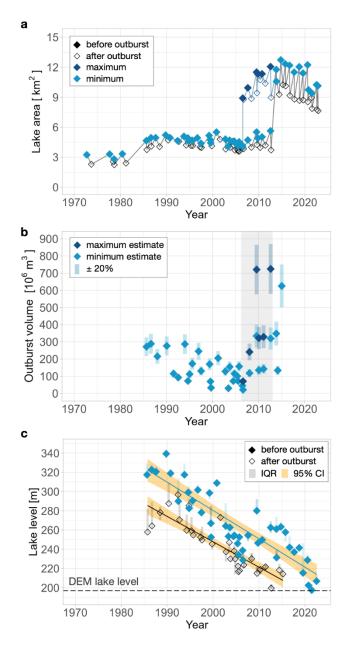
Fig. 2: Temporal changes in lake size, outburst volumes, and lake levels from 1972 to 2023. a; Lake area before and after the flood. b;

Outburst volumes with error bars assuming an uncertainty of ±20%. In a and b, data for GLOFs between 2006 and 2012 are colour-coded to minimum and maximum estimates from mapped lake extents, constrained by the uncertain lake shores along rapidly melting Fairweather Glacier (this interval is grey shaded in b). c; Lake level before and after GLOFs. The blue and black lines are linear regression models fitted to pre- and post-outburst levels, including the 95% confidence interval (CI; orange). The horizontal dashed line is the lower limit of the volume calculation (see section 3.2). Pale blue and grey vertical intervals for outbursts mark the 25th and 75th percentiles (IQR) of the lake elevations extracted from the DEM. Diamonds in a and c bracket the timing of the outburst, with filled diamonds (open) representing the last available image before (first available image after) each GLOF.

Diamonds in **a** and **c** bracket the timing of the outburst, with filled diamonds representing the last available image before the GLOF and open diamonds the first available image after the GLOF.

Desolation Lake began to form in the late 1960s when meltwater accumulated in longitudinal crevasses of Desolation and Lituya glaciers. This meltwater is visible in topographic maps and air photos of Austin Post in 1963 and 1969 (**Fig. 1d**). In the early 1980s, a single coherent water body formed and started growing on the surface of Desolation and Lituya glaciers (**Fig. 1e,f**). In the following years, the lake expanded towards rapidly retreating Desolation and Fairweather glaciers in the northwest (**Fig. 1g,h**). In 2013, Desolation Glacier had retreated so far that it no longer blocked the valley. This allowed Desolation Lake to double its surface area by connecting to meltwater trapped in crevasses in the northwestern part of the valley (**Fig. 1i,j; Fig. 2a**). In 2014, Desolation and Fairweather glaciers separated, leaving only floating ice on the lake. Until then, Desolation Lake had grown by about 10 km² within 35 years to a total area of 12.7 km² (**Fig. 1, Fig. 2a**). Since 2014, the maximum annual area of the lake decreased by about 4 km² to 8.6 km² in 2023 (**Fig. 2a**).

The minimum estimated outburst volumes of Desolation Lake range from $33 \pm 7 \times 10^6$ m³ to $625 \pm 125 \times 10^6$ m³ (**Fig. 2b**). Over the 30 years for which we have reliable estimates (1985-2014), flood volumes have at least tripled, with volumes between 200 and 300×10^6 m³ in the late 1980s and up to $\sim 700 \times 10^6$ m³ in the early 2010s (**Fig. 2c**). Flood volumes increased when the lake doubled its area by expanding towards Fairweather Glacier between 2006 and 2014 (**Fig. 1h-j; Fig. 2b**). This disintegration of Fairweather Glacier had already started in the 1980s when water-filled crevasses began to form and increase in number and size. Even before the lake claimed the area north of Desolation Glacier, the water from these crevasses drained during outbursts. We were unable to estimate the additional volume of water discharged from these crevasses, so our total estimated flood volumes are minima for this period. The lowest flood volumes were associated with floods in 2005 and 2006, just before this large-scale expansion. This two-year period had at least five detected partial drainages.

While flood volumes increased, pre- and post-flood lake levels of Desolation Lake fell substantially (**Fig. 2c**). The lake level before the 2022 GLOF was 207 m h.a.e., about 110 to 130 m lower than the pre-GLOF lake levels in the late 1980s. The post-flood levels decreased in a similar manner and dropped below the DEM-derived lake level of 197 m h.a.e. in 2016 (**Fig. 2c**). Satellite images show that the lake continued to decrease in width in the following years, indicating that the post-flood lake levels have further dropped since then (**Fig. S5**). In 2023, the last year of our record, both pre- and post-flood lake levels remained below the DEM lake level of 197 m h.a.e..

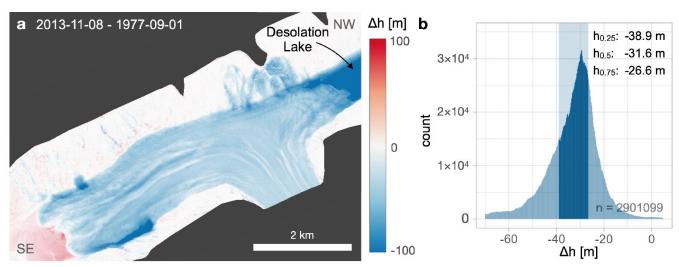
Fig. 3: Elevation change (Δh) of Lituya Glacier and surrounding area between 1977-09-01 and 2013-11-08. a; Oblique 3D view of 2013-11-08 point cloud generated from the ArcticDEM (Porter et al., 2022) coloured by vertical point cloud distance on masked (black) background. Positive and negative values show elevation gains and losses, respectively. Regions with no data are displayed in black. b; Histogram of Δh within the 2013 glacier outline (Fig. 4) with 0.2 m bin width. The dark blue shade marks the interquartile range (IQR; h-values refer to quartiles and median).

locally retreated ~1 km since 1995, decreasing the horizontal distance between the inlet at Desolation Lake and the outlet towards Lituya Bay to ~4 km in 2023 (**Fig. 3a**). Between 2013 and 2019, outwash and rockfall has accumulated at the base of the slope where the glacier front retreated with up to 80 m thickness (**Fig. 4a**).

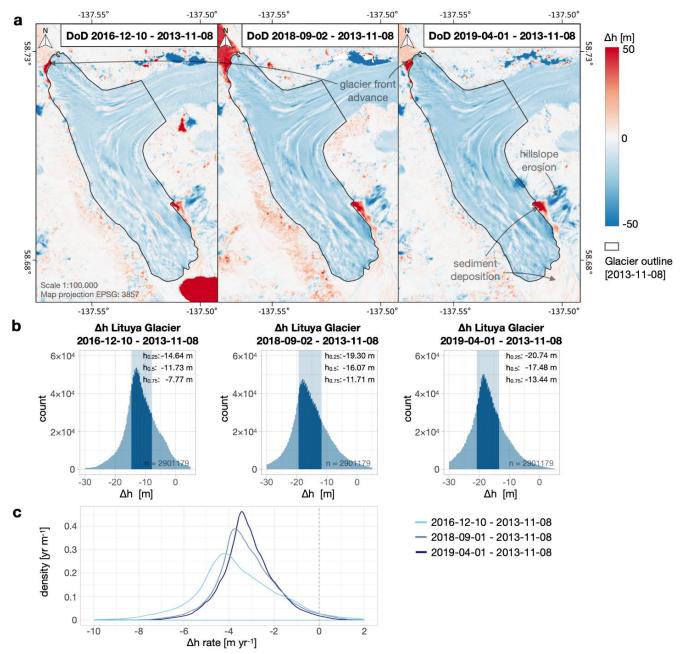
Fig. 4: Elevation time series of Lituya Glacier between 2013 and 2019. a; Elevation differences of ArcticDEMs (Porter et al., 2022) between 2016-12-10, 2018-09-02, and 2019-04-01, referenced to 2013-11-08. The 2013-11-08 glacier outline for estimating the elevation change (Δh) across the glacier is outlined in black. The high positive values on the proglacial delta in the left panel are an artefact from cloud cover in the 2016 DEM. **b**; Pixel-wise elevation changes within the 2013-11-08 glacier outline using histograms with a bin width of 0.2 m. Highlighted areas in dark blue mark the interquartile range; h-values refer to quartiles and median. **c**; Density plots of the mean annual elevation change rate across Lituya Glacier derived from the difference to the 2013 DEM.

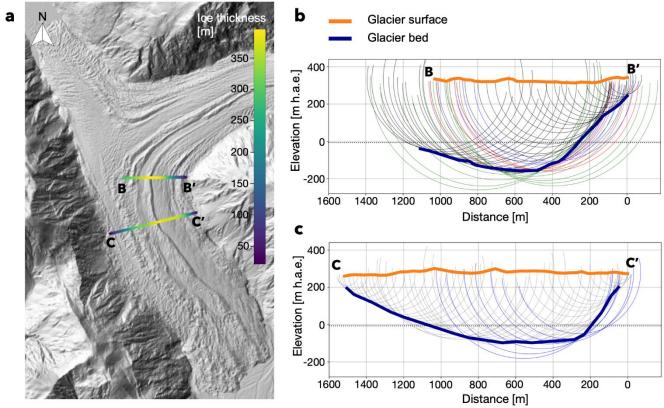
Fig. 5: Glacier geometry of Lituya Glacier along two profiles derived from an ice-penetrating radar (IPR) survey in June 2023. a; Location of the IPR profiles plotted on the 2019 ArcticDEM (Porter et al., 2022). The colour along the profiles show the ice thickness. b,c; Elevation of the glacier surface (orange) and estimated glacier bed (blue) along the profiles. The dotted line shows mean sea level (EGM96 geoid). The light curves are the return ellipses, black colours indicate first return (section 3.4).

In June 2023, we measured ice thickness and determined bedrock elevation along two transverse profiles on lower Lituya Glacier (**Fig. 5b,c**), using an impulse radar system (Kentech) with ~2.5 MHz antennas and a custom built receiver. The rough debris-covered surface and frequent crevasses made a continuous profile impossible. Instead we conducted a series of point surveys, spaced at approximately 30 m, by leap-frogging transmitter and receiver antennas. The antennas were oriented

Our IPR survey in June 2023 revealed striking differences in ice thickness and subglacial topography along Lituya Glacier (**Fig. 5a**). Ice in the higher northern profile has an estimated maximum thickness of 492 ± 20 m (**Fig. 5b**). Along the northern and southern profiles, the glacier has a mean elevation of 325 m and 280 m, respectively. We infer that more than a third of the cross-sectional area of the glacier is below sea level, with a maximum depth of 158 m below ellipsoid (h.b.e.). The lower southern profile is characterised by a shallower glacier bed with a maximum depth of 97 m h.b.e. (**Fig. 5c**). Both profiles

are asymmetric, with a more gentle west and a steeper east wall (**Fig. 5b,c**). Thus, the area with the greatest ice thickness and the lowest elevation of the glacier bed is located closer to the eastern valley wall, close to where the glacier enters Desolation Valley and separates into two branches with numerous longitudinal ice ridges covered by debris (**Figs. 5a, 6d**).

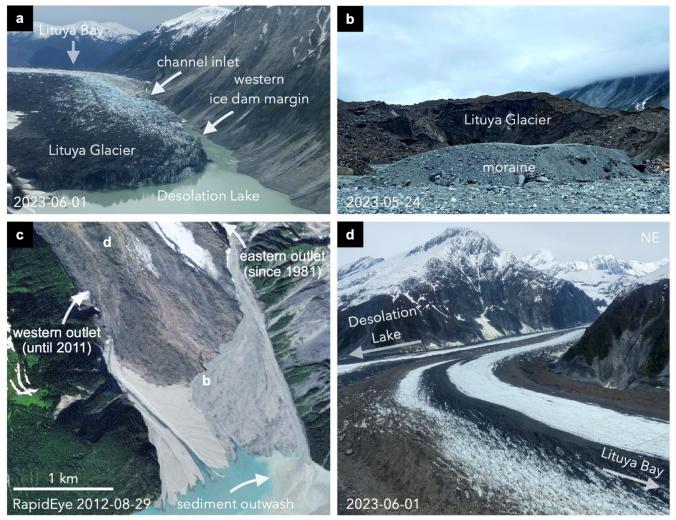
Fig. 6: Geomorphic evidence of repeated outbursts of Desolation Lake and glacier surface properties of Lituya Glacier. a; View to the south of the Lituya Glacier ice dam showing the retreat of the glacier along the west side of the dam. b; Field photo of a moraine likely built from outburst flood deposits in front of the Lituya Glacier terminus. c; RapidEye image of the proglacial delta on 29 August 2012, i.e. 10 years prior to the situation in Fig 1a, showing the colour contrast between flood deposits. Photo locations of b and d are marked in c. d; Photo of the glacier surface close to the ice divide of Lituya Glacier.

The floodwaters likely enter a channelized subglacial drainage system after flood initiation. From the quantity of outwash deposited during floods (Fig. 6c), we infer that the drainage channel must follow the glacier bed, so that the floods can entrain sediment. The reasons for the observed shift in drainage paths remains unknown. An explanation might be the geometry of Lituya Glacier, conditioned by the ice divide and frequent glacier front advances as an indicator for phases with strong ice flow, resulting in the permanent blockage of the western outlet. Dam flotation and subsequent channel enlargement have been inferred for other ice-dammed lakes, including Gornersee, Switzerland (Huss et al., 2007), Hazard Lake, YT, Canada (Clarke, 1982), Hidden Creek Lake, Kennicott Glacier, Alaska (Anderson et al., 2003), and the ice-marginal lake at Russell Glacier, Greenland (Carrivick et al., 2017). Yet, the critical lake level required for dam flotation likely competes with other factors that might explain the annual variability in the lake-level data of Desolation Lake. We observe an intermediate increase in pre-flood lake levels for three outbursts of Desolation Lake between 2009 and 2014 (Fig. 2c). This period coincides with extensive melt of Fairweather Glacier, suggesting that the pre-flood level might have been affected by a period of high meltwater inflow or experienced sudden rise due to water displacement by freshly calved ice. We further observe some drainages at very low pre-flood lake levels, for example in 1999, 2005 and 2006, that deviate from the overall trend between 1985 and 2022, likely initiated by tunnel enlargement alone (Fig. 2c). The drainage mechanism of an ice-dammed lake may change on annual basis as, for example, described for outbursts of Gornersee in Switzerland (Huss et al., 2007). Opening and enlargement of a tunnel may occur before the flotation threshold is reached, for example by melting due to the thermal energy of the lake water and frictional heat of the flow (Liestøl, 1956; Mathews, 1965; Nye, 1976; Clague and O'Connor, 2021). Furthermore, incomplete sealing of the subglacial drainage tunnel due to thermal or mechanical weakening of the ice dam can

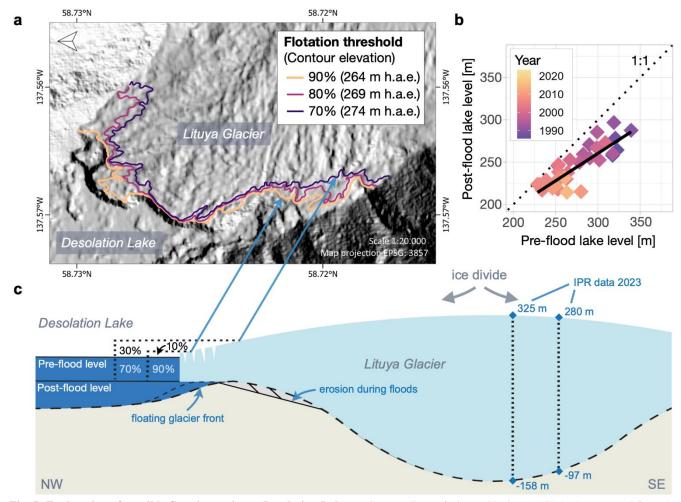
Fig. 7: Exploration of possible flotation ratios at Desolation Lake. a; Contour lines of Lituya Glacier on hillshade generated from the 2013-08-11 ArcticDEM (Porter et al., 2022). The contours show the reconstructed glacier elevation above the seal for the outburst of Desolation Lake between October and November 2013 based on different flotation thresholds (60-95%) (section 5.2). b; Post-versus preflood levels of Desolation Lake with fitted linear regression (black line) of data colour-coded to timing of the outbursts. The dotted line shows a 1:1 ratio. c; Schematic cross-section of Lituya Glacier along Desolation Valley with simplified subglacial topography below the ice dam. The marked elevations towards the ice divide are derived from the IPR survey in May 2023. The dotted lines at the ice dam schematically show the reconstruction of the glacier surface above the seal with different thresholds displayed in a.

Our time series of lake levels shows that the lake partially empties to 85-95% of its initial elevation on average (**Fig. 7b**). In contrast, other lakes that are hypothesized to drain by ice-dam flotation drain completely, for example Hidden Creek Lake (Anderson et al., 2003) and Summit Lake, British Columbia (Mathews, 1965). Considering that Desolation Lake always drained only partially, we suspect that a moraine or bedrock sill is located at a level above the lake bed to prevent the lake from completely emptying (**Fig. 7c**). Subglacial erosion could have left a bedrock high or, alternatively, provided material for a terminal moraine that is now buried beneath Lituya Glacier after its advance during the Little Ice Age. Based on these assumptions, we expect that the lake drains down to the elevation of the sill, or beyond. To allow for the observed negative trend in the post-flood lake levels, the sill would have to erode over time. Considering that the post-flood lake levels declined by at least 100 m, remobilisation of unconsolidated material of a purported moraine may be more likely rather than bedrock erosion.
