# The 2024 cascading glacial lake outburst flood in the Thame Valley of Everest region, Nepal: process, impacts and implications

**Abstract.** On the afternoon of 16 August 2024, a catastrophic flood devastated Thame Village in the Everest region of Nepal. This event resulted from a cascading glacial lake outburst flood (GLOF), where the outburst of an upstream glacial lake triggered the failure of a downstream lake in the headwaters: ~~—a complex hazard chain often overlooked in conventional risk assessments. By integrating multi-source satellite imagery, field data, climatic data, empirical estimations, and numerical modelling, we analyse the triggers, processes, and consequences of the cascading failure. We find that the upper lake, which formed in the late 2000s, expanded rapidly to 0.11 km<sup>2</sup> prior to its outburst, while the lower lake grew by 20% between 1989 and 2024. Our analysis suggests that the moraine-covered bedrock dam of the upper lake was overtopped in response to either (1) The hydrological tipping point for the upper lake was driven by intense glacier melt and calving from associated with extreme temperatures and precipitation. Its overtopping triggered

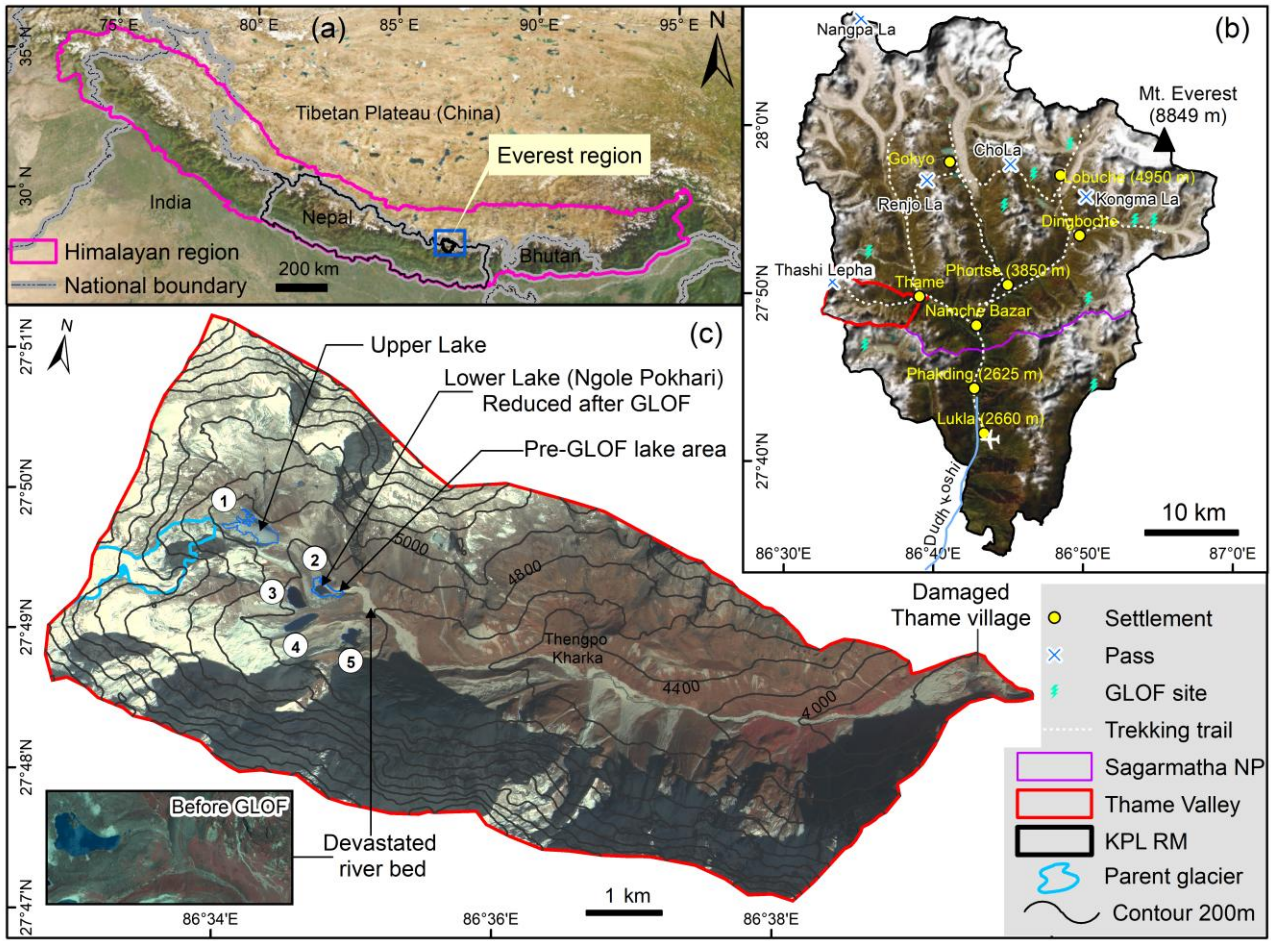
**Figure 1: Study area showing the location of GLOF site. Study area in the border regional level (a) and at Khumbu Pasang Lhamu Rural Municipality (KPL RM) of Nepal (b) with enlarged Thame Valley showing the topography after the GLOF event (c). The base images (a and b) are produced by ESRI (Sources: Esri, TomTom, FAO, USGS | Powered by Esri) and a Gaofen image of August 18, 2024 (c). The figure was created by authors using ArcGIS® software by Esri.**

The present GLOF site is located in the Thame Valley of Dudh\_Koshi basin of eastern Nepal Himalaya, often also referred as Everest region or Khumbu Himal (Figure 1Fig-4) (Byers, 2017). Nepal Himalaya hosts a dense distribution of glaciers and glacial lakes in the northern part of the country (Khadka et al., 2023). In response to climatic warming, glaciers in Nepal have shrunk by 14% between 1970 and 2010 (Khadka et al., 2023) whereas the surface area of glacial lakes have undergone 25% expansion between 1987 and 2017 (Khadka et al., 2018). The climate of this region is affected by the South Asian monsoon in summer and by westerlies in winter (Salerno et al., 2015). Most glaciers in the Everest region are valley type with expansive debris covered in the ablation zone (Thakuri et al., 2014). Nine large glaciers in the region exhibited a negative mass balance of  $-0.52 \pm 0.22$  m water equivalent (w.e.) a<sup>-1</sup> during 2000–2015

(King et al., 2017). Among different regions of Nepal, the expansion rate of glacial lakes is reported to be the highest (1.37 km<sup>2</sup> per decade) in the Everest region (Khadka et al., 2018). ~~Everest-This~~ region has also witnessed at least nine GLOF events (~~Figure 1~~Fig. 1b), among which the 1985 Dig Tsho GLOF (Vuichard and Zimmermann, 1987) and the 1998 Tam Pokhari GLOF (Lamsal et al., 2016) caused notable downstream socio-economic impacts.

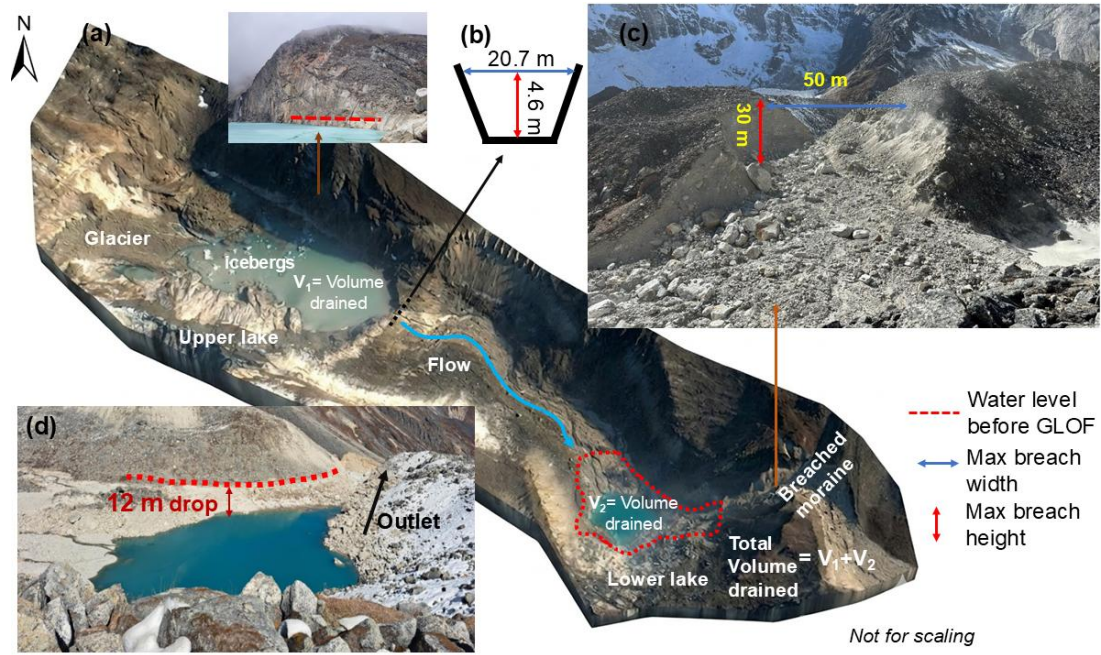
**Figure 2: Images showing the breach mechanism and associated breach parameters following the cascading GLOF. (a) The outburst of upper lake cascades into lower lake, resulting its outburst, which is characterized by a reduced water level and a breached terminal moraine. (b) Breach parameters of the upper lake and (c) lower lake and (d) observed decrease in water level of the lower lake. The image in (a) is from Gaofen-7 satellite while those in (c) and (d) are obtained from field.**

The subsequent outburst flood from the upper glacial lake triggered the GLOF from lower glacial lake. The floodwaters from the upper lake descended approximately ~~172-182~~ m and travelled about 700 m before plunging into the lower lake (Fig. S1). The steepest section is immediately adjacent to the upper lake, where the bedrock step drops 100 m vertically over a 120 m horizontal distance. The rapid influx of water and sediment substantially increased the volume of lower lake and generated surge waves in lake surface water that ultimately led to the failure of the moraine dam. Our estimate indicates that approximately ~~3.5 ( $\pm 0.57$ )~~3.6  $\times 10^5$  m<sup>3</sup> of water drained from the lower glacial lake. Subsequently, the lake level has lowered by approximately 12 m and dam has incised by approximately 50 m (Figure 2Fig-2).

397 The extent and depth of bed scour observed along the channel between the upper and lower lakes (Figure 2) provide  
398 additional evidence that Scenario A is more plausible than Scenario B. Field observations reveal that a sand plain located  
399 immediately downstream of Thengpo Kharka, approximately 500 m long and 150 m wide, temporarily stored ponded  
400 water during the event (Fig. S8). Water released during GLOF event was briefly impounded within this sand plain, which  
401 likely attenuated the flood wave and delayed its downstream propagation. This phenomenon is accurately captured by the  
402 GLOF modelling, where water is shown to have been impounded just downstream of Thengpo Kharka (Figure 7Fig-7).  
403 This temporary storage provided critical lead time for residents of Thame Village to evacuate safely. Subsequently, the  
404 impounded water overtopped and eroded the banks and bed of the ~2 km long channel between the ancient landslide dam

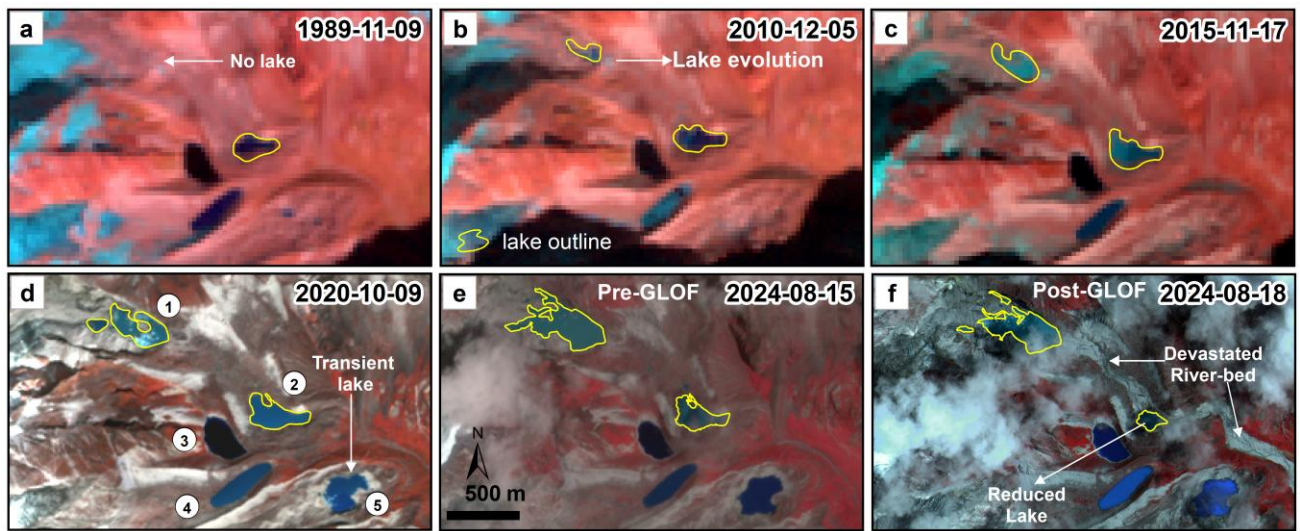
Figure 3: The evolution of glacial lakes located in the headwaters of Thame Valley in the Everest region. The background images are from Landsat (a, b and c), PlanetScope (d and e) and Gaofen (f) satellites. The figure was created by authors using ArcGIS® software by Esri.

The evolution of the glacial lake cluster located in the headwaters of Thame Valley is shown in Fig. 3. The upper Ngole lake (Lake 1) started to form in the beginning of the 21<sup>st</sup> century with progression of its parent glacier shrinkage (Fig. 4a) and reached a considerable size of  $0.018 \pm 0.009$  km<sup>2</sup> in 2010 (Figs. 3b and 4b). With rapid expansion in recent years (Fig. S4), it reached an area of  $0.11 \pm 0.004$  km<sup>2</sup> before its outburst. After its outburst, the area slightly reduced by 0.013 km<sup>2</sup>.

The lower Ngole lake (Lake 2) started to evolve before the 1980s, ~~and it had with~~ an area of  $0.04 \pm 0.01$  km<sup>2</sup> in 1989. It grew by 20% in the last 35 years (Fig. 4b). The area reduced from  $0.048 \pm 0.01$  km<sup>2</sup> to 0.015 km<sup>2</sup> after its outburst in August 16, 2024. The other lakes (lakes 3 and 4) on the southern sides were present from 1989 and a slight fluctuation of  $\pm 0.01$  km<sup>2</sup> is observed between the years (Table S3). ~~The~~ Lake 5 is transient in nature and is mostly observed in monsoon season when snow-glacier melt and rainfall are common (Fig. S4). The areas of lakes 3, 4 and 5 are 0.042, 0.042 and 0.01 km<sup>2</sup>, respectively as derived from a Gaofen-7 image of 2024-08-18.

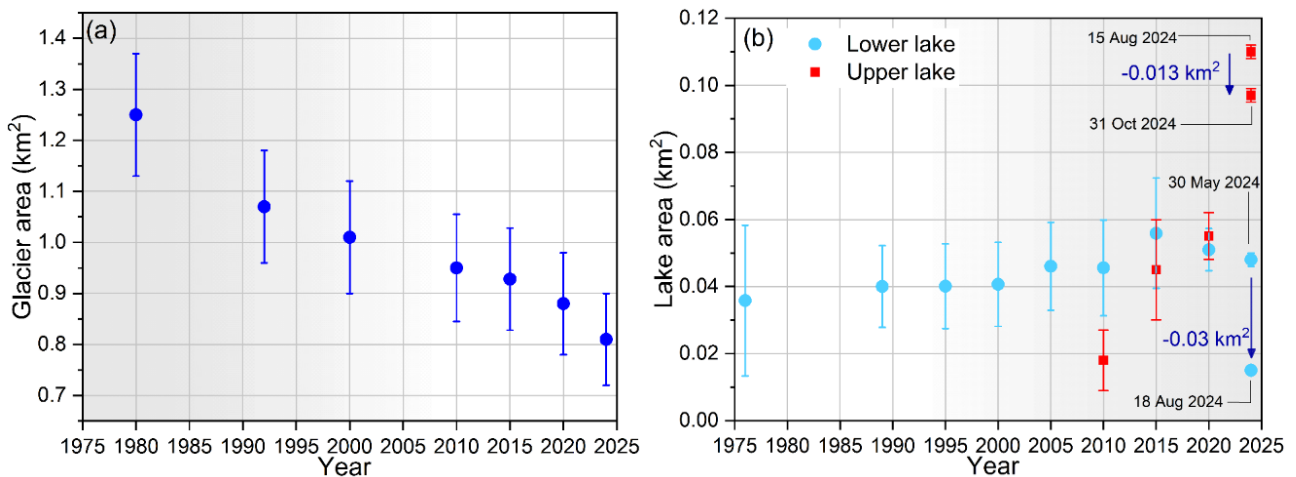
Figure 4: Changes in the area of the parent glacier (a) and the upper and lower Ngole glacial lakes (b) from 1976 to 2024.

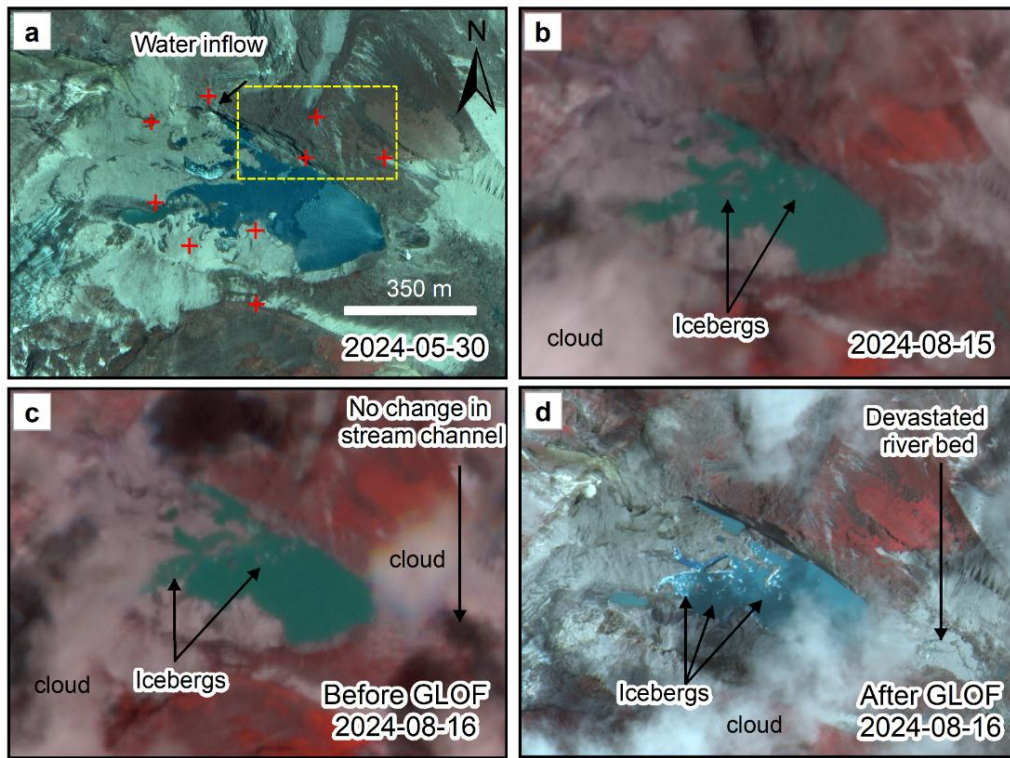
**Figure 5: Monitoring changes in upper lake and surroundings before and after the GLOF.** The red plus points indicate control points used for monitoring the changes in land surface. The yellow dashed box shows a zone of rockfall with no visible change. The image (c) is sensed on the same day just prior to the GLOF, reveals no sign of mass movement into the lake but formation of icebergs due to calving. Further, there does not appear to be any noticeable increase in the upper lake's turbidity in the post-GLOF image, e.g. caused by a rockfall. Background images (a) and (d) are sourced from Gaofen-2/7, whereas (b) and (d) are from PlanetScope. The figure was created by authors using ArcGIS® software by Esri.

High-resolution remote sensing images (Figure 5) and geomorphological/geological interpretation provides no clear definitive evidence of a contemporary rockfall or rockslides (Figure 11a) impacting the lake. The rock deposits observed along the eastern moraine margins are characterized by a dark, weathered appearance, inconsistent with the fresh, sandy or whitish talus typically associated with recent rock avalanches (Figure 11). Historical imagery and local accounts confirm these deposits were likely pre-existing (Fig. S5). All historical images (Fig. S5) depict a cluster of boulders that has been present since 2014. It appears that this section of the rockfall is partially situated on debris-covered ice that is melting, rather than directly on the lake bed. Furthermore, fresh small patches of scars observed in the north-eastern zone are an unlikely source for the GLOF (Figure 11b). The corresponding rockfall volume appears too small to generate a displacement wave capable of significantly impacting the main lake. Even if a wave were generated, the narrow strait would dampen its energy before it could propagate into the main lake. Additionally, the extreme verticality of the terrain limits the reliability of DEM differencing for detecting recent slope failures. Even if a rockfall had occurred as described by Maharjan et al. (2025), its direct impact on the lake is considered unlikely as a substantial already present debris apron (~20–30 m wide) buffers the lake from the lateral moraine slopes, intercepting material and preventing a direct, dynamic hit on the water body.

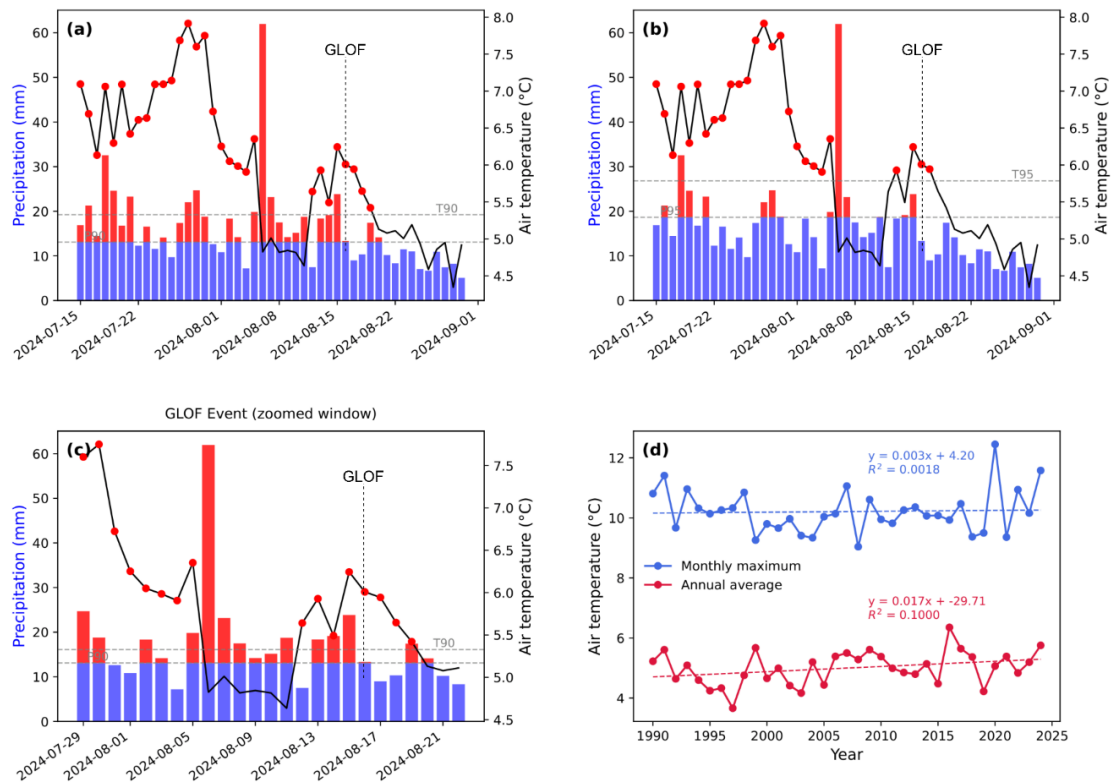
Fig. 6: Meteorological conditions of the lake region. (a) Extreme air temperature and precipitation values (red colour) before the GLOF event exceeding the 90<sup>th</sup> percentile (a) and 95<sup>th</sup> percentile (b) compared to long term (1990–2024) average climatology, a zoomed view (c) for enhanced reading and (d) the trends of annual average temperature and maximum monthly temperature of that year from 1990 to 2024.

In the month leading up to the occurrence of the GLOF, ~~an analysis of the climate data revealed that~~ several days experienced temperatures and precipitation levels that exceeded the 90<sup>th</sup> and 95<sup>th</sup> percentiles ~~thresholds compared derived from~~ long-term (1990–2024) ~~average daily~~ climatology (~~Fig. 6~~Fig. 6). ~~This indicates a period of extreme weather conditions coinciding with a GLOF event.~~ During summer months (JJAS), climatic ~~conditionse~~ ~~are generally gets~~ warmer and wetter ~~than during~~ preceding ~~autumn-spring~~ season (MAM) in Nepal. Specifically, the temperatures on ~~August-12–~~

15 August, immediately prior to the GLOF event on August 16, surpassed both the 90<sup>th</sup> and 95<sup>th</sup> percentile thresholds. Moreover, Likewise, the precipitation on August 14 and 15 also exceeded both 90<sup>th</sup> and 95<sup>th</sup> percentiles (Fig. 6a and b). Similarly, the exceedances preceding month July had experienced extreme in temperatures and precipitation were observed during July, exceeding both 90<sup>th</sup> and 95<sup>th</sup> percentiles. Extreme deviations in temperature and precipitation suggest that climate conditions were markedly warmer and wetter than historical averages for the region. This phenomenon likely contributed to accelerated glacier melt and a corresponding rise in lake volumes due to increased precipitation and enhanced ice loss in the upper lake. Compared with the same 30-day period during 1990–2024, the pre-event period (17 July–15 August 2024) was the warmest on record, with temperature exceeding the both 90<sup>th</sup> and 95<sup>th</sup> percentile thresholds (Fig. S6a).

The average annual temperature and the maximum monthly temperature during the summer seasons in the Ngole lake region have been observed to be increasing at rates of 0.015 °C and 0.003 °C per year, respectively, between 1990 and 2014 (Fig. 6d). On the day preceding the outburst, the ERA5-Land data recorded minimum and maximum temperatures of 3.7 °C and 9.7 °C, respectively with consecutive extreme wet days exceeding 10 days (Fig. 6c). Concurrently, data collected from the Phortse automatic weather station, located 11 km east at an elevation of 3,850 m, reported minimum and maximum temperatures of 7.45 °C and 14.13 °C, respectively, along with a total rainfall of 124 mm over a consecutive 14-days wet period prior to the GLOF event (Fig. S6b). This implies that the data of ERA5-Land, though being reanalysis, captures the general climatic conditions and trends of the region (Chen et al., 2021). These climatic conditions are conducive to increased glacier and snow melt, which might have been contributed glacier melt and calving, and initiation of the GLOF.

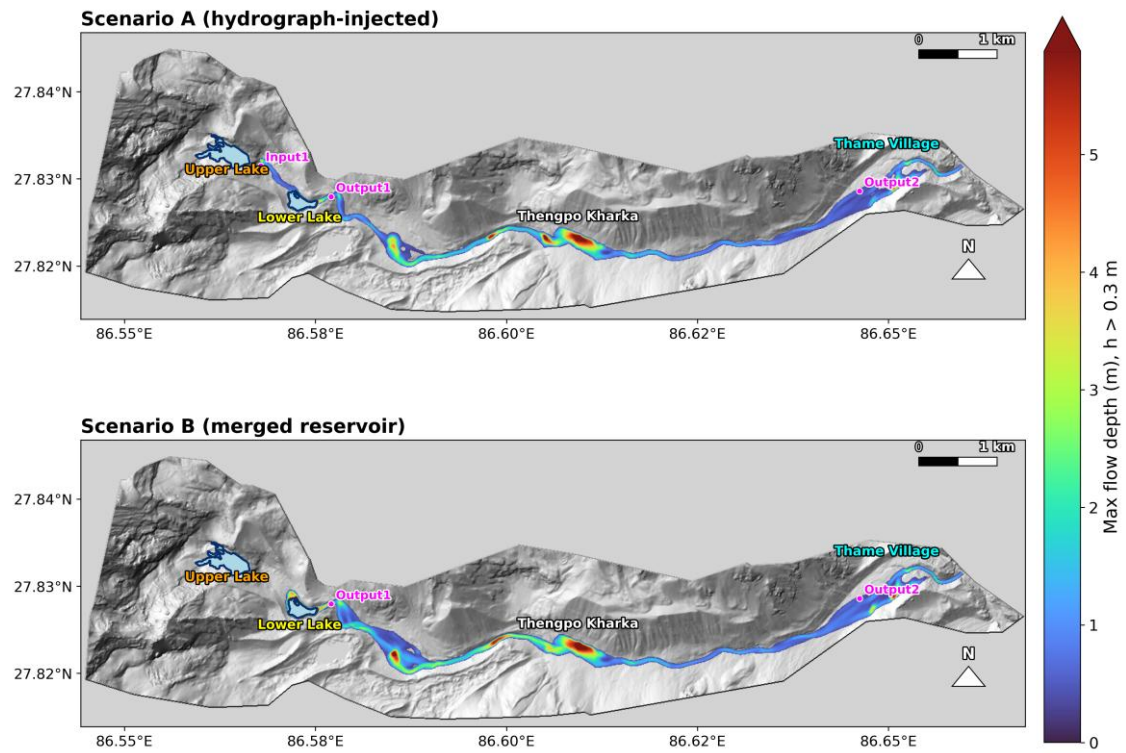
Figure 7: Simulation results of flow height (m) inundation for Scenario A and Scenario B. The figure was created by authors using QGIS and ~~the~~ The background images are hill shade of HMA-DEM, and the base images © Yandex. Note: Only flow heights  $\geq 30$  cm are considered for visualization.

382 initial breach with maximum discharge of 574 m<sup>3</sup>/s, maximum flow heights up to 4 m and velocity of 10 m/s (Figure  
383 7Fig-7, 9 and S7). Although significant channel storage effects and energy dissipation reduced the peak discharge at O2  
384 to approximately 200-548 m<sup>3</sup>/s, the magnitude and duration of the flood remained sufficient with depositions to cause  
385 severe damage, highlighting the long-term hazard posed by cascading GLOF events.

386 In Scenario B, in contrast to the sudden displacement wave in Scenario A, the failure was induced by sustained inflow  
387 from the upstream lake, which progressively increased the storage and water level of the downstream lake until  
388 overtopping and structural collapse occurred. The hydrographs illustrate the dynamic features of this breach mode. The  
389 discharge at O1 (breach output 1) shows a rapid rise to multiple peak flow, a characteristic feature of dam-break floods,  
390 followed by gradual recession (Figure 9Fig-9b). At 180-240 s after the breach, the liquid-phase discharge at O1 reached  
391 a peak of 1,24050 m<sup>3</sup>/s, accompanied by the outflow of solid-phase material originating from the dam body. The  
392 discharge at O2 (Thame Village) exhibits a delayed and attenuated yet still significant flood wave, arriving 1,340880 s  
393 (~1522.3 min) after the breach with maximum flow heights up to 4 m. This scenario highlights a comparatively slower-

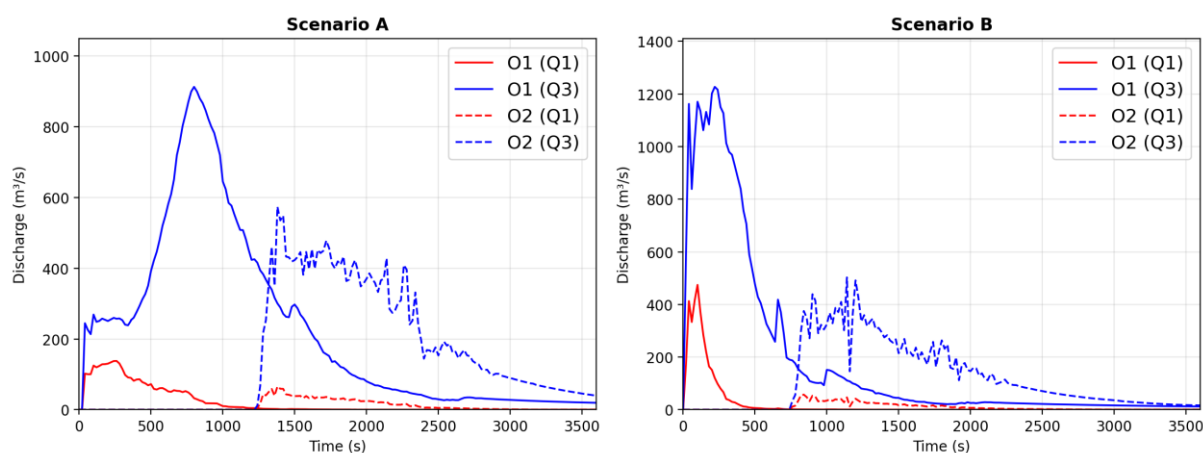
Figure 9: Hydrographs for Scenario A and Scenario B. Here, Q1 is solid phase and Q3 is fluid phase.

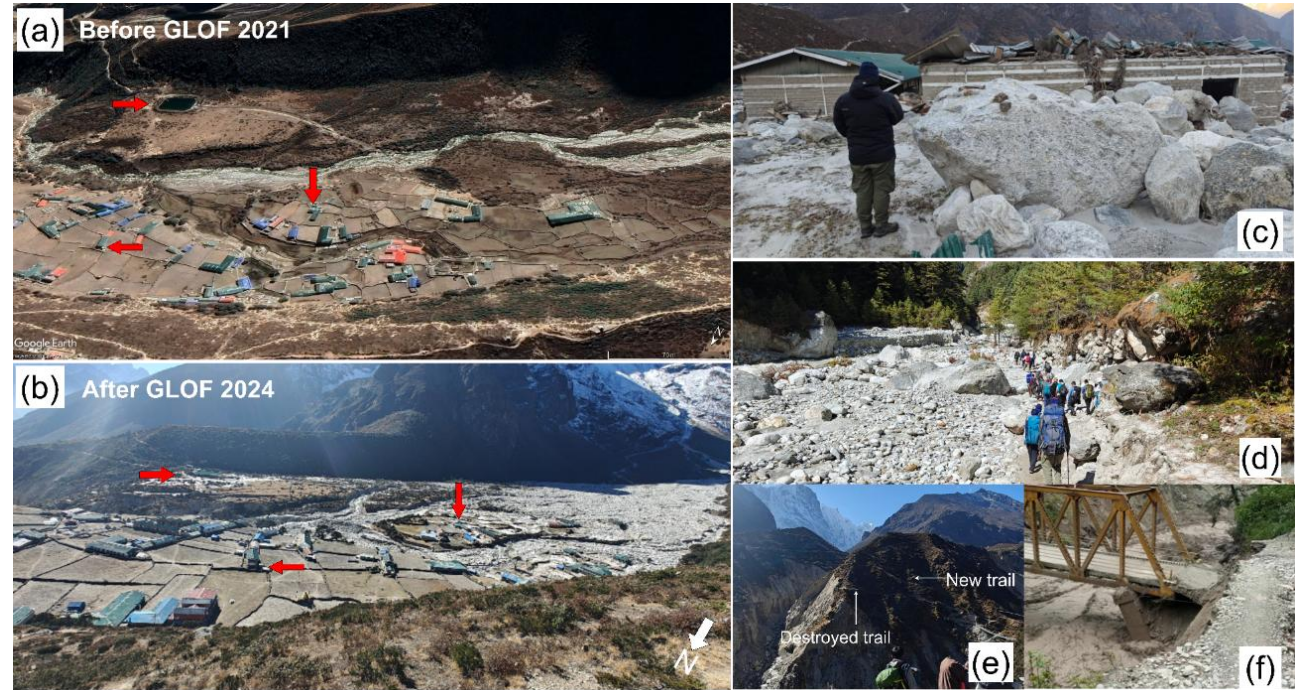
**Figure 10: Impacts of Thame Valley GLOF.** Thame Valley (a) before and (b) after GLOF, (c) the damaged Thame school, walking trails (d and e) and the motorable bridge (f). The red arrows show common feature/buildings on panels (a) and (b). Source: The picture (a) is sourced from © Google Earth 2024; images: © CNES/Airbus, Maxar Technologies, Airbus whereas others from Field Study, 2024.

The GLOF had profound impacts in the downstream areas as it turned into perilous debris flood with Thame Village being the primary deposition zone (Figure 10Figs. 10 and S9). The roaring sound of the flood and information flow from upstream to downstream areas helped the communities to evacuate during the GLOF event, leaving no casualties. The GLOF had a devastating impact on Thame Village, displacing 135 people and leading to the destruction of several tea houses and buildings, including the primary school, as well as considerable damage to agricultural fields (Figure 10Fig. 10). The detailed impact assessment shows that GLOF impacted the settlements, trekking trails, land and infrastructures worth total of 6.18 million USD in KPL RM alone (Table 6). The total length of trekking trail damaged in Thame Village was ~500 m cross-verified through images. The impacts of the GLOF were minimal outside the KPL RM; however, it caused substantial erosion and bank cutting up to 50 kilometres downstream and partially damaged a motorable bridge (Figure 10Fig. 10f).

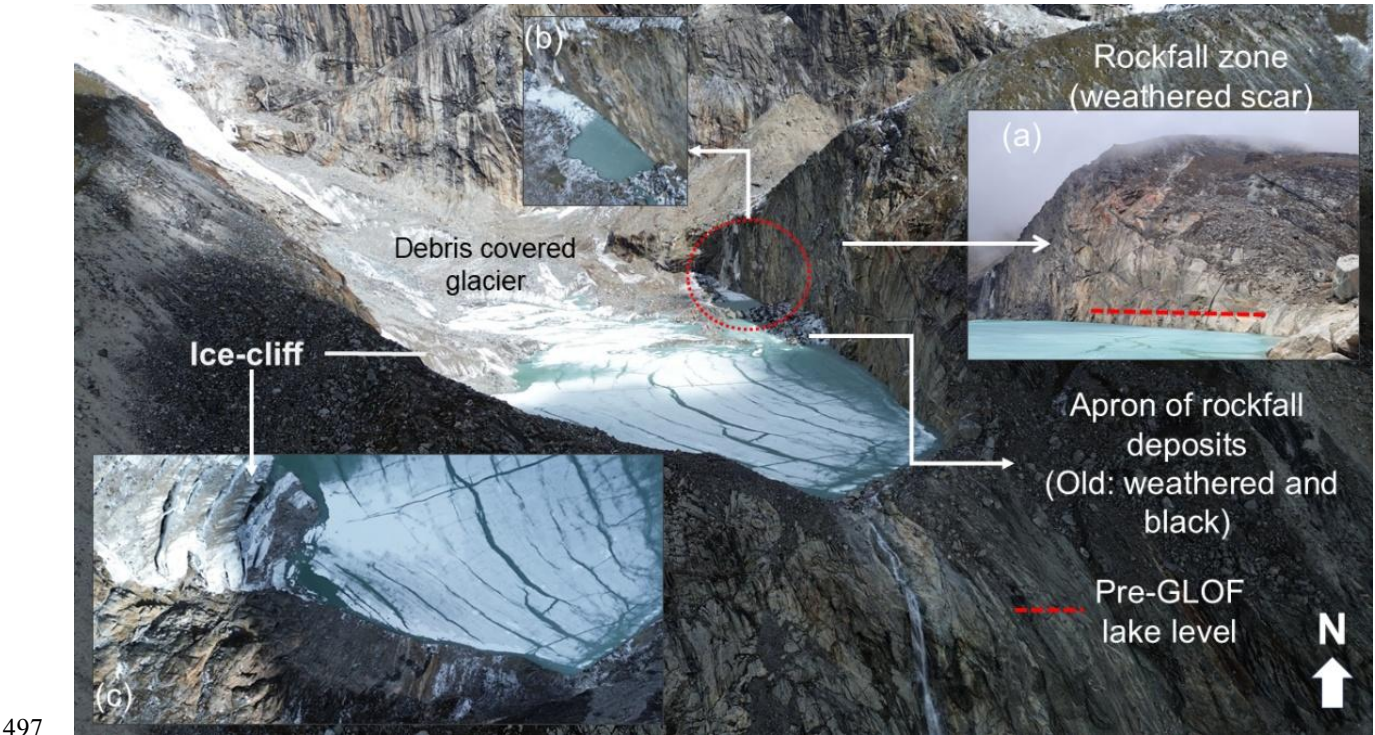
Figure 11: Bird eye view of upper lake with surrounding geology captured on May 2025. Photos: C. S. Watson, 2025
